Geotechnical Aspects of the 2016 M_w 6.2, M_w 6.0, and M_w 7.0 Kumamoto Earthquakes

Geotechnical Extreme Events Reconnaissance Association

Version 1.0

July 2016

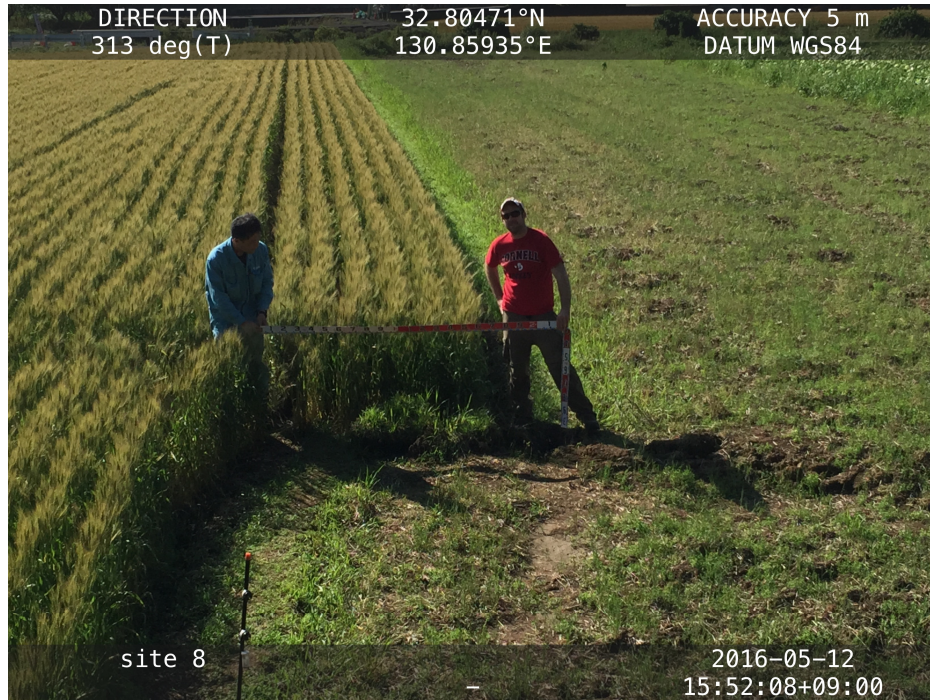
Figure 3-3. Right-lateral fault movement observed by the GEER team.

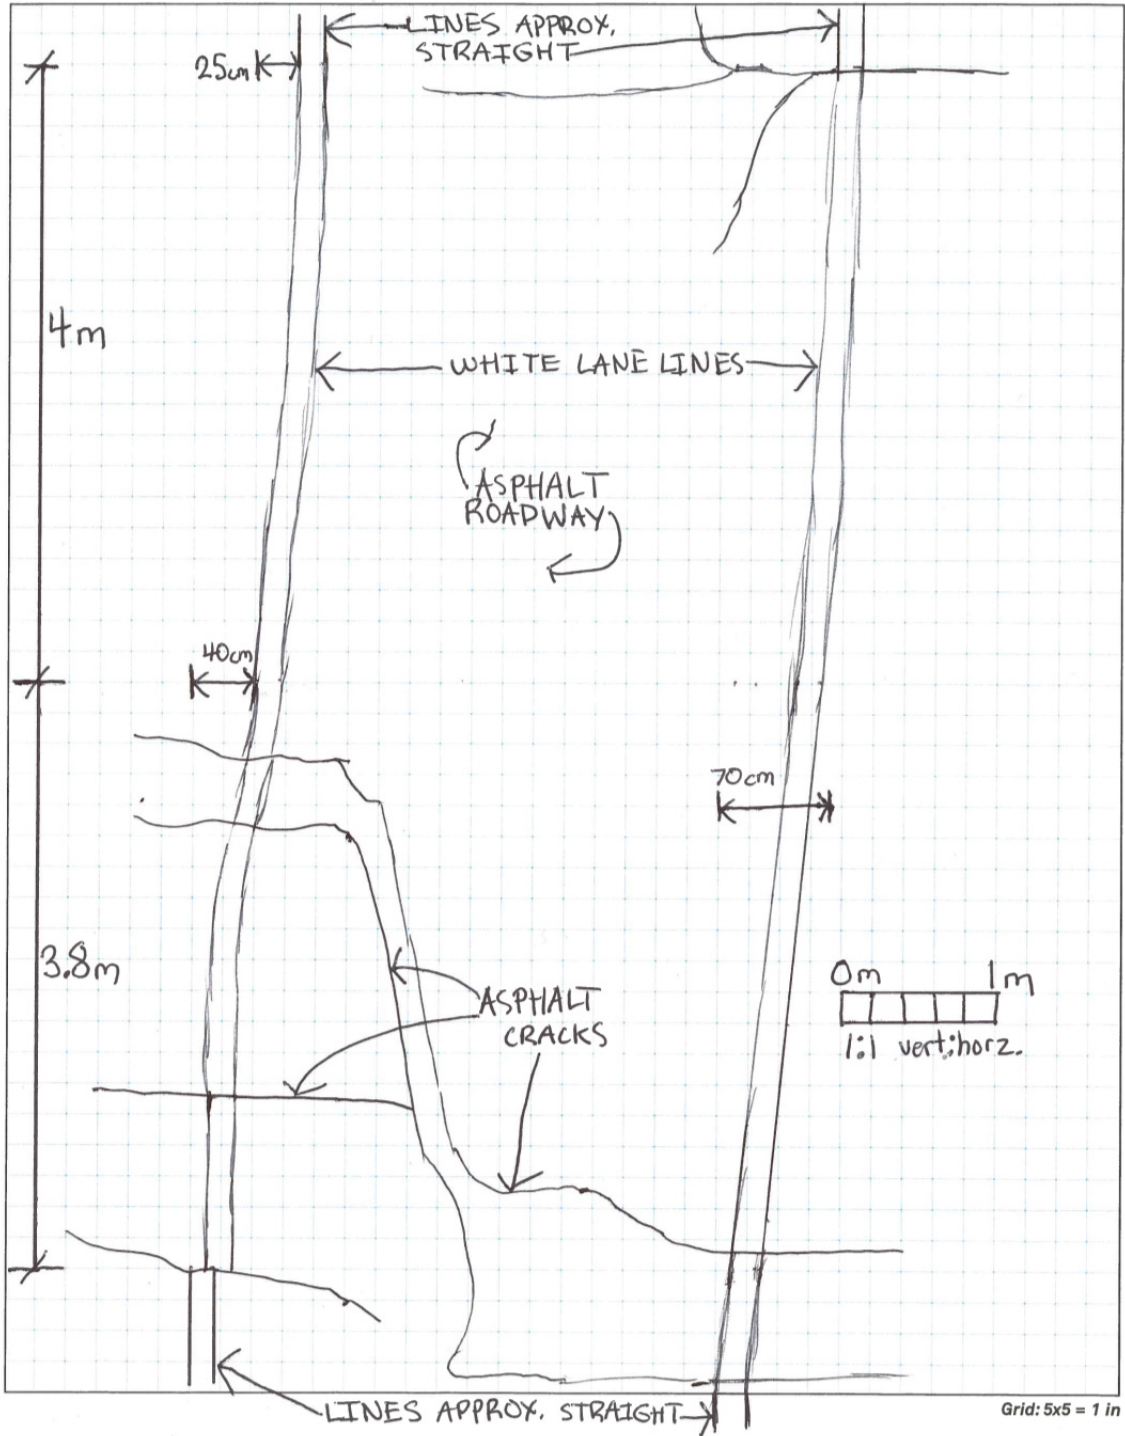
Figure 4-7. Sketch of the estimated deformation distribution and cracking associated with the roughly 0.65 m to 0.70 m of right-lateral offset along the road.

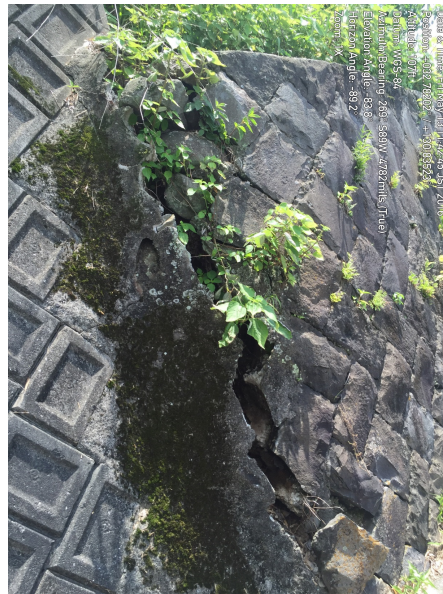
Figure 4-9. Roughly 0.4 m of right-lateral offset along the Futagawa Fault through a concrete block retaining wall.

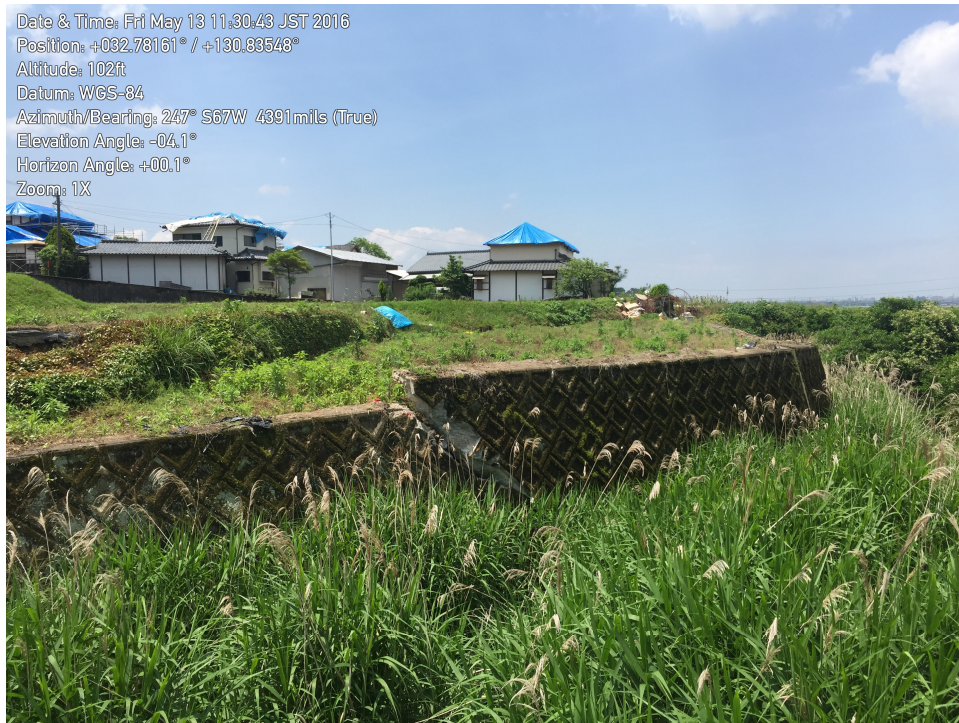
Figure 4-10. Southern strand of Futagawa Fault through fields and unreinforced masonry retaining wall.

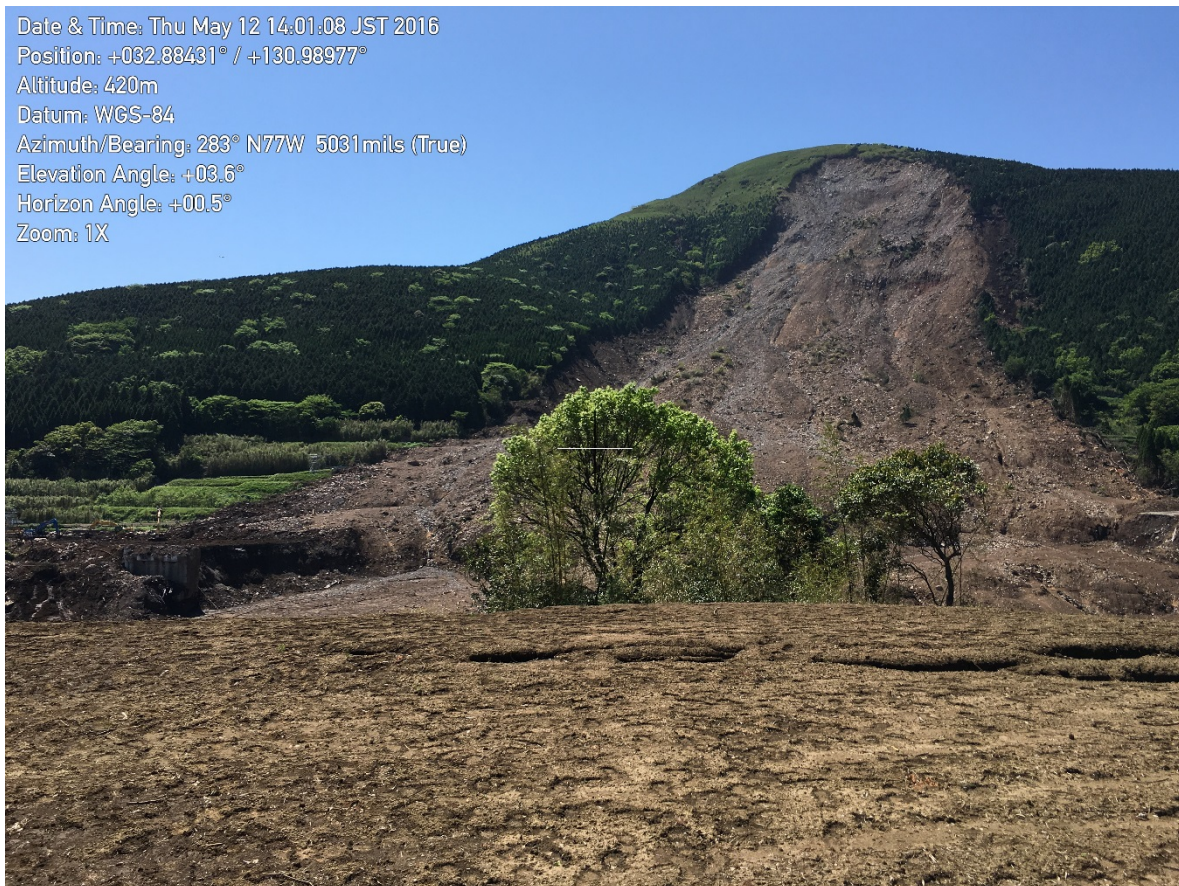
The Great Aso Landslide was likely the largest landslide that occurred in the Kumamoto Earthquakes. The head scarp of the landslide was approximately 350 m higher in elevation than a canyon that ran directly beneath the landslide area. The horizontal distance from the head scarp to the canyon was approximately 700 m. A bridge previously crossed the canyon directly beneath the landslide, but that bridge was destroyed in the earthquake, presumably by this landslide. The remnant of one of the abutments is visible in Figure 5-3. At least one fatality occurred as a result of this landslide (NZSEE, 2016). There was also significant slope failure of the canyon wall slopes throughout this area, independent of the overlying Great Aso Landslide. The Great Aso Landslide source area is mapped as Pyroxene Andesite Lava, lava flow and dike (Pa) in GSJ (2016c).

Figure 5-3. Front view of the Great Aso Landslide that likely destroyed a bridge, the remnant abutment of which is visible on the left side of the photo. The nearby fault displacement may have also contributed to the bridge collapse.

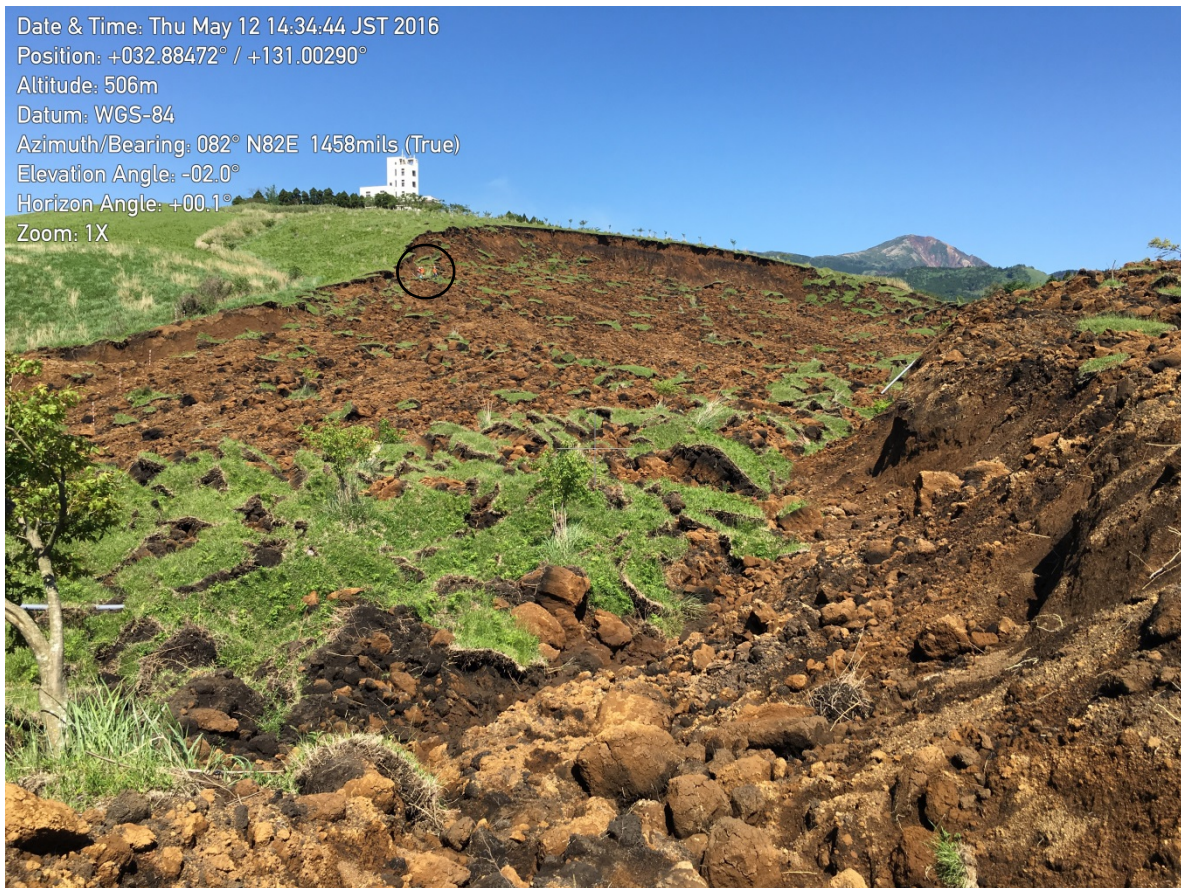
This landslide is shown in Figure 5-4. The landslide runout severely damaged some residential structures (Figure 5-5). Based on Google Earth imagery (Figure 5-6), six structures were destroyed by the landslide. Five people are reported to have died as a result of this landslide (NZSEE, 2016). The residential structures were about 250 m from the head scarp the landslide with a difference in elevation of about 40 m. The landslide flowed in several directions, and the total runout length of the landslide was up to 550 m. The landslide source area is mapped as Volcanological Laboratory Lava, lava flow (V) in GSJ (2016c).

Figure 5-4. The landslide source area, upslope of the residential structures. Note the people in orange on the left side of the slide for scale.

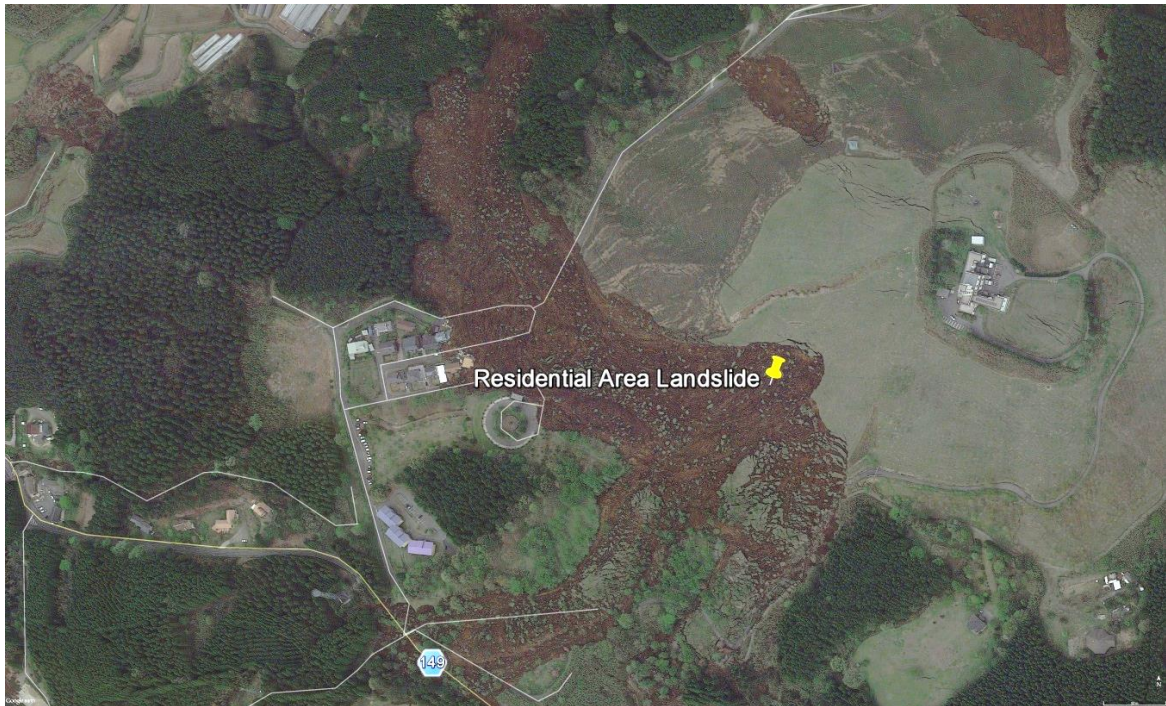
Figure 5-6. Google Earth image of the landslide, with the head scarp at right (at the pin drop) and the residential structures on the left side of the runout.

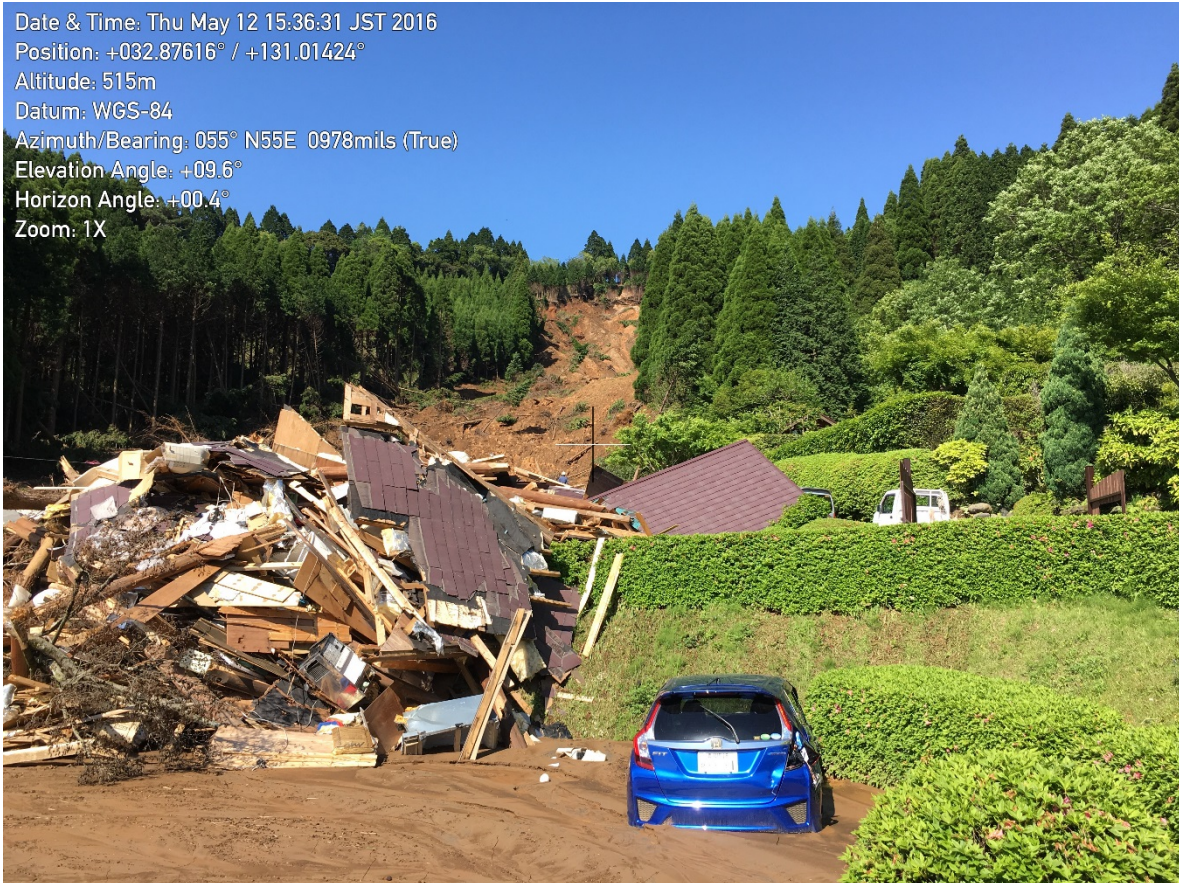
The runout of this landslide destroyed a hot spring resort and killed two people (Figure 5-7 and Figure 5-8). The resort previously comprised of about nine different buildings, six of which were destroyed by the landslide. The resort was near the tail end of the landslide runout, which was about 250 m from the head scarp (Figure 5-9). The landslide source area is mapped as Sawatsuno Lava, lava flow (S) in GSJ (2016c).

Figure 5-7. A landslide at the former site of a hot springs resort.

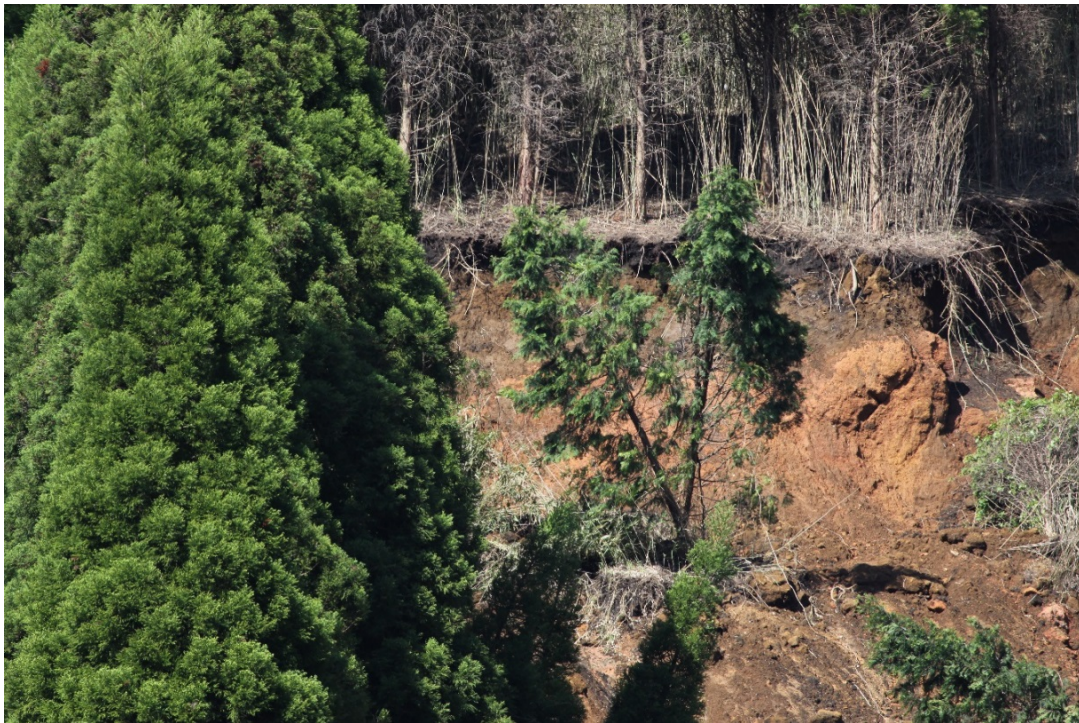
Figure 5-8. A closer view of the landslide's crest

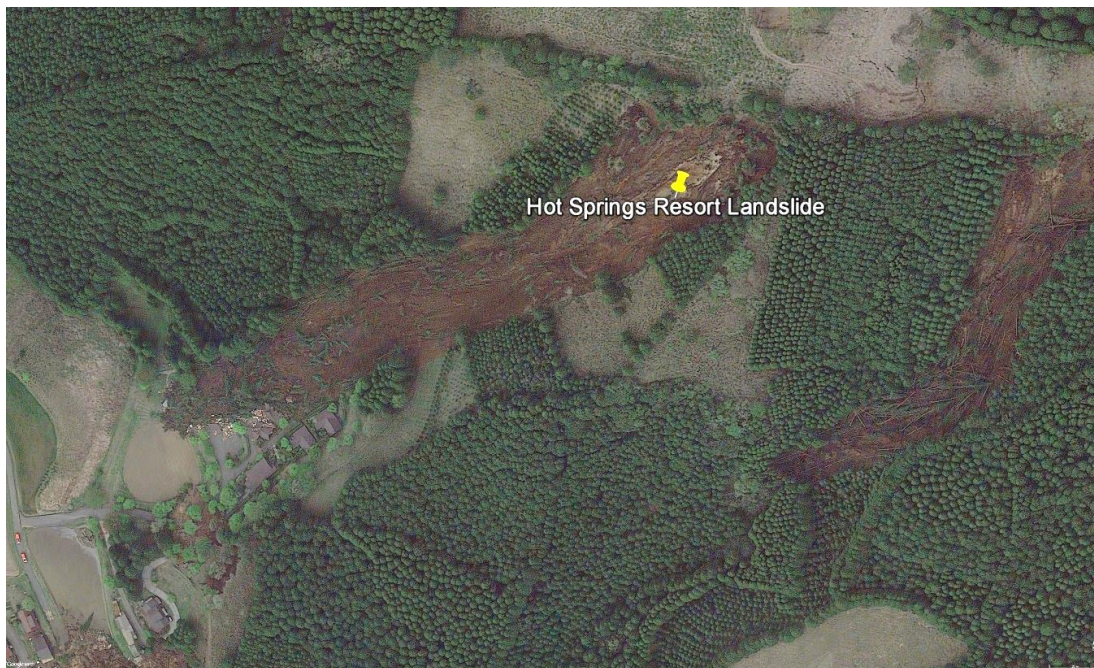
Figure 5-9. Google Earth image of the landslide, the hot spring resort was at the tail end of the landslide runout on the left, with the source area on the right.

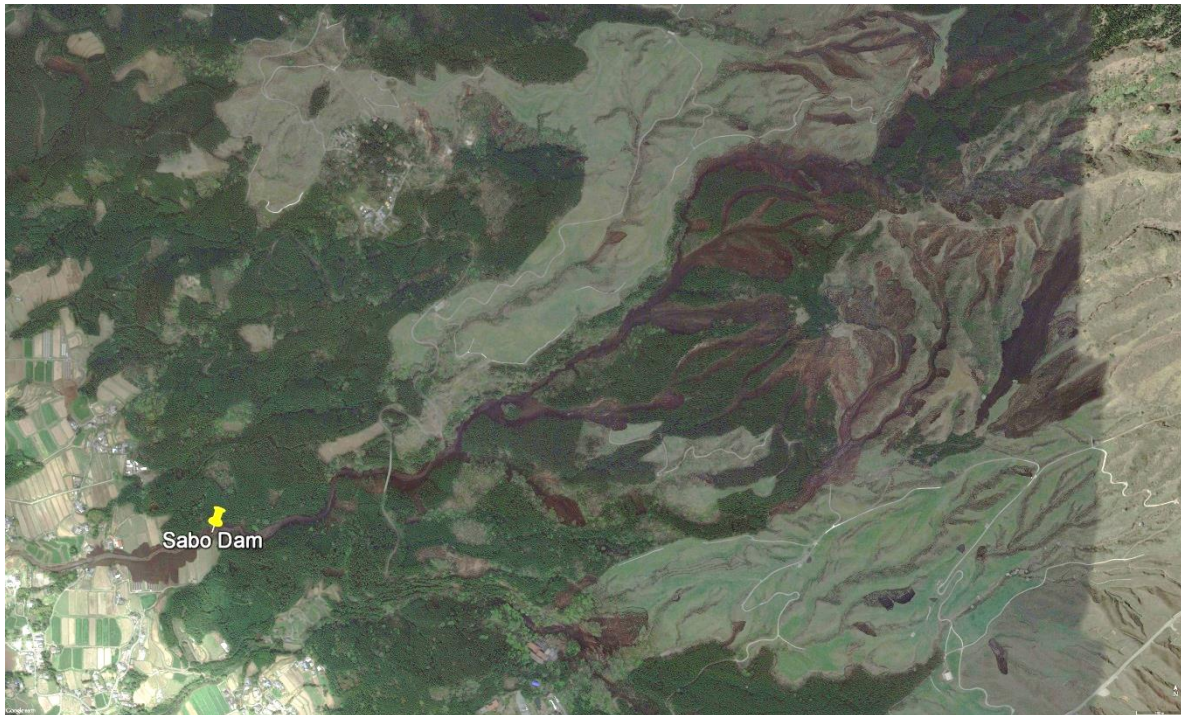
Figure 5-12. Google Earth image of the dam (located at the pin drop), the runout past the dam on the left, and the large ~2.5 km long, ~1 km wide source area to the right.

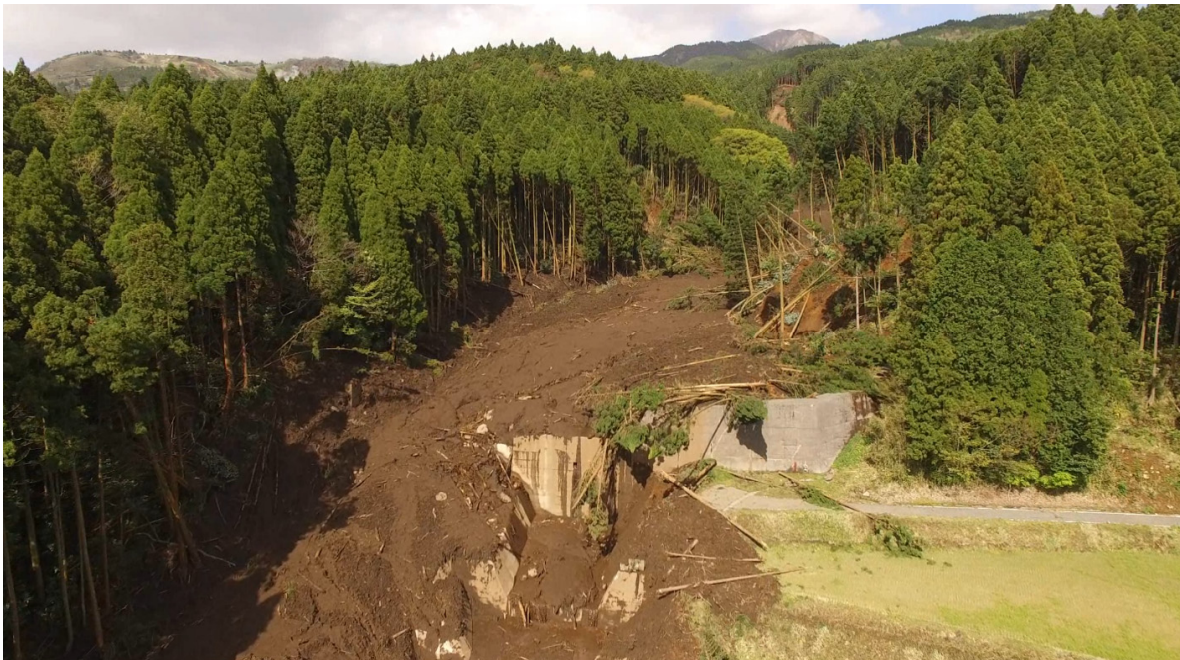
Figure 5-13. Still image from UAV video footage produced by the Geospatial Information Authority of Japan (GSI, 2016), showing the upstream condition of the dam and the sediment flow, soon after the earthquake.

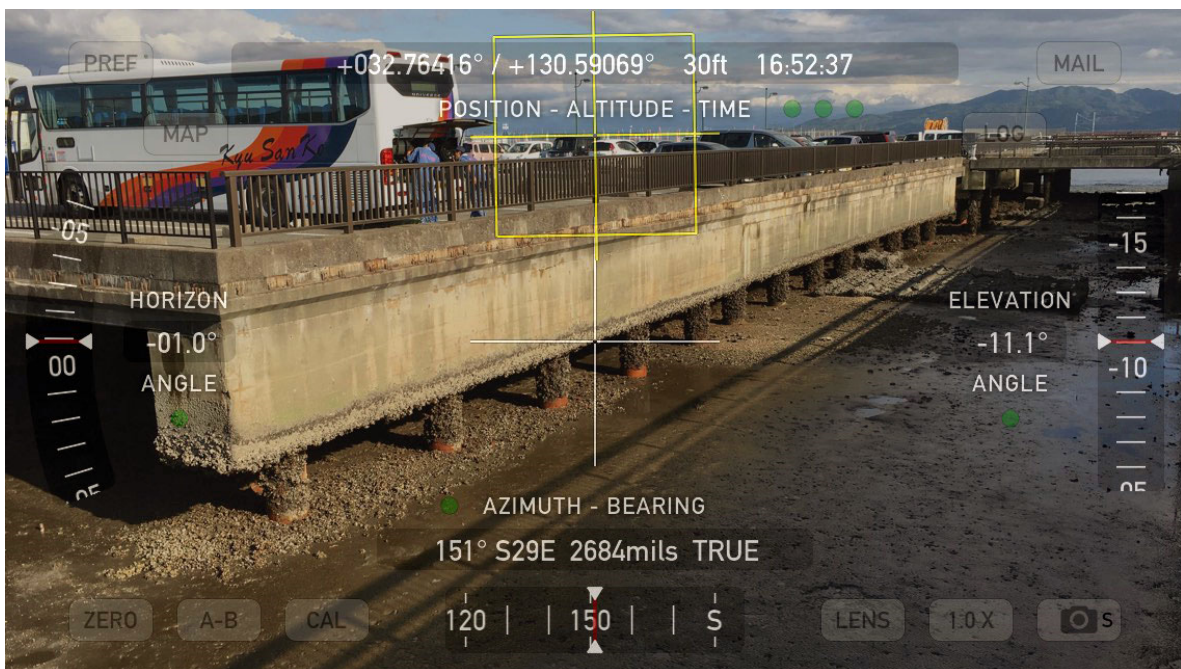
Figure 6-4. Volumetric reconsolidation in native silt apparent from the estimated 25 cm of newly-exposed red steel at the base of the piles supporting the pier.

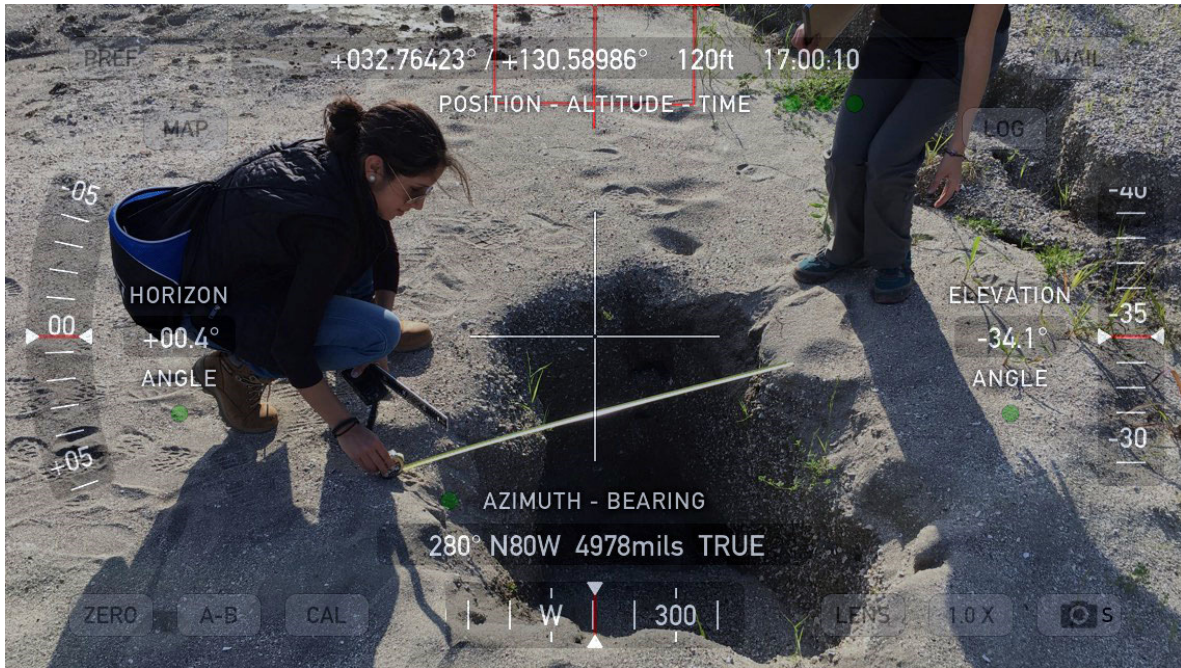
Figure 6-5. Sand blow that is approximately 1 meter in width encountered on the artificial island.

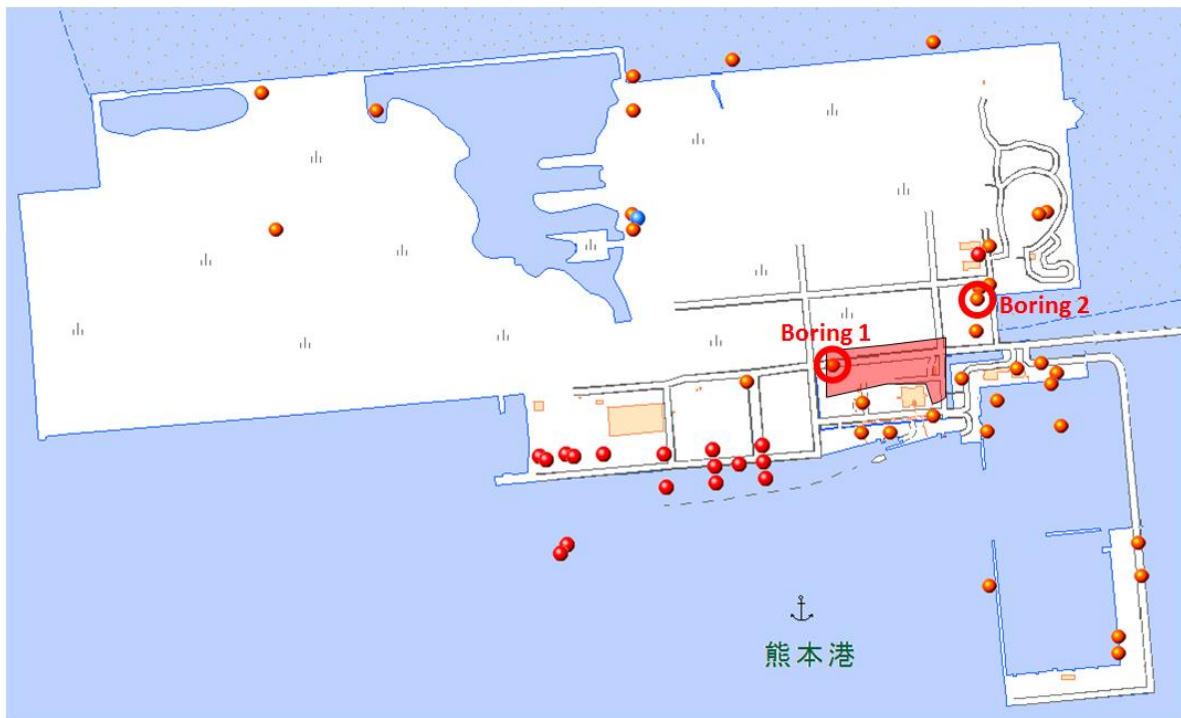
Further investigation of the GIS soil boring database (Geonews 2016) revealed some interesting findings regarding the artificial island. We observed that certain areas on the island appeared quite impacted and damaged from soil liquefaction. However, other areas of the island were not visibly impacted by liquefaction effects. Figure 6-6 presents a vicinity map of the island and the area that we observed to be significantly affected by liquefaction damage. Note that from Figure 6-6 two borings have been highlighted: Boring 1 and Boring 2. Graphics from these two logs are presented in Figure 6-7. We observe from Boring 1 that significantly more sand is present, and could explain why certain areas of the island seemed more impacted by local soil liquefaction than other. The soil logged in

Figure 6-6. Liquefaction and boring vicinity map of the artificial island. The red shaded zone delineates areas where the GEER team observed significant surface evidence of soil liquefaction. Base map from Geonews (2016).

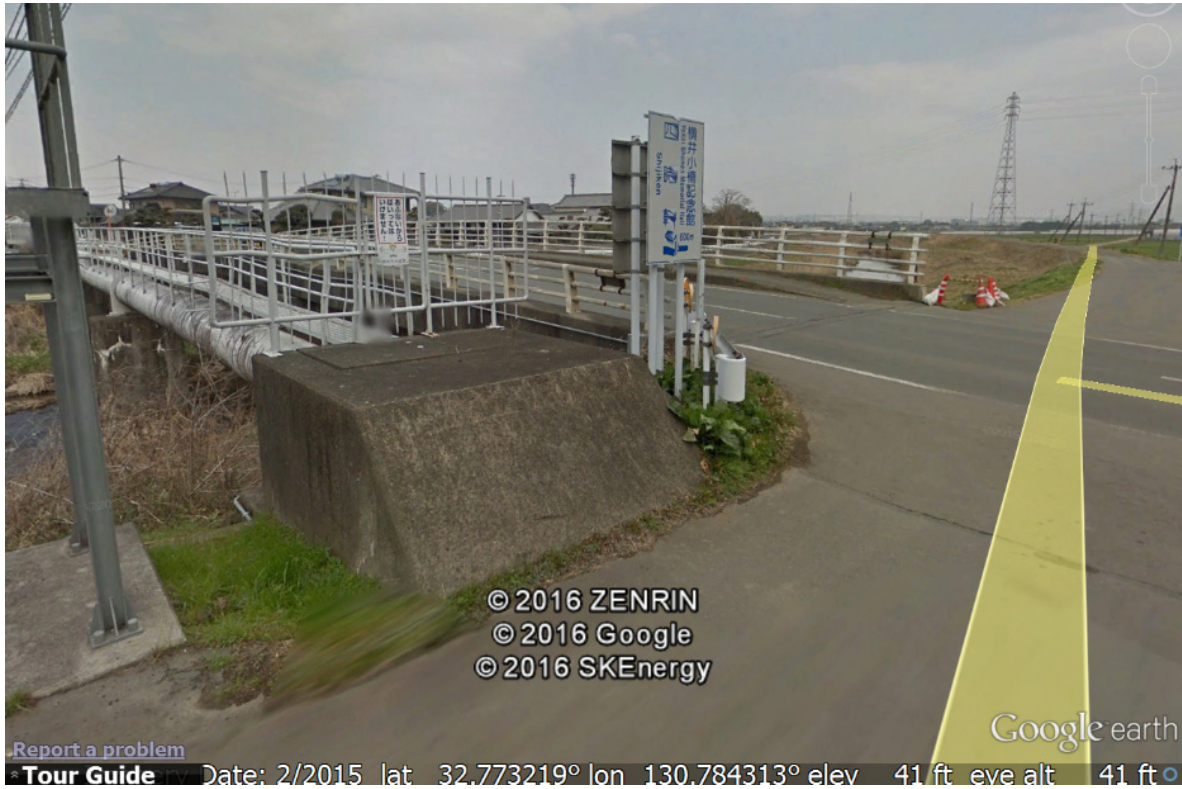
In the Minami Ward and throughout Kashimi, it was common to see settlements of approach fills at bridges, such as shown in Figure 6-8. Nearly all of these settlements were temporarily repaired with a thick asphalt overlay. It was unclear whether the observed settlements at the bridges were due to soil liquefaction, seismic compaction of the approach fill, or some combination of both. However, we are confident that the settlements observed at the bridge shown in Figure 6-8 were due largely to soil liquefaction because of the large lateral spread located adjacent to the bridge. A Google Earth Street View image of the same bridge abutment is shown in Figure 6-9. From comparing these figures, we estimate that approximately 40 cm of settlement occurred at the bridge approach.

Figure 6-9. Google Earth Street View image showing the same bridge approach to the Kumamoto earthquake sequence

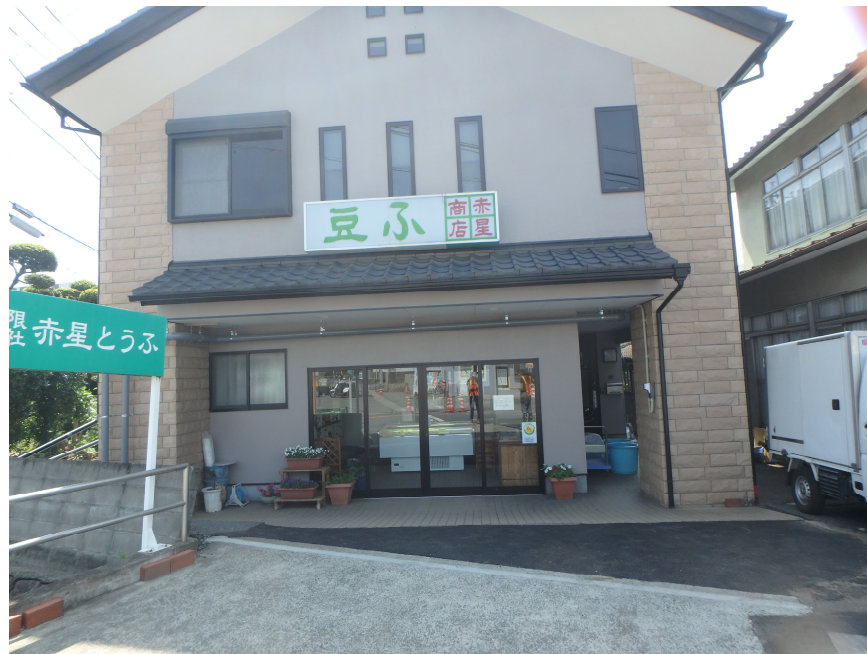
Figures 6-11 through 6-14 show pictures of damage to buildings in this neighborhood due to soil liquefaction. These structures were likely on shallow foundations and generally settled more than the surrounding ground due to shear type deformation under their foundation. No information was available on the type of foundation, ground improvement, or use of liquefaction mitigation strategies in this neighborhood. However, a number of structures were identified with little to no damage while their surrounding ground had experienced substantial settlement with evidence of sand boil. These buildings were likely on pile foundations, which protected them against damage, but the settlement of the surrounding ground and failure of lifelines connected to individual buildings still affected their performance. Obtaining additional information on soil properties as well as foundation type and details

Figure 6-11. Picture of building settlement due to soil liquefaction in the south-east corner of the Shirakawa River (coordinates: 32.770086°N; 130.692403°E). Building settlement with respect to the surrounding ground on the order of 10 cm and 2 degrees tilt.

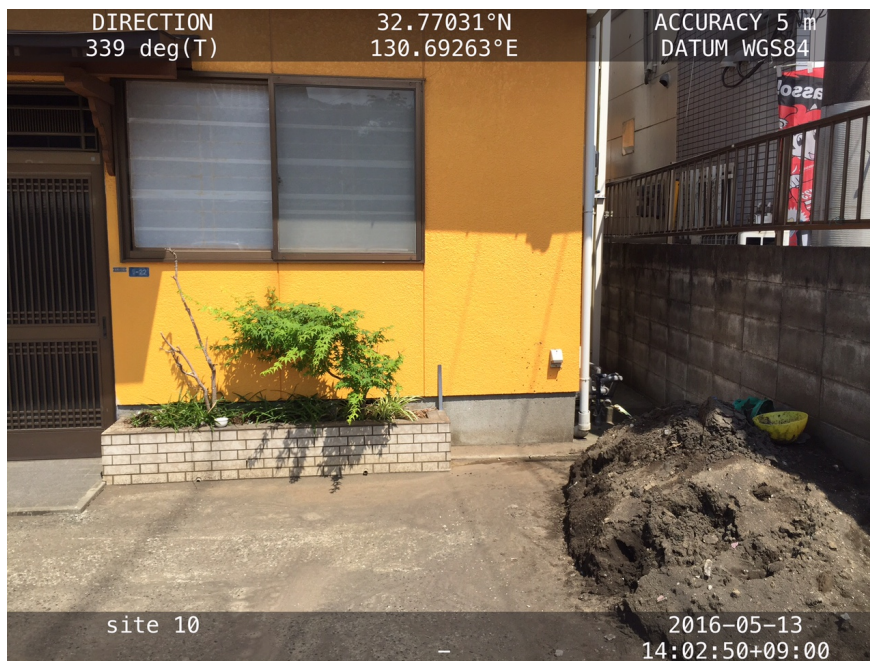
Figure 6-12. Picture of building with no damage but evidence of sand boil in the south-east corner of the Shirakawa River. Building settlement in the order of 5 cm and tilt 1 to 3 degrees.

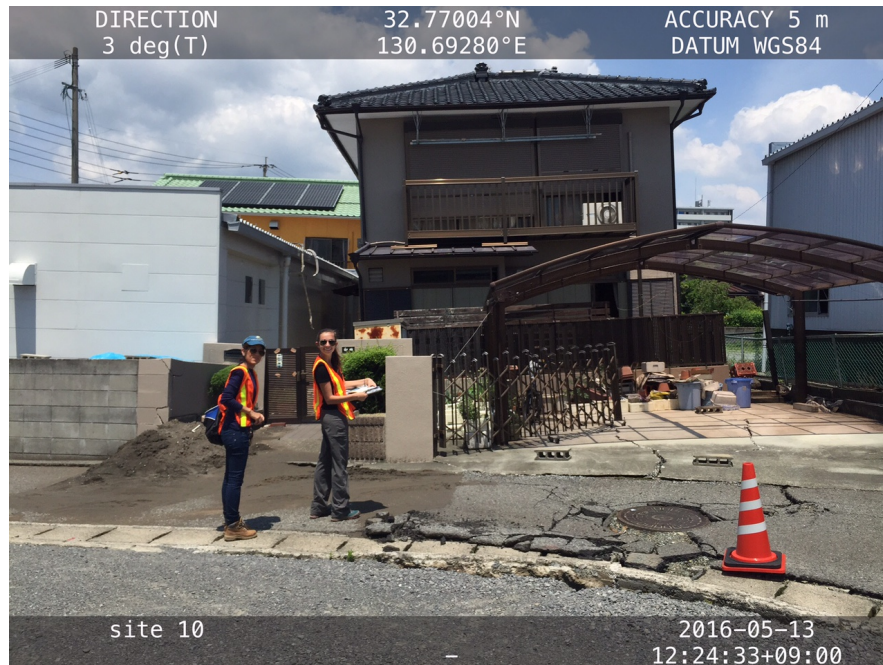
Figure 6-13. Picture of building settlement and tilt due to soil liquefaction in the south-east corner of the Shirakawa River. Building settlement with respect to the surrounding ground in the order of 10 cm and tilt of 2 degrees.

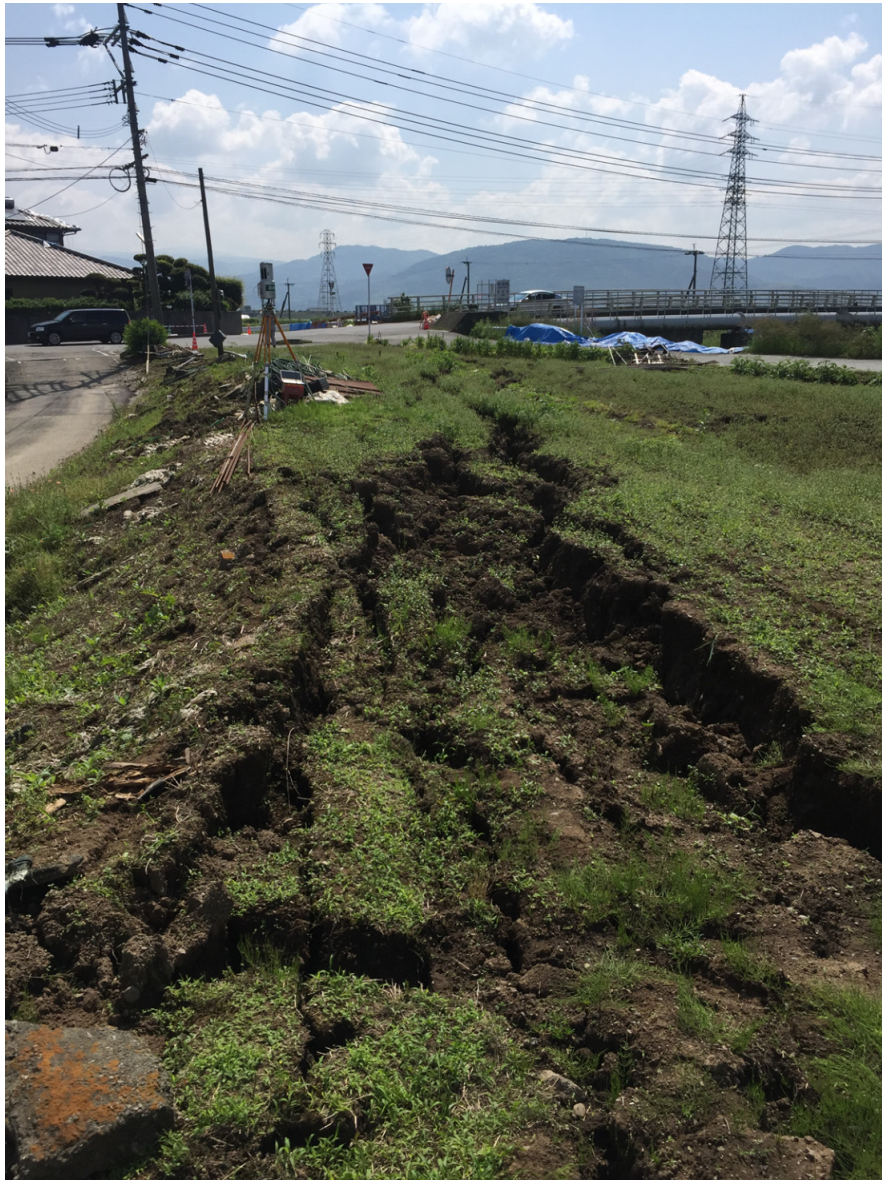
A LIDAR scan was taken at the north side of field exhibiting largest ground cracking (Figure 6-15). This area was bordered by a concrete lined drainage canal to the north, and the river to the south. Based on observations, including limited damage to the drainage canal at the north, the team believe the majority of movement was south toward the river. In the residential area north of the small canal, several extension features were observed in sidewalk blocks and around buildings, indicating slight movement of this area toward the river.

Figure 6-15. Section of lateral spread relative to location of LIDAR setup and pipeline bridge (32.77369° N 130.78384° E).

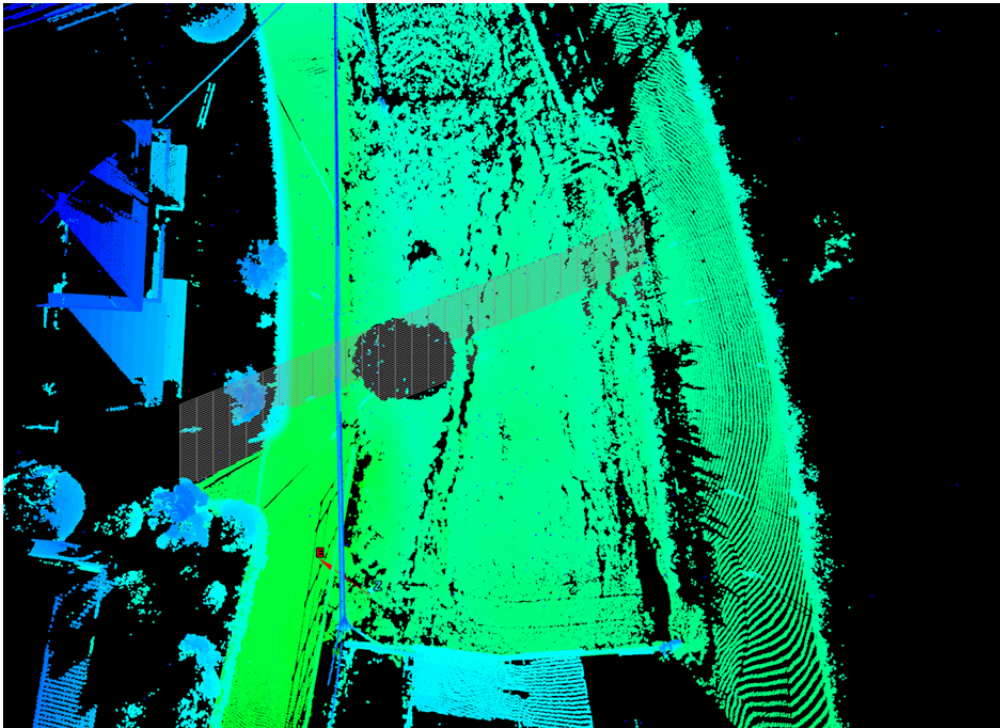
One of the rare lateral displacement locations is on the southeastern margin of Kumamoto City at Akisumachi Nuyamazu, adjacent to Route 232 crossing a tributary of the Midorikawa River (32.77369° N 130.78384° E). LIDAR was captured at this lateral spread (Figure 6-17). This site does not rise to the level of a significant case history, whereas the lack of significant lateral spread along the banks of the Midorigawa (Green River) and Shirogawa (White River) Valleys does. At Akisumachi Nuyamazu, only the portion between the roads was accessible and visible to LIDAR data collection. The zone between the road and the river was completely obscured by vegetation but likely contained continuation of lateral spread deformations. In the zone between the two roads, the average extension of the ground toward the river is estimated from aggregating displacements of objects, structures, and fissures to be 0.71 m, and the vertical displacement down to the river is estimated to be 0.25 m. These represent a minimum possible displacement, knowing that deformation occurred in the vegetated portion of the embankment.

Figure 6-17. LIDAR data through the lateral spread zone (32.77369° N 130.78384° E).

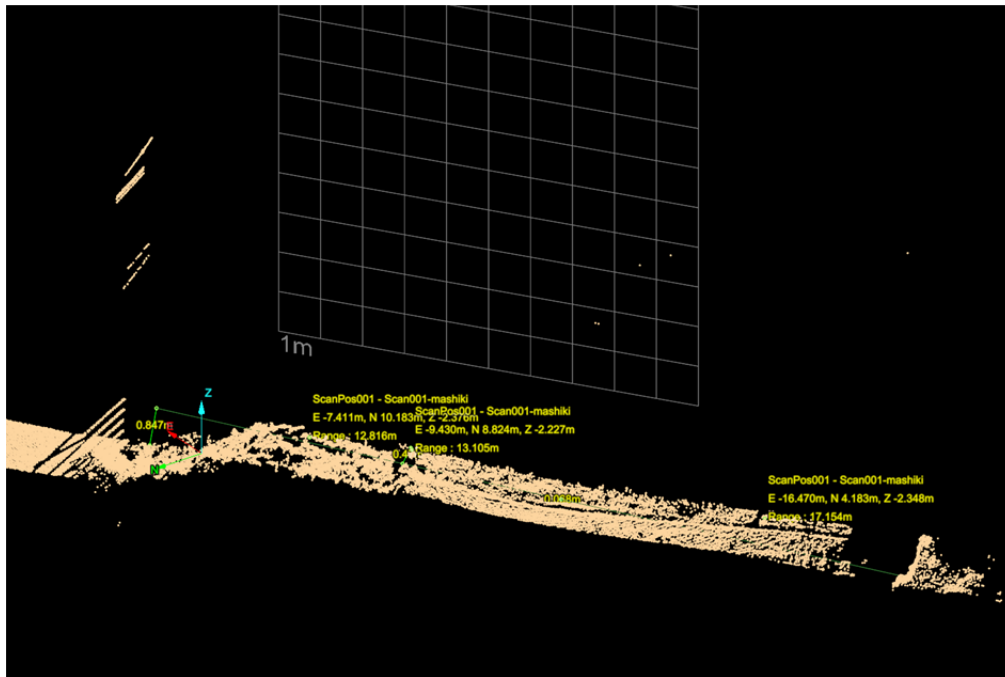
Figure 6-18. Example of lateral and vertical displacement calculation through a narrow to meter section of the lateral spread. Measurements were made continuously through the entire mass at 2 m intervals (32.77369° N 130.78384° E).

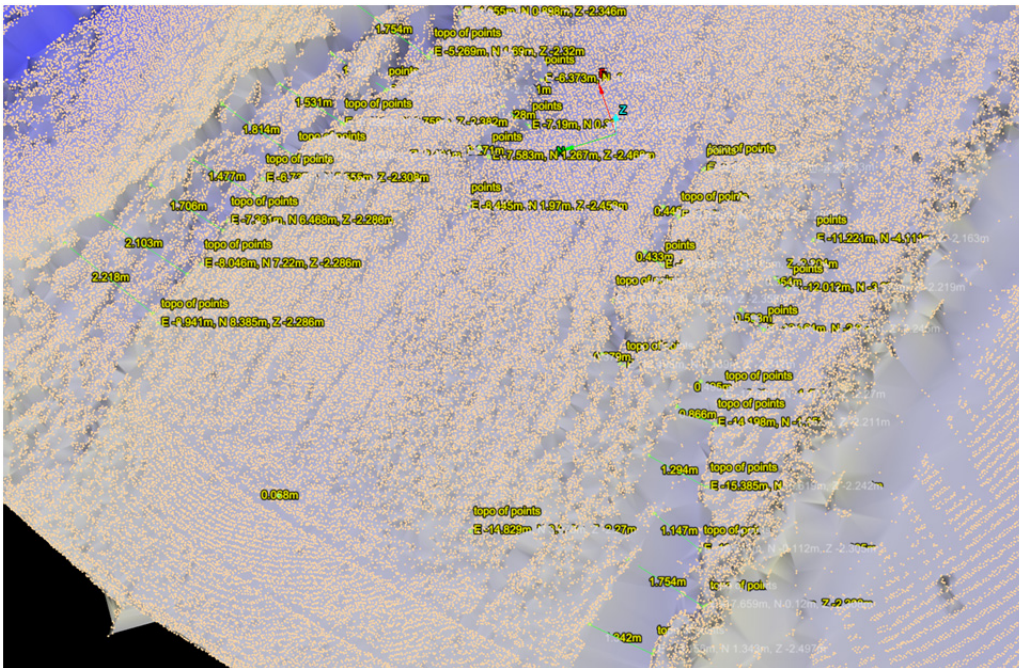
Figure 6-19. Measurements of lateral spread elevations, and fissure locations at Mashiki town (32.77369° N 130.78384° E).

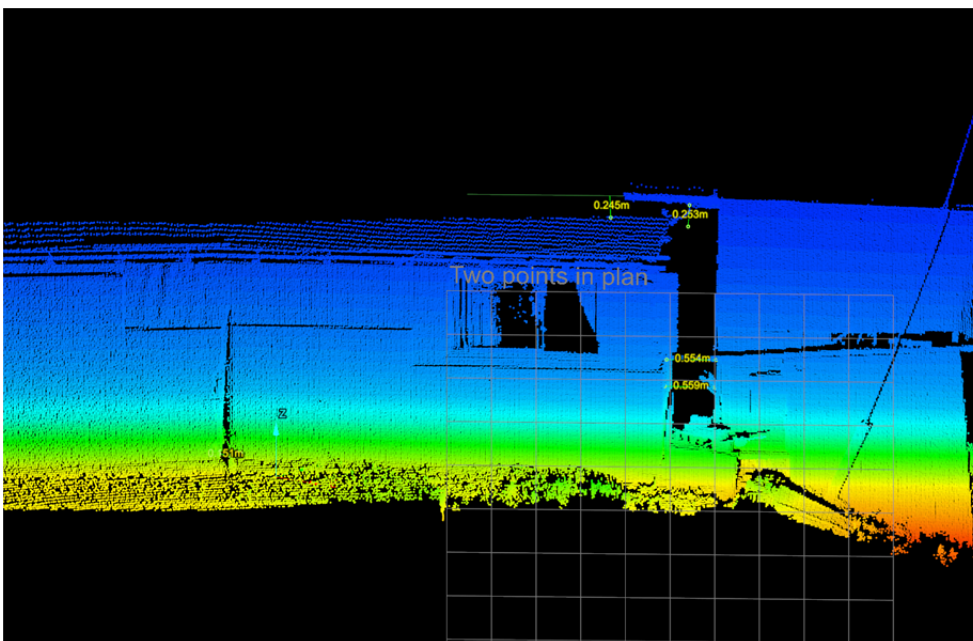
West of the LIDAR scan extension cracks propagated through a one-story concrete block structure resulting in greater than 0.5 m of relative wall displacement. Evidence of surface cracking was observed in the field to the west of this structure, generally oriented parallel to the river. Large road patches were also observed to the west along the river frontage road, likely repairs of lateral spreading. The extent of observable ground cracking to the west was within 100 m of the LIDAR scan position.

Figure 6-20. LIDAR deformation measurements through damage structures pulled apart bilateral spreading (32.77369° N 130.78384° E).

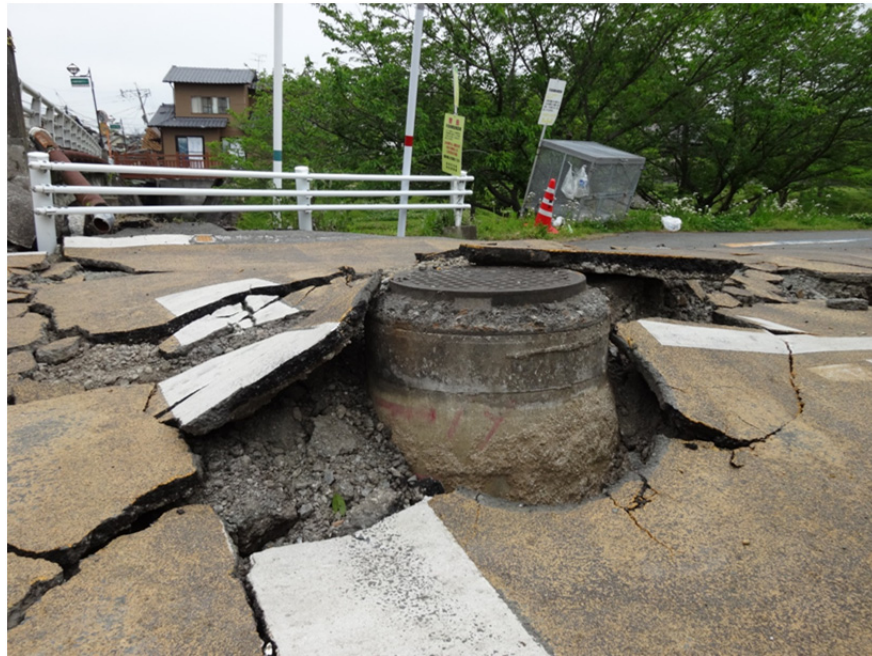
Although not visited by the GEER team during this reconnaissance mission, there were reports of damage to wastewater treatment plants. Gravity sewer pipelines suffered untold damage from ground settlement and differential movement. For example, Figure 7-5 shows an example of differential movement between a sewer manhole and surrounding ground. Buoyancy effects from liquefaction of pipeline backfill caused sewer mains to rise, resulting in significant damage to roads and a number of reported automobile accidents.

Figure 7-5. Differential movement between sewer manhole and ground surface likely caused by liquefied pipeline backfill (photo courtesy of JSCE).
