Geotechnical Aspects of the 2016 M_w 6.2, M_w 6.0, and M_w 7.0 Kumamoto Earthquakes

Geotechnical Extreme Events Reconnaissance Association

Version 1.0

July 2016

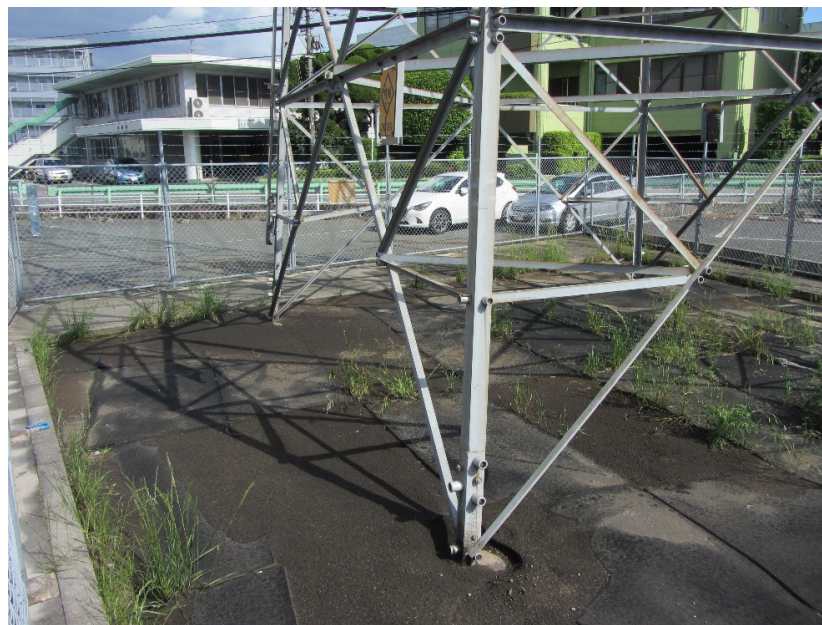
Restoration of power to the majority of the region was relatively rapid due to the locations of power generation and substations outside of the most severe shaking. Landslides in the Aso area caused damage to a 66-kV transmission tower foundation (Tower No. 7 shown in Figure 7-8), threatening collapse. Construction of temporary towers caused delays in supply restoration to the Aso area. Transmission towers within Kumamoto City liquefaction zone demonstrated no observable tilting or foundation settlement (Figure 7-9).

Figure 7-9. Transmission tower in a heavily liquefied zone with no observed tilting or foundation settlement. (32.768987, 130.691186).

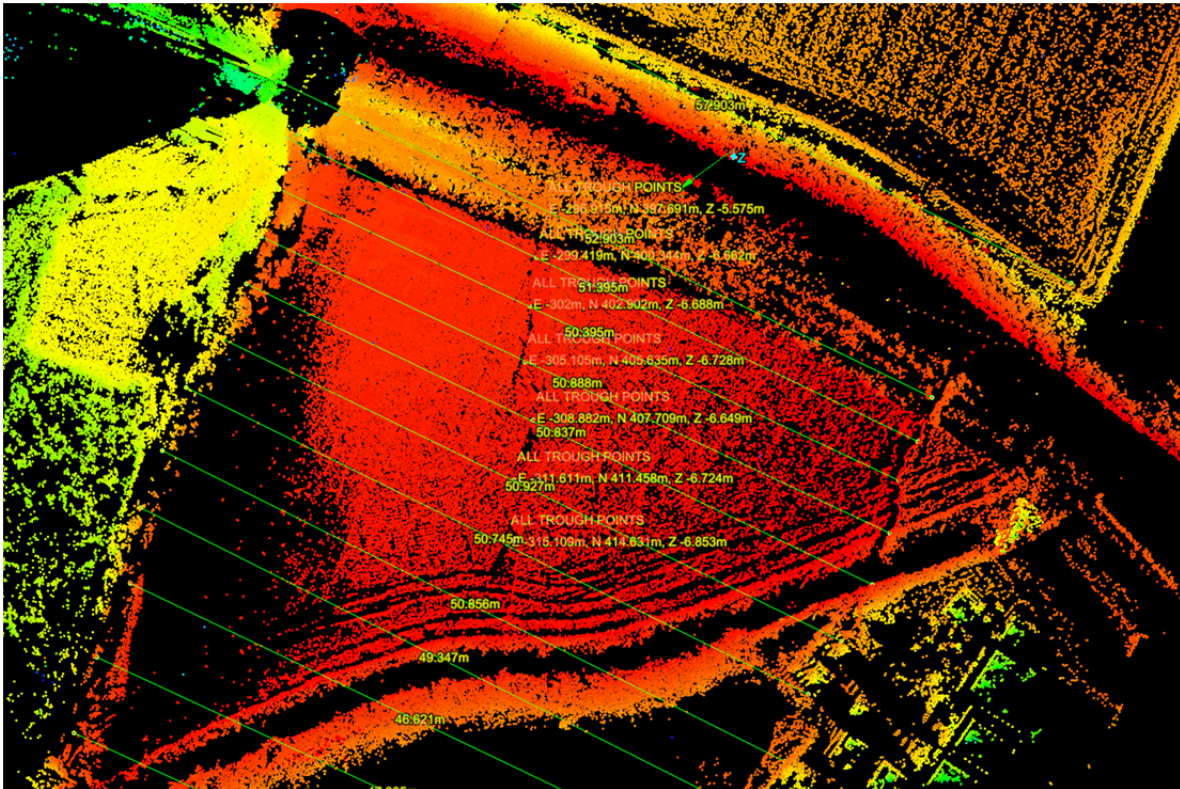
Figure 8-2. Measurements of fault graben offset and width using point-, line-, and area-query tools on LIDAR point cloud data at Aso Caldera (Site RK7, 32.95109N, 131.02763E)

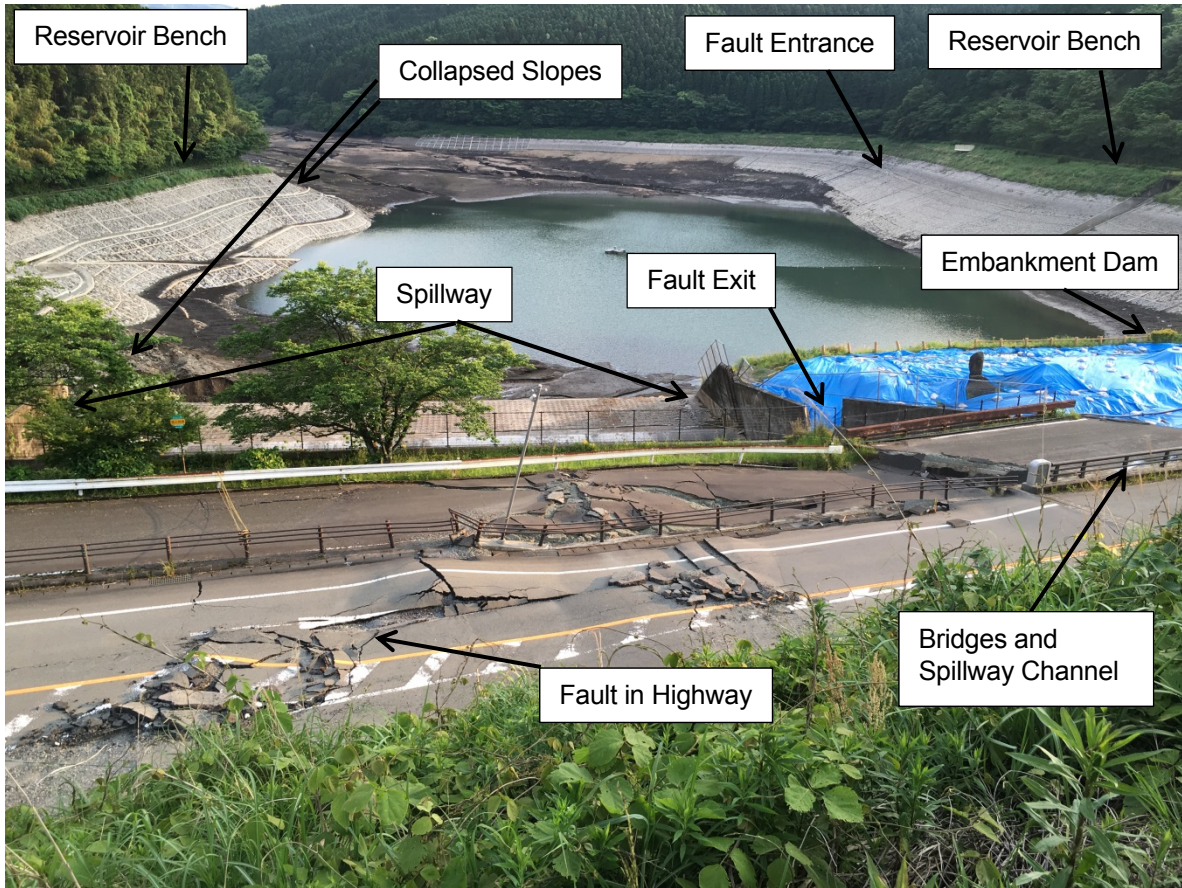
Figure 9-1. Overview of the dam site (32.84167°, 130.93202°).

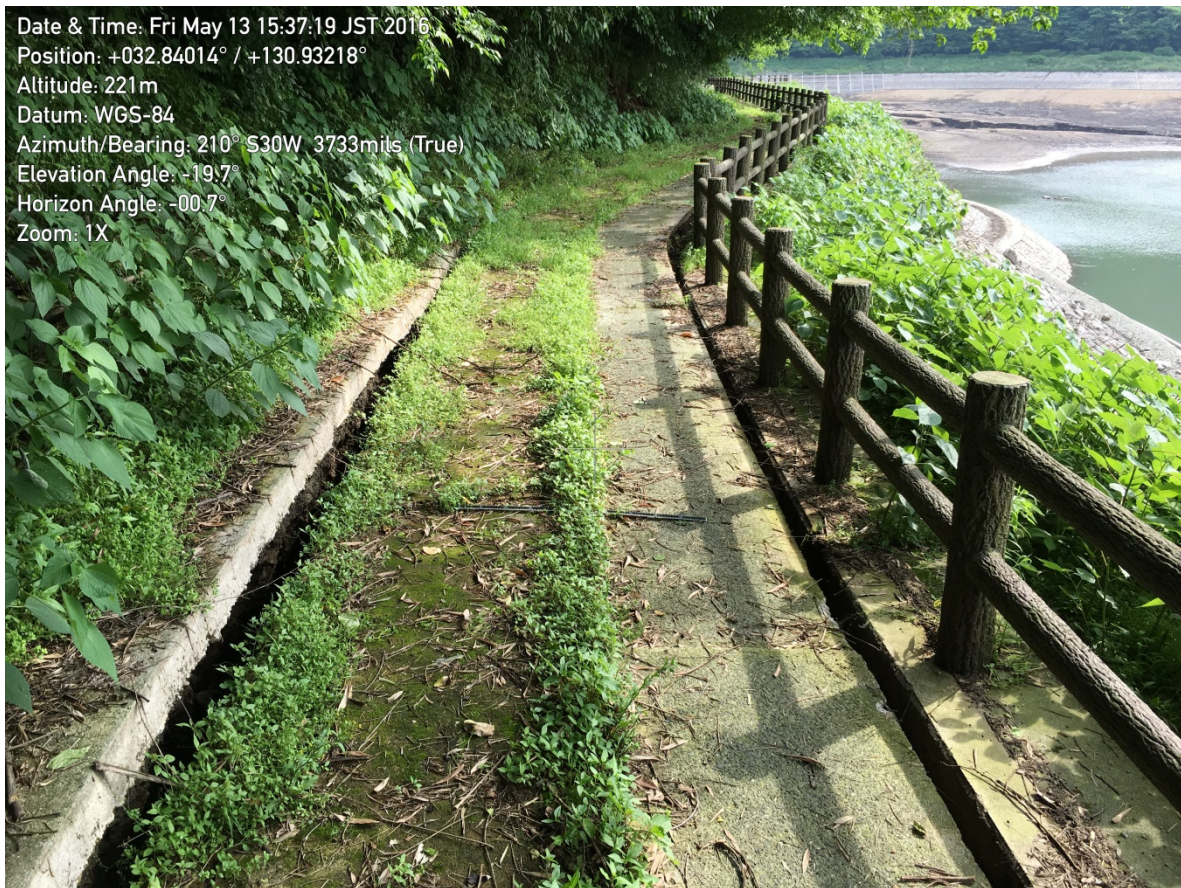
Around nearly the entire reservoir bench, slope movements of 0.2 to 0.5 m (measured based on the length of the horizontal offsets in cracks observed on the bench, not necessarily representative of the total magnitude of slope movement if upslope movement occurred too or of the vertical component of slope movement, see Figure 9-2). No slope movement in the upper natural slopes was obvious from the bench; however, we did not hike into the overlying slopes to examine them. At the northwestern corner of the reservoir, at the nearby bridge, a large landslide occurred in the same formation (Figure 9-3). Complete slope failures of the reservoir bench and underlying slope occurred at two locations: just to the east of the spillway and on the eastern flank of the reservoir (Figure 9-4). The reservoir's gatehouse was significantly back tilted, and the reservoir bench in front of the gatehouse was significantly tilted toward the reservoir (Figure 9-5). The movements at and around the gatehouse were much greater than was typical for the reservoir benches elsewhere.

Figure 9-2. Slope displacements typical of nearly the entire bench running the circumference of the dam.

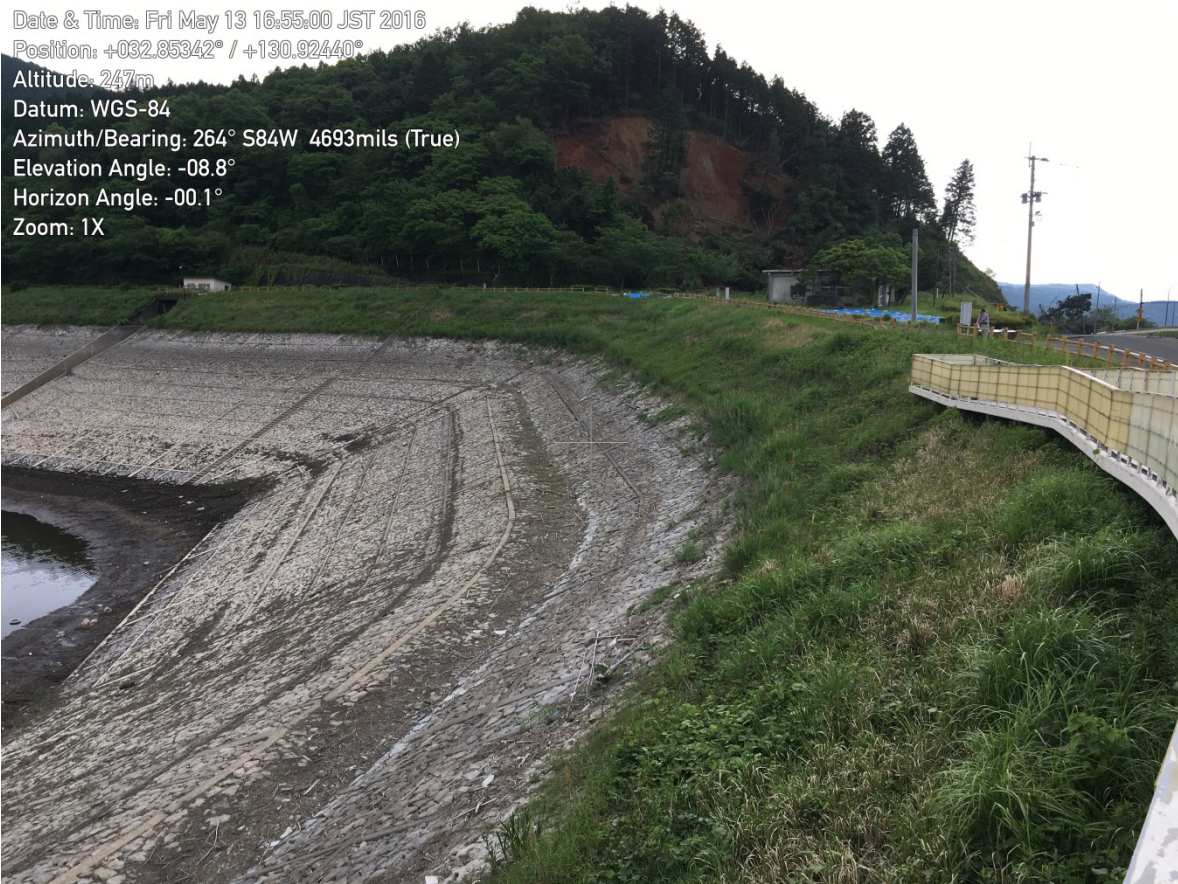
Figure 9-3. A major landslide of the hill adjacent to the reservoir.

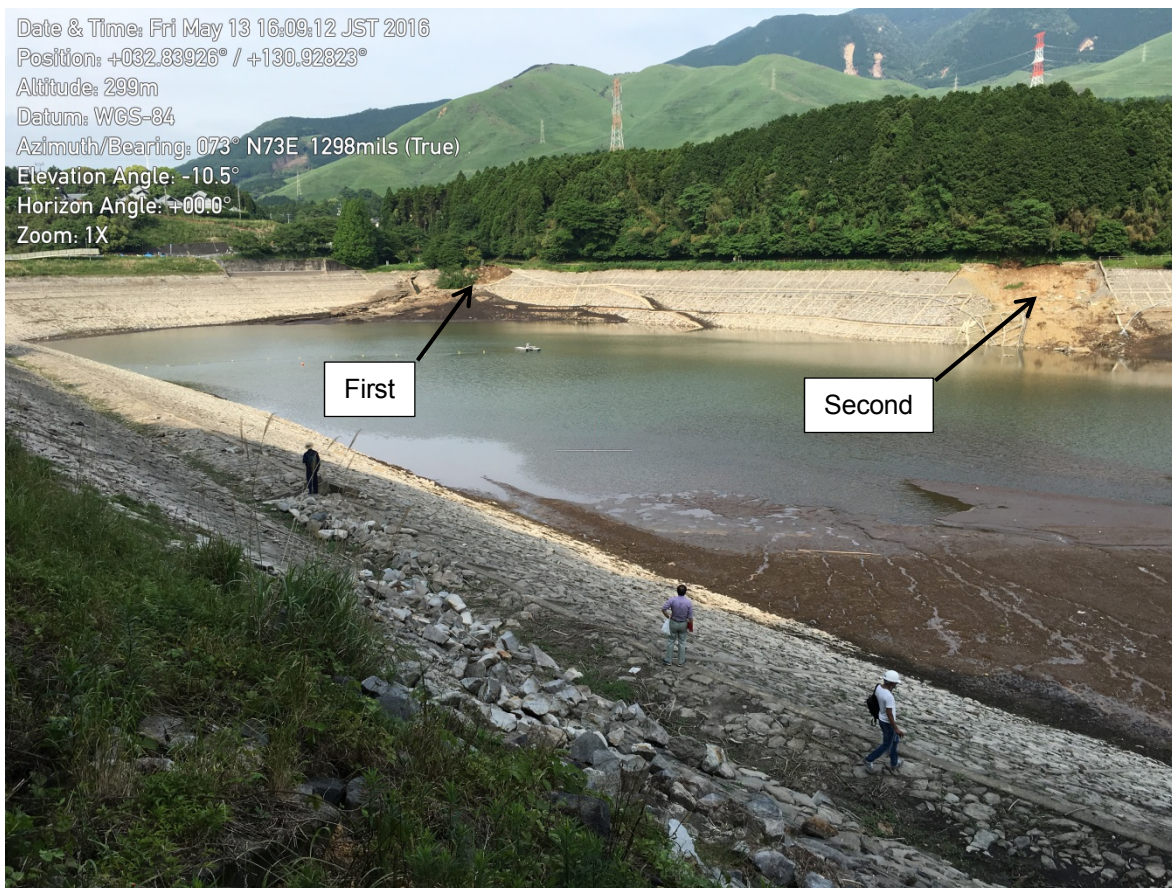
Figure 9-4. The two collapsed side slopes of the reservoir.

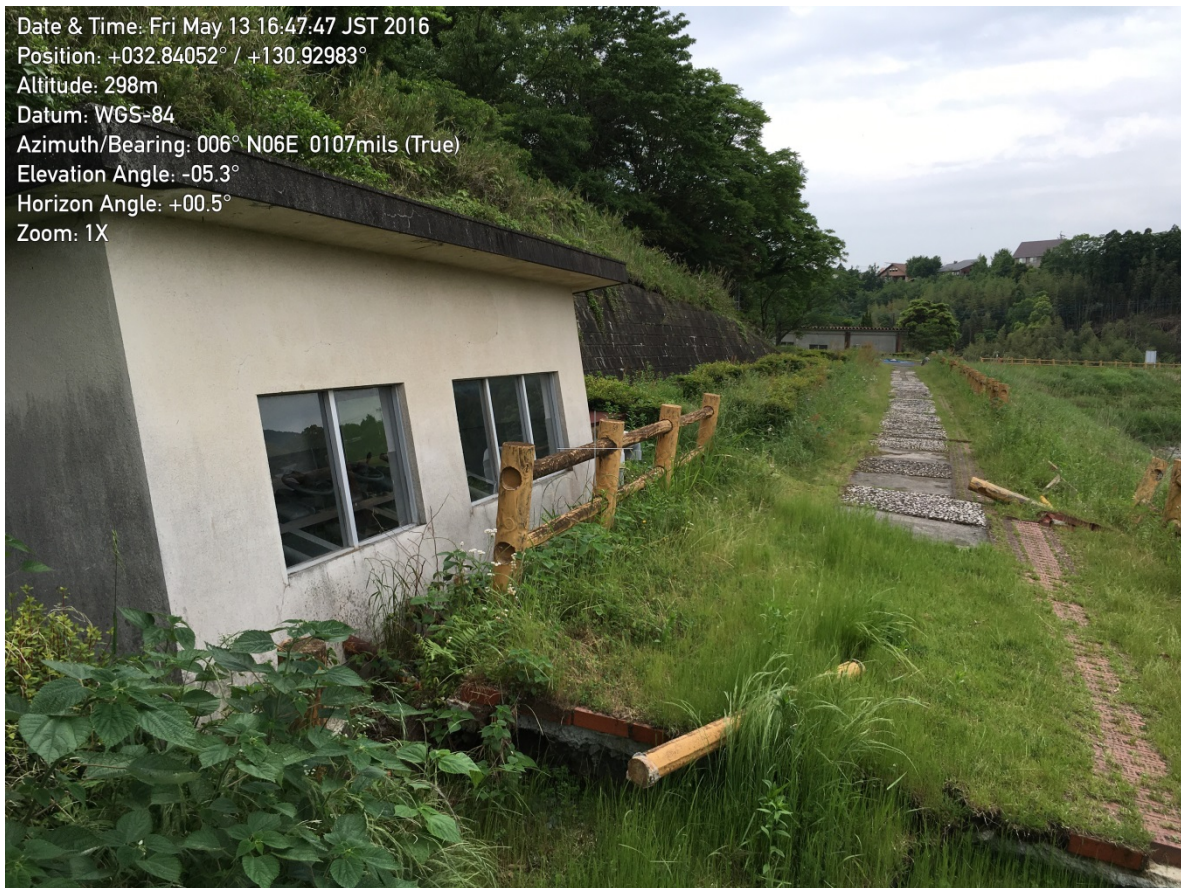
Figure 9-5. Significant back tilting of the gatehouse and forward tilting of the reservoir bench in front of the gatehouse.

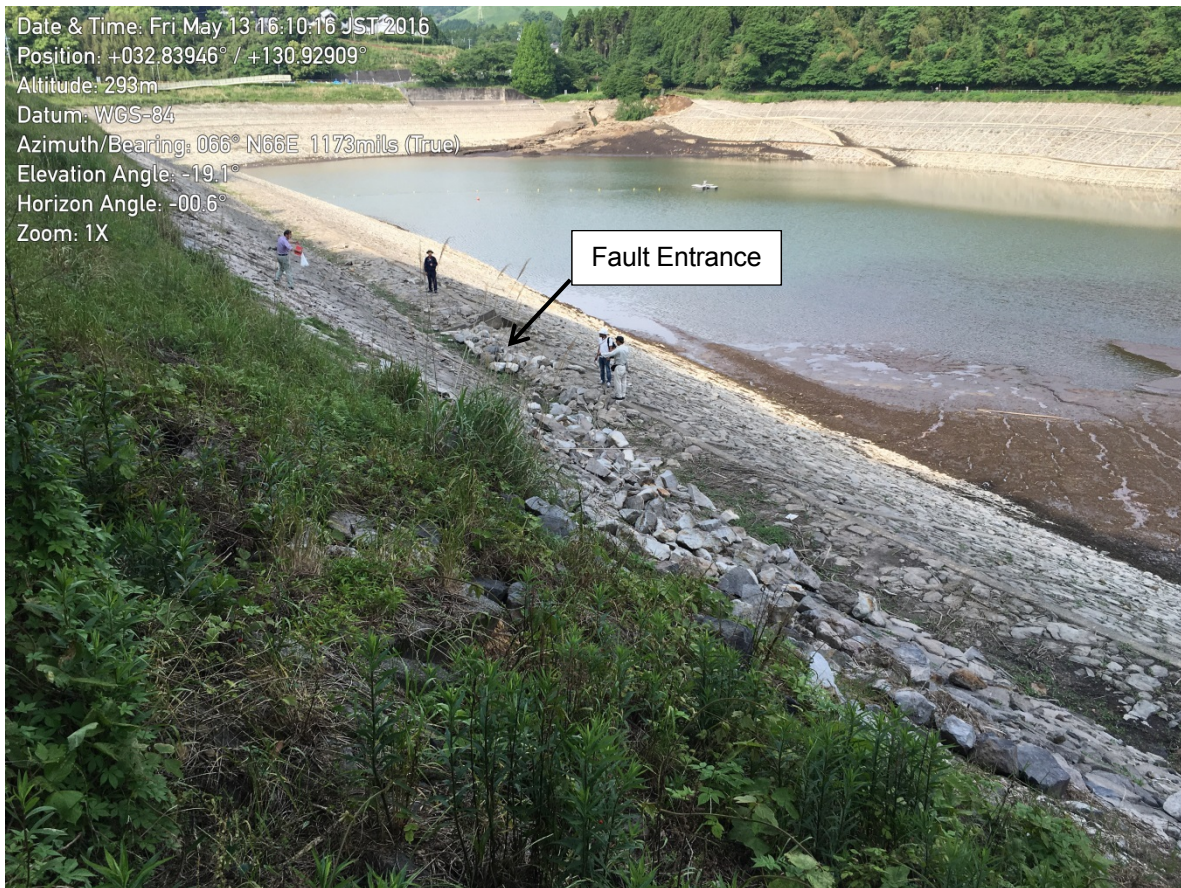
The initial fault crossing of the Futagawa Fault (based on our understanding of the rupture sequence) was through the western side of the reservoir, through the reservoir side slope (Figure 9-6). Significant ground disturbance and tree collapse was observed in the natural slope above the reservoir bench. The bench itself was highly distorted at the fault crossing (Figure 9-7). The reservoir side slope below the bench was relatively intact, except that the riprap was disturbed (i.e., "dilated") as a result of shearing and the concrete gridwork was offset and damaged (Figure 9-8). A primary fault break was located here based on dilation of the riprap; however, many other possible secondary strands were noted. It was very difficult to measure fault offsets, or the number of secondary faults, because of large slope movements (discussed above) were coincident with the fault movement here. Many of the offsets in the concrete grid were left lateral and therefore likely slope related. A set of stairs leading from the reservoir bench down to the bottom of the reservoir was located at the approximate location of the fault crossing. The stairs were about 70 to 80 cm higher than the reservoir bench, indicating the bench here may have moved downwards significantly as a result of slope movement, possibly exacerbated by the fault movement. It is estimated, however, that the right lateral strike slip movement of the Futagawa Fault here was at least 50 cm, if not more with secondary faults and ground strain added. LIDAR data may be best to estimate the total movement. No significant vertical fault offset was noted; however, LIDAR data may provide a better estimate.

Figure 9-6. The location of the main fault strands entrance into the reservoir, visible by the “dilation” of the riprap side slope armoring.

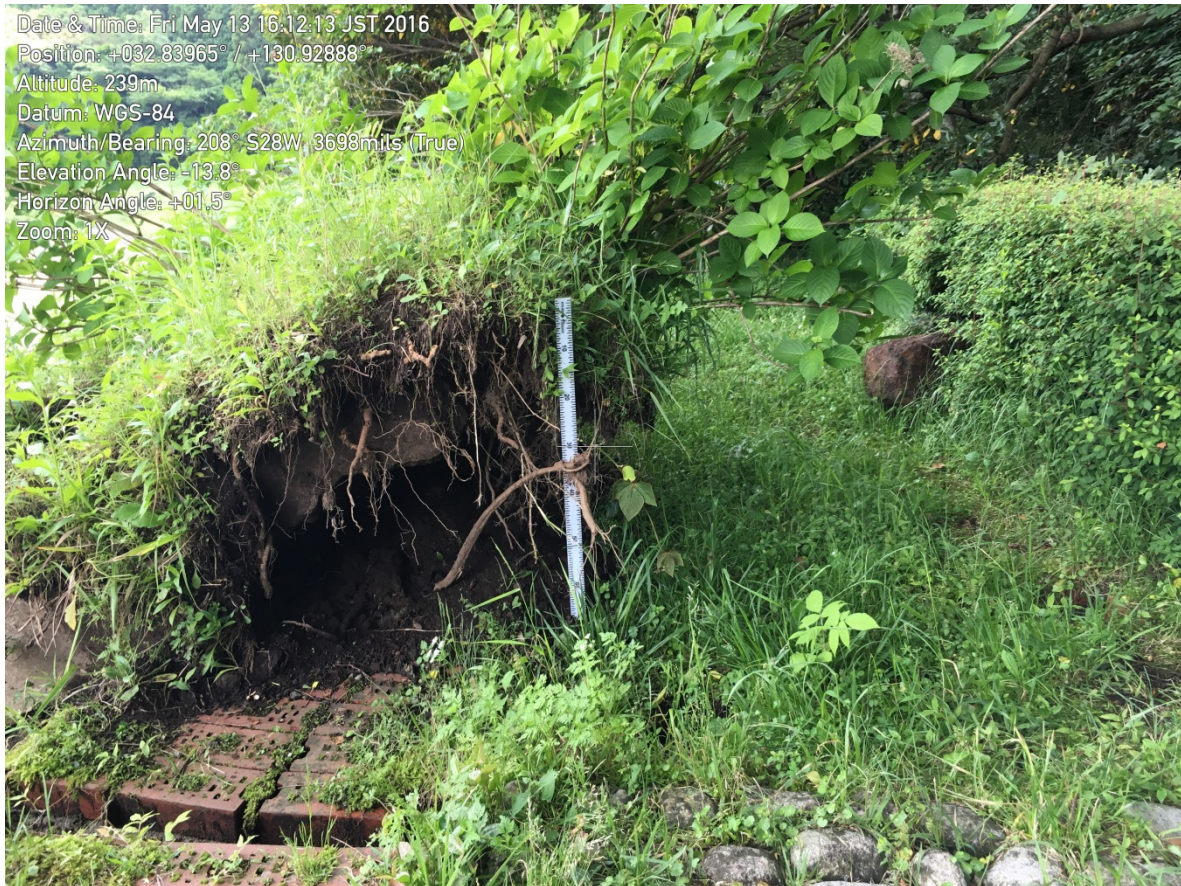
Figure 9-7. The reservoir bench at the location of the fault entrance into the reservoir. Note the vertical offset of this staircase, possibly resulting from the combination of fault movement and slope movement here.

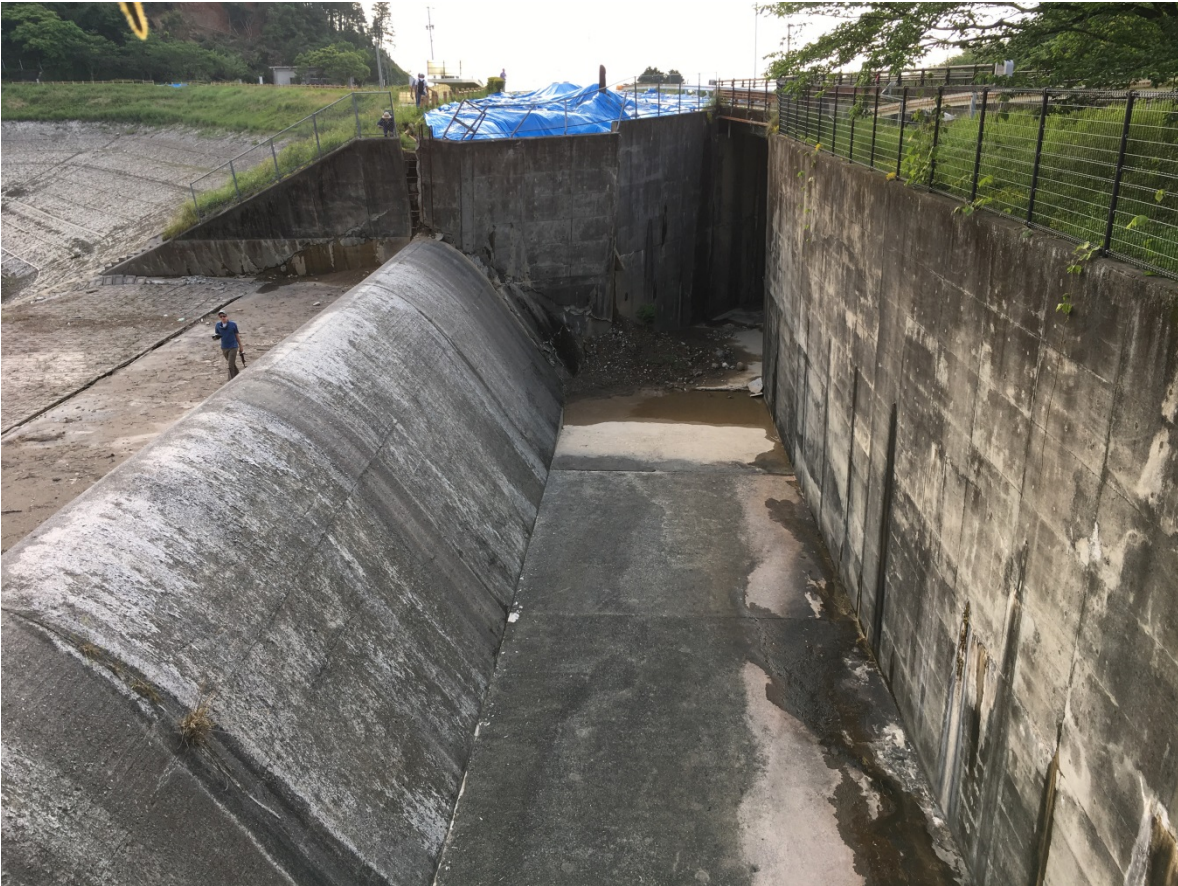
The location at which the Futagawa Fault exited the reservoir was approximately between the spillway and the spillway outlet channel (Figure 9-9). Disturbance caused by the fault could be noted in the slopes below the spillway, similar to the initial fault crossing into the reservoir discussed above. We examined the inside of the spillway and spillway outlet channel and measured the offsets likely caused by the fault movement (Figure 9-10, Figure 9-11, Figure 9-12, Figure 9-13, Figure 9-14, and Figure 9-15). See Figure 9-16 for a sketch of the offsets measured inside the spillway and outlet channel for details.

Figure 9-9. Overview of the condition of the spillway.

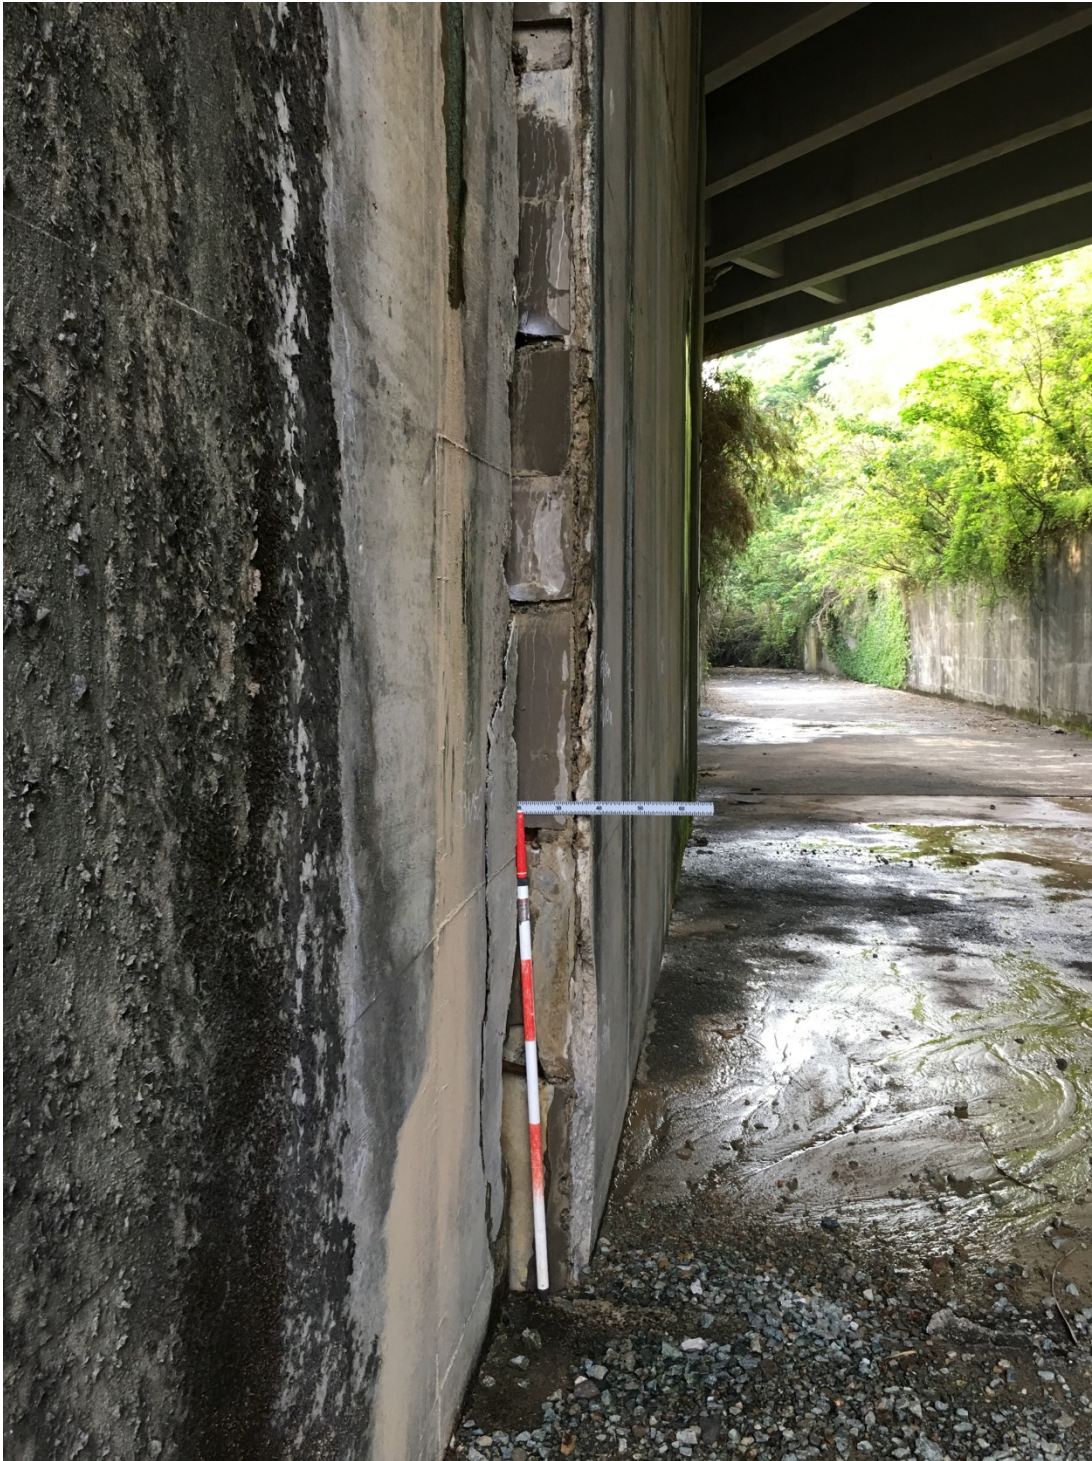
Figure 9-12. A smaller offset at a joint in the spillway outlet channel due to the movement and rotation of the spillway.

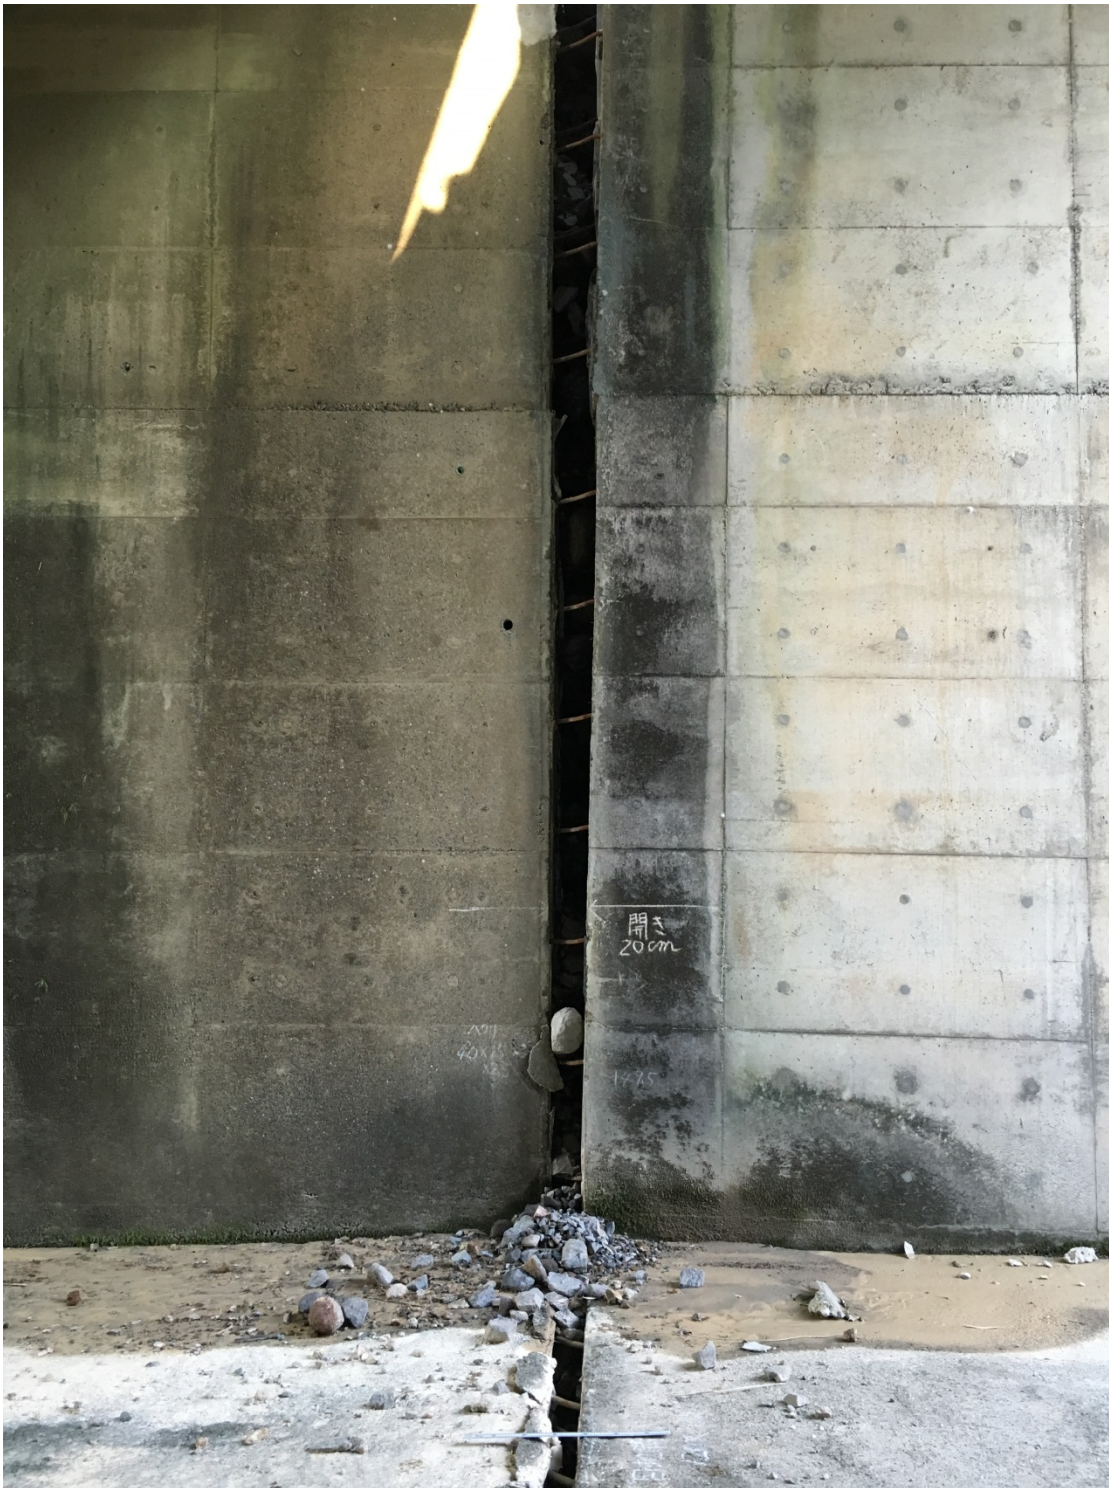
Figure 9-13. Another offset at a joint in the spillway outlet channel due to the movement and rotation of the spillway. Note the change in horizontal separation from top to bottom.

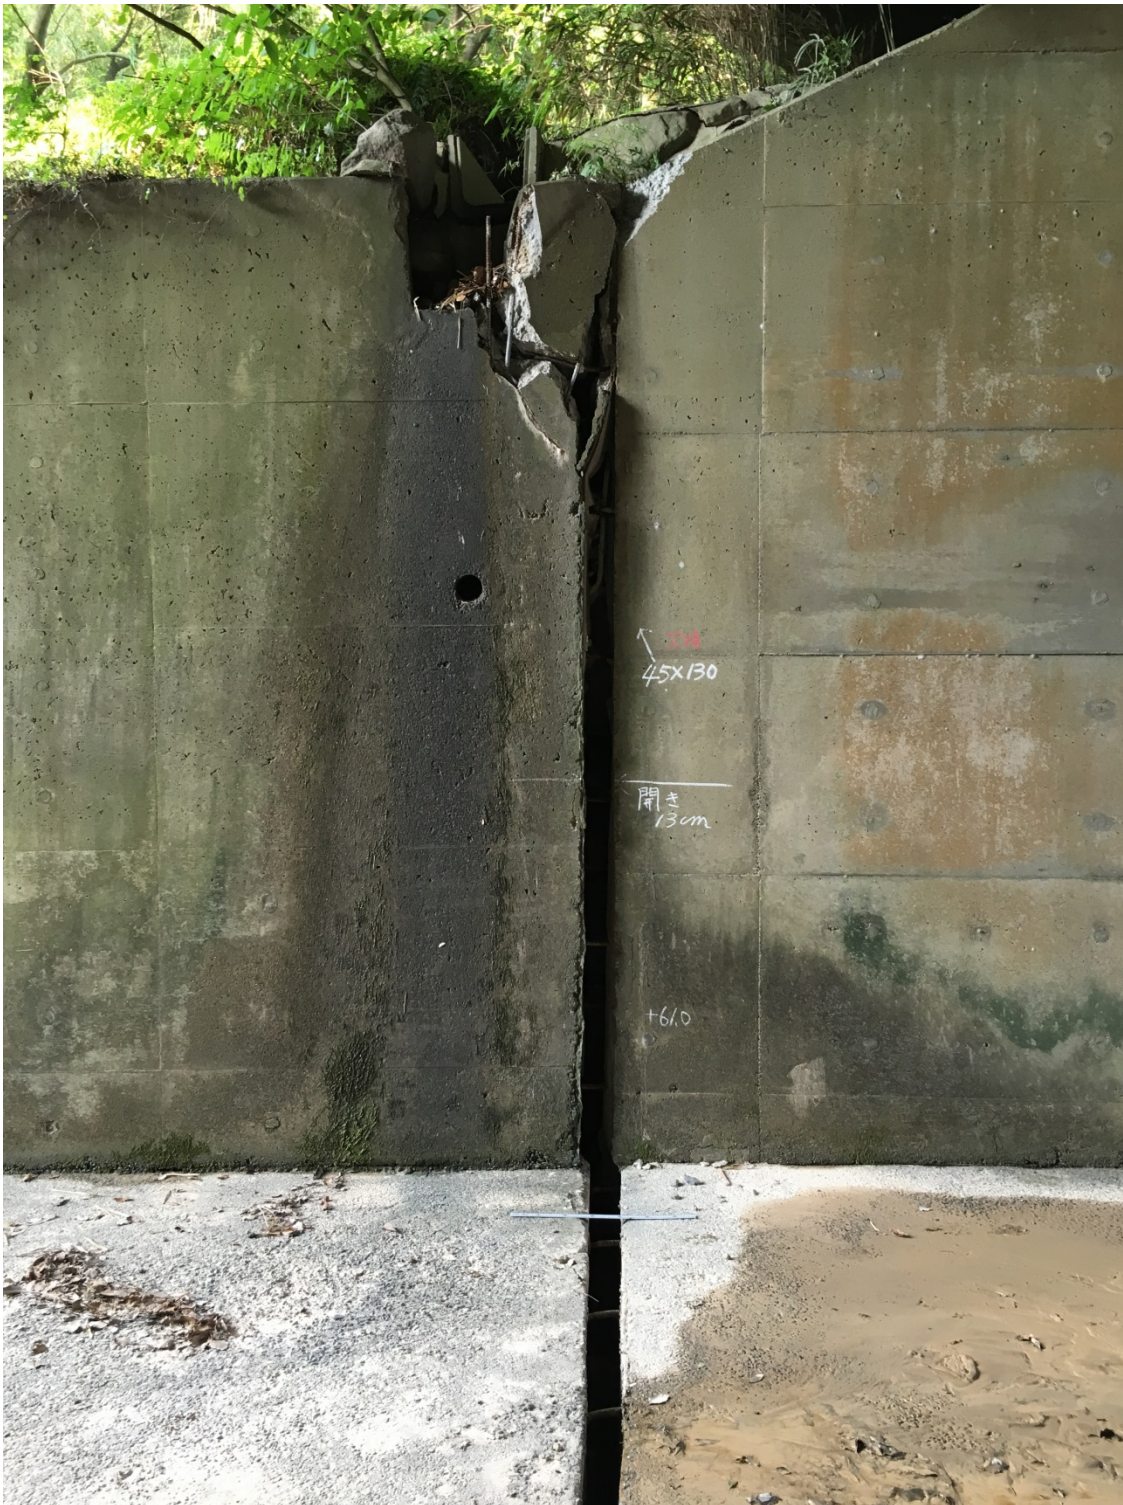
Figure 9-14. Another offset at a joint in the spillway outlet channel due to the movement and rotation of the spillway.

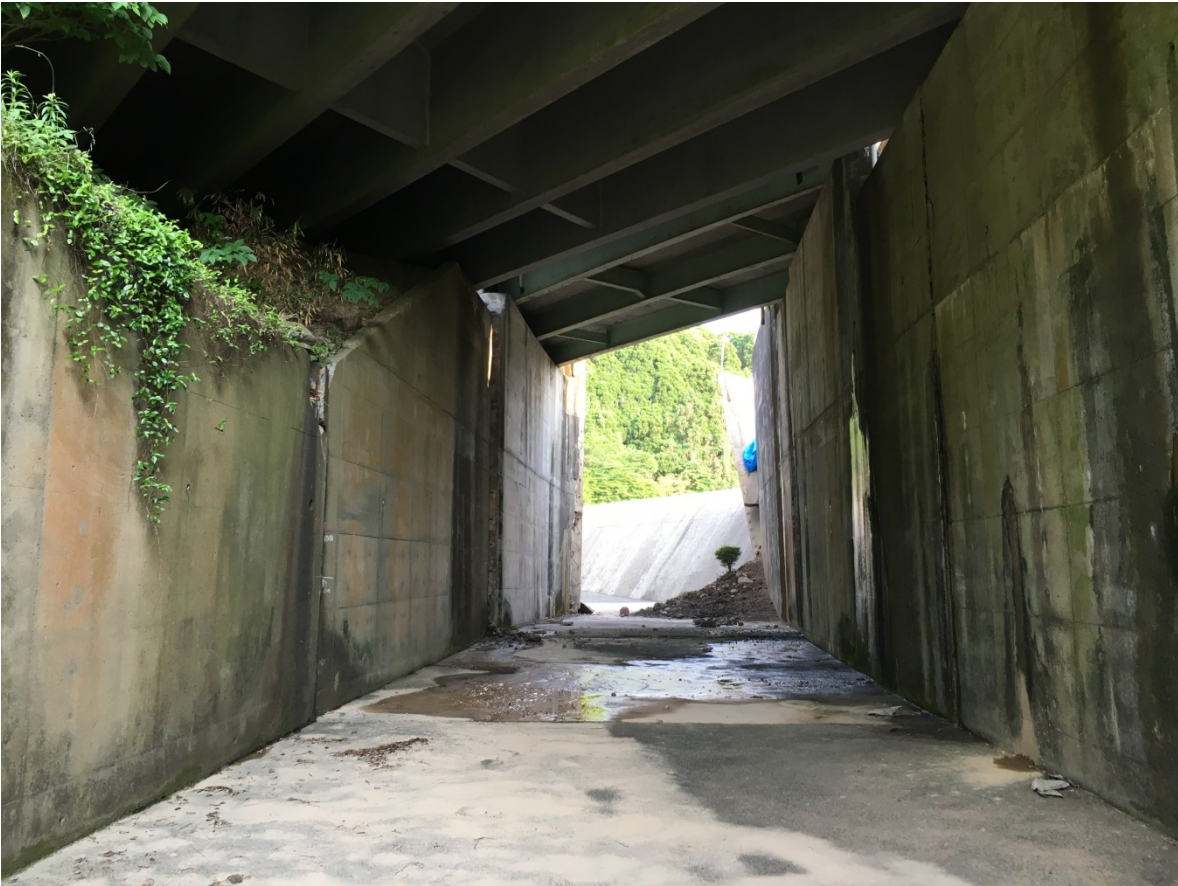
Figure 9-15. Overview of the offsets and rotations in the spillway outlet channel joints, facing back towards the spillway.

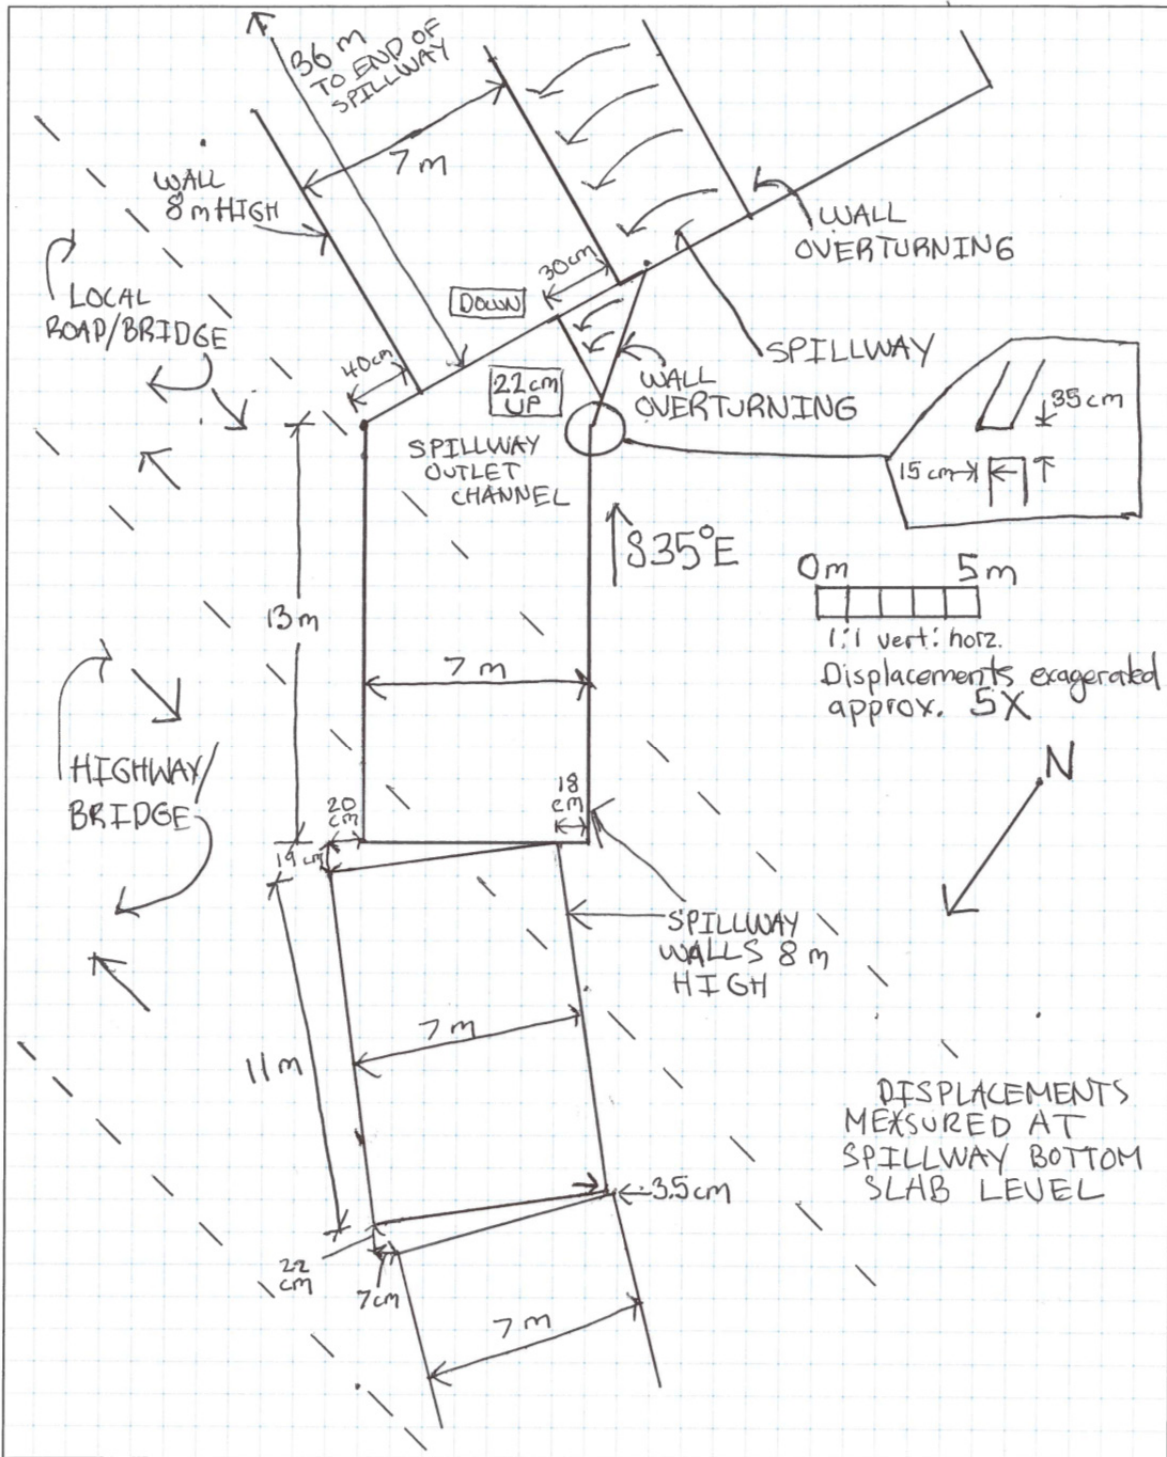
Figure 9-16. A sketch of the offsets measured inside the spillway and spillway outflow channel.

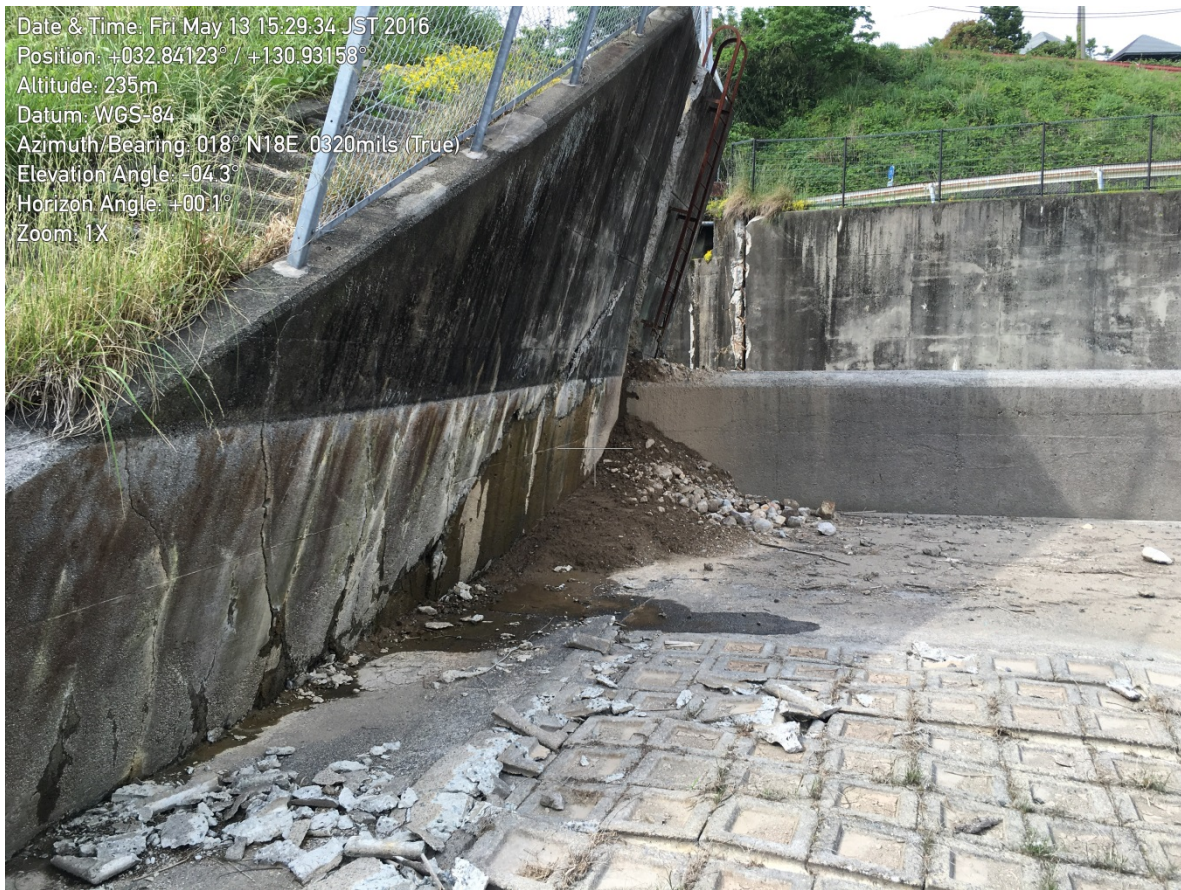
The fault movement apparently caused failure of one of the spillway training walls, which caused a significant amount of soil to fall into the spillway (Figure 9-17). A secondary rupture apparently went through the right side of the spillway based on offsets recorded there (Figure 9-18). In the roadway above the spillway, the fault movement caused significant shearing of the road (Figure 9-19). Fault movement was at least 50 cm of right lateral strike slip in this area, potentially with some minor vertical movement; although a significant amount of deformation could have been distributed off of the main fault break in bending or in secondary faults, so the total offset would be best estimated with LIDAR. An unreinforced concrete block retaining wall on the opposite side of the road partially collapsed as a result of fault rupture (Figure 9-20). The retaining wall was about 50 cm in thickness. Above the road, the fault ruptured through a hill that the wall was retaining. Three apparent offsets were noted in a road that went up the side of this hill, as shown in Figure 9-21, based on guardrail distortion and pavement disturbance.

Figure 9-17. A close up of the left spillway training wall.

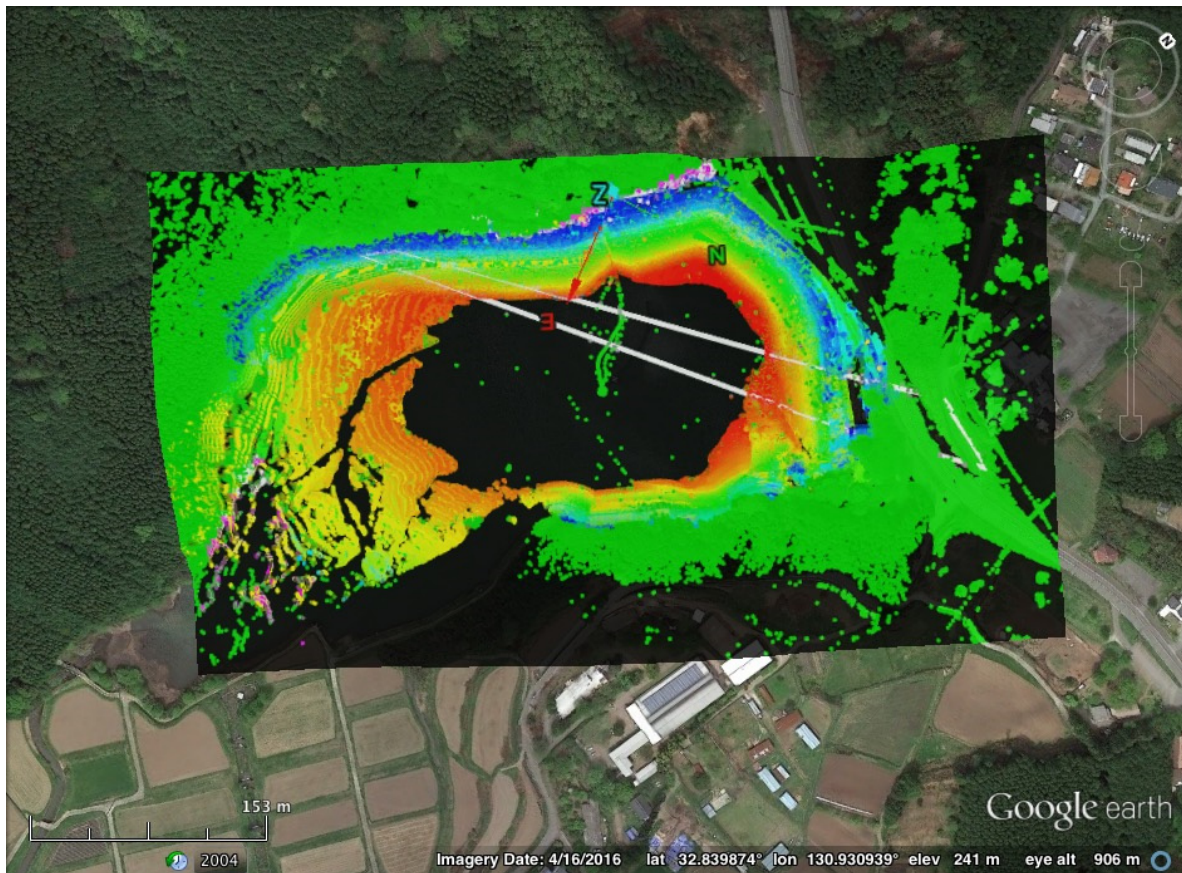
An overview of the reservoir LIDAR data can be seen in Figure 9-23, and an example of the roughening of the embankment facing can be seen in Figure 9-24. In Figure 9-23, the width of the Futagawa Fault rupture lays between the polygons. It can be seen the fault enters the reservoir from the southwest slope, crosses a corner of the reservoir, and exits through the dam embankment and spillway. The width of the zone of the fault rupture widens as it crosses the dam, spillway, road, and the hot springs resort on north side of the road. At the southwest, where the fault enters the dam, the width of the fault zone is approximately 9 m. On the northeastern side of the dam where the embankment and spillway are located, the width of the fault rupture zone is 25 m (Figure 9-23).

Other aspects of the damage to the dam include the failure of concrete spillway as the rupture passed through it. In Figure 9-23, the western spillway wall broke 2 to 3.5 m below the wall top and is leaning into the spillway cavity at 74°. Other gaps and openings in the spillway walls was 1.1 m on the eastern end of the spillway and on the western end was 2.1 m, exposing soil backfill. Had the reservoir water overtopped the spillway, the soil behind the damaged concrete would have easily been eroded and a progressive and potentially catastrophic down-cutting of the spillway would have been possible.

Figure 9-23. Lidar data set for the Oh-Kirihata Dam. Coverage focused on the dam embankment, spillway, and the rupture zone passing beneath the reservoir wall rock facing (32.84123, 130.93158).

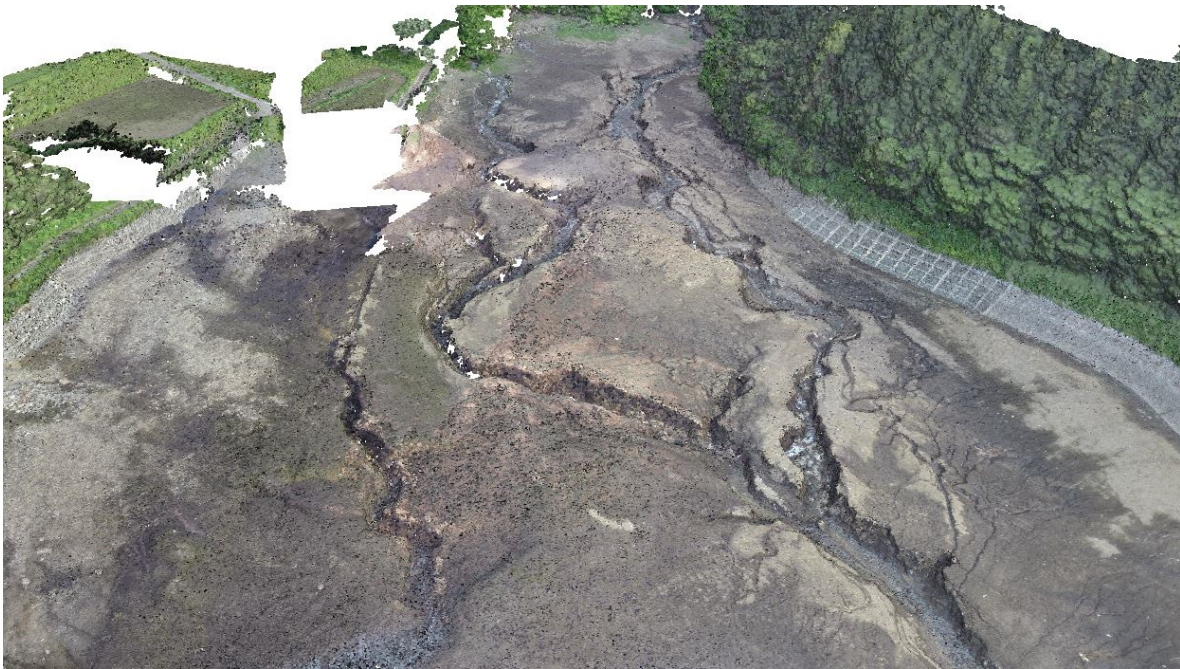
Figure 9-27. Screenshot of the 3D dense point cloud of the erosion zone in the dam; developed from UAV-based imagery (32.84123, 130.93158).
