Geotechnical Aspects of the 2016 M_w 6.2, M_w 6.0, and M_w 7.0 Kumamoto Earthquakes

Geotechnical Extreme Events Reconnaissance Association

Version 1.0

July 2016

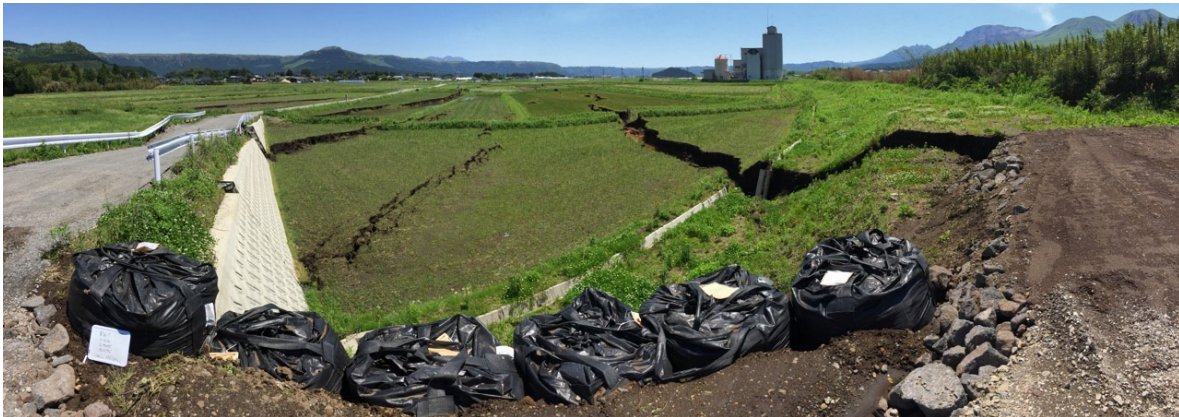
The Futagawa Fault surface fault rupture extended northeast into the southwestern corner of the Aso Caldera, a region of active volcanism. An approximately 10-km-long section of ground movement, herein call the “depression zone”, occurred coseismically (according to the observation of a resident who witnessed the earthquake), roughly projecting out from the point at which the Futagawa Fault ruptured into the caldera, up and to the northwestern end of the caldera. This depression zone was typically a 30-m to 110-m wide trough of depression with near vertical offsets on each side of the trough with vertical movement often 0.5 m to 2.5 m and minor strike-slip movement on the order of tens of cm. See Figure 9-28 for a typical free-field expression of the “depression zone”.

Figure 9-28. The zone of depression viewed in several rice fields.

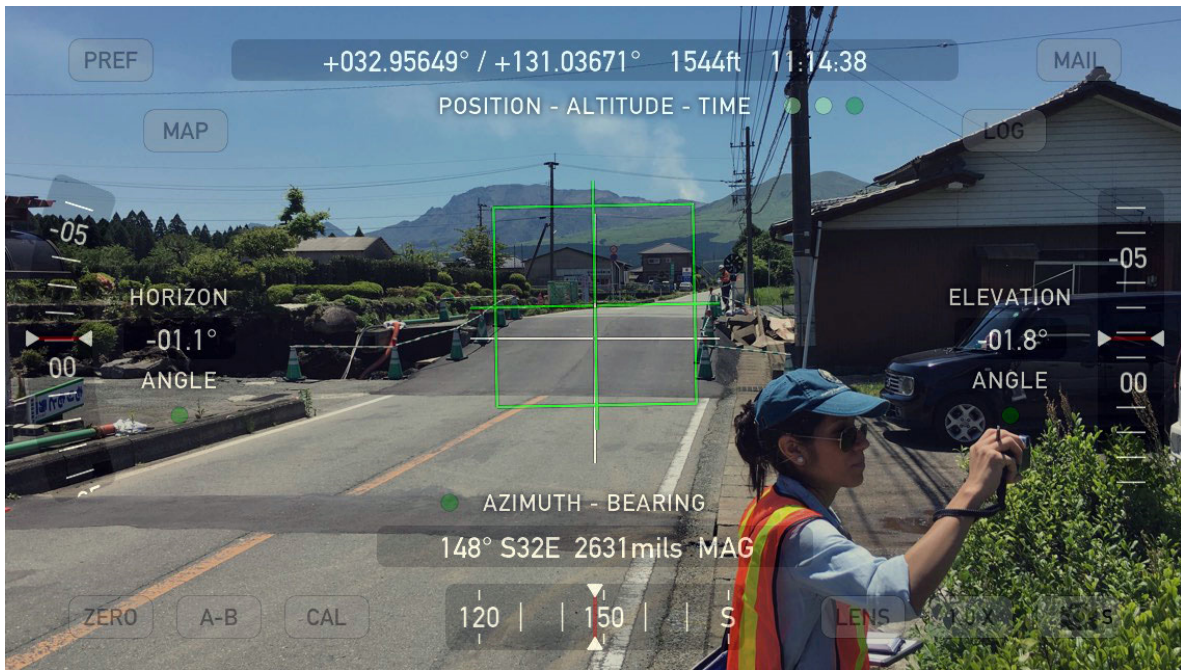
At a location where the depression zone crossed roughly orthogonal to a road (Figure 9-29), a detailed profile across the depression zone was made, noting cracks in the asphalt, concrete storm drain covers, tilting in utility poles, and other features possibly caused by the depression zone ground movement. See Figure 9-30 and Table 9-1 for the measurements made during the investigation. As noted in this profile, the south edge of the depression zone formed a small popup block, where there were two main edges of the depression zone on the south side that bounded a small block of soil that popped up relative to the surrounding area. The typical affect the depression zone had on infrastructure in this area is shown in Figure 9-31 and Figure 9-32.

Figure 9-29. Road along which the detailed profile of cracks and offsets was measured.

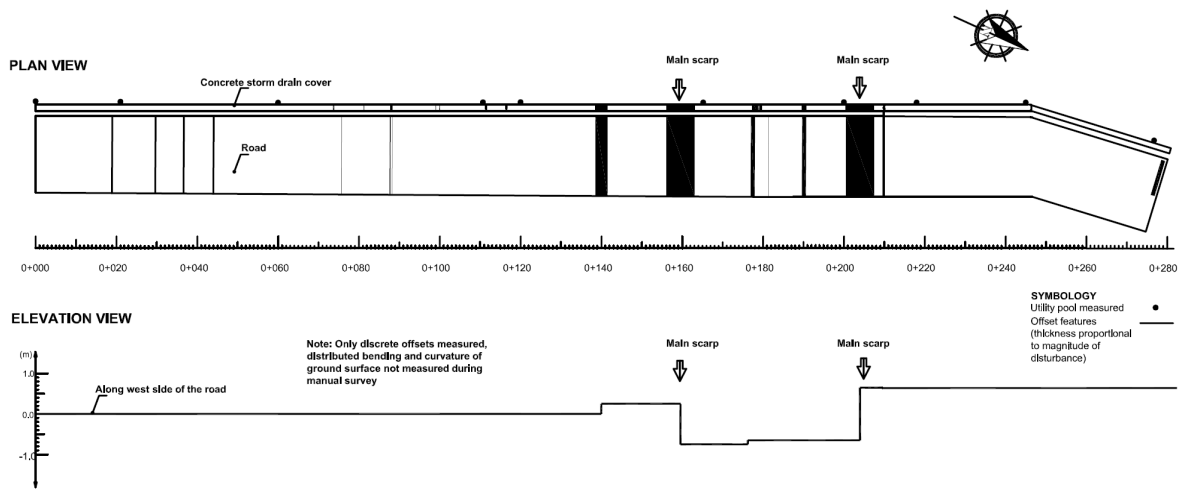
Based on the data collect, the north side of the depression zone is likely the primary fault, while the south side is likely the secondary, antithetic fault. This interpretation is based on a small popup block of soil that occurred on the south edge of the depression (Figure 9-30), which is usually associated with the secondary fault side. There were more cracks and general disturbance on the south side of the depression zone, which would be more typical of the secondary fault side (the hanging wall of the primary fault), and limited disturbance north of the depression zone, which would be more typical of the footwall side of the primary fault (Figure 9-30). If the primary fault was on the north side of the depression zone, that would imply the causative fault was an inward dipping normal fault (dipping inwards towards the center of the caldera), which is what many literature sources suggests is common for ring faults.

Figure 9-30. Profile of observed cracks and offsets along a road that crossed the depression zone, as measured by GEER.

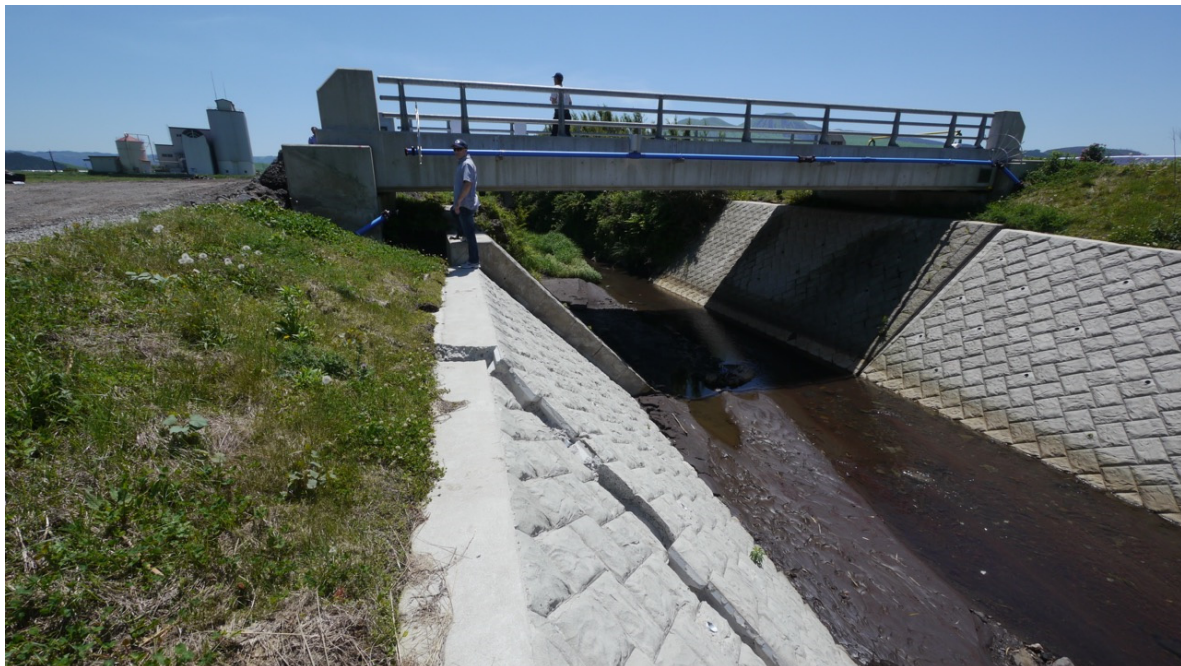
At the bridge that crossed the depression zone, the question of interest is, “if the depression zone is a fault-related feature causing settlement of the entire soil column extending to the ground surface, wouldn’t the piles founded in that same soil column also have settled by the same amount?” Further studies are required to understand how the soil around the bridge foundations settled, but not the bridge itself. These observations lend credence to the theory that the depression zone was caused by a sediment-related phenomenon like consolidation or compaction of sediment and not fault-related. However, it is also possible that the bridge piles crossed the fault at depth, causing the piles to keep the entire structure on a single side of the fault and thus limiting damage and distortion of the bridge (e.g., Oettle and Bray, 2013).

Figure 9-33. A bridge that spanned an edge of the depression zone (close to 32.9511°, 131.0275°).

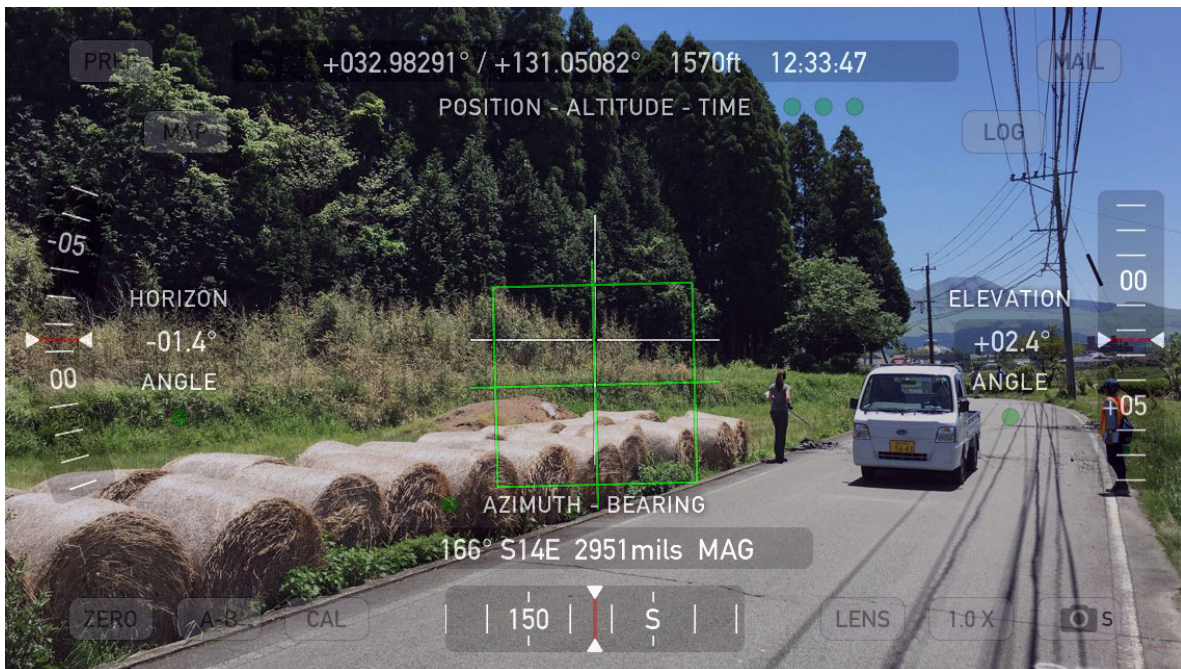
Figure 9-35. The depression zone crosses into a hill.

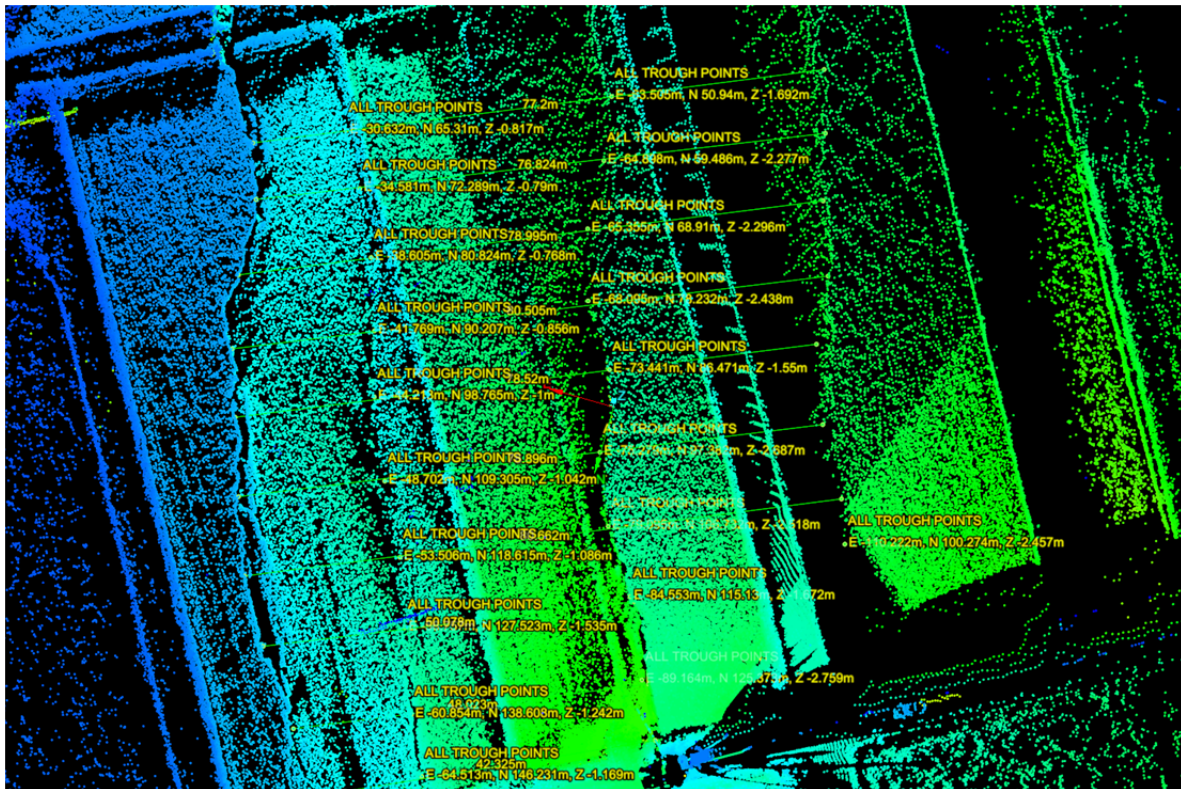
The depression depth varies across the length of the graben and from the south side to the north side. On the south side of the graben, the average depth of the step of the bounding fissure varied from west-to-east from 1.25 m to 0.5 m. The maximum vertical offset of the graben fissure on the south side was 2.39 m (Figure 9-37).

Figure 9-37. Measurements of varying graben width were performed at 10 m steps orthogonal to the axis of the graben. In this figure, the depression fissures on the west end of the LIDAR capture are clearly visible, as well as intermediate fissures that typically had vertical displacements less than 10 cm (approximately 32.9511, 131.0275).

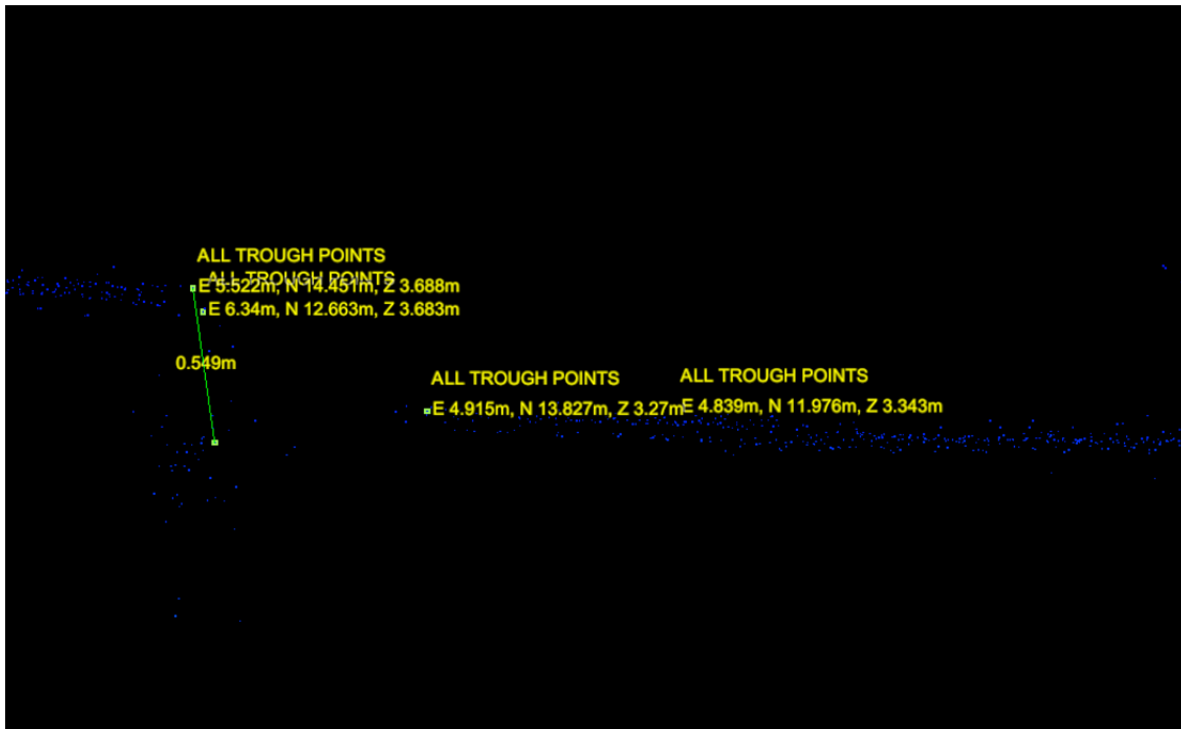
Figure 9-38. Example of fissure step-down measurement along the north side of the graben. Point query was used to determine the vertical elevation offset (approximately 32.9511, 131.0275).

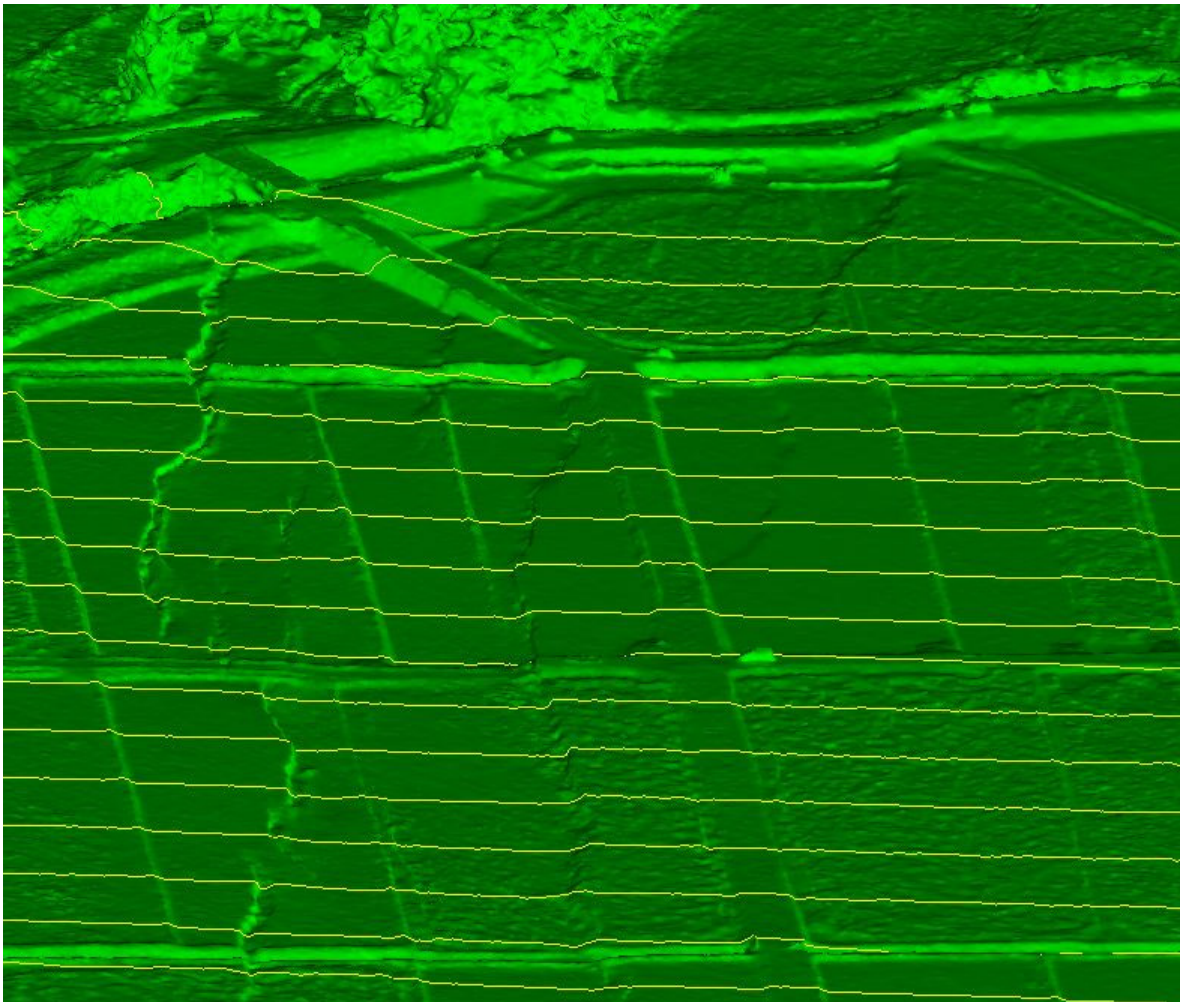
Figure 9-40. UAV estimated ground surface profiles across the depression zone (approximately 32.9511°, 131.0275).

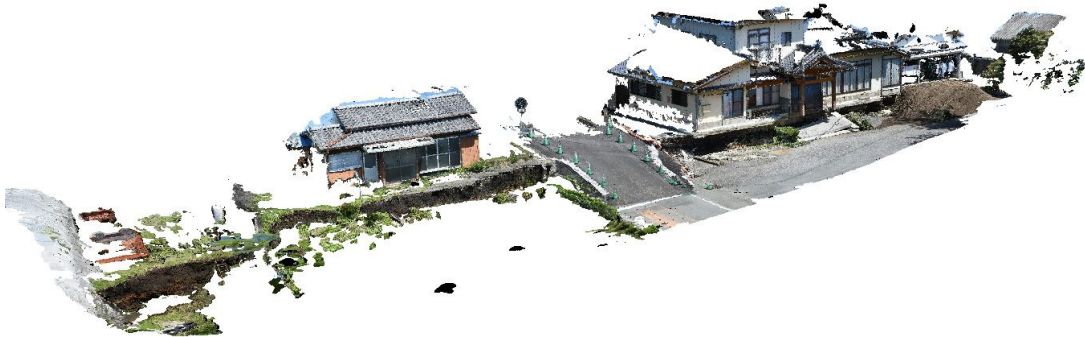
Figure 9-41. Screenshot of the 3D textured model of homes and road damaged by the depression zone (32.95663° N 131.03670° E). The model was developed from approximately 50 digital photographs captured with a Nikon D7100 DSLR camera.

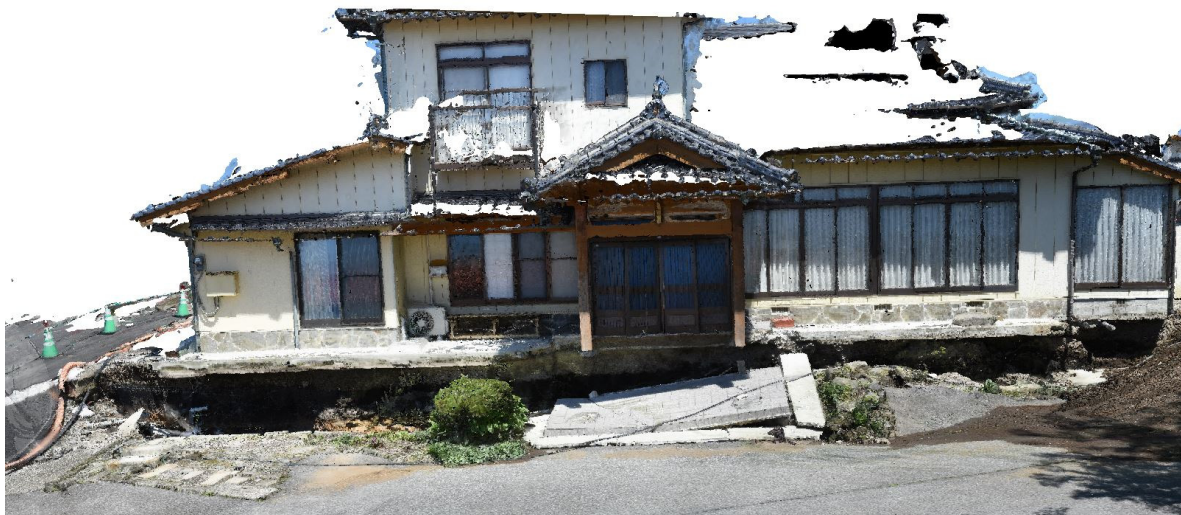
Figure 9-42. Screenshot of a 3D textured model of a house damaged by the depression zone. The model was developed from approximately 50 digital photographs captured with a Nikon D7100 DSLR camera (32.95663° N 131.03670° E).

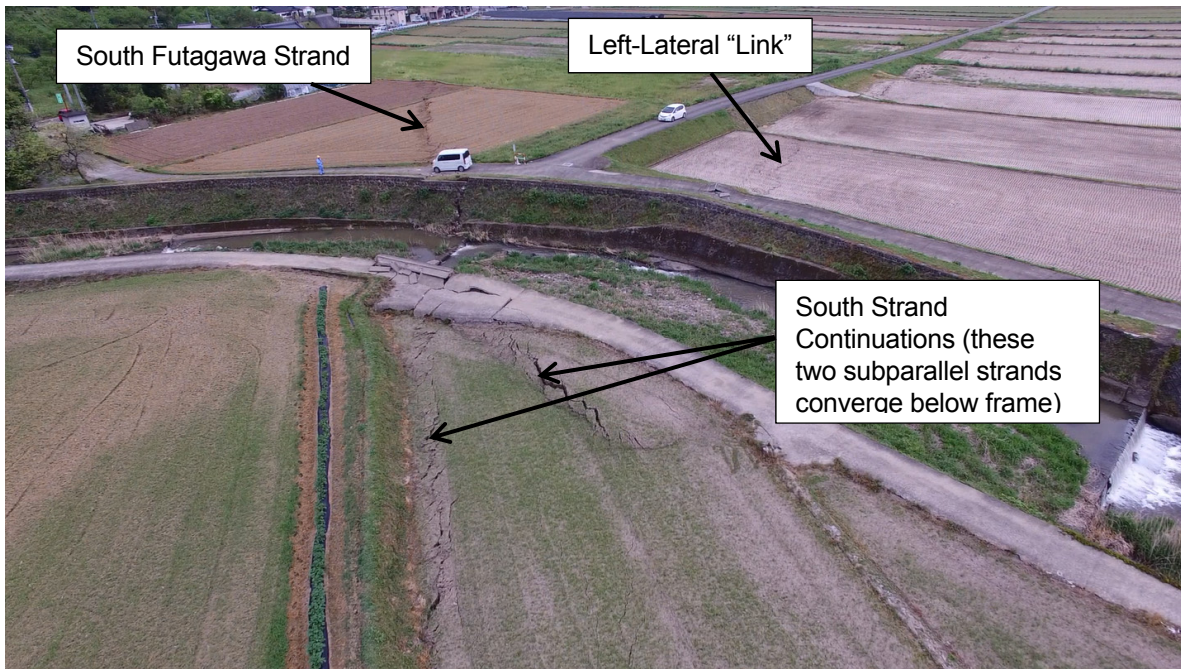
Figure 9-45. Two conjugate fault strands, a southern strand of the Futagawa Fault and a left-lateral link between a more northern strand of the Futagawa Faults (not shown, about 0.6 km north) and this southern strand, rupture through a canal. The link fault does not appear to continue to the other side of the canal (in the bottom of the photo). The south Futagawa strand in the bottom of the photo occurs as two subparallel strands that converge below the frame. This image is a still from UAV video provided by the Geospatial Information Authority of Japan (GSI, 2016).

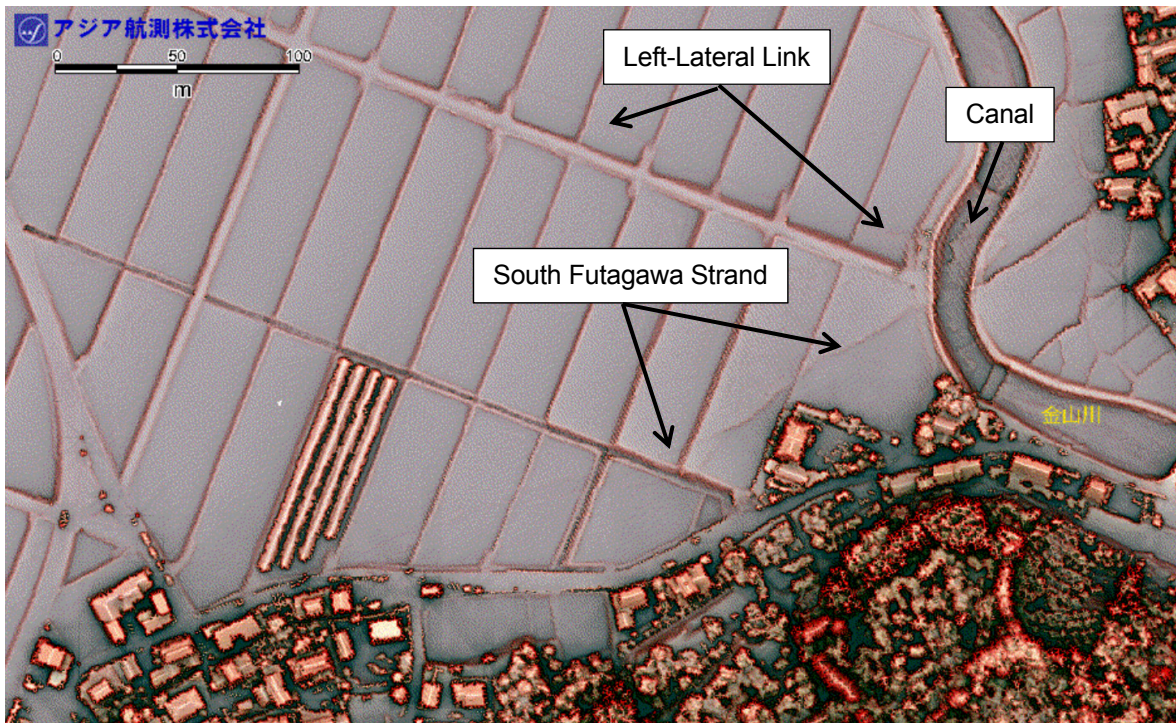
Figure 9-46. Aerial LIDAR of the canal area, showing differential movement from just before and just after the mainshock, from Asia Air Survey (2016).

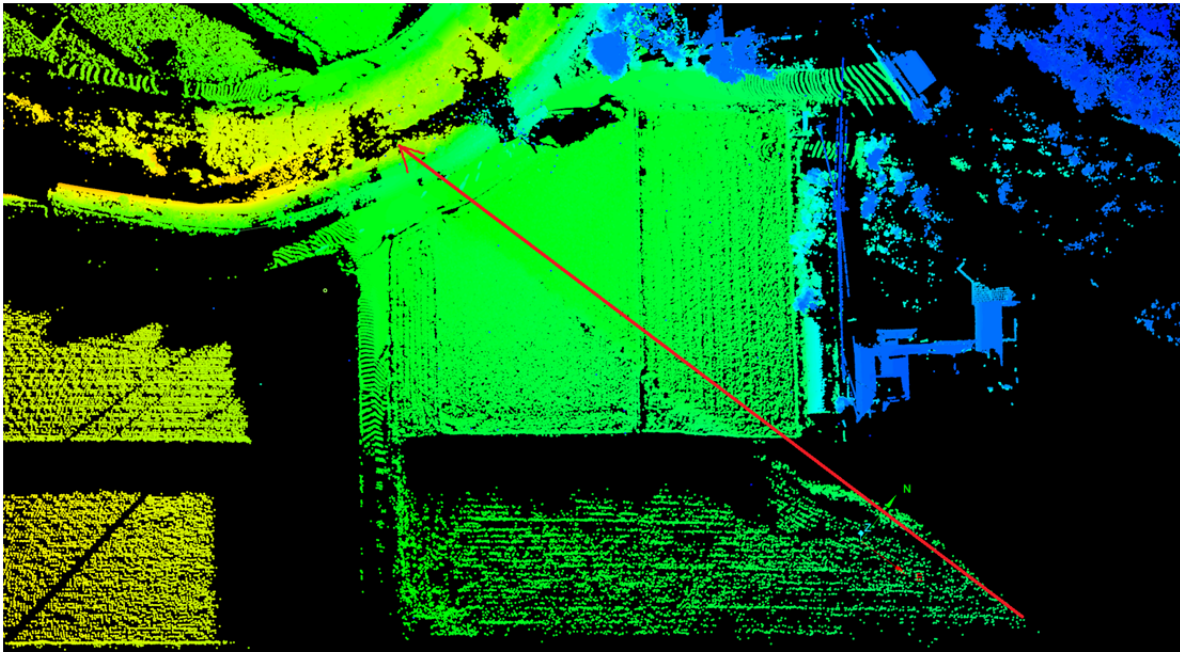
Figure 9-49. Projection of the main strand of the Futagawa fault from the southwest (lower right) to the northeast (upper left). The levee break occurs in the upper left portion of the image at the arrow tip (approximately 32.79731, 130.85361).

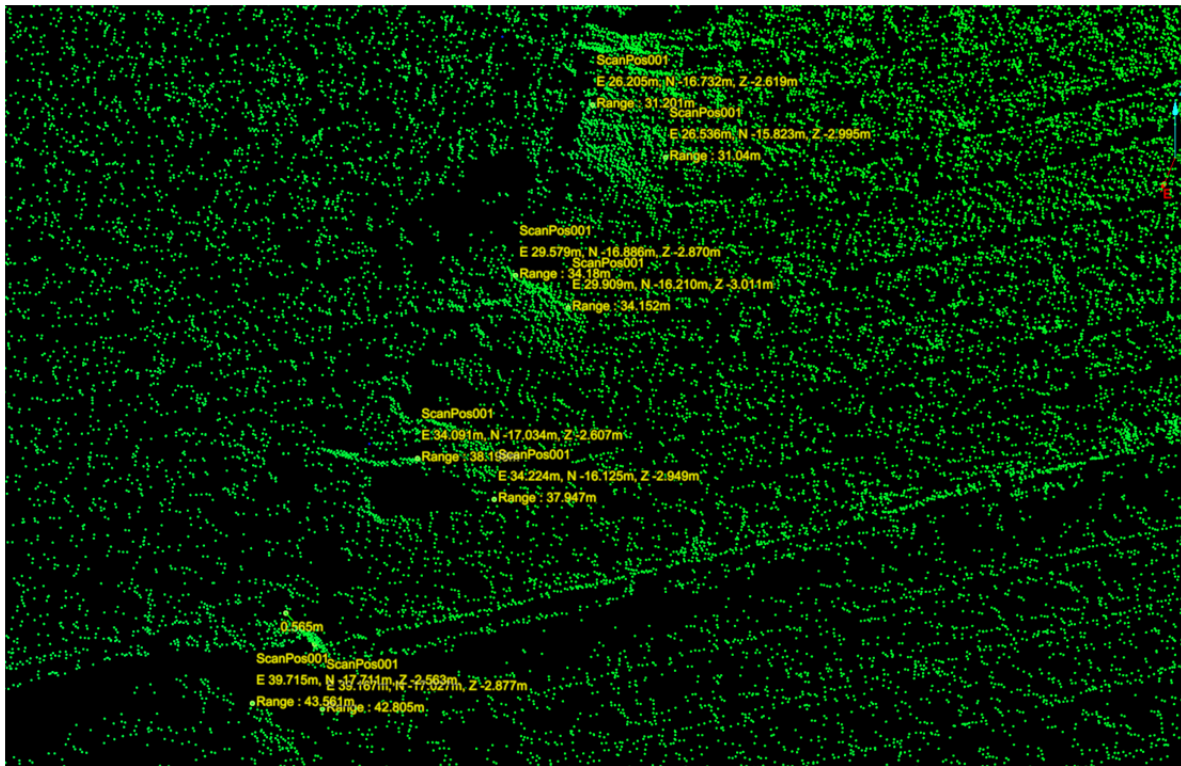
Figure 9-50. Example of measurement of horizontal offset (note offset in the plowed field) and vertical step of the Futagawa fault crossing an agricultural field (approximately 32.79731, 130.85361).

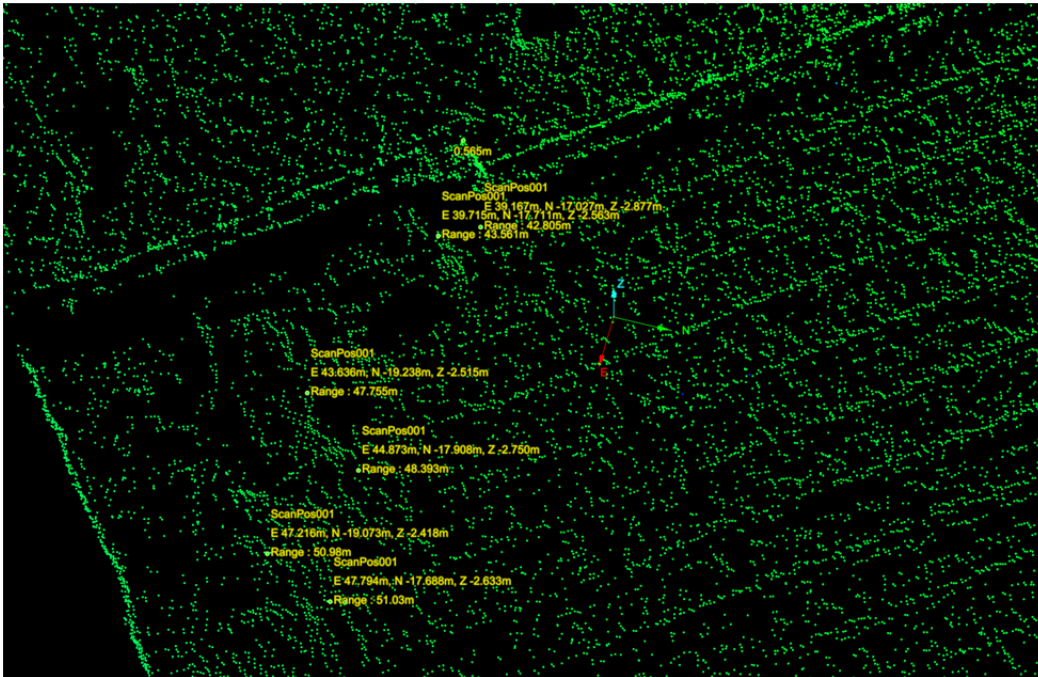
Figure 9-51. Example of measurement of horizontal offset (note offset in the plowed field) and vertical step of the Futagawa fault crossing an agricultural field (approximately 32.79731, 130.85361)

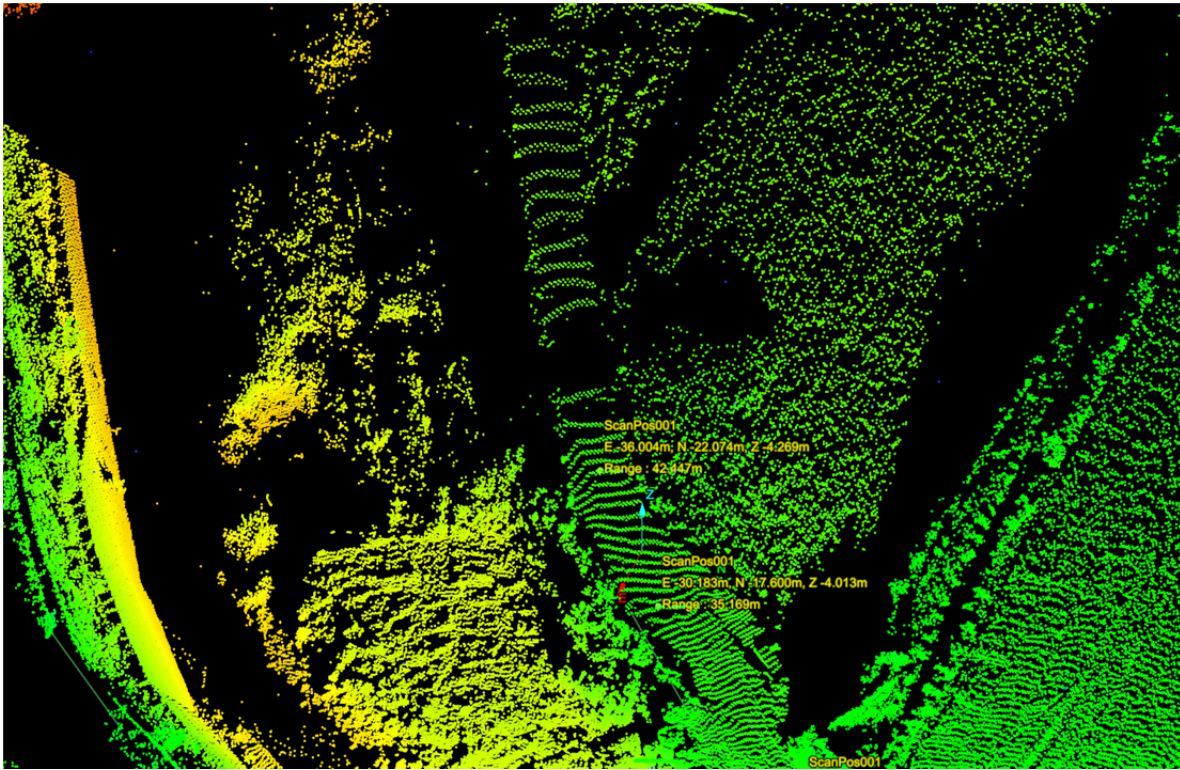
Figure 9-52. Road offset on the east side of the levee offset of the Futagawa fault (approximately 32.79731, 130.85361).

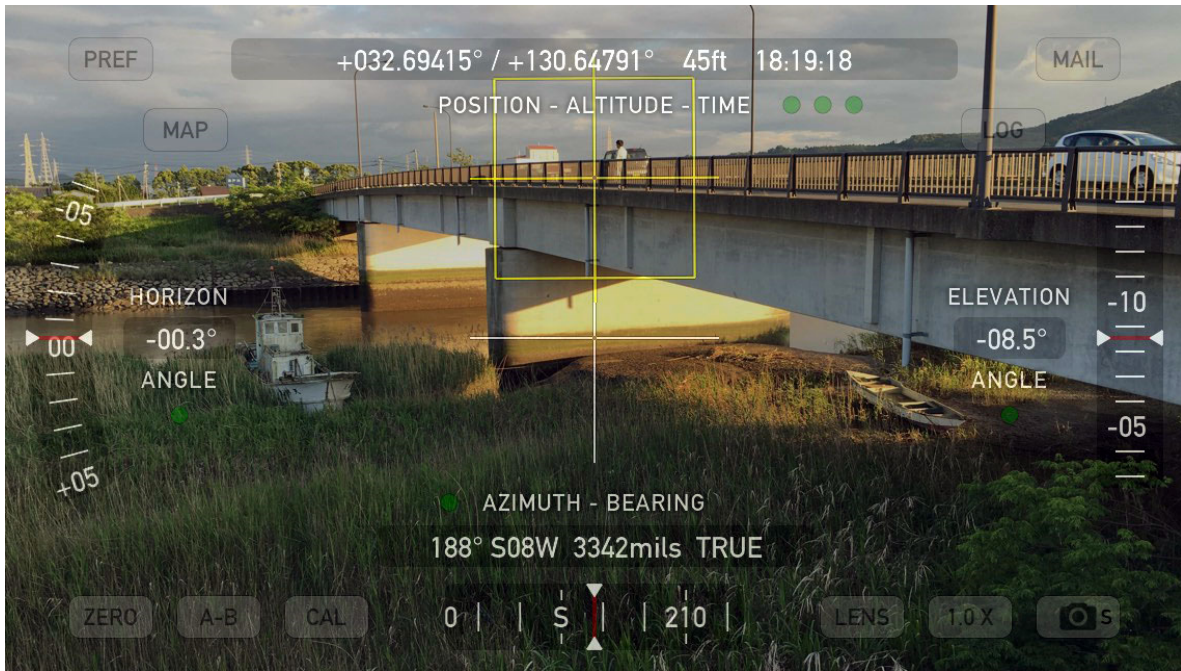
We believe that a zero-displacement lateral spread may have occurred at the large highway bridge on Route 501 crossing the southern tributary of the Midorikawa River near Minamihashirikami (32.69389° N 130.64776° E). The bridge is shown in both Figure 9-53 and Figure 9-54. Investigation beneath the northern abutment of this bridge revealed very minor ground cracks and some small sand boils comprised of fine, dark sand as presented in Figure 9-55. No evidence of lateral spread was visible in the free-field around the bridge, but the existence of sand boils and minor cracking near the northern abutment suggests that at least one soil layer liquefied during the Kumamoto earthquake sequence. This bridge is located approximately 12 kilometers to the southwest of the epicenter of the main shock.

Figure 9-54. View of the Route 501 bridge looking to the south.

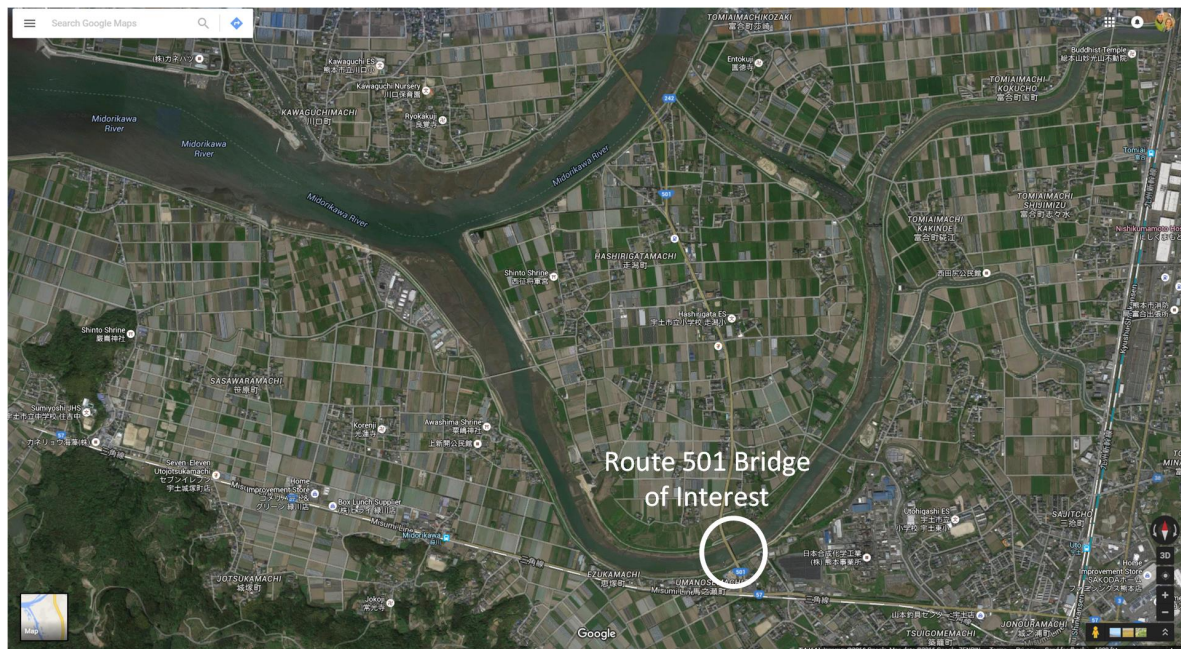
Figure 9-53. Overview map of Route 501 bridge, where we believe a zero-displacement lateral spread may have occurred.
