GEOTECHNICAL EXTREME EVENTS RECONNAISSANCE (GEER) ASSOCIATION

Geotechnical Reconnaissance of the 2016 M_w 6.3 Meinong Earthquake, Taiwan

GEER Association Report No. GEER-046

Version 2: July 14, 2016

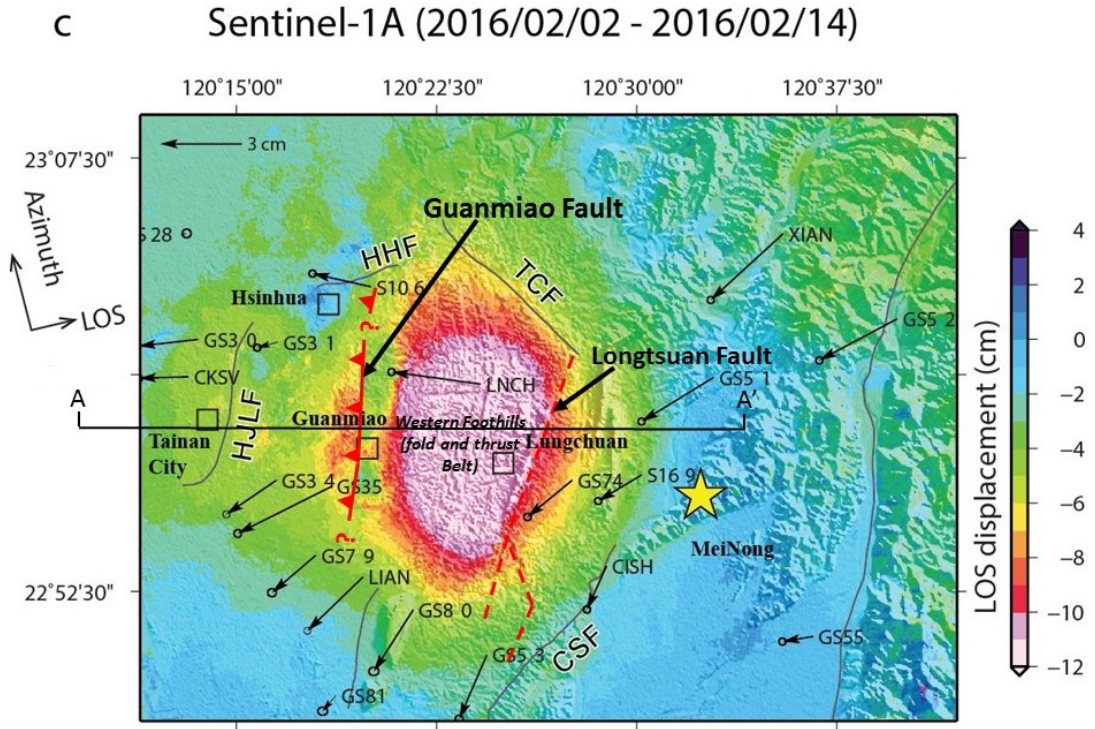
A sharp N-S trending displacement lineament separating the area of uplift (Guanmiao Hills) and the down-dropped Guanmiao Valley shows up very clearly on the InSAR imagery. This sharp displacement lineament appears to delineate a west-dipping, N-S trending fault along the western margin of the Guanmiao Valley, now referred to as the Guanmiao Fault. Existing geologic maps indicate synclinal folding is present in the Guanmiao Valley (CGS, 2005) and Prof. C.T. Lee of National Central University, has discussed a possible fault in this location but no published evidence of faulting has been previously mapped along this sharp displacement lineament that moved during the 2016 Meinong earthquake.

Figure 2-12: Interpreted InSAR image showing the Guanmiao fault and uplift of the Western Foothills Fold and Thrust Belt; See Figure 2-13 for cross section (courtesy of M. H. Huang and JPL-Caltech Advanced Rapid Imaging and Analysis [ARIA] project); the Sentinel-1 image contain Copernicus data.

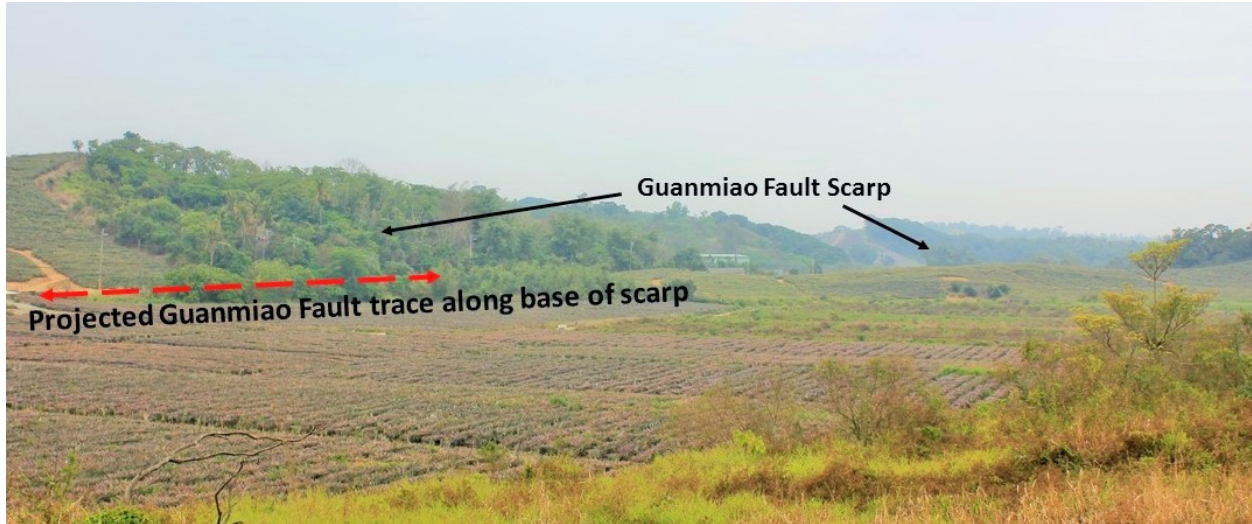
Figure 2-14: View to the northwest of the N-S trending linear Guanmiao Fault scarp (Lat. 22° 59' 41.69" N; Long. 120° 19' 40.98" E).

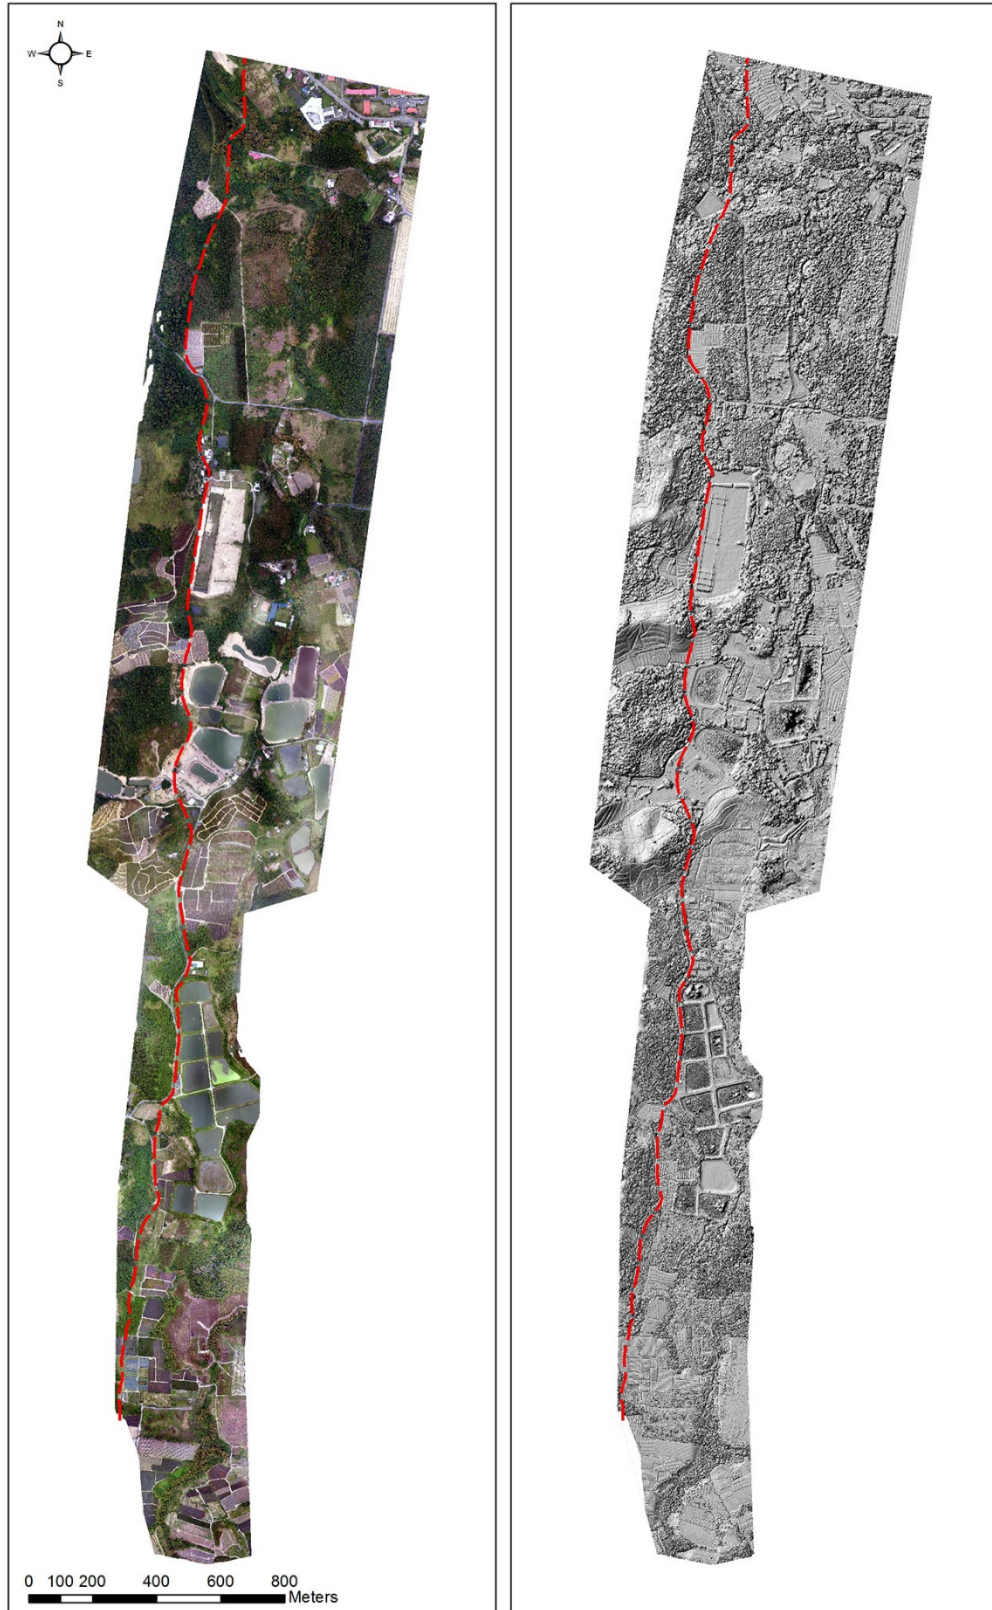
Several days were spent inspecting this lineament and mapping the structure of the hills to the west that are shown to have uplifted during the recent Meinong EQ. As part of our field reconnaissance we collected aerial imagery from two unmanned aerial vehicles (U.A.V. or drones) along approximately 4-5 km of this lineament north of Hwy 3 between Guanmiao and Xinhua. This imagery allowed us to create a 3-D digital elevation model (DEM) to more accurately examine the geomorphic characteristics along this sharp lineament.

Figure 2-15: Orthophoto mosaic (left) and DEM imagery collected from UAV photographs along the Guanmiao Fault (shown in red) between Guanmiao and Xinhua, Taiwan.

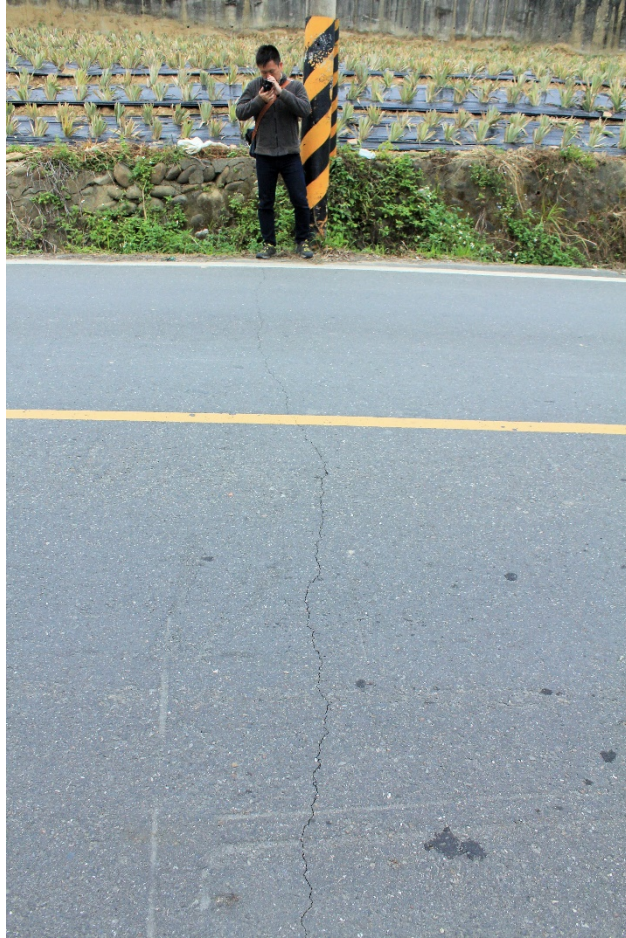
Figure 2-16: View to the north along one of two fresh line cracks within a roadway near Xinhua. The crack is parallel to and aligned with the mapped projection of the Guanmiao Fault but is not conclusive evidence for surface rupture (Lat. 23° 01' 28.30''N; Long. 120° 19' 40.87'' E).

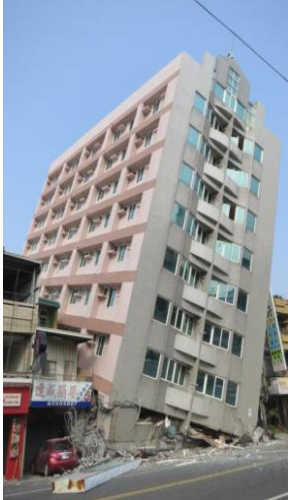
(2) King's Town Bank (京城銀行), Sinhua District, Tainan City

Figure 5-3: Images of collapsed buildings sans the Weiguan Jinlong Complex(維冠金龍大樓) and Wanglin Hotel – Guiren (旺林飯店歸仁館), which are discussed in a subsequent section (organization following Table 5-2).

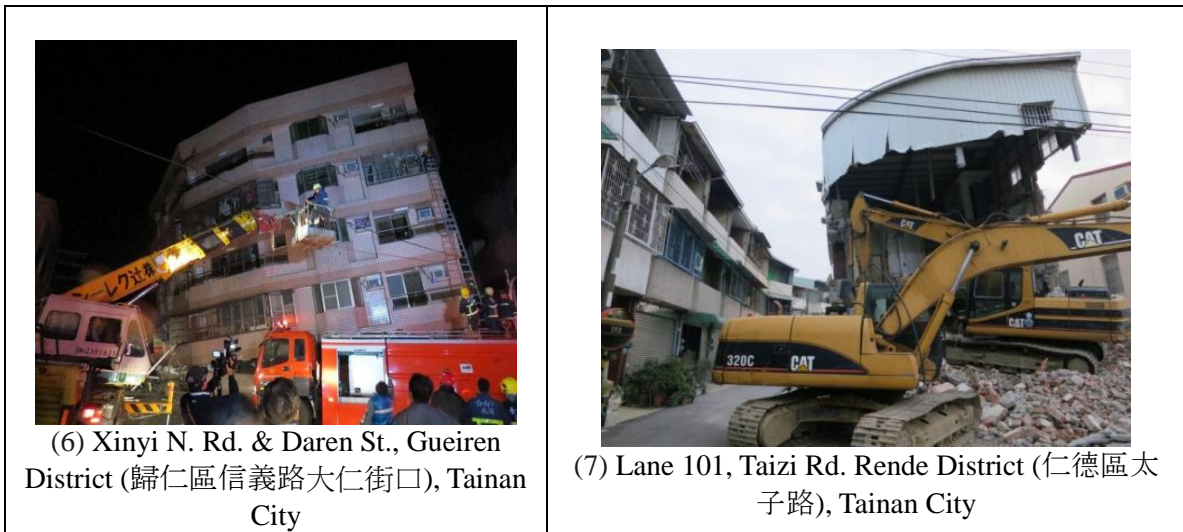
Figure 5-3 (continued): Images of collapsed buildings sans the Weiguan Jinlong Complex (維冠金龍大樓) and Wanglin Hotel – Guiren (旺林飯店歸仁館), which are discussed in a subsequent section (organization following Table 5-2).

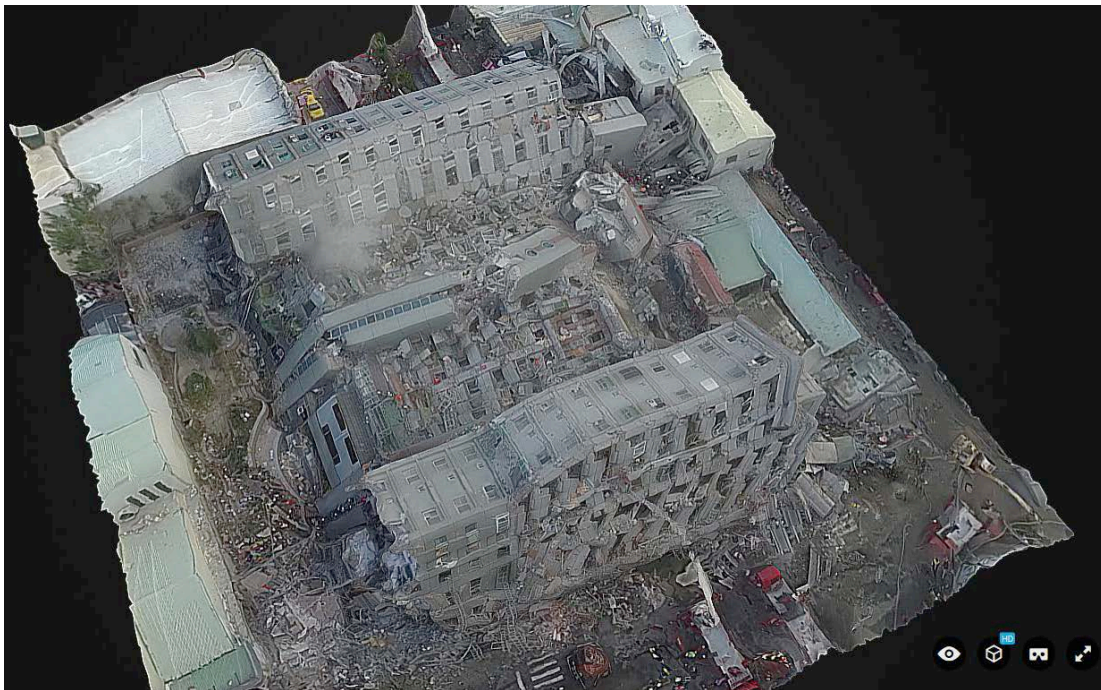
Figure 5-5: Aerial model generated with a UAV flight over the collapsed Weiguan Jinlong Complex (120.261,23.0052) (Created by the Department of Geomatics, NCKU, Tainan, Taiwan).

The collapse of the Weiguan Jinlong Complex (Figure 5-5) in Yongkang district resulted in the loss of 114 lives. This building was a 16-story reinforced concrete structure constructed between 1992-1995 (Figure 5-6), thus it likely followed reinforcing detail provisions comparable to ACI 318-89 (Table 5-1). According to Mr. Justin Shih, who performed an extensive analysis of this building post-event, the structure was designed for a minimum horizontal shear force of $V = 0.062W$, with an estimated period (for an $h_n = 52.5\text{m}$) of 1.17s. Modal analysis by Mr. Shih identifies this period as the torsional mode; and review of field measurements during the 2016 event at station TAI in Tainan city indicates large spectral accelerations at about 1s (Figure 5-7). Due to its vintage, this building was also subjected to the Sept 21, 1999 event (921 earthquake), however suffered no damage. Seismic stations TAI1 and TAI2 were the closest to this building at 4.4 and 5.7km away respectively; and for comparison station TAI1 recorded peak accelerations of 105 and 148gals, whereas these values were about half this amplitude at 44gals and 87gals in the NS and EW directions respectively, during the 921 earthquake (Figure 5-8). In addition to the much larger amplitude ground shaking at periods closer to those of the building, importantly, several structural features likely contributed to the collapse of this building. These include its irregular floor plan and elevation and poor (non-ductile) detailing practices. Standing more than 50-m tall, the building's first floor height vertical irregularity of 5.5m compared to the uniform floor height of the remainder of the building (3.2m), was more than 1.5 times greater. Non-ductile detailing practices included the use of short 90-degree hooks (rather than 135 degree hooks), insufficient beam-column confinement, and the use of inadequate coupler splices at column rebar (particularly notable in the first floor columns (Figure 5-9b)).

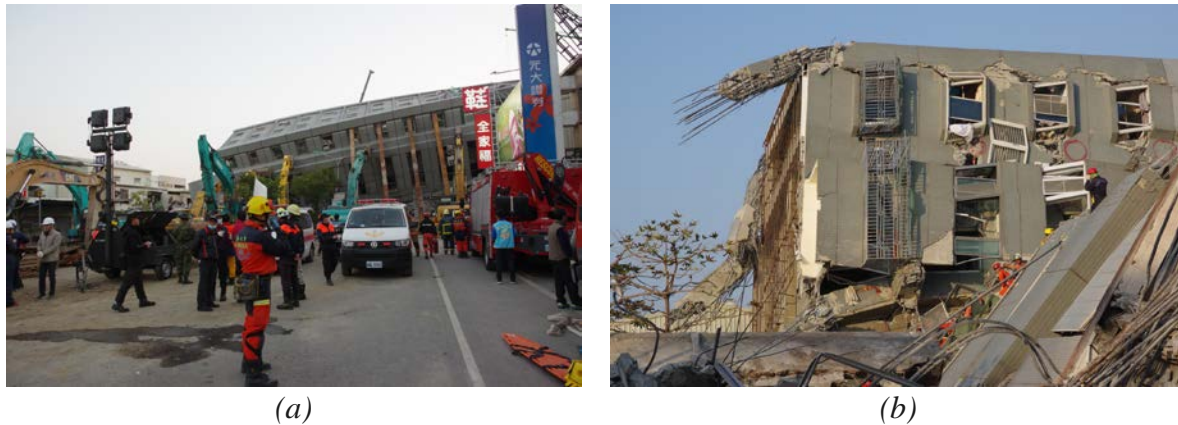
Figure 5-9: Weiguan Jinlong complex (120.261,23.0052): (a) North column damage to building and (b) close-up of building column reinforcement, which directly pulled out at the first floor. (images courtesy of Justin Shih).

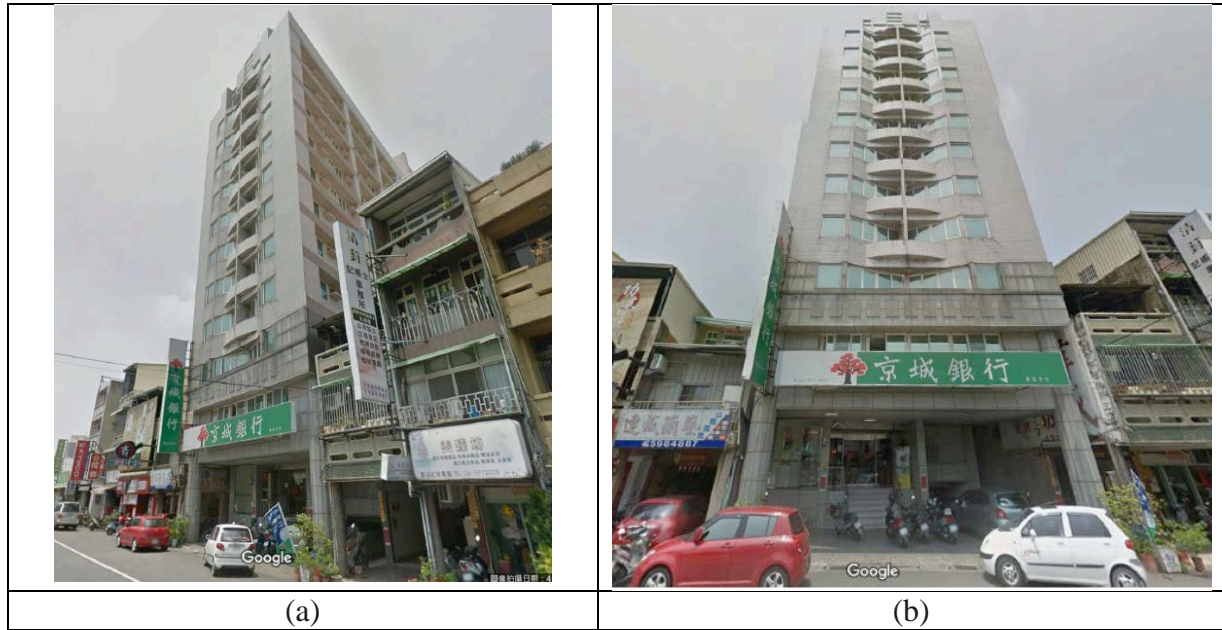
The King's Town bank was a 10-story mixed use (retail/residential) building in Sinhua District that collapsed at its lower floors (Figures 5-10 and 5-11). The ground floor of this building was notably taller than the uniform floor height over floors 2 through 10. Because of a substantial wall located at the rear of the building compared in contrast to the large open walkway in at its

front, it is likely that the primary response of the building was torsional, resulting in large displacement demands on the singular frame at the front of the building. Two mid-rise residential structures approximately, 100-m from this building, suffered minor damage during the earthquake, without impact to their continued use after the earthquake (Figure 5-12).

Figure 5-10: King's Town Bank Google street view images before the earthquake (23.036, 120.301).

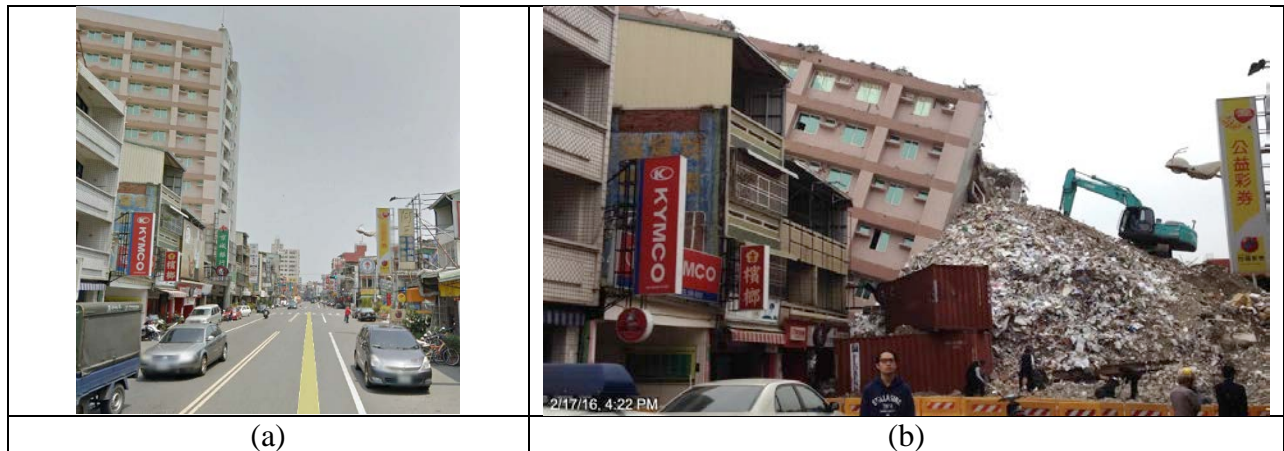
Figure 5-11: King's Town Bank (a) prior to earthquake and (b) during demolition (February 18, 2016) – both views looking East (23.036, 120.301).

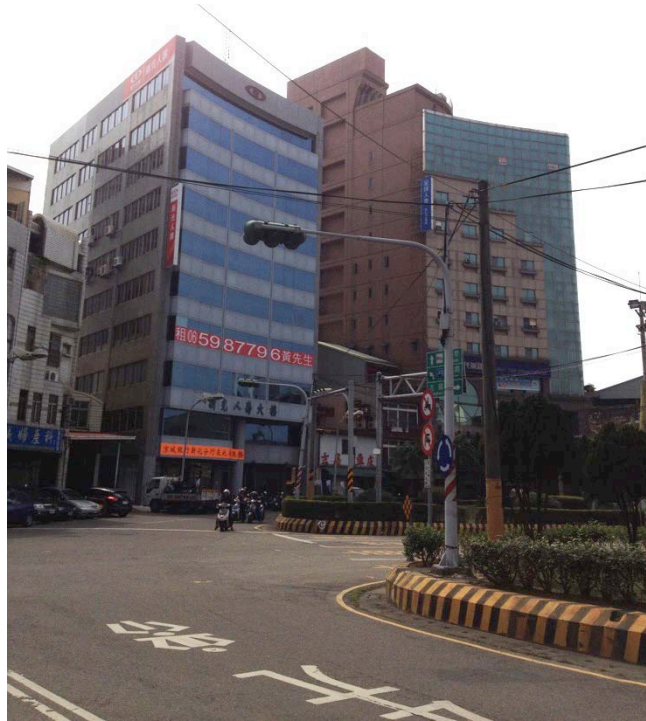
Figure 5-12: Pair of 10 and 12 story buildings about 100m from the King's Town Bank (23.0363, 120.300) – the building on the right suffered minor damage. Both were operational after the earthquake.

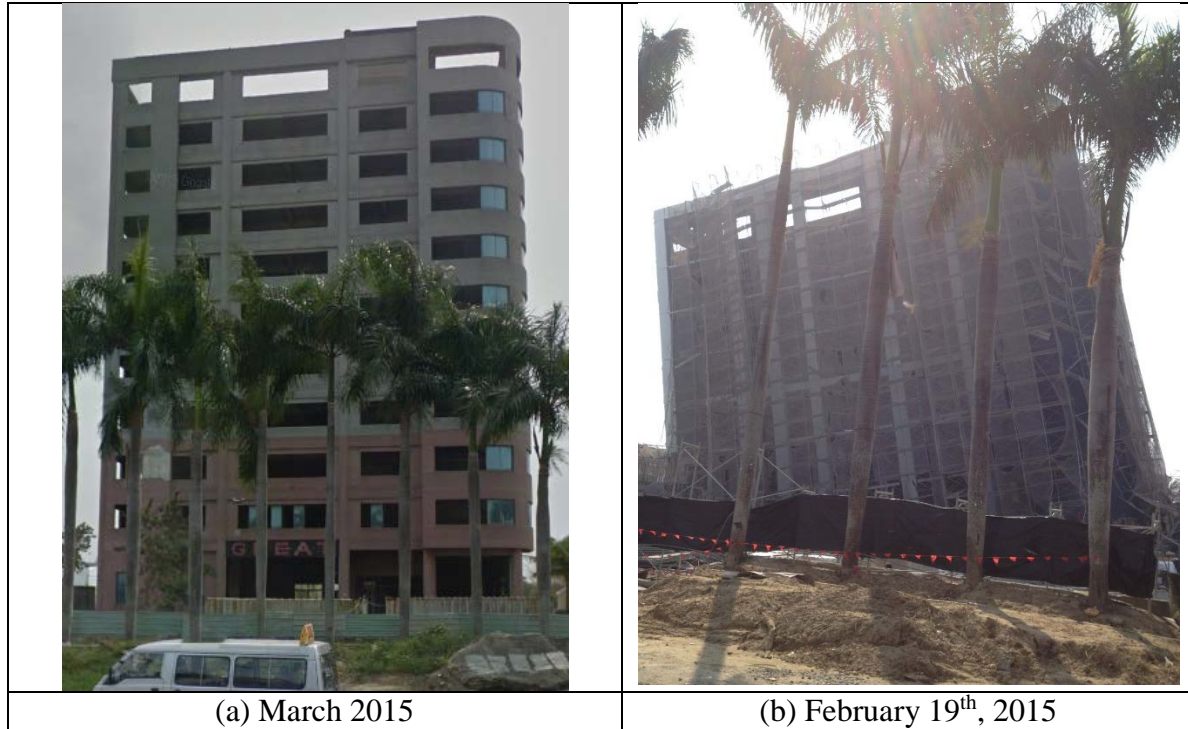
The Wanglin Hotel - Guiren (旺林飯店歸仁館) collapsed during the Meinong earthquake (Figure 5-13). This building was a 10-story plant office building completed in 1996. However, this building had not been occupied for the past 20 years. In 2014, Wanglin Hotel (旺林飯店) purchased the building and began remodeling the building to serve as a hotel. The online announcements provided by the new owner, Wanglin Hotel, indicated that the remodel was non-structural. A photograph from Google Street View taken in March 2015 before the earthquake and a photograph taken by the GEER team on February 19th, 2016 are shown in Figure 5-13. After the earthquake, the lower 5 stories collapsed on the west side and the lower 6 stories collapsed on the east side. As a result, the building leans toward the east at a 15 degree angle. No evidence of soil liquefaction or movement of the foundation were noted at this site. For safety concerns, the GEER team did not conduct observations inside of the building. However, damaged columns in this building exhibited evidence of nonductile detailing. The lateral force resisting system appeared to be unbalanced, most likely causing a torsional response to the earthquake motion, imposing large displacement demands on tall first story columns. The common locally adopted style of leaving a walkway in the front area of buildings rendered a major shortcoming to this and other buildings, resulting limited lateral load resistance and precipitating a torsional problem. In this particular building, vertical and plan structural irregularities also appeared to significantly contribute to its collapse.

Figure 5-13: Photographs of the Wanglin Hotel, Guiren (旺林飯店歸仁館) before and after the earthquake.

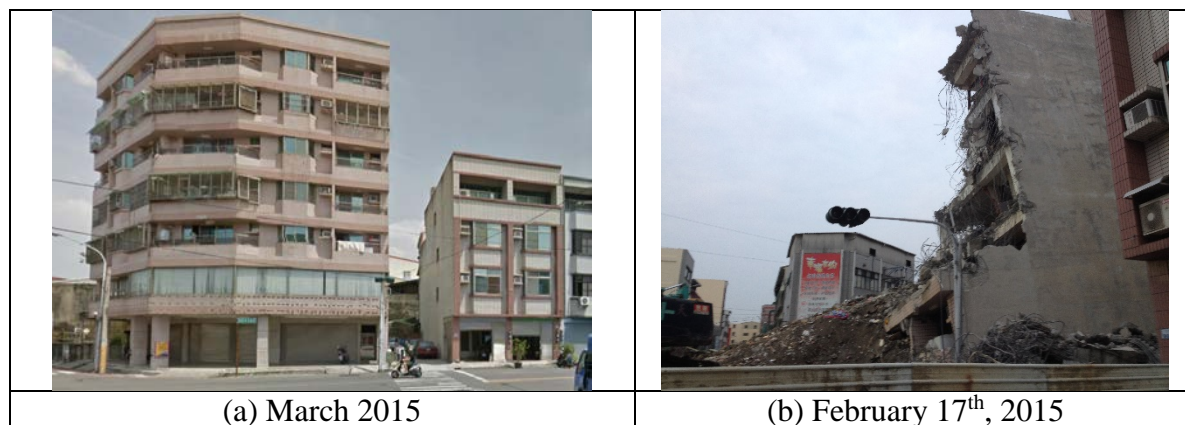
The street building at the intersection of Xinyi N. Rd. & Daren St., in Gueiren District, Tainan was a 6-story building with residential occupancy. A photograph of the building before the earthquake from Google Earth street view is shown in Figure 5-14a. The street side of this building was constructed without walls to allow a pedestrian sidewalk of about 3 meters width. This is a common architecture feature called 騎樓 (veranda) in Taiwan. A photograph of a nearby 4-story building is also evident in the right side of Figure 5-14a. This 4-story building was not damaged by the earthquake. Columns in the veranda area of the building that collapsed failed during the earthquake, and the building tilted toward the street following the earthquake. This building was under demolition during the GEER team visit (Figure 5-14b). However, the team noted no evidence of soil liquefaction or manifestations of movement of the buildings foundation at this site.

Figure 5-14: The Street Building at Xinyi N. Rd. & Daren St., Gueiren District, (歸仁區信義路大仁街口) before and after the earthquake

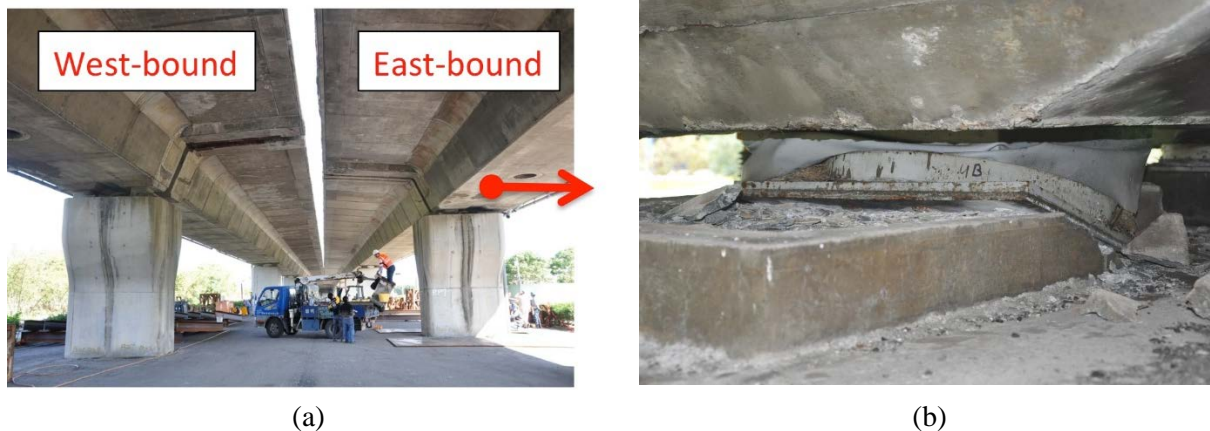
Bridges in the region impacted by the earthquake generally performed well. Nearly all bridges were functioning following the main event, although several were noted to have sustained at least minor cosmetic damage. The only bridge not functioning was the East-bound direction of elevated, provincial highway 86 bridge #24 (22.9258, 120.5380), which was closed to traffic immediately after the earthquake. NARLabs surveyed this bridge and presented its findings during an NCREE briefing which the GEER team attended. What follows is a summary of their observations (Liu, 2016). Bridge #24 along highway 86 is approximately 29 km west of the epicenter, and was constructed in 1996. Teles predicted the PGA near the site was 0.25g. Constructed with a single cell box girder superstructure supported on 13 piers, which are each in turn carried by a pile group, the East-bound direction of this structure spans 555 m. Failure of the bridge manifested due to the unseating of spans RP5-RP9, which were supported on either hinged or movable bearing types. NARLabs reports a maximum residual gap between the West and East bound spans as 59 cm (Liu, 2016) (Fig 6-1).

The maximum separation of 59 cm between the east and west-bound directions reportedly included outward displacement of the east-bound direction of over 40 cm and over 10 cm of displacement of the west-bound direction. The reported maximum permitted displacement of the bridge is 70 cm. The bridge was closed for repair during the GEER reconnaissance and repair construction was proceeding (Fig 6-2).

Figure 6-1: Provincial highway 86 bridge # 24: (a) separation of east and west bound elevations and (b) failure of hinge bearing at RP9. (Images courtesy of Dr. Kuang-Yen Liu, NARLabs).

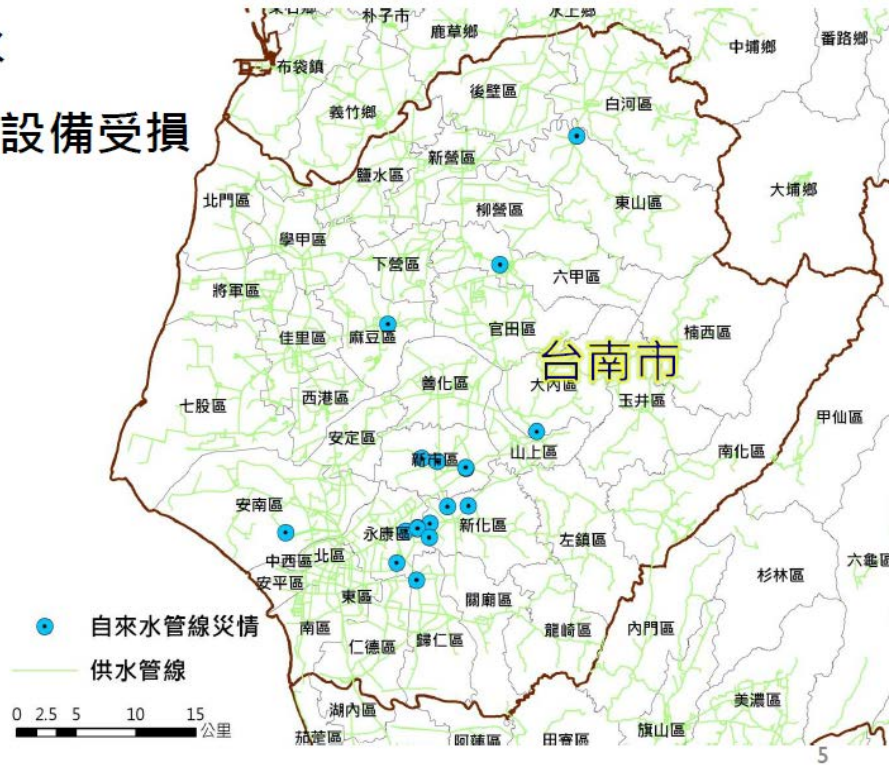
Figure 6-3: Location of Damaged Waterline (from NCDR).

Based on the information provided by Taiwan Water Corporation, 26 damage locations were identified in pipelines with diameters of 300 mm or greater with the largest damaged pipe being 2,400 mm in diameter. Figure 6-3 shows 18 of the 26 locations reported. Pipeline materials that experienced damage

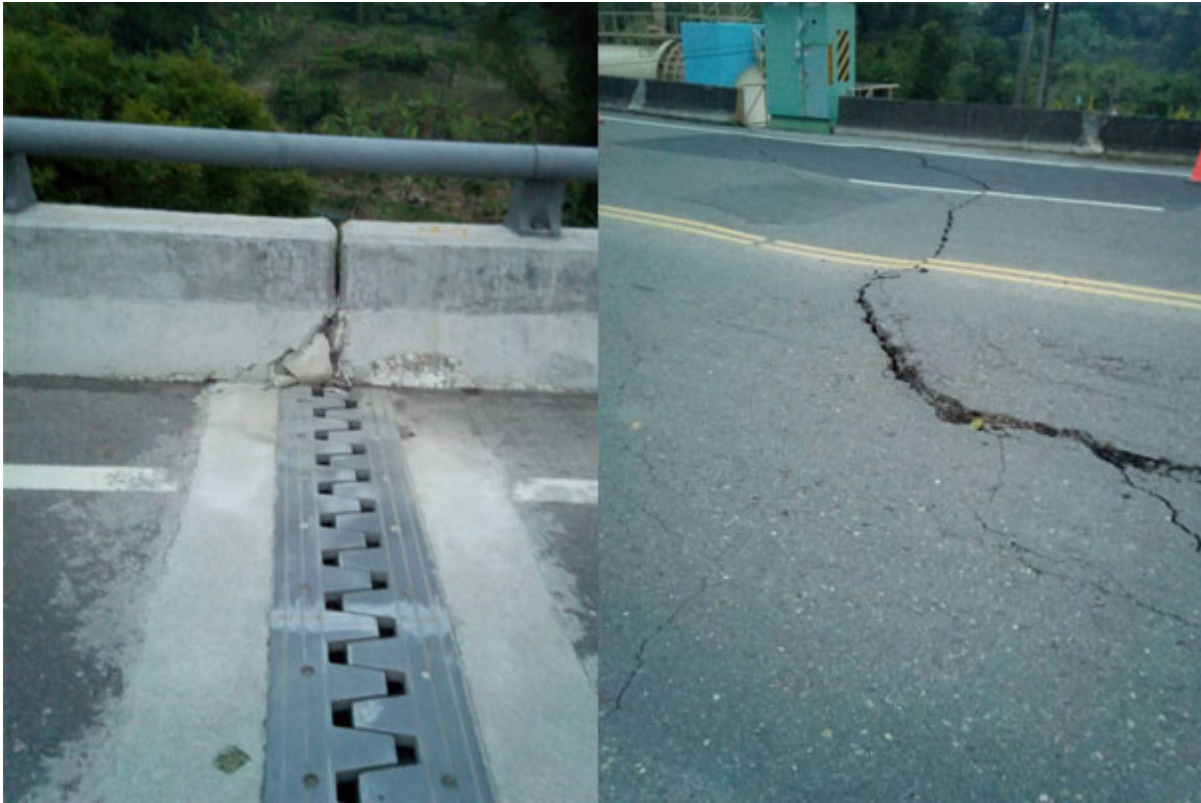
Tai-3 highway near Sta. 369K, pavement bulged 20 cm from earthquake (Figure 6-7). At the Don-Shi-Pu (東勢埔) bridge, differential movement of 10 cm occurred across the bridge deck. The road was closed as a precautionary measure. The Taiwan High Speed Rail (bullet train) suspended service to 30 km north of Tainan city. After a mandatory post-earthquake inspection, full service was restored by 2/7/2015 17:00. The Taiwan Rail Corporation reported minor distress of rails north of Tainan near Chia-Yi. Train operation was not suspended but operated at a reduced speed in the distressed zone. This repair was completed on 2/17/2016 and the train restored to normal operation at 19:00. There was no reported impact to air traffic.

Figure 6-7: Pavement and Bridge Deck Distress along Tai-3 Highway.

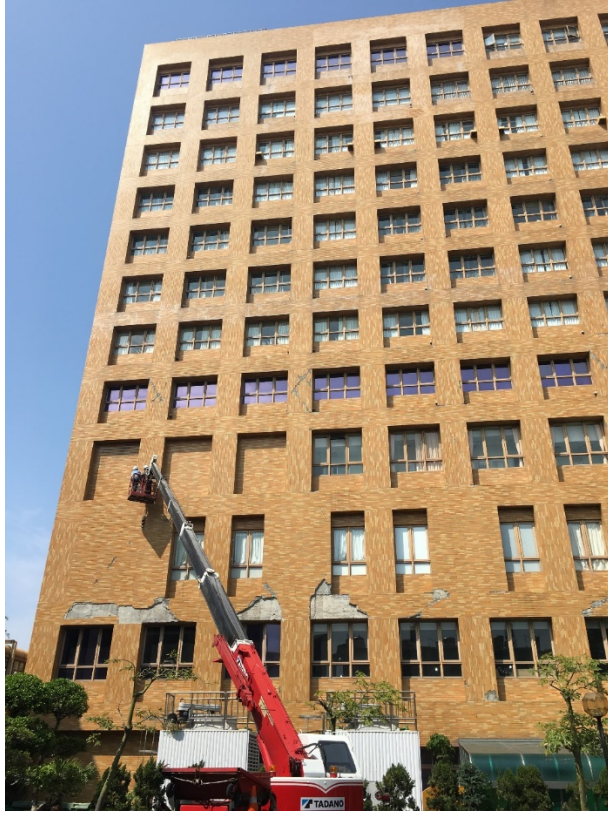
Taiwan media reported that the response by hospitals, fire departments, and other emergency operations was not significantly hindered following the earthquake. While the GEER team did not visit emergency facilities during its efforts, U.S. engineers from Degenkolb did; therefore, what follows is a summary of their findings. Degenkolb engineers visited two hospitals while in Tainan: the NCKU University hospital (成功大學醫院) and the 1200 Bed Chi-Mei Hospital (奇美醫院). The Chi-Mei Hospital was closest to the damage sites therefore received the most casualties. This hospital (Figure 6-8) consists of two main bed towers with a connecting tower structure, with a total of 1200 beds (mostly 4 beds per room). Each of the three buildings is seismically separated from the other. The towers are 12 stories above ground. One tower has two stories below grade, and the other has four stories below grade. The first tower was constructed in the 1980's and the other in 1992. From the exterior of this structure, removed brick veneer removed from a number of wall piers/columns was visible. Hospital staff indicated that the veneer had been removed to avoid falling hazards. Review by local engineers indicated that cracks to the concrete core of the building were small; and that the veneer was the most significant damage to this building. The lone nonstructural failure highlighted by hospital staff was the failure of a 10-12" chilled water pipe near the 11 and 12th floors. After the earthquake, this hospital received approximately 100 patients, mostly with minor injuries. No disruption of service occurred to this hospital. The NCKU hospital (成功大學醫院) observed very minor damage in the form cracking of brick veneer, however very little concrete cracking underneath.

Figure 6-8: 1200 Bed Chi-Mei Hospital (奇美醫院) (23.02095, 120.22206) (image courtesy of Degenkolb).

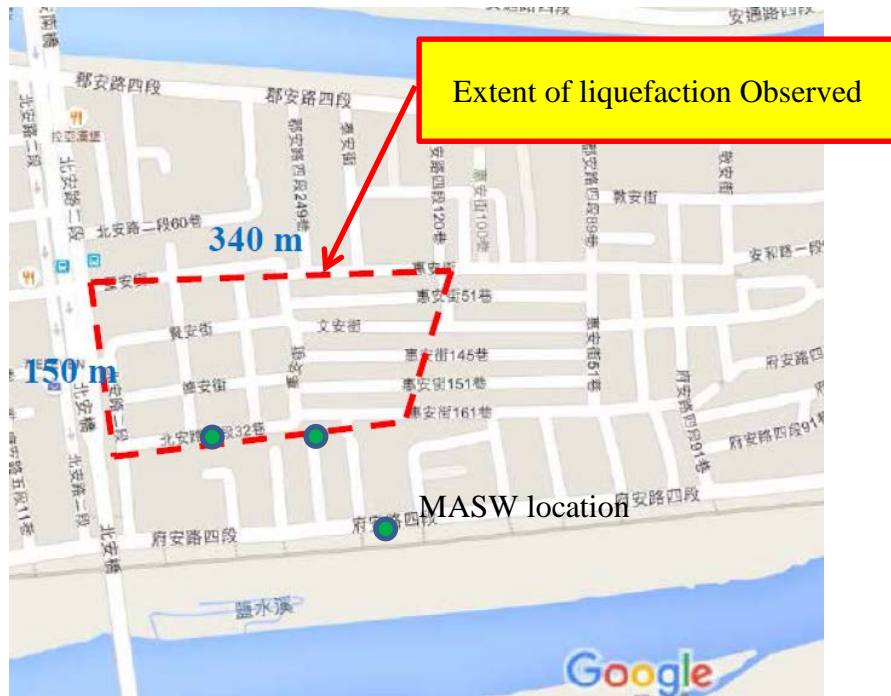
The Annan site is located in the Dinshi community of Annan district, Tainan city. Based on the distribution of sand boils and building settlement, the zone of liquefaction of the Annan site is outlined in Figure 7-2. Overlapping the current and the 1898 maps in Figure 7-3, clearly indicates that the liquefaction occurred in the area mapped as an old fish pond, with the two sides of the liquefied boundaries located along the mapped old dike. Field reconnaissance identified differential settlement along the dike as high as 50 cm in some locations.

Figure 7-2: Liquefied zone of the Annan site ([23.025585°, 120.207441°](https://www.google.com/maps/@23.025585,120.207441)).

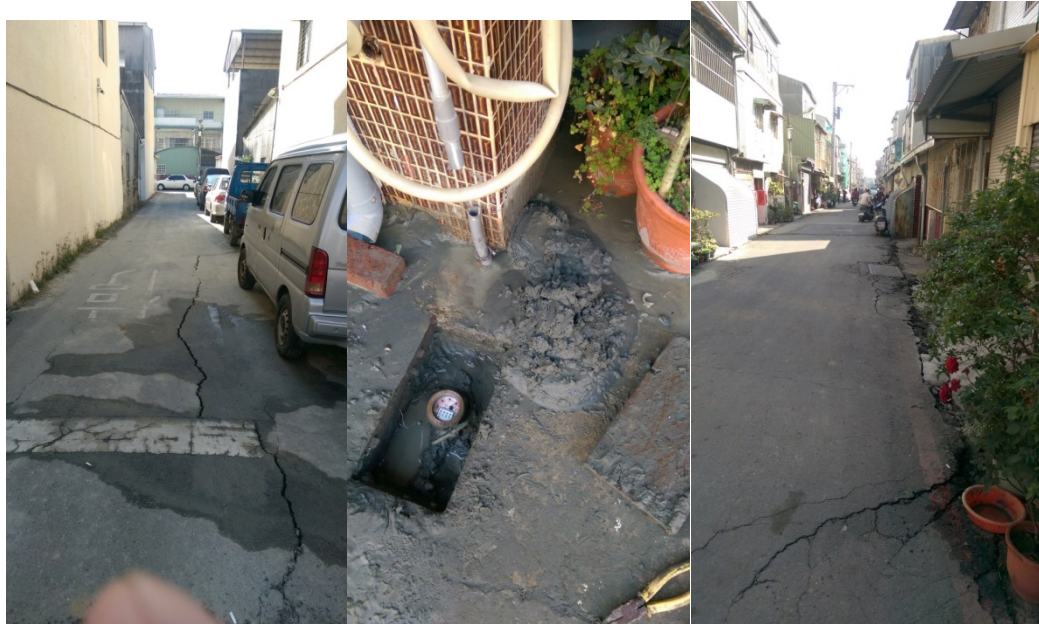
Exterior hardscape evidence of damage was readily visible in the form of pavement cracking; sand boils, and disconnected water supply lines (e.g. Figure 7-4). Liquefaction in this developed area is generally manifest at the surface in several ways: sand ejection along structural perimeter boundaries and along utility lines, building tilting and/or settlement resulting from liquefied foundation soils, and sand ejection along edges of the interior slab (Figure 7-5).

Figure 7-4: Typical failure patterns of pavement crack, breakage of water pipe, and foundation settlement in the Annan district.

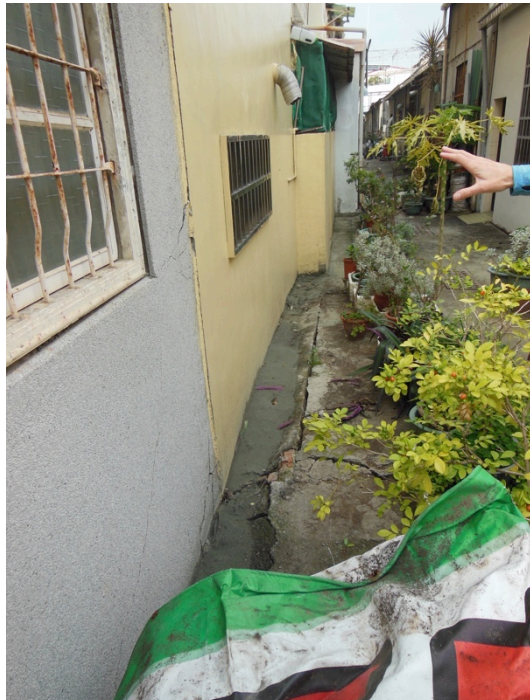
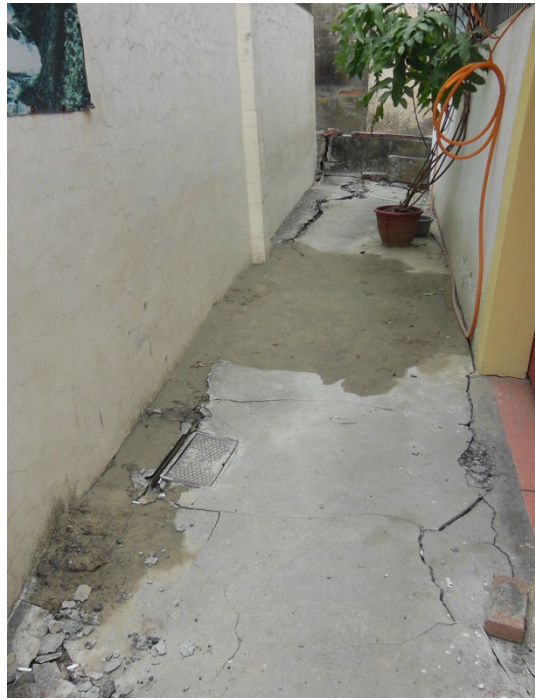
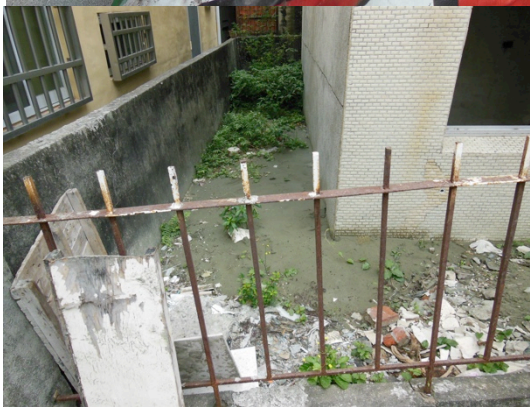
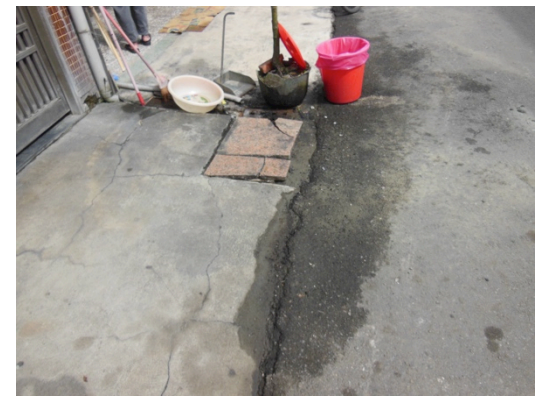
Figure 7-5: Liquefaction surface manifestation in the Annan District ([23.025697](#), [120.207138](#)).

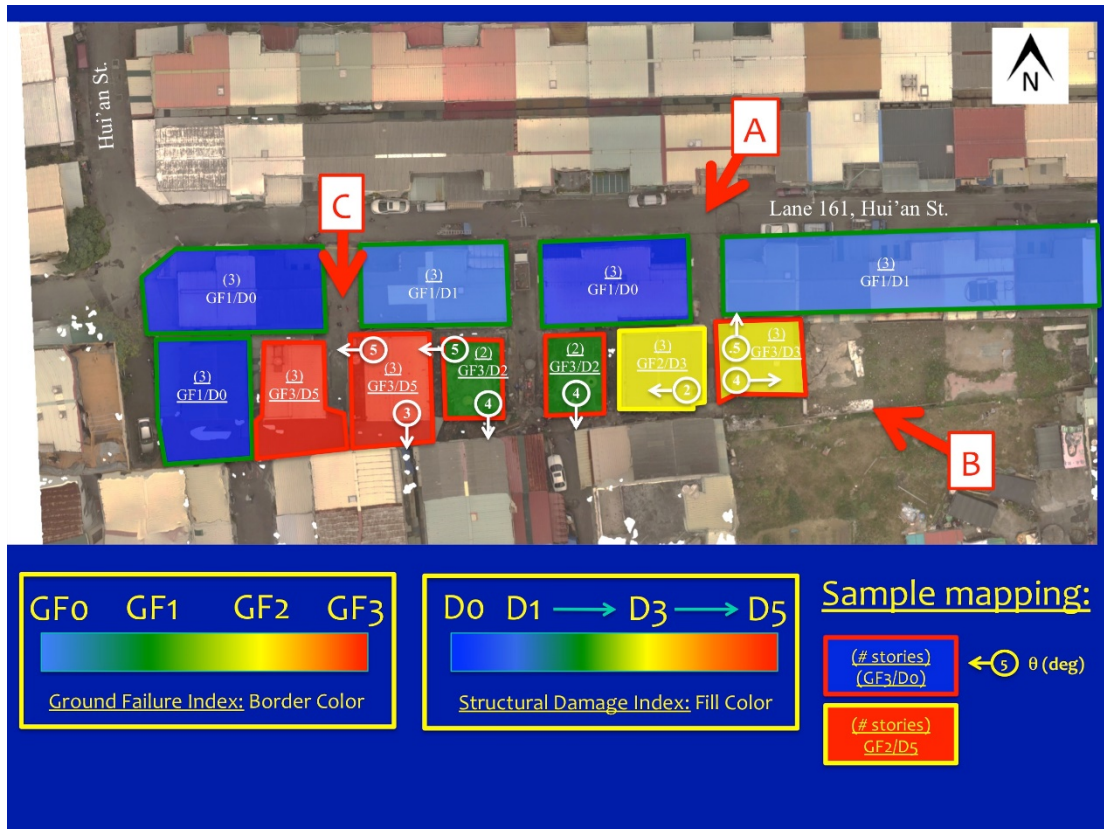
Figure 7-6 adapts the ground failure-structural damage mapping used in Bray and Stewart (2000) with a simple color-coding overlaid on individual buildings in a local region most heavily damaged. This map is useful as it provides context to the extent of ground failure as contextualized with foundation damage and its link with physical damage state of buildings in the region. To interpret the map, note that ground failure is delineated via color-coding of the border of individual buildings; while structural damage is delineated via color-coding of the fill used within the building outline.

Several important aspects can be investigated in the context of Figure 7-6. Beginning with the highly dominant blue shading at the exterior building, these long buildings consistently observe little to no structural damage as graded with a structural damage index between D0 and D1; despite the presence of ground failure features, though graded as minor GF1. The pair of photos shown in Figure 7-7 articulates an example of a nominal ground failure graded as GF1, where settlement of the structure is observed; yet at most damage to the structure is only cosmetic in nature (graded as D1); despite the manifestation of settlement, the lack of significant structural damage is likely due to the well connected and continuous foundation of this building. Moreover, no building extensions were noted in these buildings. In contrast, structures within the interior of the damage map shown in Figure 7-7 demonstrate significant structural damage (graded as yellow through red or D3->D5), these excessive structural damage regions of the district were mostly associated buildings with structural discontinuities primarily at the foundation, and often associated with light-weight single story addition regions.

Figure 7-6: Assessment of ground failure – structural damage index (A, B, C denote images shown in Figures 7-7, 7-8, and 7-9, respectively). (center of region at: 23.0254°, 120.2074°).

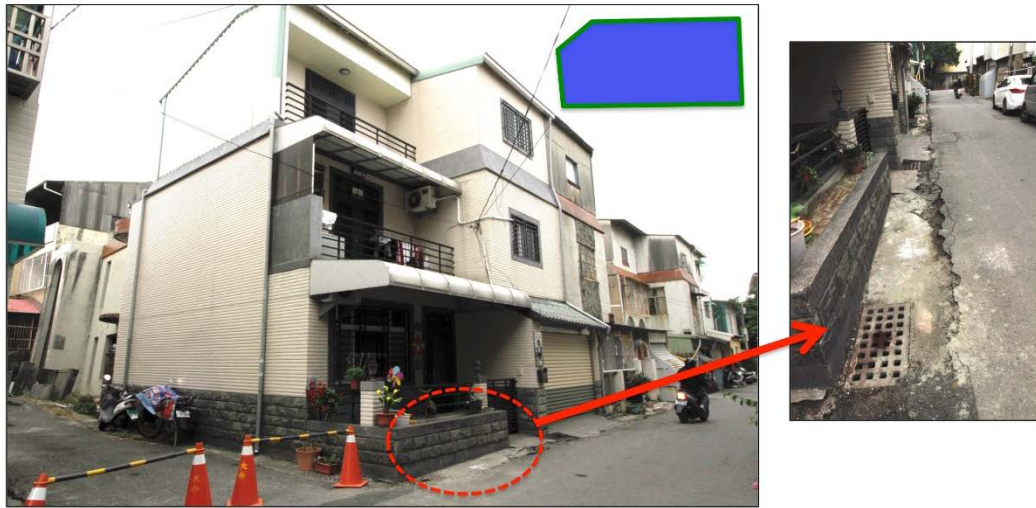
Figure 7-7: Example of mapping GF1-D0 (or GF1-D1). (23.025561°, 120.207827°).

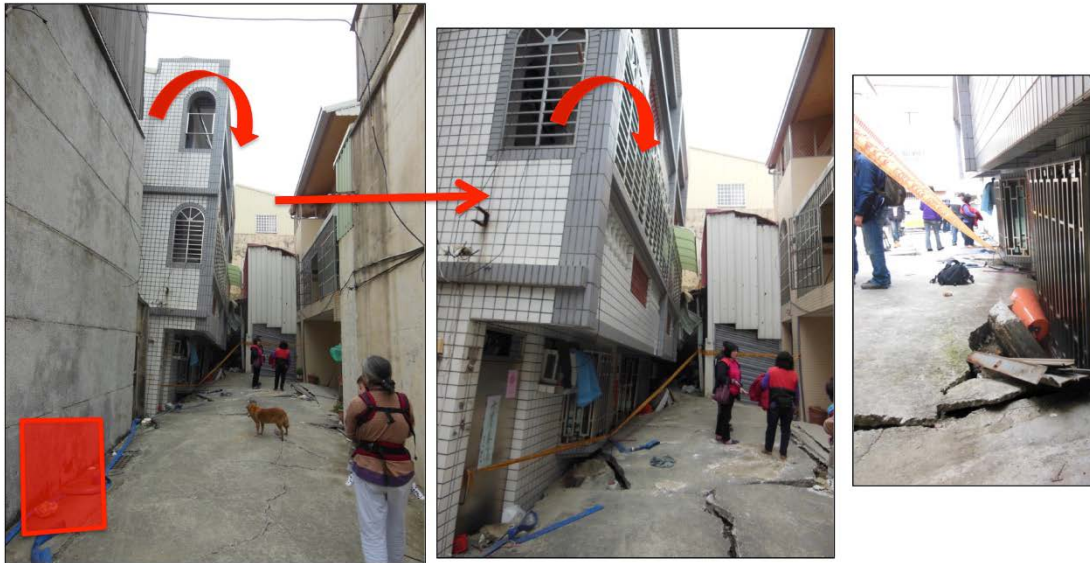
The sequence of images in Figure 7-9 articulates severe ground failure and corresponding structural collapse. For reference, a pre-earthquake image obtained from Google streetview is shown in Figure 7-10. This alleyway, though narrow; provides a perspective of a number of important features. In Figure 7-9, to the left an excessively tilting and settling building, within the middle a single story (high-bay) addition is visible. The middle single story (high-bay) addition is attached to a 3-story structure on the right, which suffered excessive settlement on the

order of more than 30cm. The lightweight single story high-bay structure, which shows significant distortion, is subject to significant shear strain imposed due to its attachment to the main residence to the right, which is clearly at a state of collapse; as is the building suffering excessive rotation (~ 5 degrees to the West and ~ 3 degrees to the South). The building on the left in this image sequence experienced differential settlement between the perimeter footing and outside pavement greater than 75 cm (see right image in Figure 7-9). The alley generally heaved about 30cm between the settling buildings on either side. To gain perspective on this scene, a suite of LiDAR scans was collected at this site (near the image denoted as C in Figure 7-6); the 3D model generated from these scans may be found in Report Part 2 documenting this event.

Figure 7-9: Example of mapping worse case ground and structural damage combination (GF3-DF5). (23.025442° , 120.207400° ; Lane 161, Hui'an St)

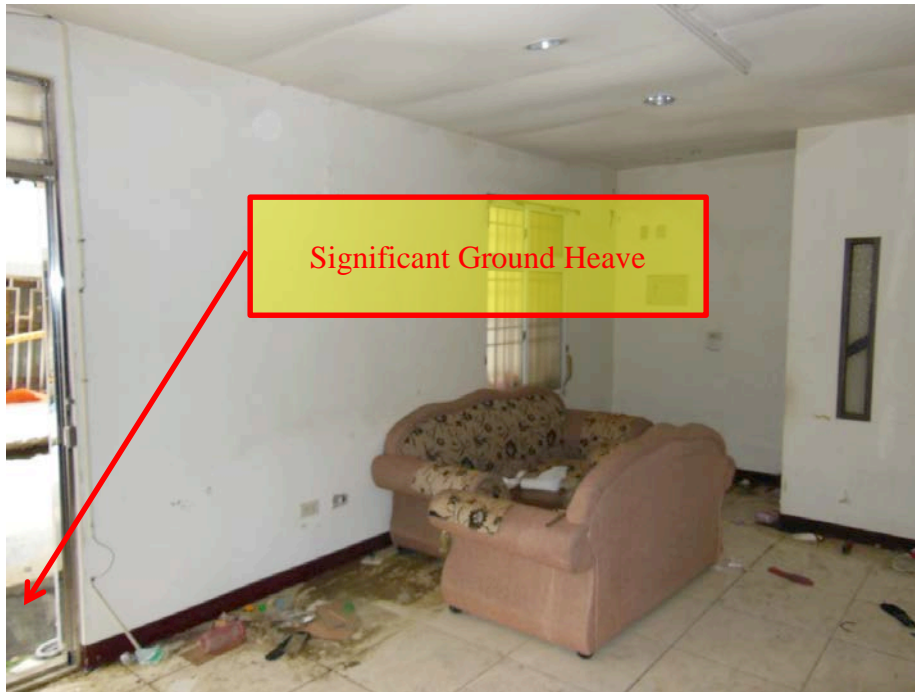
A common theme in this region and others impacted by liquefaction is that, perimeter footings, if continually connected, performed well even though the building experienced significant

differential movement as manifest in observations of the surrounding soils (e.g. Figure 7-11). In contrast, unreinforced slabs not tied to the foundation heaved and suffered complete disconnection in some cases in response to surrounding liquefaction (Figure 7-12). Perimeter footings connected with adequately reinforced grade beams generally performed well, even with structures that experienced significant displacement. Figure 7-11 shows that although the ground heaved more than 30 cm outside of the front door of this residence, no structural cracks were observed on the interior walls nor distorted window frames. In this situation, settlement of the building was fairly uniform, rendering very little to no differential displacement onto the structure. Meanwhile ejected sand was observed along slab edges.

Figure 7-11: Building that survived liquefaction-induced settlement and ground heave ([23°01'31.5"N 120°12'25.8"E](#)).
