GEOTECHNICAL EXTREME EVENTS RECONNAISSANCE (GEER) ASSOCIATION

Geotechnical Reconnaissance of the 2016 M_w 6.3 Meinong Earthquake, Taiwan

GEER Association Report No. GEER-046

Version 2: July 14, 2016

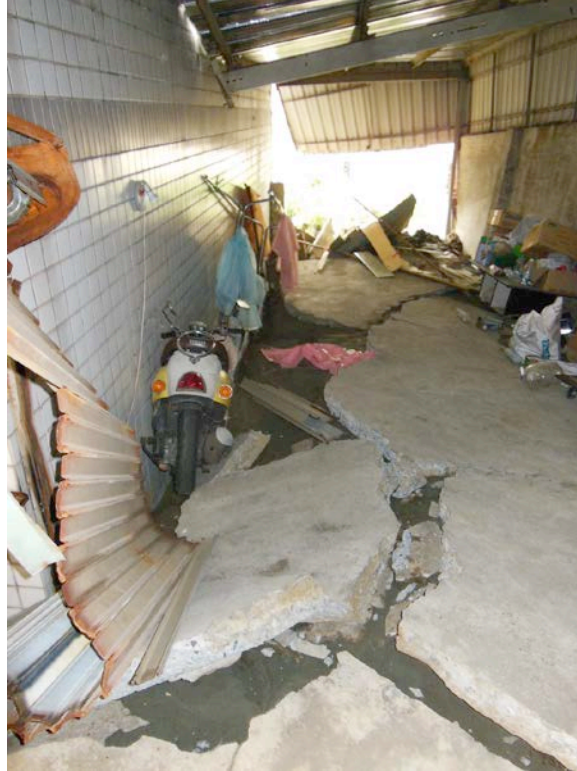
differential movement as manifest in observations of the surrounding soils (e.g. Figure 7-11). In contrast, unreinforced slabs not tied to the foundation heaved and suffered complete disconnection in some cases in response to surrounding liquefaction (Figure 7-12). Perimeter footings connected with adequately reinforced grade beams generally performed well, even with structures that experienced significant displacement. Figure 7-11 shows that although the ground heaved more than 30 cm outside of the front door of this residence, no structural cracks were observed on the interior walls nor distorted window frames. In this situation, settlement of the building was fairly uniform, rendering very little to no differential displacement onto the structure. Meanwhile ejected sand was observed along slab edges.

Figure 7-12: Damaged unreinforced slab in liquefied soil of the illegal expansion behind the building shown in the left portion of Figure 7-9 (23.0253°, 120.2074°).

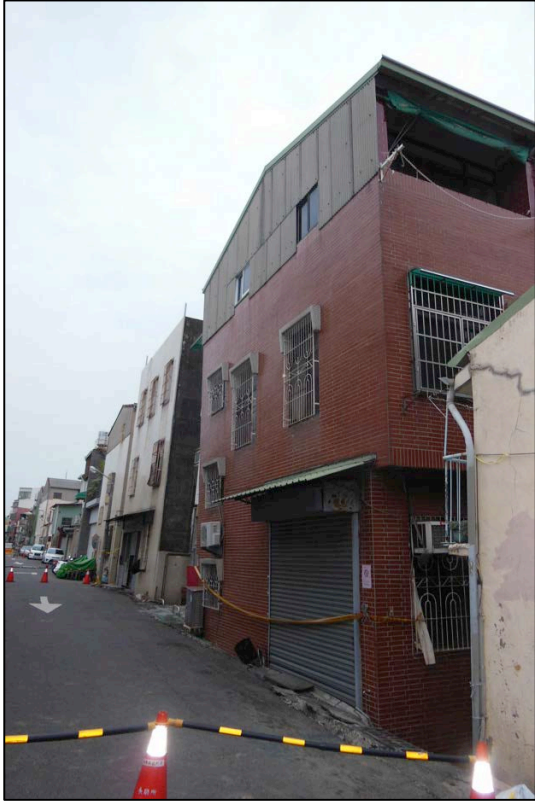
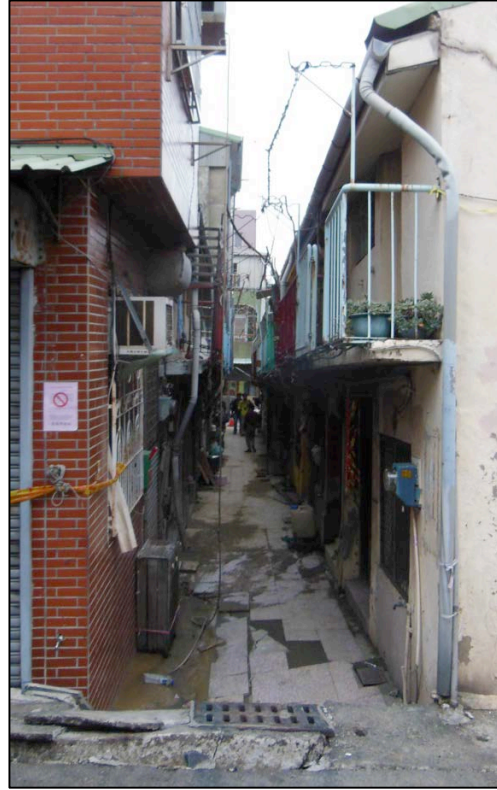
Figure 7-17: Severely tilted building in Wenhe Street and adjacent alley with significant expression of hardscape liquefaction features ([23°00'12.7"N 120°11'30.5"E](#)).

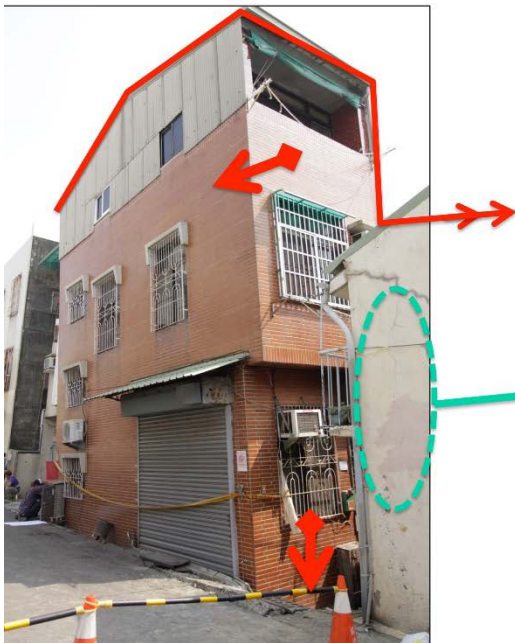
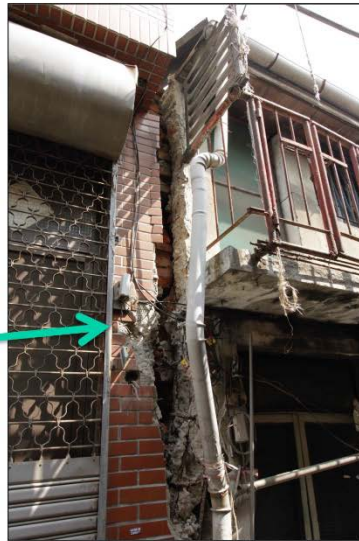
Figure 7-18: Approximately orthogonal perspective and local view (left and right respectively) of the damaged building shown in Figure 7-17; note the well delineated structural hinge that developed along the brick-concrete interface of the right image (older portion of structure on right). The green denotes that the image on the right is taken behind the building. (23.003471°,

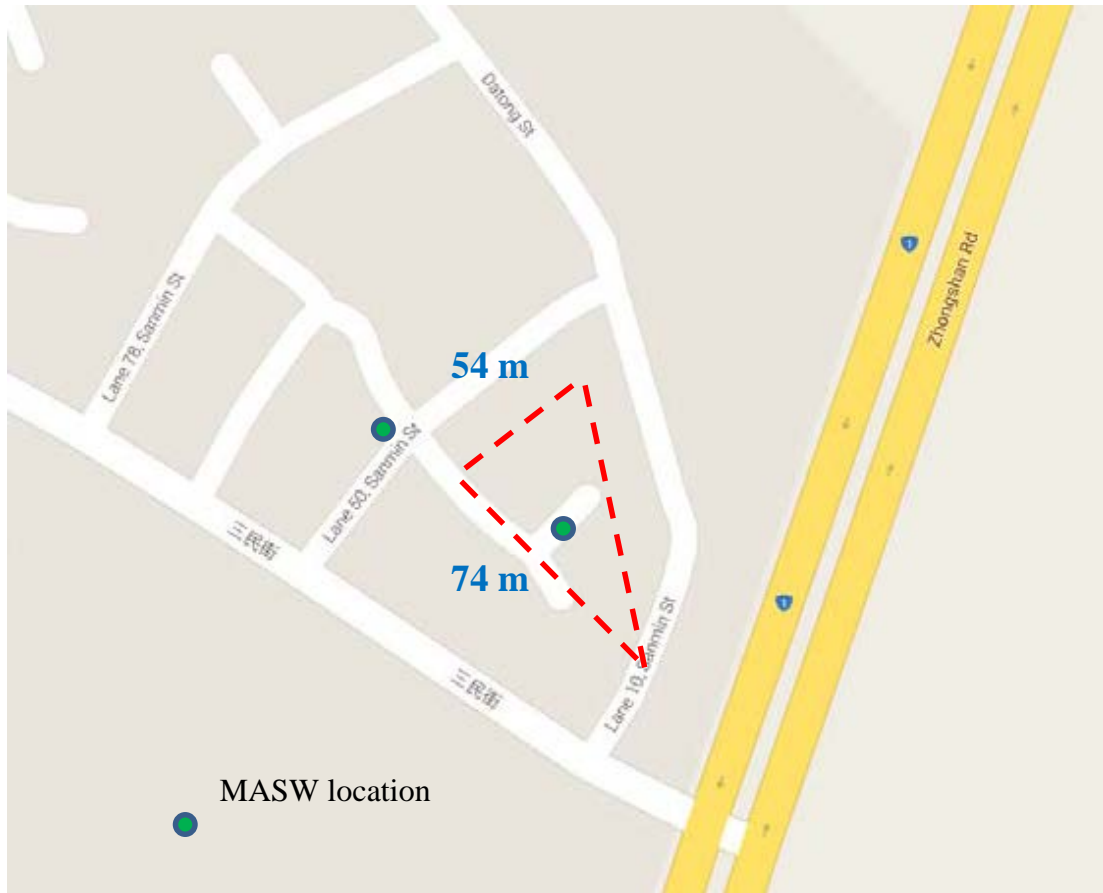
The Xinshi site is located in Lane 50, Sanmin St. of Xinshi district, Tainan City. The liquefied zone of the Xinshi site is marked as shown in Figure 7-20. Figure 7-21 shows this region with a 1921 map. It can be seen that the liquefied zone occurred in a triangular shaped area of an old pond/ water area and the two sides of liquefied boundaries coincide with the old dike. Field reconnaissance shows that the differential settlement along the dike could up to 30 cm. All of the buildings within this triangle zone were constructed by the same company in 1989 with spread footings connected with perimeter grade beams as foundation. According to one of the building owners, the triangle area was a fish pond before it was backfilled for residential development.

Figure 7-20: Approximate liquefied zone of the Xinshi site.

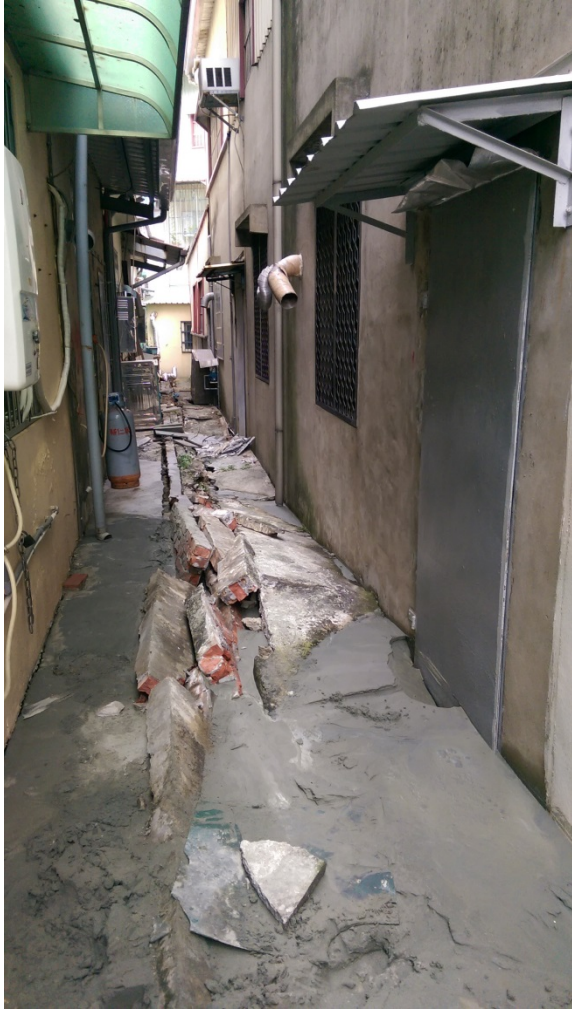
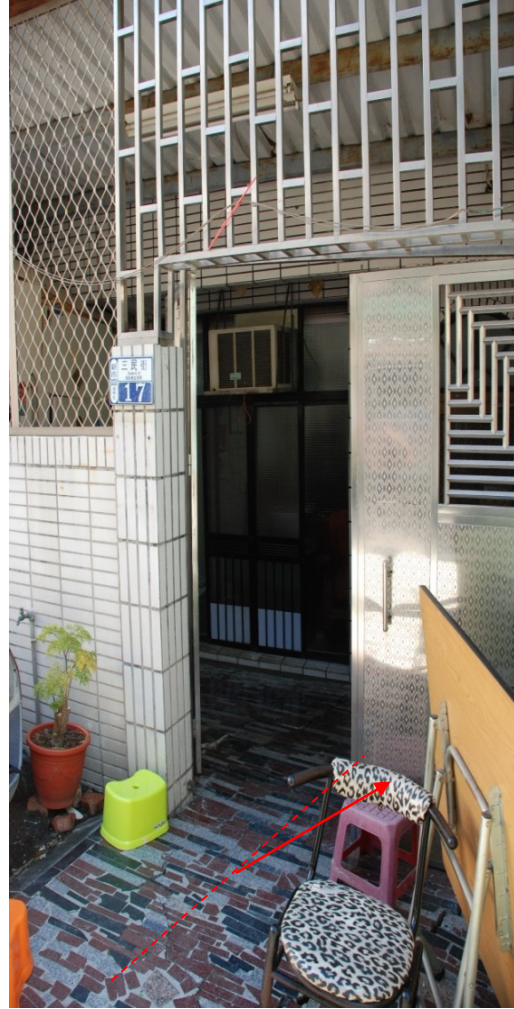
Liquefaction in this area was widely evident, with building settlement and extensive pavement heave both within garage/carports and along exterior hardscape/pavement. The average differential displacement was about 60 cm within the entire triangular region. The boundaries of the old pond can be located at the fire lane and the garage along Alley 10 of Lane 50 (Figure 7-22). Differential settlement along the fire lane was measured to be about 25-30 cm. Most of the ejected sands had been removed when the team arrived, however ground settlement was estimated from ground heave (Figure 7-23) and differential settlement along the edges of buildings. While most of the multi-story residential buildings were constructed in a modern era, illegal add-ons were common. In this neighborhood, additions consisted primarily of carports or front porches added to the front of the buildings or kitchen extensions added towards the back. These add-ons usually are not structurally connected to the main building and thus suffered greatly from differential ground movement resulting from liquefaction even through the buildings sustained only minor and repairable damages (Figures 7-24 and 7-25). The excessive moment of unconnected foundations at this site resulted in large strains induced in supporting beams of the carport and other structures; as shown in Figure 7-26. This form of damage necessitated the demolition of the extensions. At the time of the GEER team visit, demolition of one of the car ports columns was being conducted, and it was noted that the column supporting the car port lacked a foundation and structural connection to any adjacent foundations (Figure 7-26).

Figure 7-22: Damage to buildings at the Xinshi site (left: fire lane with expressed surface manifestation and building settlement and right: garage expressing significant hardscape damage).

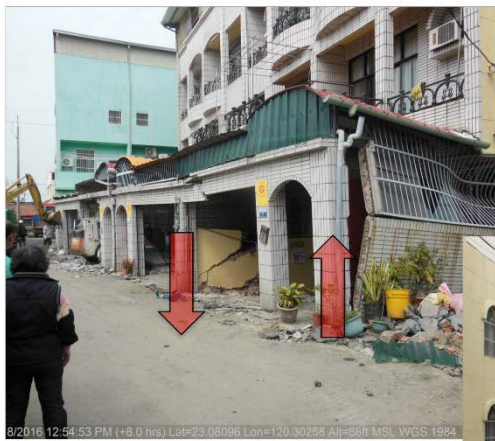
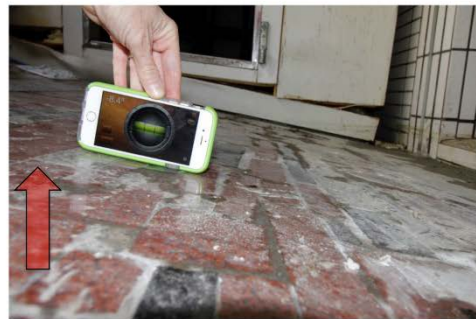
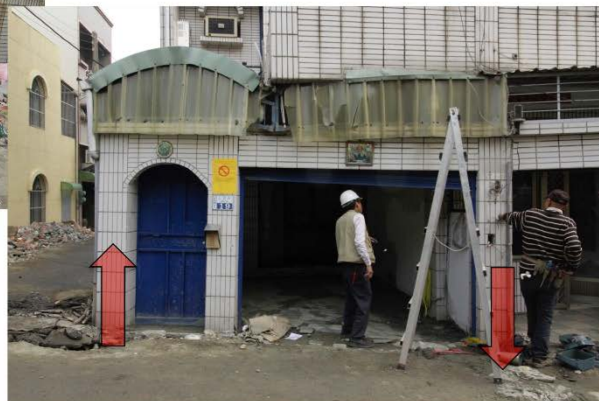
Figure 7-25: Structural hinge mechanism developed due to movement of unconnected foundations at carport add-ons at the Xinshi site. ([23.08096, 120.30258](#)).

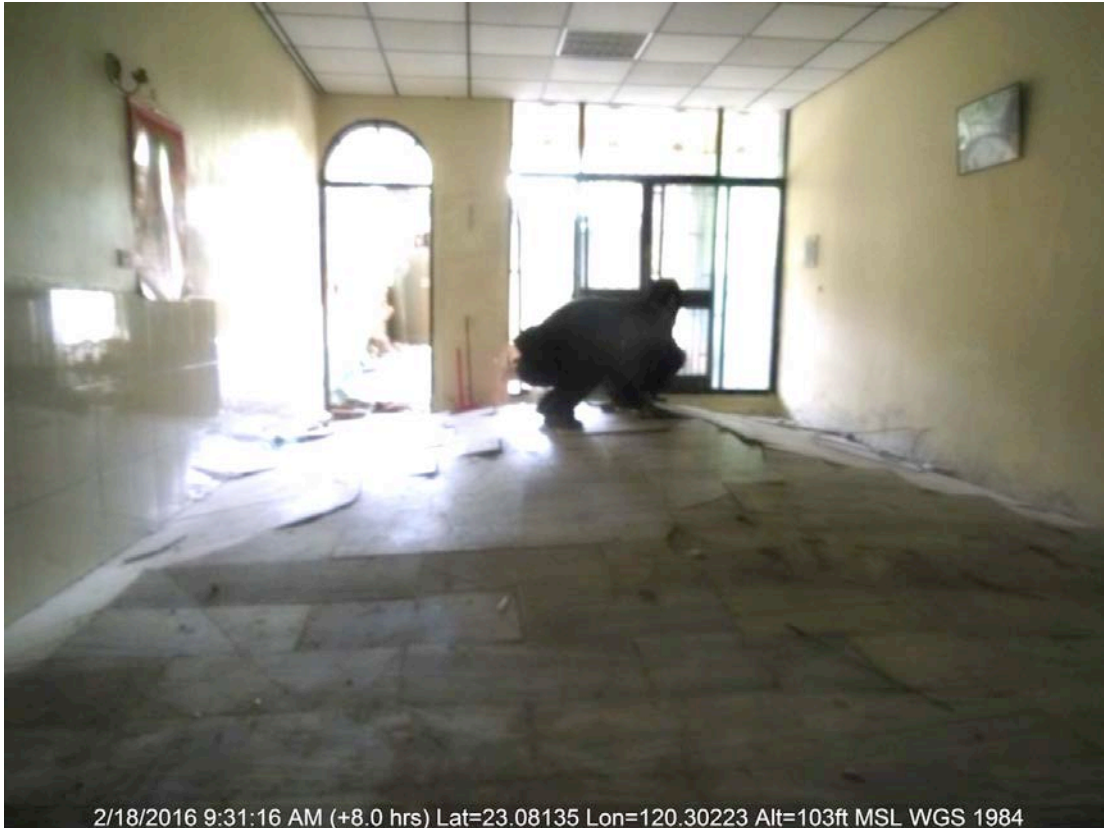
Figure 7-28: Heaving of Unreinforced Interior Slab ([23.08135, 120.30233](#)).

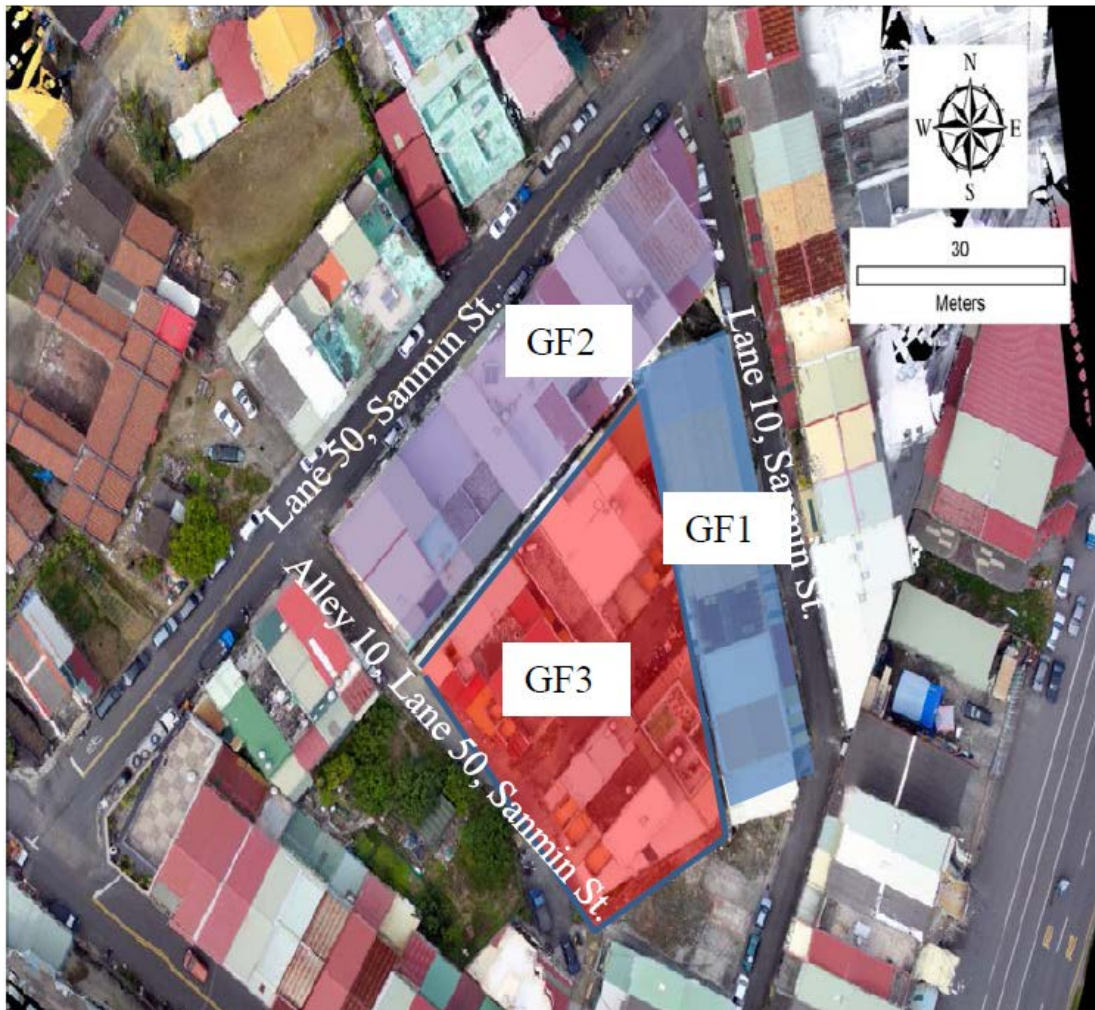
The ground failure index assessment for this region is shown on Figure 7-29. The GF3 zone is controlled by total settlement. In the surrounding area, no visible signs of liquefaction were observed.

Figure 7-29: Ground failure index assessment of Xinshi site (By C.C. Tsai).

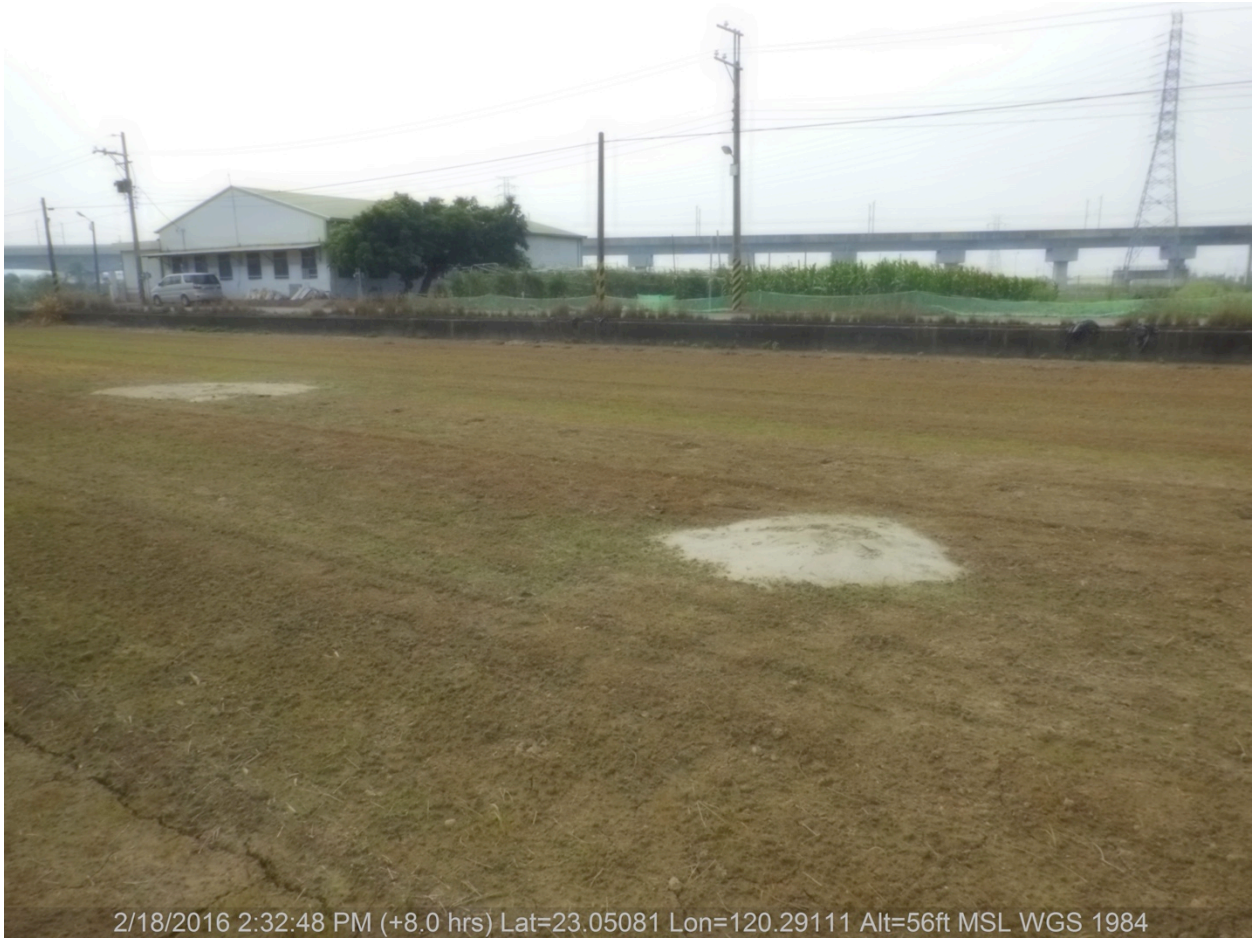
Due to its wide-open nature and limited infrastructure, this area observed quite distinctly visible surface manifestation of sand boils following this earthquake. Within the open field at least 20 major sand boils with diameters in excess of 1 meter were visible (Figures 7-33 and 4-34). One of the sand boils suggests multiple ejecta, likely manifest from aftershocks (Figure 7-35).

Figure 7-32: Open Field Liquefaction in Xinghus (THSR Viaduct in Background)
([23.05081, 120.29111](#)).

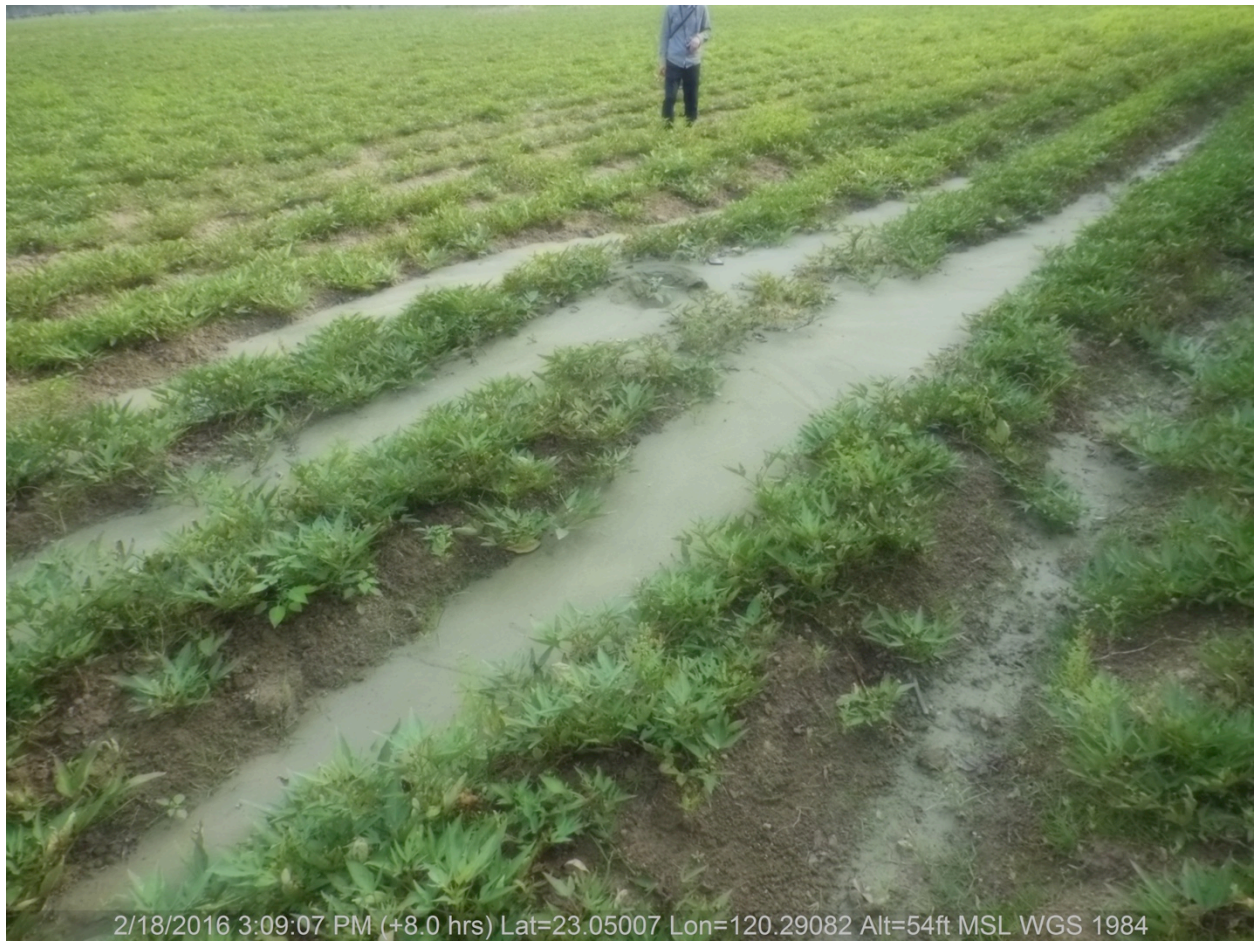
Figure 7-33: Sand Boil in Xinhua ([23.05007, 120.29082](#)).

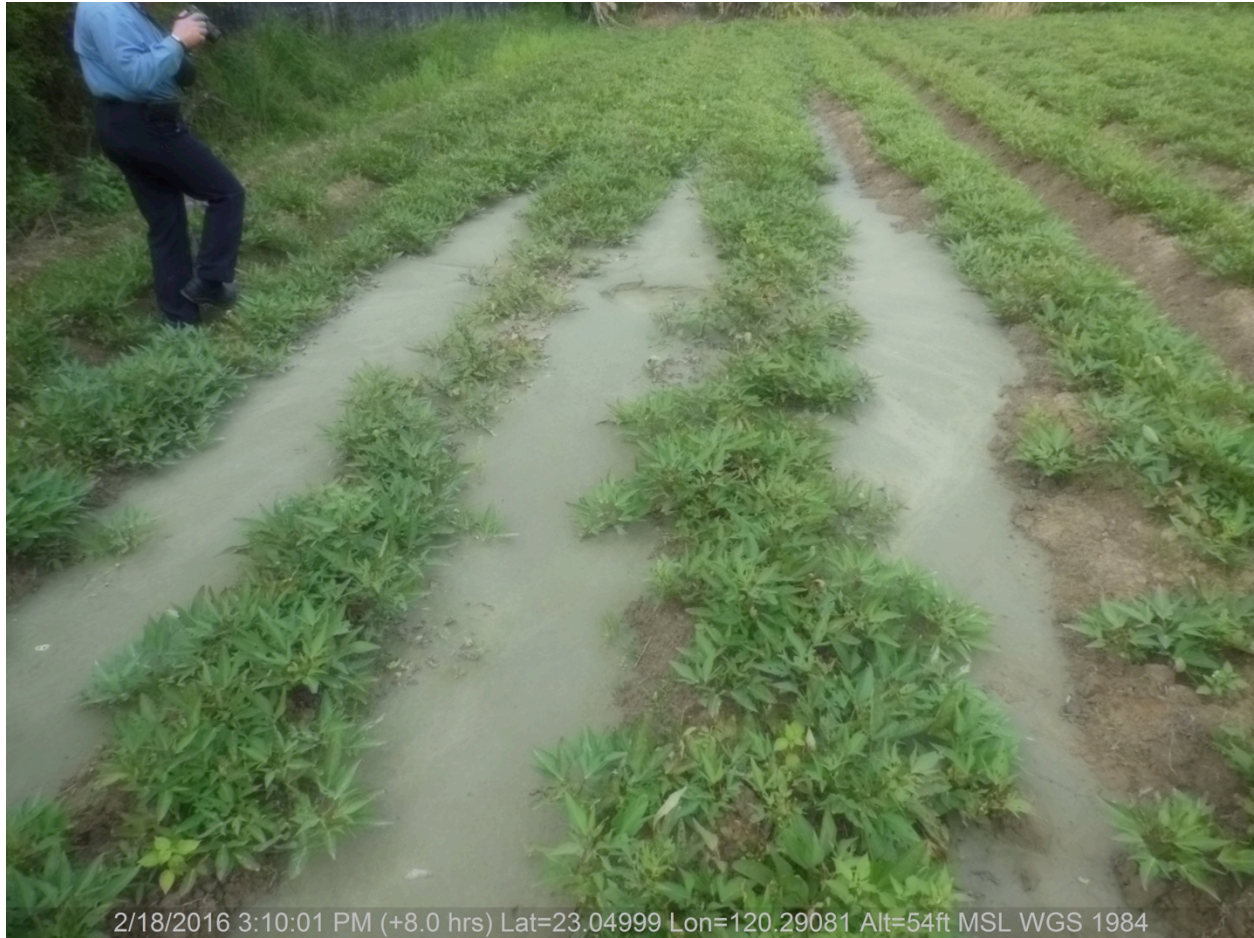
Figure 7-34: Sand Boil in Xinhua ([23.04999](#), [120.29081](#)).

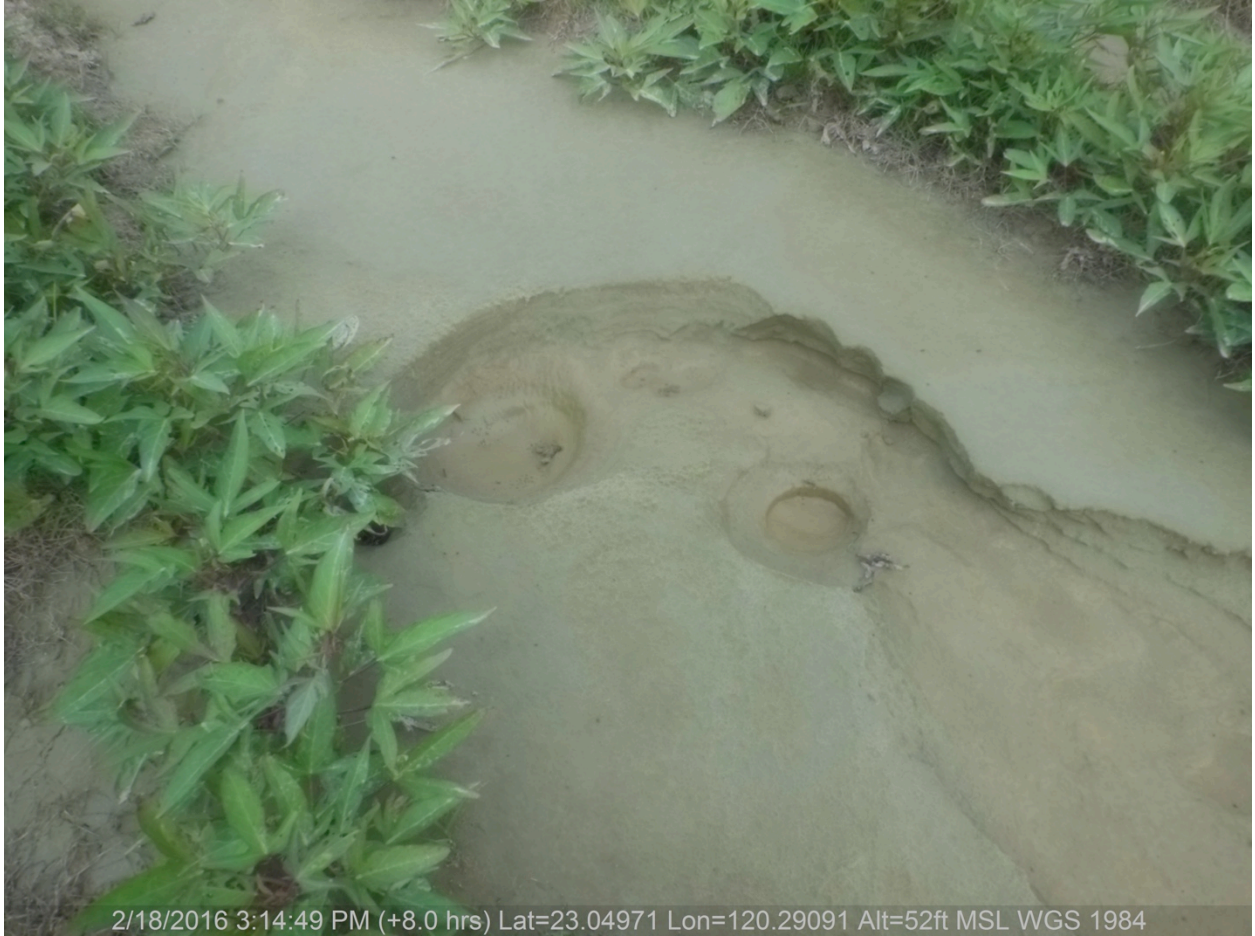
Figure 7-35: San Boil in Xinhua ([23.04971, 120.29091](#)).

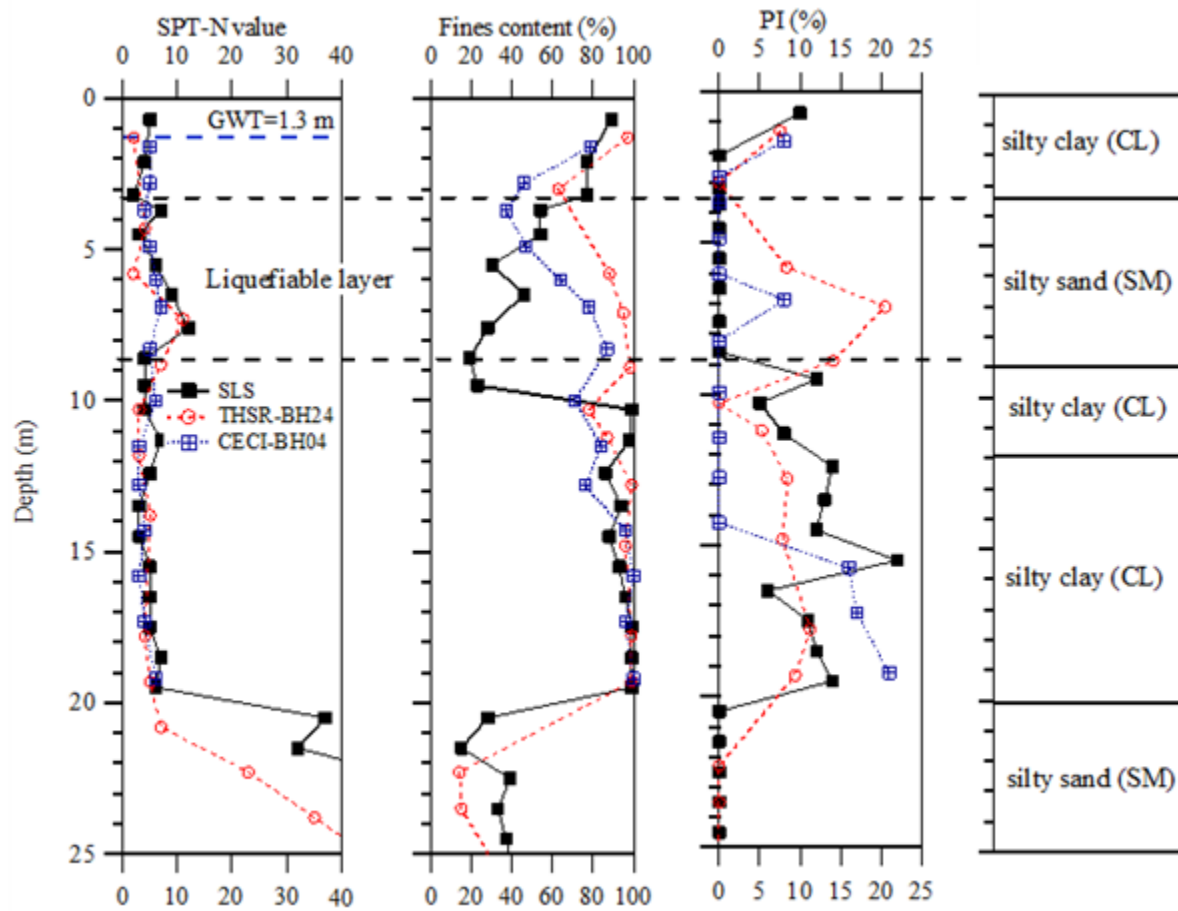
Detailed soil conditions at the Xinhua site can be found in Chang et al. (2011). The groundwater table in this area is about 1.3 m below grade. The liquefiable layer is located between 3 to 9 m deep in a silty fine sand (SM) layer with fines content from 15 to 80% (Figure 7-36). The near surface non-liquefiable silty clay cap contributed the near perfect sand boils manifestation in this area. Liquefaction analyses using SPT-N values, CPT-qc and Vs are shown in Figure 7-37. This will be a good site to install a downhole array for studying the effects of fines content on liquefaction triggering and boundary effects of pore pressure accumulation.

Figure 7-36: Compiled Borehole Logs and Soil Layers (Chang et al. 2011).

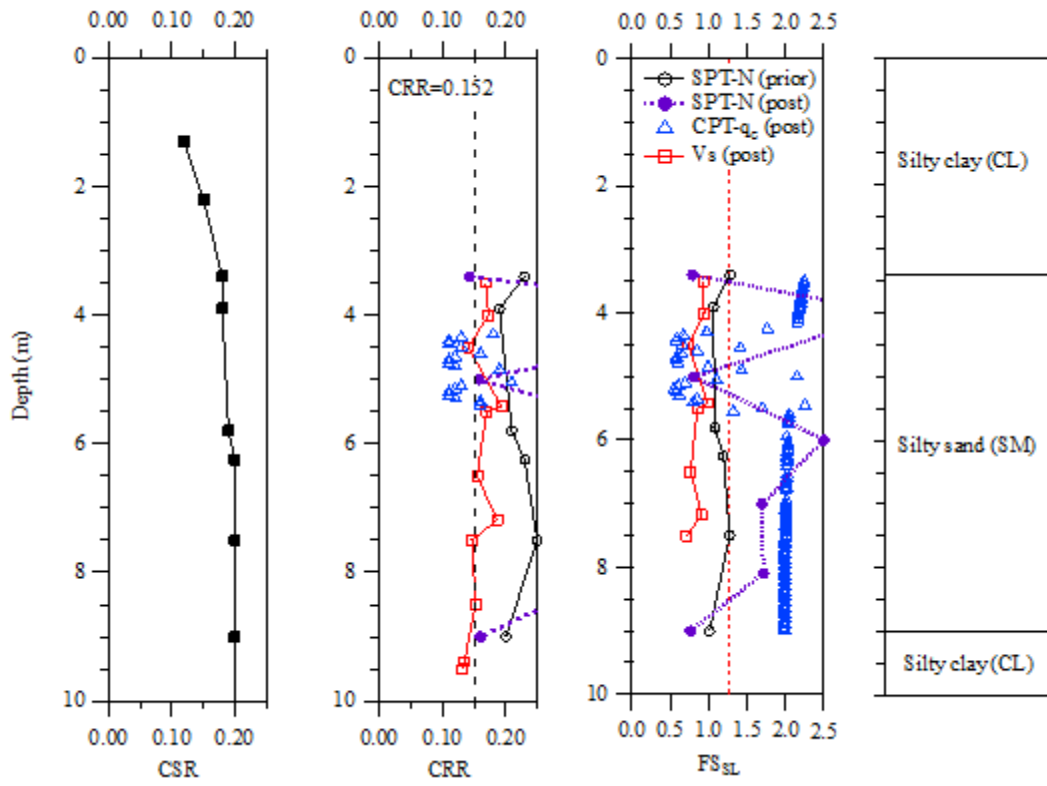
Figure 7-37: Liquefaction Analysis of Xinhua Site.

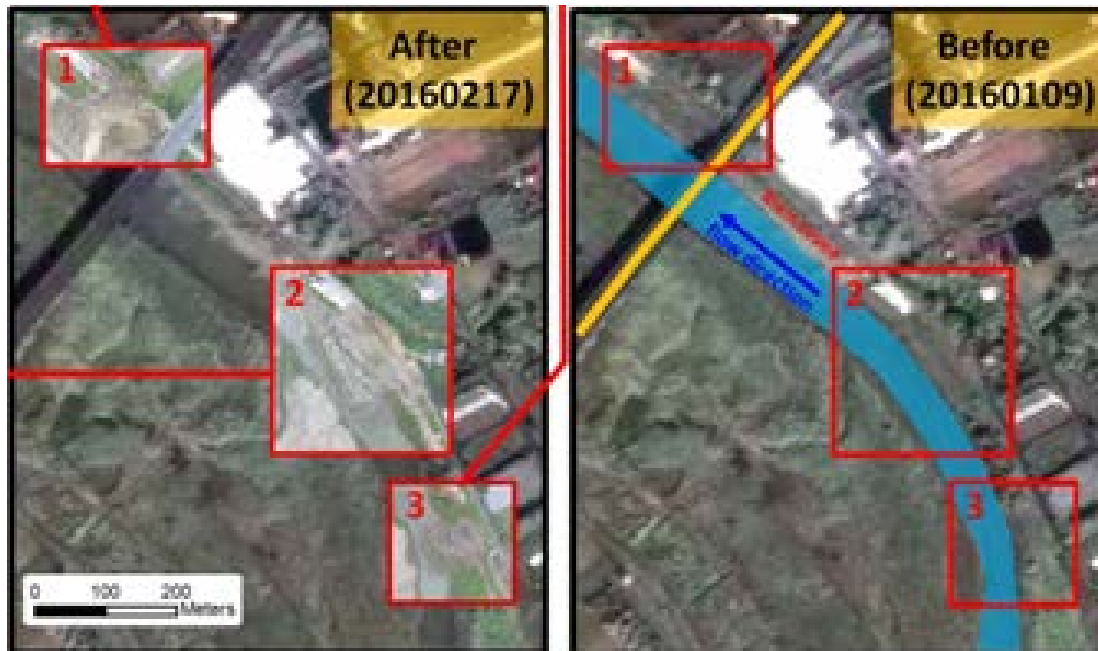
During the February 6, 2016 Meinong earthquake, three sections of the Rixin levee (日新堤岸) along the northern bank of Tseng-Wen river failed along a 800-m stretch near where the river crosses under the Freeway No.3 bridge in Guantian (官田區) District, Tainan (23° 9'12.40", 120°20'37.68"). All three failures lie on the erosional bank (active margin) of the meandering river that is contained by the Rixin Levee. Two of the three failures have either partial or complete concrete slab slope protection and the third failure had no concrete slope protection. In this report, the three failures are numbered Nos.1, 2, and 3 from north-west to south-east or in the upstream direction as shown in Figure 8-1. The height of the levee is estimated to be about 5~7 meters measuring from the levee crest to the toe of the failed surface. Aerial photo comparisons of the levee before and after the earthquake are shown in Figure 8-2.

Figure 8-2: Pre- and Post-Failure Geometries of the Levee Slopes.

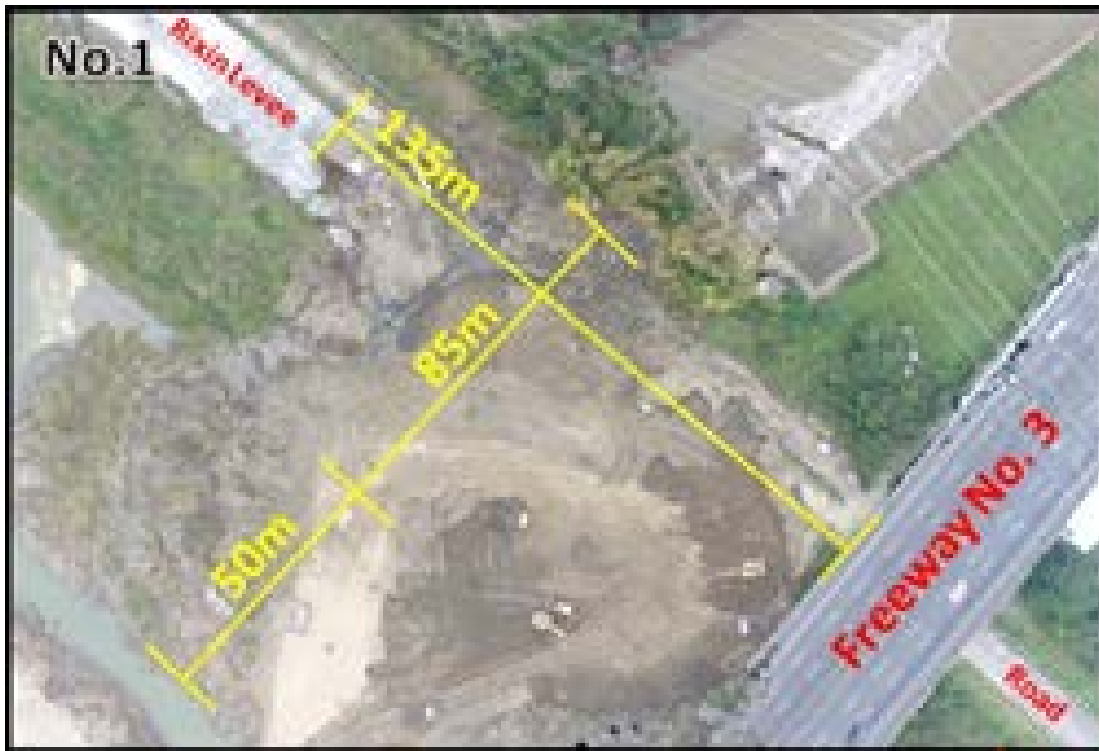
Failure No. 1 occurred in a graded levee embankment about 70 meters downstream from the Freeway No. 3 bridge crossing (Figures 8-3 and 8-4), at: Lat: 23° 9'13.23", Long: 120°20'34.98". The failure width measured along the scarp is about 135 meters (Figures 8-5 and 8-6). The run-out distance (top of levee scarp to the toe of the sliding body) is about 135 meters (Figure 8-5). The landslide toe blocked the 50 m wide actively flowing river, and temporarily formed a debris dam.

Figure 8-5: Layout of Failure No. 1 (23° 9'12.40", 120°20'37.68").

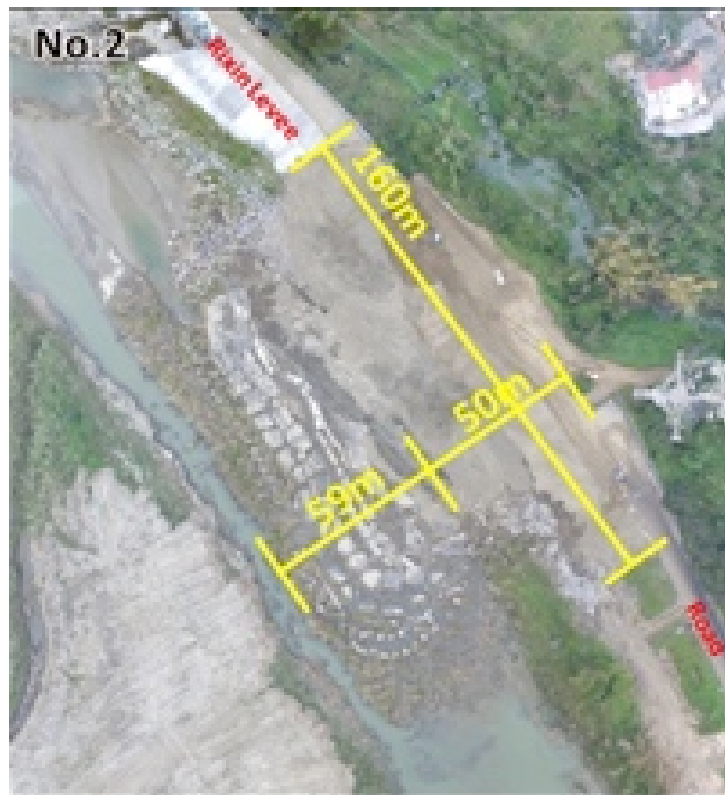
Failure No. 2 is located about 400 meters upstream of the Freeway No. 3 bridge (23° 9'3.26", 120°20'47.59"). The width of the landslide along the head scarp is about 160 meters and the landslide length is 109 meters from scarp to toe (Figure 8-13). The landslide mass also temporarily blocked the river forming a landslide dam (Figures 8-13 and Figure 8-15). The levee fill material is mainly a mixture of predominantly loose silty sand with gravel. An unreinforced concrete slab protected the embankment prior to failure and is visible as detached blocks near the landslide toe (Figures 8-14 through 8-17). Near the levee toe, the slope is generally flat at 5:1 (H:V) to 10:1 (Figure 8-17).

Figure 8-13: Layout of Failure No. 2 and Layout (23° 9'3.26", 120°20'47.59").

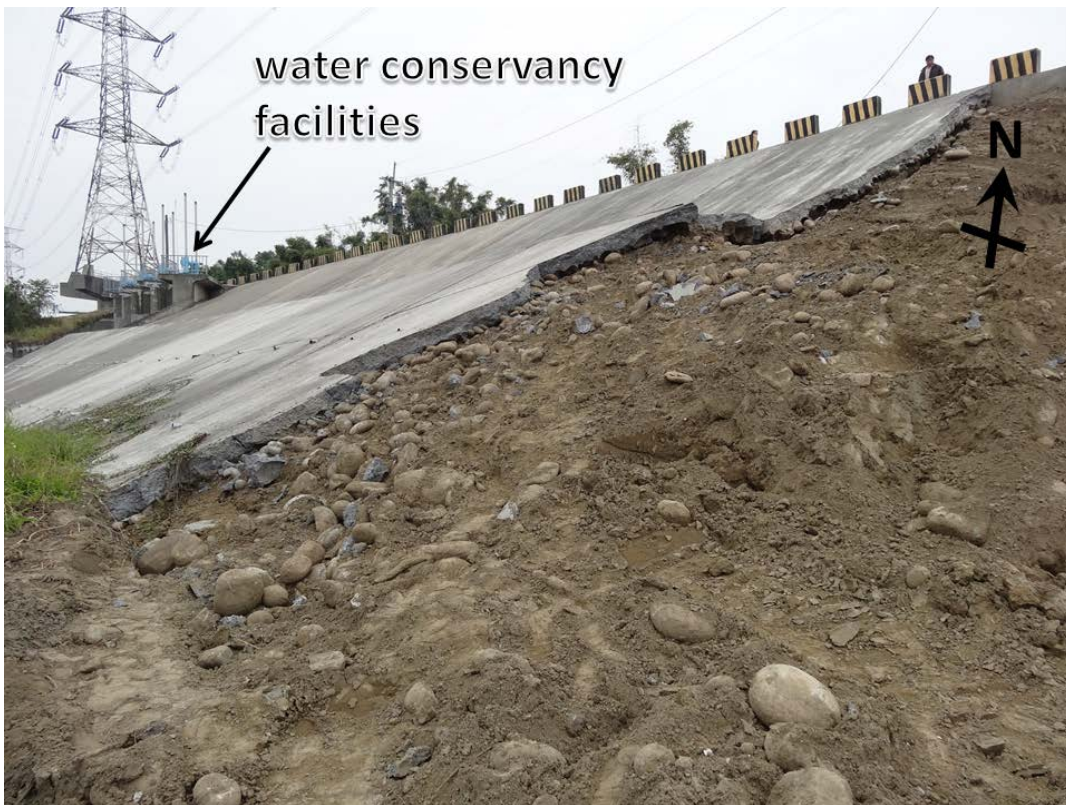
Figure 8-16 Concrete Slab and Piles Used to Protect Area near Levee Failure No.2. (23.151245, 120.346236).
