GEOTECHNICAL EXTREME EVENTS RECONNAISSANCE (GEER) ASSOCIATION

Geotechnical Reconnaissance of the 2016 M_w 6.3 Meinong Earthquake, Taiwan

GEER Association Report No. GEER-046

Version 2: July 14, 2016

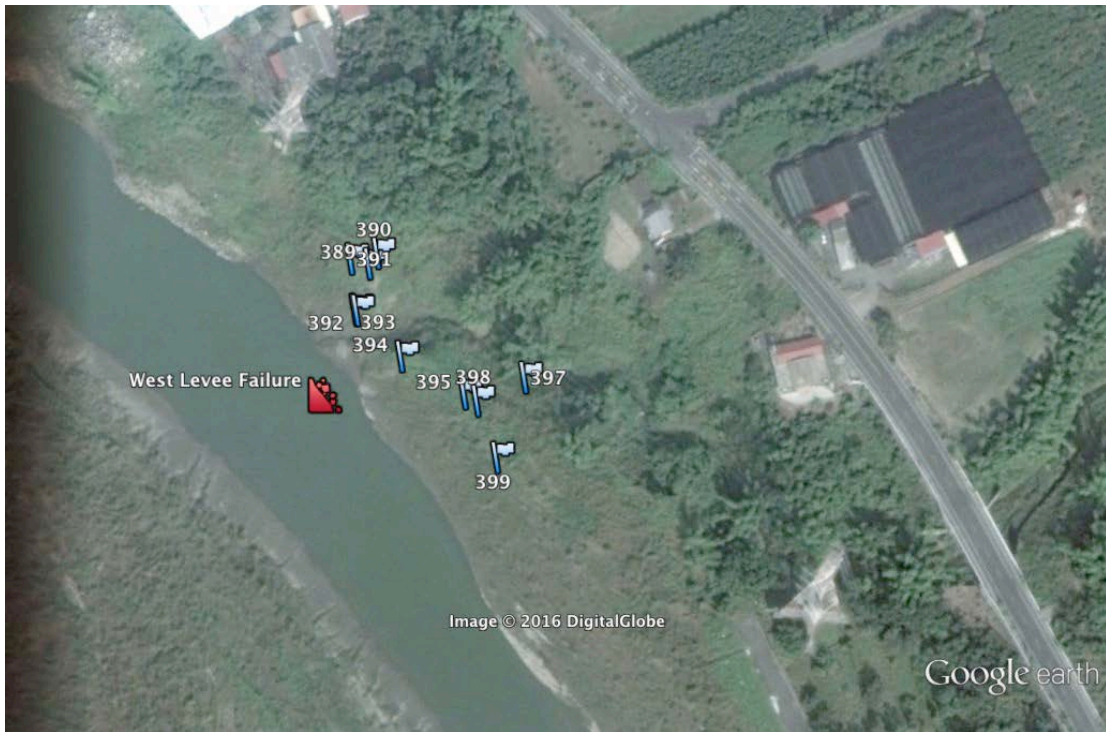
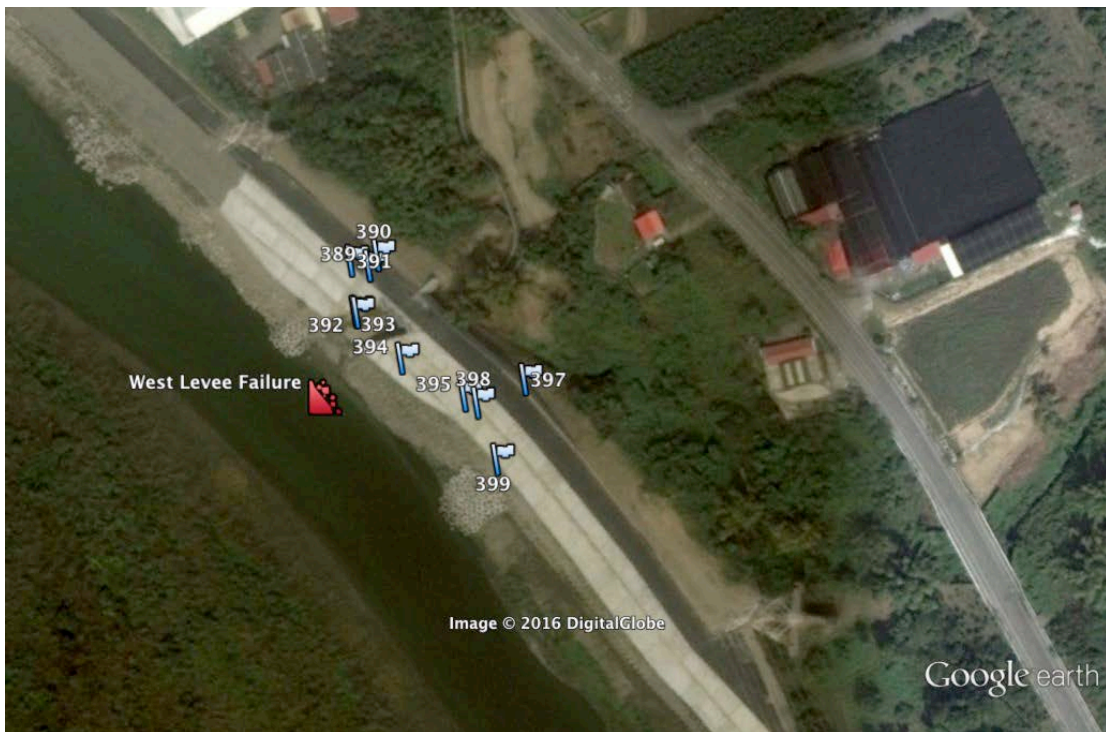
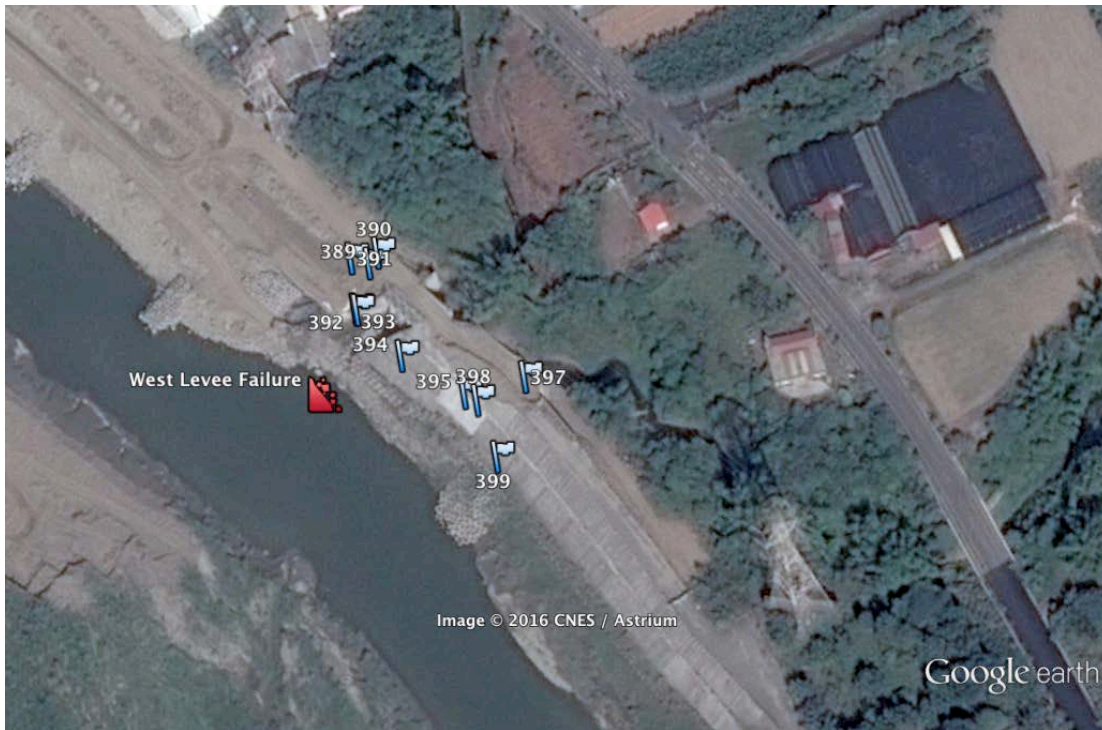
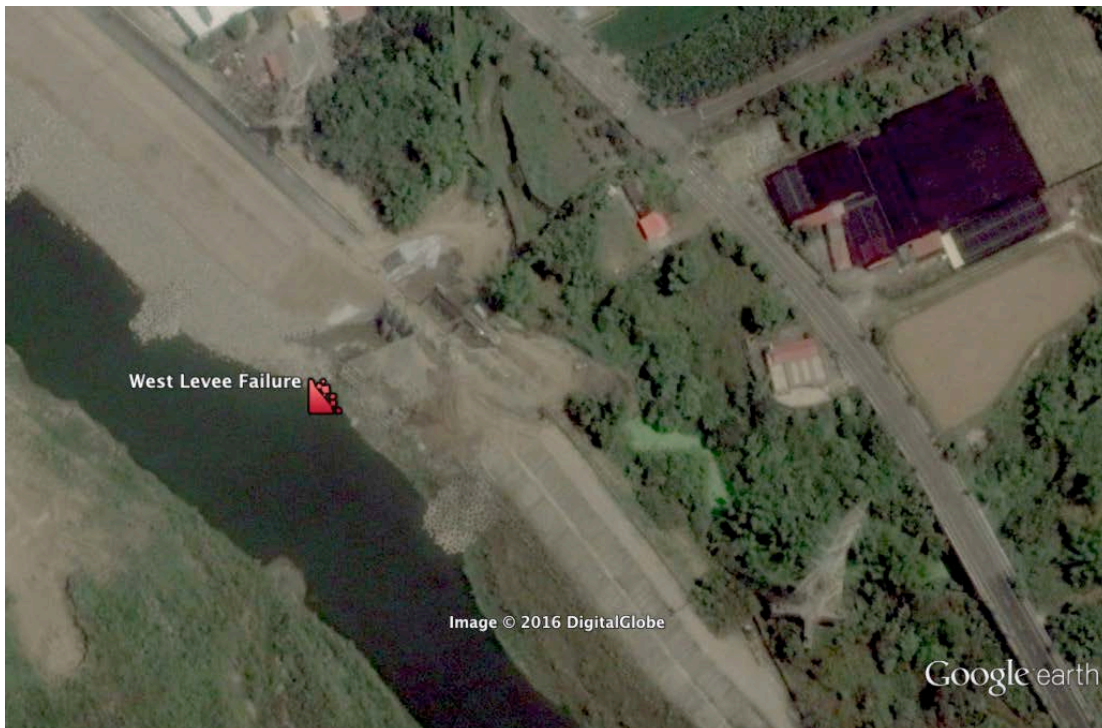
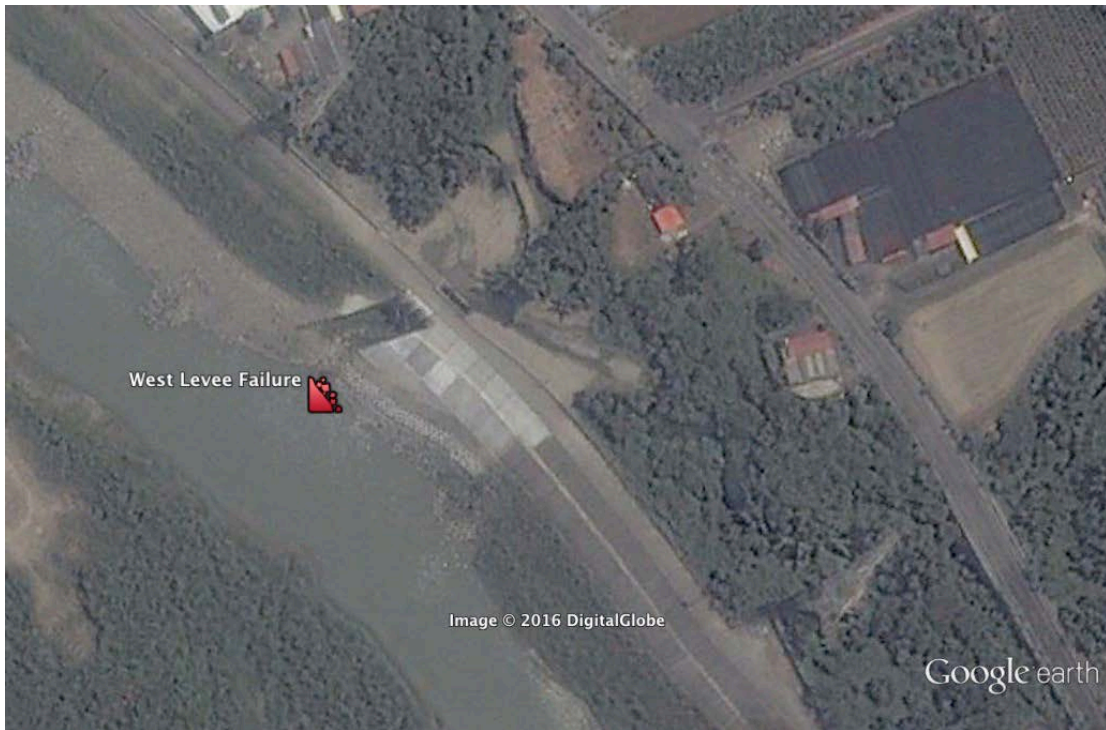
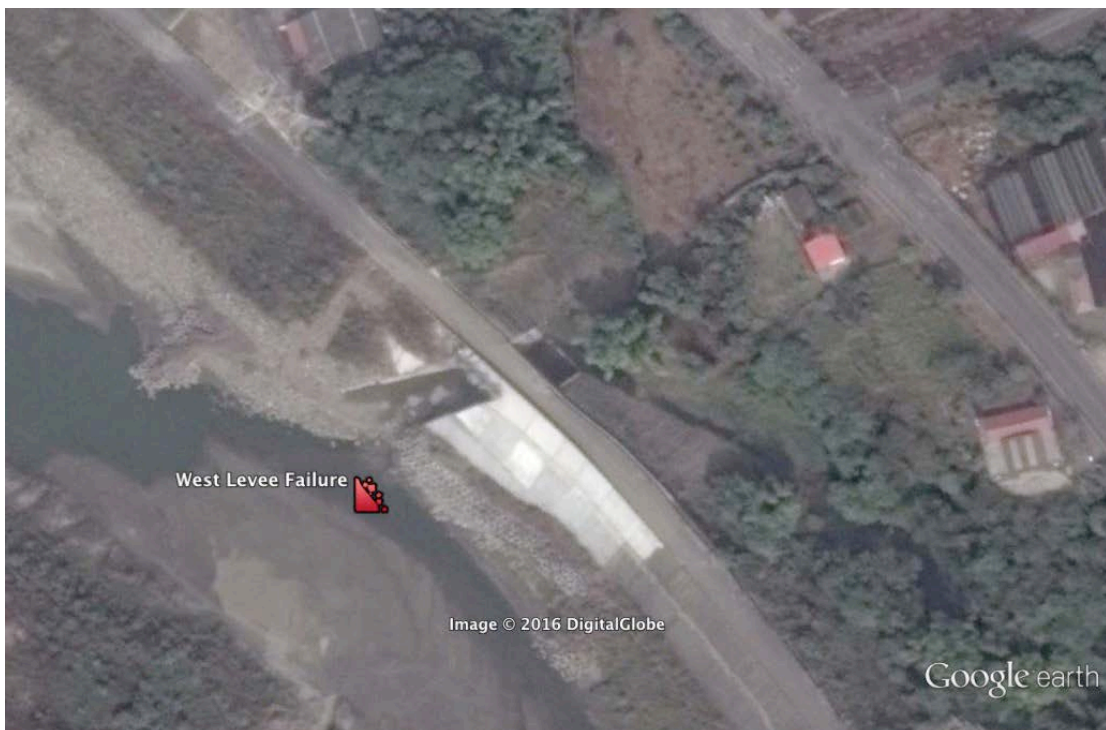
Based on a review of Google Earth historical photos (Figure 8-18 through 8-23) it appears that the area close to failure No. 2 has experienced multiple slope failures and multiple repairs in the past. We confirmed with the local engineer that prior to the earthquake; this section of the levee failed during a heavy storm event in June 2012 and was later repaired.

Figure 8-18: Google Image of region where Failure 2 occurred (image date in 1/2012).

Figure 8-19: Google Image of region where Failure 2 occurred (image date: 4/2012).

Figure 8-20: Google Image of region where Failure 2 occurred (image date: 2/2014).

Figure 8-21: Google Image of region where Failure 2 occurred (image date: 5/2014) – note the visible constructed structural spillway.

Figure 8-22: Google Image of region where Failure 2 occurred (image date: 8/2014).

Figure 8-23: Google Image of region where Failure 2 occurred (image date: 11/2015).

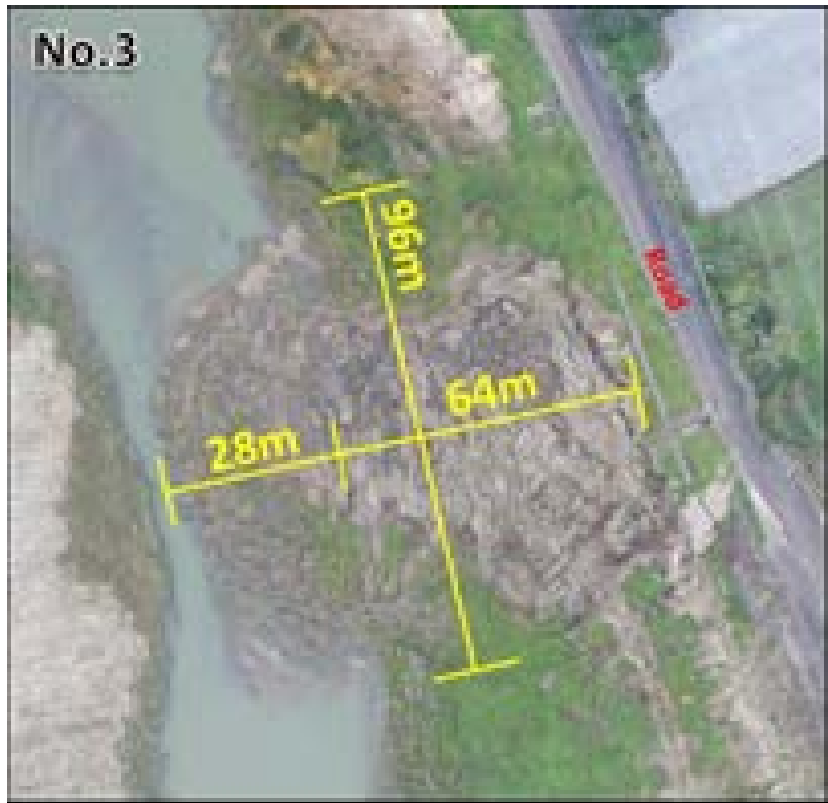
Failure No. 3 occurred in an unprotected levee about 670 meters upstream from the Freeway No. 3 bridge crossing (Figure 8-26, location: 23° 8'55.24", 120°20'52.46"). The width of the landslide measured along the levee crest is about 96 meters and the length of the landslide is 92 meters measured from scarp to toe. The slide mass also blocked the river and temporarily formed a small debris dam (Figure 8-27). Levee materials observed here are artificial fill composed of alluvial gravel, sand and clay. The road behind the landslide crown was not damaged and the scarp is about 2 meters in height. Within the slide mass, seepage flow and ponding was noticed indicative of a high ground water level behind the levee (Figure 8-28).

Figure 8-26: Layout of Failure 3.(23.148325, 120.347631)

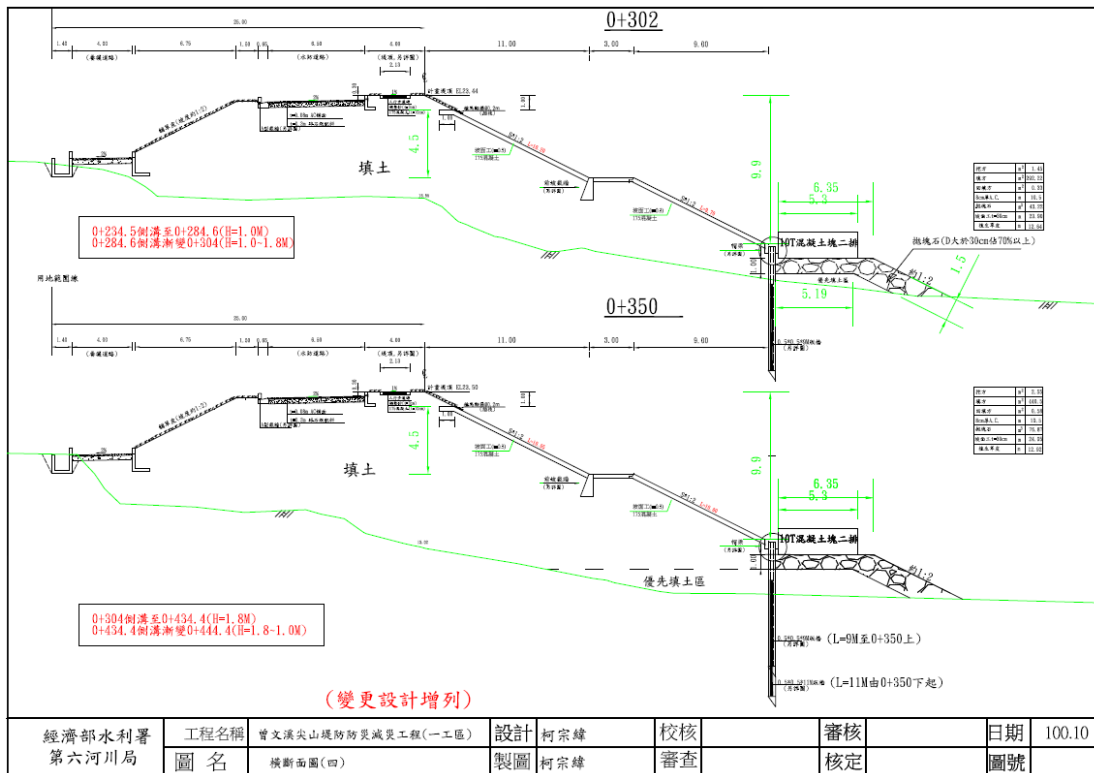
A pile foundation was installed at the toe of the levee between Failure 1 and 2 to protect the water conservancy facilities and the factory behind the levee. This pile enhanced section of the levee survived the earthquake with only minor damage.

Figure 8-29: Portion of the Levee Protected Piles (between Failure 1 and 2) Serviced the Earthquake.

The adverse condition could be resolved if extended retrofit and drainage control is performed for the levee embankment. One example successfully used along this section is by installing piles at the waterside levee toe (Figure 8-29).

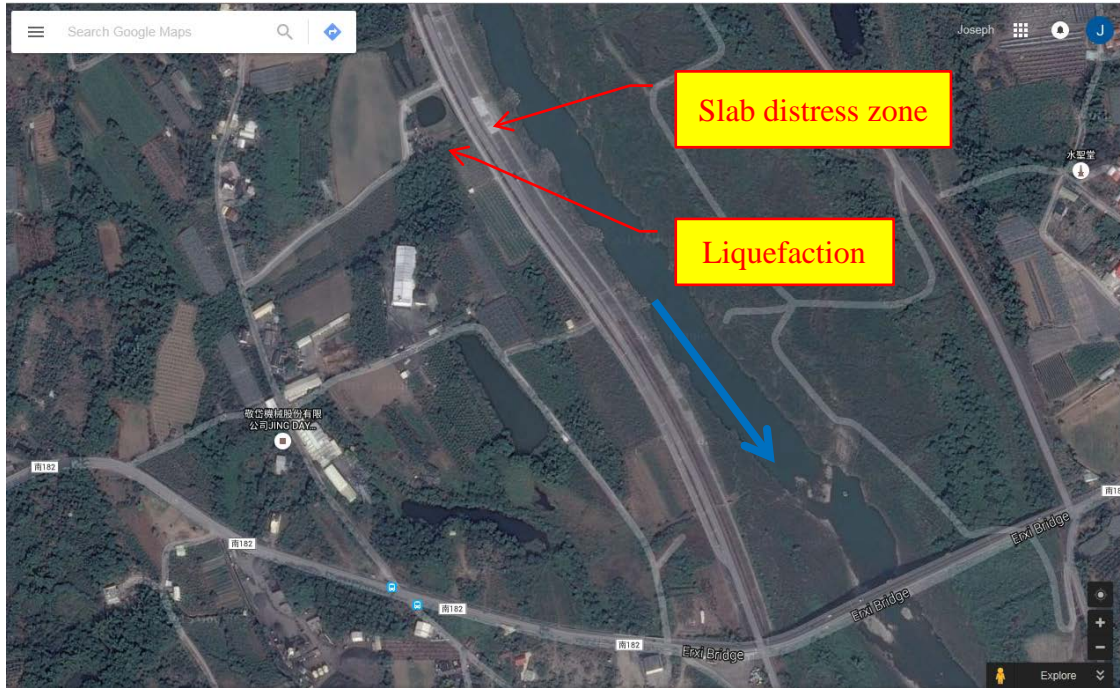
On the right (west) bank of YenSwei River approximately 770 m upstream (north northwest) of ErXi bridge in Danei District (大內區), liquefaction likely contributed to the distress of a section of concrete slab levee protection (Figure 8-30). Location of this distressed zone is approximately Lat: 23.120964, Long: 120.379392. The total distressed zone measures about 120 meters measured along a previously repaired section of the levee with added riprap protecting the toe. The concrete slab distress occurred along the contact between the horizontal slab protecting the crest and the slab protecting the embankment. The horizontal separation is about 30 cm (Figure 8-31). Some of the separation occurred along a newly replaced section where limited re-bar can be seen to connect the horizontal and inclined slabs. Observation of the rebar indicates that it does not have adequate bond length (less than 5 cm) and was pulled from the inclined slab. In some areas, there was no rebar connecting the horizontal and inclined slabs. Minor buckling and shear cracking was also observed on the newly placed inclined slab (Figure 8-32 and 8-33) as well as fresh distress along old repairs (Figure 8-34). The concrete slab also broke at the toe of the levee (Figure 8-35). Patches of sand deposits can be seen on the bench where concrete cracking exists (Figure 8-36), however, there is no clear evidence to indicate that these sand deposits liquefied.

Figure 8-30: Aerial View of ErXi Bridge Levee Failure Site.

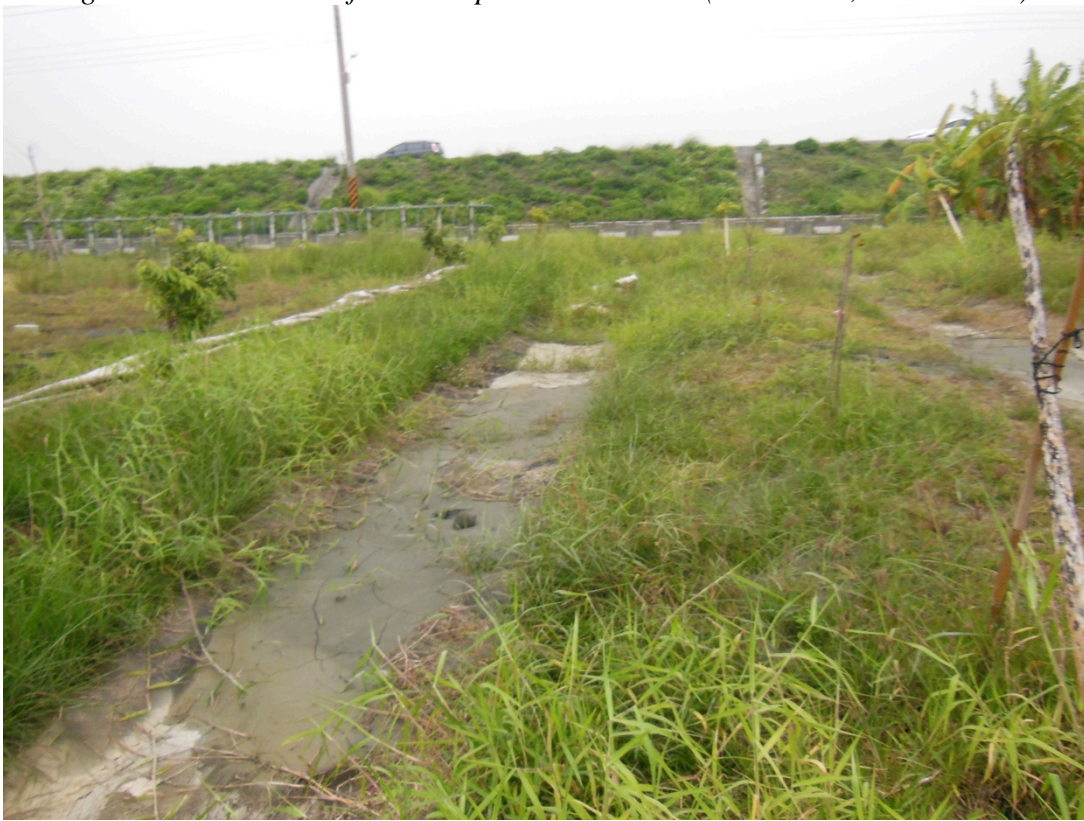
On the landslide of the aforementioned slab distress zone, evidence of minor liquefaction in the nearby farm field was observed (Figure 8-37). The sand boils ejected less than about 5 cubic feet of sand and silt but the manifestation of liquefaction occurred in a fairly small farm field measuring 20 m by 40 m. The levee road south of the distressed area undulates in excess of 30 cm, which suggests unstable subgrade but the movement of the supporting soil is limited and did not damage the pavement but nevertheless may have undermined the slab (Figure 8-38). Along this stretch of the levee, NCREE reconnaissance observed cracking of the embankment toe (Figure 8-39).

Figure 8-37: Evidence of Liquefaction on Land slide of Levee (23.120823, 120.378989).

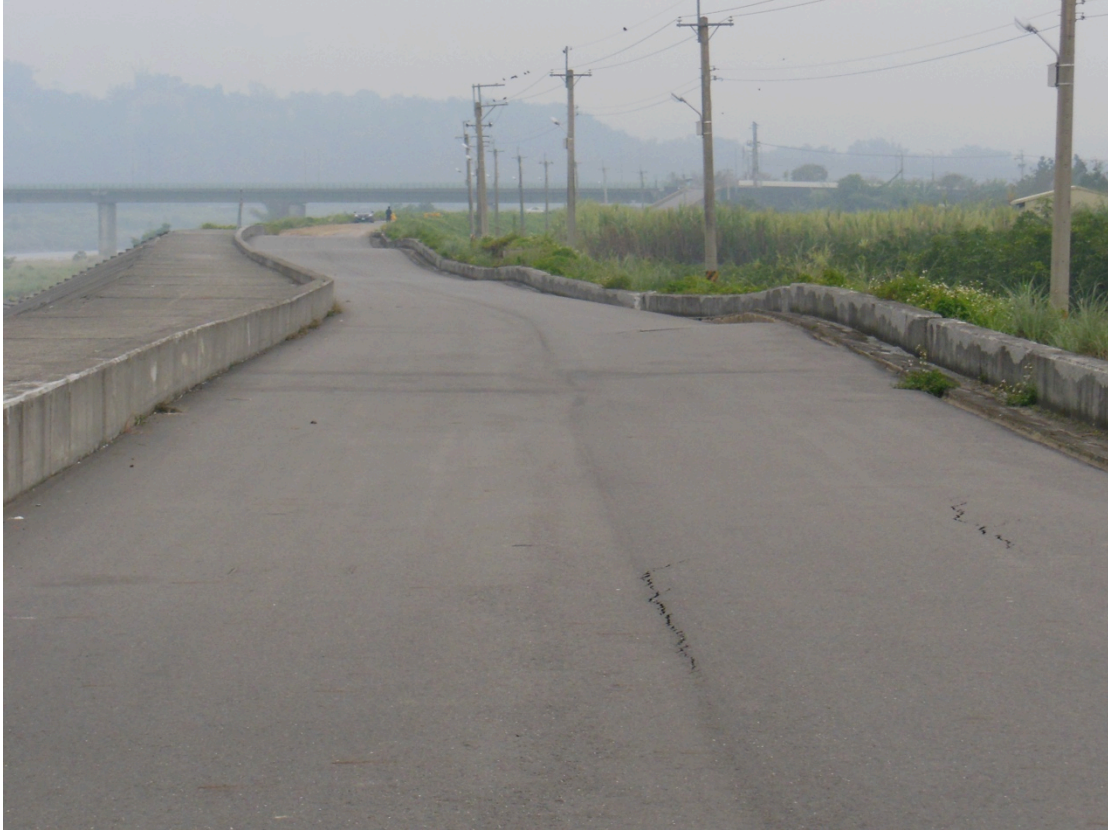
Figure 8-38: Undulation of Levee Crest Road (23.120114, 120.379819).

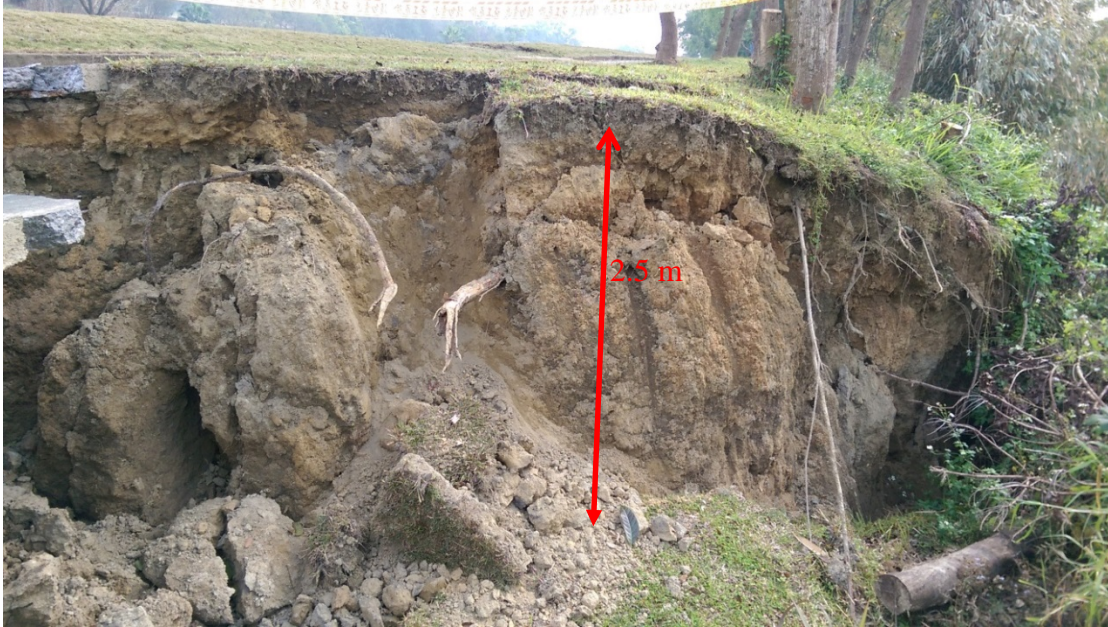
Figure 8-41: Maximum vertical drop at the south end of the Nanboa golf course (23.151721, 120.370245)

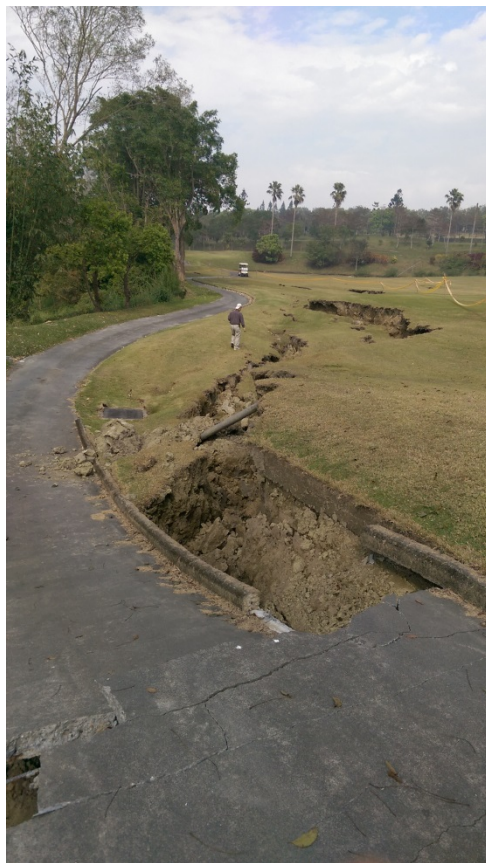
Based on field observation of the rupture pattern, the location of water table, the consistency of the compacted fill material, and water cave around the drainage pipe several days after the earthquake, the slope failure is considered to be the result of movement of a coherent block of compacted fill triggered by the inertial forces from the earthquake during ground shaking.

Figure 8-42: Surface rupture at the crest of sliding mass at Nanboa golf course (23.151721, 120.370245).

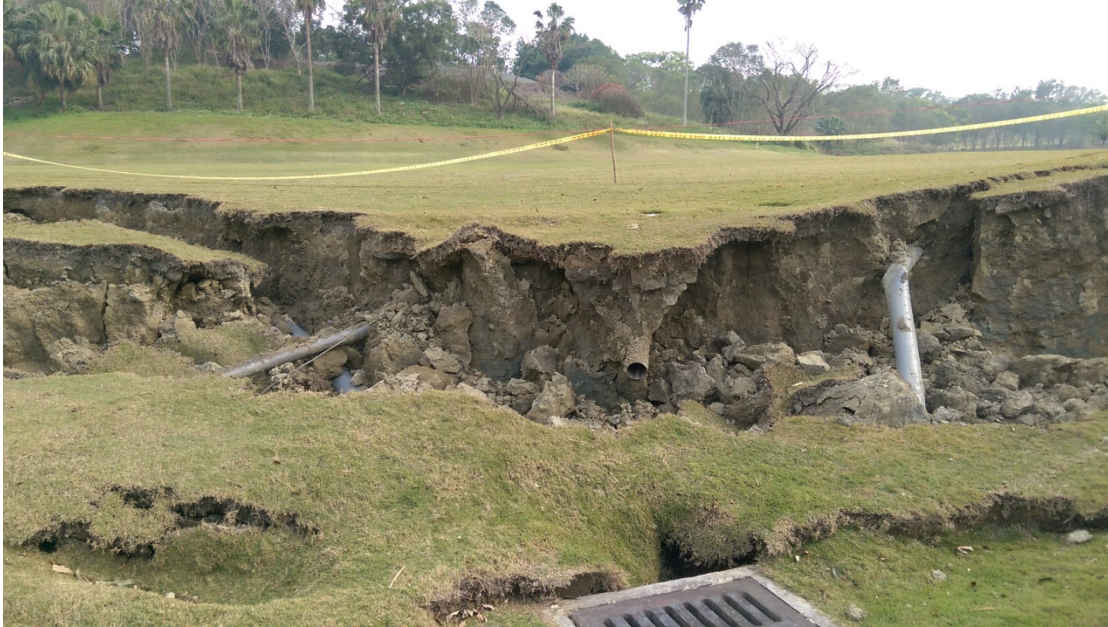
Figure 8-43: Watering pipes along the surface rupture. (23.151721, 120.370245)

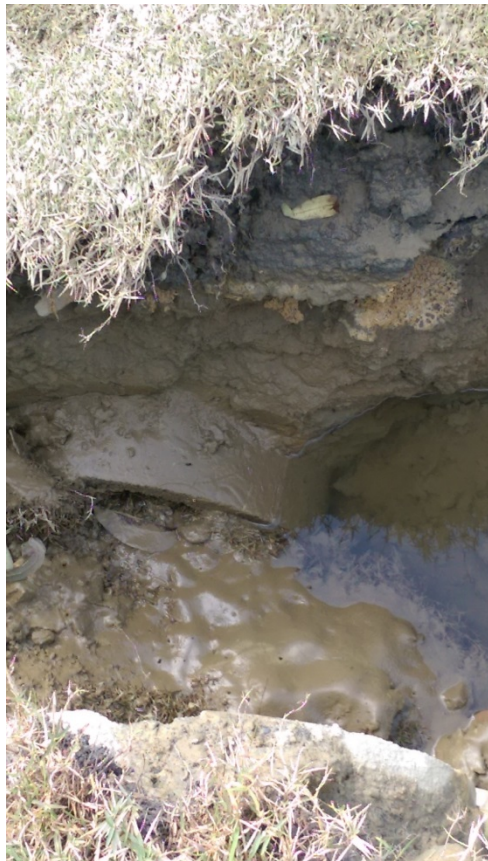
The consistency of the fill allowed the scarp to stand vertically for several days after the earthquake. Regular watering of the golf course and potential leakage from the pond allowed the near surface soil in the slide mass to be in a moist condition but far from saturation. Because February is the dry season in southern Taiwan and no evidence of groundwater was noticed in the scarp area nor observed in the deep cracks, the subsurface compacted fill material materials is believed to be unsaturated. The groundwater table is estimated to be at a level similar to creek (estimated to be no less than 8 m from the crest). Several PVC pipes buried below the surface in the fill (used for water pumping and irrigation for the maintenance of the course) were ruptured by the slide as shown in Figure 8-43. A 30 cm drainage pipe passed through the mid-section of the rupture and was broken after the failure. The water caved around the drainage pipe indicating that the soil has low permeability and the sliding surface has healed after the sliding.

Figure 8-44: broken drainage pipe.(23.151721, 120.370245)

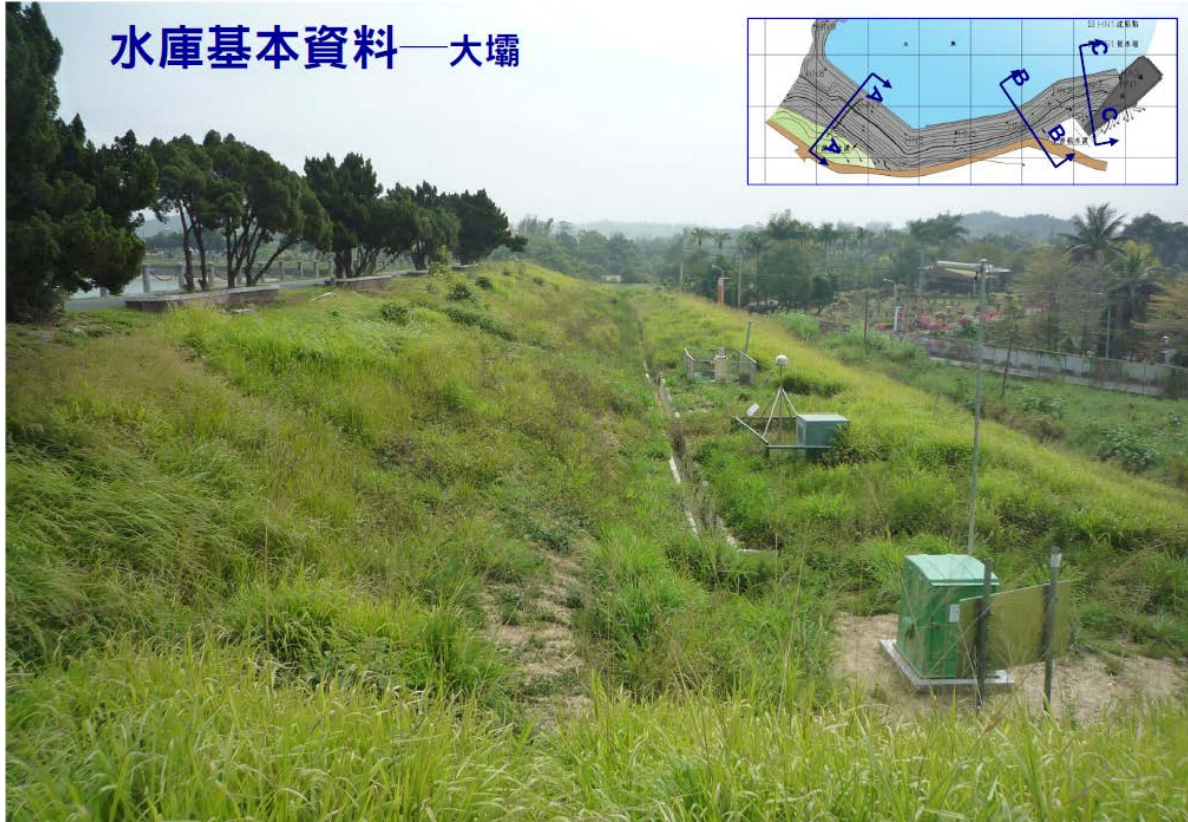
This is the first dam built in Taiwan. Construction started in 1831 and completed in 1846. Since its original construction, the dam has experienced four damaging earthquakes. The 1906 and 1946 Chia-Yi earthquake and Hsinghwa earthquake both caused the dam to be breached after which it was later rebuilt, with the current layout likely reflecting the 1946 re-build (Figure 9-9). The current dam is 15.3 meters high and has a 3:1 (H:V) downstream slope and a similar slope but with a steep upstream drop on the upstream side as shown in Figure 9-11. No internal drain or toe drain was installed along the maximum section. Figure 9-10 shows a downstream view of the dam. Based on the vintage of the dam, it is expected that minimal compaction effort (animal walking) was made during construction. The 2010 M6.4 Jiashian earthquake caused the dam to crack again and develop a transverse crack 6 meters long and 4 meters deep (Figure 9-12). The crack was excavated and repaired. The 2016 Meinong earthquake caused the dam to experience longitudinal compression and bulging of the AC pavement, and ten transverse cracks listed in Table 9-4 and shown in Figure 9-13. The deepest crack measured 100 cm deep and occurred at the same location as the 2010 post-Jiasian earthquake repaired crack. Most other cracks are surficial. The dam experienced about 0.3g ground motion in the freefield. Figures 9-14 through 9-16 show the cracking created by the Meinong earthquake.

Figure 9-10: Downstream View of Hu-Shan-Pi Dam.

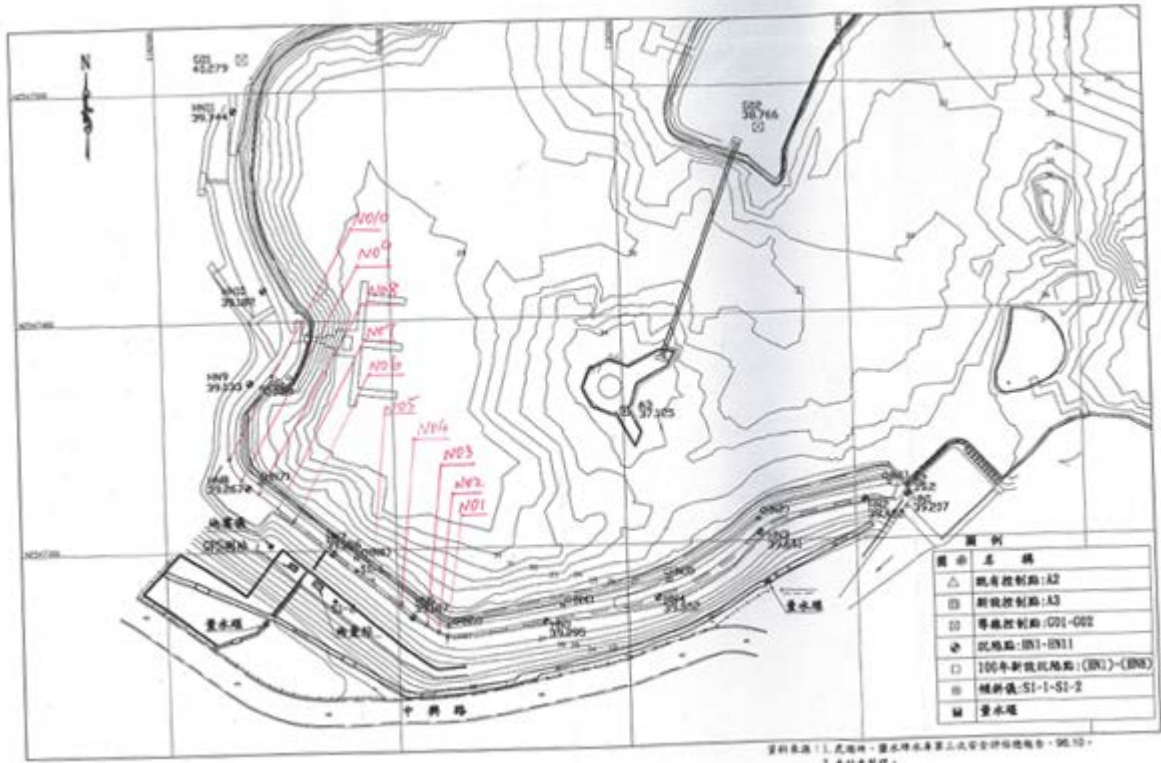
Figure 9-13: Cracking caused by 2016 Meinong Earthquake.

圖 2-6-1 虎埤埤壩監測器中佈置圖

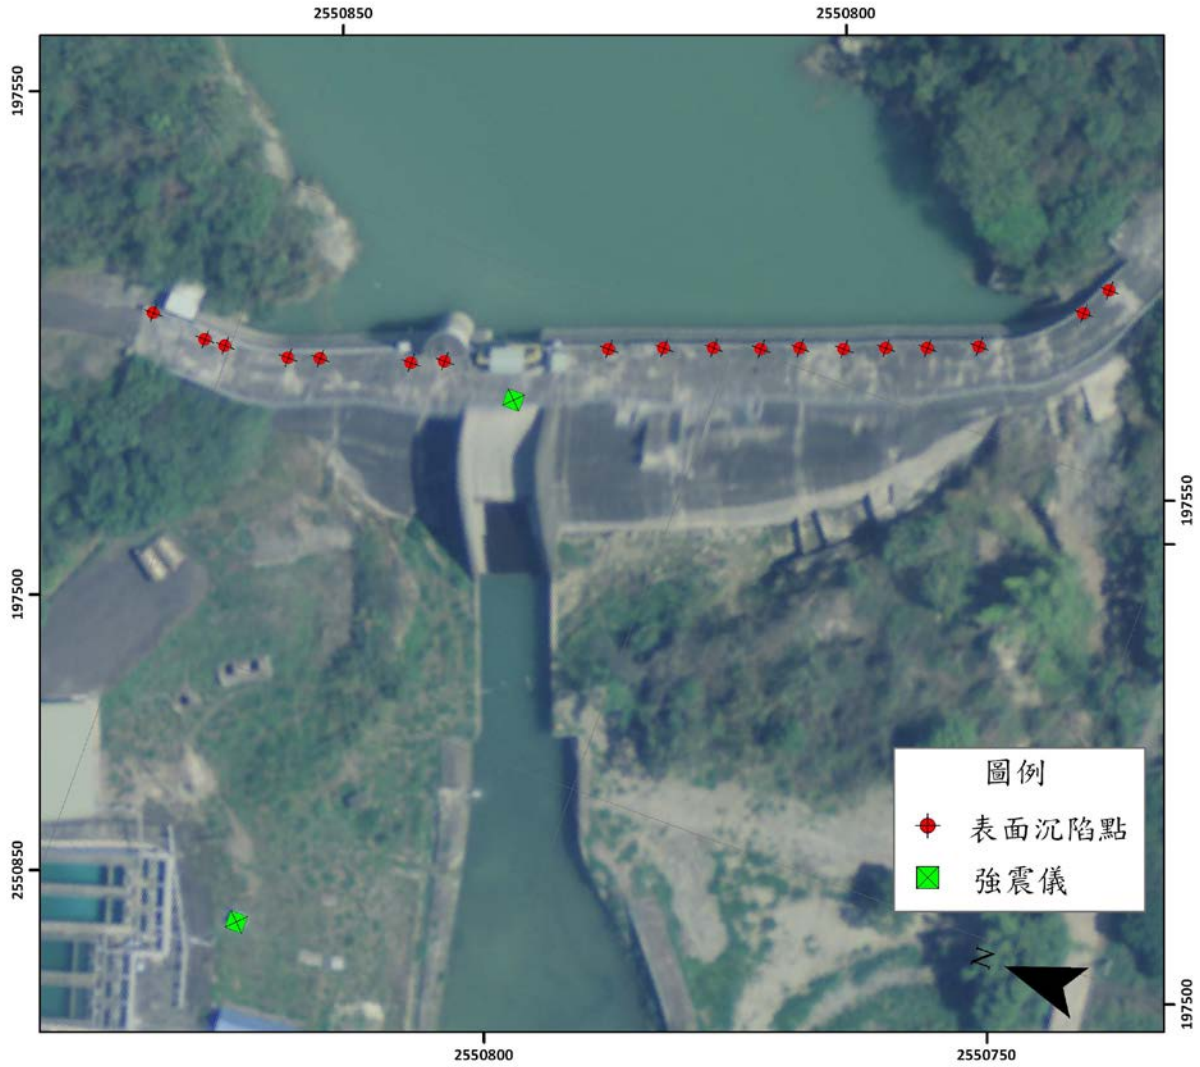
The Gin-Mian Dam is a concrete gravity dam. The ground motion was amplified from its toe of 0.25g to the crest of about 0.30g. No damage was reported at this dam.

Figure 9-17: Aerial view of the Gin-Mian Dam.

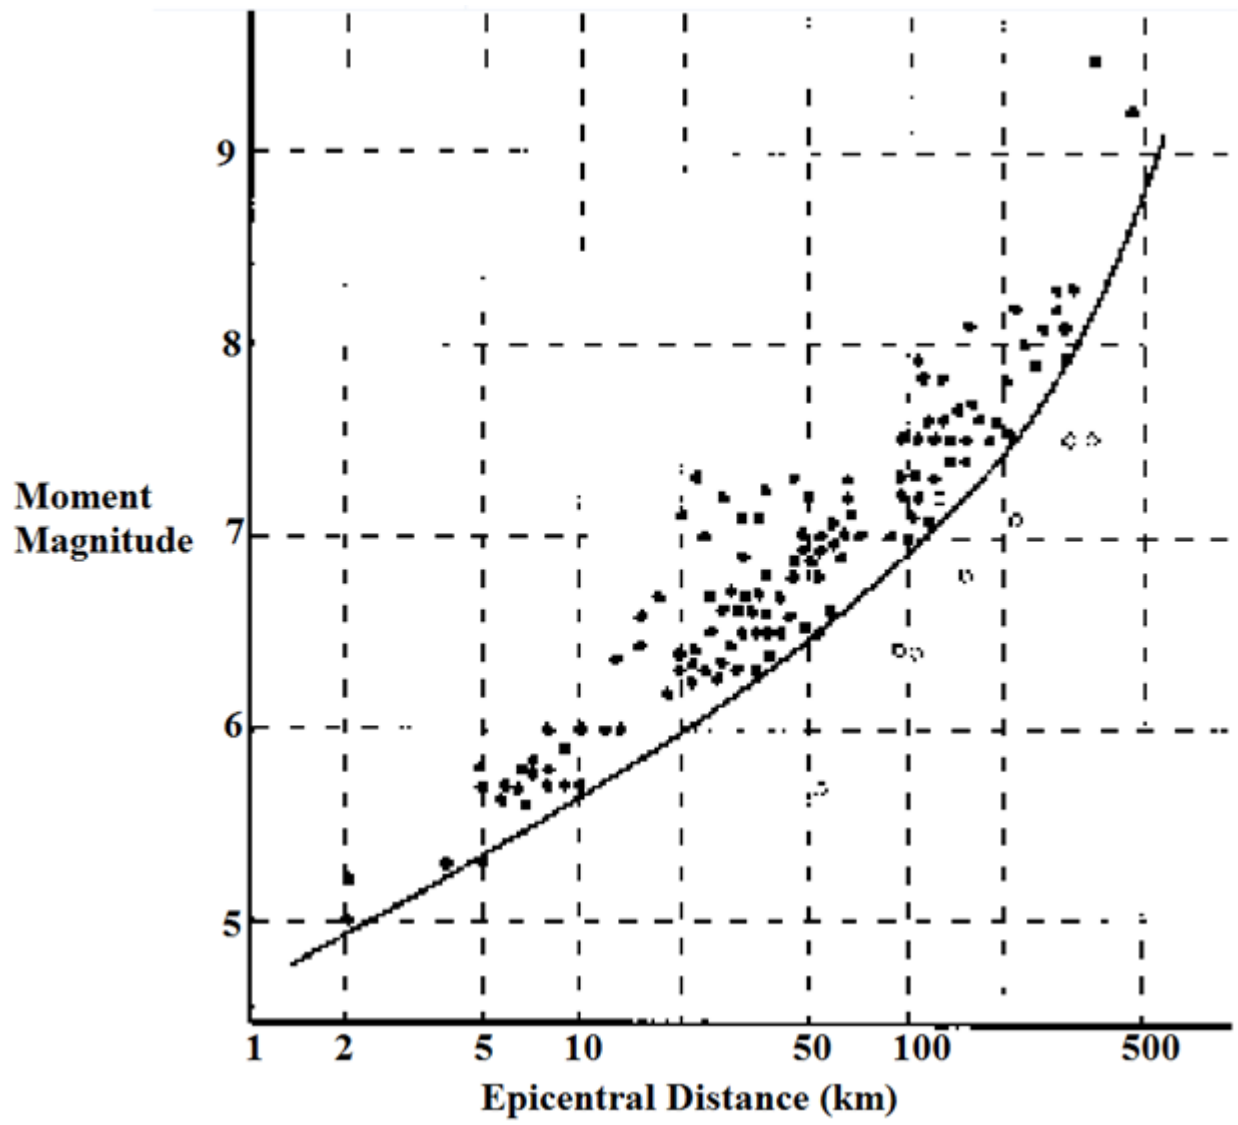
Liquefaction occurred primarily in Tainan City, approximately 40 km from the epicenter of the Meinong earthquake. While this liquefaction may appear unusual due to the relative small magnitude and large distance, it does agree with the lower bound from liquefaction case histories summarized by Ambraseys (1988) as shown in Figure 10-1. Based on ground response presented in Chapter 4, the thick alluvial deposit may have responded to the distance earthquake and amplified the attenuated ground motion and lengthen duration of the surface motion. This is similar to the 1989 Loma Prieta earthquake where liquefaction occurred in the Marina District of San Francisco located 90 km from the epicenter of the Mw 6.9 earthquake. In this case, the loose backfill liquefied because the soft Bay mud underlying the sandy fill amplified the weak attenuated motion.

Figure 10-1: Historical Observation of liquefaction Case Histories (Ambraseys, 1988).

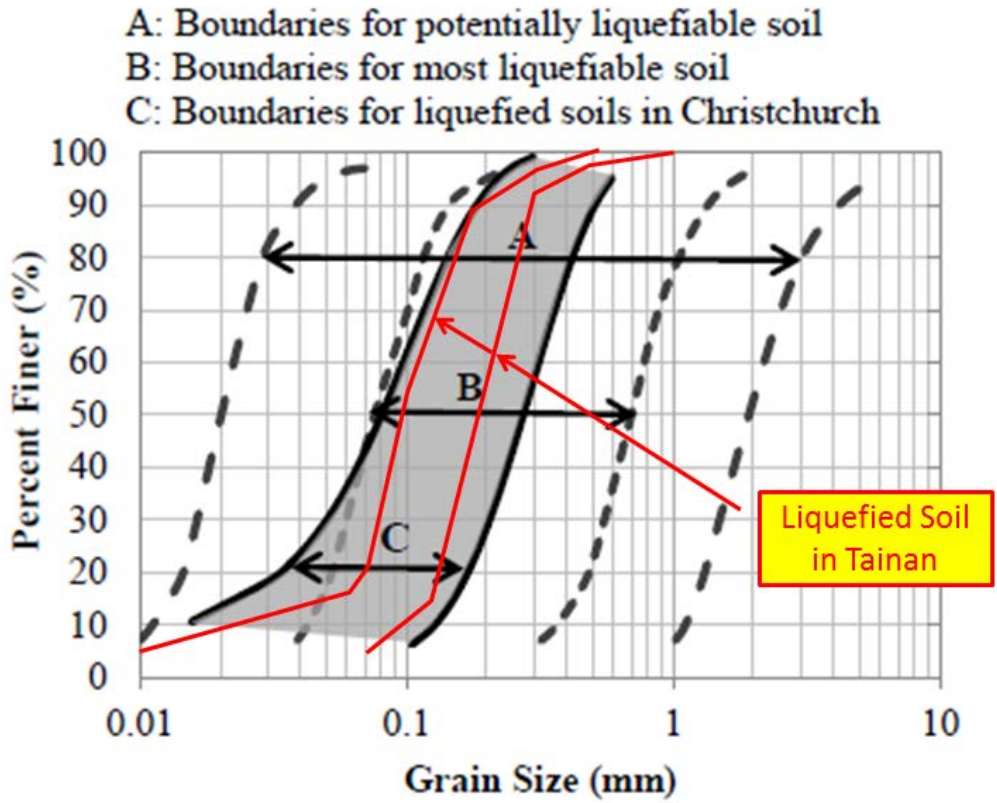
Soil gradation curves obtained from ejecta material taken at liquefied sites show that the soils that liquefied did not fall outside the recognized material susceptible to liquefaction. However, similar to the New Zealand Christchurch earthquake, the grain size distributions for Meinong liquefied soils fall on the finer grain range as shown in Figure 10-2. Similar to The Christchurch earthquake, the Xinhua site that liquefied in this event liquefied in the 2010 Jiasian earthquake with the same magnitude and epicenters separated by less than 10 km,

Figure 10-2: Comparison of Liquefiable Soil in New Zealand and Tainan (Modified after [USGS](#)).

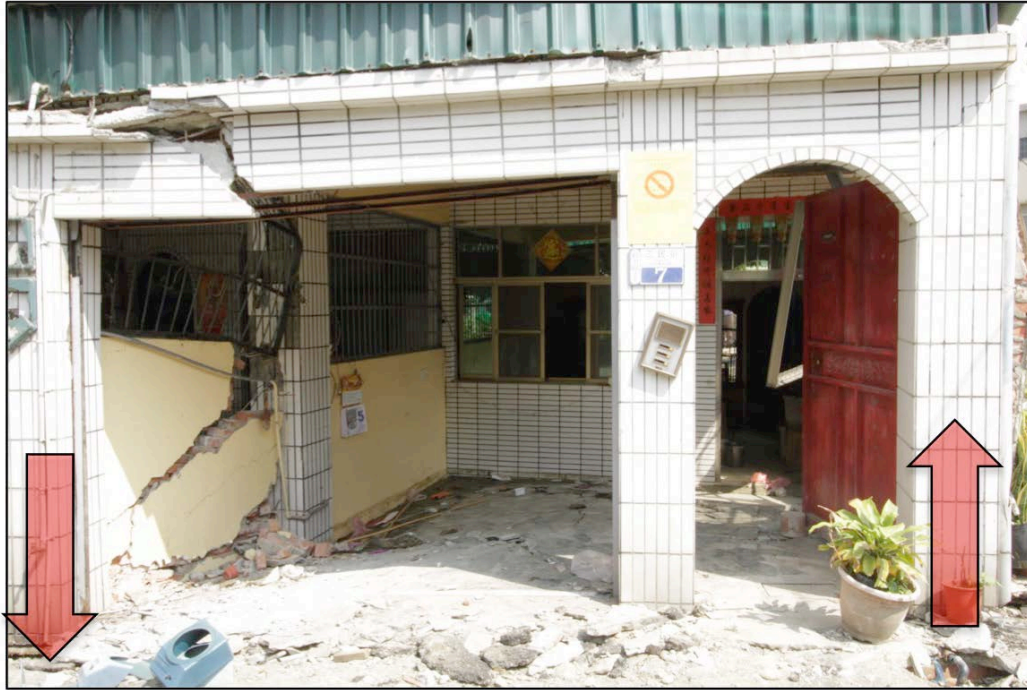
Figure 10-3: Development of a structural hinge within a beam supporting a carport at the Xinshi site due to column heave (right side) and settlement (left side) of structure. This carport was demolished, while the interior of the building supported on grade beams connecting spread footings performed well ([23.08096](#), [120.30258](#)).

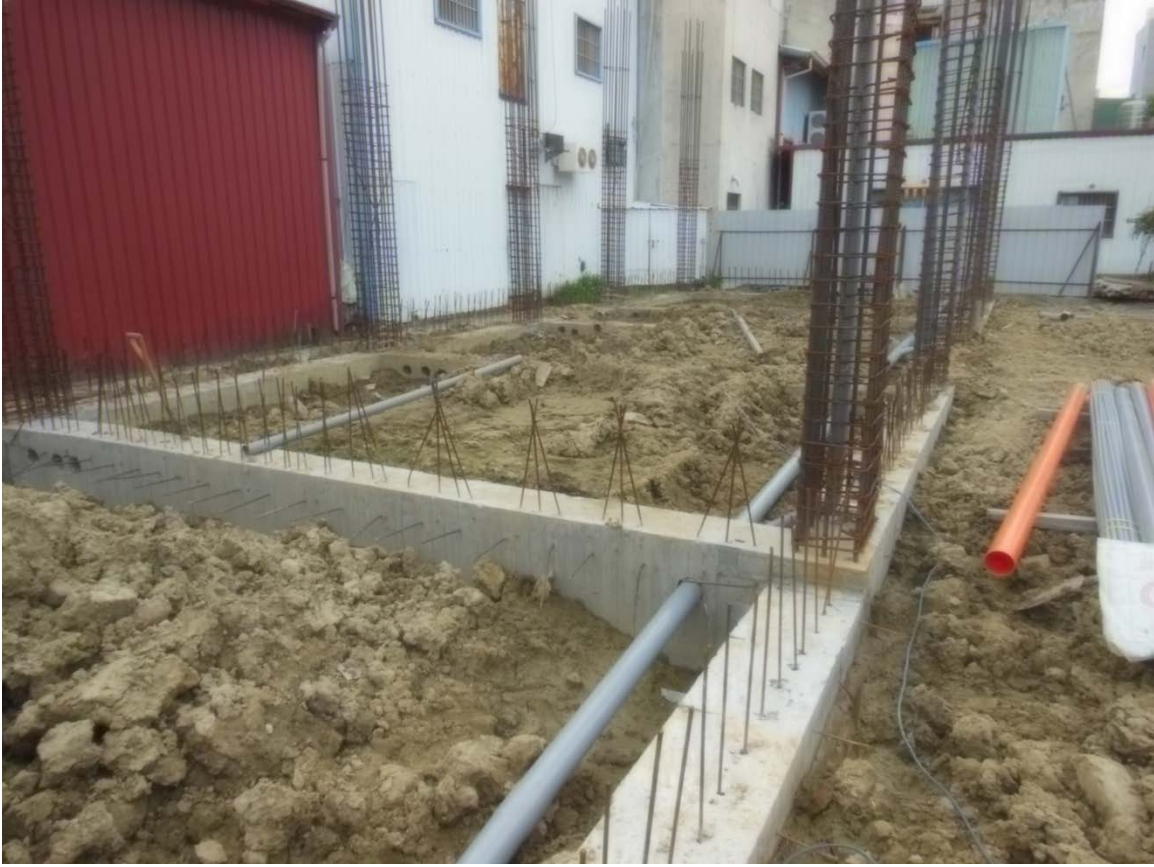
Although liquefaction occurred in a number of local regions within the city of Tainan, as noted, these were localized during this event to areas supported on prior pond features where poor quality backfill had been utilized. While this highlighted the historical significance of these features, the resulting building performance was generally good when well-connected foundations were used. On the other hand, features of buildings lacking well connected foundations (such as car ports and other additions) suffered extensive damage, in some case with propagation of large shear strains into the structure resulting in development of structural hinges (e.g. Figure 10-3). Modern Taiwanese design adopting continuous grade beam features will no doubt result in improved performance (e.g. Figure 10-4). The presence of basements below buildings was also noted to result in good performance of the superstructure of the building; despite adjacent liquefaction ground failure.

Figure 10-4: Modern grade beam design in Taiwan (building under construction in Tainan City).
