The Hydraulic and Geotechnical Aspects of the South Carolina Floods of October 1-5, 2015 Related to Offshore Hurricane Joaquin

GEER Association Report No. GEER-052 December 19, 2016

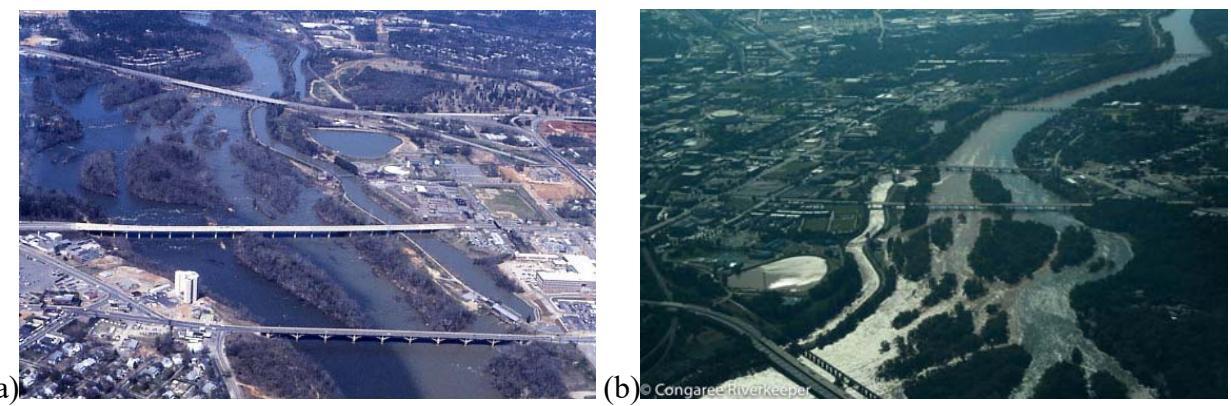
The Columbia Canal extends 5.6 km (3.5 miles) along the east bank of the Broad and Congaree Rivers shown in Figure 13. The confluence of the Broad and Saluda Rivers forms the Congaree River at Columbia, SC. The Columbia Canal was designed to enable the navigation of the Broad and Congaree Rivers at their confluence in Columbia. The canal was completed in 1824 and enlarged in 1891. The redesigned Columbia Canal was about 46 m wide and 3 m deep. The canal includes a diversion dam, an intake gate, a spillway, and a powerhouse. The Columbia Canal Hydroelectric Plant completed in 1896 was designed to supplement electricity produced by Columbia Mills. It is owned by the City of Columbia and Lockhart Power operates the powerhouse under contract. Water enters the canal through the intake, flows down the canal, is normally released through the powerhouse at the downstream end of the canal, and flows into the Congaree River. The powerhouse contains seven turbine/generator units with a total generation capacity of 10.6 MW. If the powerhouse is not generating or otherwise unable to release water, then the spillway is used for canal outflow. The Columbia Canal is inspected six times a year with results reported to the Federal Energy Regulatory Commission (FERC). The last inspection was less than two months before the flooding on Aug. 14, 2015. FERC classified the Columbia canal as a significant dam given its importance for the water supply of the city of Columbia, while the downstream flood hazard remains limited as any breaches or overflow would spill right back into the Broad and Congaree Rivers.

Figure 13. Aerial views of the Columbia Canal along the east bank of the Broad and Congaree Rivers. The confluence of the Broad and Saluda Rivers forms the Congaree River at Columbia, SC (N 33.99841°, W 81.05502°). Note the brown sediment laden water of the Broad River and the dark water of the Saluda River downstream of Lake Murray and the Saluda dam: (a) undated photo from South Carolina Department of Archives and History (SCDAH, <u>www.nationialregister.sc.gov</u>); (b) October 6, 2015 post canal breach photo from Congaree Riverkeeper (<u>www.congareeriverkeeper.org</u> via their Twitter and FB).

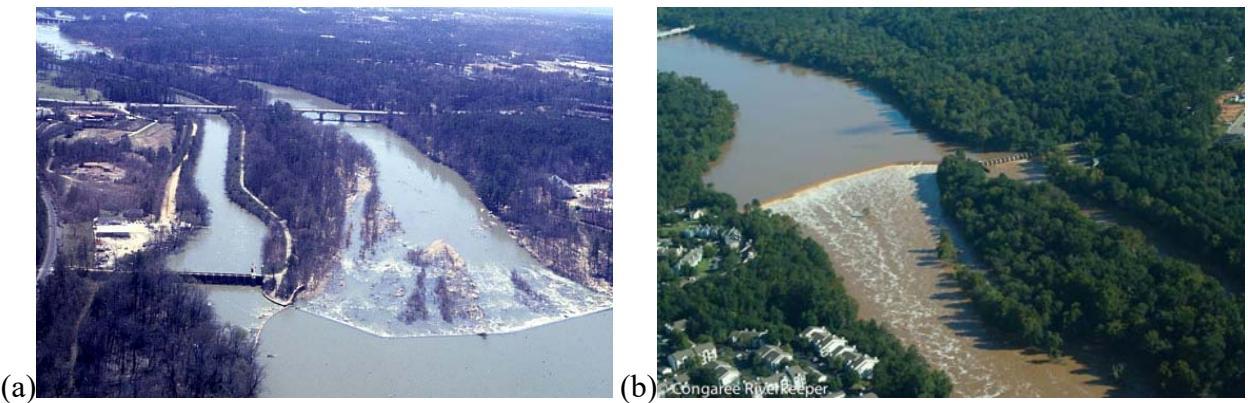
The diversion dam along the Broad River forms the Columbia reservoir at the entrance into the Columbia Canal shown in Figure 14. The intake into the Columbia Canal includes inflow control structures in the form of 12 sluice gates and a presently unused navigation lock.

Figure 14. Aerial views of the diversion dam and guard lock regulating the inflow into the Columbia Canal along the east bank of the Broad River some 5 km upstream of downtown Columbia, SC: (a) undated photo from South Carolina Department of Archives and History (SCDAH, <u>www.nationialregister.sc.gov</u>), (b) October 6, 2015 photo from Congaree Riverkeeper (<u>www.congareeriverkeeper.org</u>, N 34.03334°, W 81.06860°).

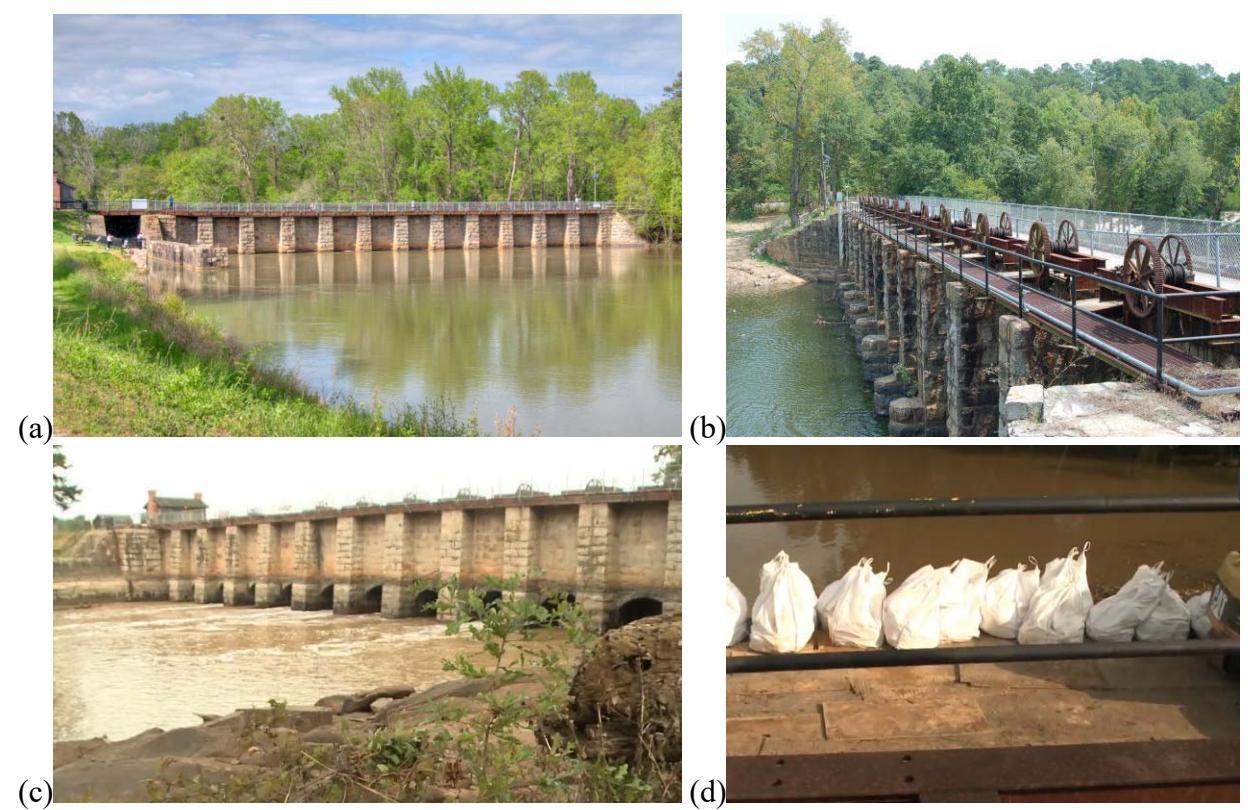
The headworks structure with the unused navigation lock and the 12 sluice gates in quiet times is shown in Figure 15a. The lifting mechanism with two large gears per gate to rise and lower the sluice gates vertically appear old but seemingly operable (Figure 15b). The 12 intake sluice gates were unable to completely shut off the inflow into the canal as designed for canal maintenance and emergency situations. This structure is owned by the City of Columbia and under operation permit from the Federal Energy Resources Commission (FERC). There is no evidence of Broad River water overtopping the intake structure or the berm that connects eastward to the railroad grade. The bulk of the floodwater in the canal originated from the inflow through incompletely sealed

intake gates. The snippets from the media footage of October 13, 2015 show the inflow through the 12 sluice gates exposed by the lower water level inside the Columbia Canal after the downstream breach (Figure 15c). The media footage also features the attempts to reduce the inflow into the canal by placing thousands of sand bags in front (upstream) of the sluice gates (Figure 15d). Lateral surface runoff over the canal length of 5 km may have further contributed to the inflow.

Figure 15. Columbia Canal intake structure: (a) downstream side of the unused navigation lock and the 12 sluice gates for inflow control in Feb. 2011 (<u>www.vickiwilsonphotos.wordpress.com</u>), (b) upstream side of the head-structure with the lifting mechanisms for the 12 sluice gates (<u>www.scgreatoutdoors.com</u>), (c) downstream side on October 13, 2015 with the visible inflow into the Columbia Canal with (d) numerous sand bags emplaced on the upstream side of the sluice gates in an attempt to reduce the inflow (snippets from <u>http://on.wltx.com/1Lt0Eii,</u> N 34.03334°, W 81.06860°).

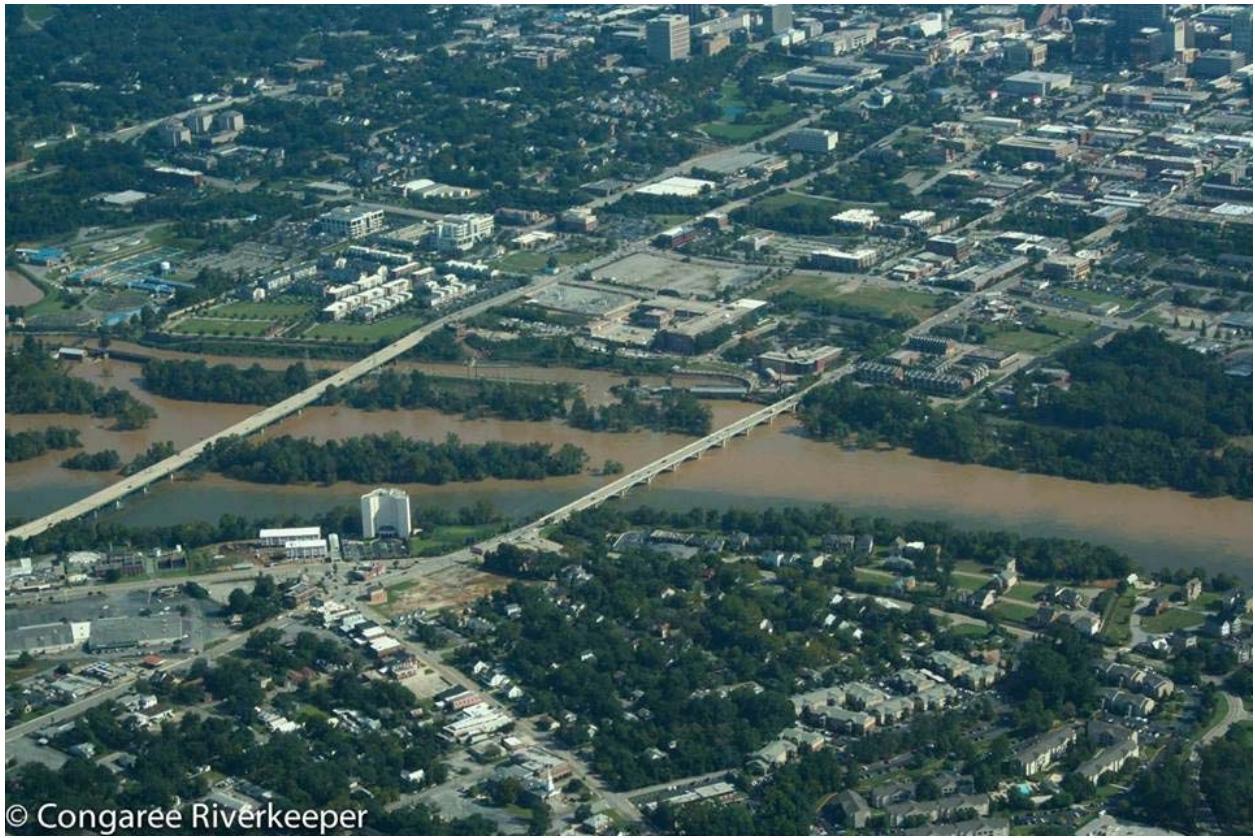
The Columbia Canal spillway in the form of a lateral side-weir is located some 250 m upstream of the Jefferson Davis McMahan Bridge, which takes South Carolina Highway 12 (SC 12) or Jarvis Klapman Boulevard across the Congaree River at the confluence of the Broad and Saluda Rivers shown in Figure 16. The Columbia Canal breach is located some 250 m downstream of the Jefferson Davis McMahan Bridge (SC 12) and an equal distance upstream of the Gervais Street Bridge.

Figure 16. Aerial view of the Congaree River formed by the confluence of the Saluda River (blue water in foreground) and Broad River (sediment laden brown water) with the Columbia Canal in the background. In the center of the image is the Gervais Street Bridge with the power house and the breach upstream along the canal dike (N 33.99796°, W 81.05018°). The Jefferson Davis McMahan Bridge (SC 12) is located 0.5 km upstream of the Gervais Street Bridge and the side weir spillway another 250 m upstream of SC 12. October 6, 2015 photo from Congaree Riverkeeper (www.congareeriverkeeper.org via their Twitter and FB).

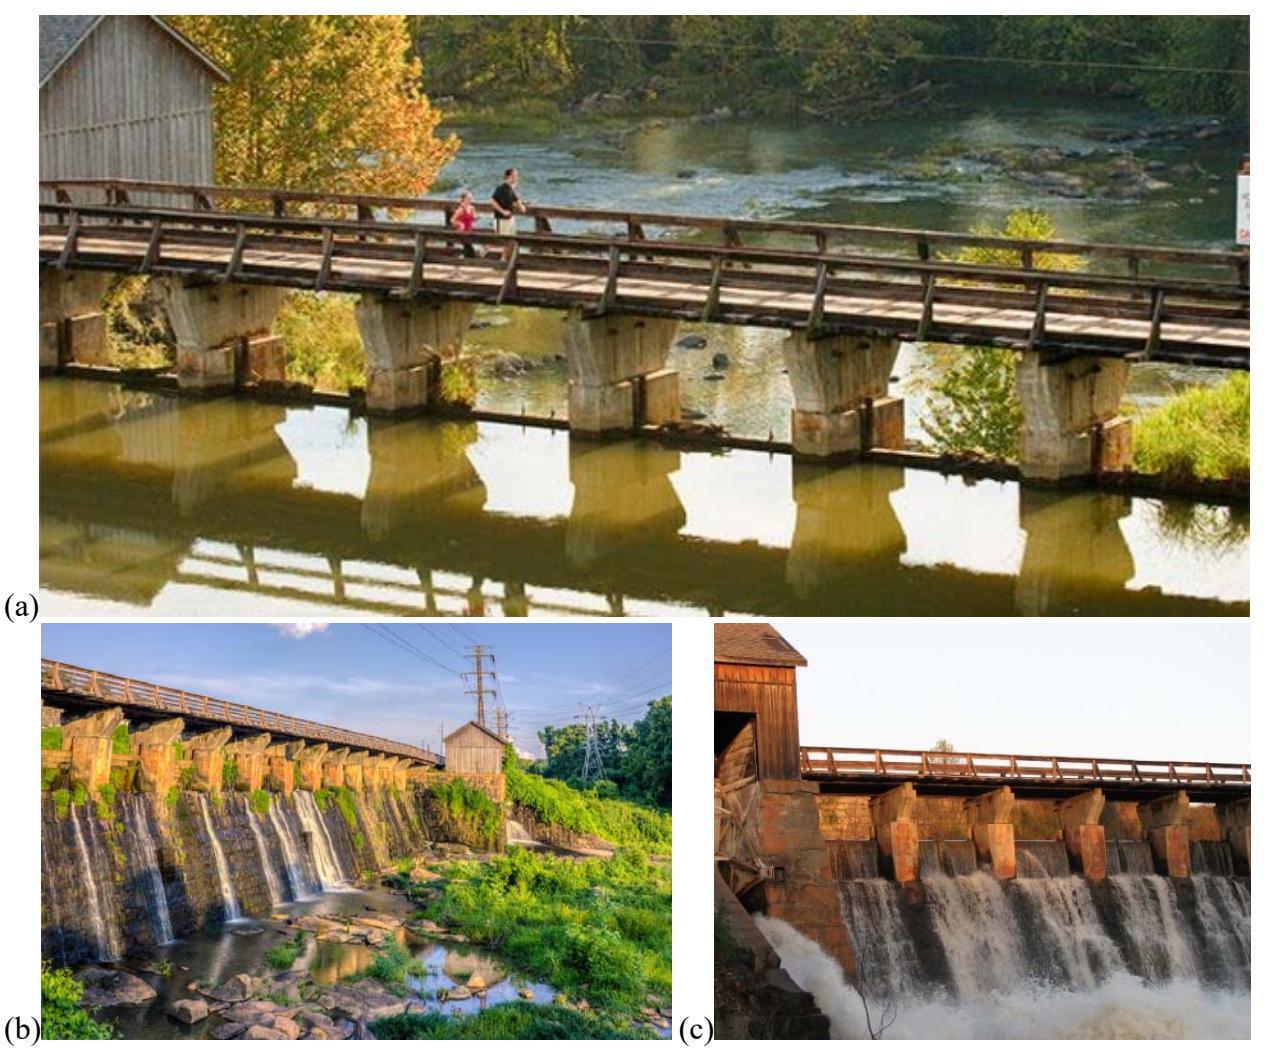
The spillway is built into the Columbia Canal dike in the form of a side-weir discharging excess water back into the Broad River. The spillway consists of 2 radial (Tainter) gates, which allow regulation of the water level maintained in the canal. The emergency spillway itself consists of 14 weir segments with the original ability to insert stoplogs into vertical slots along the pillars to adjust the crest height above the baseline weir crest. The stoplogs raise the normal crest height up to a height of about 75% of the vertical adjustment slots along the pillars as shown in pre-flood archive photos (Figure 17). Normal spillage level apparently is preferred to be far above the base of the total design opening corresponding to the base of the pillars. The vertical grooves in the pillars are there to allow such adjustments.

Figure 17. Side-weir spillway from Columbia Canal to Broad River consisting of 2 regulated radial gates and 14 weir segments with stoplogs (N 34.00199°, W 81.05372°): (a) Columbia Canal spillway to Broad River before flooding event (<u>www.discoversouthcarolina.com</u>), (b,c) downstream of side weir with stoplogs installed in vertical adjustment slots along pillars raising crest height [(b) <u>www.fineartamerica.com/featured/columbia-canal-rob-sellers.html</u>, (c) <u>www.sciway.net/sc-photos/albums/midlands-sc/columbia-canal-spillway.jpg</u>].

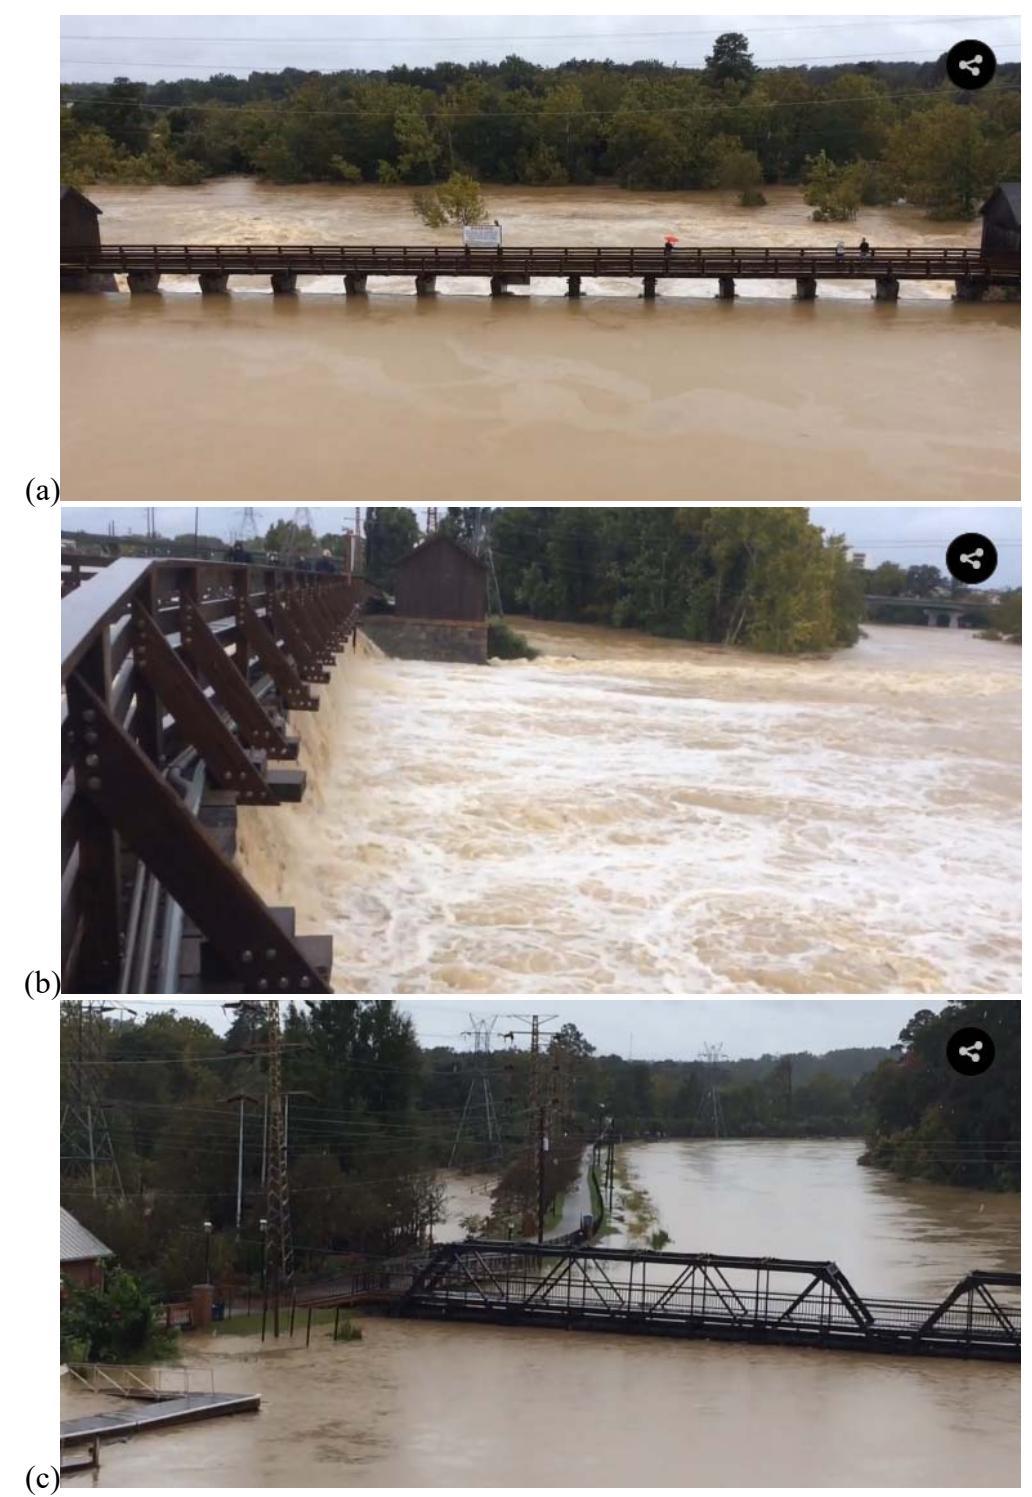
The Sunday October 4, 2015 video footage recorded during the flood prior to the nighttime breach shows the water spilling through the 2 sluice gates and the 14 bays of the side weir shown in Figure 18 (snippets from <u>www.thestate.com/news/article37721334.html</u>). The video footage also shows the downstream of the side weir highlighting a free overflow characterized by the nappe flow. The water level in the Broad River downstream of the spillway reaches flood stages but remains well below the base of the weir crest. The upstream water level in the Columbia Canal reaches the underside of the beams of the pedestrian bridge providing access to the Riverfront Park. Water continues to flow strongly under the bridge and towards the spillway.

Figure 18. Spillway and Columbia Canal prior to breach on Sunday October 4, 2015: (a) View of spillway from canal to Broad River. Note stoplogs remained installed and raise weir crest height up to a height of about 75% of the vertical adjustment slots along the pillars; (b) downstream view of the side weir overflow into Broad River. Note the river stage is well below the base of the weir crest and free overflow occurs. The water level in the canal may have been lowered by removing stoplogs; (c) upstream view of the canal with water level raised to the beams of the pedestrian bridge, which provides access to the Riverfront Park 100 m upstream of the spillway. All snippets from www.thestate.com/news/article37721334.html (N 34.00199°, W 81.05372°).

The head gates did not completely limit inflow into the Columbia Canal. The powerhouse was flooded, due to raising tailwater in the Congaree River, and was knocked offline and ceased releasing water. The water level in the canal continued to rise, and the spillway radial gates were opened, but the emergency spillway stoplogs remained installed blocking the 14 bays to about 75% of the height of the adjustable grooves. The Columbia Canal water level kept rising and eventually overtopped the earthen dike about 0.5 km downstream of the designated side weir spillway. The dike breached at about 3 a.m. on Monday October 5, 2015 based on media reports (www.charlotteobserver.com/news/local/article37956342.html). The downstream dike breach dramatically lowered the water level in the Columbia Canal revealing the side weir crest with installed stoplogs on Monday morning October 5, 2015 (Figure 19a). It appears that the stoplogs were permanently installed either as molded concrete or cement covered. During our visit the stoplogs were removed in the 12 central side weir openings, while the lateral two side weirs are permanently cemented and the lateral radial gates were fully open on October 11, 2015 (Figure 19b,c,d). The reduced water levels after the flood both in the approach to the side-weir of the Columbia Canal and downstream of the spillway are shown in Figure 19.

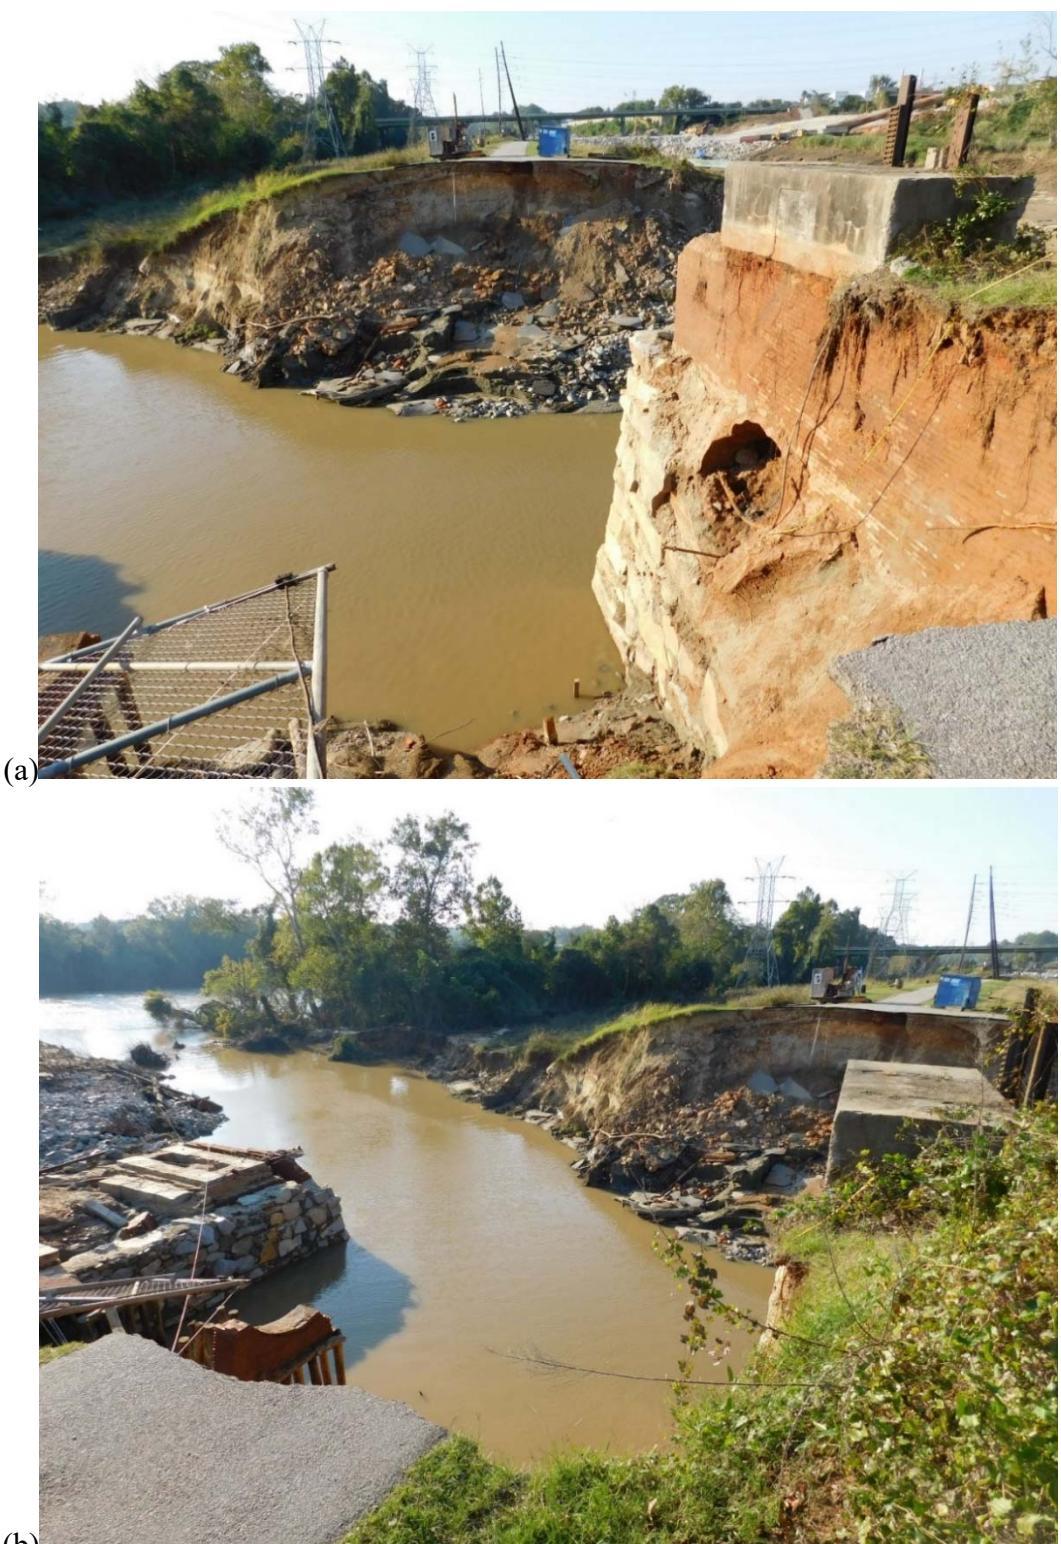
The initial Columbia Canal dike breach of 3 am on Monday October 5, 2015 occurred at the location of a rock wall some 20 m upstream of the Lockhart Power Substation #559 and 80 m upstream of the power house shown in Figure 20. At the crest level the breach extends 26 m upstream from the rock wall, while at the waterline only 12 m with the water surface 9 m below the dam crest as shown in Figure 21. The rock wall on the downstream end of the breach is directly upstream of a buried historic pipe and intake structure with a lifting mechanism for a sluice gate attached to a concrete block on the levee crest shown in Figure 22. The rock wall remained intact from the canal side of the levee profile, but failed from the road way on the levee crest towards downstream exposing the support structure of the historic pipe buried below the levee crest road. The length of the breach along the road on the dam crest expands to 40 m on the river side of the levee (Figure 23). The buried rock walls and pipe were part of the historic hydroelectric station that used to power the Columbia textile mill. As illustrated in the interpretive sketch shown in Figure 24, at the breach location the levee was constructed on top of older fill and/or floodplain sediments that thicken towards the Canal and were abutted against a buried stonemasonry wall. Extensive slumping along the Canal side of the right levee bank (facing downstream in flow direction) occurred after the initial breach due to rapid lowering of the Canal water level. The wrackline in the vegetation growing along the road embankment on the levee crest indicates that the Canal water level rose to within 0.3 m of the levee's crest, but did not overtop directly upstream of the breach. However there was slight overtopping with over wash on the order of 0.1 m on above the levee crest downstream of the breach between the buildings of the Lockhart Power Substation #559 and the power house (Figure 25). The peak discharge in the Broad River 1 mile upstream of the Columbia Canal intake or 4 miles upstream of the initial breach was reached more than 8 hours prior to the levee breach. The peak stage at the breach locations may have been reached approximately 6 hours prior to the breach. The cause of the initial breach was likely due to piping of levee soils along the soil-wall contact exacerbated by overtopping at the breach location. The groves between wall stones and the planar soil-to-stone contact provided the most likely paths for the piping that led to the initial breach at 3 am on Monday October 5, 2015.

Figure 22. Columbia Canal dike breach of October 5, 2015 some 20 m upstream of the Lockhart Power Substation #559: (a) Upstream view with the rock wall on the downstream end of the breach. Note the orifice shaped feature marking a buried pipe of a historic intake with a sluice gate lifting mechanism attached to the concrete block at the levee crest. (b) Support structure of the historic pipe buried below the road (photos: October 13, 2015; N 33.99796°, W 81.05018°).

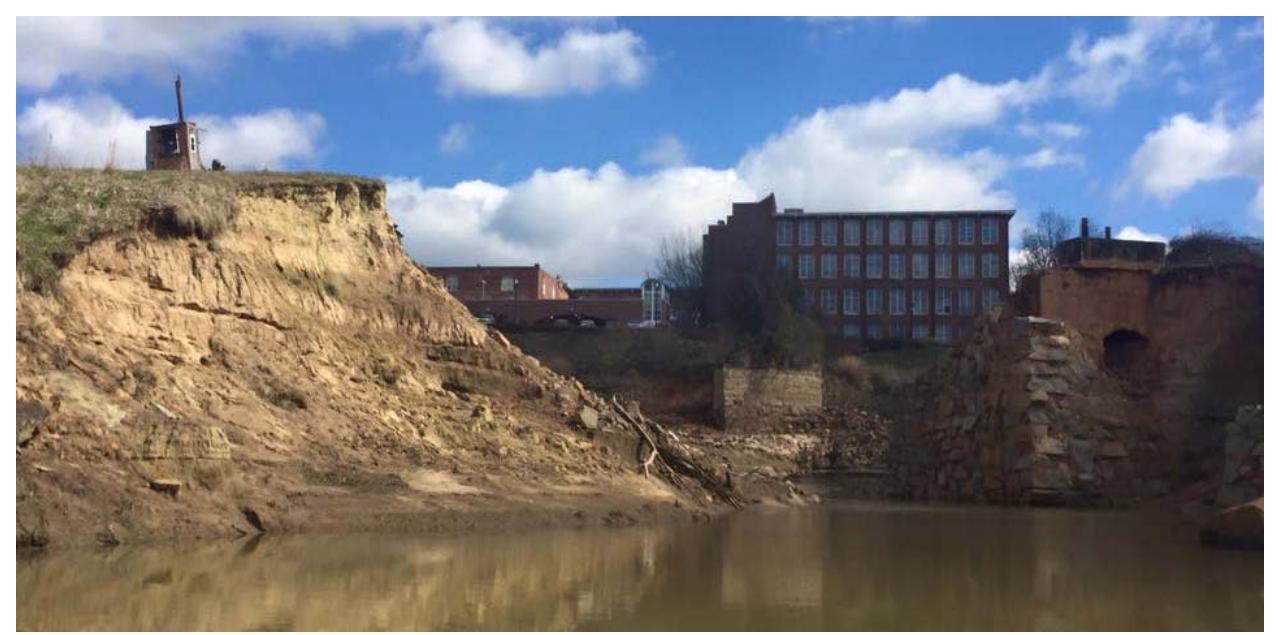
Figure 23. Columbia Canal dike breach of October 5, 2015 some 20 m upstream of the SCE&B Substation #559: Upstream view with the rock wall on the downstream end of the breach (to the right in photo). Note the orifice shaped feature in the rock to brick wall transition marking a buried pipe of a historic intake with a sluice gate lifting mechanism attached to the concrete block at the levee crest (photo March 4, 2016 from Congaree Riverkeeper: www.congareeriverkeeper.org via their Twitter and FB).

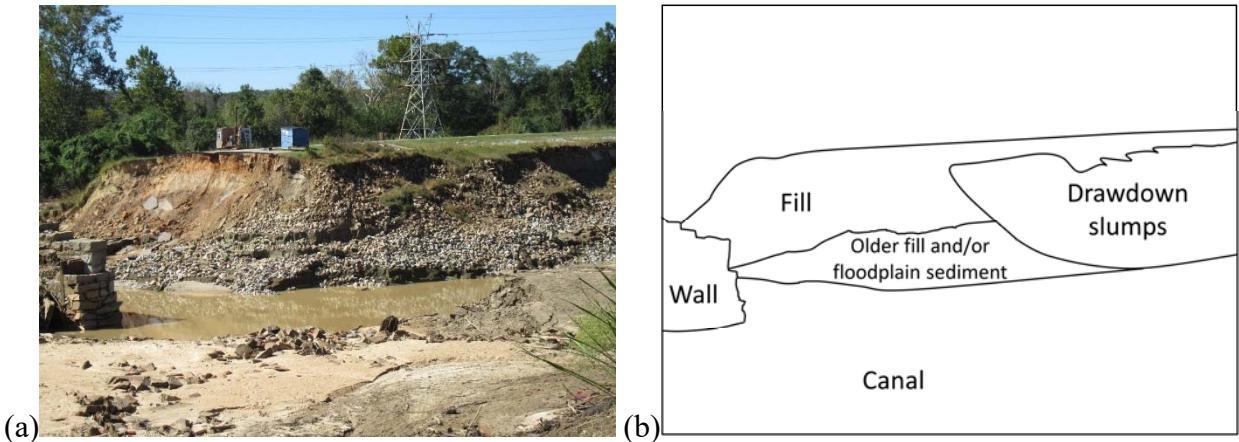
Figure 24. Columbia Canal dike breach of 3 am on Monday October 5, 2015: (a) Westward view of the breach and upstream levee on October 14, 2015; (b) interpretive sketch of the geotechnical levee composition (N 33.99796°, W 81.05018°).

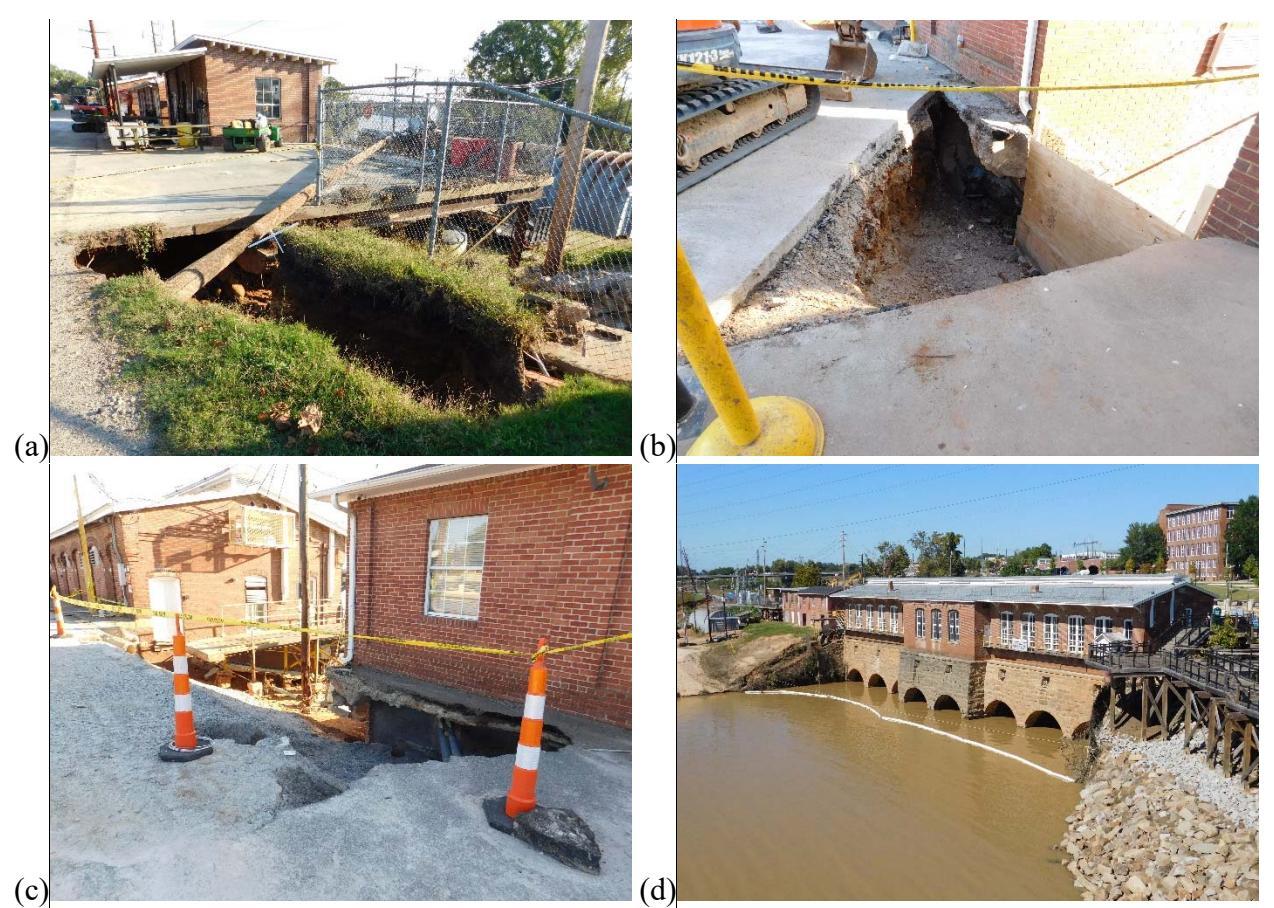
Figure 25. Overtopping of Columbia Canal dike: (a,b,c) Over wash erosion between the buildings of Lockhart Power Substation #559 upstream of the power house, but downstream of the breach (photos: October 13, 2015; N 33.99751°, W 81.04965°); (d) erosion on the downstream side of the levee from over wash funneled between the buildings upstream of the power house (photo: October 11, 2015; N 33.99716°, W 81.04932°).

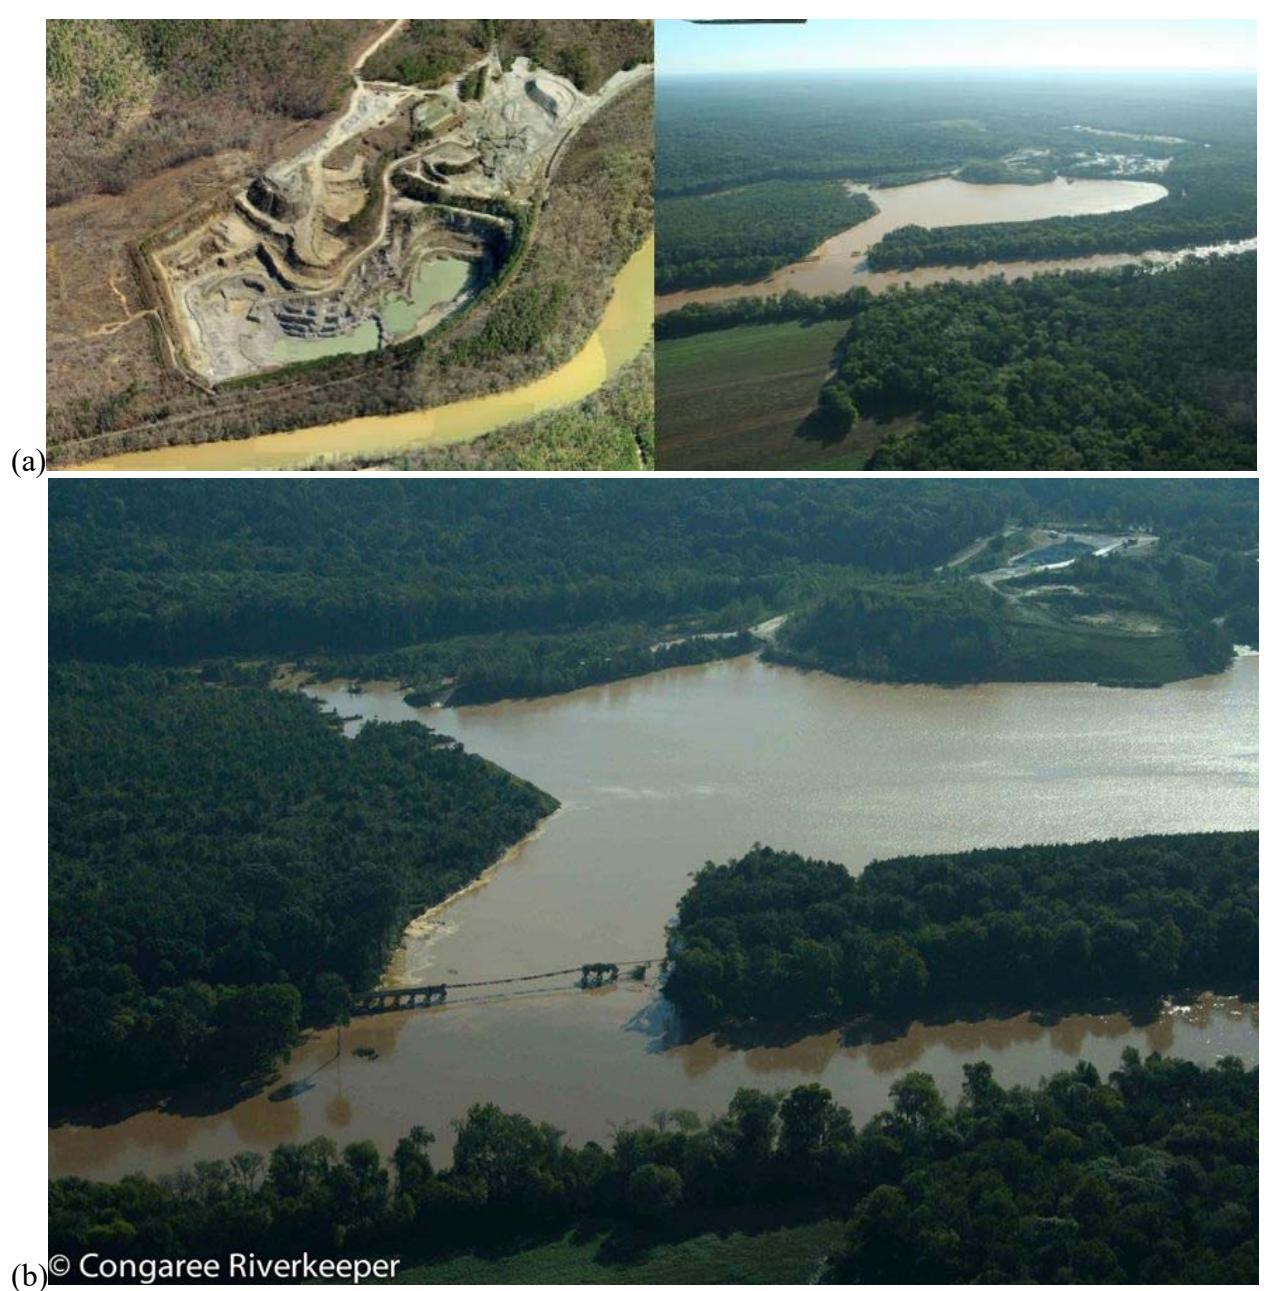
The eastern or left (in flow direction) Broad River embankment breached some 8.5 km upstream of the I-20 Broad River Bridge corresponding to 10 km upstream of the intake to the Columbia Canal (Figure 10). The Norfolk Southern Railroad trestle and the Martin Marietta Rock Quarry (North Columbia Quarry) are shown in before and after aerial photographs in Figure 29.

Figure 29. Aerial views of the Norfolk Southern Railroad trestle and the Martin Marietta Rock Quarry (North Columbia Quarry) the east bank of the Broad River 10 km upstream of the Columbia Canal: (a) undated archive photo; (b,c) flooded quarry with 200 m breach in left Broad River embankment and collapsed railroad bridge in October 6, 2015 photo from Congaree Riverkeeper (www.congareeriverkeeper.org via Twitter/FB; N 34.11447°, W 81.11935°).

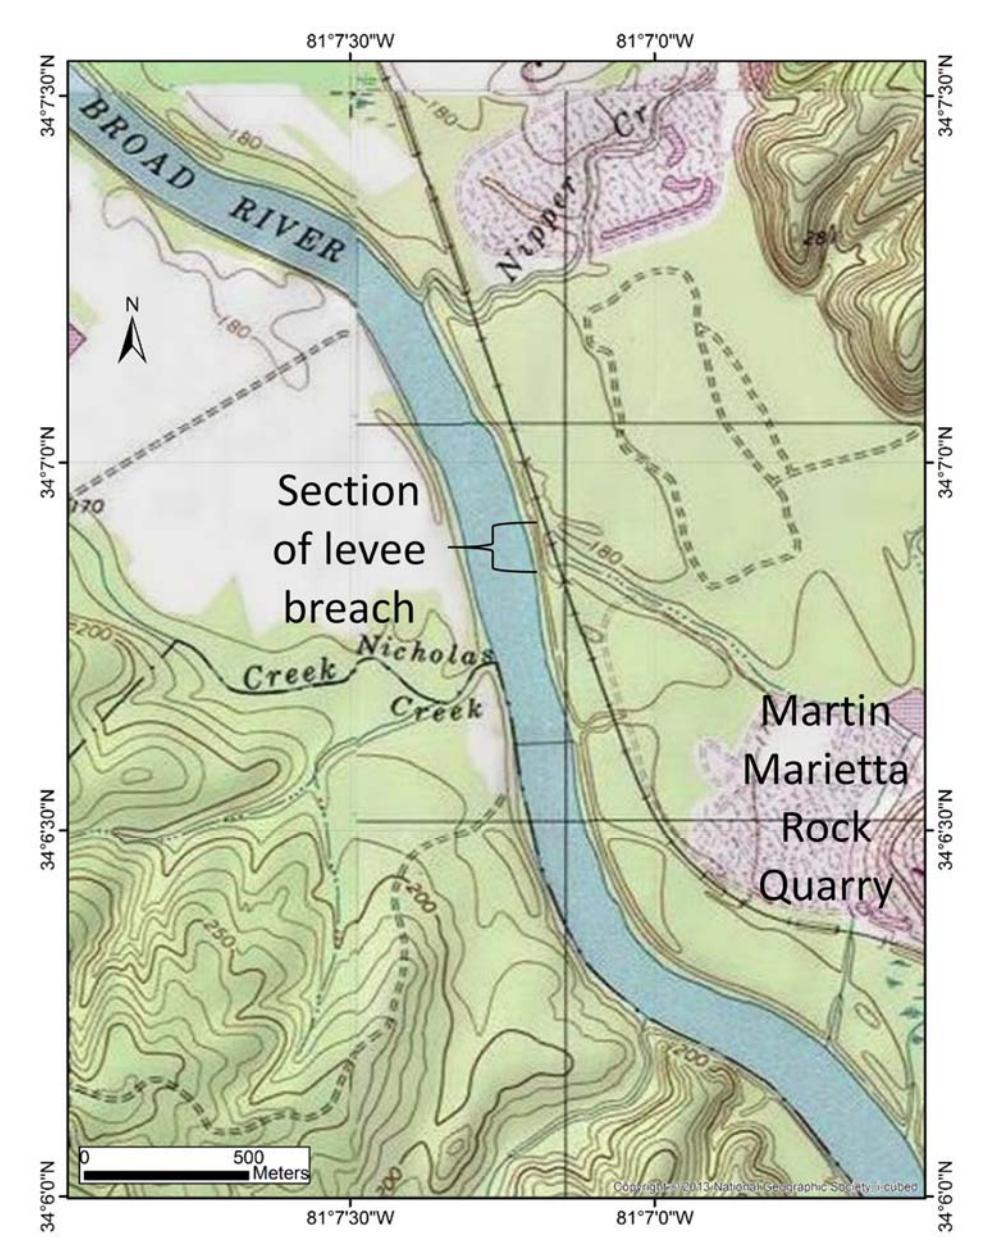
The 1997 USGS 7.5-minute topographic map of the area is shown in Figure 33 and provides additional insight into the levee breach. The levee was about 30-m-wide in the breached area, which is much narrower than at other locations along the Broad River. Thus, it is likely that the levee in the area of the breach was man-made to prevent flood waters from entering the drainage leading to the quarry.

Figure 33. 1997 USGS 7.5-minute topographic map showing locations of the breached levee and the Martin Marietta rock quarry.

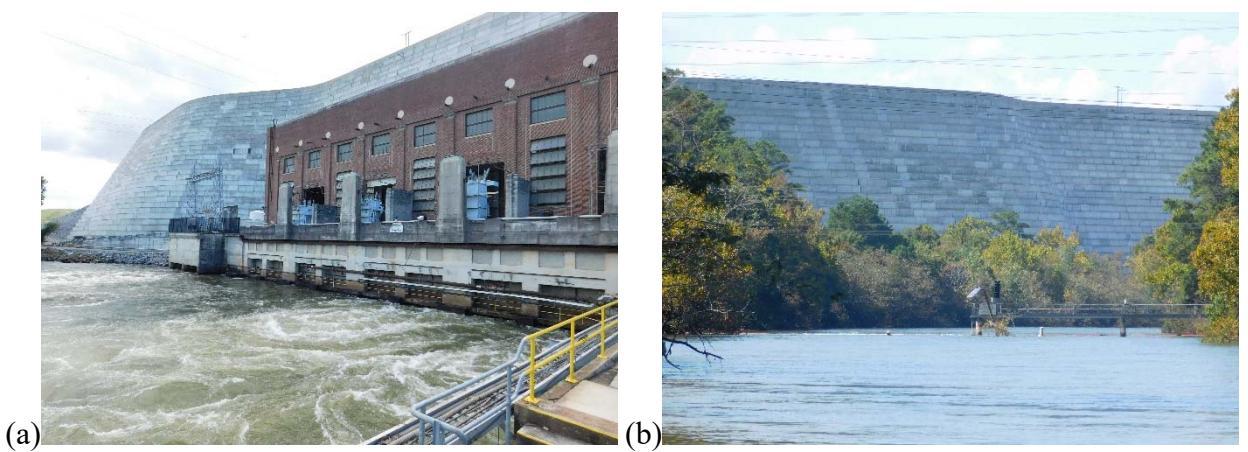
Figure 38. Saluda dam with RCC back-up dam built in 2005 for seismic remediation: (a) powerhouse with tailrace outflow and location of USGS gauge 02168501 (N 34.05390°, W 81.21652°); (b) Saluda River USGS gauge 02168504 some 700 m downstream of the Saluda Dam (N 34.05088°, W 81.20959°). The rafted debris entangled on the support structure marks the engulfing flooding and explains the drop out of the gauges (photos: October 12, 2015).

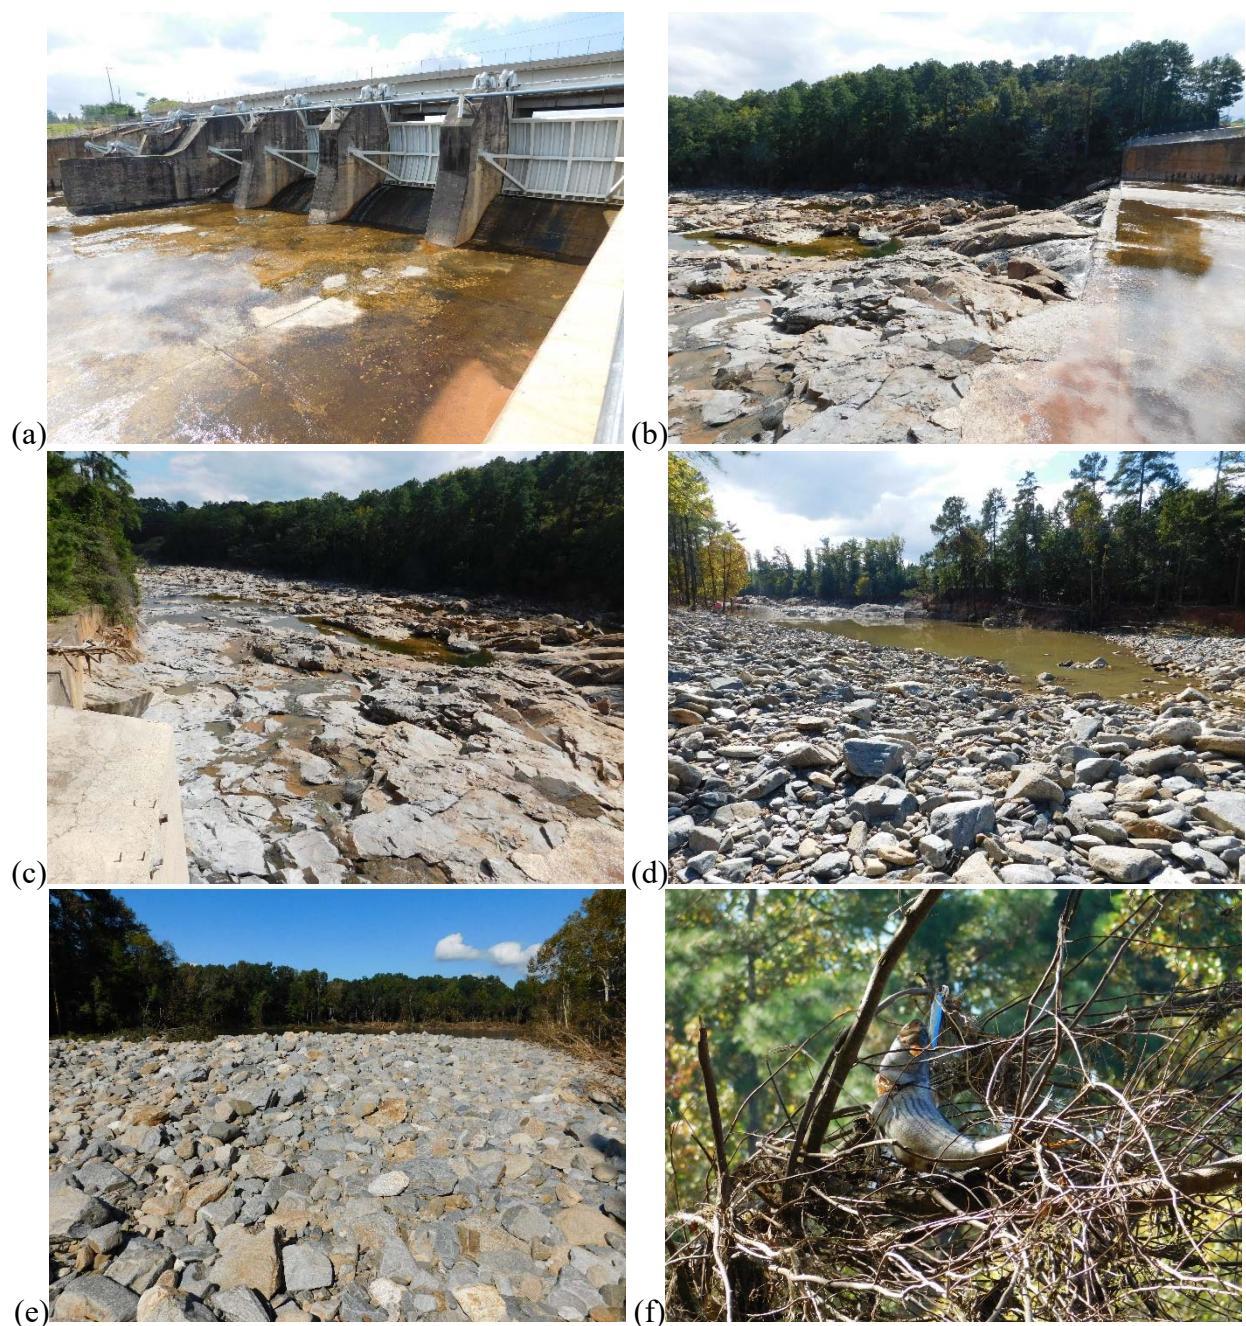
Figure 44. Emergency spillway aftermath: (a) Control weir with 6 Tainter gates located 150 m south of the Saluda Dam at Lake Murray; (b) ski-jump transition from the 40 m long concrete apron downstream of the gates to the bedrock; (c) 1.9 km long spillway section excavated into bedrock; (d) 100 m long scour hole 200 m upstream of confluence with Saluda River; (e) cobble and boulders forming a 60 m long berm at the confluence with the Saluda River; (f) fish and rafted debris 5 m up in a tree above the cobble berm along the spillway (photos: October 12, 2015). Locations (a,b,c): N 34.04035°, W 81.21579° and (d,e,f): N 34.04832°, W 81.20556°.

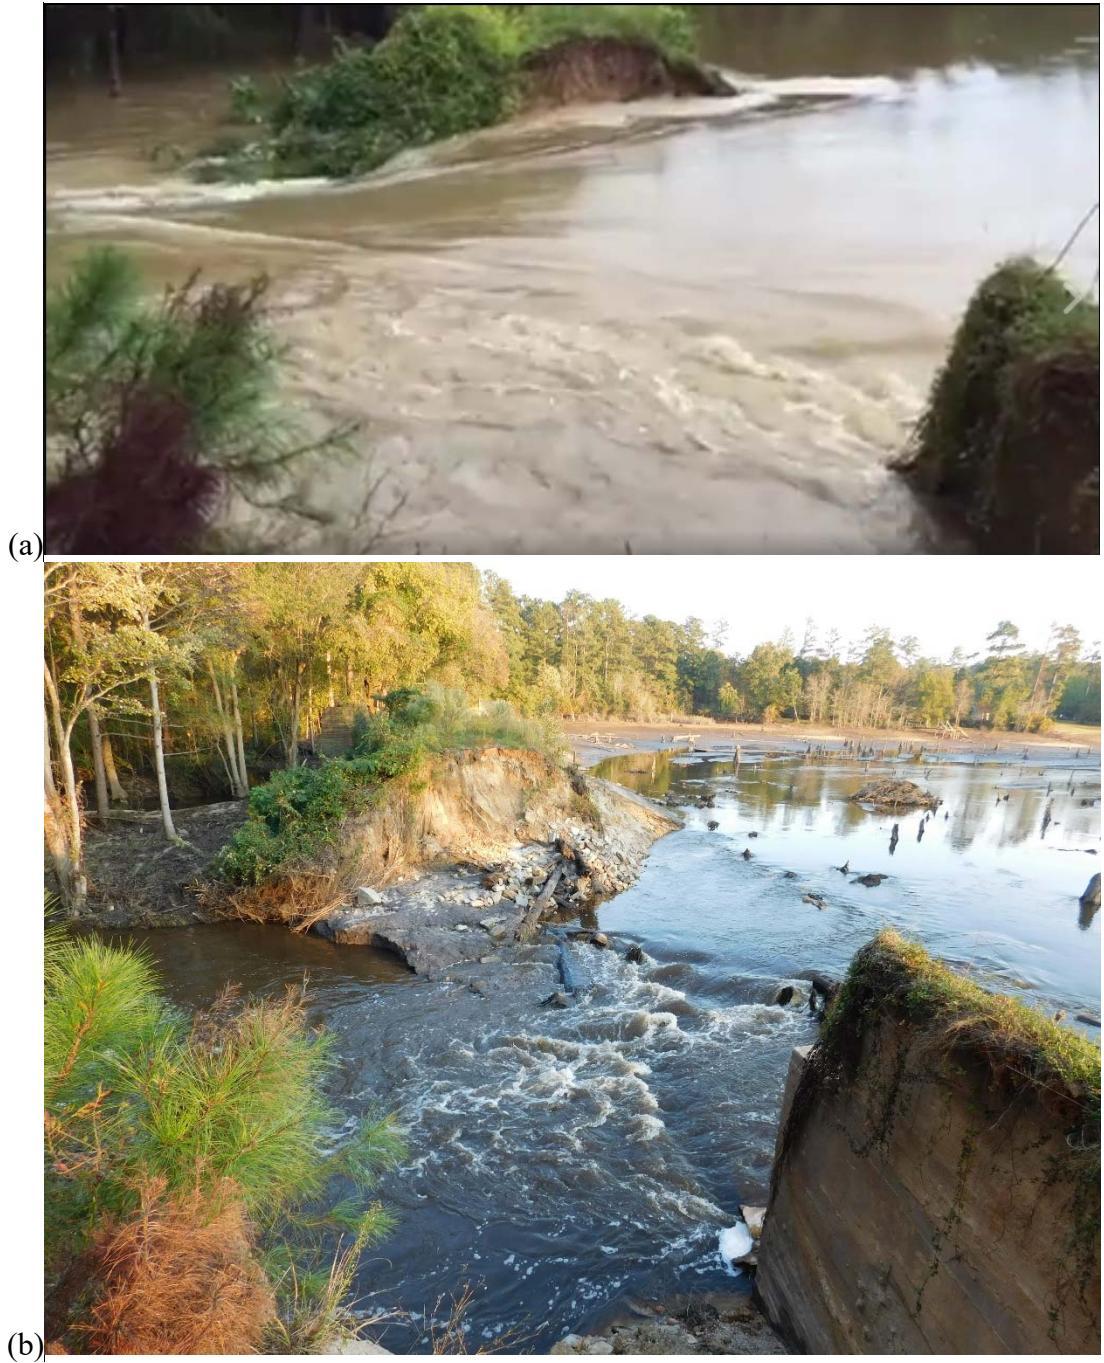
- Figure 47. Barr Lake Dam breach: (a) massive outflow through the breach without evidence of overtopping on October 4, 2015 (https://www.facebook.com/LexingtonPD/videos); (b) 20 m long dam breach at the interface between two dam profiles with and without a vertical concrete I-wall in the earthen dam (photo: October 13, 2015; N 33.95876°, W 81.26025°).
