The Hydraulic and Geotechnical Aspects of the South Carolina Floods of October 1-5, 2015 Related to Offshore Hurricane Joaquin

GEER Association Report No. GEER-052 December 19, 2016

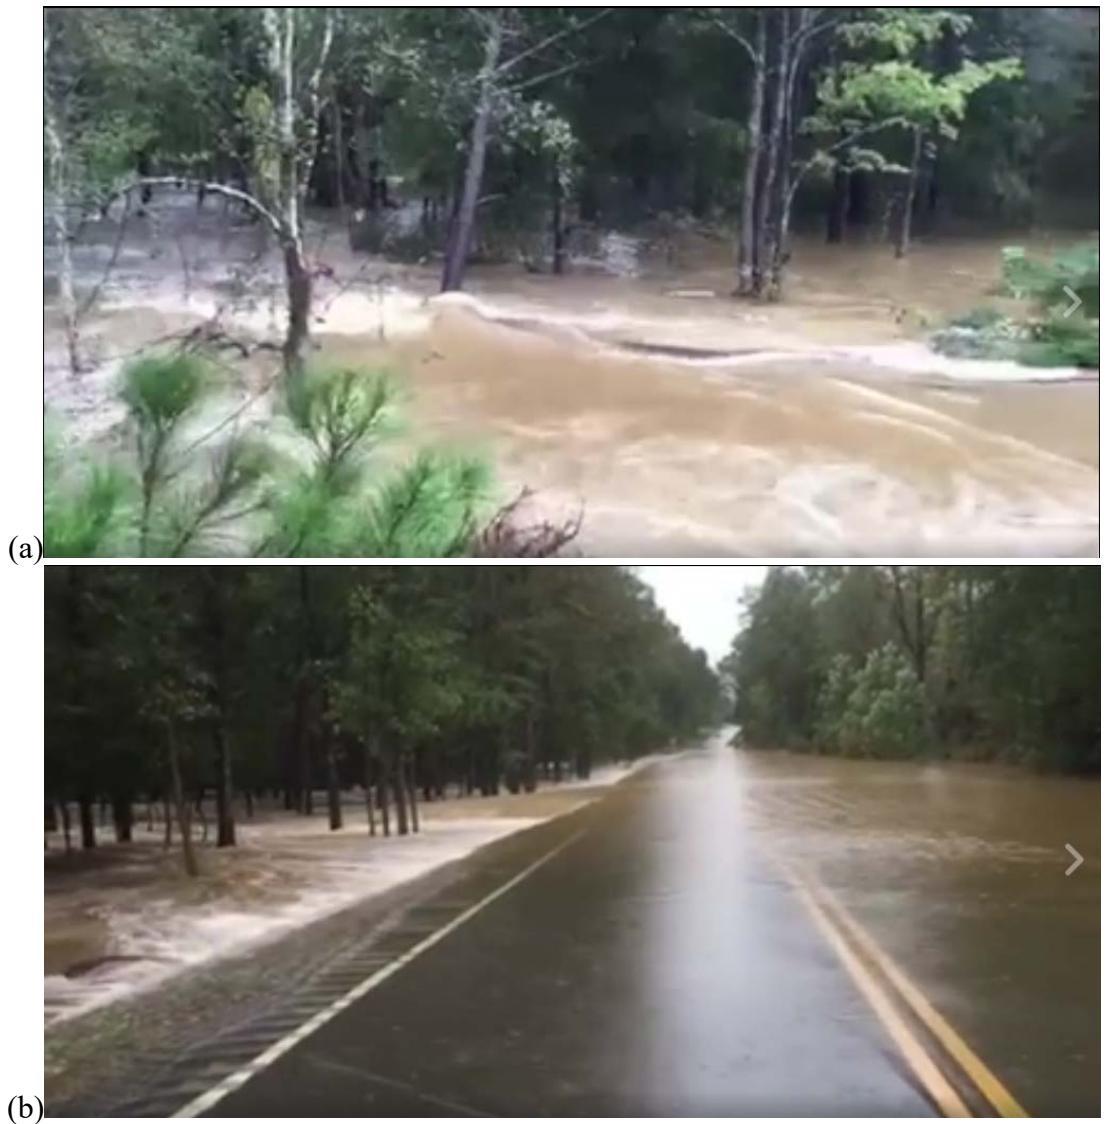
Barr Lake Dam impounds upper Twelve-Mile Creek with an earthen embankment 2 miles (3.2 km) southwest of Lexington, SC. The Barr Lake Dam is the most upstream along Twelve-Mile Creek. Barr Lake reservoir has a surface area of 100 acres (0.4 square km). The area around Barr Lake is presently transforming with the construction of a 450-house residential development by the Barr Lake Development. Barr Lake Dam is 625 ft (190.5 m) long and 14 ft (4.3 m) high. Barr Lake Dam (D-1717) is classified by S.C.-DHEC into category C2, which means that failure will not likely cause loss of life but may damage infrastructure. The earthen embankment dam breached just 40 m to the west of the left gated concrete Twelve-Mile Creek outflow and 100 m to the west of the right gated concrete outlet shown in Figure 46. The 20 m long breach at a transition from a dam section with a vertical concrete I-wall to a pure earthen dam is shown in Figure 47 with the upstream left wingwall and the downstream left footing remaining. The lake level rose to the crest height overwhelming the emergency spillway and overtopping at the lowest section caused the failure. The breaching was facilitated by channeling along the interface between the concrete wall and the earthen dam. Scouring around the end of the concrete I-wall similar to abutment scour facilitated the erosion and breaching once dam overtopping occurred. Piping may also have played a role in the breaching process. However, the extremely low rise of Barr Lake Dam limits hydraulic pressures available for piping. The massive dam break outflow ultimately draining the reservoir flooded a forest downstream and overflowed the Wildlife Road some 150 m downstream shown in Figure 48.

Figure 48. Barr Lake Dam breach downstream flooding: (a) massive outflow through the breach into the forest on October 4, 2015 (N 33.95876°, W 81.26025°); (b) flooding of Wildlife road some 150 m downstream of the dam breach on October 4, 2015 (<u>https://www.facebook.com/LexingtonPD/videos</u>; N 33.95954°, W 81.25879°).

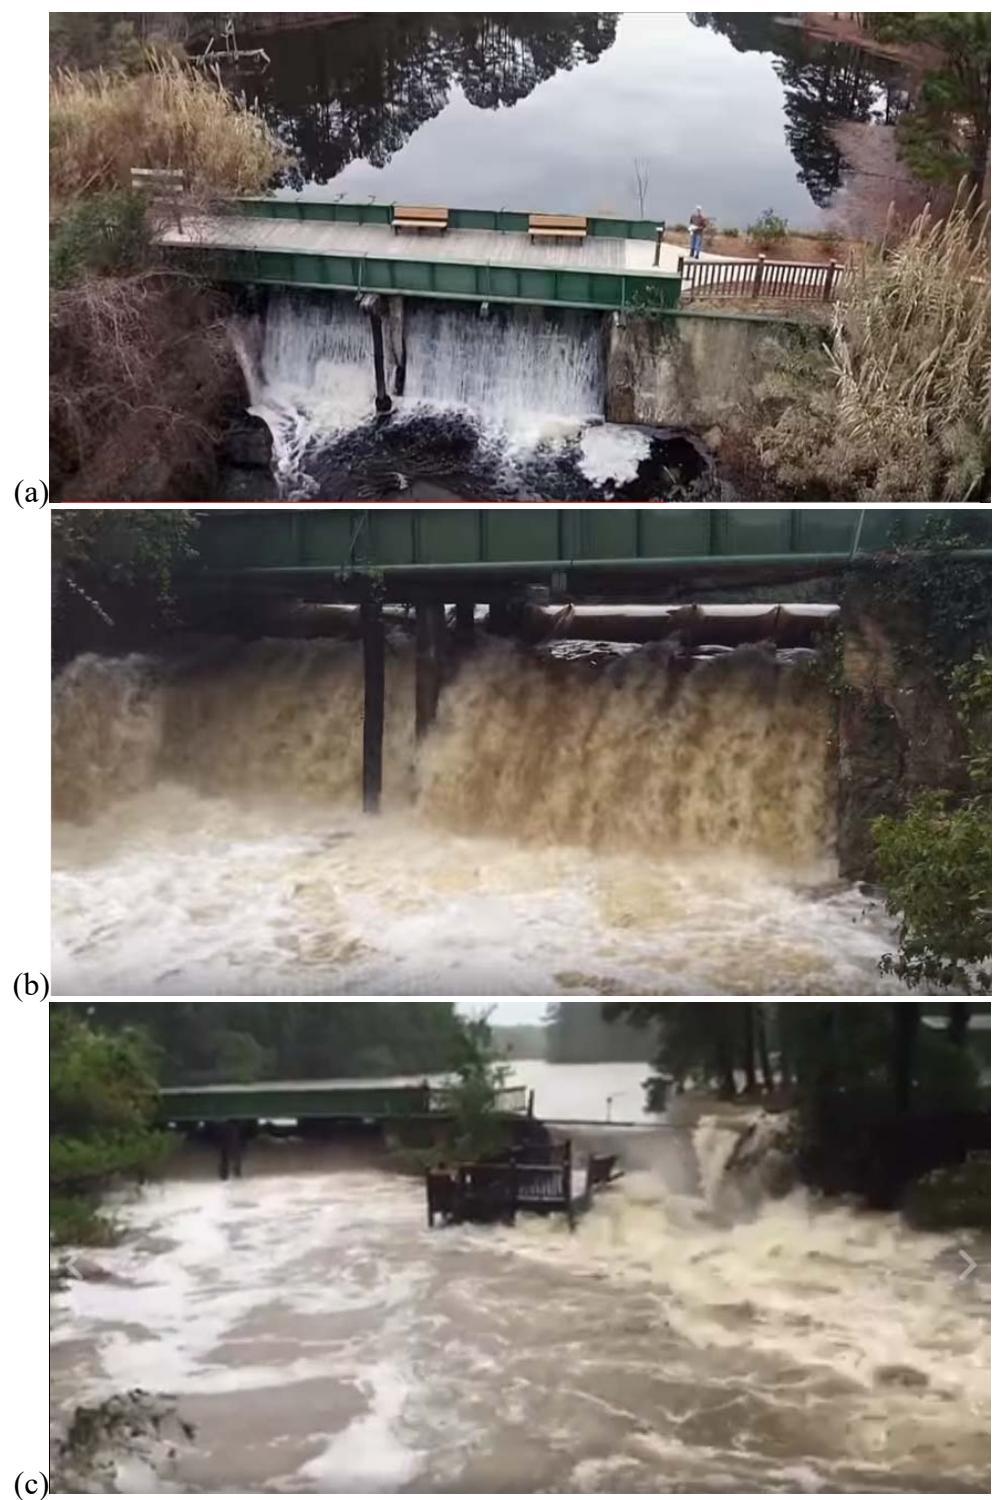
Figure 49. Gibsons Pond Dam: (a) Drone view of concrete dam with weir flow and pedestrian bridge on December 3, 2013 (snippet from video by Robbie Robinson <u>https://www.youtube.com/watch?v=_LpUje-EoPw</u>); (b) massive weir discharge but no debris damming under the bridge on Saturday October 3, 2015 (snippet from video by Firefighter Chris Jackson <u>https://www.youtube.com/watch?v=bHeI8doV1E8</u>); (c) dam breach on northern (left in flow direction, right in photo) abutment and partial debris damming at weir crest under steel bridge on October 4, 2015 (<u>https://www.facebook.com/LexingtonPD/videos</u>; N 33.96949°, W 81.24360°).

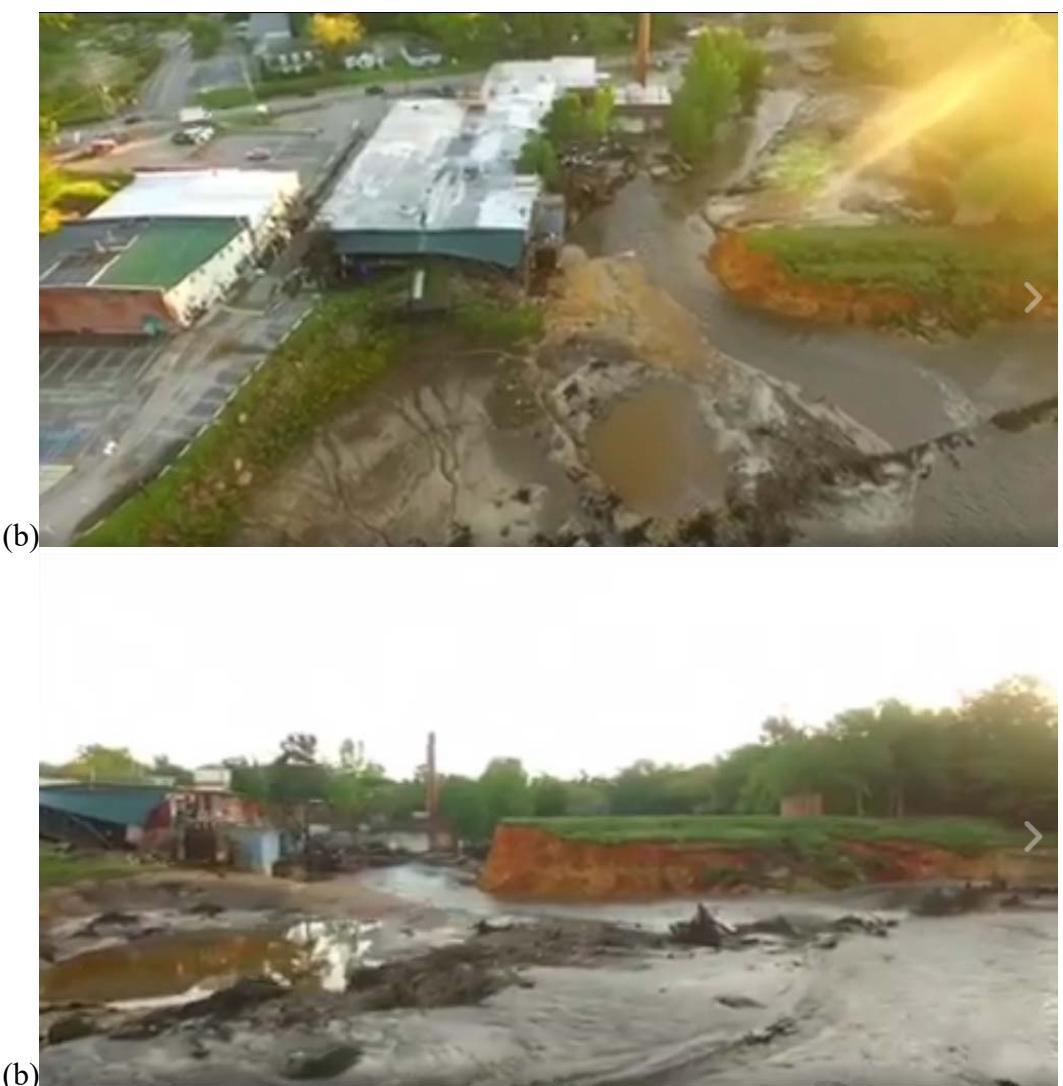
Figure 51. Old Mill Pond Dam breach in aerial drone views on Sunday October 4, 2015: (a) Old textile mill turned shopping center to the north (left) of breach and US-1 downstream; (b) downstream view from the pond towards the breach flanked by the Old Mill building to the north (left) and remaining earth fill dam to the south (video snippets from: https://www.facebook.com/LexingtonPD/videos; N 33.97683°, W 81.22961°).

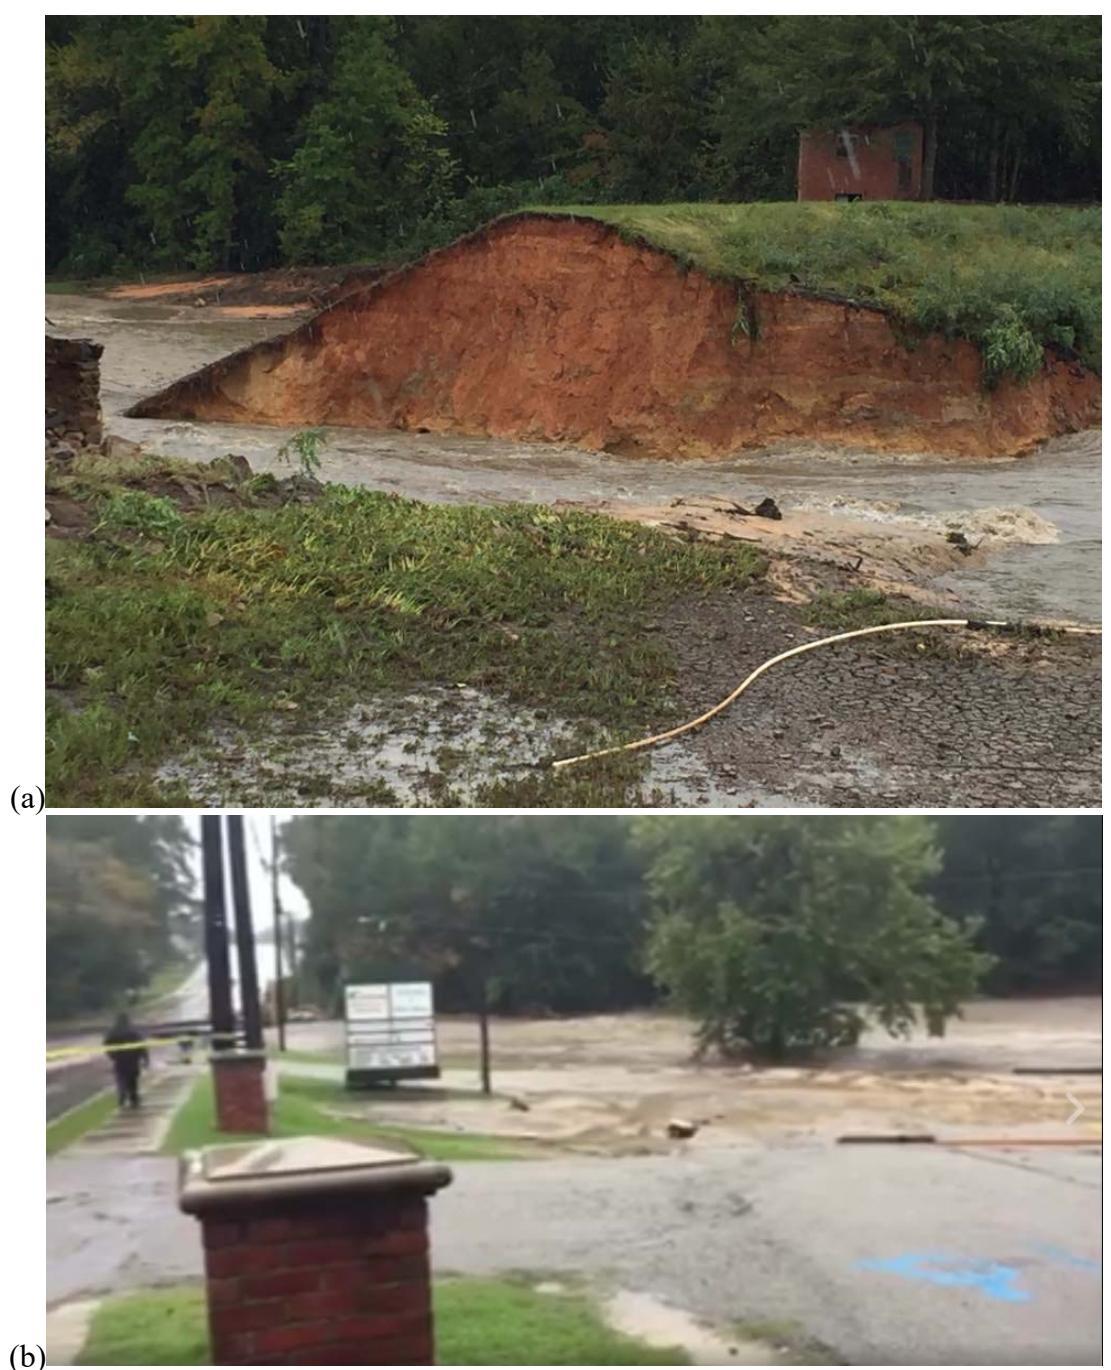
The dam breached at the location of the northern abutment of the earthen fill towards the Old Mill building with the intake and the penstock undergoing repair work. The first mobile photo uploaded at 6:44am (dawn at 6:55am) on October 4, 2015 by the Lexington Police Department shows a fully developed breach with an outflow water level at half the dam crest elevation shown in Figure 53(a). The water level continued to drop in the following hours: Flood discharge through the breach at 9:39am (Figure 53b) and significantly lowered water level in the pond at 12:47pm (Figure 54a). The discharge overwhelms the two box culverts under Highway 1 (US-1) and flooding overtops the highway bridge shutting down Lexington's Main Street shown in Figure 54(b).

Figure 54. Old Mill Pond Dam breach on Sunday October 4, 2015: (a) Significantly lowered water level in the pond and reduced outflow at 12:47pm (photo upload: <u>https://www.facebook.com/LexingtonPD/photos</u>; N 33.97683°, W 81.22961°); (b) discharge overwhelms the two box culverts under US-1 and floods the highway at 9:37am (video upload: <u>https://www.facebook.com/LexingtonPD/videos</u>; N 33.97730°, W 81.22813°).

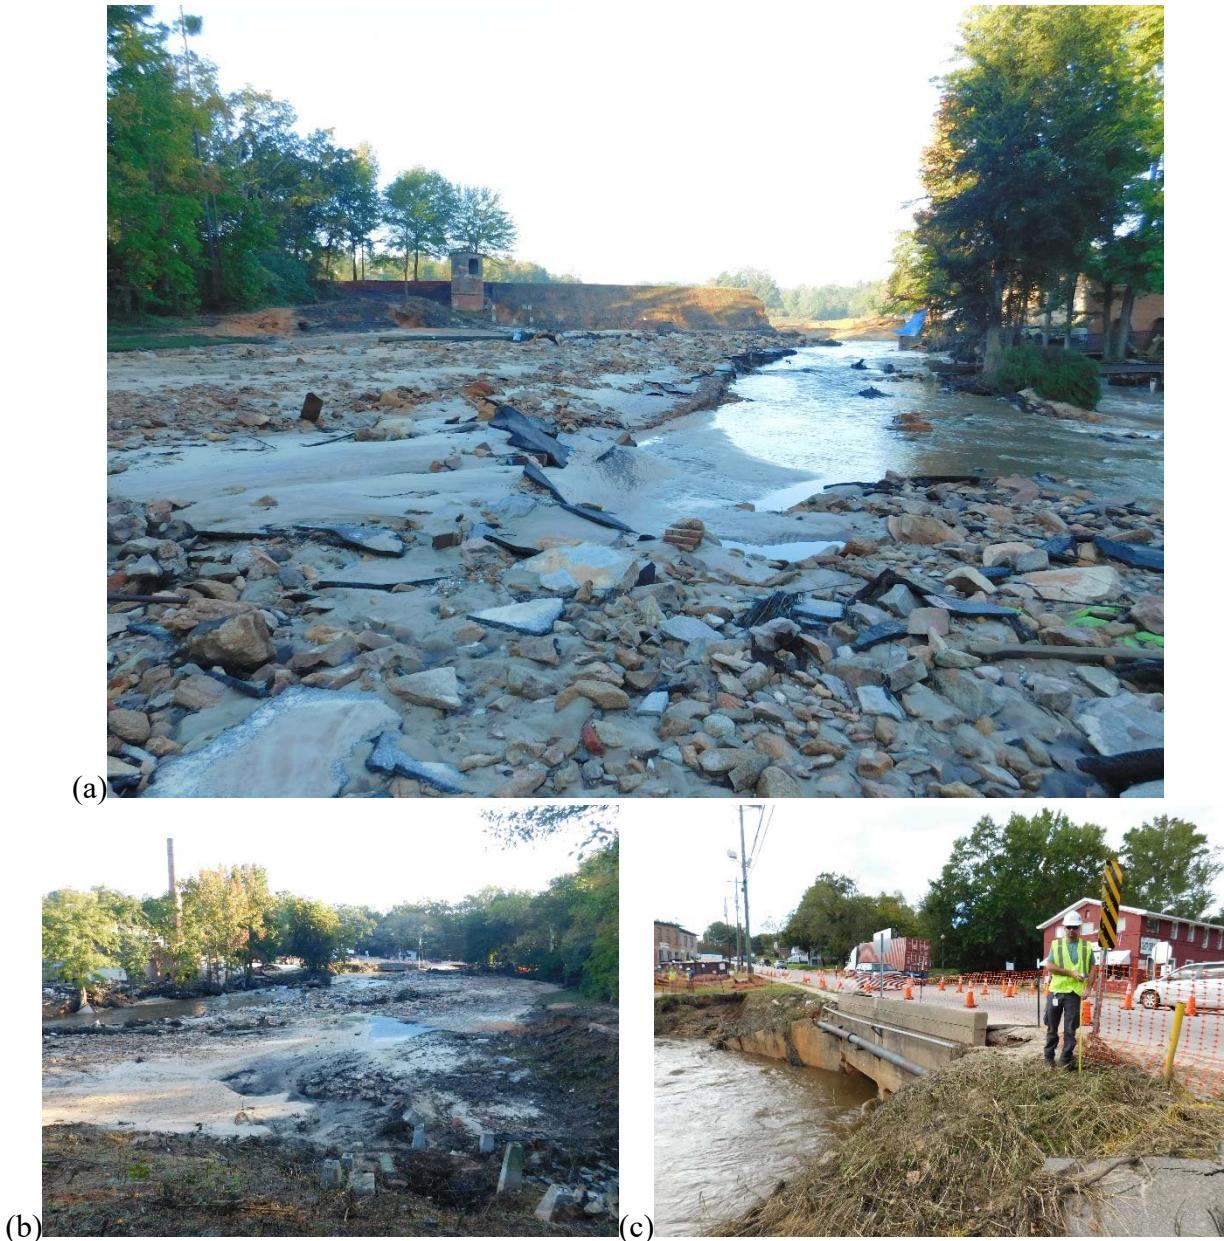
The dam failure exposed trapezoidal embankment profile of the earth fill dam on the southern (right) side of the breach shown in Figure 57(b). The dam consists of fairly homogeneous reddish sandy fill that most likely came from an area of the pond just upstream of the right abutment. Twelve-Mile Creek has eroded some of the upstream section of the dam and carved into the more resistant, tan saprolite foundation material shown in Figure 58(a). At the time of survey, the breach had a length of more than 31 m along the crest. Dam overtopping evidence was found in the form of wrack and rafted debris wrapped around trees on the dam crest shown in Figure 58(b). All along the downstream slope of the Old Mill Pond Dam, at the time of our reconnaissance visit, the vegetation was lying flat. The overtopping induced shooting discharge on the downstream slope caused scour holes and erosional features downstream of the brick tower built on the downstream slope shown in Figure 58(c). The wrack wrapped around trees, flat lying vegetation and erosional features on the downstream slope indicate that the dam had been completely overtopped along the entire crest length shown in Figure 59(a,b). The overtopping and discharge through the dam breach overwhelmed the two box culverts under the US-1 highway shown in Figure 59(c).

Figure 59. Overtopping evidence downstream: (a) Upstream view of Old Mill Dam overtopped along the entire crest length given erosional features on remnant dam from left to right abutment; (b) downstream view of Twelve-Mile Creek towards US-1; (c) two box culverts under US-1 overwhelmed by flood waters given wrack on road signage due to overtopping (photos: October 12, 2015; N 33.97730°, W 81.22813°).

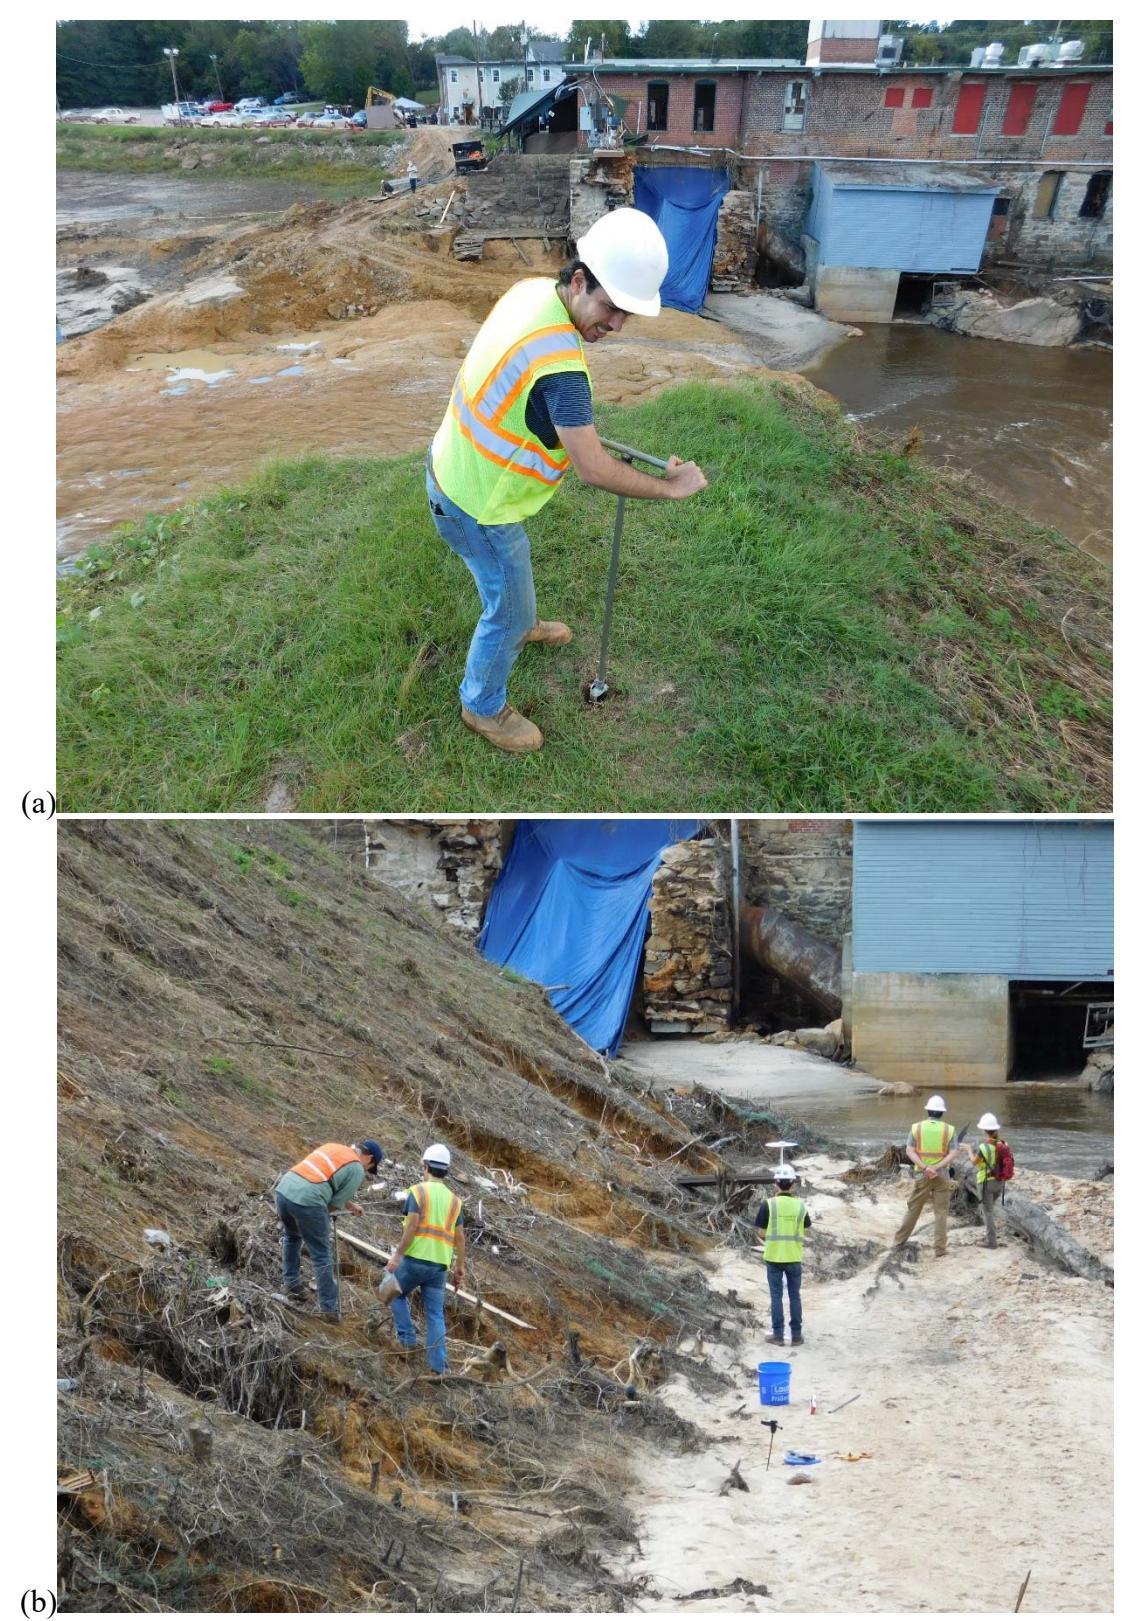
Additionally, soil samples were collected at Old Mill Pond Dam with hand augers from crest to toe shown in Figure 61 and from erosional features shown in Figure 62. An octo-copter drone survey of the Old Mill Dam breach was conducted (Figure 63). The video imagery from the octo-copter drone survey was processed with the drone mapping software Pix4D based on Structure-from-Motion (SfM). A 3-dimensional image of the reconstructed Old Mill Pond Dam breach is shown in Figure 64.

Figure 61. Soil samples being collected with hand augers from the crest to the toe of the Old Mill Pond Dam: (a) N 33.97676°, W 81.22950°; (b) N 33.97663°, W 81.22911° (photos: October 12, 2015).

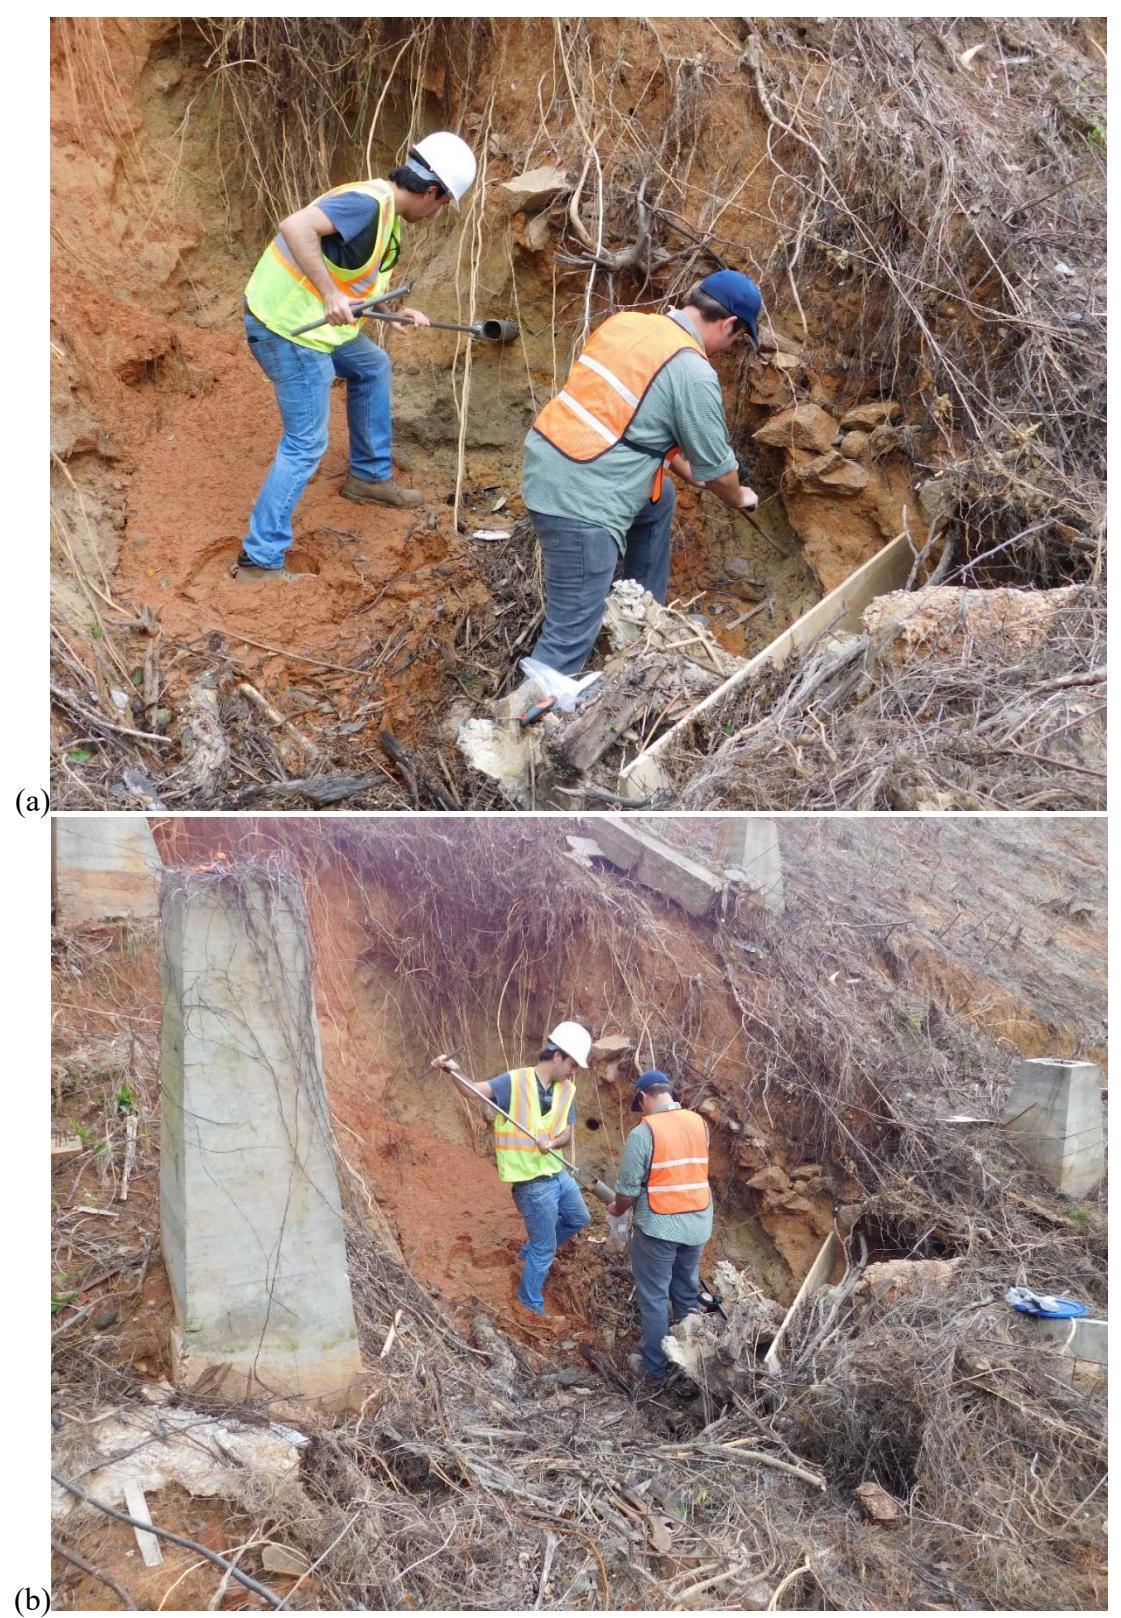
(b)
 Figure 62. Soil sampling in an erosional feature neat the toe of the Old Mill Pond Dam (photos: October 12, 2015; N 33.97663°, W 81.22911°).

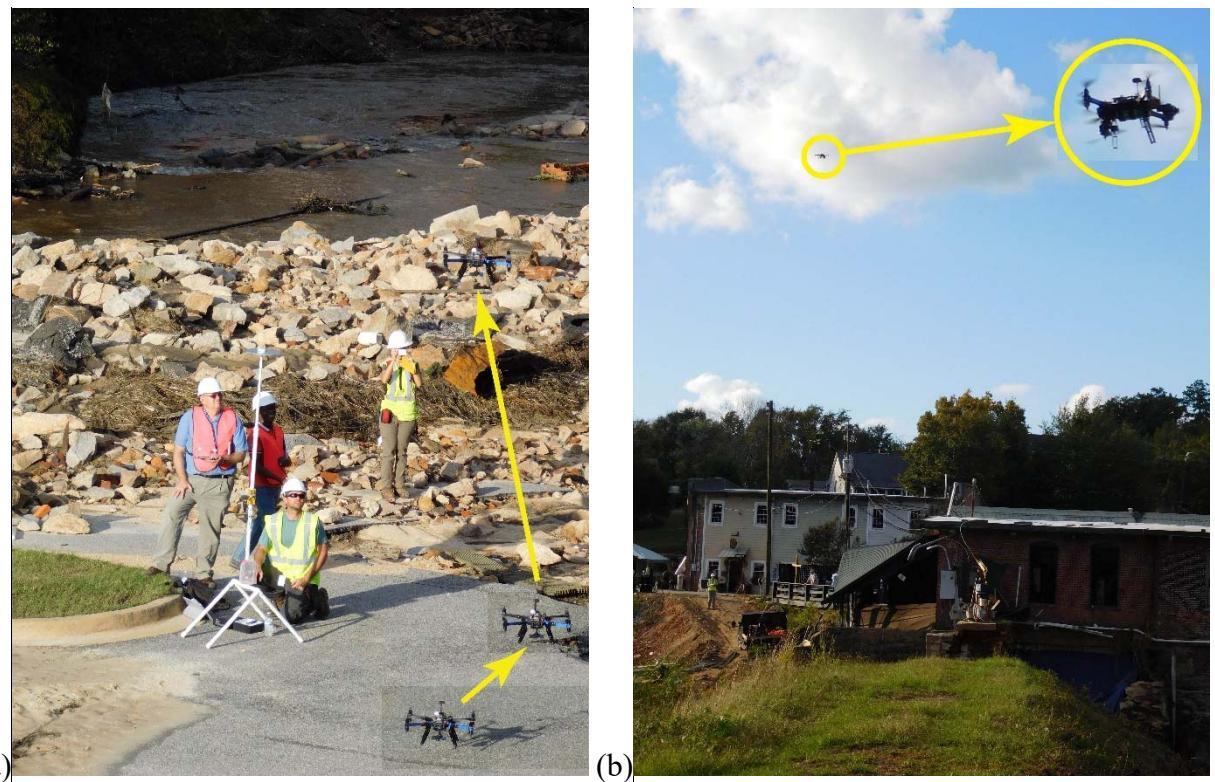
(a)
 (b)
 Figure 63. Octo-Copter Drone Survey of the Old Mill Dam breach for SFM-reconstruction: (a) N 33.97663°, W 81.22911°; (b) N 33.97676°, W 81.22950° (photos: October 12, 2015).

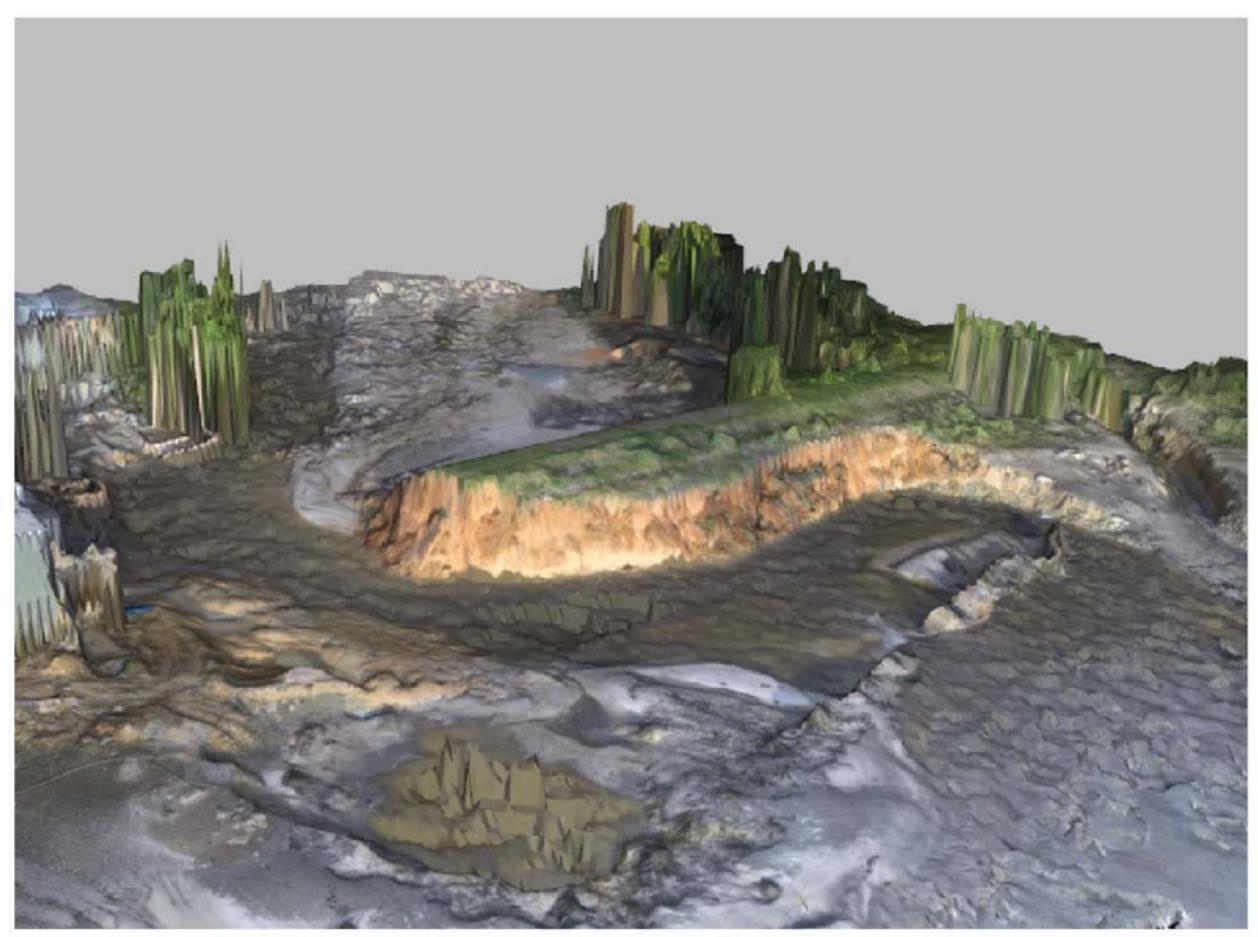
Figure 64. Downstream 3-dimensional view of the Old Mill Pond Dam breach based on SfM-reconstruction from the Octo-Copter Drone Survey (N 33.97683°, W 81.22961°).

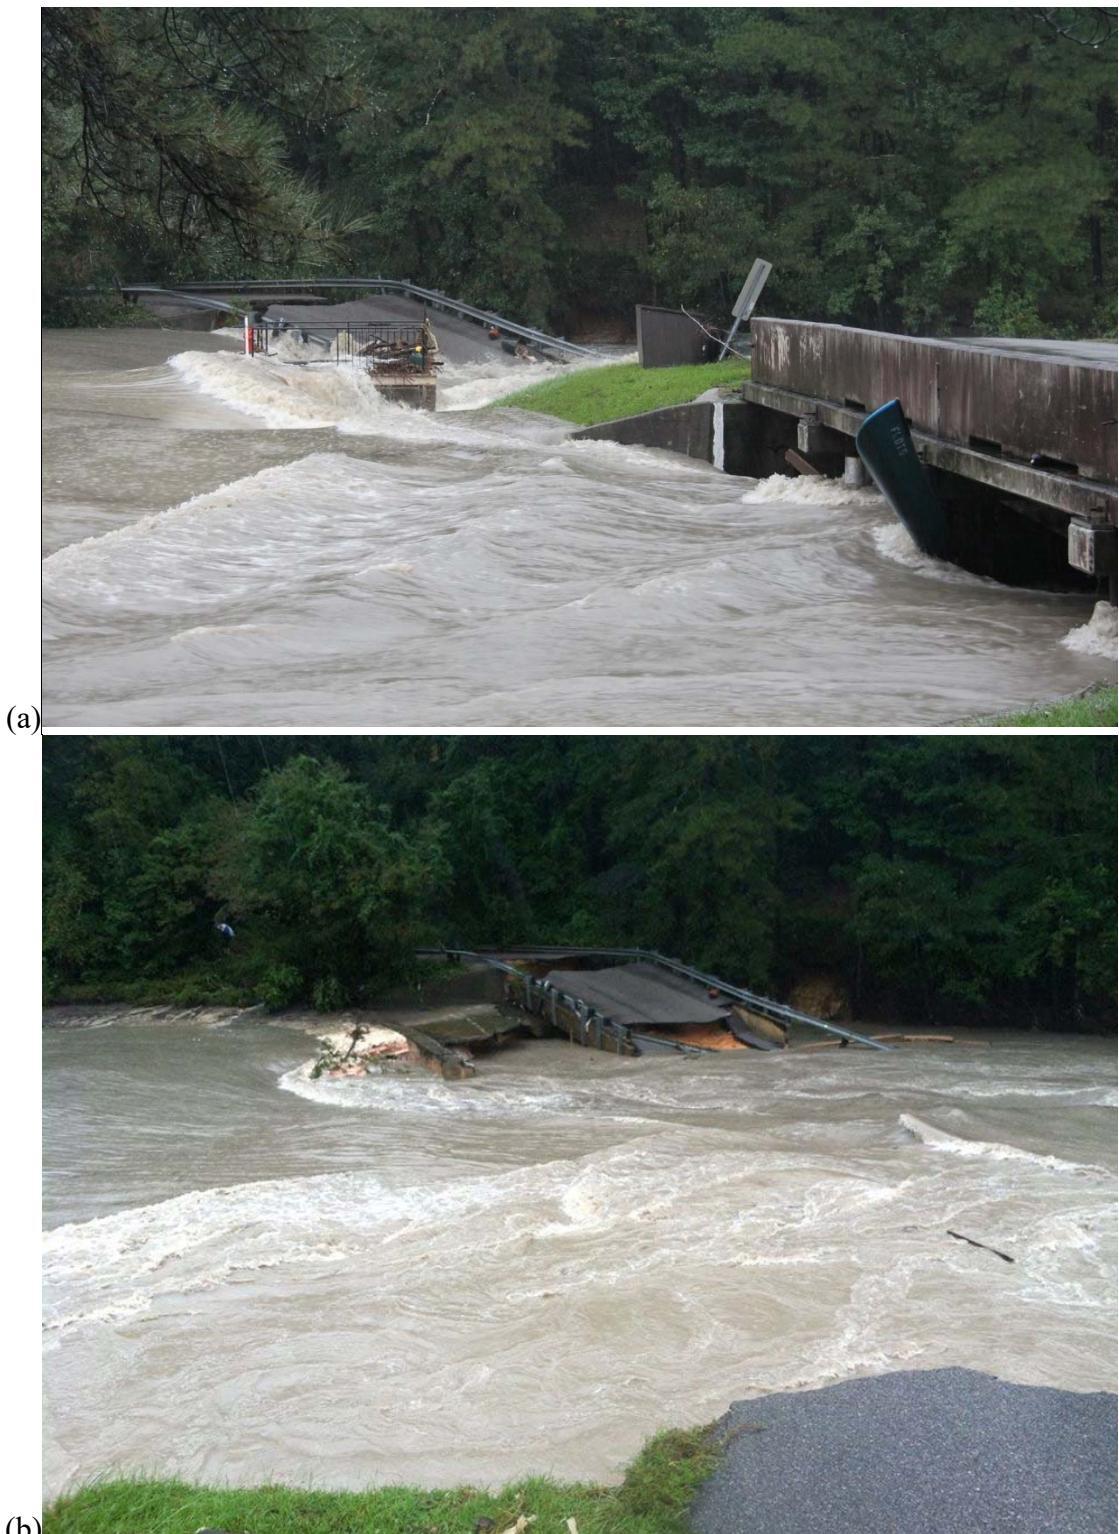
The dam breached at the location of the left (eastern) spillway as shown in Figure 75(a) as the breach is forming in a photo without an exact time stamp. Overtopping occurred for a short period of time based on the debris at the tilted road marker sign near the center of the dam. The solid concrete wall with small drainage openings on top of the bridge crossing the right spillway would limit initial overtopping at this location. The later photo uploaded at 12:07pm on October 4, 2015 by the Gills Creek Watershed Association shows a fully developed breach with a significantly lowered outflow water level shown in Figure 75(b). The water level continued to drop in the following hours with flood discharge through the breach and the right (western) spillway at 2:51pm shown in Figure 76. The road way collapsed on a 47 m section or almost half the dam crest length. The washed away section formed a 36 m long open breach, while the remnants of an 11 m long collapsed road way segment remained dislocated.

Figure 75. Cary's Lake Dam breach on Sunday October 4, 2015: (a) Breach forming at location of left (eastern) spillway (exact time of photo remains to be determined as via Pinterest); (b) Fully formed breach at 12:07pm with significantly lowered reservoir level due to the downstream propagating dam break wave (photo: Gills Creek Watershed Association www.gillscreekwatershed.org; N 34.04866°, W 80.95764°).

breach forming at the location of the smaller left spillway shown in Figure 75(a). Aerial views of Jackson Creek with the flushed out Cary's Lake upstream and the Rockbridge Road Bridge downstream of Cary's Lake Dam breach are shown in Figure 85.

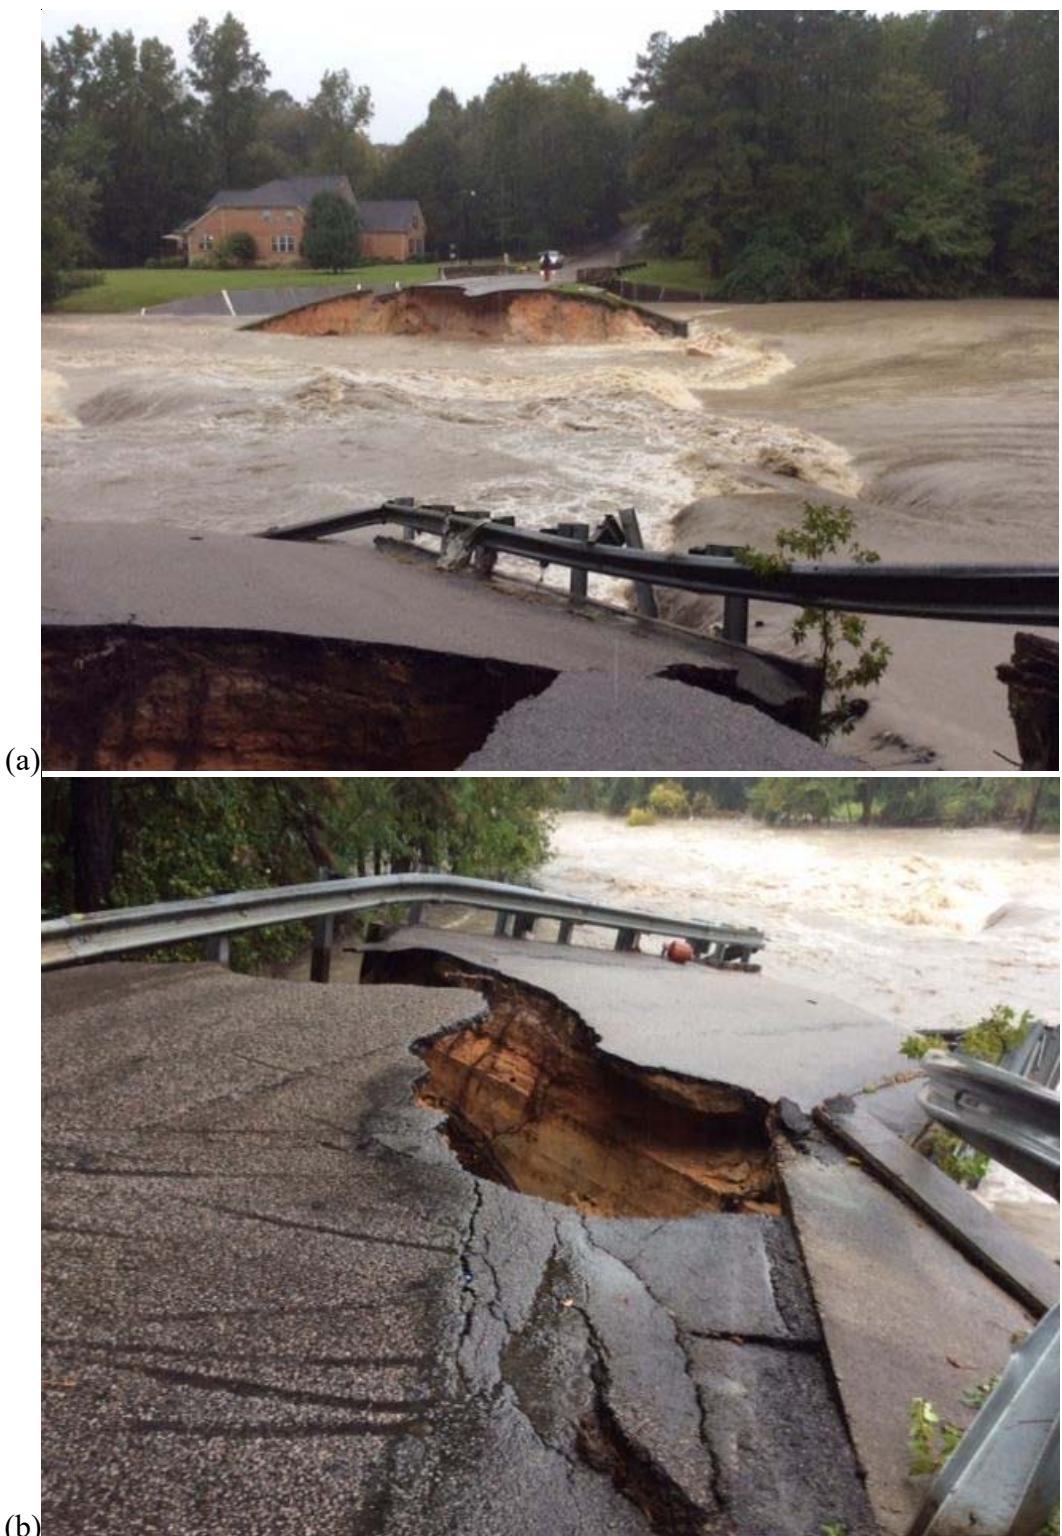
Figure 76. Cary's Lake Dam breach on Sunday October 4, 2015: (a) Westward view of the fully formed breach with the intact right (western) spillway in the background at 2:51pm with a significantly lowered reservoir water level; (b) downstream view with the breach at the failed left (eastern) spillway at 2:51pm; (photos: Gills Creek Watershed Association www.gillscreekwatershed.org; N 34.04866°, W 80.95764°).

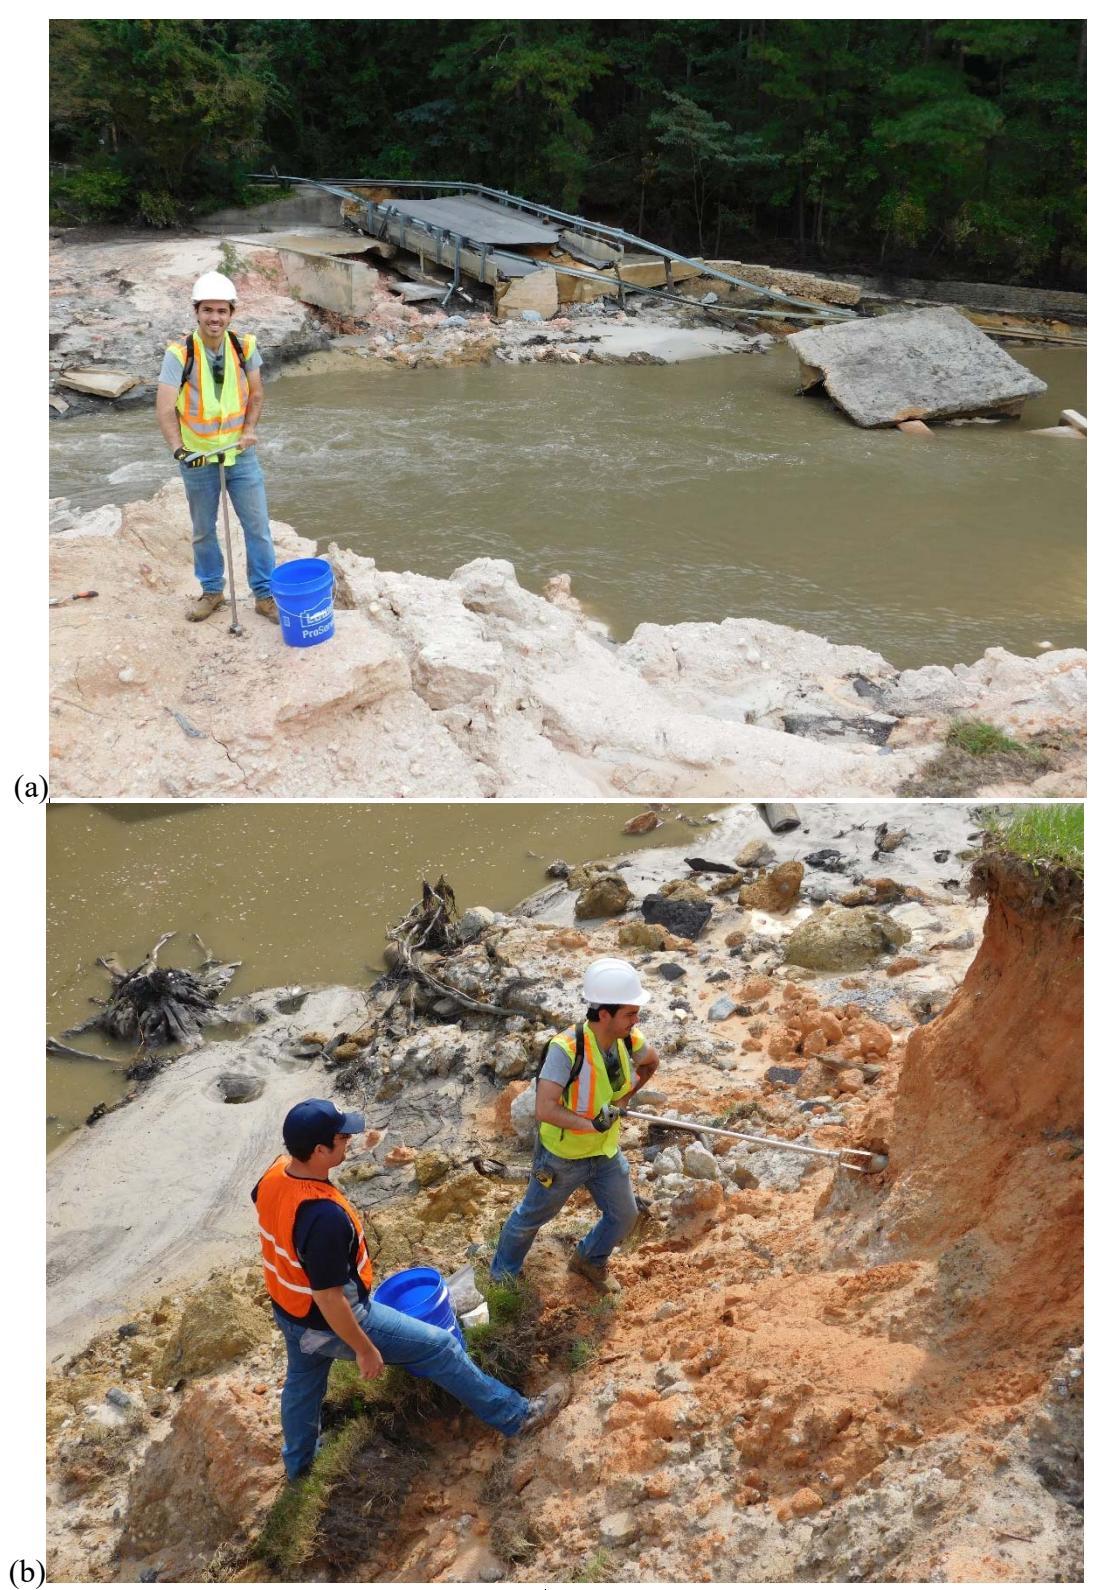
Soil samples were collected with hand augers throughout the failure surface towards the larger spillway on the right abutment (Figure 81). The earth fill making up the dam was zoned as shown in Figure 82. Select locations of soil sampling are shown in Figure 82(b). The upstream zone was formed of medium stiff, light reddish brown clayey sand with angular pieces of white clay (Sample #5) to medium stiff white to pinkish gray silty clay with some sand (Sample #4). The white clay was likely brought to the site from a kaolin mine located about 17 km northeast of the site, just off of Interstate I-20. Flood discharge over this more erosion-resistant clay left it without vegetation and moderately scoured. The center and part of the downstream zones were formed of yellowish red silty sand with some gravel and clumps of white clay (Sample #1). This material appears to be a mixture of local reddish residual soils and imported white kaolin clay. A second downstream zone was formed of light yellowish brown silty gravel with some sand and clay (Sample #2) to soft, light olive brown sandy silt (Sample #3).

Figure 81. Cary's Lake Dam breach: Soil samples collection with hand augers from below the crest to the toe of the right abutment failure surface (photos: October 13, 2015; N 34.04866°, W 80.95764°).

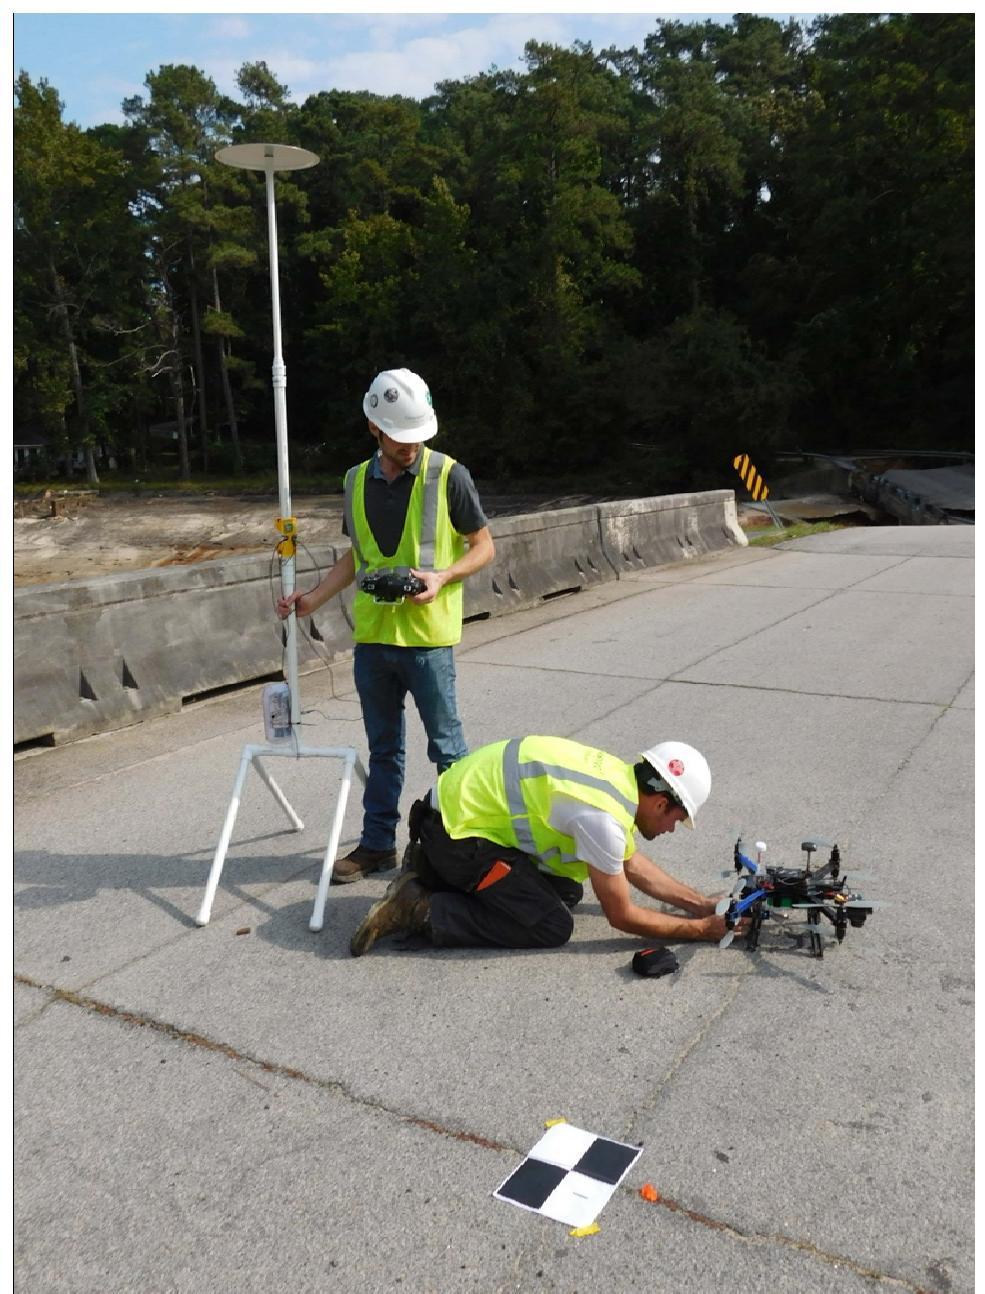
Figure 83. Octo-copter drone survey of the Cary's Lake Dam breach for SFM-reconstruction (photos: October 13, 2015; N 34.04866°, W 80.95764°).
