The Hydraulic and Geotechnical Aspects of the South Carolina Floods of October 1-5, 2015 Related to Offshore Hurricane Joaquin

GEER Association Report No. GEER-052 December 19, 2016

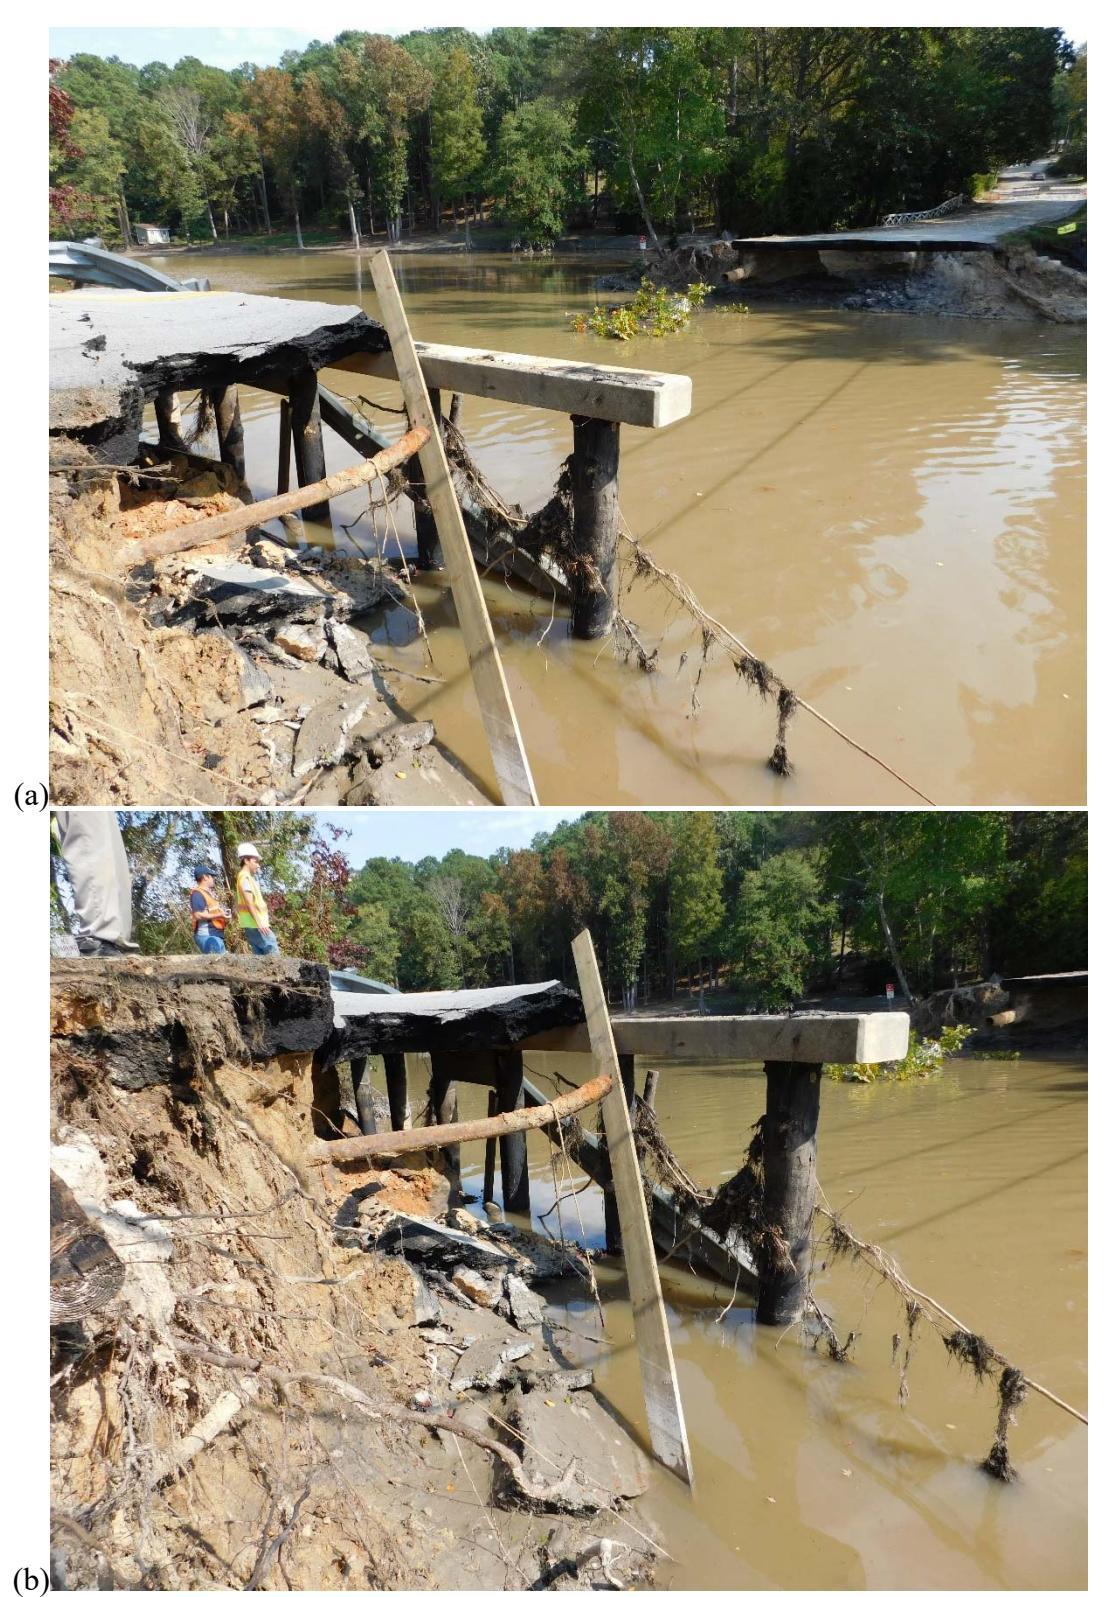
Rockbridge Road Bridge crosses Jackson Creek 400 m downstream of the Cary's Lake Dam breach. Rockbridge Road Bridge was overtopped, washed out and completely destroyed by the flood discharge as shown in Figure 86. The flood discharge overtopped the road way and bridge deck by at least 0.7 m based on high-water marks in trees along the right bridge abutment. The overflow carried the bridge away over the entire Jackson Creek width leaving a 24 m long gap in Rockbridge Road. The bridge was rebuilt and reopened in June 2016.

(b) Figure 86. Rockbridge Road Bridge washed away: (a) upstream view from the right (western) abutment; (b) wash out on the right bridge abutment (photos: October 13, 2015; N 34.04516°, W 80.95709°).

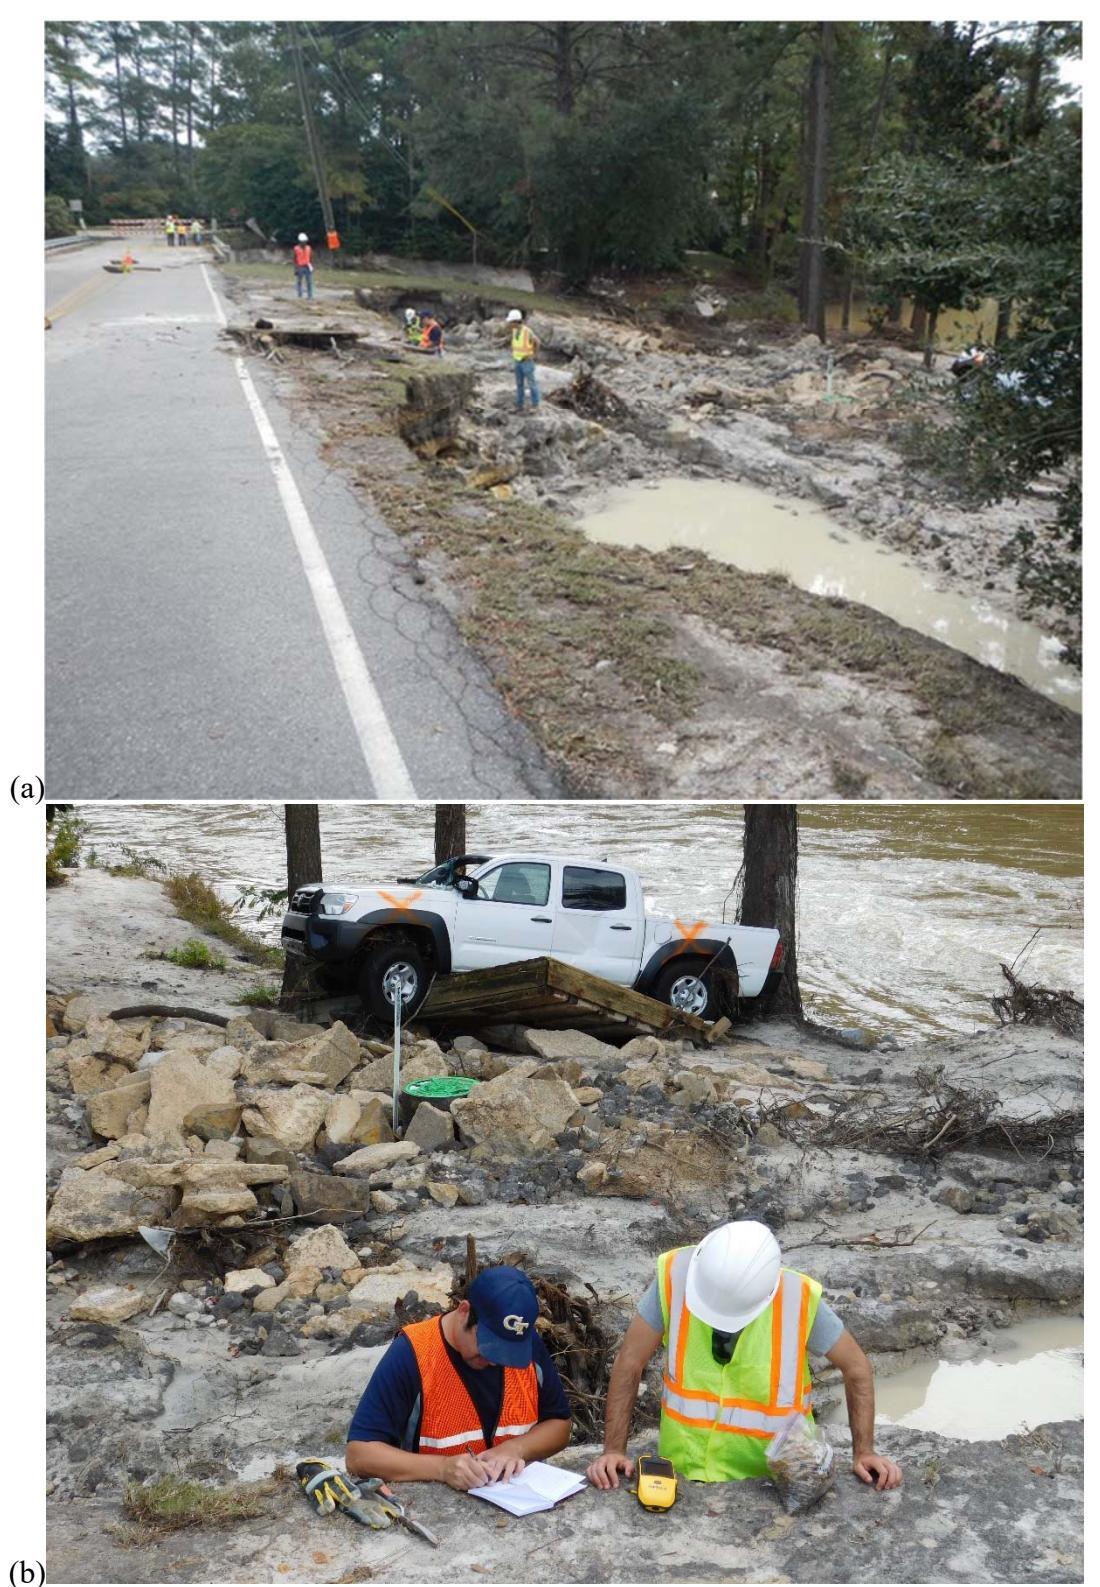
The roadway on Spring Lake Dam was overtopped by about 1m based on high watermarks in the vegetation along the lakeside of the dam. The overflow severely damaged the concrete spillway due to scouring at downstream interfaces between the concrete and earth fill shown in Figure 87. The overtopping flood discharge eroded the downstream embankment of the earthen dam up to the roadway shown in Figure 88(a). A Toyota Tacoma pick-up truck attempted to drive through the discharging floodwaters overflowing the roadway and was washed off the road. Fortunately the vehicle was stopped by trees 20 m downstream as shown in Figure 88(b). The driver was stuck in the vehicle for four hours until he could be rescued. This serves as a warning not to drive through rushing flood discharges even when water depths appear small.

(b)
Figure 88. Spring Lake Dam: (a) Massive erosion on the downstream embankment due to overtopping the roadway;
(b) pick-up truck (Toyota Tacoma) washed off the road by flood waters, while attempting to drive across the dam, was stopped by trees downstream (photos: October 13, 2015; N 34.03708°, W 80.95531°).

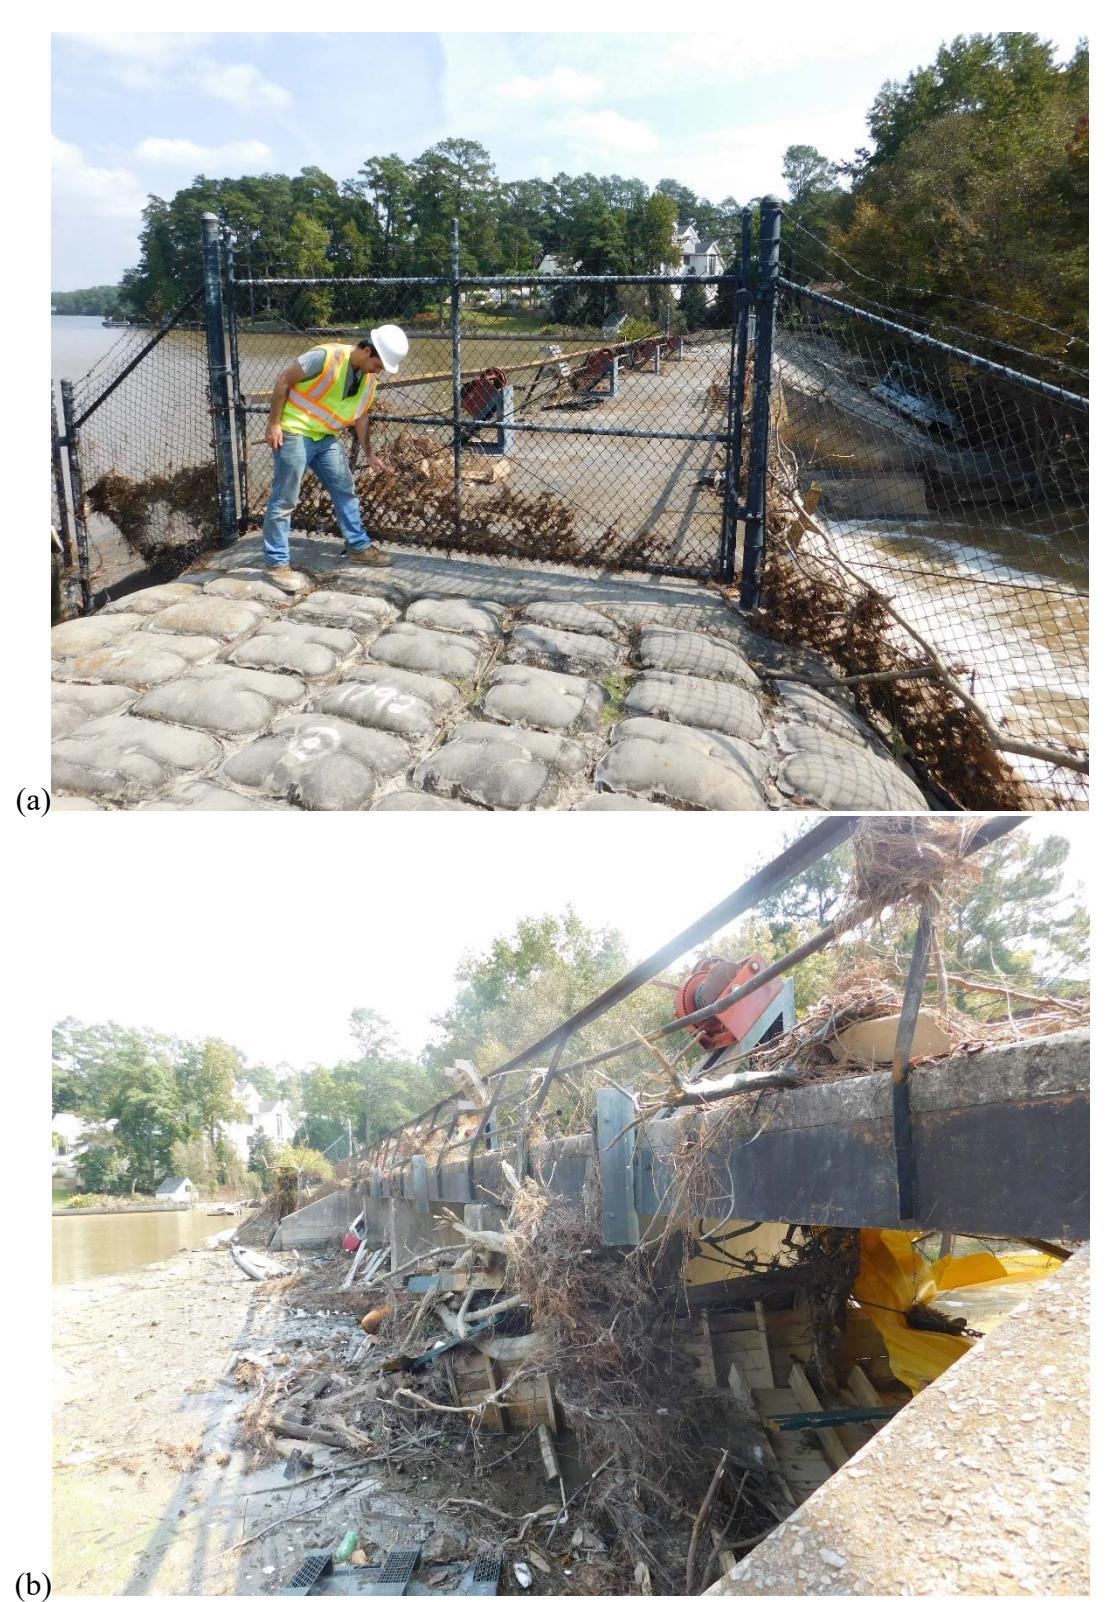
(b)
Figure 90. Forest Lake Dam overtopping: (a) High water marks in the fence on the dam crest; (b) debris damming of the gated spillway reduced the spillway capacity (photos: October 13, 2015; N 34.02217°, W 80.96281°).

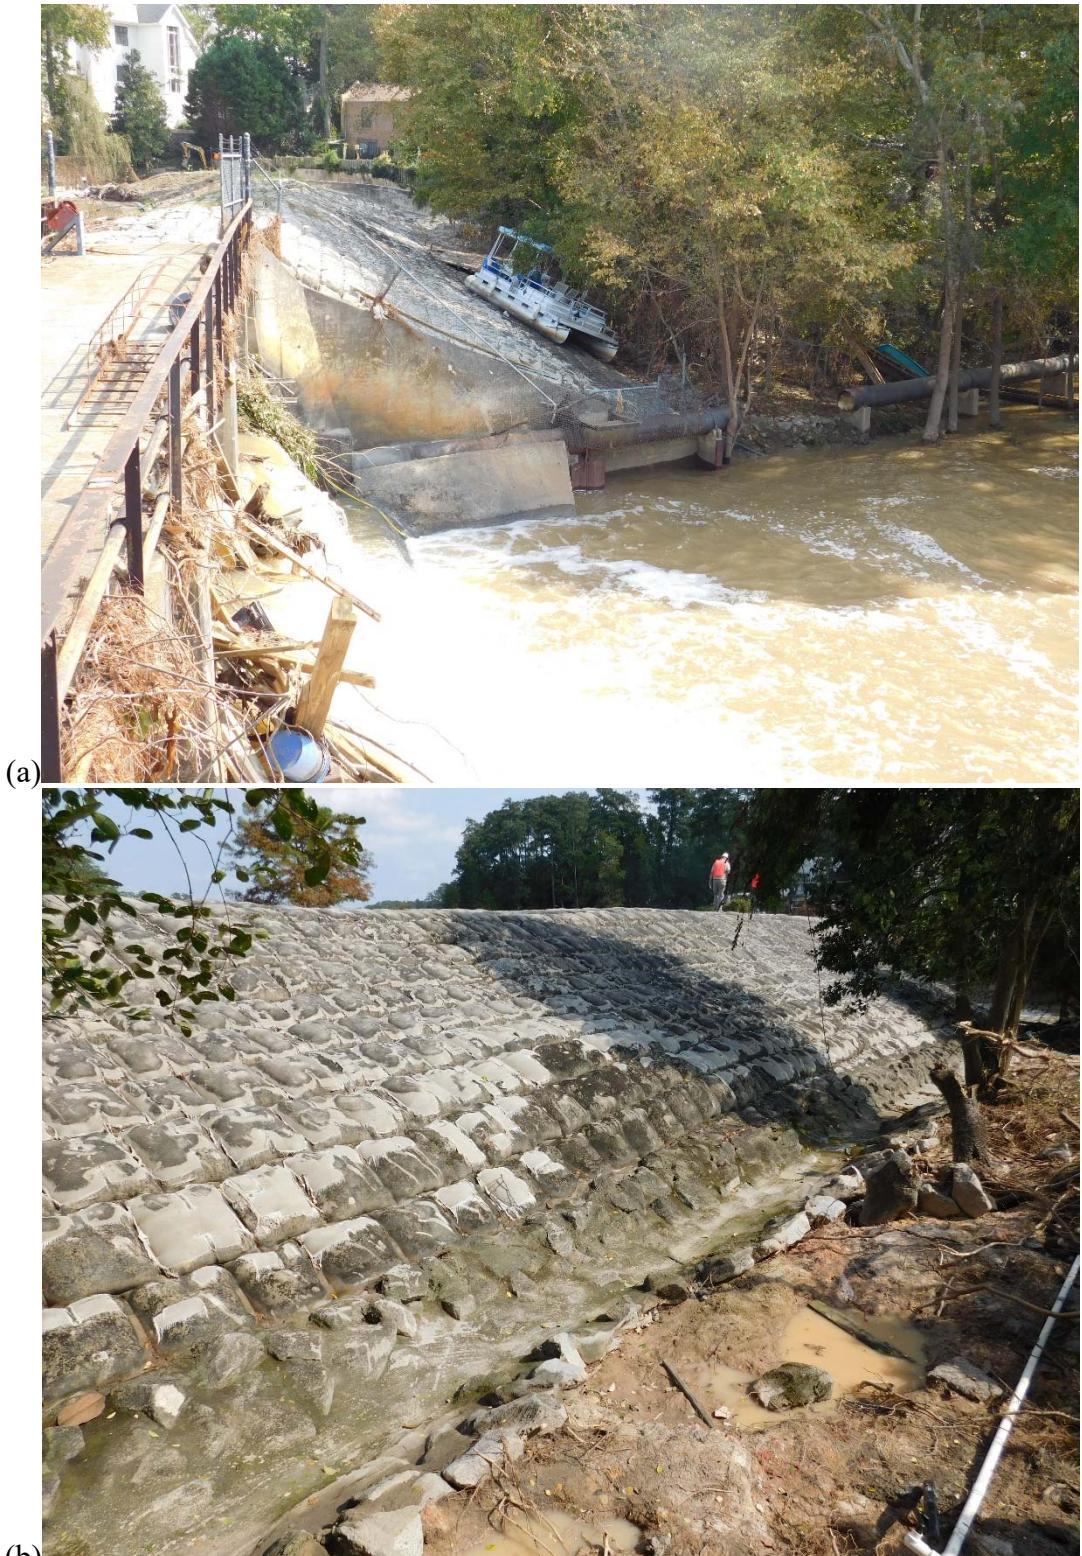
The Forest Lake Dam was overtopped on October 4, 2015 by the combined flood discharges from Jackson Creek and Gills Creek as shown in Figure 89. The flood discharge in Jackson Creek was amplified by the cascading dam breaks and dam break waves. The dam breaks upstream in Gills Creek occurred later on October 5, 2015. Forest Lake Dam was overtopped by up to 1m based on high watermarks in the railings and fences along the dam crest as shown Figure 90. The overflow also washed a shallow draft pontoon boat over the embankment dam as shown in Figure 91(a). The articulating bag mats served as overtopping protection and prevented erosion on the embankment dam itself. Incipient erosion was apparent at the toe of the embankment dam at the transition from the articulated bag mat armor to downstream soil as shown in Figure 91(b). Essentially Forest Lake Dam serves as an example of how slope armor can prevent or significantly reduce erosion and damage due overtopping of earthen dams.

(b) Figure 91. Forest Lake Dam overtopping: (a) Pontoon boat washed over the left embankment dam; (b) erosion and incipient scouring at the transition from the articulating bag mats to downstream soil (photos: October 13, 2015; N 34.02217°, W 80.96281°).

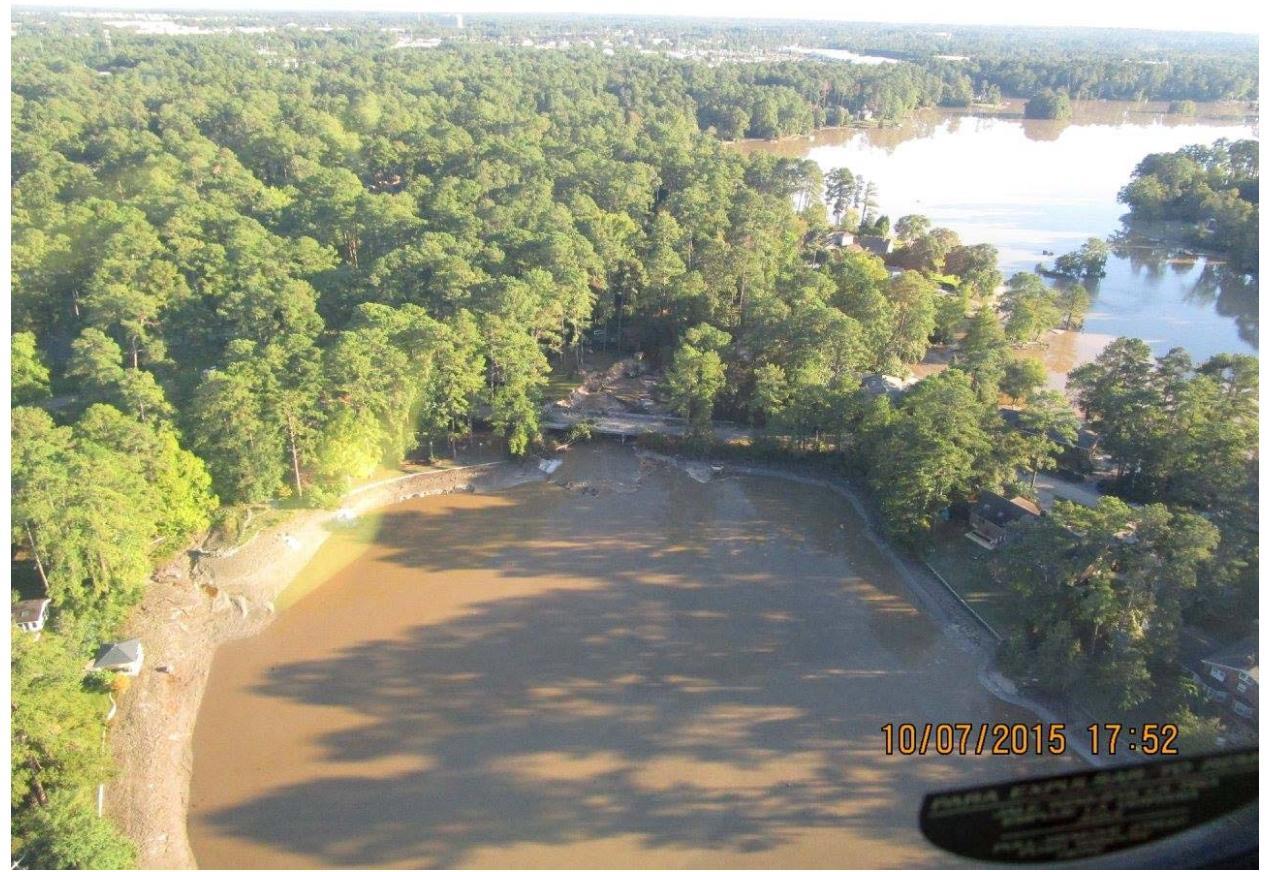
The uncontrolled spillway at Lower Rockyford Lake Dam was completely removed on October 5, 2015 by the mostly unregulated flood discharges from upper Gills Creek as shown in Figure 92 and Figure 93. The concrete spillway was completely washed out from under the bridge along with the underlying earth fill and abutment scouring as shown in Figure 94. The remains of the concrete spillway were scattered in the Gills Creek downstream of the bridge as shown in Figure 95. The discharge from Lower Rockyford Lake flows directly into Forest Lake, where it is joined by the waters from the tributary Jackson Creek. However, the dam breaks upstream in the tributary Jackson Creek watershed to the north occurred earlier on October 4, 2015. Hence the upper Gills Creek and Jackson Creek watersheds upstream of Forest Lake can be viewed independently.

Figure 92. Lower Rockyford Lake Dam wash out of the uncontrolled overflow concrete spillway in an aerial view from the Rockyford Lake towards Forest Lake on October 7, 2015 (photos from Gills Creek Watershed Association via: www.facebook.com/GillsCreekWatershedAssociation; N 34.03595°, W 80.95195°).

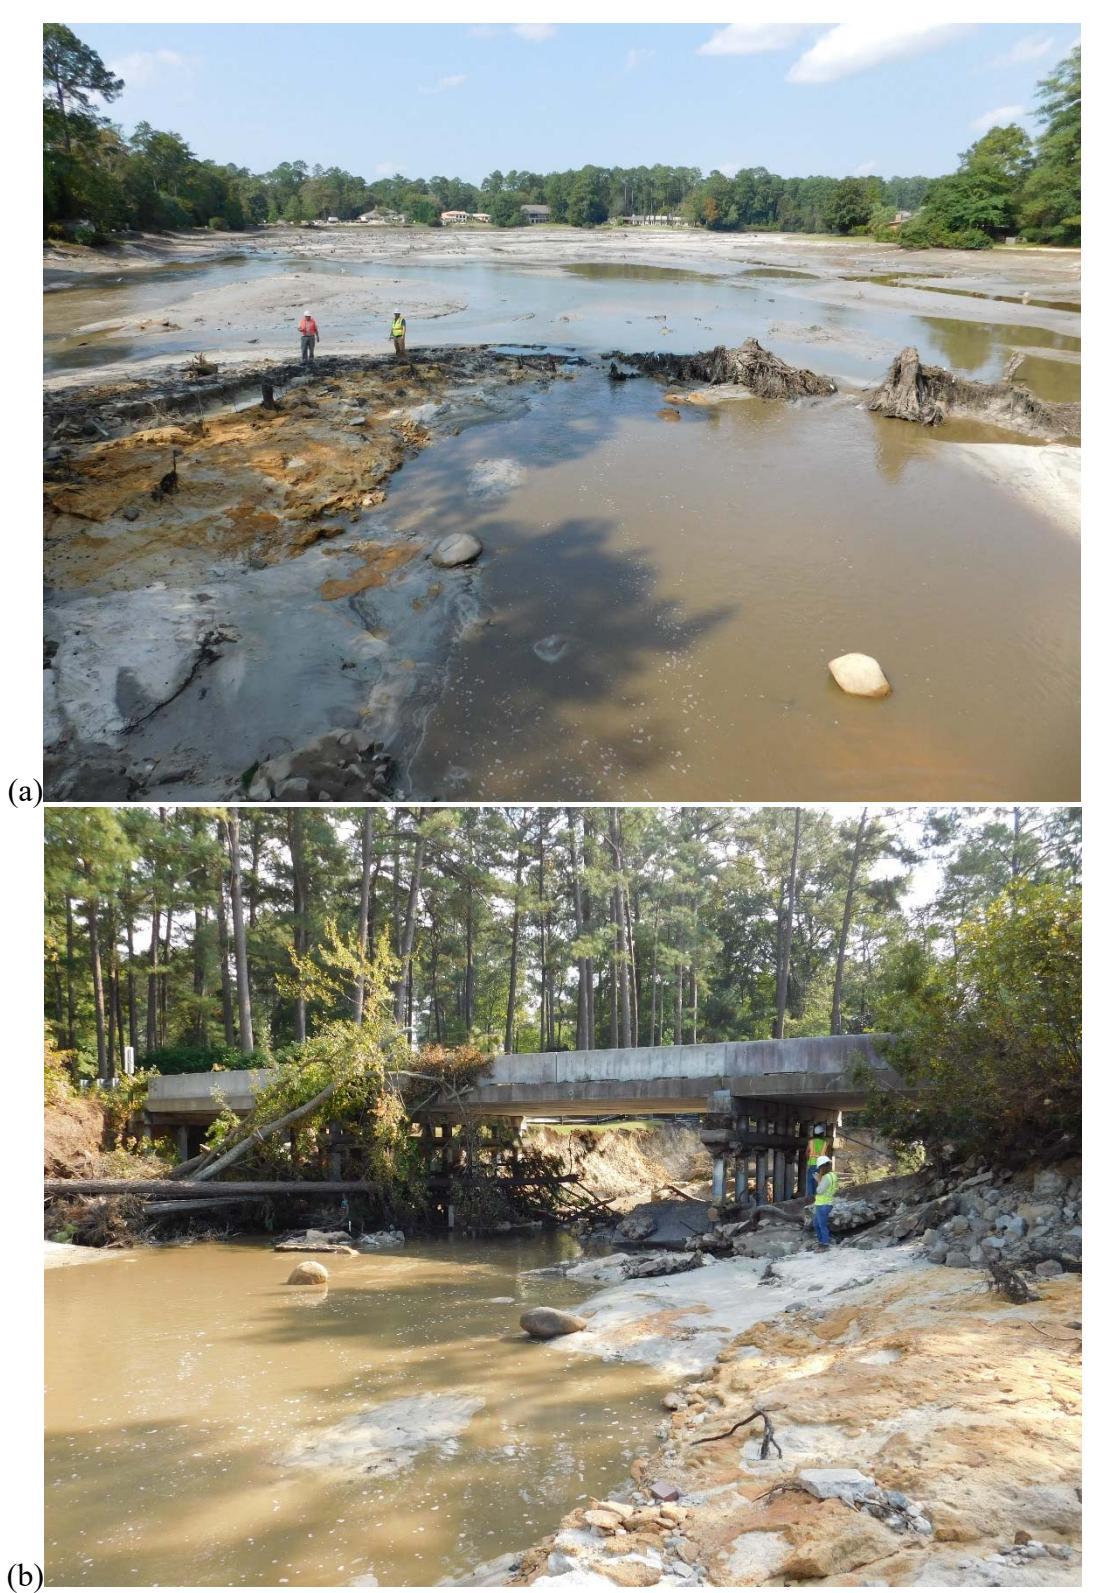
(b)
 Figure 93. Lower Rockyford Lake Dam: (a) Emptied lake upstream of the dam; (b) wash out of the uncontrolled overflow concrete spillway under the bridge (photos: October 13, 2015; N 34.03609°, W 80.95208°).

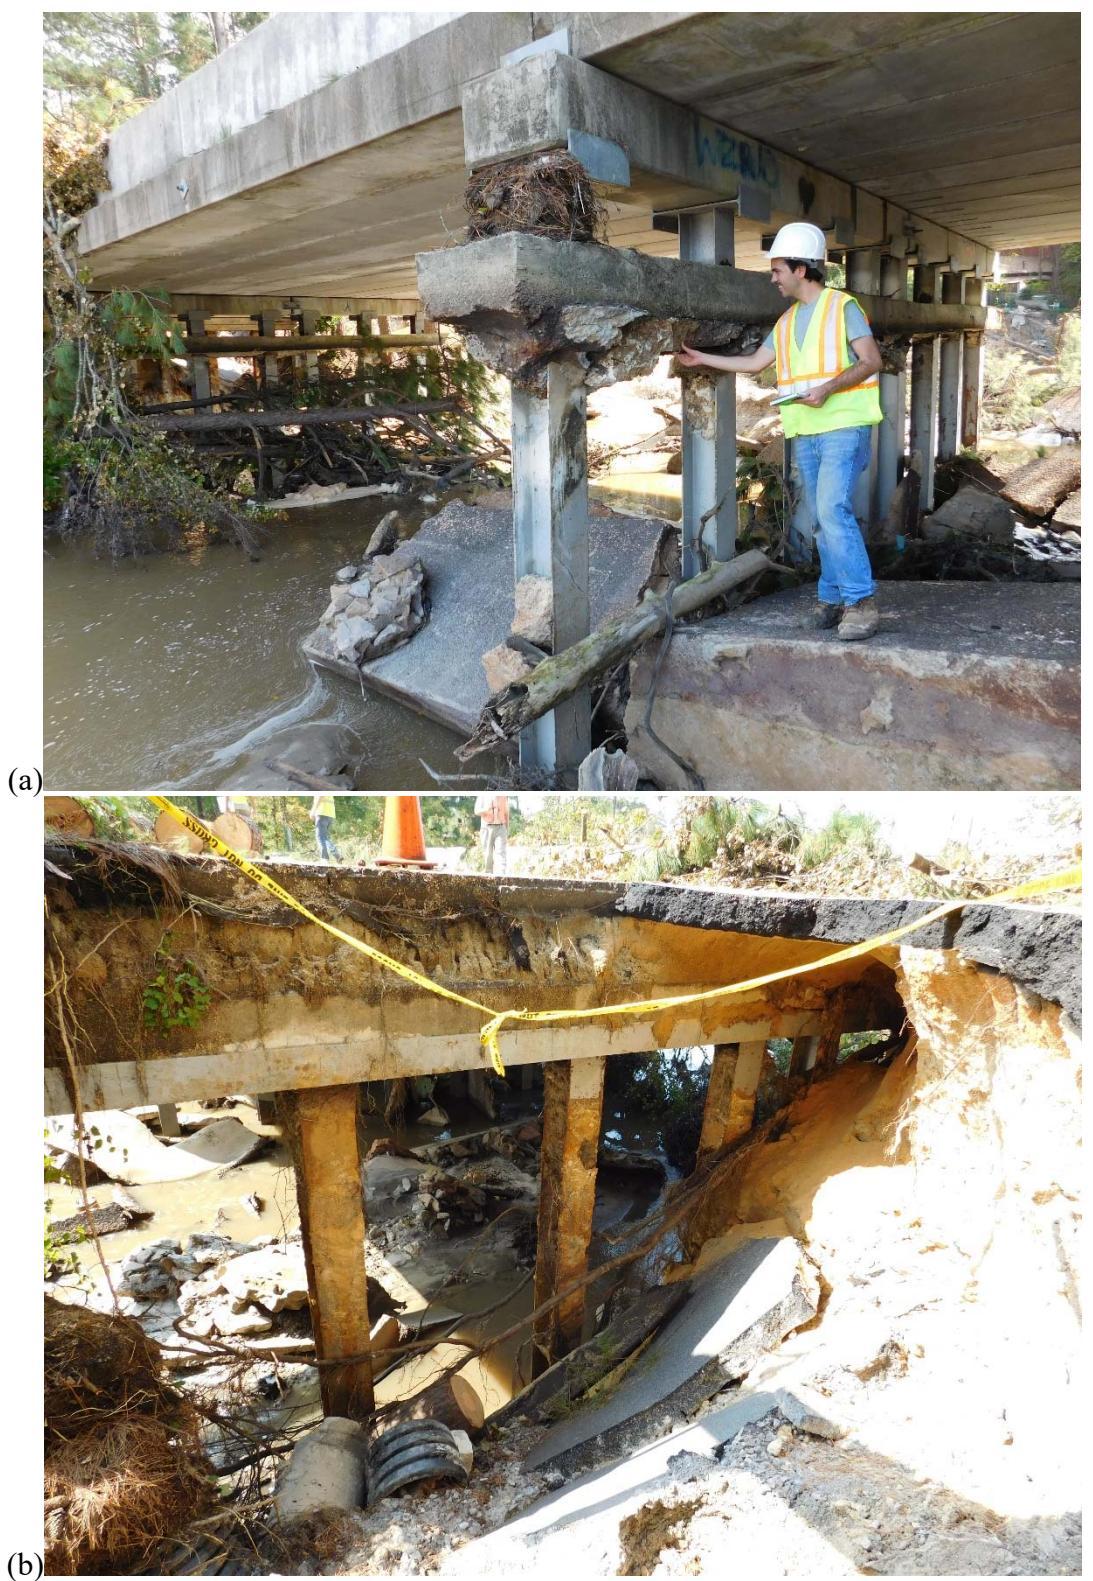
Figure 94. Lower Rockyford Lake Dam: (a) Wash-out of the entire uncontrolled overflow concrete spillway under the bridge; (b) erosion and scour on the downstream edge of the left abutment (photos: October 13, 2015; N 34.03595°, W 80.95195°).

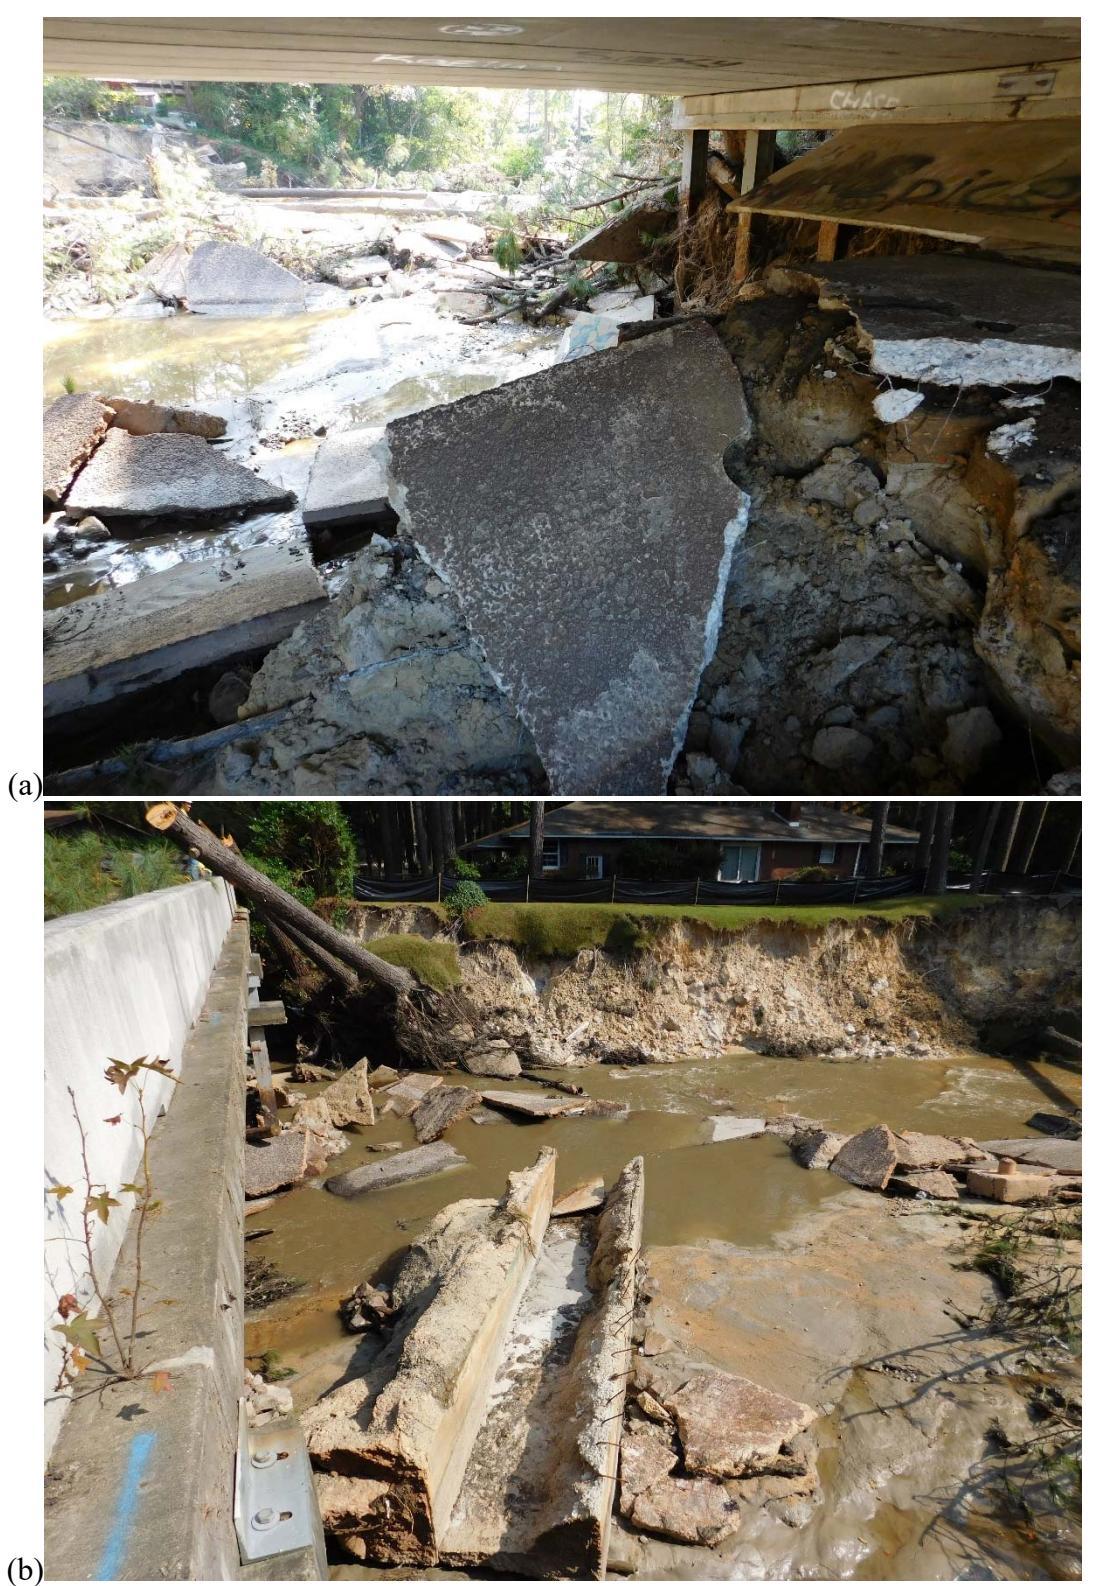
Figure 95. Lower Rockyford Lake Dam: (a) Uncontrolled overflow concrete spillway washed-out under the bridge;
(b) remains of concrete spillway scattered downstream in Gills Creek (photos: October 13, 2015; N 34.03595°, W 80.95195°).

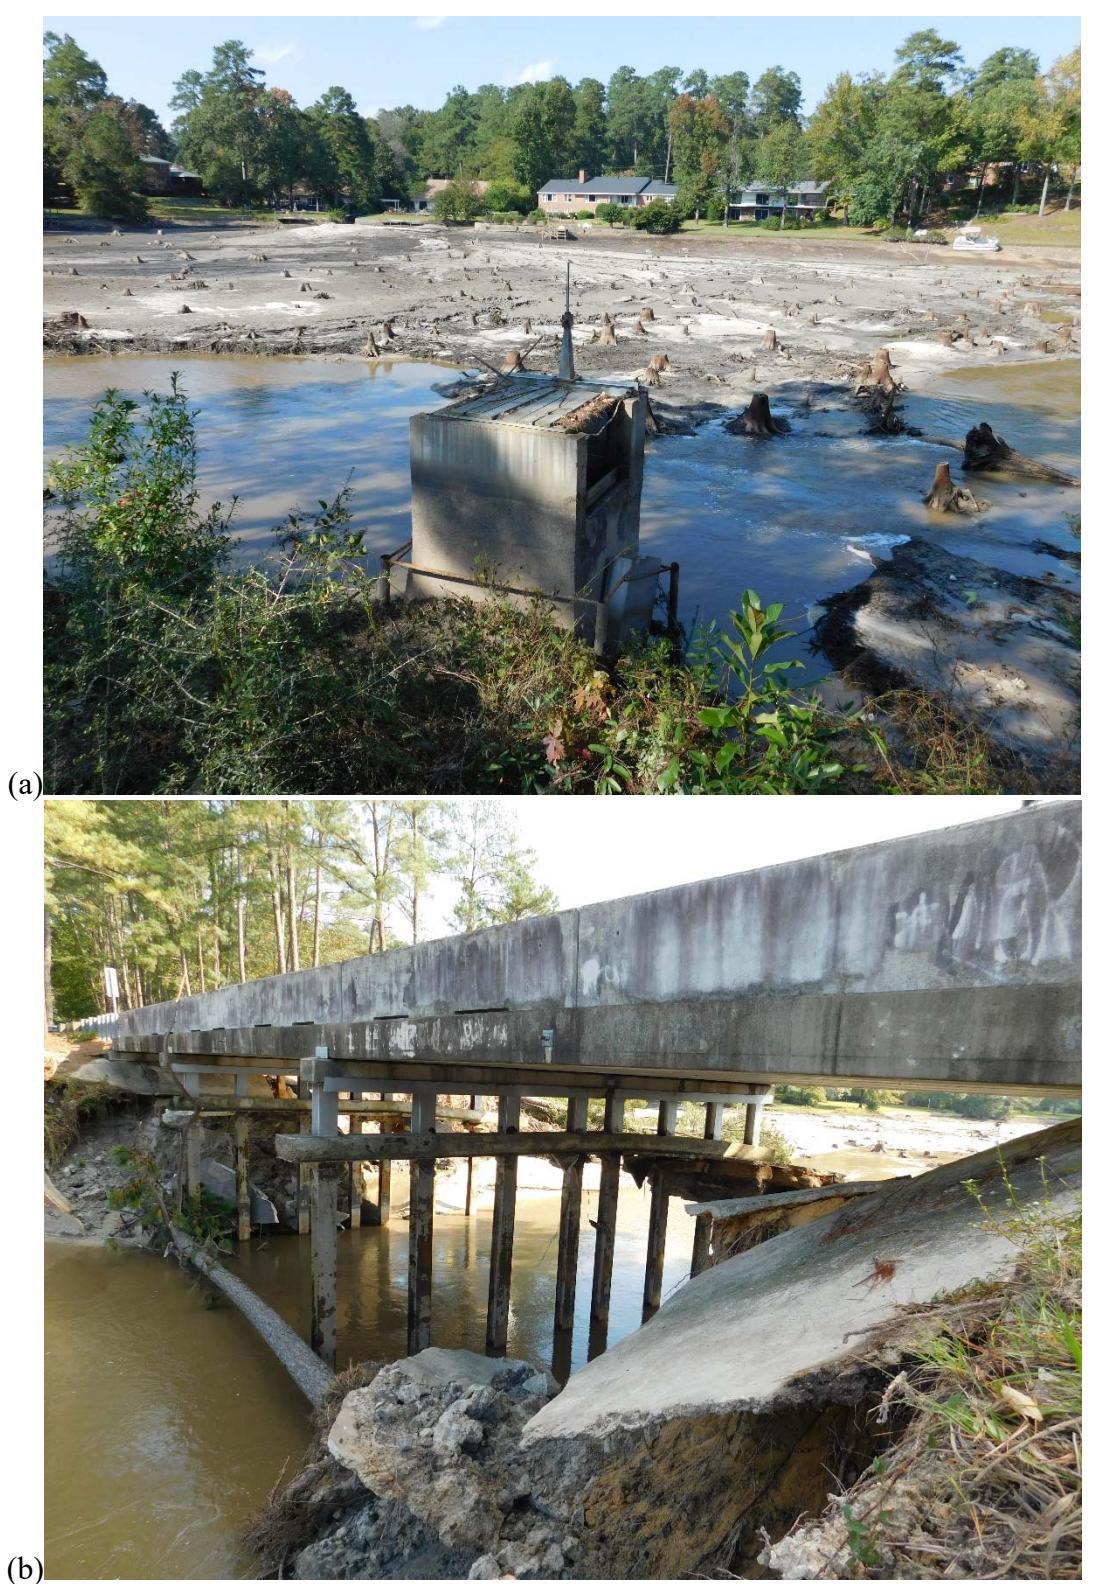
The uncontrolled spillway at Upper Rockyford Lake Dam was completely removed on October 5, 2015 by the mostly unregulated flood discharges from upper Gills Creek as shown in Figure 96(b). The concrete spillway was completely washed out from under the bridge along with the underlying earth fill and downstream abutment scouring as shown in Figure 97. The discharge from Upper Rockyford Lake flows directly into Lower Rockyford Lake. The damage patterns characterized by a complete wash-out of the uncontrolled overflow concrete spillways and downstream abutment scouring were almost identical at Upper and Lower Rockford Lake Dams.

(b)
 Figure 96. Upper Rockyford Lake Dam: (a) Emptied lake upstream of the dam with the drop box inlet; (b) wash out of the uncontrolled overflow concrete spillway under the bridge (photos: October 13, 2015; N 34.03955°, W 80.95151°).

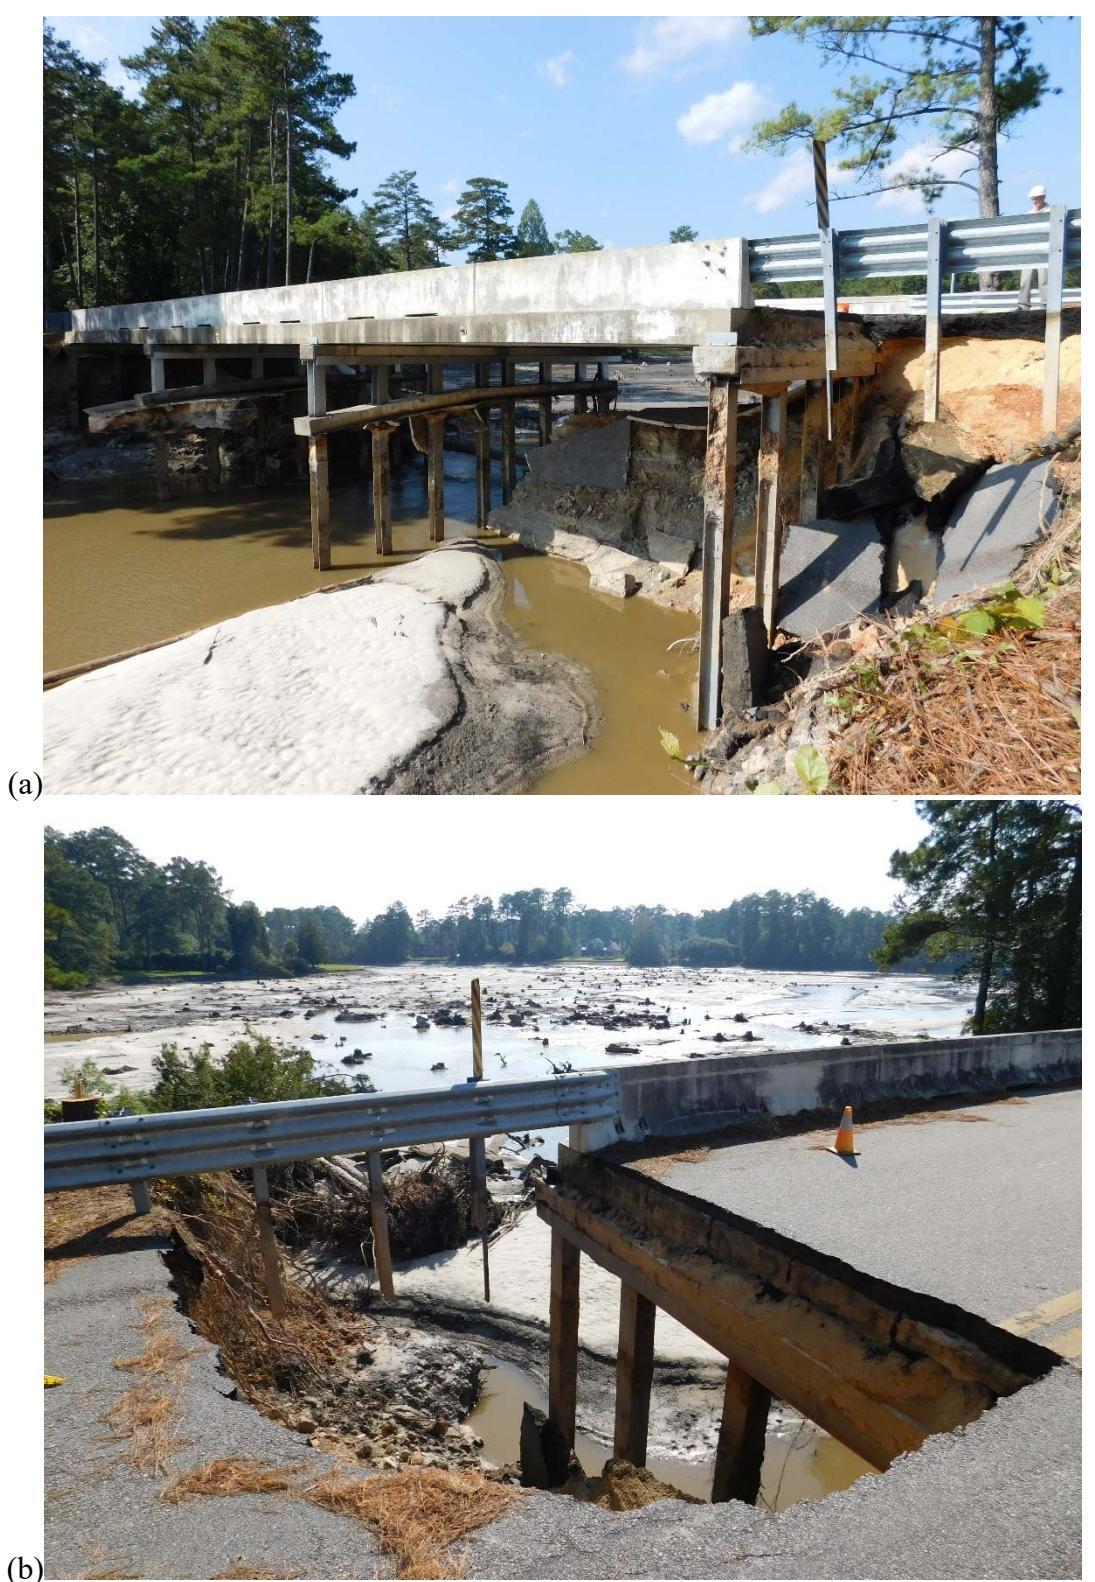
(b)
Figure 97. Upper Rockyford Lake Dam: (a) wash out of the uncontrolled overflow concrete spillway under the bridge;
(b) erosion and scouring on the downstream edge of the left abutment (photos: October 13, 2015; N 34.03955°, W 80.95151°).

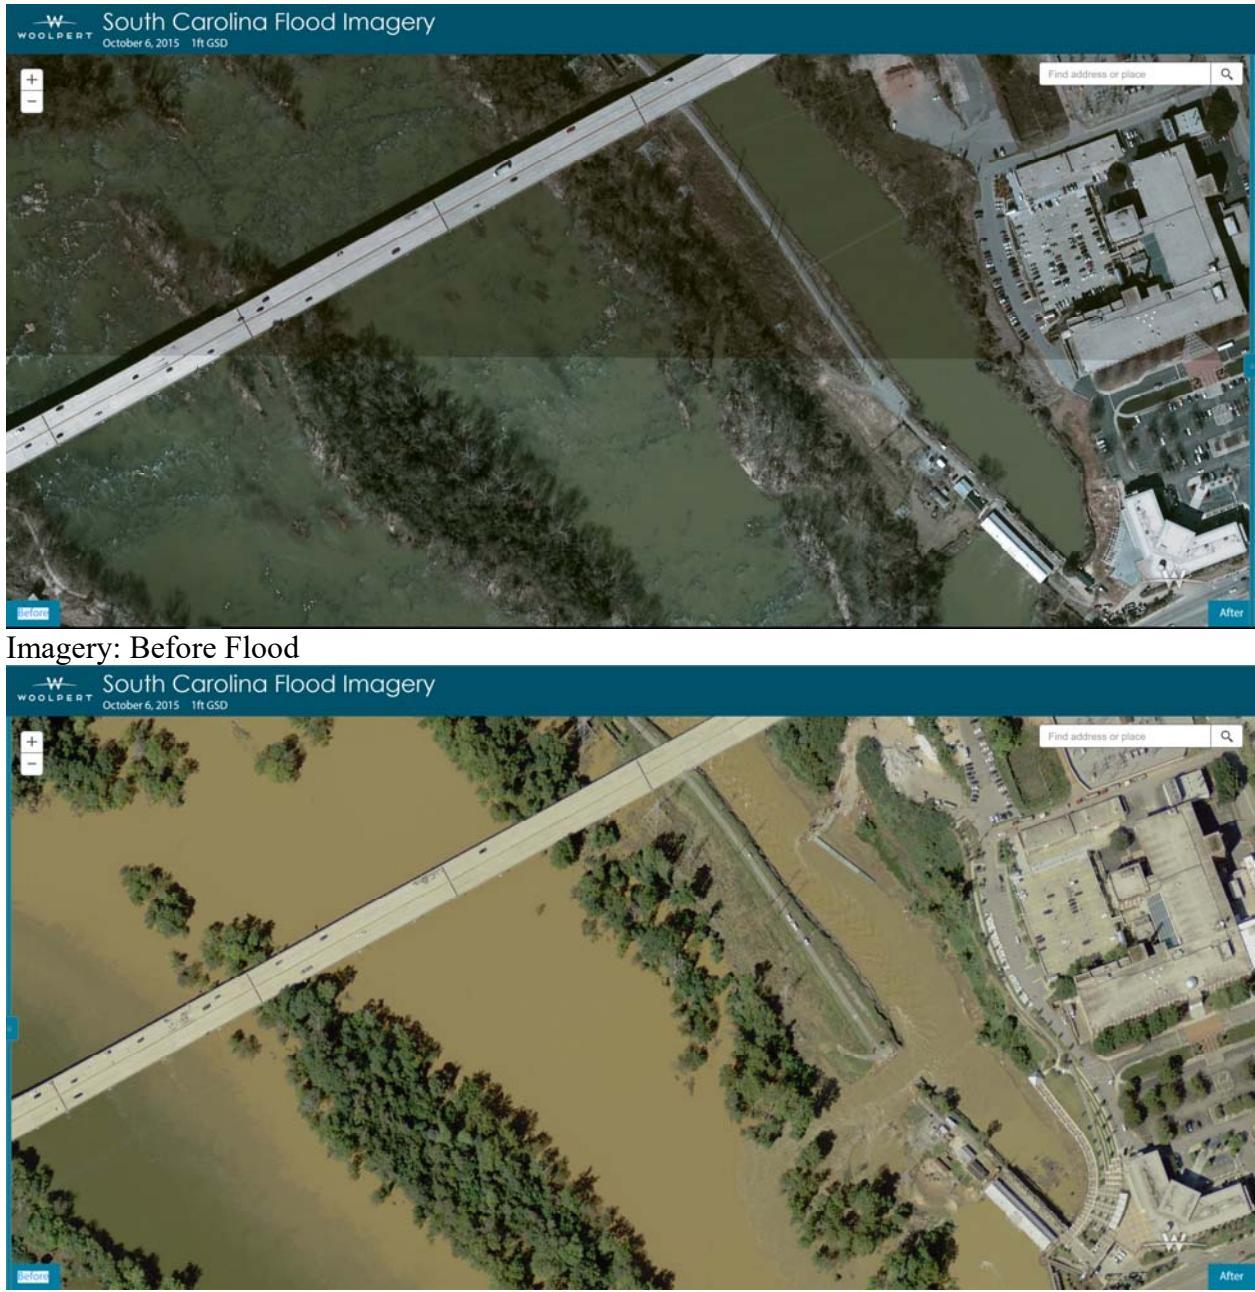
Columbia Canal levee breach (N 33.99796°, W 81.05018°)

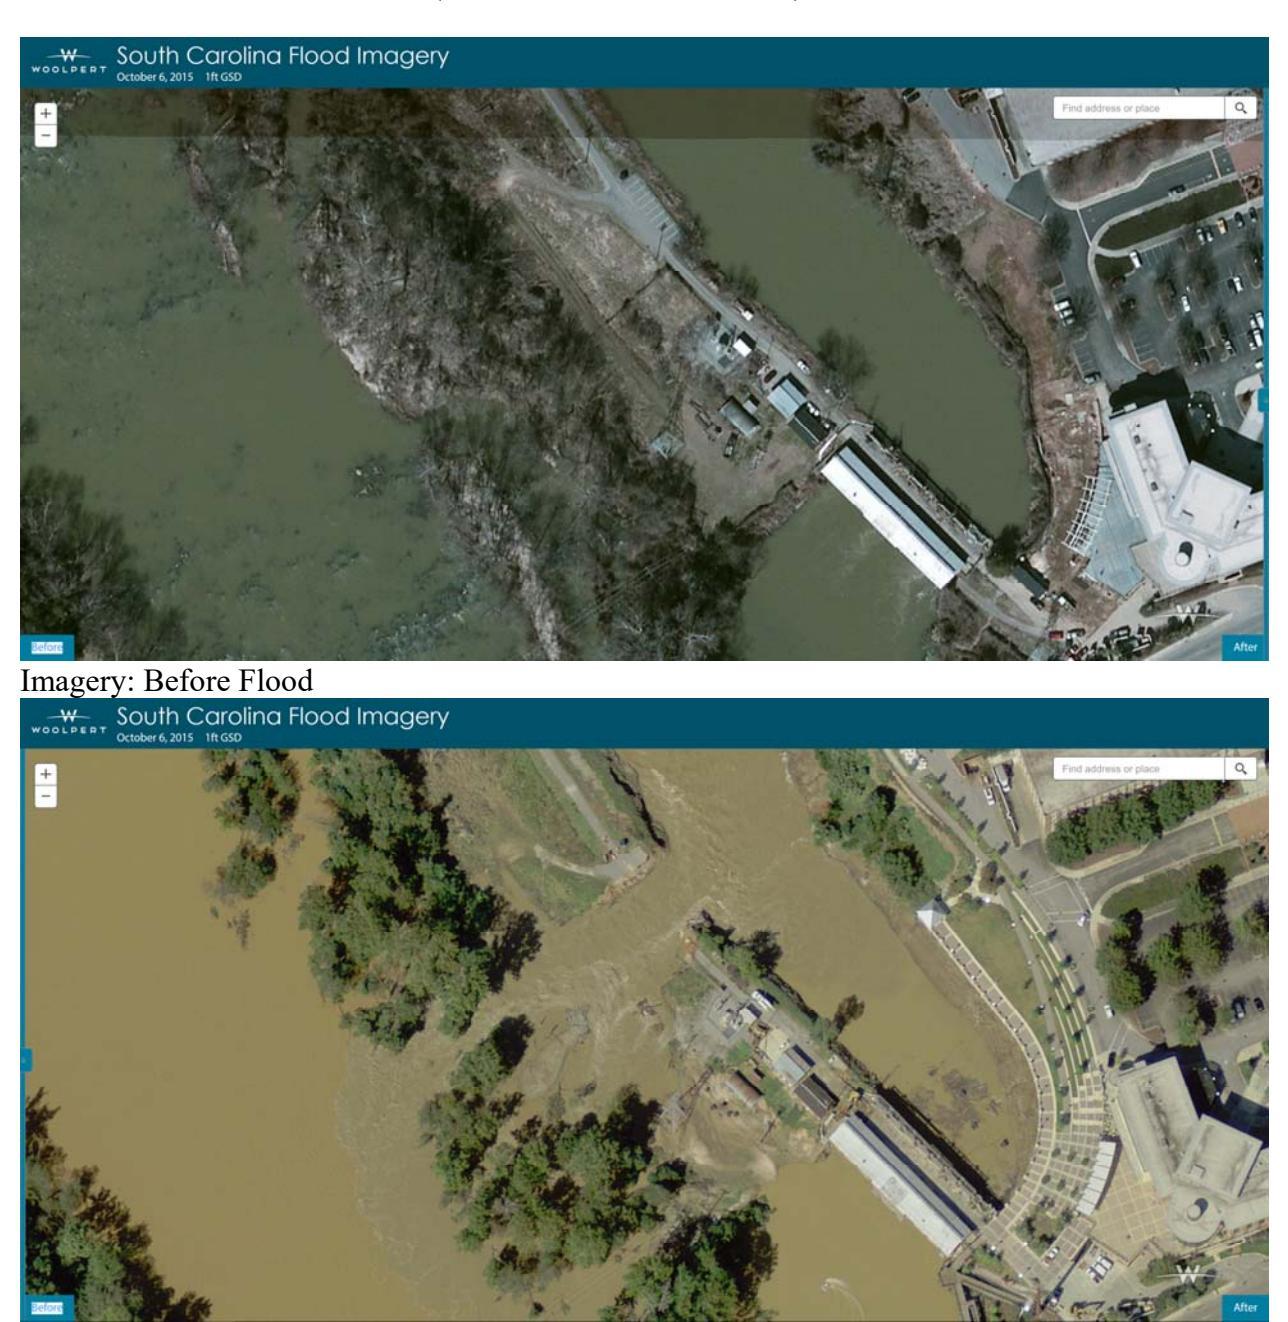
Columbia Canal levee breach (N 33.99796°, W 81.05018°)
