The Hydraulic and Geotechnical Aspects of the South Carolina Floods of October 1-5, 2015 Related to Offshore Hurricane Joaquin

GEER Association Report No. GEER-052 December 19, 2016

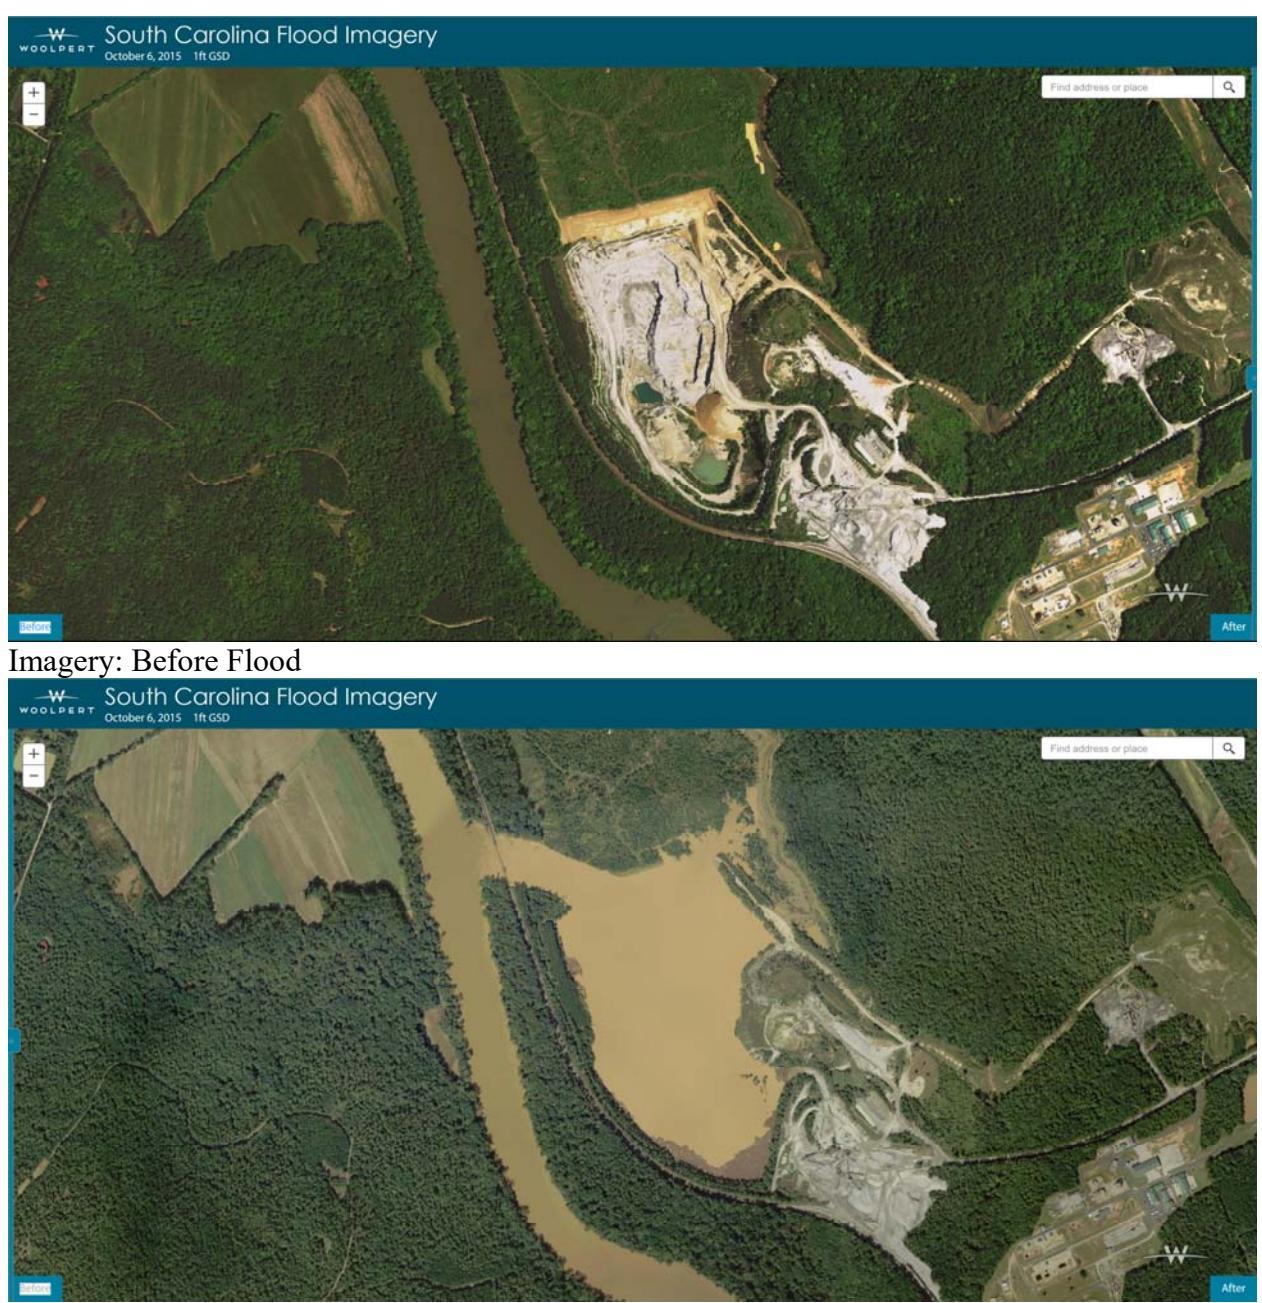
Broad River levee breach (N 34.11447°, W 81.11935°)

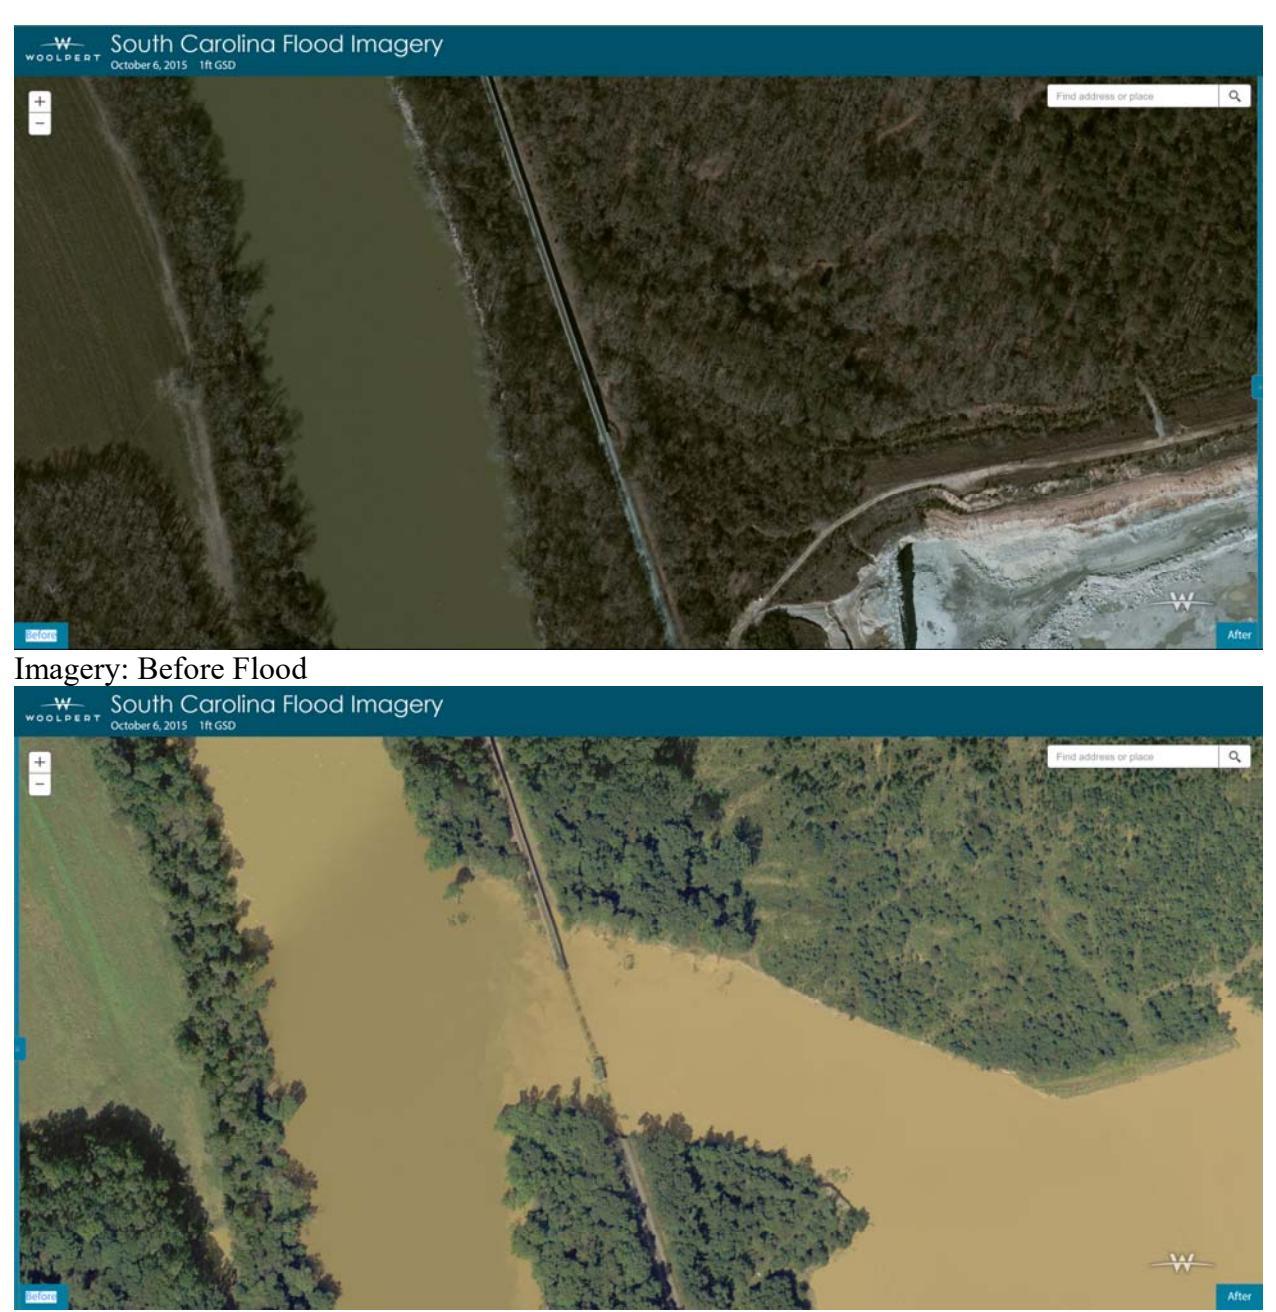
Broad River levee breach (N 34.11447°, W 81.11935°)

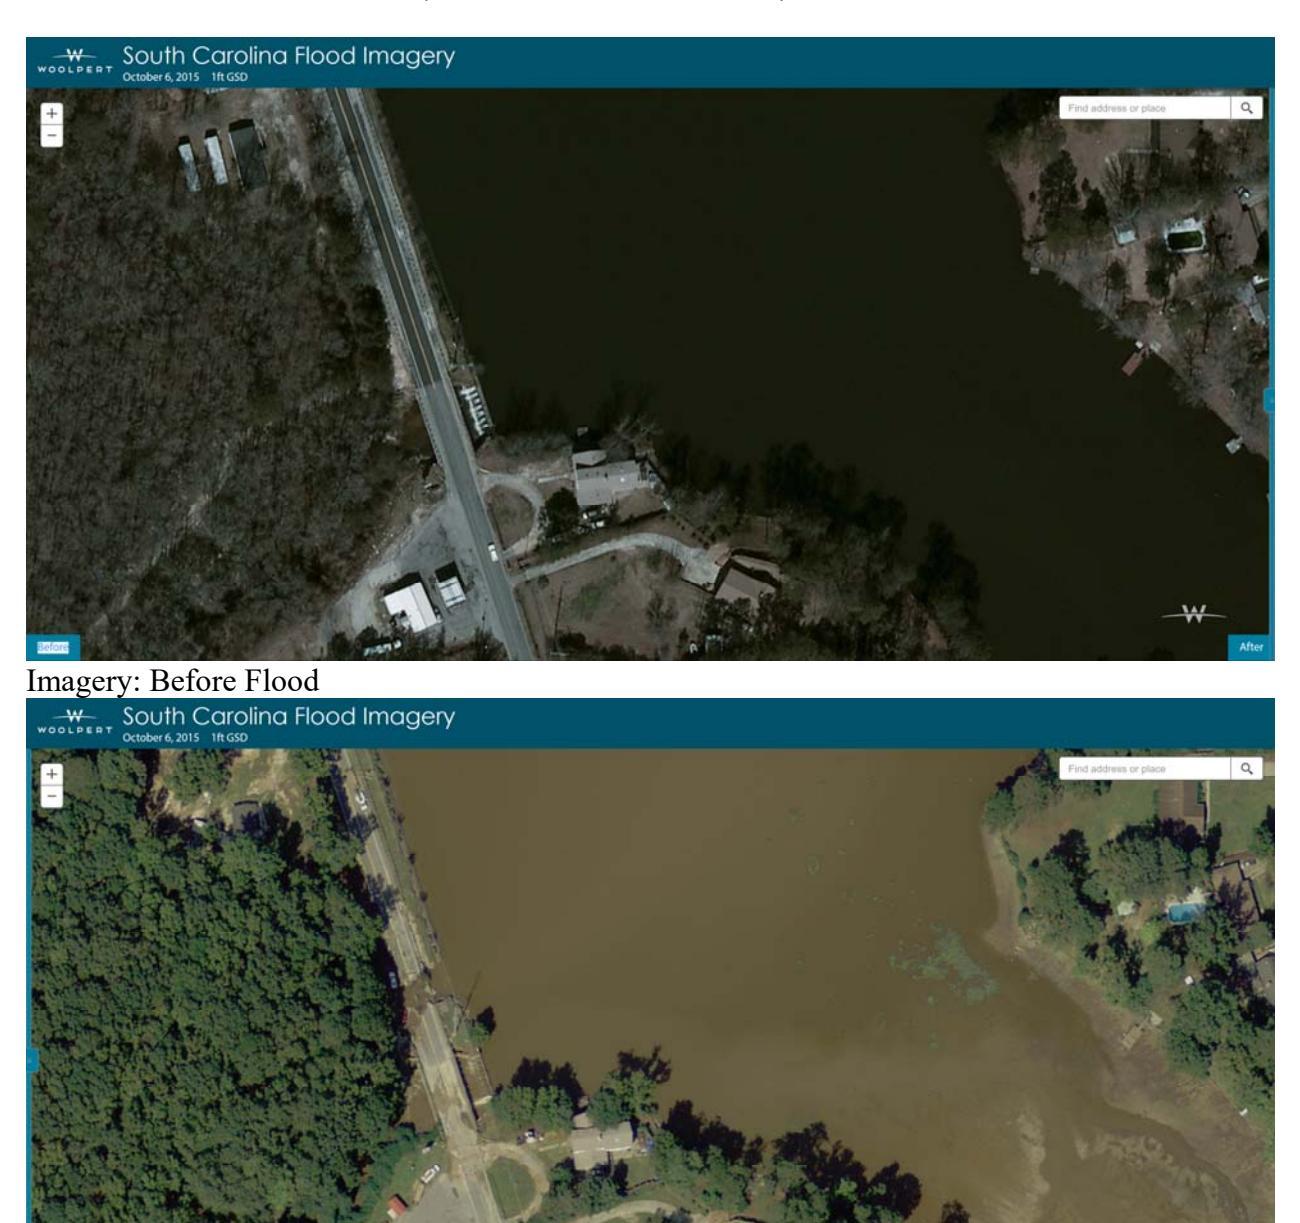
Lake Elizabeth Dam breach (N 34.11253°, W 80.98766°)

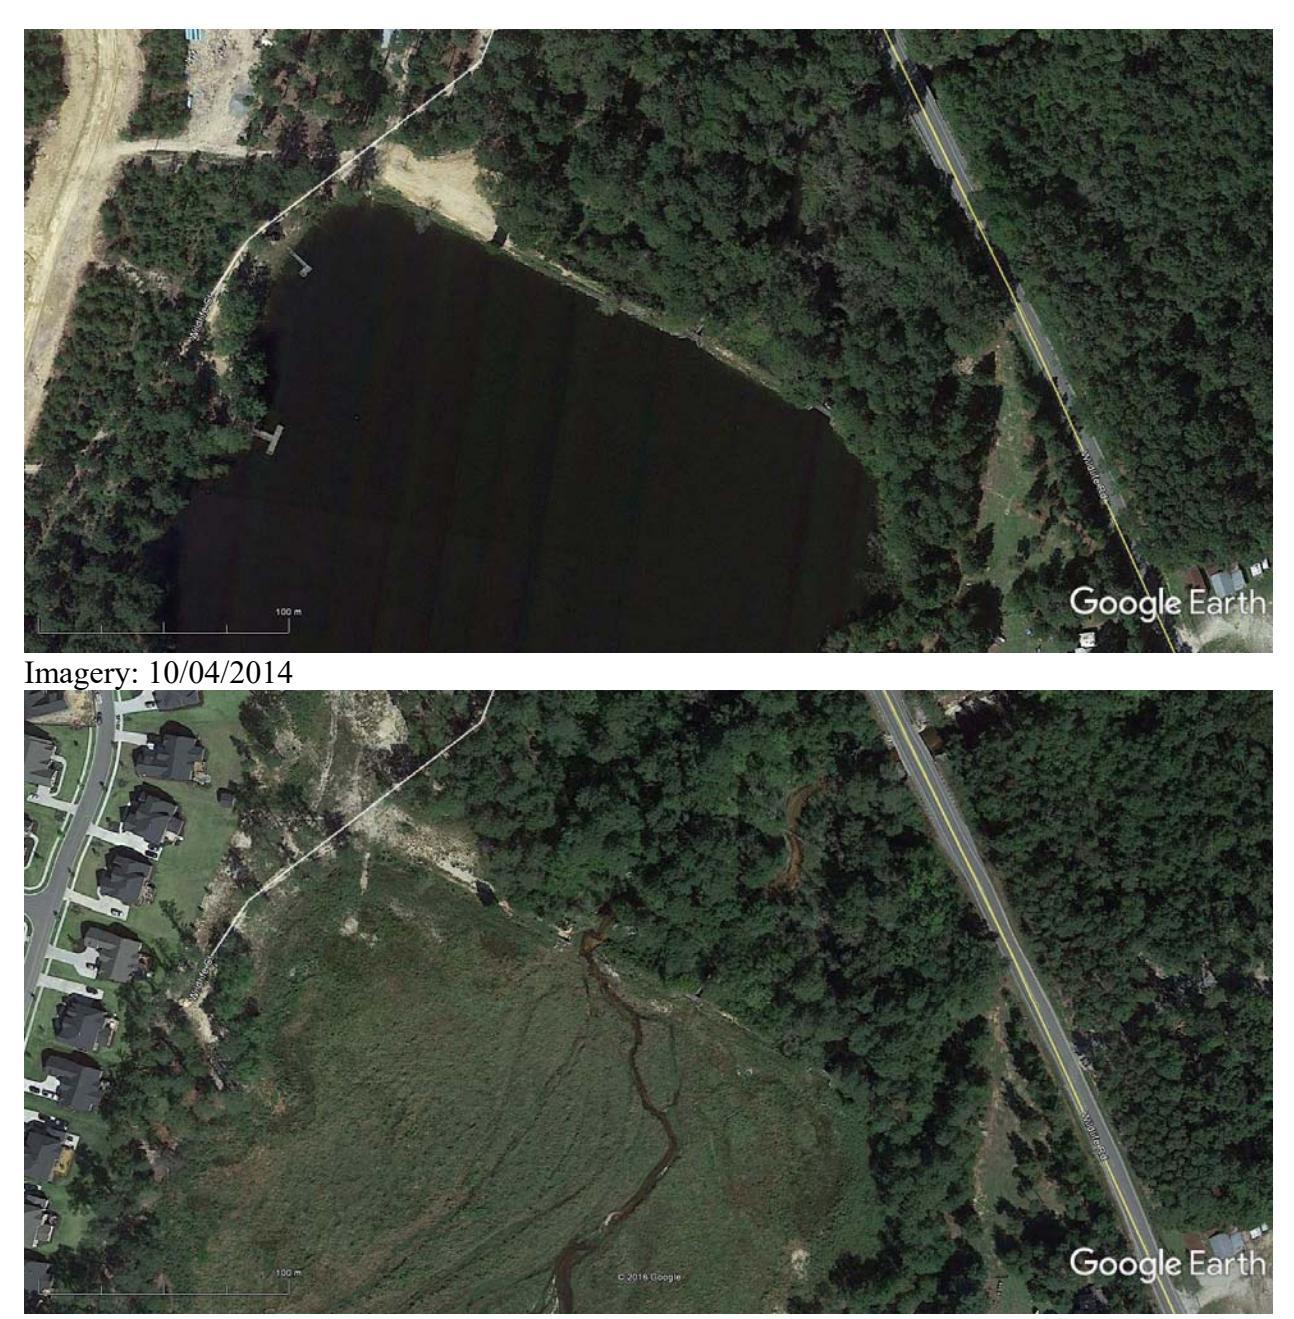
Barr Lake Dam breach (N 33.95876°, W 81.26025°)

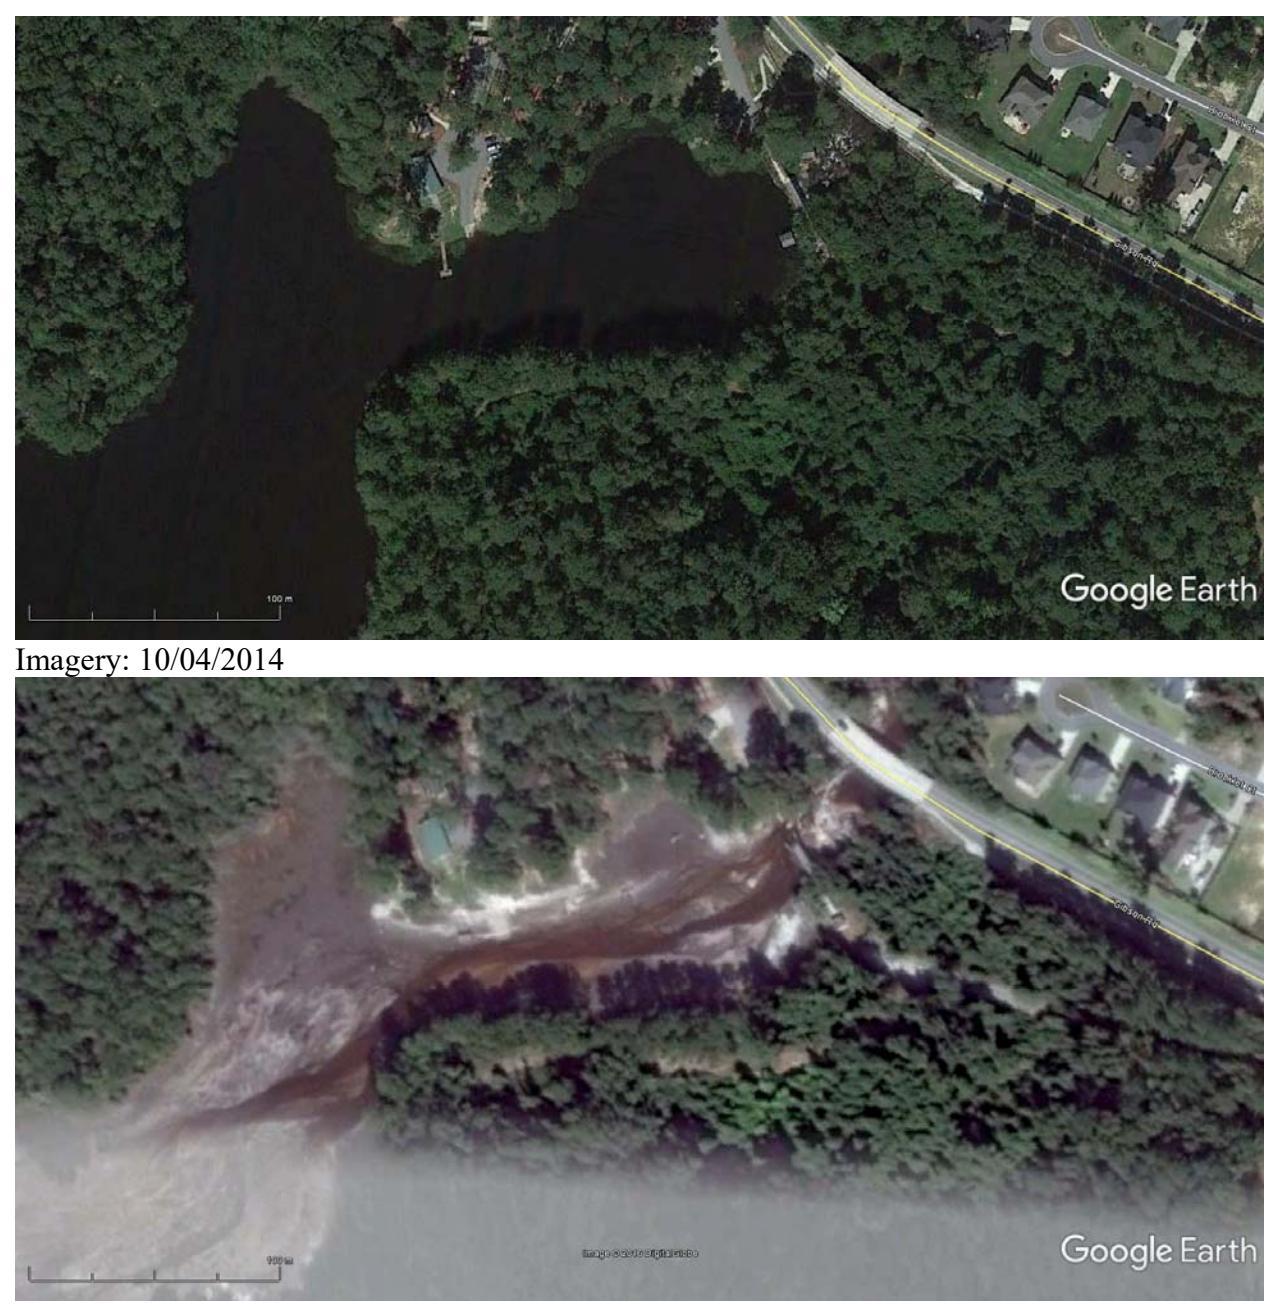
Gibsons Pond Dam breach (N 33.96949°, W 81.24360°)

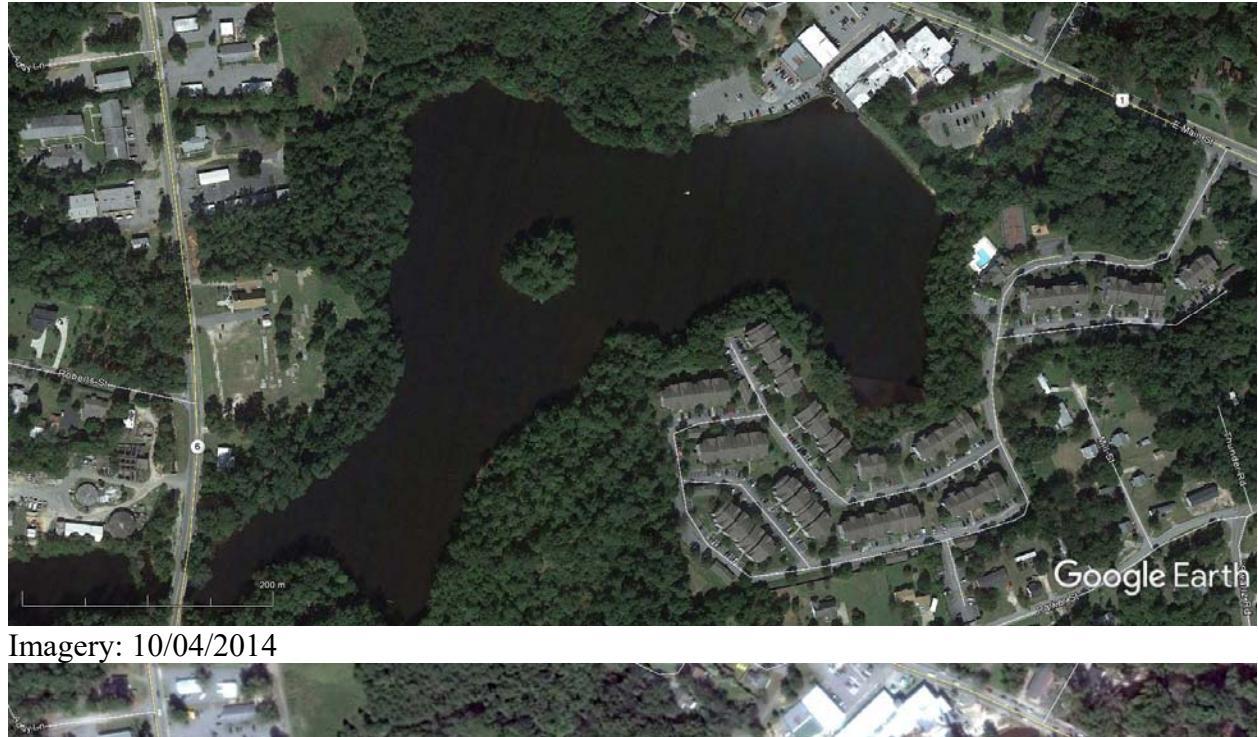
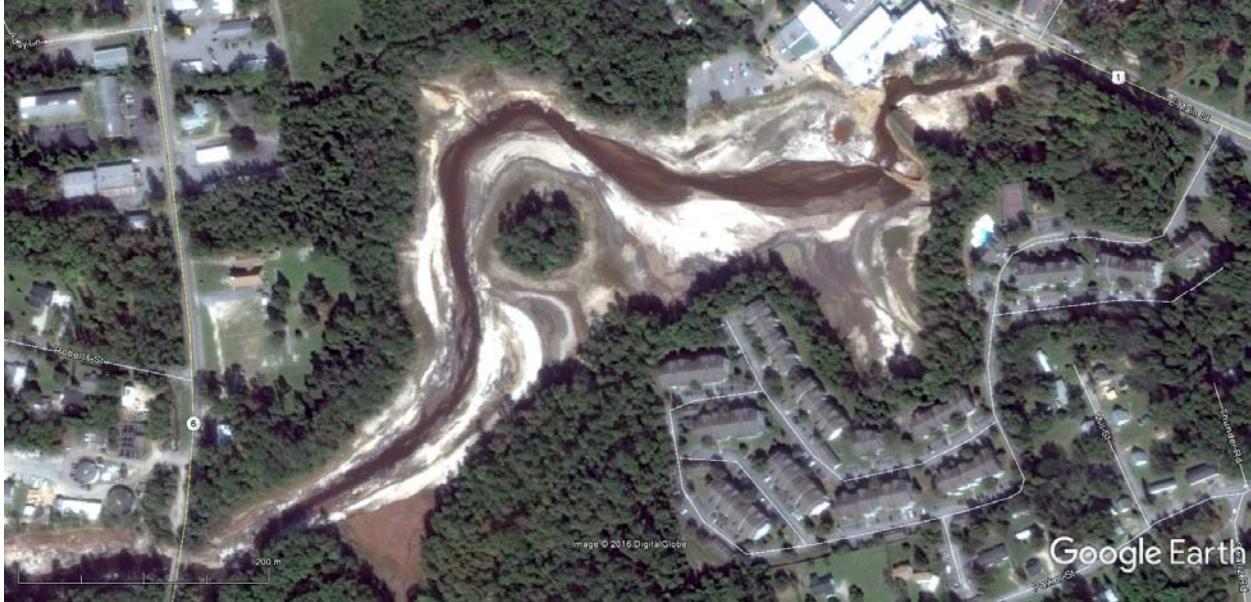
Old Mill Pond Dam breach (N 33.97683°, W 81.22961°)

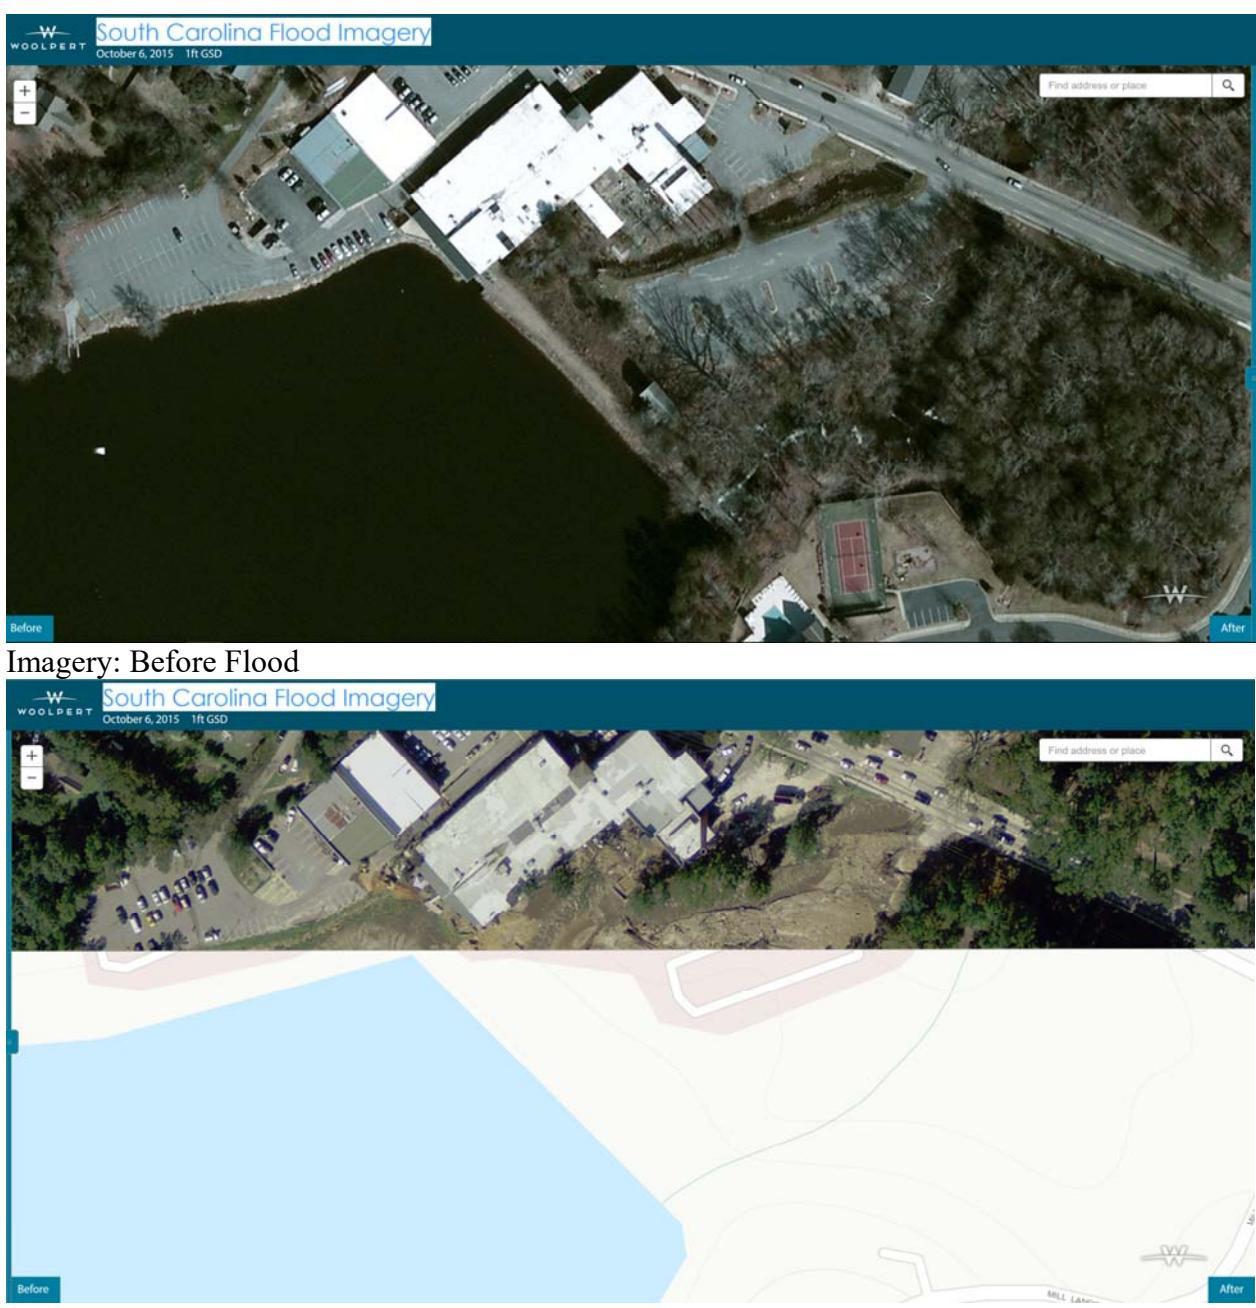
Old Mill Pond Dam breach (N 33.97683°, W 81.22961°)

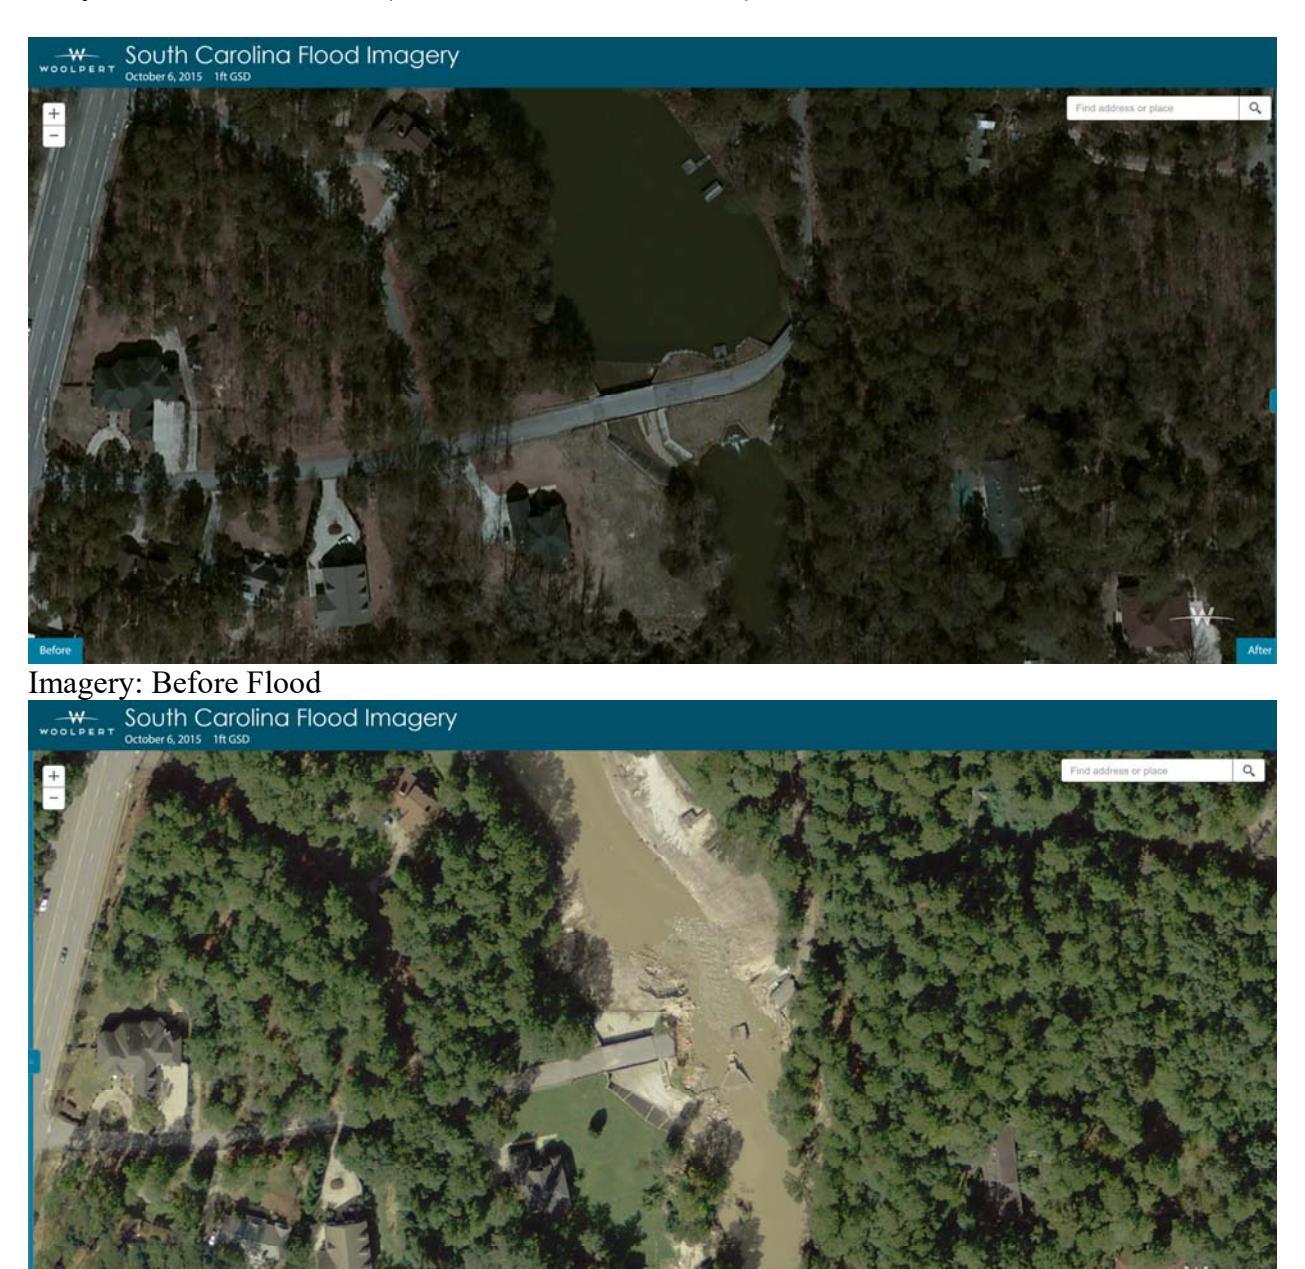
Cary's Lake Dam breach (N 34.04866°, W 80.95764°)

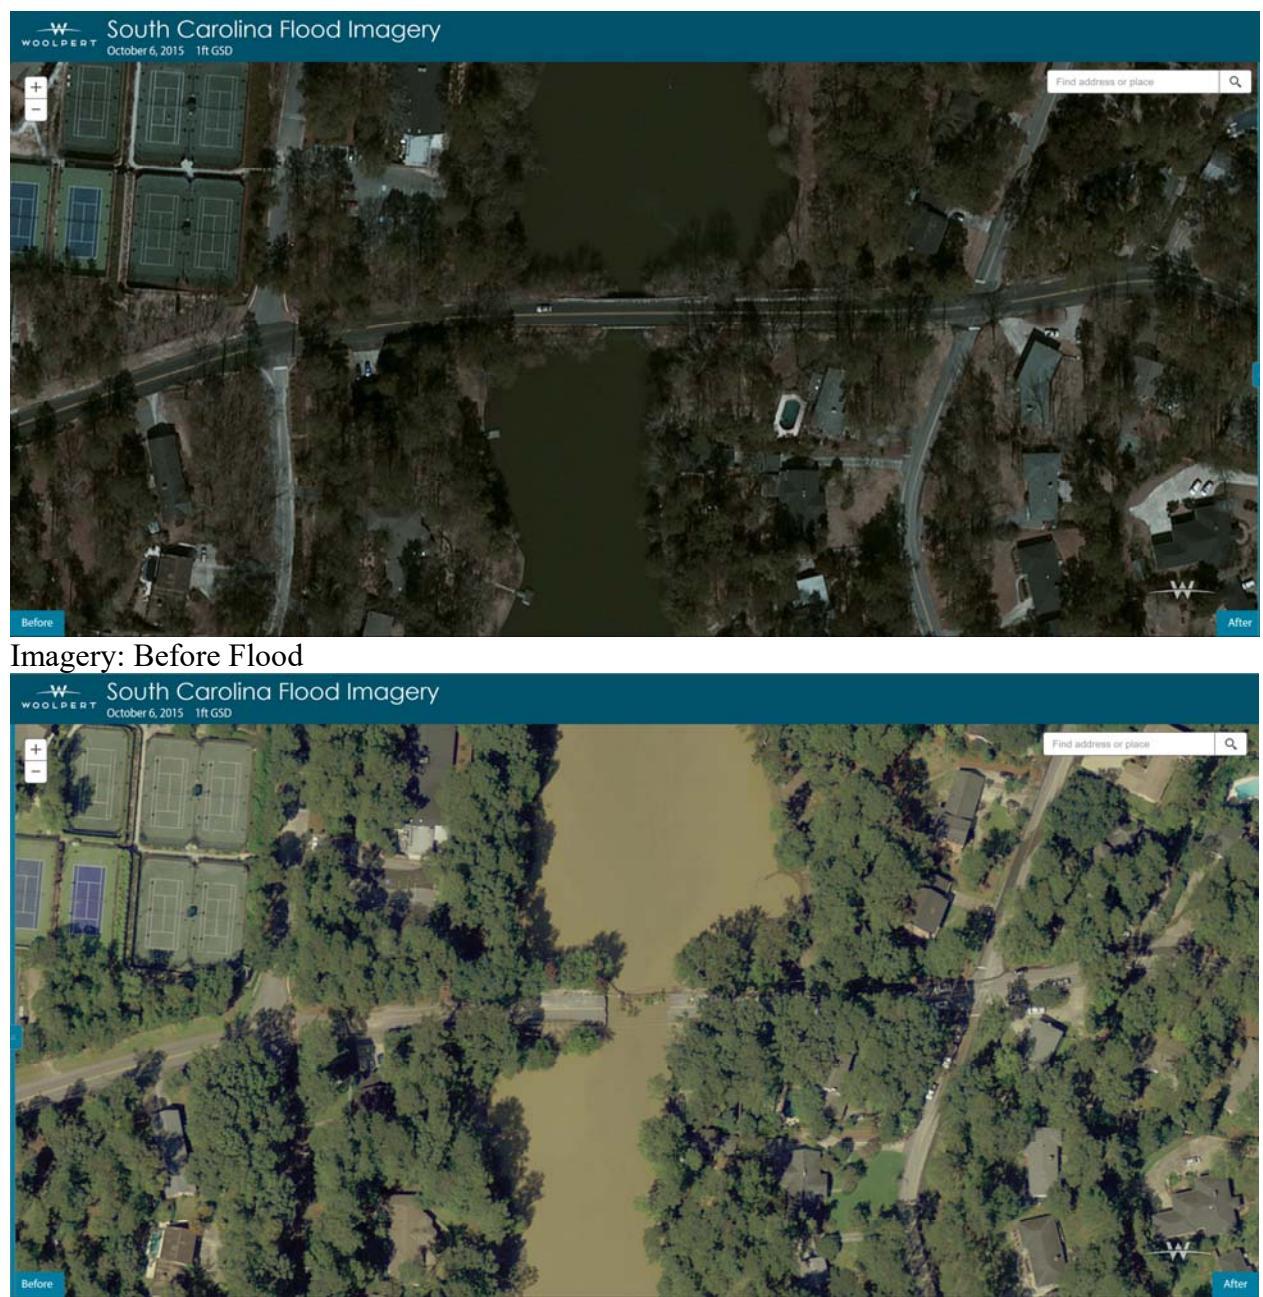
Rockbridge Road bridge washed away (N 34.04516°, W 80.95709°)

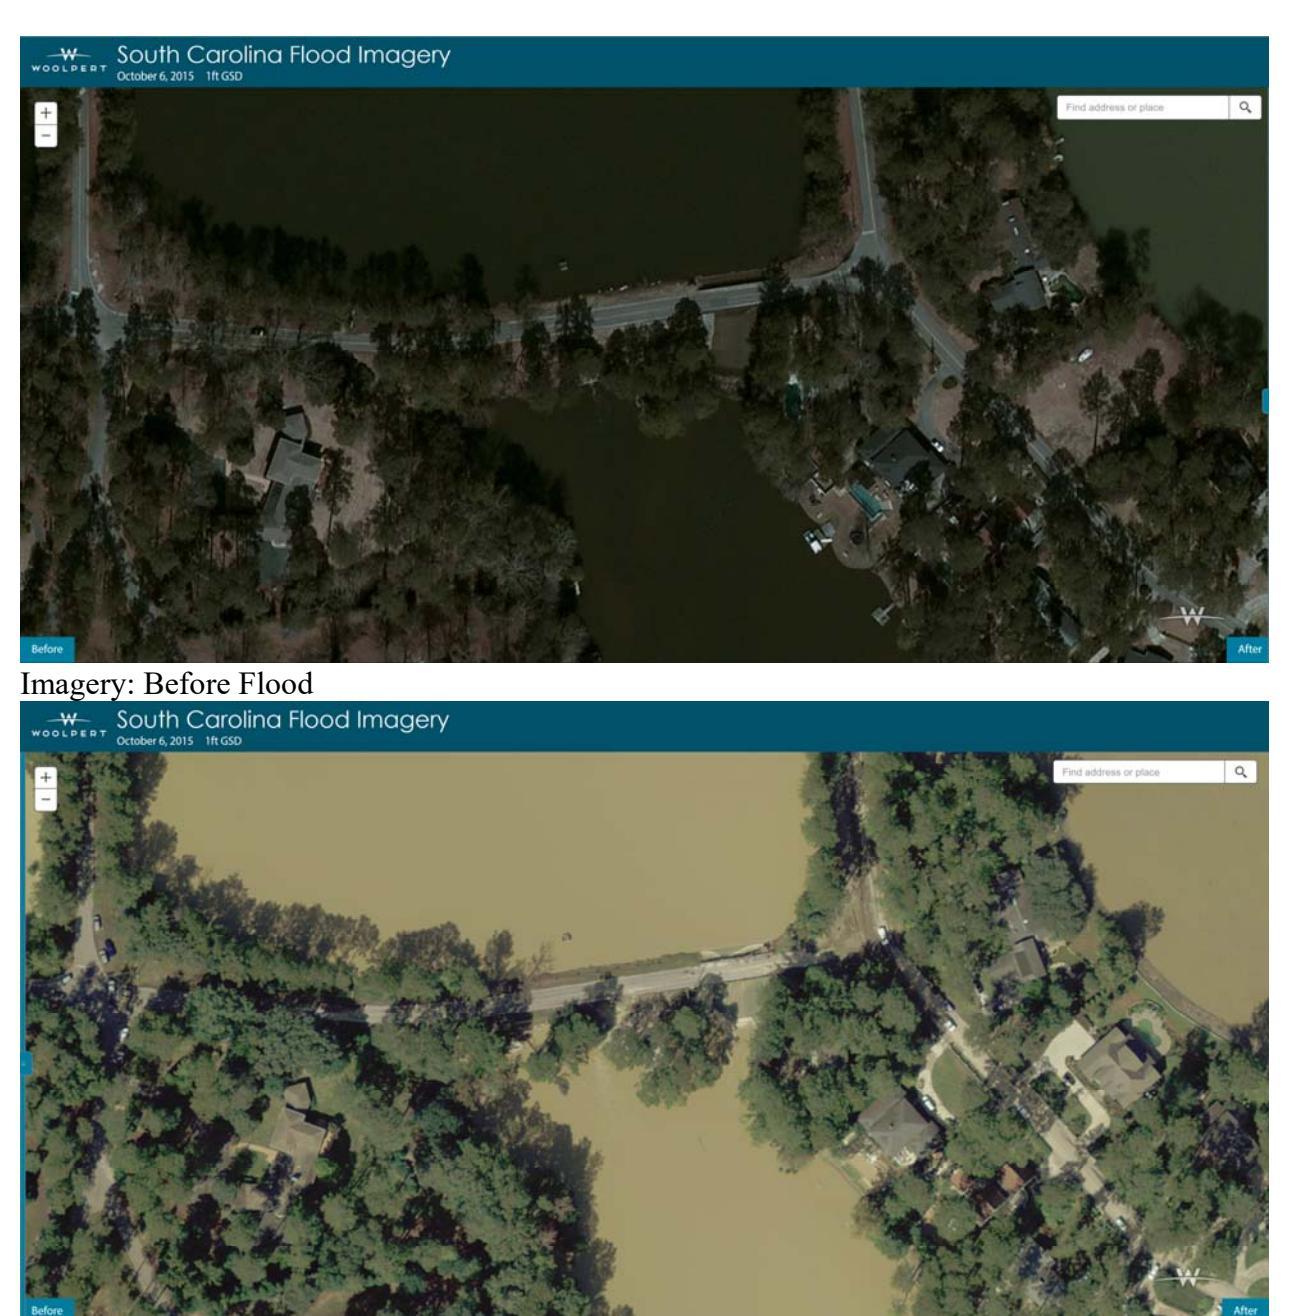
Spring Lake Dam overtopped (N 34.03708°, W 80.95531°)

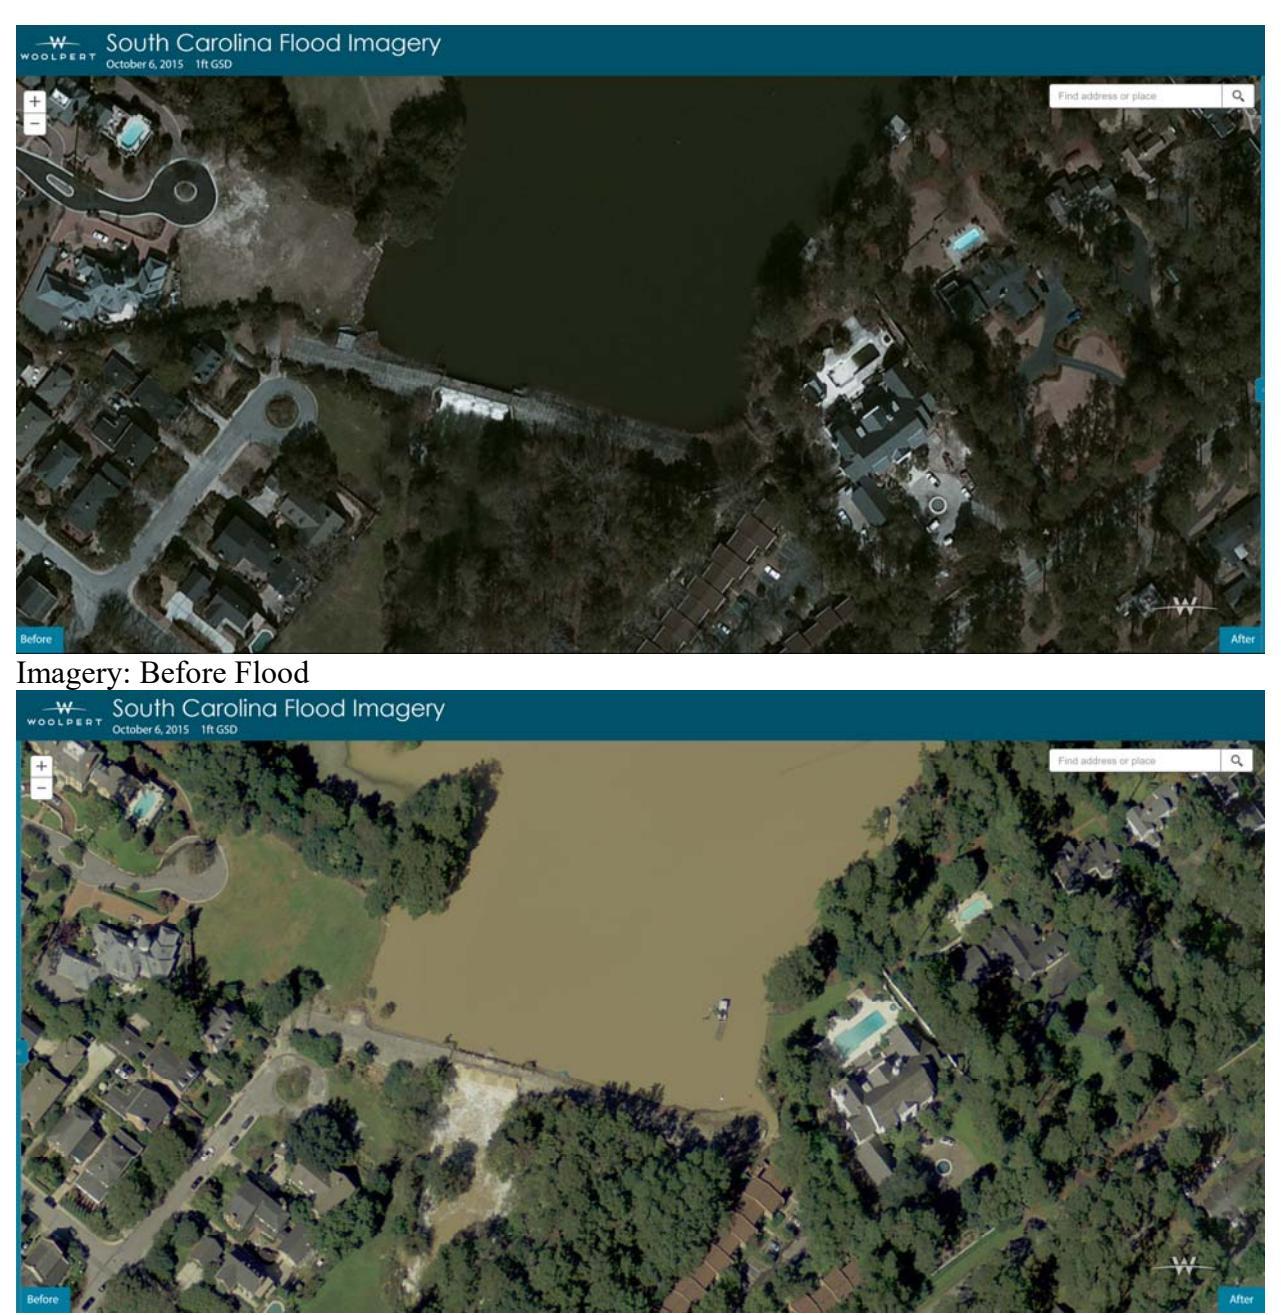
Forest Lake Dam overtopped (N 34.02217°, W 80.96281°)

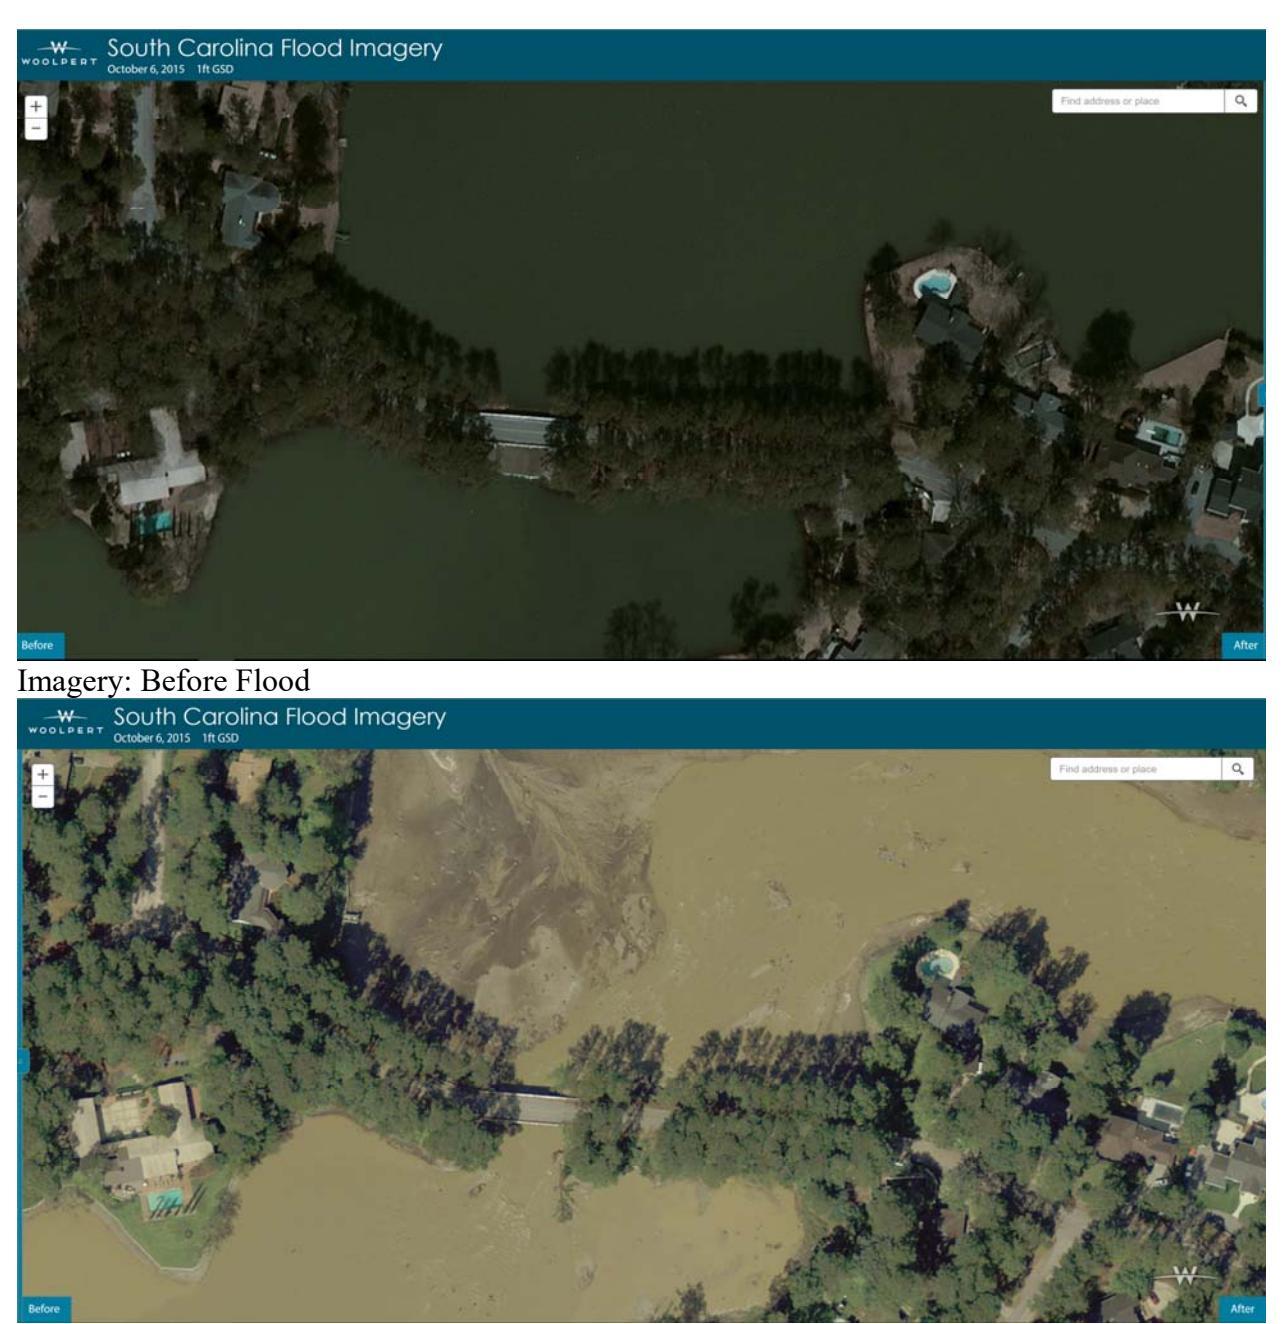
Upper Rockyford Lake Dam spillway washout under bridge (N 34.03955°, W 80.95151°)

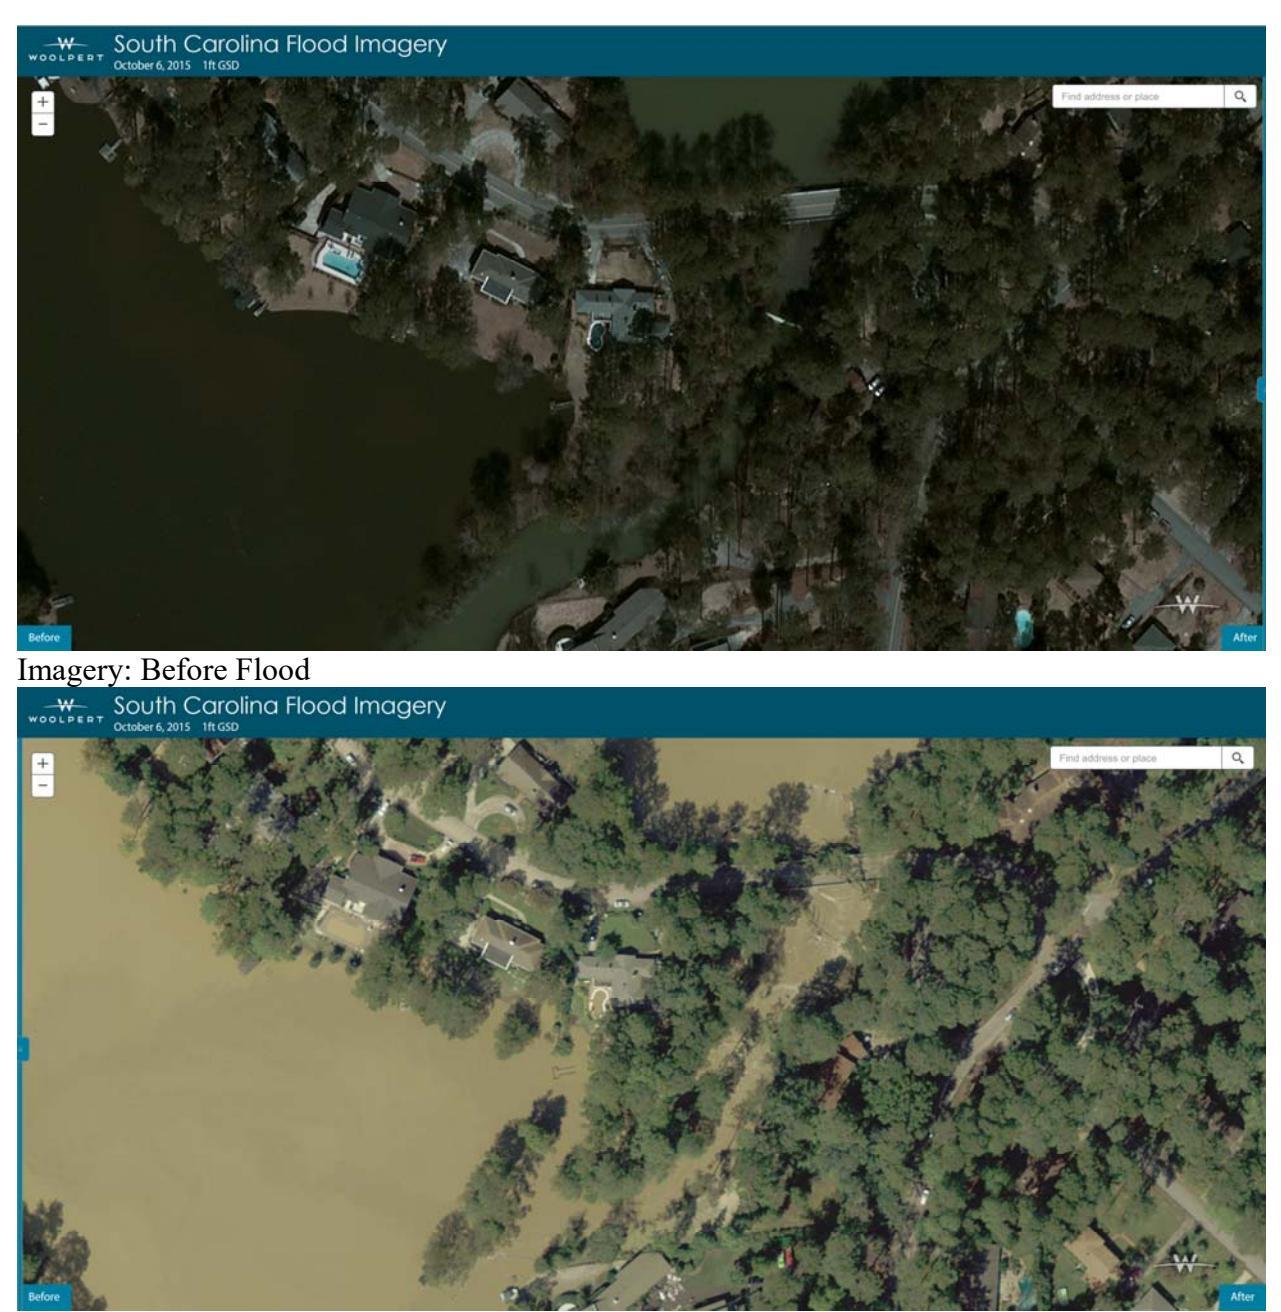
Lower Rockyford Lake Dam spillway washout under bridge (N 34.03595°, W 80.95195°)
