**Figure 6.2** Pre- and post-earthquake satellite/aerial imagery (top and bottom, respectively) of the port at Port-au-Prince, Haiti (N18.555058°, W72.351144°). Imagery courtesy of Google Earth.

**Figure 6.5** Annotated aerial image of Port de Port-au-Prince showing locations of damage due to the earthquake. Imagery courtesy of Google Earth. (N18.555058°, W72.351144°)

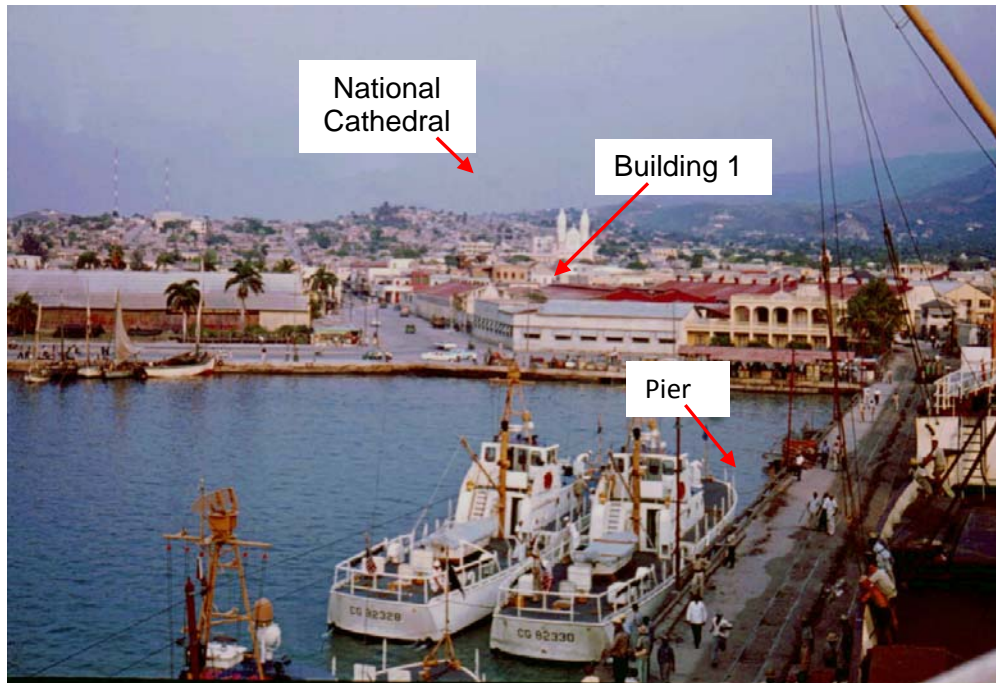
**Figure 6.3** Photograph of the port circa 1962 (Source unknown).

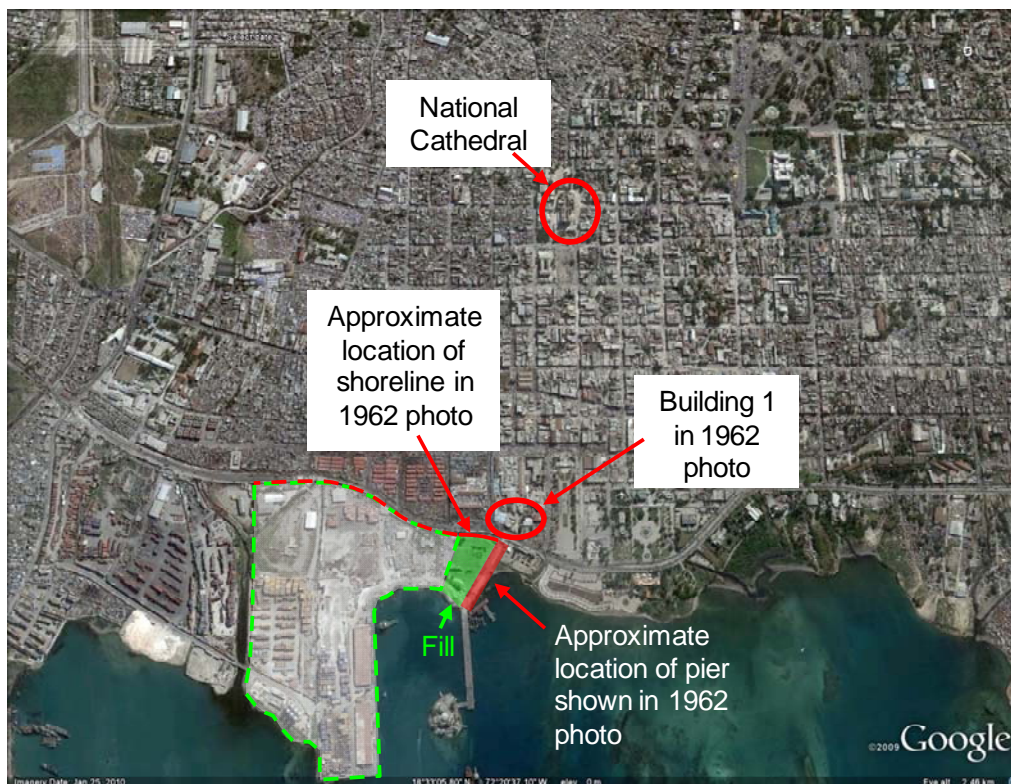
**Figure 6.4** Recent aerial image of port, with the landmarks shown in Figure 6.2 annotated. The extent of the fill to the North (left) is unknown and is thus annotated by dashed lines. Imagery courtesy of Google Earth.

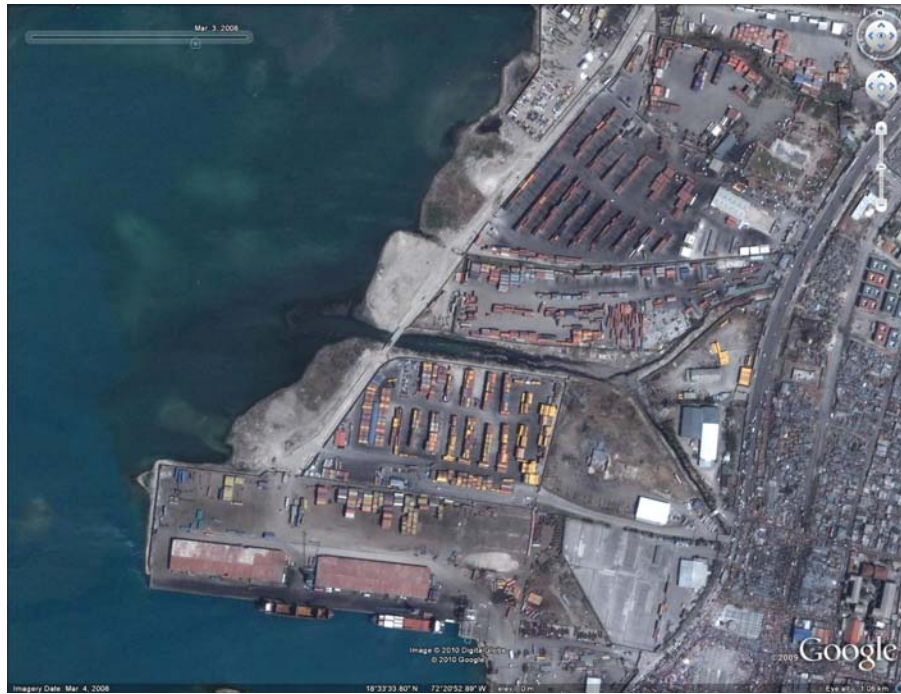
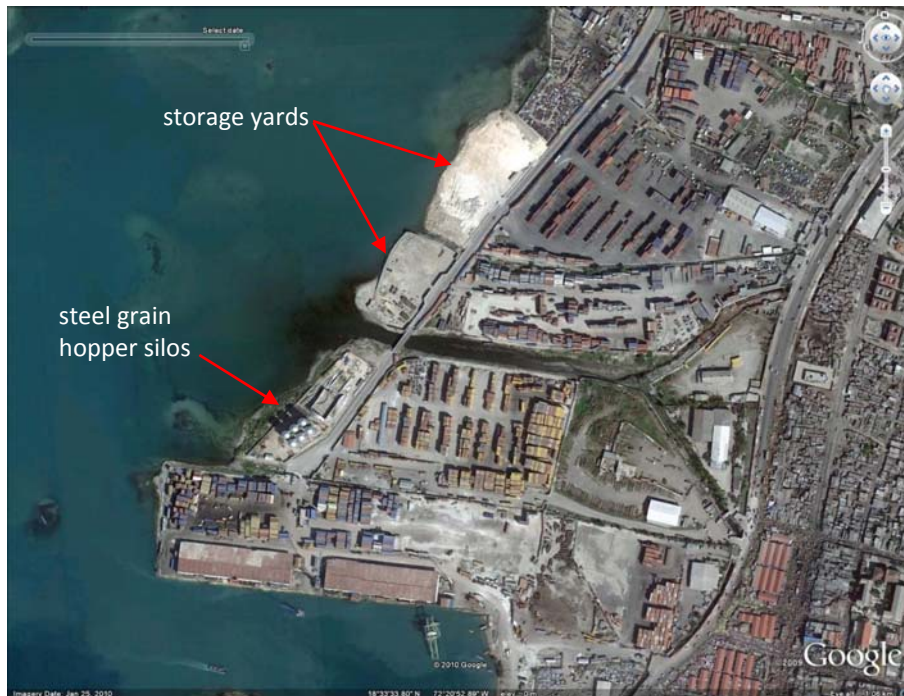
North of the main port facility along the shoreline, there were six steel grain hopper silos and two storage yards (Figure 6.17). From aerial imagery, it was determined that the grain silos were built sometime between March 2008 and January 2010. As shown in Figure 6.18, lateral spreading occurred behind the silos (westward side), but the silos and their foundation system showed no visible signs of distress (Figures 6.18 and 6.19). The amount of grain in the silos at the time of the earthquake is unknown. Also, the foundation system for the silos is unknown at this time. Extensive lateral spreading occurred in the two storage yards that are just north of the silos (Figures 6.20 through 6.24). Approximately 2.4 m of cumulative lateral displacement was measured at the northern storage yard. A unique feature of these lateral spreads is that the fill is garbage overlain by cobbly soil (Figure 6.24). However, it is believed that sand underlying the garbage fill liquefied and caused the lateral spreading.

**Figure 6.17** Aerial imagery of the northern part of the port facilities before the steel grain hopper silos and storage yards were built (top: image from March 2008) and after (bottom: image from January 2010). Imagery courtesy of Google Earth.)

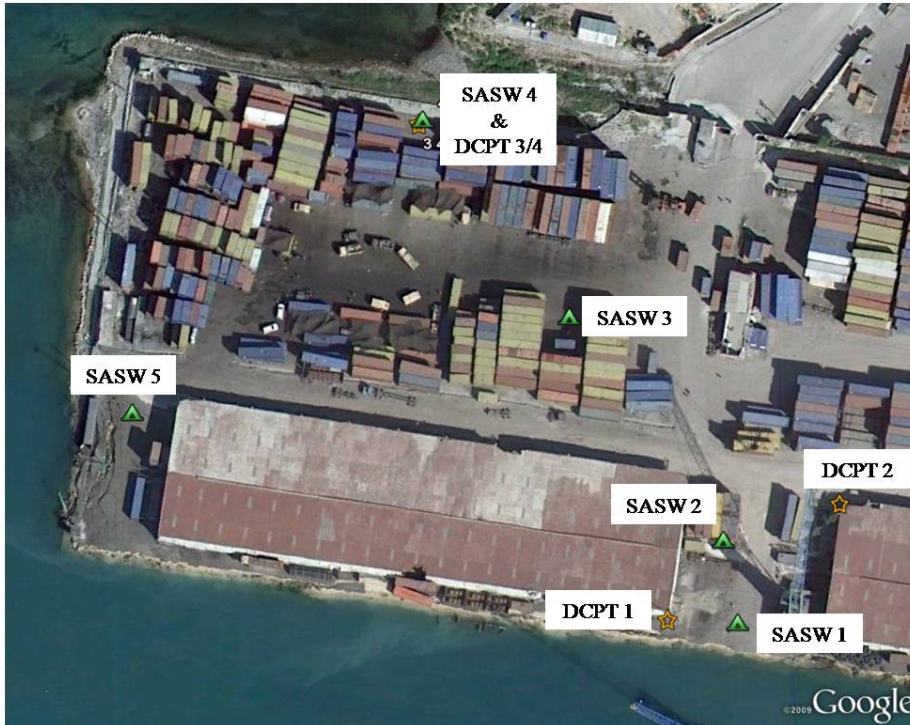
To identify the depth(s) and thickness(es) of the soil layer(s) that liquefied at the port, Spectral Analysis of Surface Waves (SASW) and Dynamic Cone Penetrometer Test (DCPT) tests were performed at various locations. All the tests were conducted on Monday, February 1, 2010. The test locations are shown in Figure 6.26, with the latitude and longitude coordinates for each provided in Tables 6.1 and 6.2 for the SASW and DCPT, respectively. Photos of the test setups are shown in Figures 6.27 and 6.28.

**Figure 6.26** Spectral Analysis of Surface Waves (SASW) and Dynamic Cone Penetrometer Test (DCPT) locations at the port in Port-au-Prince Haiti. Imagery courtesy of Google Earth. (Approximate long. and lat. of center of image: 18°33'27.09"N 72°21'03.51"W)

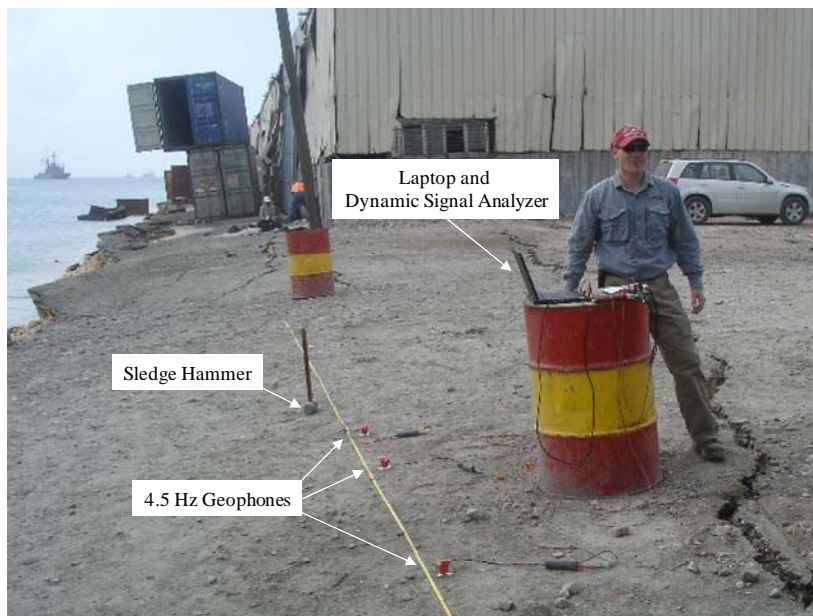
**Figure 6.27** Lightweight, dynamic equipment used to conduct SASW testing in Haiti. This photograph was taken at the location of SASW 1, facing West. (N18.556635°, W -72.350202°).

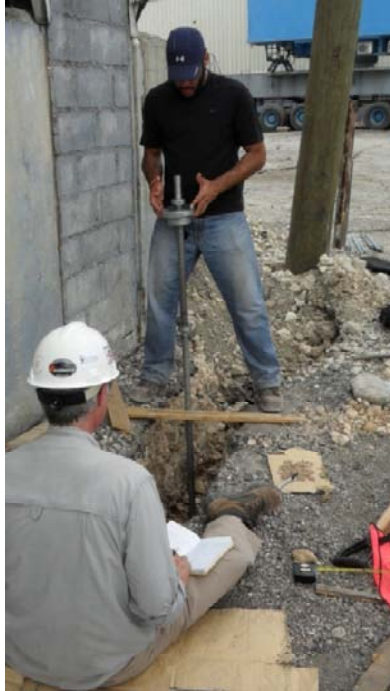
**Figure 6.28** Dynamic Cone Penetrometer Test (DCPT). This photograph was taken at the location of DCPT1, facing East. (N18.556681°, W -72.350398°).
