7.0 LIQUEFACTION AND LATERAL SPREADING

7.3 Coastal Failure west of L'acul

7.4 Coastal Failure near Fouche

7.5 Coastal failure near Grand Goâve.

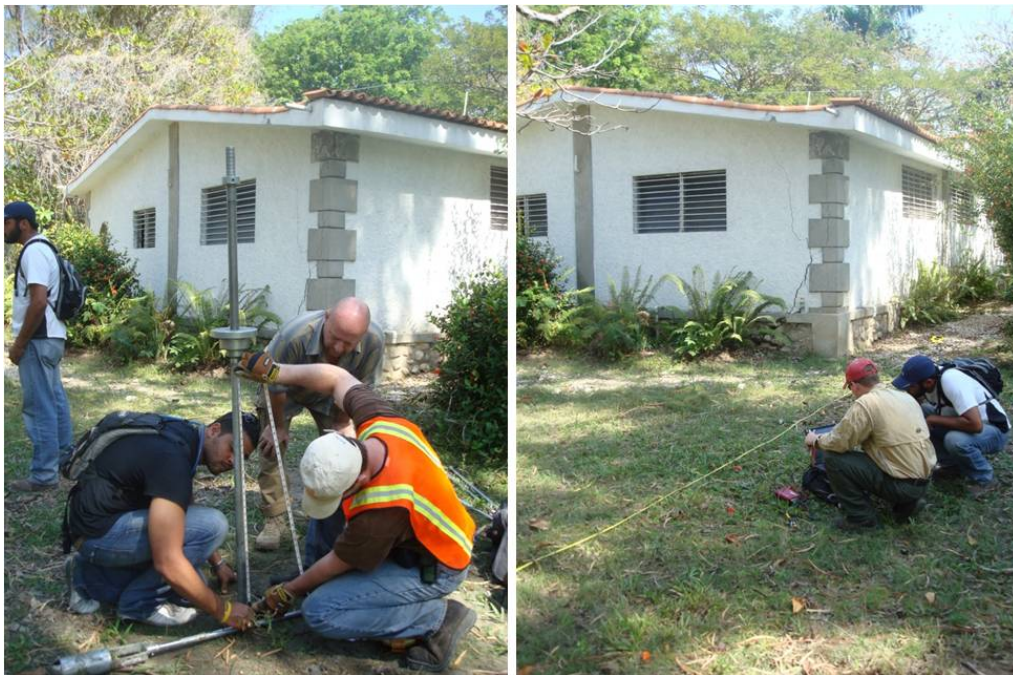
During the reconnaissance efforts, the team conducted one DCPT and one SASW line near several sand blows at the eastern end of the failed zone (Figure 7.8 and Figure 7.14), and one SASW line outside of the failed zone to the east (Figure 7.8). A second DCPT was attempted in this non-failed area but a thick layer of fill precluded augering beyond a few inches. Figure 7.15 presents the results of the DCPT in the failed zone. As illustrated in Figure 7.15, loose sand was encountered at a depth of about 0.7 m (2.5 ft), underlying a low permeability cap layer consisting of clayey sand and silty clay. The sands became medium-dense to dense at a depth of about 1.6 m (5.5 ft). The results from SASW testing are still being processed and will be included in future versions of this report.

Figure 7.14. DCPT and SASW testing performed at coastal failure site near village of Fouche. Approximate image coordinates: $18^{\circ}25'35.12''\text{N}$, $72^{\circ}43'31.61''\text{W}$.

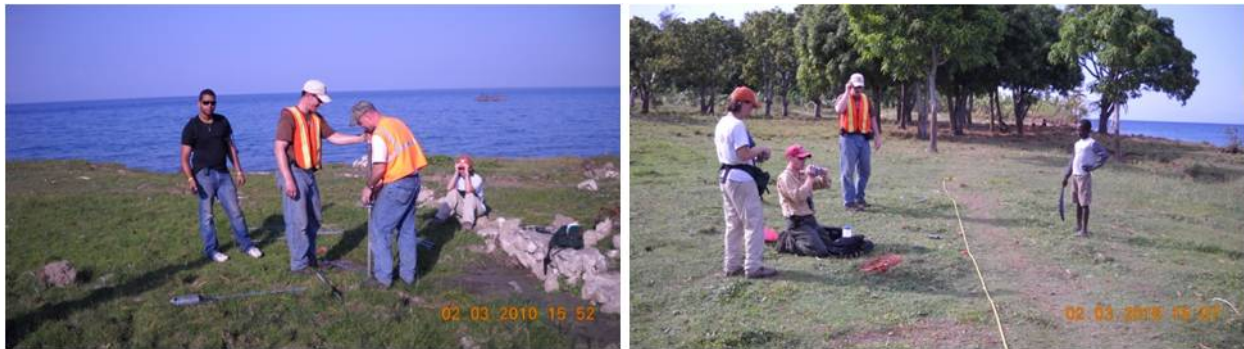
During reconnaissance, the team performed two DCPT and one SASW line near several sand blows at the inward end of the failed zone (Figure 7.16 and Figure 7.22). Figure 7.23 presents the results of the DCPT. As illustrated in Figure 7.23, loose sand to silty sand was encountered at a depth of about 0.8 to 0.9 m (2.6 to 3.0 ft), underlying a low permeability cap layer consisting of clayey silt. The sands became medium-dense to dense at a depth of about 1.1 to 1.6 m (3.6 to 5.3 ft). The results from SASW testing are still being processed and will be included in future versions of this report.

Figure 7.22. DCPT and SASW testing at coastal failure site near village of Grand Goâve. ($18^{\circ}25'53.64''\text{N}$, $72^{\circ}45'37.76''\text{W}$ for left image, $18^{\circ}25'54.16''\text{N}$, $72^{\circ}45'37.85''\text{W}$ for right image)
