Geoengineering and Seismological Aspects of the Iwate Miyagi-Nairiku, Japan Earthquake of June 14, 2008

GEER Web Report 2008 v.1

September 12, 2008

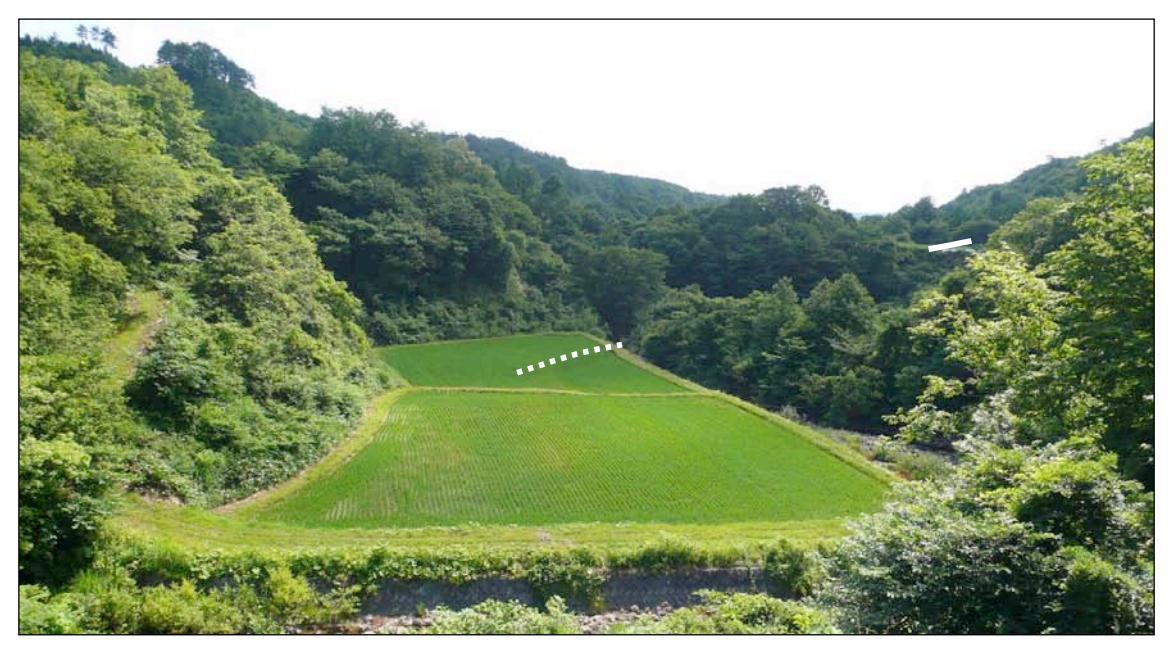
At Mochikoro bridge in Ikawa ku, Oshuu City (point 1), a surface fault trace appeared in a rice field following the earthquake (see Figure 3.3 and Figure 3.4). At point A (yellow mark) in Figure 3.3 the asphalt pavement was pushed up against the north abutment of the Mochikoro bridge and may be a compressional feature of the fault displacement. Latitude and longitude values for the four sites

Figure 3.4. Looking east from the south end of the bridge at Surface fault trace at Oshuu City, Ikawa Ku, Mochikoro bridge. (Photo by Jörgen Johansson.)

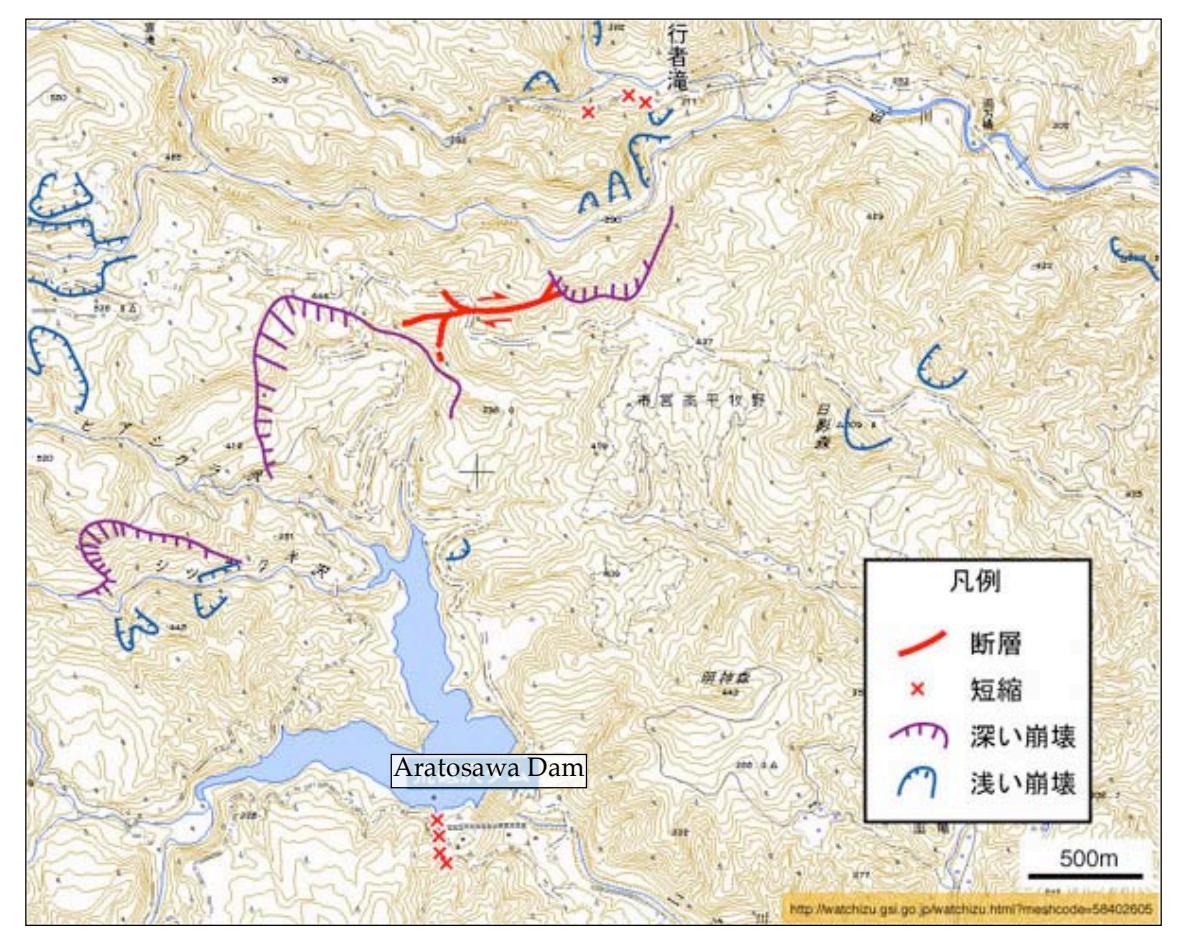
At Aratosawa dam (point 9) a strike slip fault trace was discovered very close to big landslide that is described in section ??. According to the Active Fault Research Center this is a fault induced surface feature, which can not be explained by landsliding. Thus if this was a fault, then how it may be related to triggering the large landslide needs to be clarified. Just south of the dam office, on the road to the dam office, there are 3 locations with road damage (see Figure 3.9) due to 0.2m east-west compression and 0.3-0.4m vertical displacement (see Figure 3.10). As seen in Figure 3.10 the deformations are quite large, but a concrete ditch next to the road did not crack at all. We could not find any crack in the surrounding ground and the retaining walls above the road (see Figure 3.9) suffered no damage, which is quite mysterious. On the other hand, just north of this location (see Figure 3.11) a concrete retaining wall suffered compression and shearing. The close-up in Figure 3.12 shows how the upper part of the retaining wall moved outward.

Figure 3.8. Map with landslide escarpment and surface fault (after [2]).

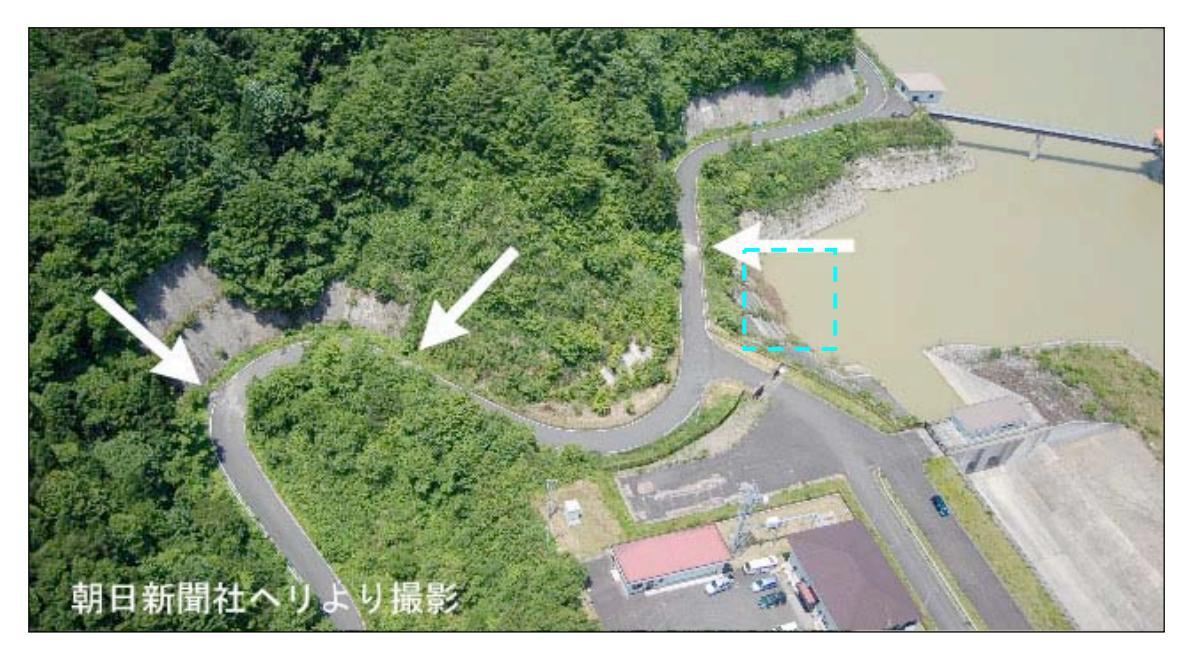
Figure 3.9. Aerial photo of 3 road cracks. The right most road damage is shown in Figure 3.10. Close ups of the area in blue rectangle are shown in Figure 3.11 and Figure 3.12.

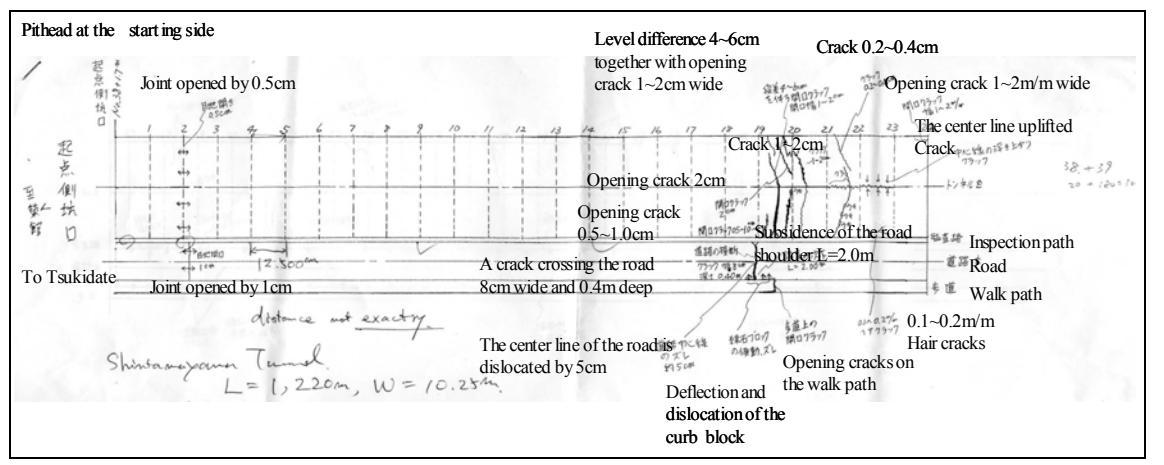
The Shintamayama tunnel is located some 20km to the east of Ichinoseki City, on prefectural route 42, just to the south of the Kurikoma dam (see Figure 3.13). The 1220 m long 10.25m wide, and 4.7m high tunnel consisted of 97 12.5m long segments (see Figure 3.15). It sustained cracks some 20 mm wide at 250m, 1-3 mm at 400m, and cross section compression at 600m (segment 20, 32, 48) from the East mouth respectively, shown by red marks in Figure 3.13 and in detail in Figure 3.15. A detail of the cracks at segement 20 and 21 are shown in Figure 3.14. There most of the cracks were extensional. Blue arrows show that the eastern segment moved down with respect to the western segment, while red ones show the opposite. Numbers in parentheses show these relative displacements in mm. The 50 meter portion closest to the east mouth was extended with openings 5mm up to 2cm wide between the segments (see Figure 3.15.)

Figure 3.15a) Crack map segement 1-24 of shintamayama tunnel. Crack map provided by local reconstruction engineers

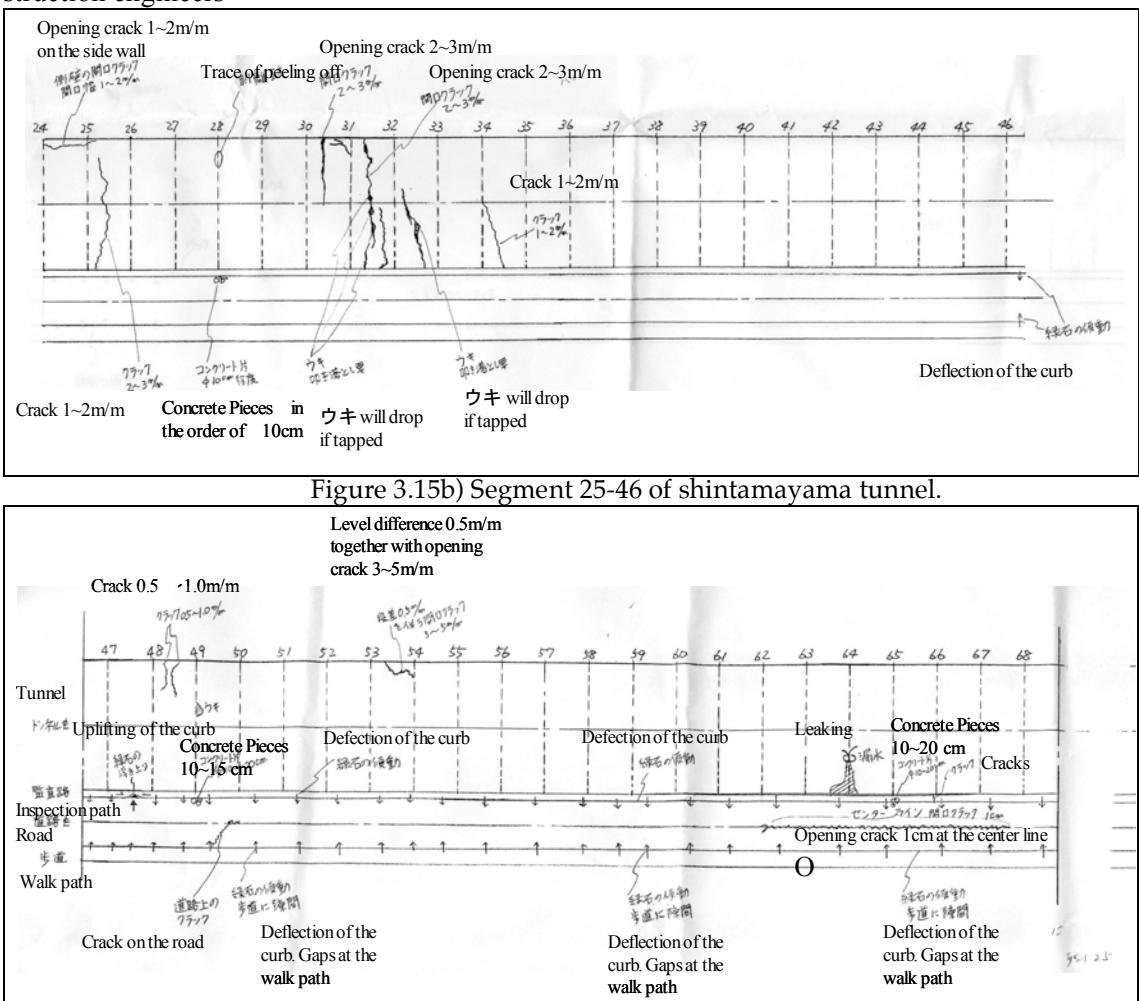
Figure 3.15c) Segment 47-68 of shintamayama tunnel.

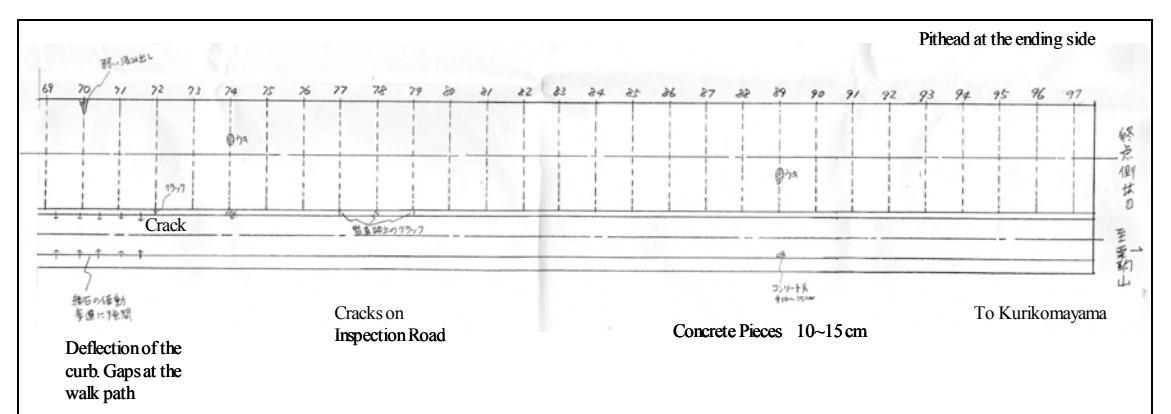
Figure 3.15d) Segment 69-97 of shintamayama tunnel.

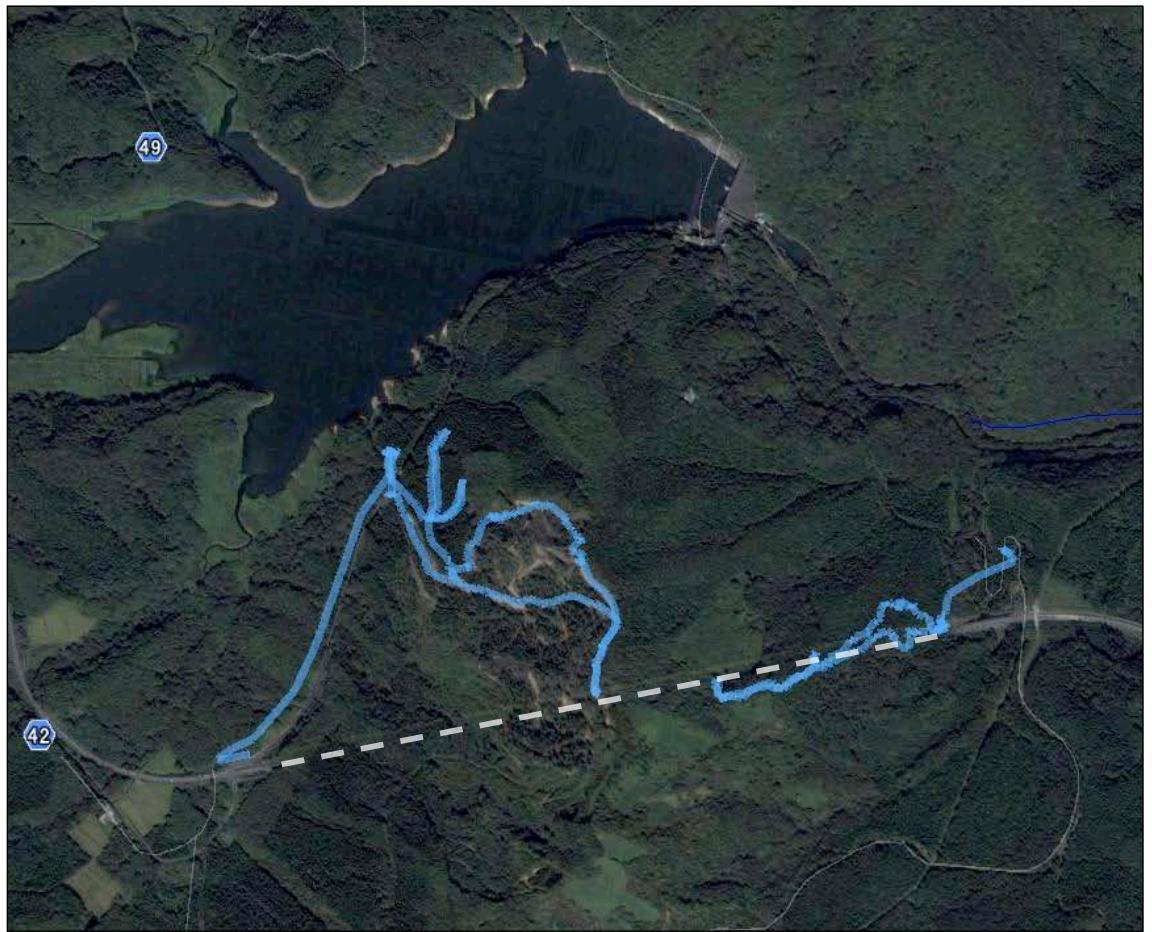
We also went on top of the hill , through which the tunnel crosses, however we found no cracks or other signs of major landsliding and/or surface faulting. (Figure 3.16 shows the GPS tracks.) There was only some shallow surface failure and stones that had jumped out of their locations. As of this writing it seems that the induced damage is more likely due to a landslide as indicated with blue dashed line in Figure 3.13, than related to the a possible surface fault. Therefore if the cause is a deep-seated landslide, long-term monitoring will be a must for rational repairs.

Figure 3.16. Google Earth view of Shintamayama tunnel (white dashed line) with GPS tracks in light blue. We found neither major slides nor any fault offsets.

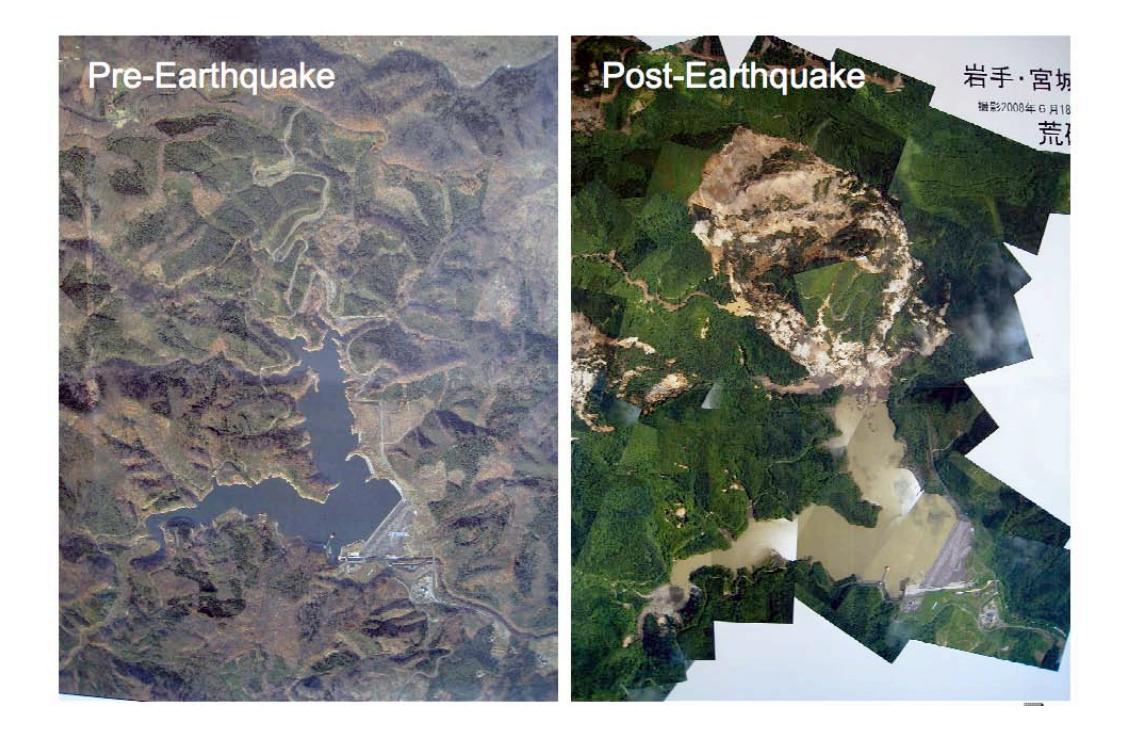
Aratozawa Dam, Miyagi Prefecture: The volume of the landslide entering the Aratozawa reservoir is believed to be about 1.5 million cubic meters, entering approximately 500 meters beyond the pre-event shoreline of the north arm of the reservoir. The total volume of the slide is estimated at 50 million cubic meters (Figure 4.2). This slide is comparable to the giant landslide that occurred near Yamakoshi Village in the Uonuma Hills of Niigata during the 2004 Niigata Prefecture Chuetsu Earthquake (Refs. ES 2006, 6ICGCHE). The Aratozawa landslide was a deep translational slide in steep terrain with a large runout of disintegrating material at the toe. The landslide was composed of weakly cemented weathered volcanic ash, and volcanoclastic material. The height of the headscarp varies from 50-150 meters in height. The landslide extends about 1.2 kilometers in length, and is on average 800 meters wide. The depth is estimated to average 50 meters. More detail regarding the Aratozawa Dam, landslide and seiche are provided below.

Figure 4.2: Aratozawa dam and reservoir prior to, and after, the earthquake (Site S27, N38.8837° E140.856°, 6/27/08 17:00).

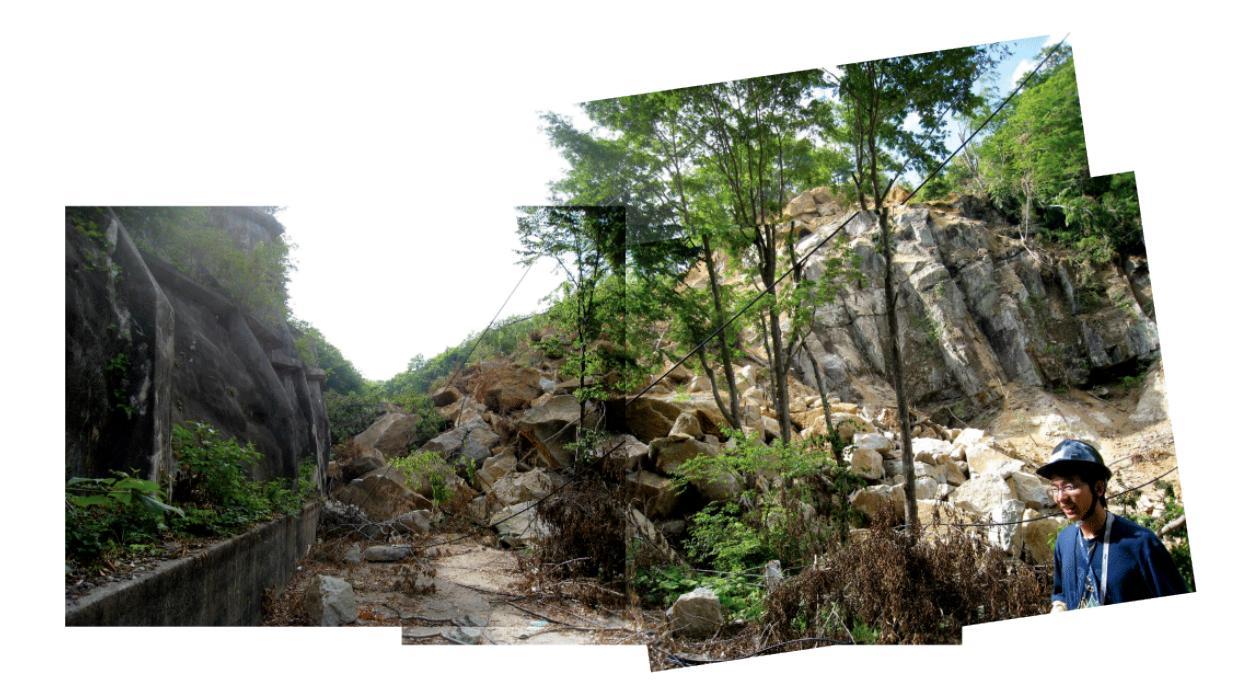
Near Mt. Kurikoma at the Komanoyu Onsen near the head of Route 457 in Kurihara, Miyagi Prefecture, along the border of Iwate Prefecture, several large rock avalanches were loosened by the earthquake. One of these landslides struck the Onsen killing one of the owners and several guests. The reconnaissance team was able to access the downslope end of the rock avalanche that was composed of large blocks up to house size that crossed route 457 (Figure 4.3). In Iwate Prefecture, failure of a rock mass collapsed a large steel frame bridge on route 342 (Figure 5.8). Rockfall was typically associated with extremely steep terrain and cliffs in excess of 50° (Figure 4.4).

Figure 4.3: Rock avalanches on Route 42 west of Numano-Mori Mountain.

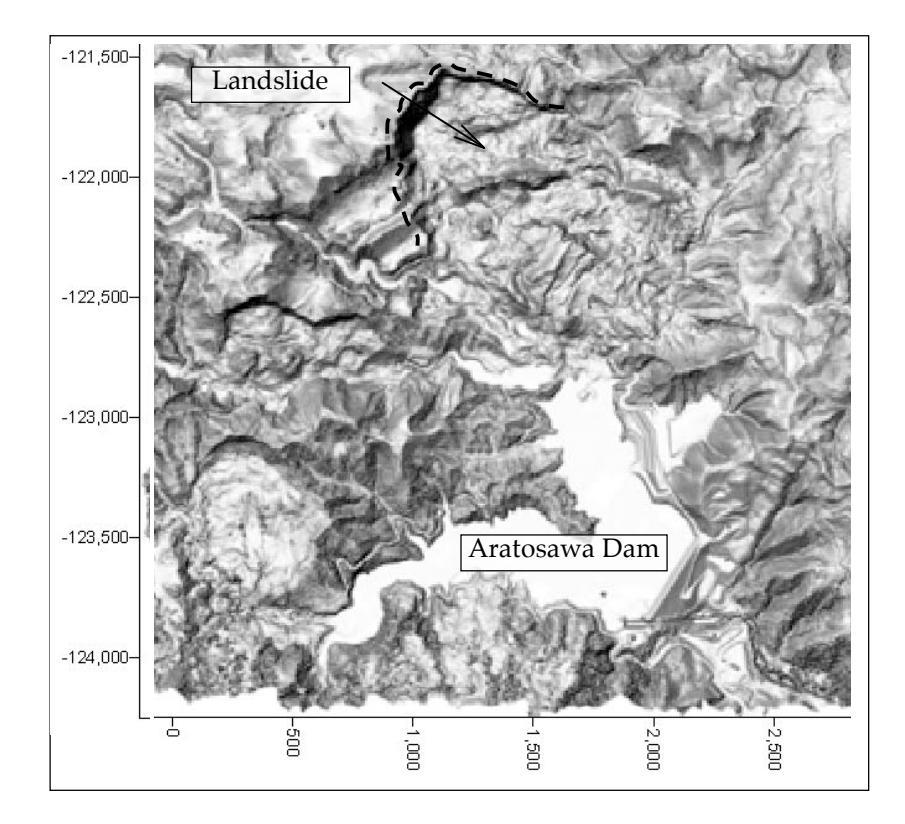
Figure 4.10. Laser scan of Aratosawa dam and landslide area. (Aero Asahi Co. provided the digital elevation model). Figure .10 shows a laser scan of the Aratosawa dam and landslide area provided by the Aero Asahi Co. The coordinates are based on the JGD10 Grid. They numbers are in meters. The y-axis numbers have a -1 cut of from the left side, i.e. 23,500 should be -123,500 etc.

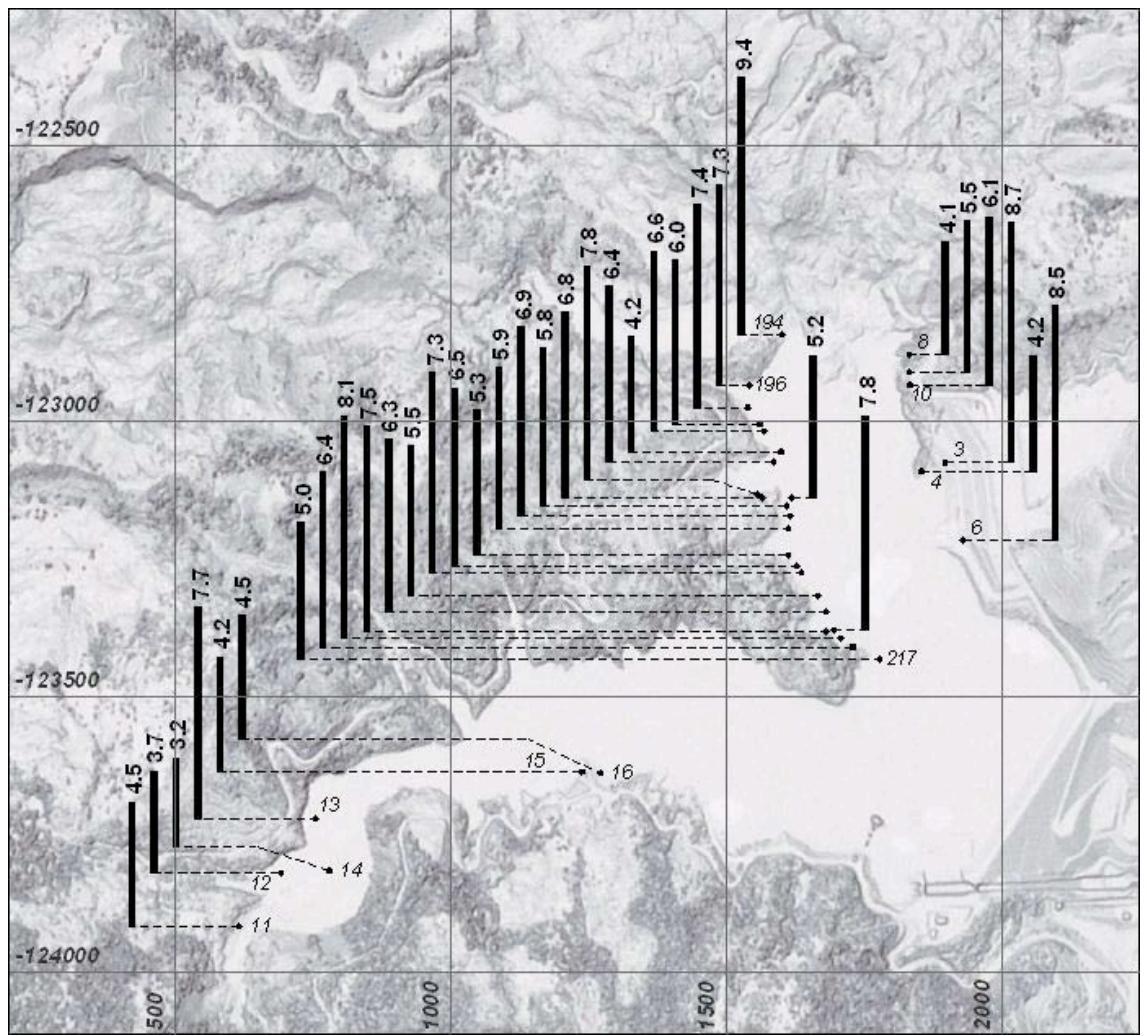
The seiche heights (from Table 4.3) were plotted in Figure 4.13. We can see that on the right side in the Figure 4.13 (East side) the elevation increases from 4.1 meters to 8.7. On the Western side there is a zig-zag patterns of heights, whether this may be due to the topographical features of the lake border and/or due to error in our measurements. It is not always easy to find the highest high-water-mark in the field. At the far end, points 11,12, 14 in Figure 4.13, heights are lower, likely since here the seiche wave can can spread and run up long distances. However at point 13 which is close to a fairly steep location the seiche height reached 7.7m.

Figure 4.13. Seiche heights with respect to the pre-event lake elevation measured in the field on July 13 and July 25.

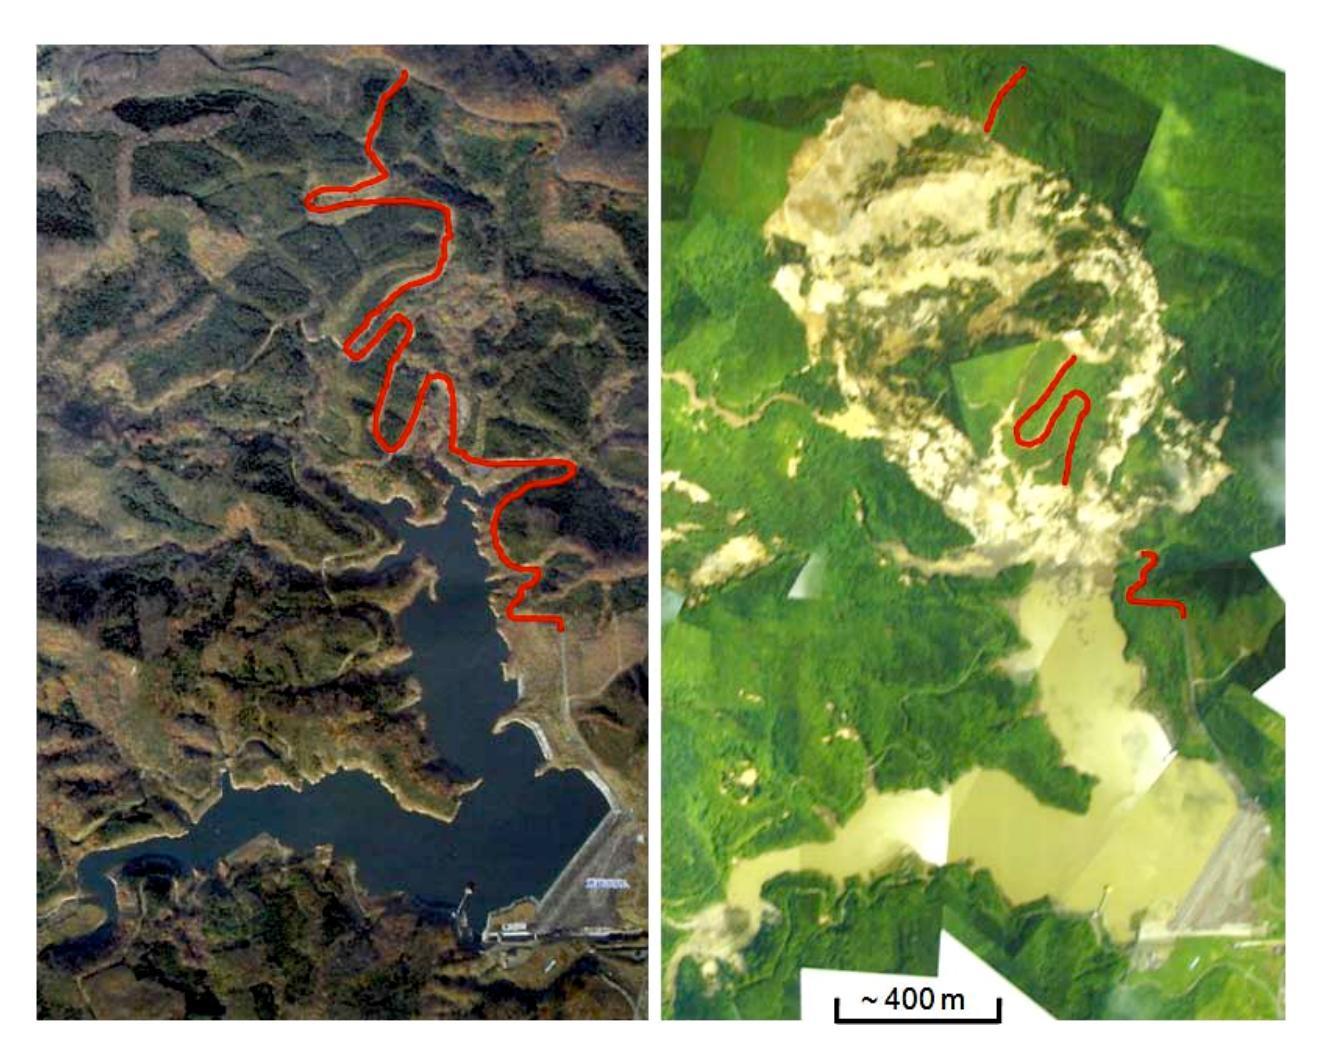
Another spectacular roadway failure was caused by a massive landslide above Aratozawa Dam. The volume of the landslide was estimated to be 50 million cubic meters, of which approximately 1.5 million cubic meters slid into Aratozawa Reservoir. The landslide carried a section of road more than 3.5 km-long with it. Figure 5.11 (Site S27) shows aerial photographs of the reservoir before (left) and after (right) the earthquake. The red lines in the photographs highlight the section of road that extended from the reservoir up onto the mountain prior to the earthquake and subsequent landslide. As can be seen, much of the road was completely swept away and destroyed by the landslide. However, one set of switch-backs along the road remained relatively intact, despite being displaced approximately 300 m to the southeast. Figure 5.12 (Site

Figure 5.11: Aerial photographs of Aratozawa Dam before (left) and after (right) the earthquake. The massive landslide (estimated at 50 million cubic meters) seen in the post earthquake photo destroyed a section of road more than 3.5-km long. The section of the road affected by the landslide is highlighted in red in both images. Notice the set of switch-backs in the post earthquake image that was left relatively intact despite being displaced approximately 300 m to the southeast by the landslide (Site S27, N38.8837° E140.856°, 6/27/08 17:00).

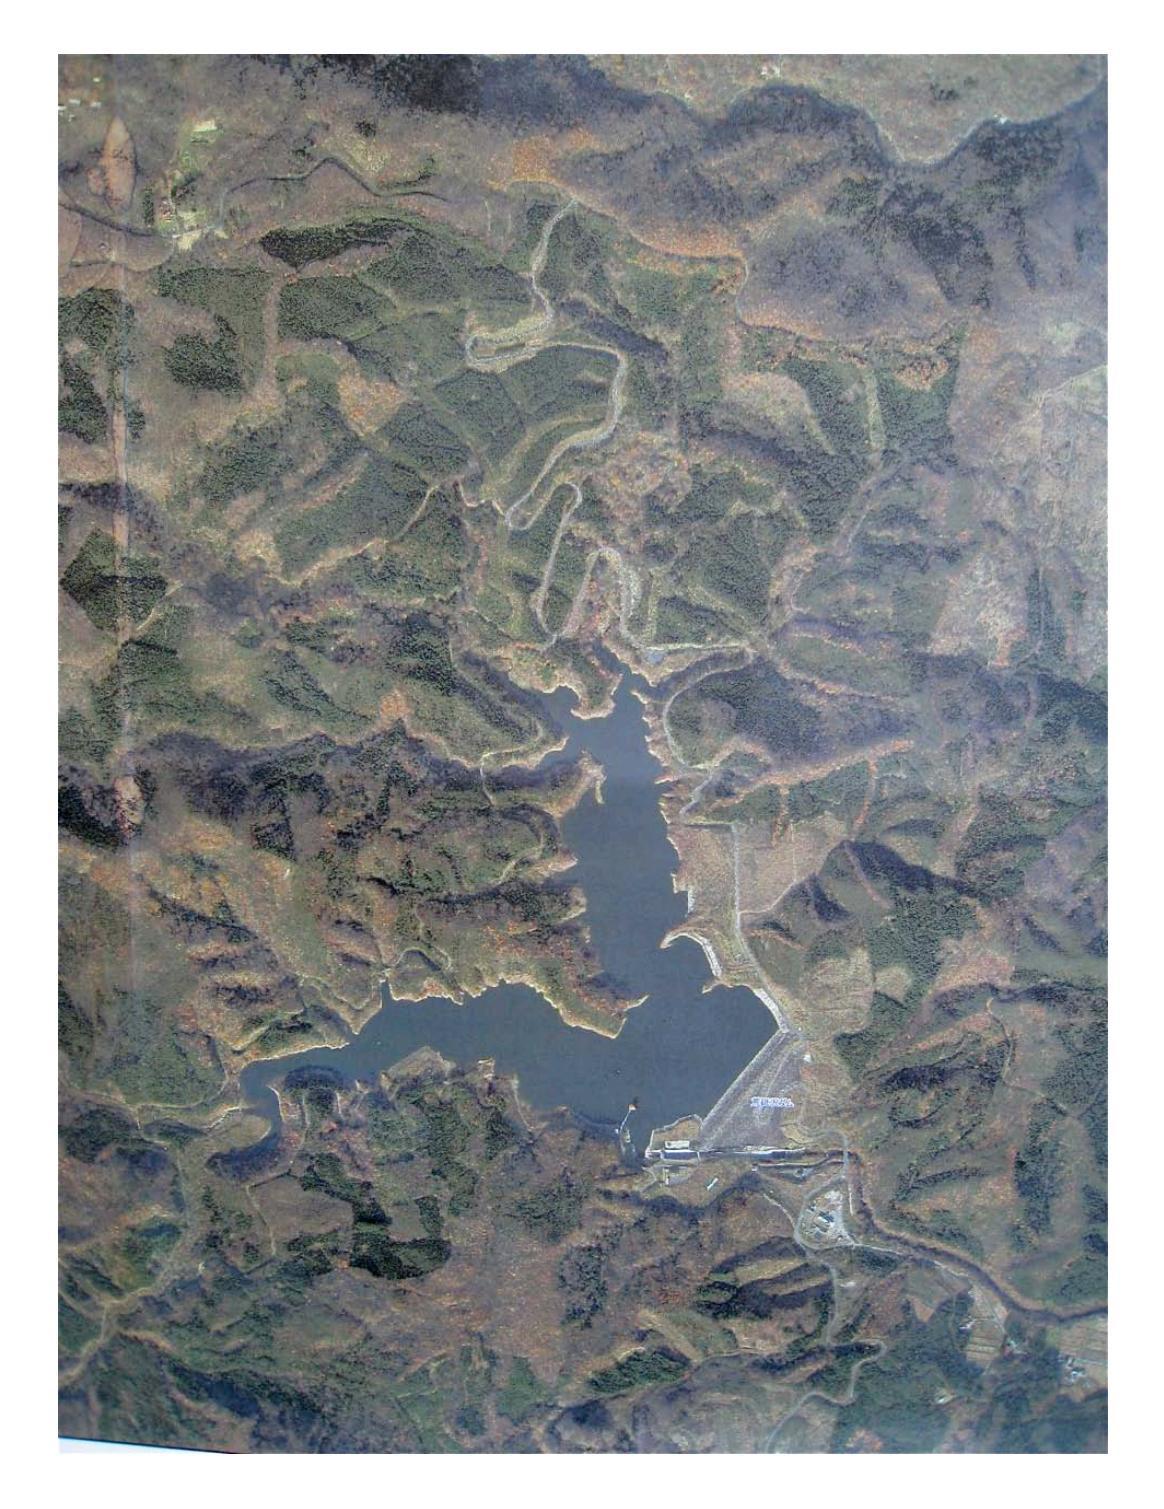
Figure 6.1 Aerial photo of the Aratozawa dam and reservoir prior to the earthquake. Image courtey of the Aratozawa dam operators, Miyagi Prefecture.

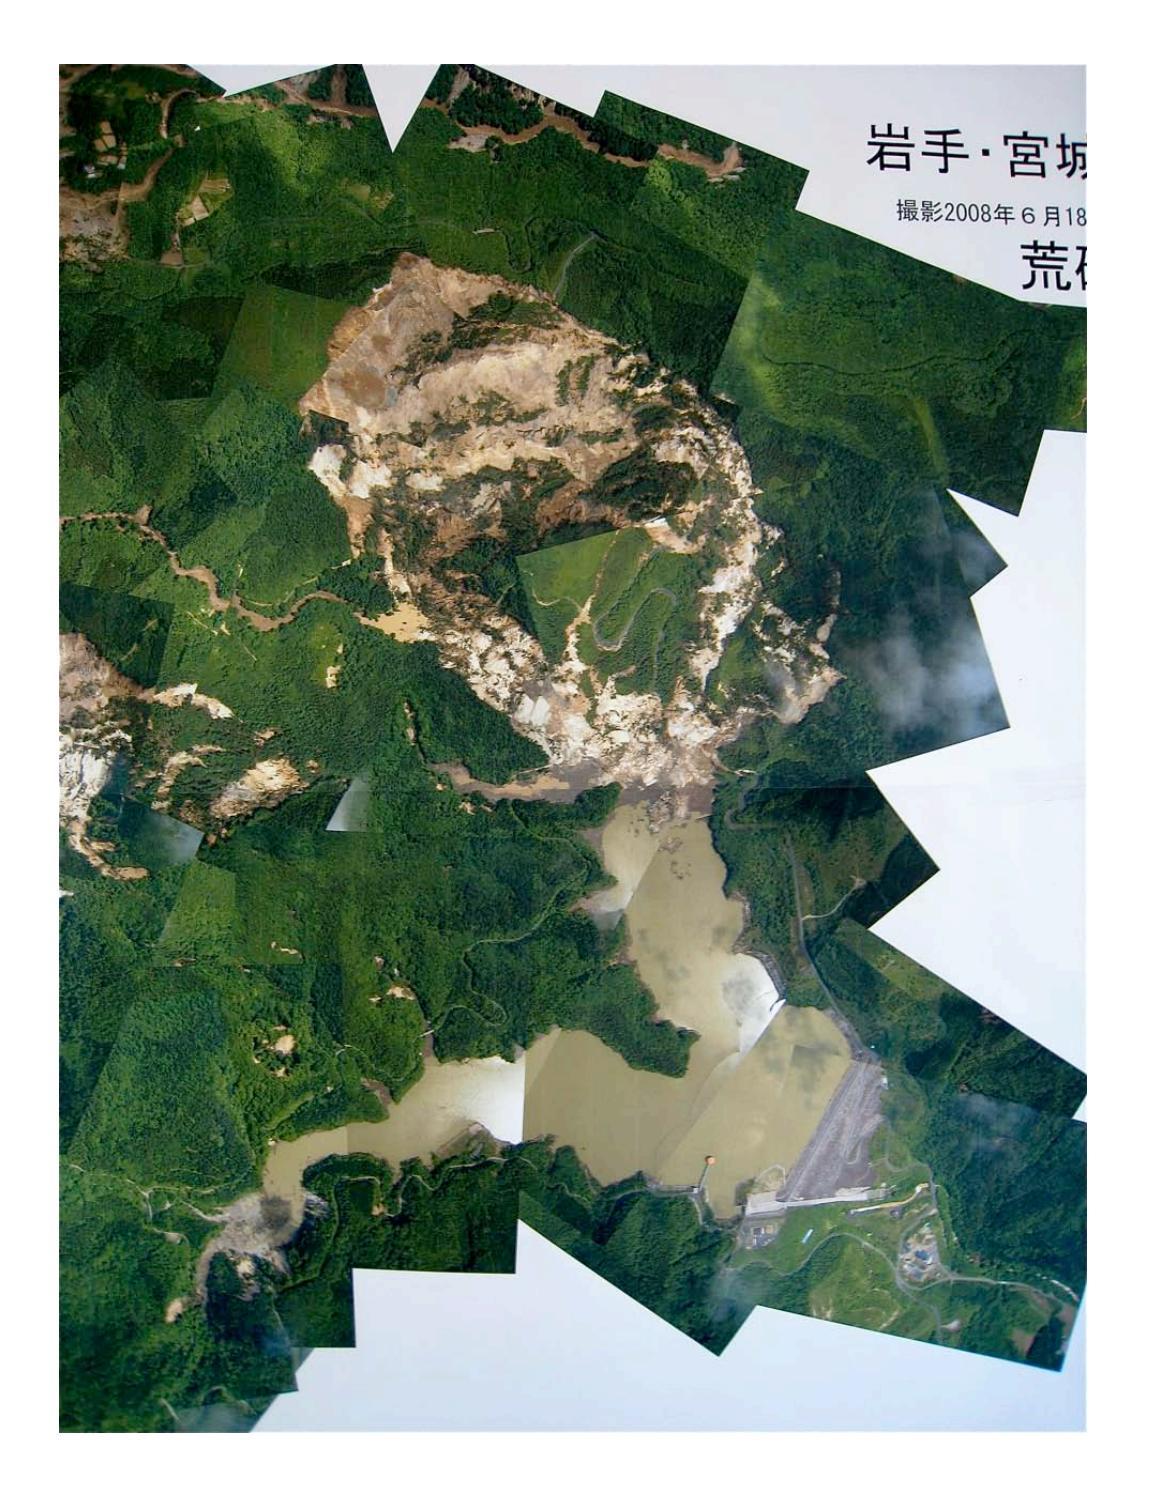
The most significant case history of earth dam deformation occurred at the Aratozawa (Indigo Dye Lake) Dam in Miyagi Prefecture (Site 27; N38.8837°, E140.856°). Aratozawa Dam is a large earth dam that was slightly damaged during the earthquake. It is of interest for several reasons: (1) It is the largest earth dam in close proximity to the earthquake epicenter, (2) a massive landslide above the dam partially slid into the reservoir and created a large wave that overtopped the spillway, (3) a 3-level downhole ground motion array recorded the earthquake motions at the dam, and (4) some minor cracking, and settlements ranging from 20 - 40 cm, were observed along the crest of the dam following the earthquake.

The effect of the differential settlements of the rockfill shell and core were to depress the crest and cause rotation of monuments inward toward the center line of the dam. The crest road is a bordered by granite columns that are held in place at their base by a small rebar peg and connected to one another by a chain. Several of these monuments collapsed in irregular directions. The remaining standing monuments on both the upstream and downstream side were inclined toward the center of the crest due to the settlement of the core. These monuments were vertical prior to the earthquake. Another indication of core settlement is an observation pipe that emerged from a manhole near the center of the dam crest. This pipe is for estimating normal (static) crest and internal settlements of the dam. At the time of the GEER observation, the pipe appears to have moved upwards relative to the dam crest approximately 27 cm. We believe that the pipe may be partially dragged down with the dynamically settling crest approximately 13 cm and otherwise decoupled from the remaining settlement of the crest. This allowed it to emerge from a manhole cover. The sensor hole and pipe used to monitor settlement is in 5 m segments and extends 75 m to the bottom of the dam. A tunnel beneath the core of the dam was dry prior to the earthquake and is now leaking at approximately 1 liter per minute, indicating possible minor cracking of the core.

Figure 6.2 Aerial photo collage of the Aratozawa dam and reservoir on June 18, 2008, four days after the earthquake. Image courtey of the Aratozawa dam operators, Miyagi Prefecture.

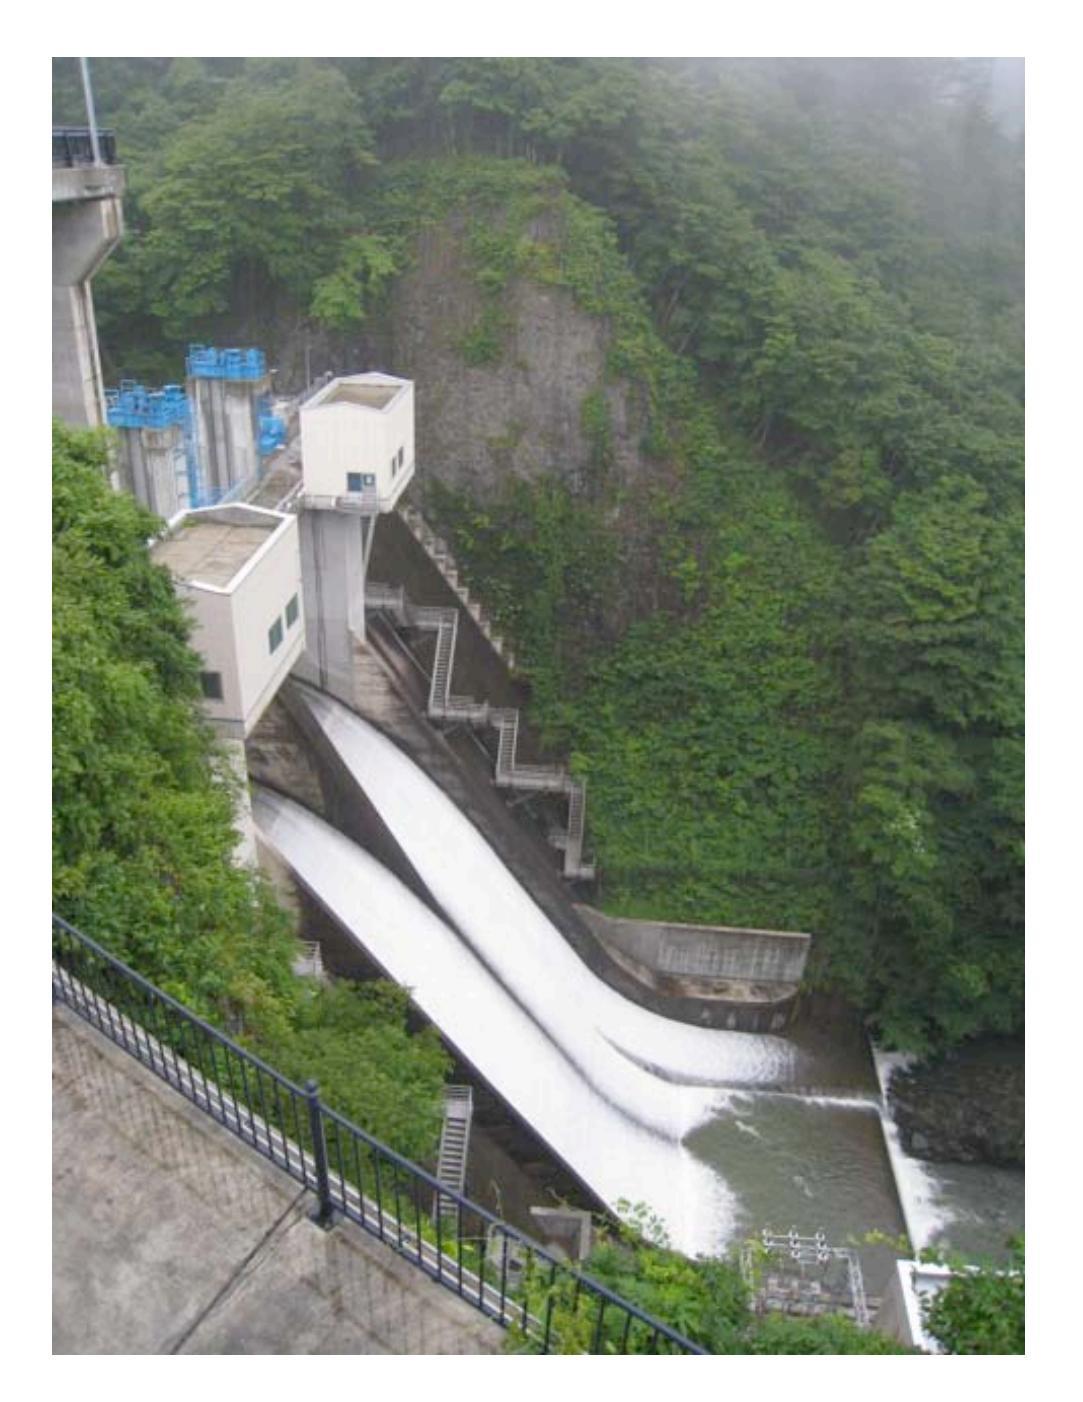
E140.918°). There was no damage to this dam, however a large landslide entered the reservoir at the north side of the dam. The reservoir water seiched but did not cross the spillway. Several large landslides on the west end of the reservoir raised concern about other landslides entering the waters, and the reservoir is being emptied as a precaution.

Figure 6.9 The undamaged spillway of the concrete Kurikama dam, Miyagi Prefecture. Water was being released from the reservoir to drain it for inspection.

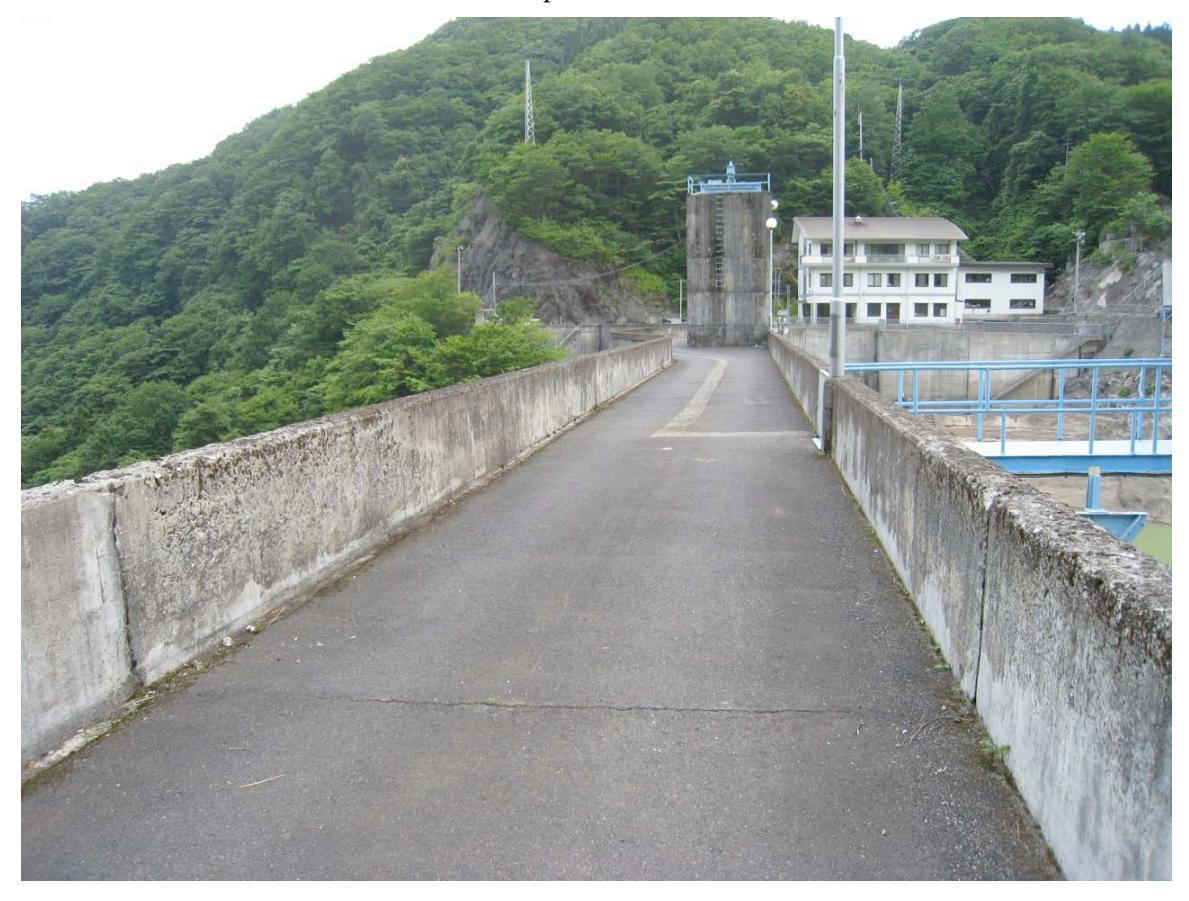
Figure 6.10 The undamaged crest of the concrete Kurikama dam, Miyagi Prefecture.

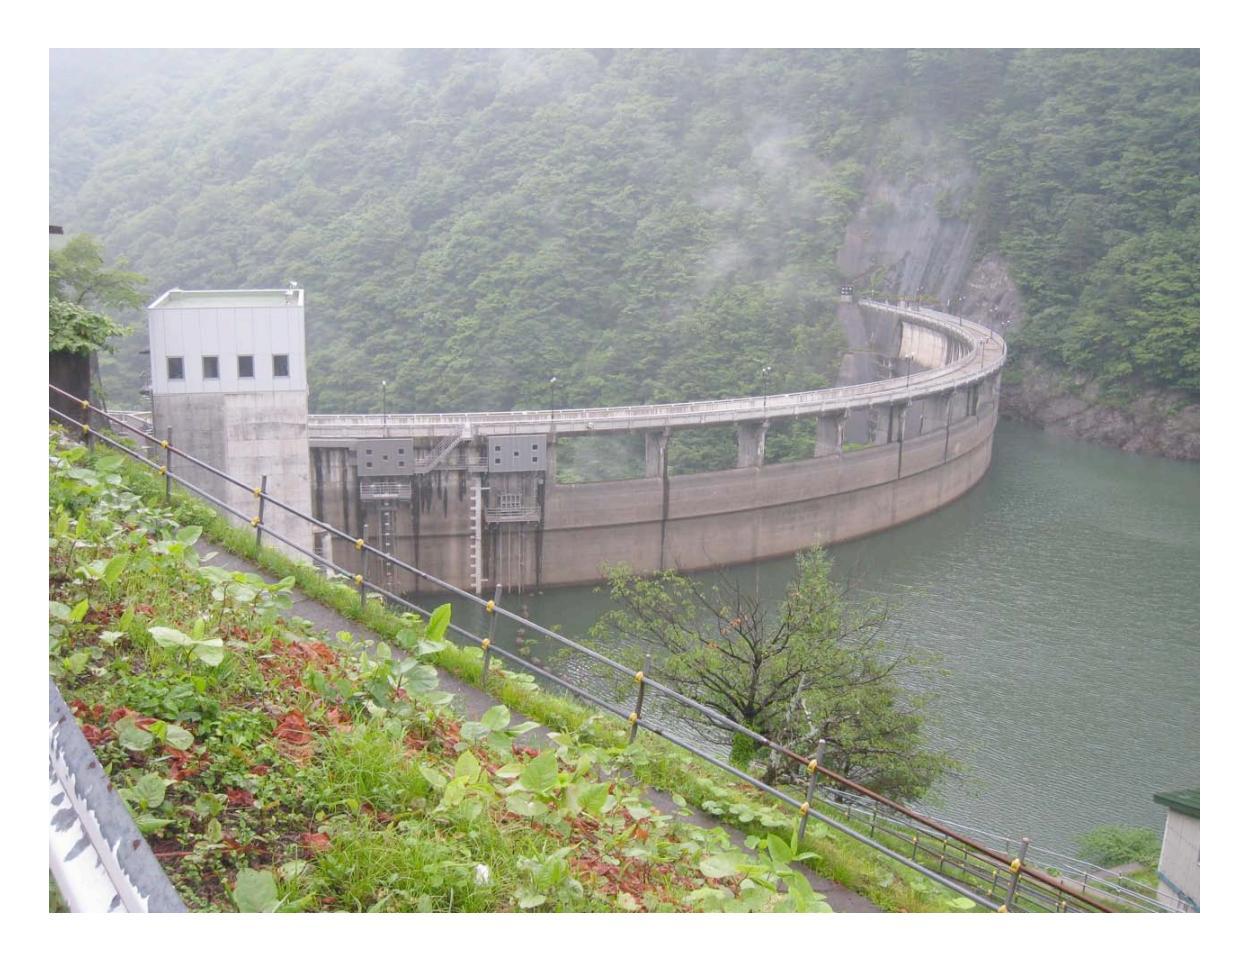
Naruko Concrete Dam is located in northwestern Miyagi Prefecture at Site 57 (N38.75377, E140.70644) and had no apparent damage. This dam was not impacted by landslides.

Figure 6.12 The undamaged Naruko dam, Miyagi Prefecture. No landslides were observed on the margins of this dam.
