Geoengineering and Seismological Aspects of the Iwate Miyagi-Nairiku, Japan Earthquake of June 14, 2008

GEER Web Report 2008 v.1

September 12, 2008

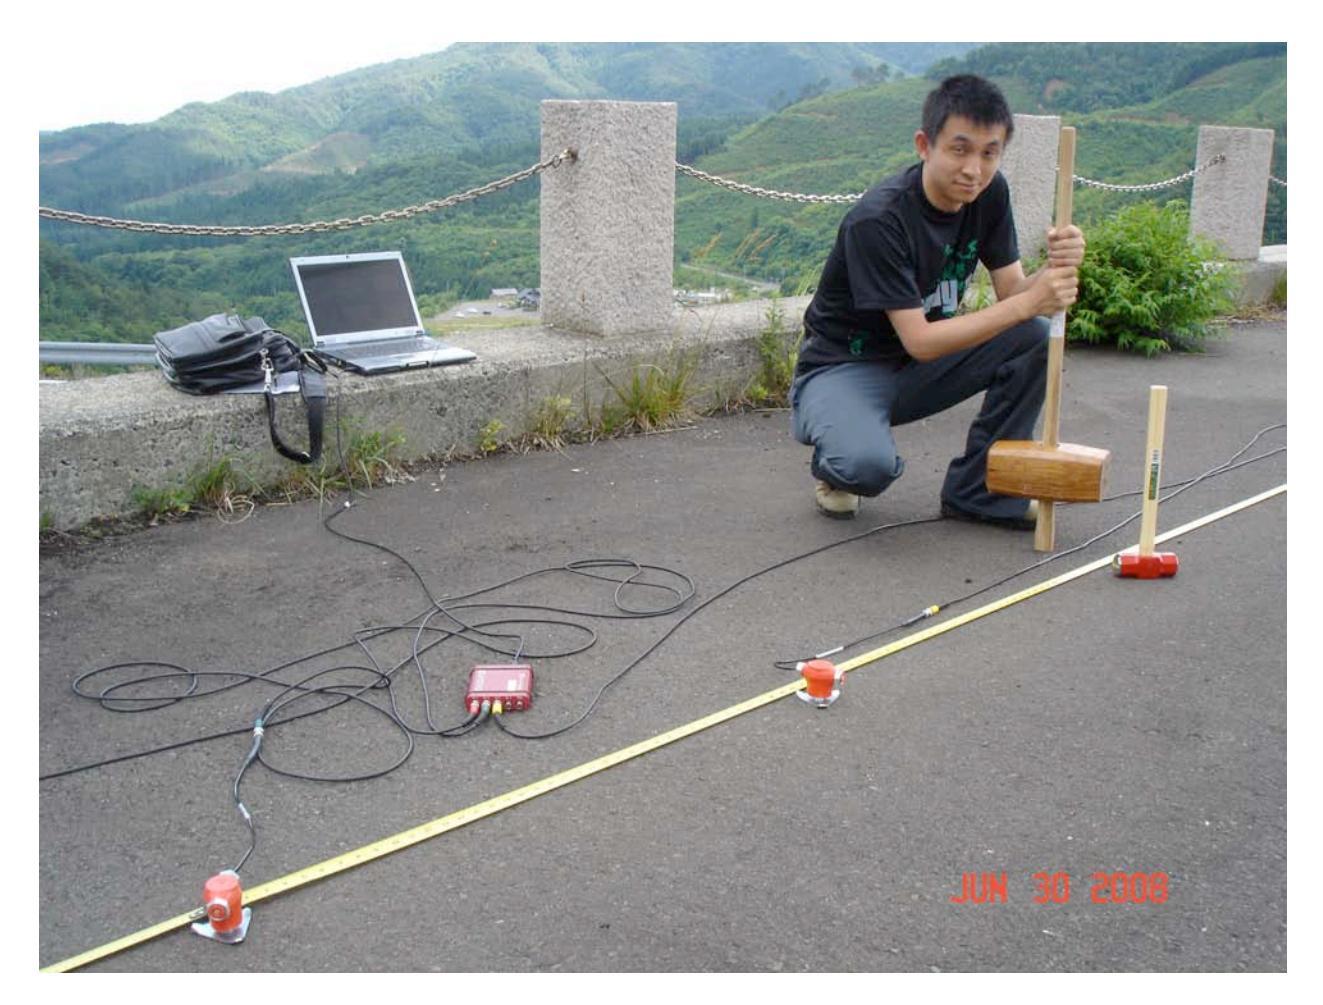
The SASW field measurements were made using three 4.5 Hz geophones, a 'pocket-portable' dynamic signal analyzer, and two hammers purchased in Japan (Fig. 7.1 – Site 27). The geophones are model GSC-11D's manufactured by Geo Space Technologies, while the analyzer is a 'pocket portable' Quattro system manufactured by Data Physics Corporation. The Quattro is a USB powered, 4-input channel, 2-output channel dynamic signal analyzer with 205 kHz simultaneous sampling rate, 24 bit ADC, 110 dB dynamic range, and 100 dB anti-alias filters. It is controlled with a flexible, windows-based software package (Data Physics Signal Calc) that has measurement capabilities in both the time and frequency domain. The compact, highly portable nature of this setup is ideal for earthquake reconnaissance efforts where shallow V_s profiles may be desired.

Figure 7.1: Compact, highly portable equipment owned by the University of Arkansas was used to conduct shallow SASW tests at three locations along the crest of Aratozawa Dam. The field measurements were made using three 4.5 Hz geophones, a 'pocket-portable' dynamic signal analyzer, and two hammers purchased in Japan. The V_s profiles generated from these measurements extended to a depth of approximately 7 m. The field measurements took less than 30 minutes per location (Site S27, N38.8837°)

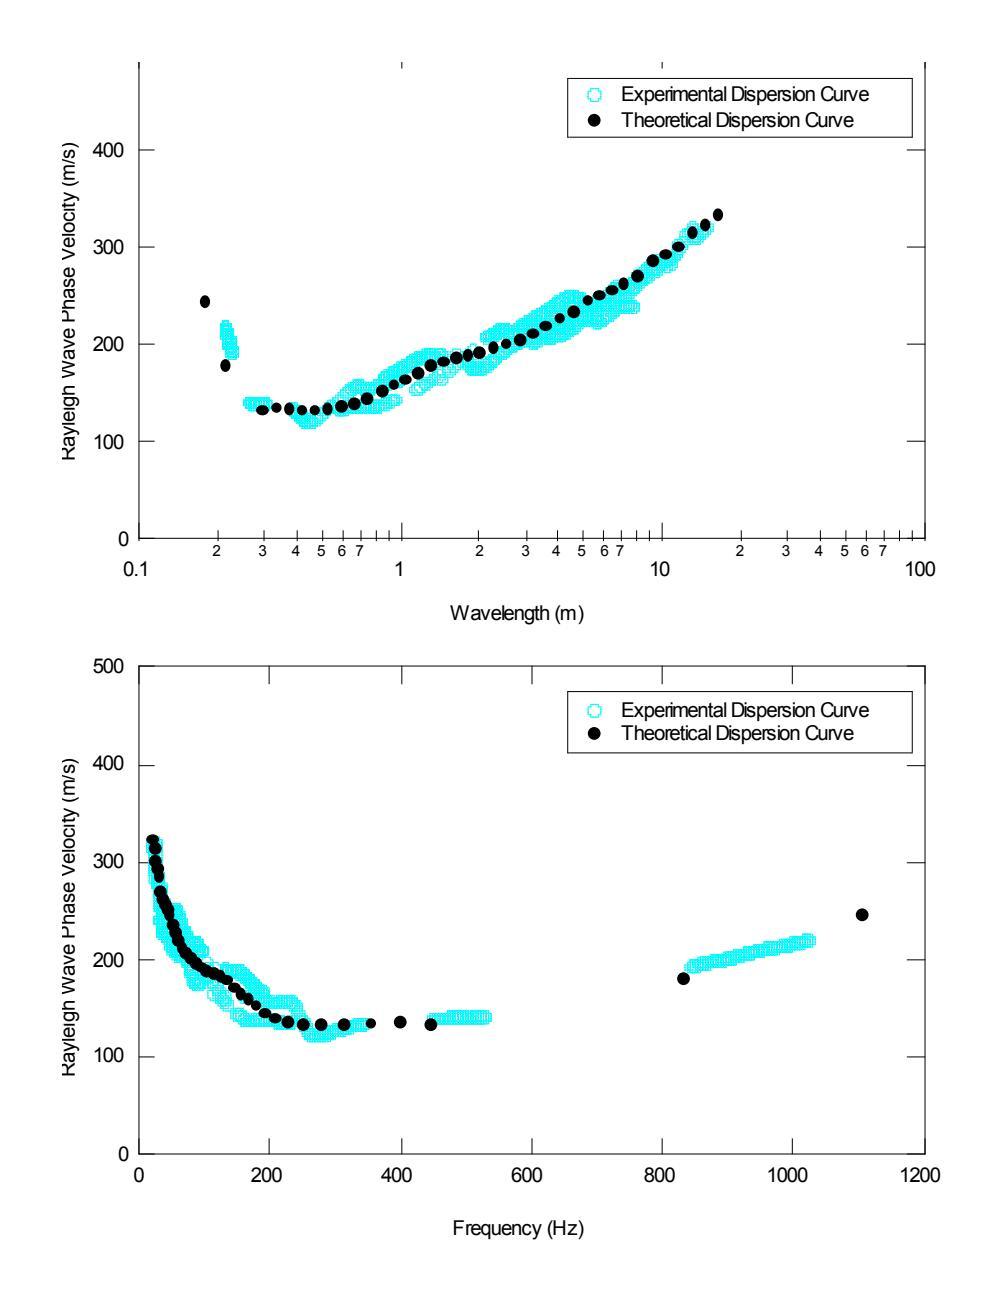
The experimental dispersion curve data obtained at Site 1 are provided in Fig. 7.2, both in terms of wavelength and frequency. At this site, experimental wavelengths between approximately 0.2 - 14 m were resolved at frequencies between approximately 20 - 1000 Hz. The theoretical dispersion curve that was fit to the experimental data is also shown in Fig. 7.2. The theoretical dispersion curve was obtained through iterative forward modeling using the '3D solution' in WinSASW (Joh 1996), which accounts for fundamental and higher-mode surfaces waves as well as reflected body waves. The dispersion trend shows a velocity inversion at short wavelengths (high frequencies) followed by a normally dispersive trend of increasing phase velocity with increasing wavelength (decreasing frequency). The velocity inversion is caused by a stiff asphalt layer at the ground surface, which is underlain by relatively soft compacted fill.

Figure 7.2: Experimental and theoretical dispersion curves for location SASW 1 on the crest of Aratozawa Dam.

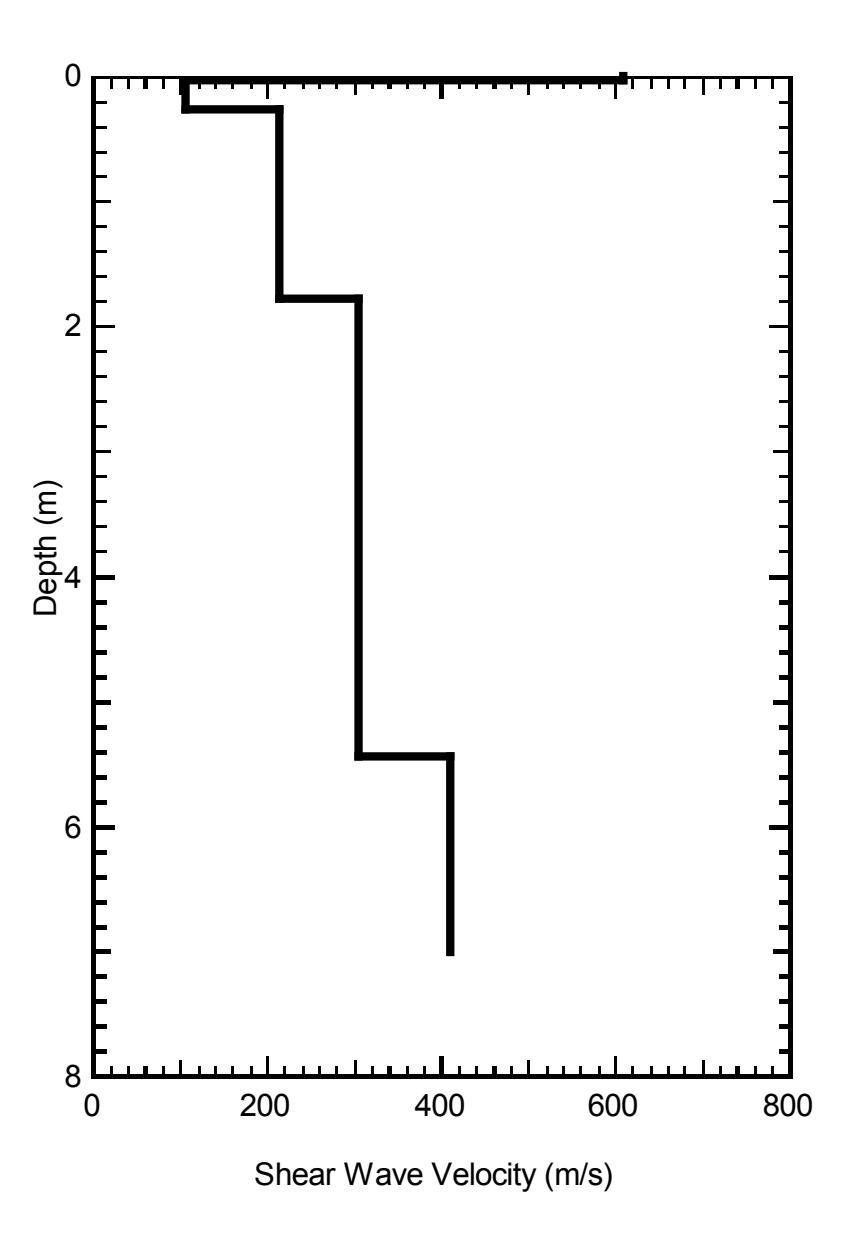
The V_s profile corresponding to the final theoretical dispersion curve for Site 1 is shown in Fig. 7.3. The properties assumed for each layer in the profile through forward modeling are provided in Table 7.2. The maximum depth of the V_s profile was limited to approximately $\frac{1}{2}$ of the maximum measured wavelength. It can be seen that the fill is quite soft (less than approximately 200 m/s) down to a depth just less than 2 m. In particular, a very soft layer (just over 100 m/s) more than 20 cm thick exists just below the asphalt. These soft layers likely played a role

in the crest settlement observed at the dam. It should be noted that soil liquefaction in these shallow layers did not occur as the water level in the reservoir at the time of the earthquake was well below the crest.

Figure 7.3: Shear wave velocity profile for location SASW 1 on the crest of Aratozawa Dam.

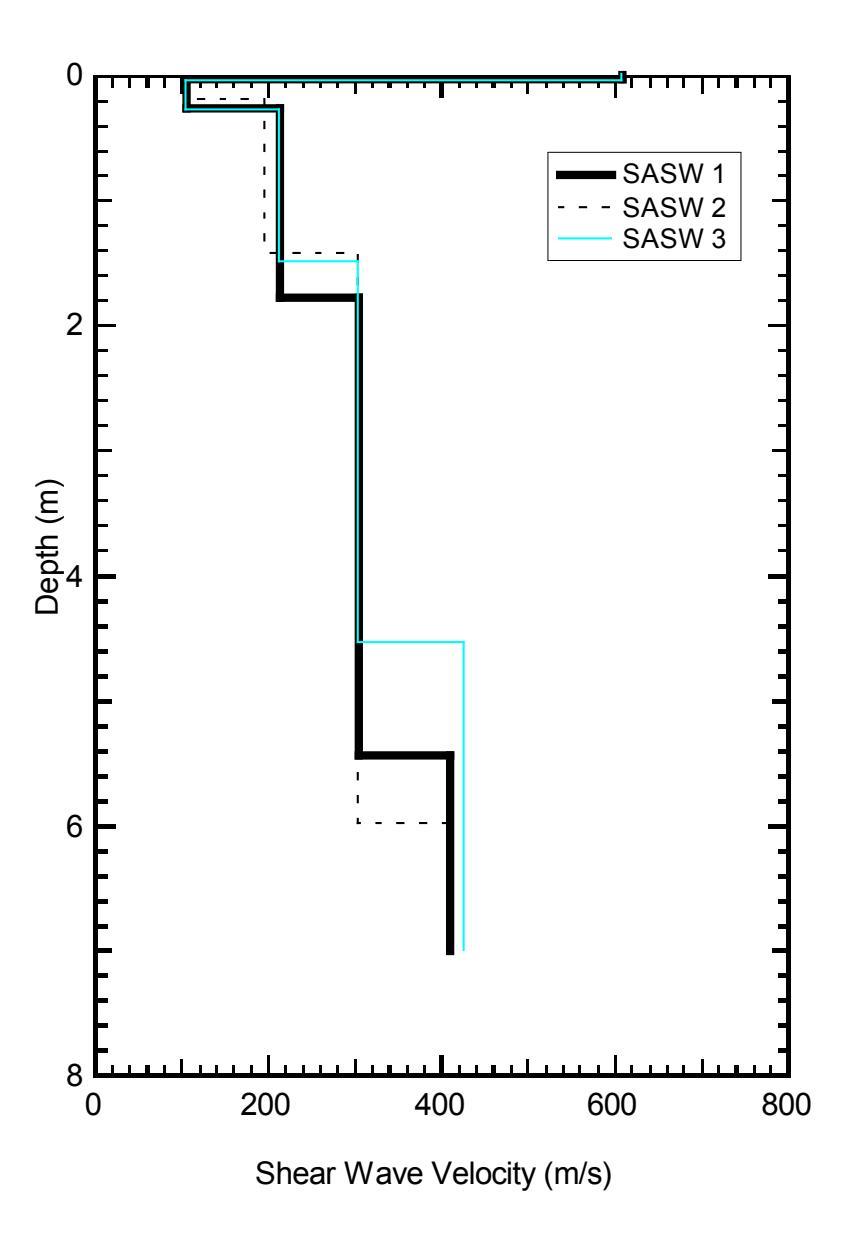
The dispersion curve data for sites SASW 2 and SASW 3 are similar to that shown for SASW 1, and are therefore not shown for the sake of brevity. However, all three V_s profiles are compared in Fig. 7.4. It can be seen that the Vs profiles for all three sites are quite similar, and primarily differ only in the depth to where the velocity surpasses 400 m/s. The depth to this stiffer layer is greatest near the center of the crest (SASW 2) and is smaller near the abutments (SASW 1 and 3). These results seem to agree with field observations that the crest was visibly higher at the center line of the dam than at the abutments (i.e. a thicker layer of soft surficial fill exists near the center of the crest). Furthermore, each velocity profile shows a very soft layer (~ 100 m/s) directly below the asphalt pavement. The assumed properties for each layer in the profiles for sites SASW 2 and SASW 3 are provided in Tables 7.3 and 7.4, respectively.

Figure 7.4: Comparison of shear wave velocity profiles for locations SASW 1, SASW 2 and SASW 3 on the crest of Aratozawa Dam.
