**THE KFARNABRAKH LANDSLIDE OF NOVEMBER 30TH, 2015:
*A Geological and Geotechnical Evaluation of the Landslide
and Risk of Future Failures***

Report of the NSF Sponsored GEER Association Team

GEER Association Report No. GEER-047

March 16, 2016

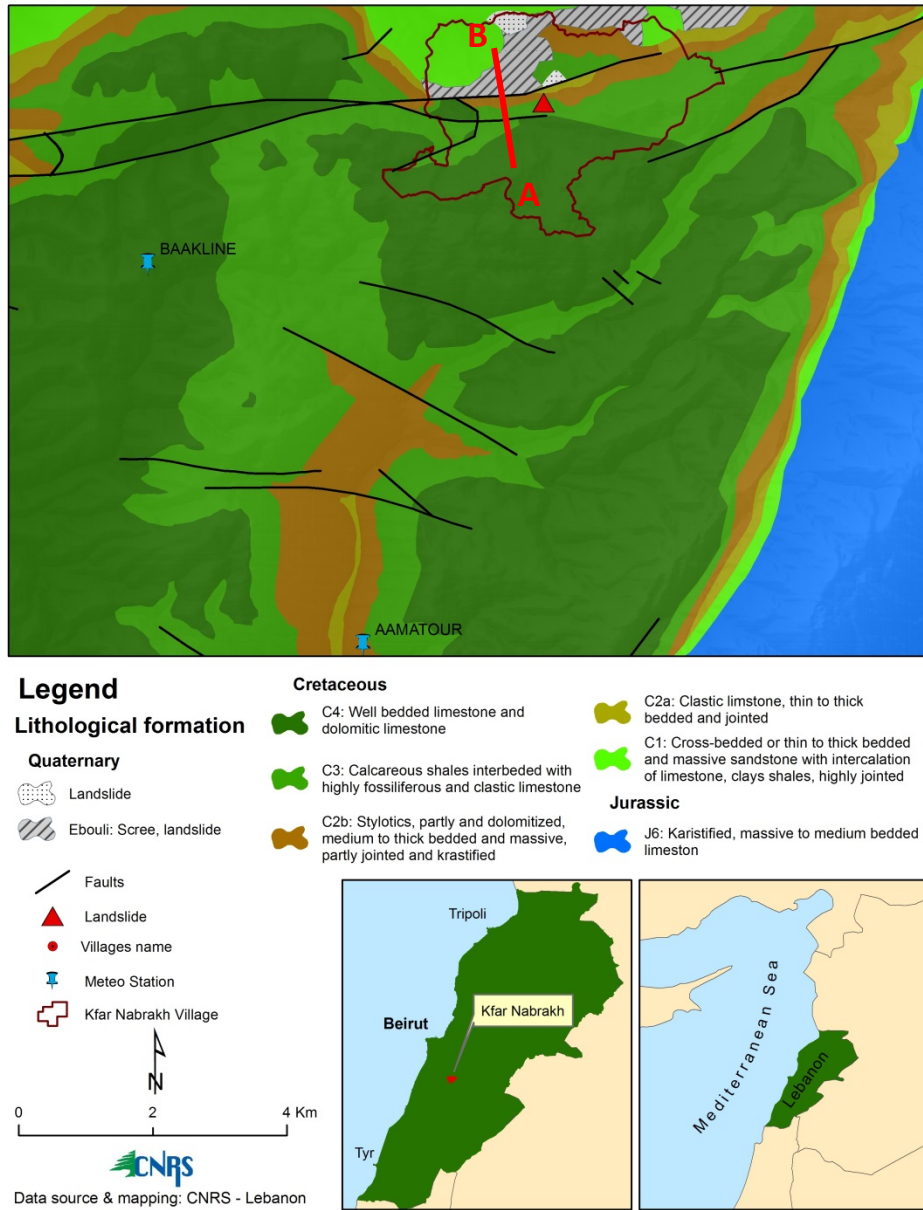
Figure 6: Geologic Map of the Kfar Nabrah area.

The Kfarnabrakh area consists mainly of pseudo-tabular lower Cretaceous rocks. These are incised by the westward flowing Safa River. An entire stratigraphic sequence can be observed on the northern flank of this drainage facing Kfarnabrakh as shown in Figure 6. A cross-section of the formations near the failure area along line AB is presented in Figure 7. The stratigraphy is superimposed over the cliff surface image in Figure 8 to show the alignment of the different strata with the outcrop.
