**Authors:** Youssef M.A. Hashash (UIUC), Binod Tiwari (CSF), Robb E. S. Moss (CalPoly), Domniki Asimaki (Caltech), Kevin B. Clahan (LCI), D. Scott Kieffer (TUGraz), Doug S. Dreger (UCB), Amy Macdonald (TT), Chris M. Madugo (PG&E), H. Benjamin Mason (OSU), Menzer Pehlivan (MRCE), Deepak Rayamajhi (OSU), Indra Acharya (TU) and Basanta Adhikari (TU).

## Executive Summary

The April 25, 2015 Gorkha (Nepal) Earthquake and its related aftershocks had a devastating impact on Nepal. The earthquake sequence resulted in nearly 9,000 deaths, tens of thousands of injuries, and has left hundreds of thousands of inhabitants homeless. With economic losses estimated at several billion US dollars, the financial impact to Nepal is severe and the rebuilding phase will likely span many years.

The Geotechnical Extreme Events Reconnaissance (GEER) Association assembled a reconnaissance team under the leadership of D. Scott Kieffer, Binod Tiwari and Youssef M.A. Hashash to evaluate geotechnical impacts of the April 25, 2015 Gorkha Earthquake and its related aftershocks. The focus of the reconnaissance was on time-sensitive (perishable) data, and the GEER team included a large group of experts in the a

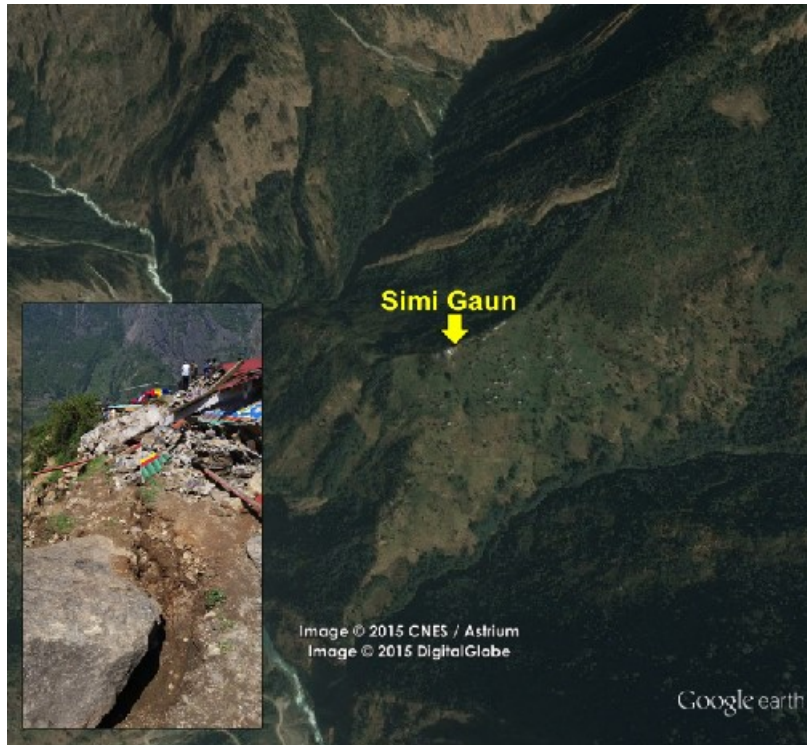
Figure 4-21 Ridge top damage and school collapse, Simi Gaun, near upper Tamakoshi Dam, (27 52' 22.5" N, 86 13' 50.6" E).

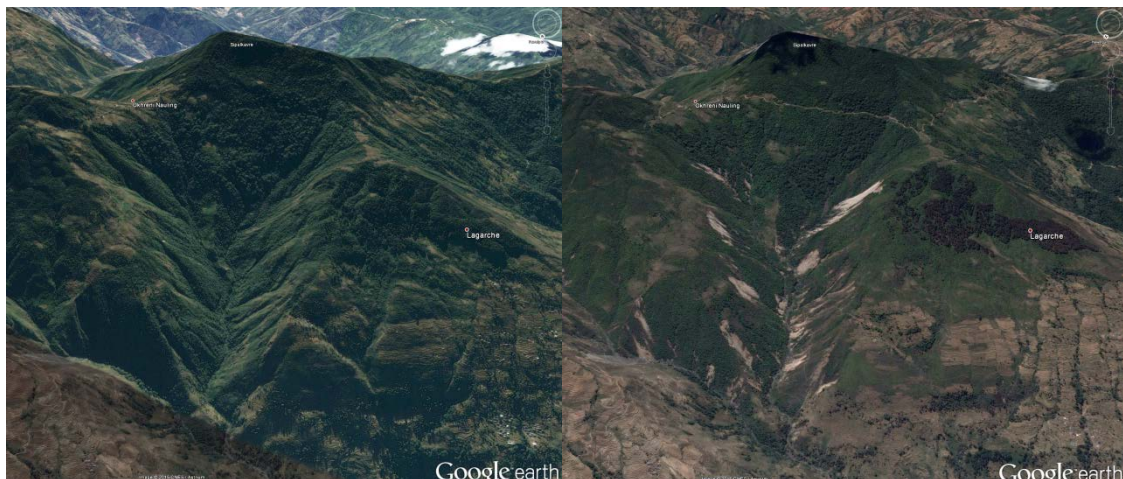
Figure 5-1 Satellite imagery from December 2014 (left) and May 2015 (right), 27°52'3.57"N, 85°39'5.41"E. Light scars in right image indicate areas of earthquake-induced landsliding.

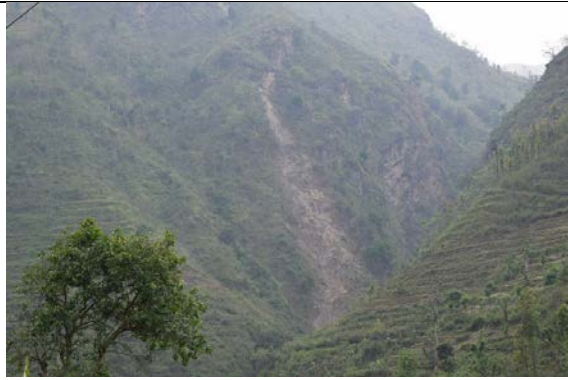
Figure 5-3 Typical landslides observed along Prithivi Highway alignment.

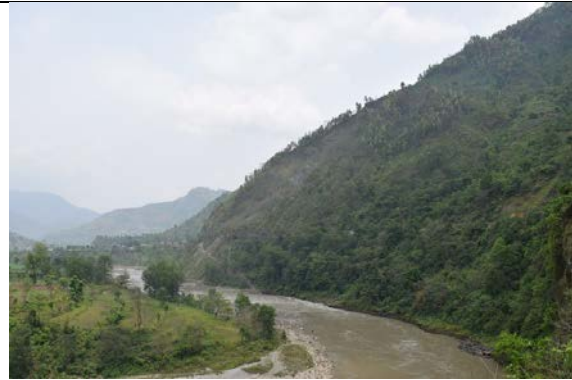
Figure 5-4 Pre-existing Krishnabhir Landslide, which performed well during the 2015 earthquake.

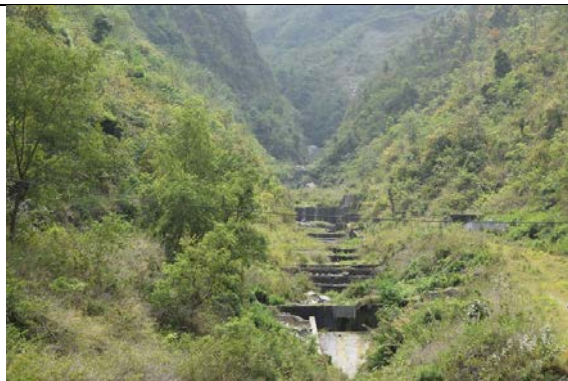
Figure 5-5 Check dams near the powerhouse of Marshyangdi Hydropower Project, which performed well during the 2015 earthquake (27°52.5'0"N 84°32.4'0"E).

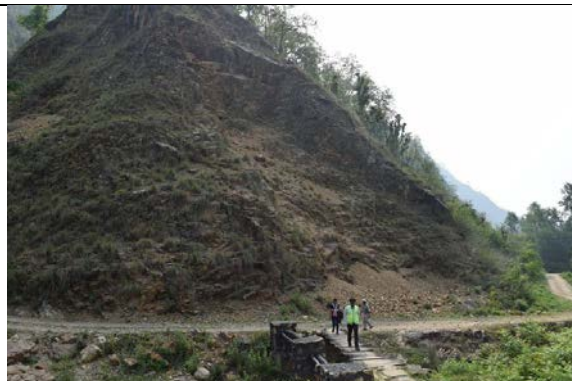
Figure 5-6 Rockslides observed at the Marshyangdi Hydropower Project dam site during the 2015 earthquake mainshock.

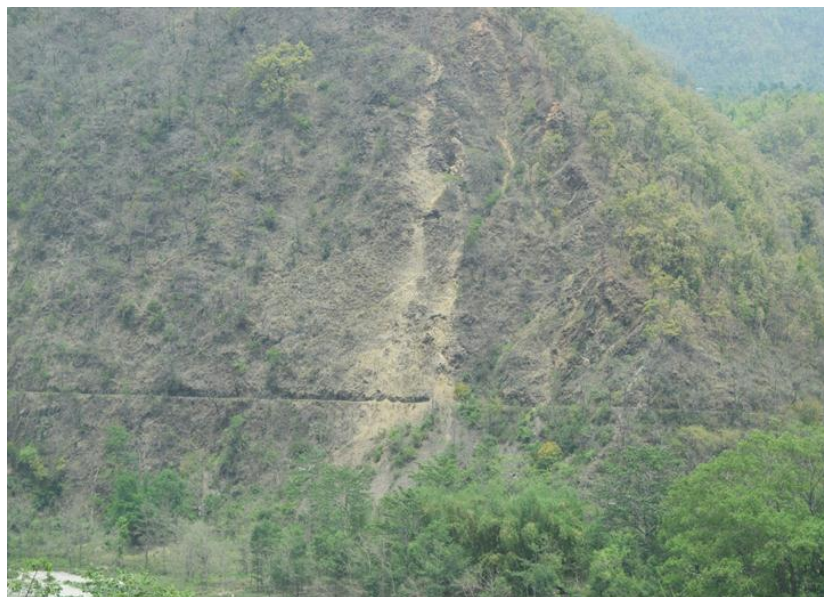
Figure 5-7 An irrigation channel alignment affected by rockslide.

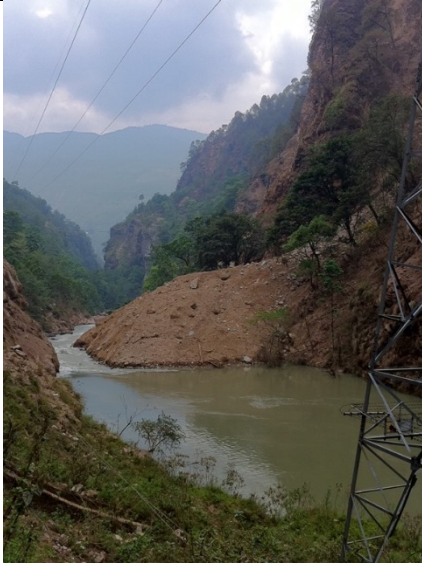
Figure 5-8 Landslide dam near the village of Listikot on the Sunkoshi River adjacent to the Araniko Highway (27° 52' 43.22" N; 85° 54' 12.17" E).

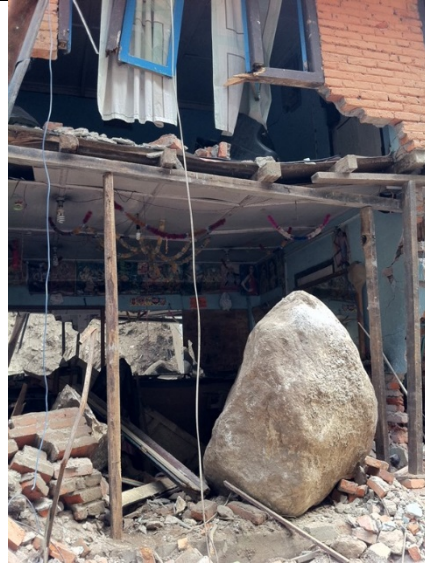
Figure 5-9 Destroyed building along Araniko Highway in Kodari (27° 58' 17.61" N; 85° 57' 43.51" E).

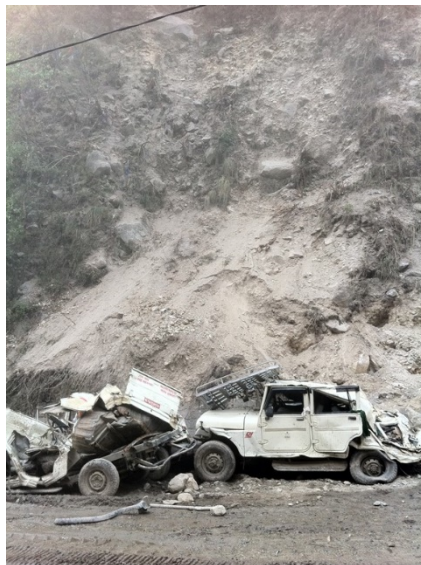
Figure 5-10 Destroyed vehicles along Araniko Highway in Kodari (27° 58' 21.55" N; 85° 57' 46.18" E)

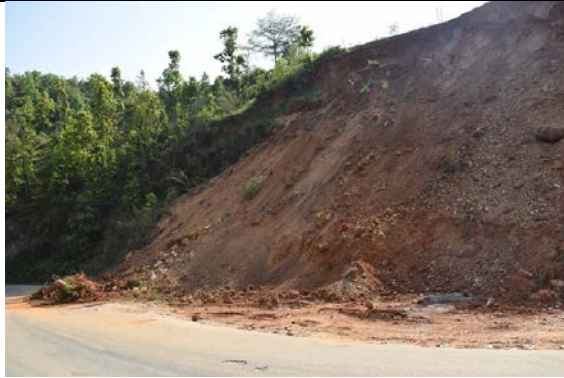
Figure 5-11 Typical landslide observed at the Panchkhal-Dolalghat sector of the Araniko Highway.

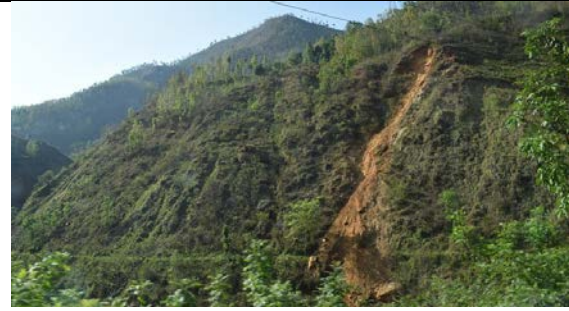
Figure 5-12 Extent of the landslides observed a few kilometers ahead of Dolalghat at Araniko Highway.

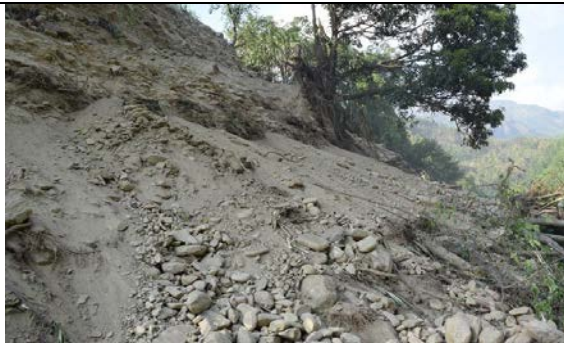
Figure 5-13 Typical rockslide mass observed along the Dolalghat-Lamo Sangu Sector of the Araniko Highway.

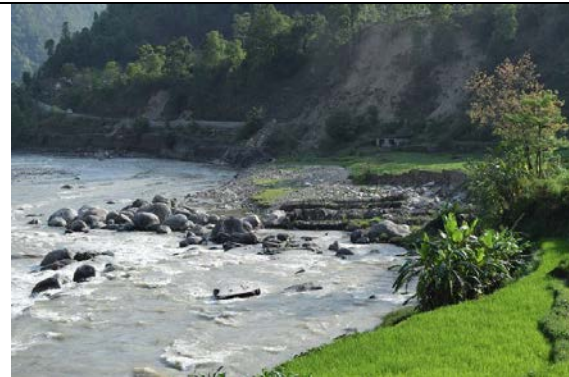
Figure 5-14 Reactivation of an existing landslide along the Araniko Highway that was triggered due to stream undercutting (27°44.7'0"N 85°47.5'0"E).

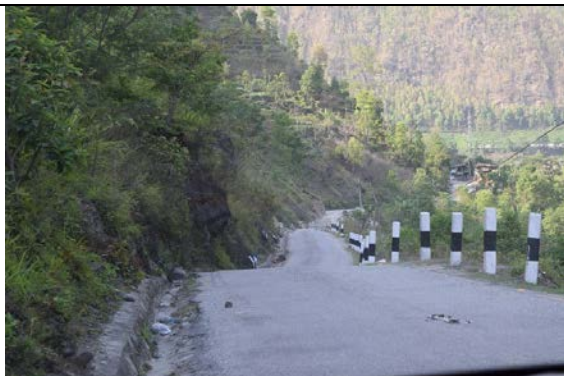
Figure 5-15 Landslide observed along the Dolalghat – Lamosangu sector of the Araniko Highway.

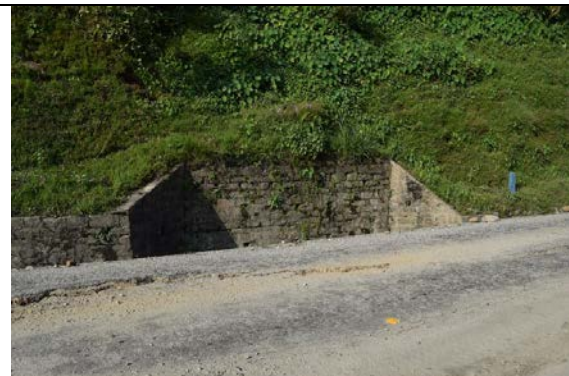
Figure 5-16 A subsurface drainage work installed at a landslide site along the Araniko Highway performed well during the earthquake.

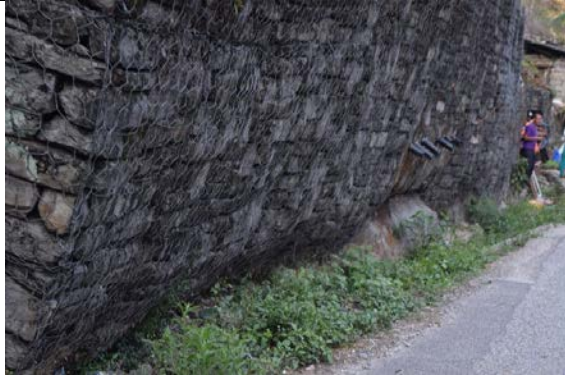
Figure 5-17 Gabion Retaining wall implemented as the landslide prevention work for existing landslide tilted after the 2015 earthquake.

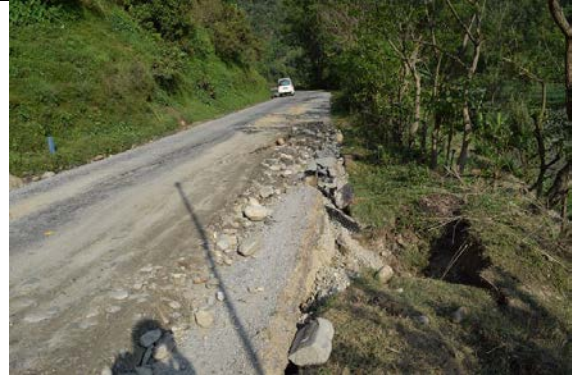
Figure 5-18 Typical road fill settlement observed along the Araniko Highway.

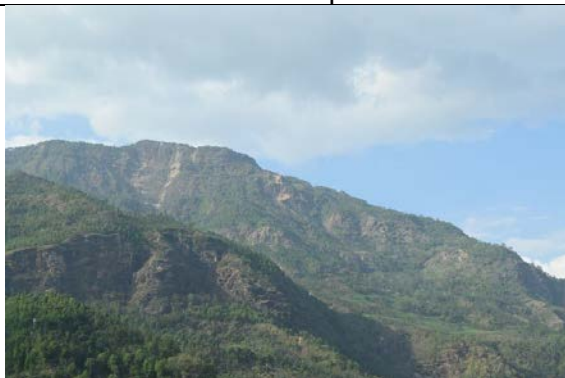
Figure 5-19 Typical cracks observed on the ridge of the mountain which has potential to trigger large scale landslides and block the Sunkoshi River.

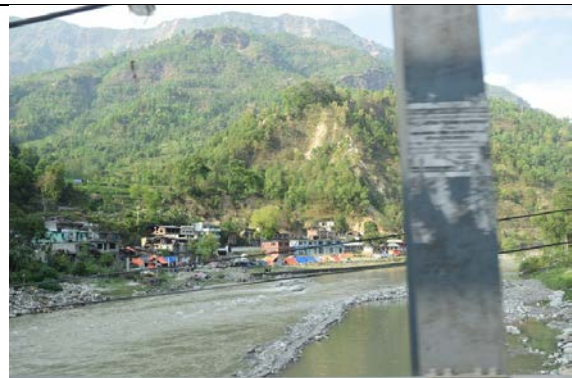
Figure 5-20 Residential area along the Araniko Highway near Lamosangu exposed to potential landslides.

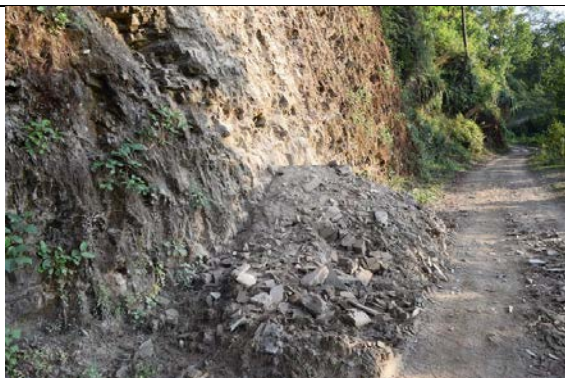
Figure 5-21 Typical rockfall observed along Lamosangu – Manthali Road

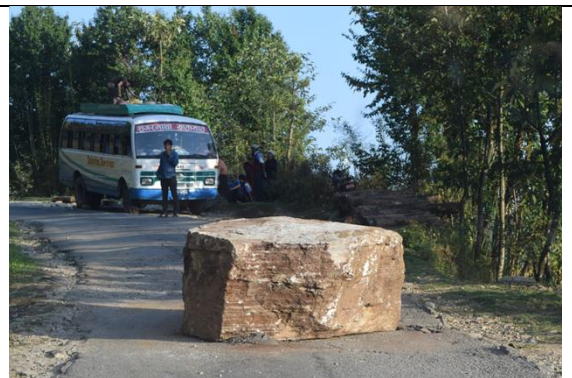
Figure 5-22 Boulder that rolled down from a ridge onto the road.

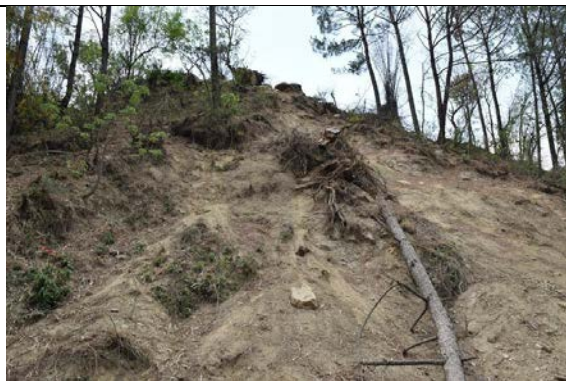
Figure 5-23 Typical rockfall source observed along the Melamchi Water Supply Project Access Road.

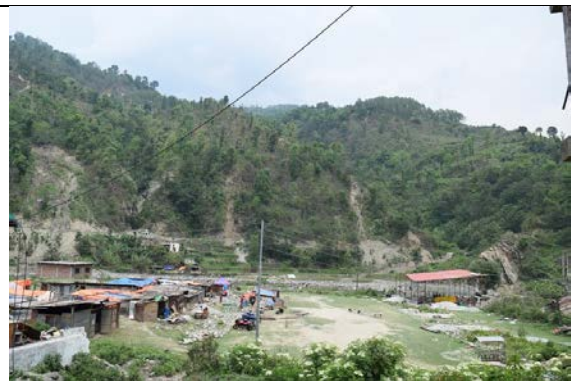
Figure 5-24 Dense landslides along the alignment of Melamchi Water Supply Project Access Road (27°49.8'0"N 85°34.5'0"E).

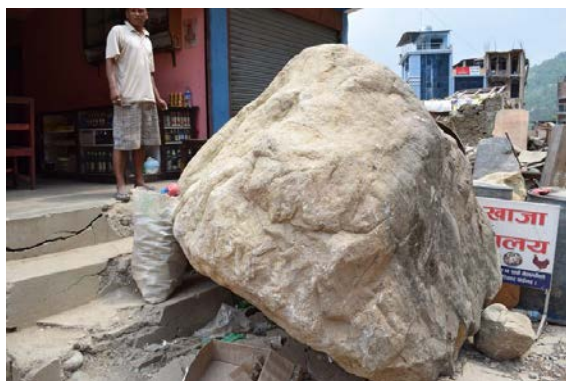
Figure 5-25 Boulder that rolled down a slope after the mainshock.

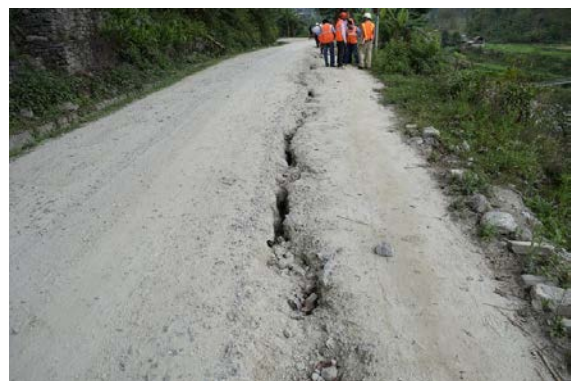
Figure 5-26 Settlement crack along the roadway.

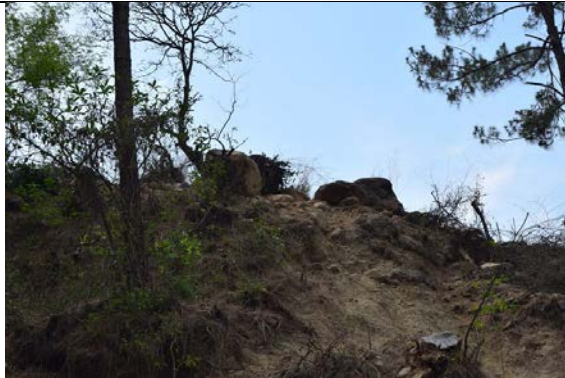
Figure 5-27 Loose boulders on top of a slope.

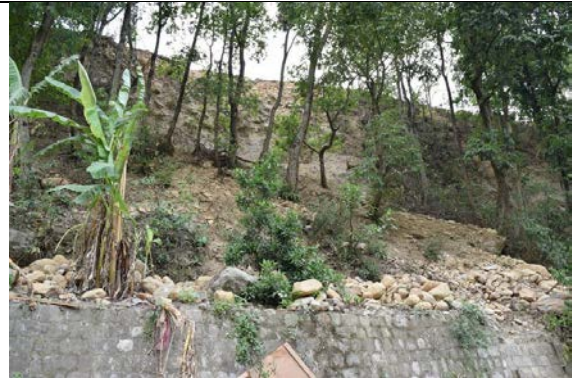
Figure 5-28 Walls performed well during ground shaking.

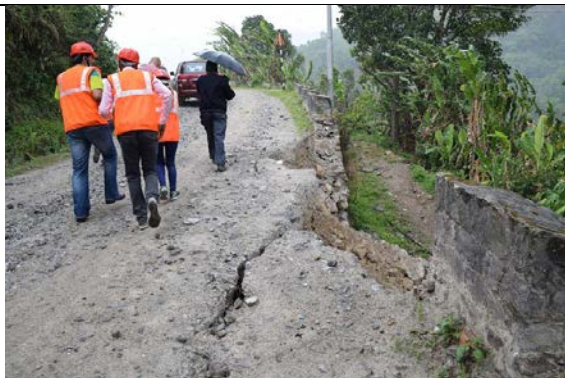
Figure 5-29 Damage to retaining wall due to excessive settlement and ground shaking.

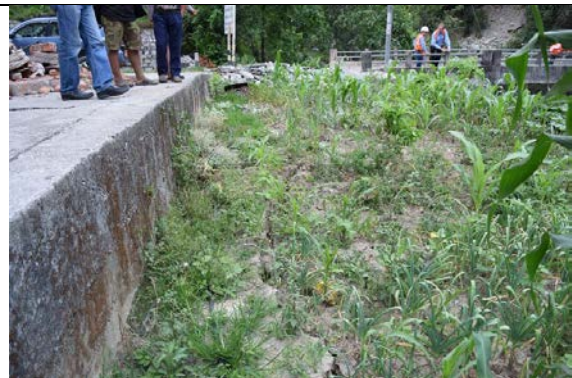
Figure 5-30 Settlement cracks observed along a bridge abutment.

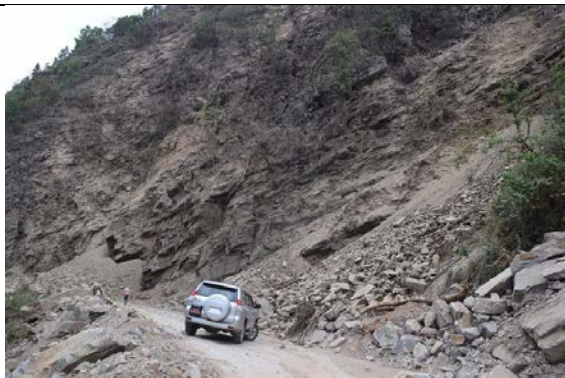
Figure 5-31 A rockslide that poses a potential hazard to the roadway and below.

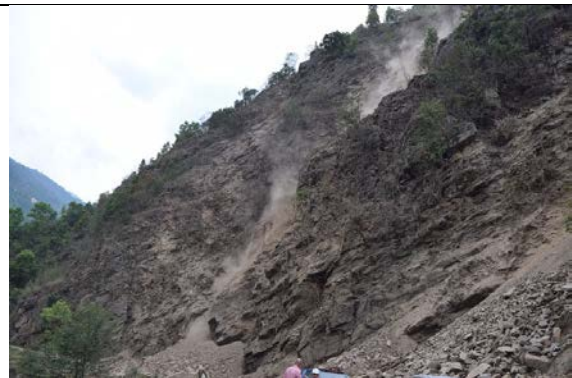
Figure 5-32 Rockfall, as evidenced by the dust, observed during field reconnaissance (27°58.5'0"N 85°33.9'0"E).

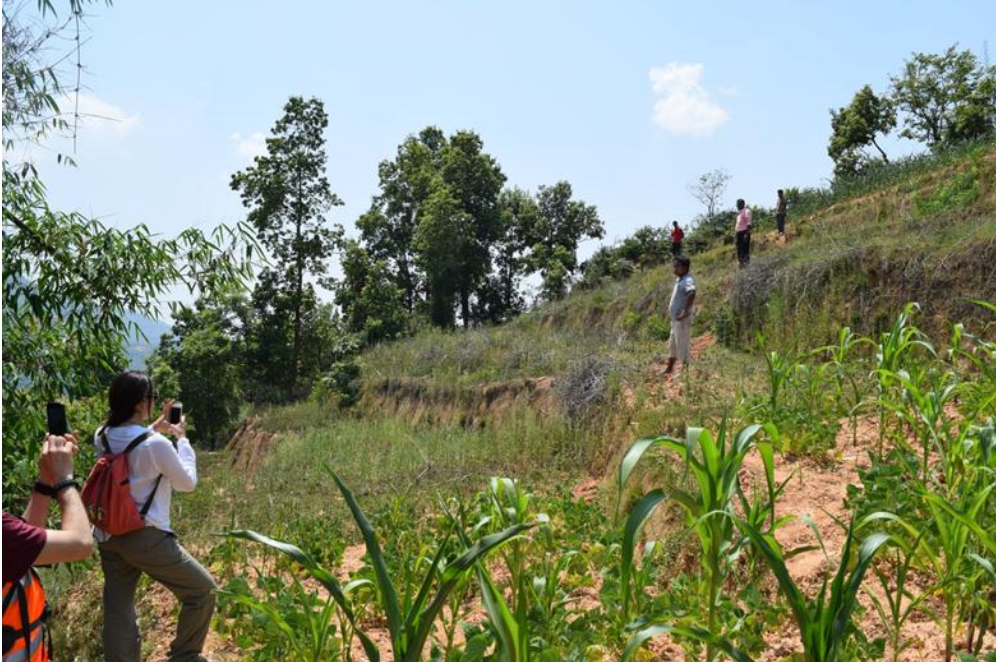
A landslide fissure was observed at the ridge of Ramkot Village, which is located at the edge of the Kathmandu Valley (Figure 5-33). The extensive fissure is more than 15 cm wide (Figure 5-34).

Figure 5-33 Head scarp observed on the ridge of the slope triggered by the 2015 earthquake.

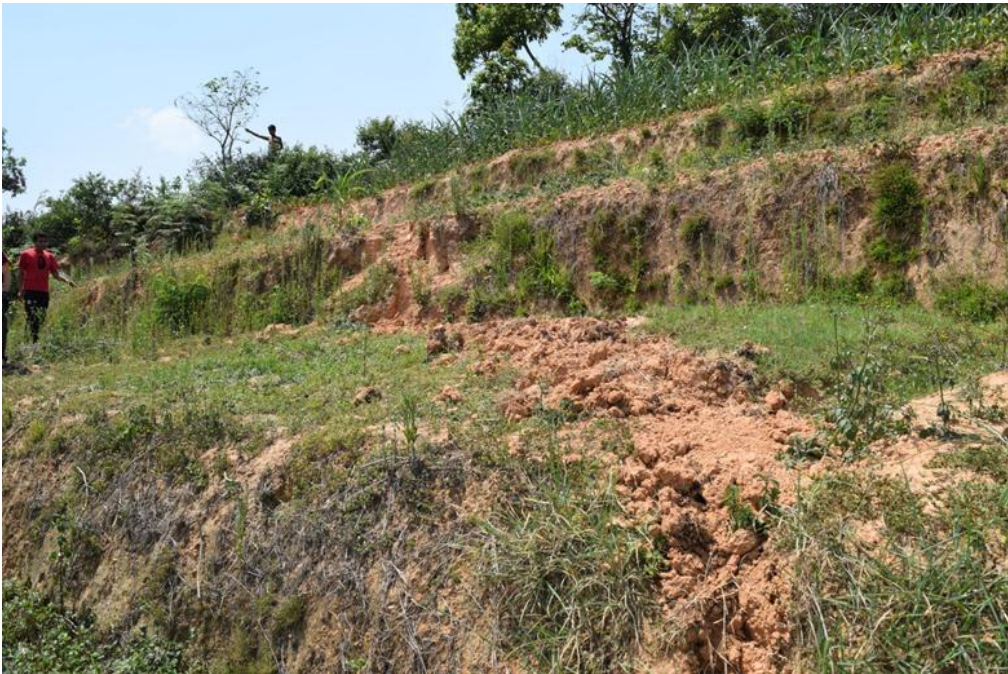
Figure 5-34 Head scarp crack was wider than 15 cm.

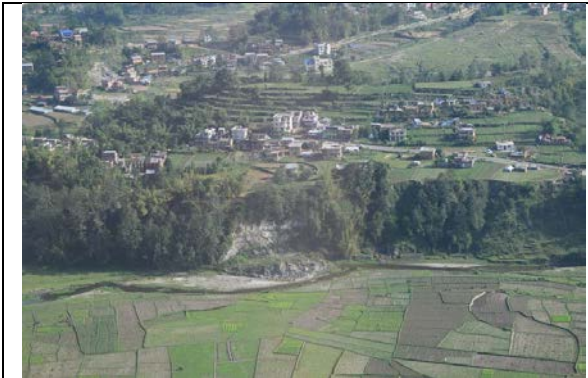
Several landslides were observed along the roads and river banks on the aerial reconnaissance route from Kathmandu to Lama Bagar (Figure 5-35) and along the river terrace slopes which might predated the earthquake (Figure 5-36). Several rural roads were affected by seismic induced landslides (Figure 5-37 through Figure 5-39). Ridge lines along the

Figure 5-36 Landslide along the river bank at Indrayani, near Kathmandu Valley.

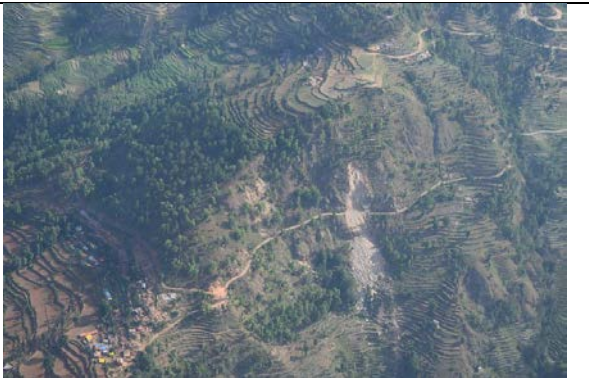
Figure 5-37 Mountain roads that have been affected by landslide triggered by the 2015 Earthquake.

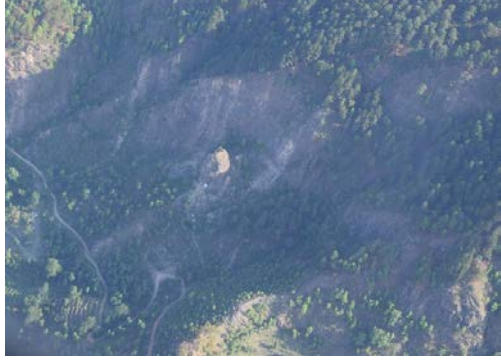
Figure 5-38 Landslides that have affected several mountain roads along the air-route.

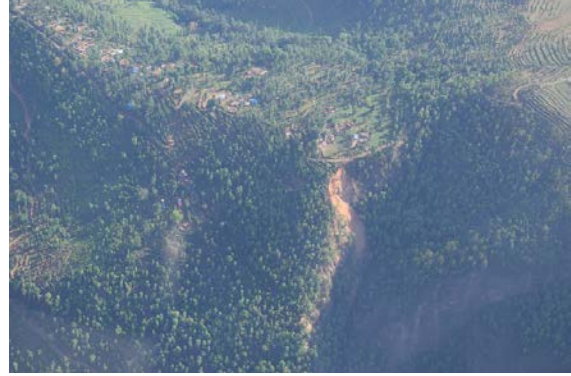
Figure 5-39 Small landslide triggered by the earthquake affected a road and a village along the air-route to Lamabagar.

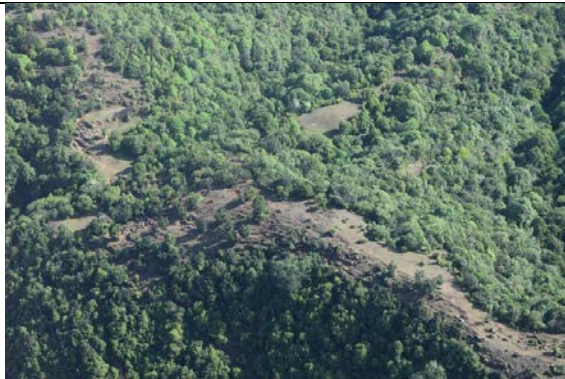
Sunkoshi River are locally highly fractured (Figure 5-40 through Figure 5-44) and may potentially experience additional significant activity during the monsoon season. Some of these landslide deposits contain large boulders (Figure 5-45 and Figure 5-46) can potentially be destabilized during the monsoon season or future seismic events.

Figure 5-40 Fissures created on the ridge of mountain due to the earthquake shaking.

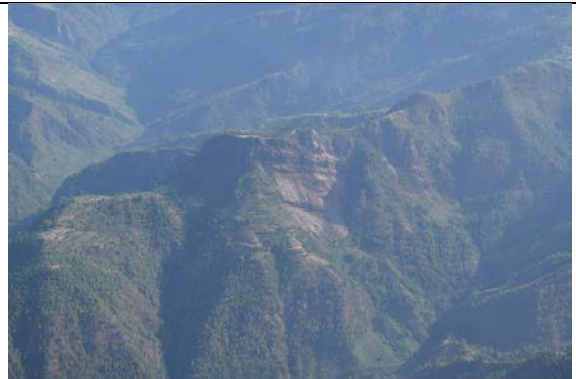
Figure 5-41 Seismically triggered landslide on a ridge.

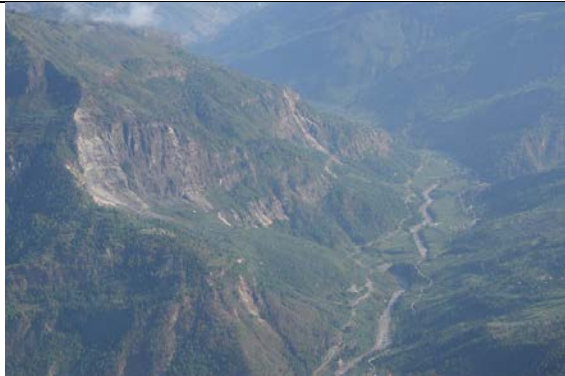
Figure 5-42 Slope vulnerable to post-earthquake rainfall induced landslides that could potentially block the natural stream.

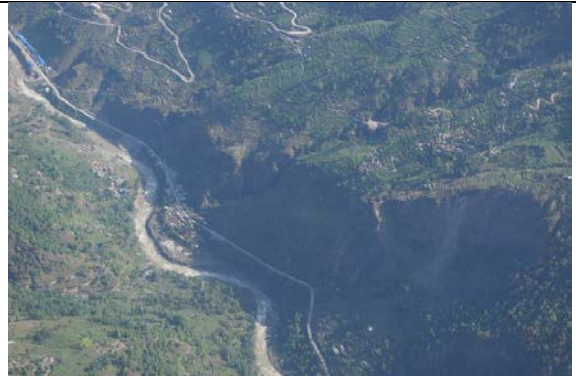
Figure 5-43 Settlement at along a bank near a potential landslide.

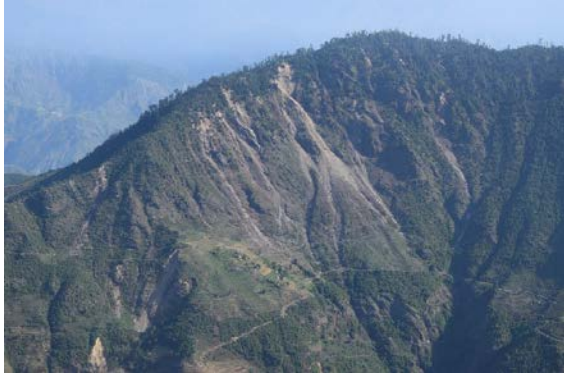
Figure 5-44 Landslide fissures triggered by the recent earthquake along the hillslope.

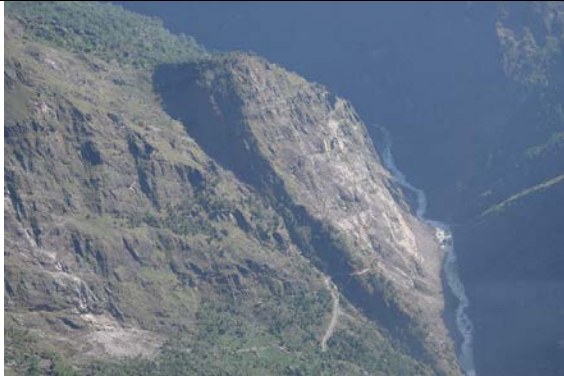
Figure 5-46 Source of landslide.

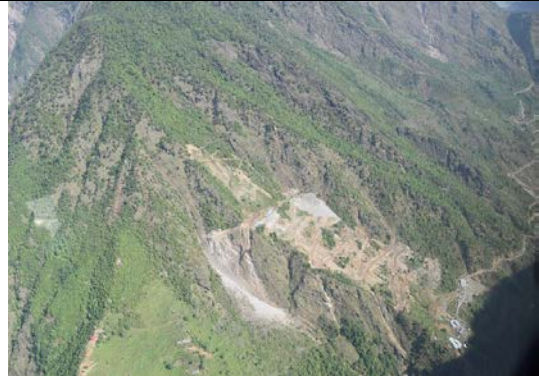
The access road to the Upper Tamakoshi Hydro Power project, in particular the Singati-Lama Bagar Sector (Figure 5-47 through Figure 5-52) is amongst the most heavily affected areas. The majority of the road alignment was rendered impassable due to landslide activity. The road is narrow and was constructed across very steep topography, exacerbating the impacts of the recent earthquake. Although gabion retaining walls generally performed well, with localized incidents of damage. Both the upstream and downstream areas from the dam site of the Hydro Power Project were affected by multiple rock fall events (Figure 5-53 through Figure 5-55). The boulder sizes, having travelled a distance of over 100 m, indicate high levels of ground shaking (Figure 5-56 and Figure 5-57). However, no ground motion observation data was available in the area.

Figure 5-47 Locations with large scale landslide potential along the Charikot-Lamabagar Road.

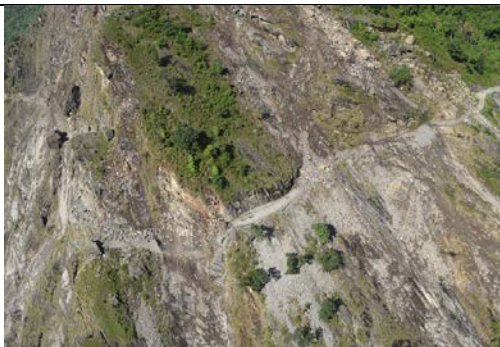
Figure 5-48 Charikot-Lamabagar road sector affected by landslides triggered due to the earthquake.

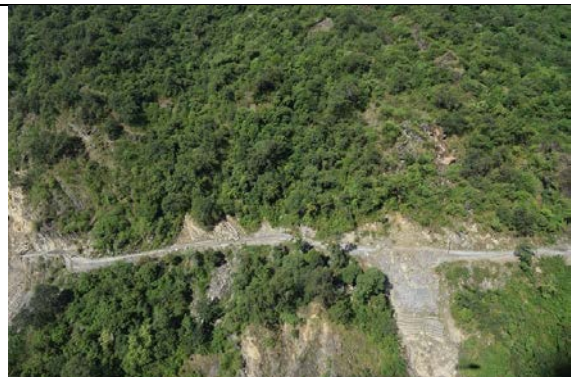
Figure 5-49 Gabion retaining walls that did not perform well along the Charikot-Lamabagar Road.

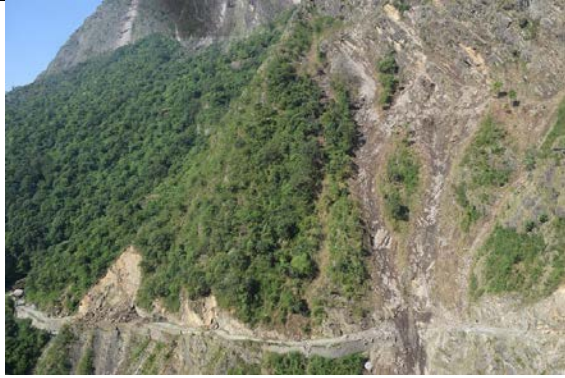
Figure 5-50 landslides observed along the road alignment constructed along steep terrain.

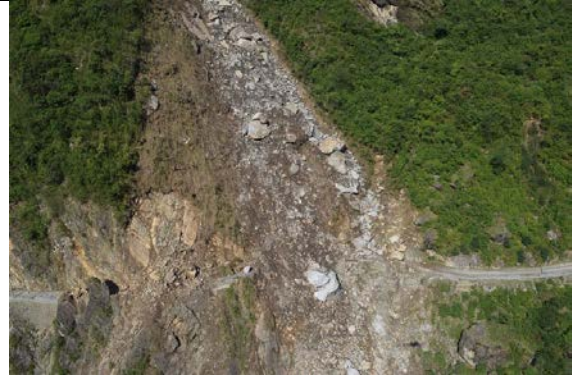
Figure 5-51. Large scale landslides that affected the Charikot-Lamabagar Road sector

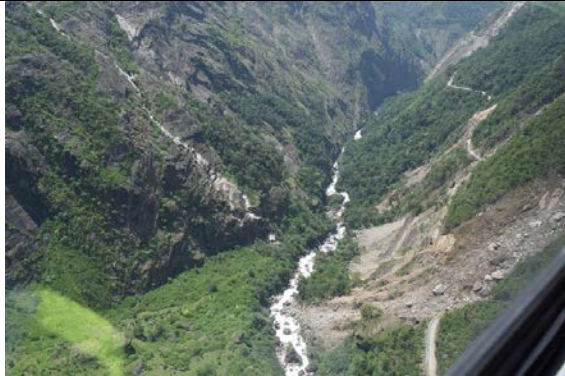
Figure 5-52 Landslide near the dam site of the hydropower project that damaged the road.

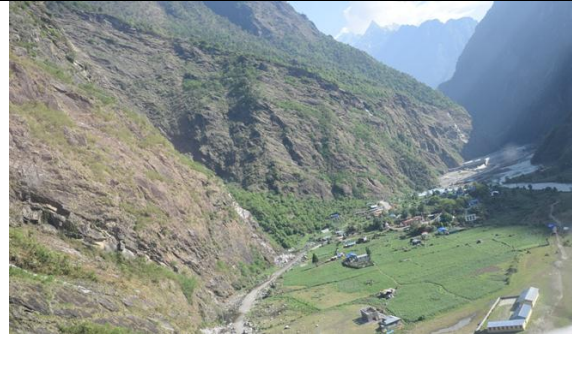
Figure 5-53 Landslides observed along dam site of the Upper Tamakoshi Hydropower project

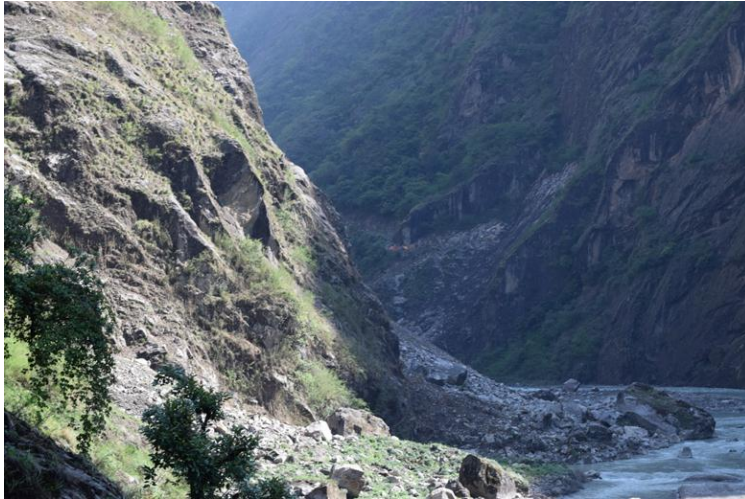
Figure 5-54 Rockfall upstream of the hydropower project.

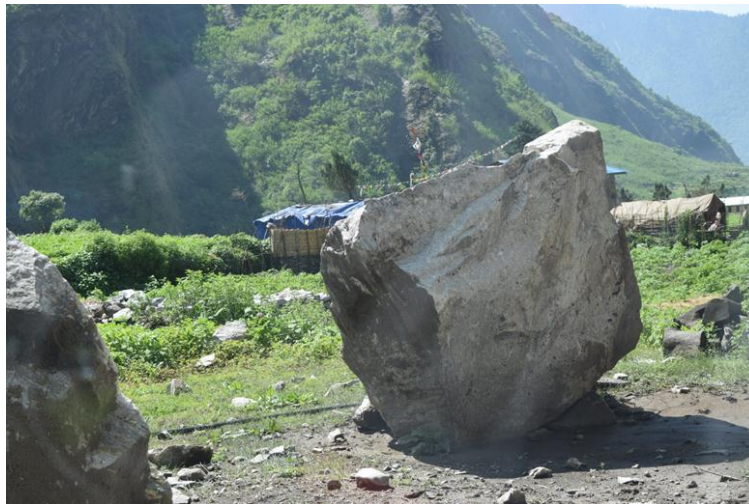
Figure 5-55 Large boulder from the top of the slope near the dam site.

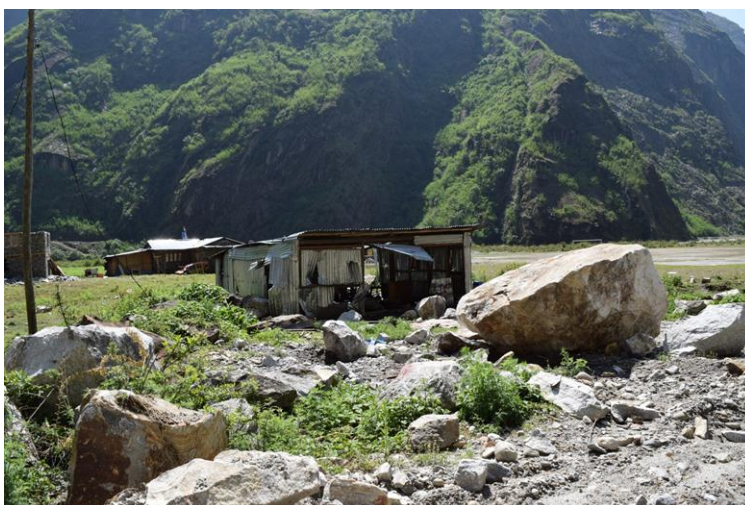
Figure 5-56 Local shop destroyed by the boulder.

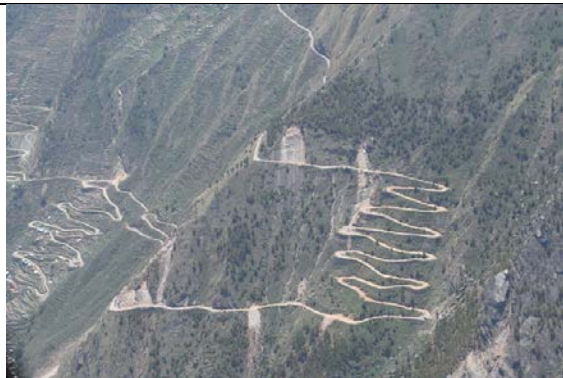
This area of Nepal (Figure 5-57) was also significantly affected by earthquake triggered landslides. In particular, the region between Nuwakot and Rasuwagadi exhibited many dry, raveling-type landslides (Figure 5-58 through Figure 5-60). Several of these landslides blocked the Trishuli River and its tributaries (Figure 5-61 through Figure 5-71) and also affected villages. Several hydropower projects, including the Chilime, Rasuwagadi and Trishuli were adversely impacted by the landslides (Figure 5-72 through Figure 5-74). Access roads to these hydropower projects and majority of the gabion retaining walls constructed along them were damaged by the landslides. Villages situated both above and below the landslides may be at risk due to the potential for landslide reactivation during the monsoon season or future ground shaking (Figure 5-75 through Figure 5-81). Large perched and precarious boulders were also observed above the villages. At several locations along the Trishuli River up to the Nepal - Chinaborder, massive landslides completely or partially blocked the Trishuli River (Figure 5-82).

Figure 5-59 Local feeder road to the Trishuli-Rashuwagadi Road impacted by the landslide.

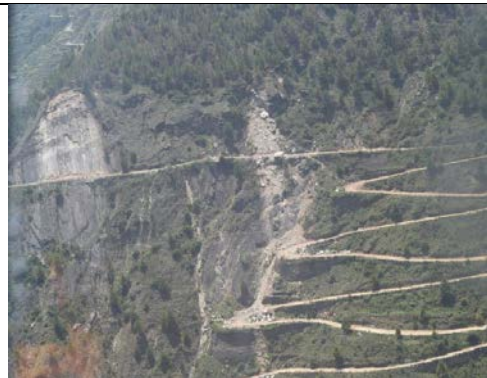
Figure 5-60 Gabion retaining walls on the feeder road to the Trishuli-Rasuwegadi Road damaged by the earthquake.

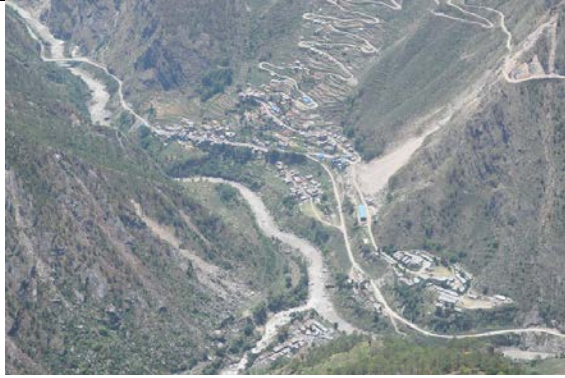
Figure 5-61 Access road to a Hydropower project being affected by the earthquake induced landslides.

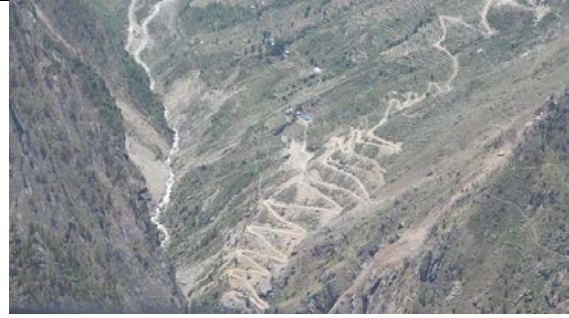
Figure 5-62 Tributary of the Trishuli Rivers partially blocked by the earthquake induced landslide debris.

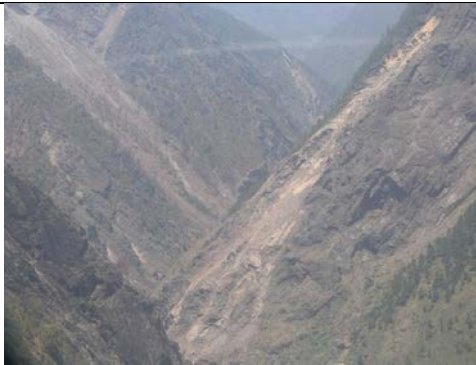
Figure 5-63 Slopes along both banks of the Trishuli River being affected by the seismically triggered landslides.

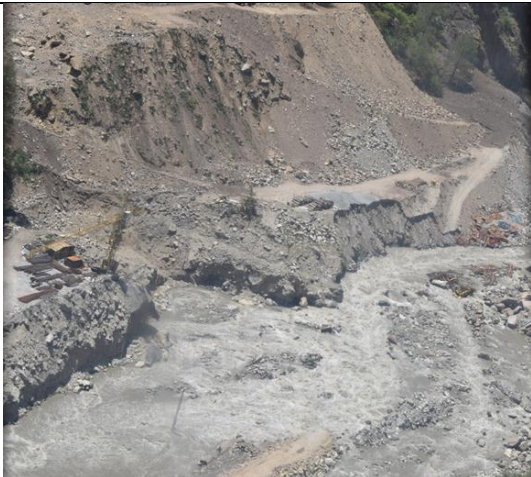
Figure 5-65 Landslide debris partially blocks the Trishuli River near a hydropower project.

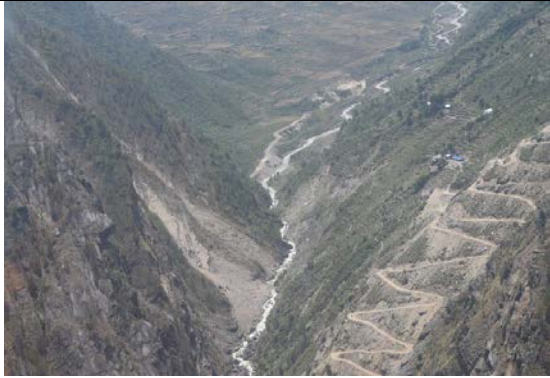
Figure 5-67 Tributary of the Trishuli River partially blocked by the landslides triggered on both sides.

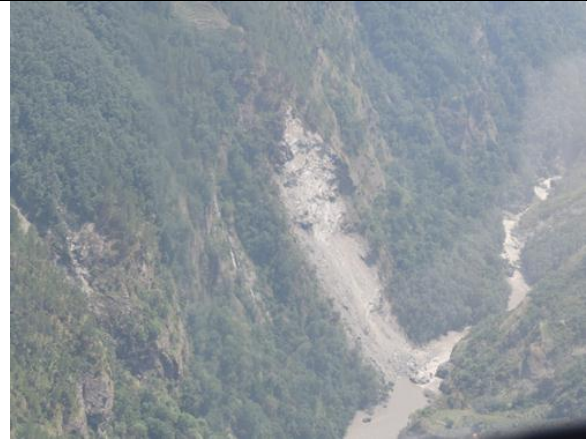
Figure 5-68 A large scale seismically induced landslide that partially blocked the Trishuli River.

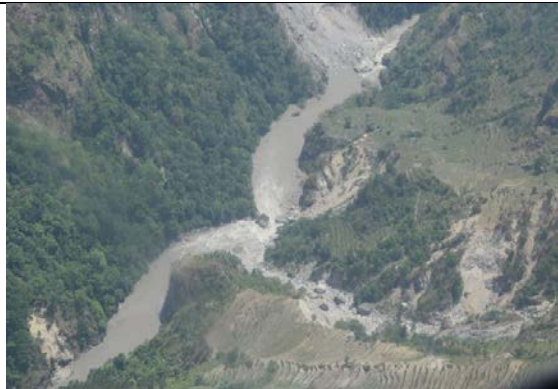
Figure 5-69 Water inundation along Trishuli River due to landslide induced natural dam formation.

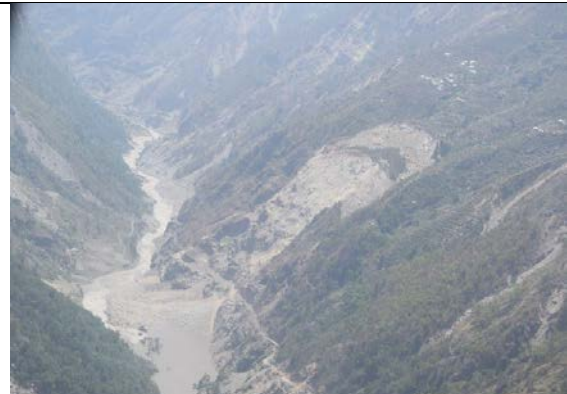
Figure 5-70 A large scale landslide not only blocked Trishuli River, note the village above the headscarp.

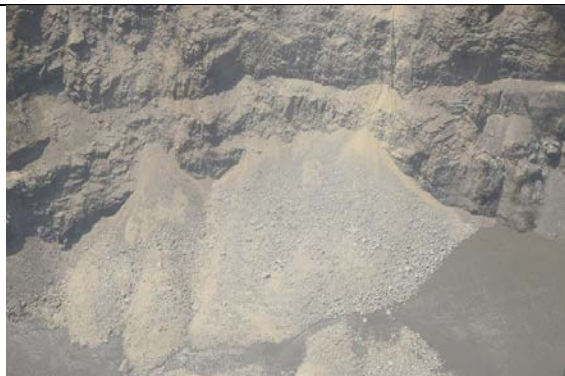
Figure 5-71 Closer view of the landslide dam at the Trishuli River (28°14.9'0"N 85°27.6'0"E)

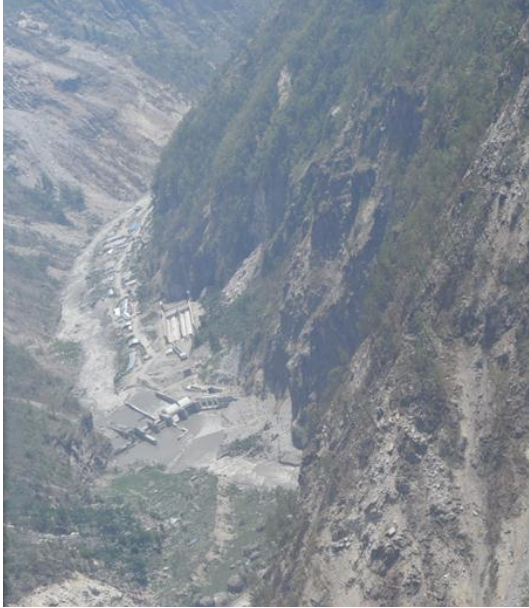
Figure 5-73 Upstream side of a hydropower project affected by large scale landslides.

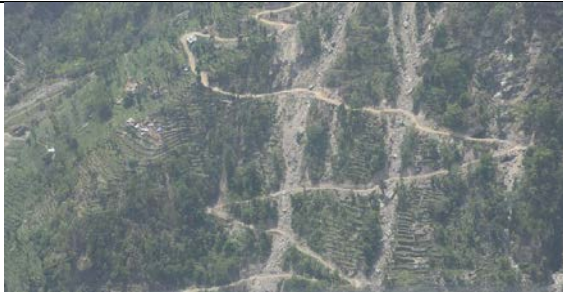
Figure 5-75 Regular road sector of the Trishuli-Rasuwagadi Road affected by landslides.

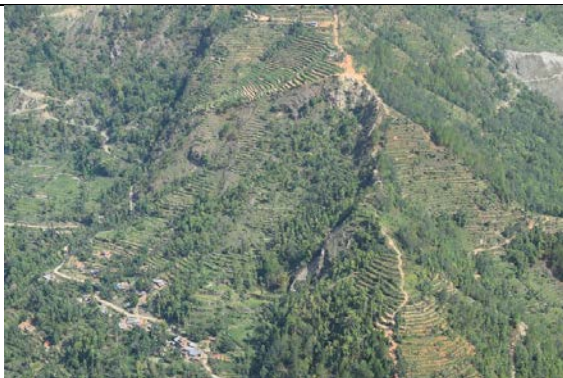
Figure 5-77 Villages below a large pre-existing landslides.

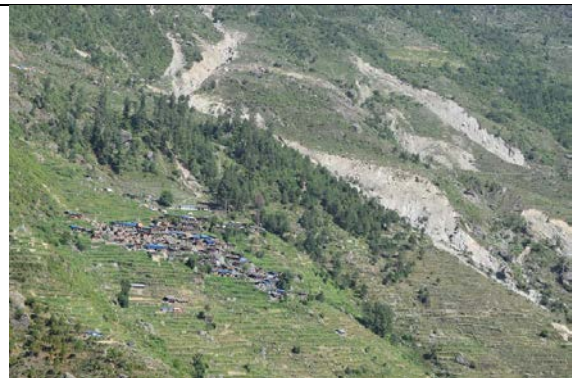
Figure 5-78 A village close to a large landslide site that could potentially block the Trishuli River.

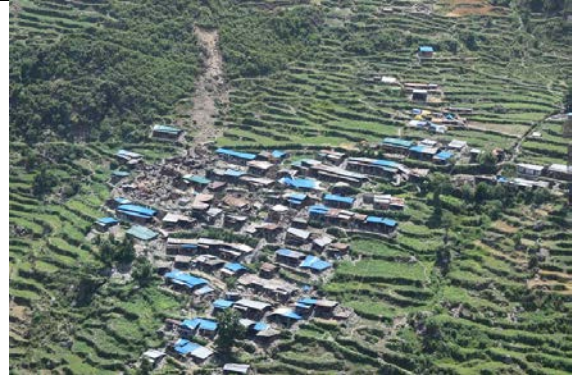
Figure 5-80 A village near Dhunche heavily damaged by the landslide debris originating from a slope above the village.

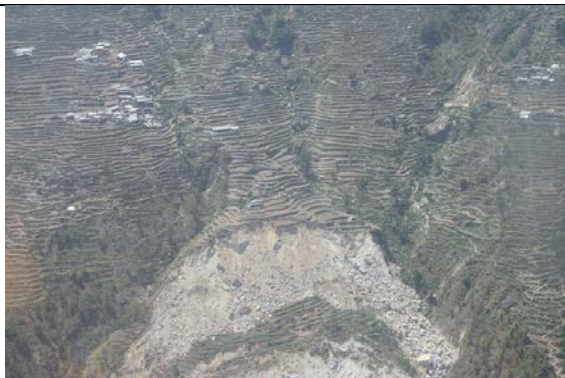
Figure 5-81 A village above a large scale landslide that has potential to block the Trishuli River.

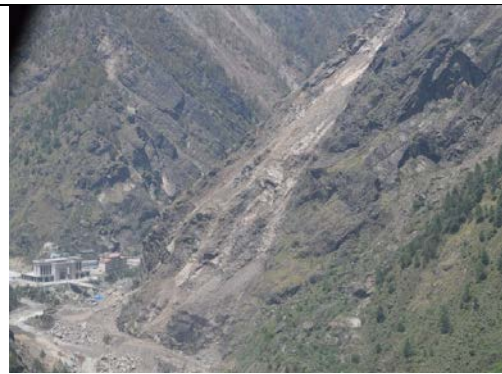
Figure 5-82 Trishuli River near the Chinese border at Rasuwagadi partially blocked by large landslides.

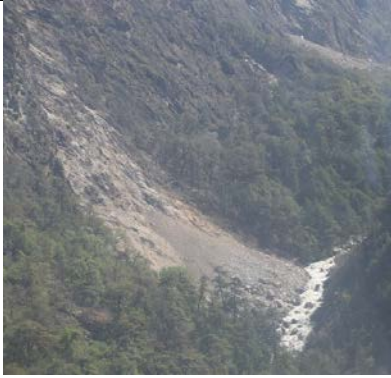
Figure 5-83 A large seismically induced landslide mass narrowing the width of Langtang River.

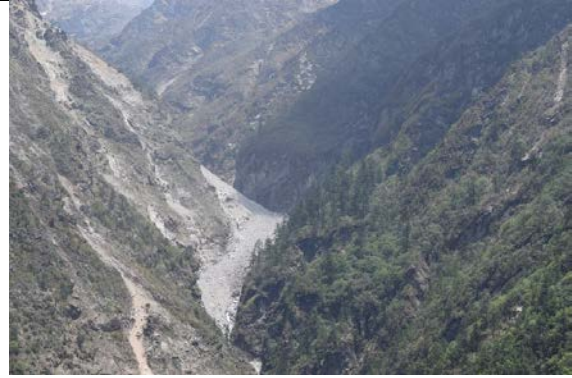
Figure 5-84 Another location where Langtang River is blocked by landslide debris.

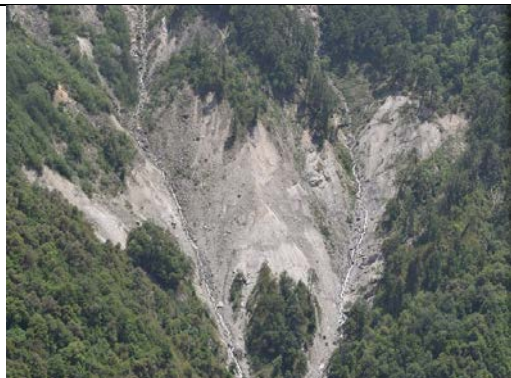
Figure 5-85 Several large scale landslides along the bank of the Langtang River.

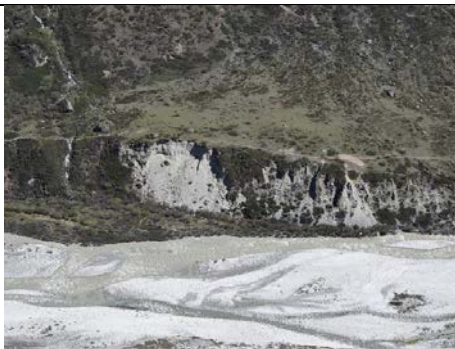
Figure 5-87 Upstream of the Langtang River with sediments from loose debris mass that slid after the earthquake.

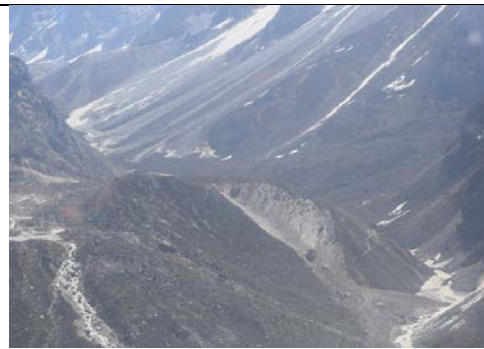
Figure 5-88 Langtang River blocked by landslide debris at multiple locations.

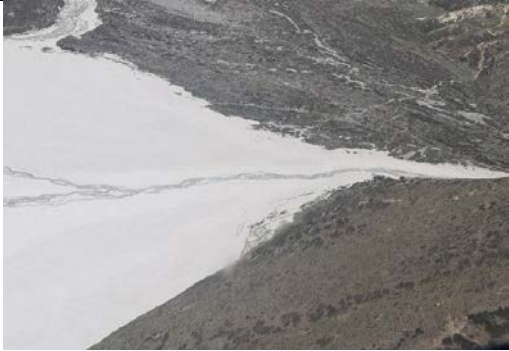
Figure 5-89 Debris fan observed at the upstream of Langtang River near Kyamgjon Kharka (28°12.2'0"N 85°35.2'0"E).

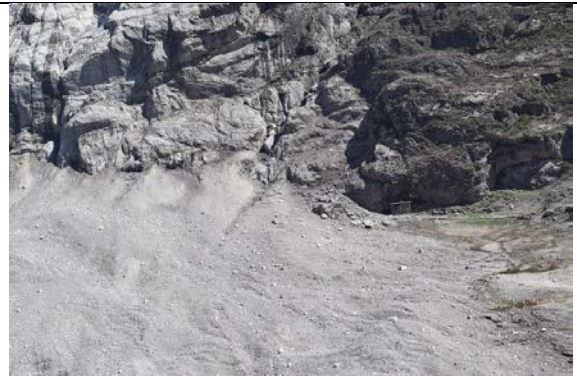
Figure 5-100 Foot of the debris shoot (a 3 story building on the middle left was the only building undamaged in the area).

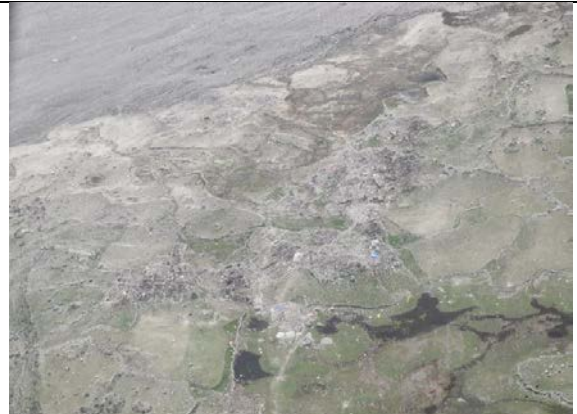
Figure 5-102 Aerial view of Langtang Village that was destroyed by the debris avalanche air blast.

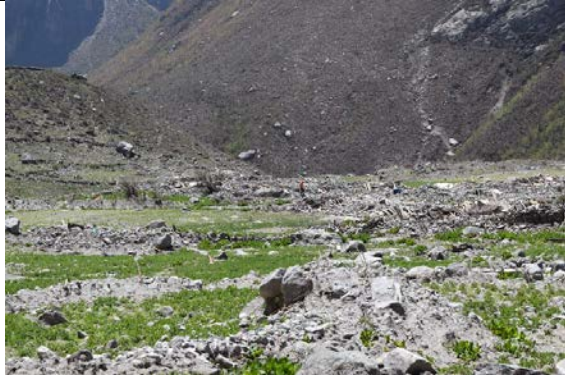
Figure 5-103 Closeup view of the debris field in the Langtang Valley. The buildings were flattened towards the direction of air blast induced by the avalanche.

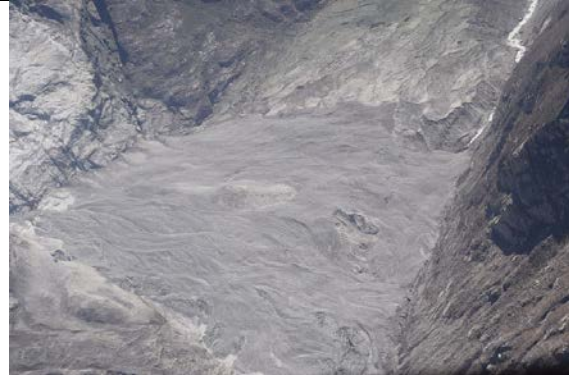
Figure 5-104 Langtang River blocked by the debris avalanche.
