**Authors:** Youssef M.A. Hashash (UIUC), Binod Tiwari (CSF), Robb E. S. Moss (CalPoly), Domniki Asimaki (Caltech), Kevin B. Clahan (LCI), D. Scott Kieffer (TUGraz), Doug S. Dreger (UCB), Amy Macdonald (TT), Chris M. Madugo (PG&E), H. Benjamin Mason (OSU), Menzer Pehlivan (MRCE), Deepak Rayamajhi (OSU), Indra Acharya (TU) and Basanta Adhikari (TU).

## Executive Summary

The April 25, 2015 Gorkha (Nepal) Earthquake and its related aftershocks had a devastating impact on Nepal. The earthquake sequence resulted in nearly 9,000 deaths, tens of thousands of injuries, and has left hundreds of thousands of inhabitants homeless. With economic losses estimated at several billion US dollars, the financial impact to Nepal is severe and the rebuilding phase will likely span many years.

The Geotechnical Extreme Events Reconnaissance (GEER) Association assembled a reconnaissance team under the leadership of D. Scott Kieffer, Binod Tiwari and Youssef M.A. Hashash to evaluate geotechnical impacts of the April 25, 2015 Gorkha Earthquake and its related aftershocks. The focus of the reconnaissance was on time-sensitive (perishable) data, and the GEER team included a large group of experts in the a

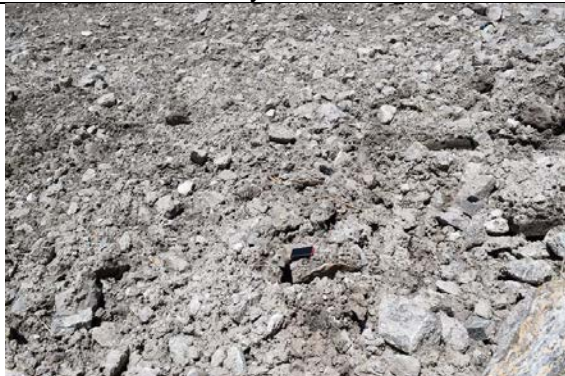
Within days of the  $M_w$ 7.8 Gorkha Earthquake, a large debris avalanche buried over 200 people in the Langtang Village located at the Latitude of  $28^{\circ} 12' 55.43''N$ ; Long –  $85^{\circ} 30' 8.95''E$ ; Alt 3297 m above msl. Google Earth images of the debris avalanche area prior to and after the avalanche are depicted in Figure 5-95 and Figure 5-96, respectively. Although Langtang Village is not clearly visible in the Google Earth image, higher resolution images are presented in Figure 5-97 through Figure 5-99, and a detailed view of the village area is shown in Figure 5-98. The estimated length and width of the debris is 400 m x 900 m, respectively. Based on an average estimated depth of about 5m, the overall debris avalanche volume is estimated at about 2 million  $m^3$ . The source of the debris mass is estimated to be 2 km from the current debris deposit, representing a relief on the order of 1,600m (Figure 5-97 and Figure 5-98). Part of Langtang Village was buried under the landslide debris, with the remainder destroyed by associated air blast effects. The air blast flattened forested areas along the left bank of the river (Figure 5-101). Structures beyond the distal reaches of the debris avalanche also succumbed to violent air blast (Figure 5-102 and Figure 5-103). Where the debris mass completely blocked the Langtang River channel, the river passed under the debris mass and thus avoided ponding of surface water (Figure 5-104). The debris materials were very loose and wet at the time of visit (Figure 5-105). More than 95% of the debris materials were finer than 0.5m (Figure 5-106).

Figure 5-105 Typical sizes of the debris avalanche mass materials (28°13'0"N 85°30.2'0"E).

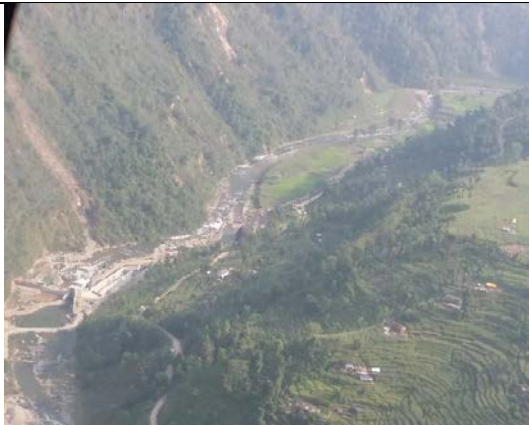
Figure 5-108 Dam site of a hydropower station near Barpak is vulnerable to potential landslide in the next rainy season or earthquake event.

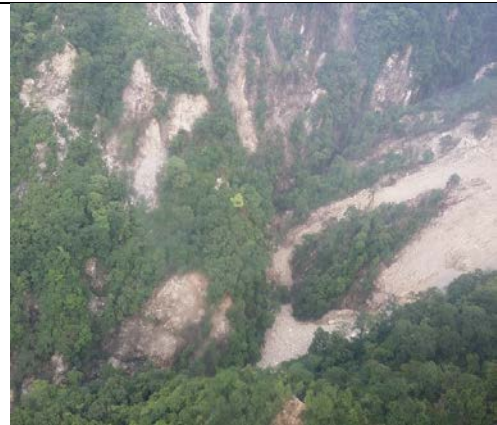
Figure 5-109 Seismically induced landslides near Barpak blocked the natural flow of a stream.

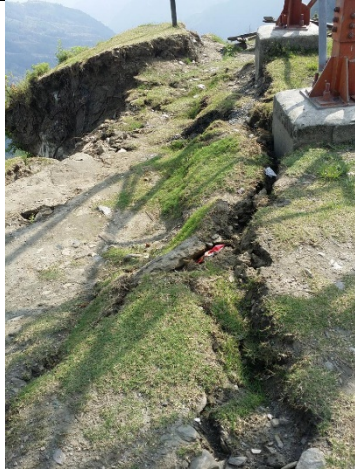
Figure 5-110 Main scarp of a seismically induced landslide observed at the north east edge of the Barpak Village, epicenter of the April 2015 Gorkha earthquake.

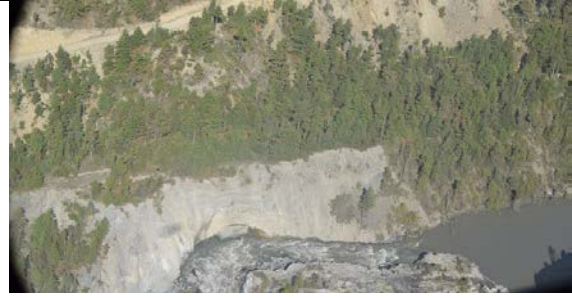
The aerial route covered in this section is shown in Figure 5-112. The Manang area, especially at elevations higher than Chame, is composed of very loose sediment and weathered materials (Figure 5-113). The 2015 Gorkha Earthquake destabilized the sediments locally and dammed the Marshyangdi River a few kilometers downstream of Higde Airport (Figure 5-114). Very loose debris masses that have potential to slide down and block the Marshangdi River were observed extending to Lake Tilicho (Figure 5-115). Many landslides were also observed along the banks of Budi Gandaki River in the direction of Prok (Figure 5-116). Those landslides partially blocked the river and damaged the road connecting Arughat to Arukhet at several locations (Figure 5-117). There were many large scale landslides between Arukhet and Prok that partially blocked the Budi Gandaki River (Figure 5-118). A tributary of Budi Gandaki River near Prok was also blocked at several locations due to earthquake induced landsliding.

Figure 5-114 A landslide that blocked Marshangdi River temporarily right after the 2015 Gorkha Earthquake.

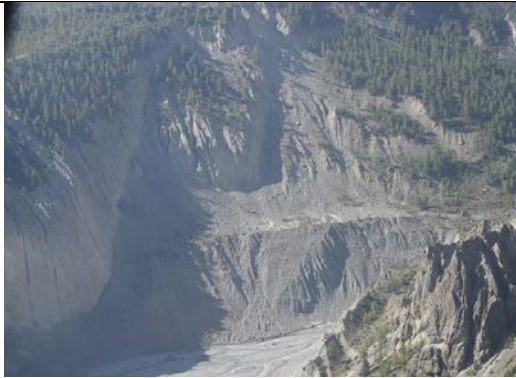
Figure 5-115 Loose sediment mass along the trekking route from Manang to Lake Tilicho ( $28^{\circ}4.97'0''N$   $85^{\circ}13.8'0''E$ ).

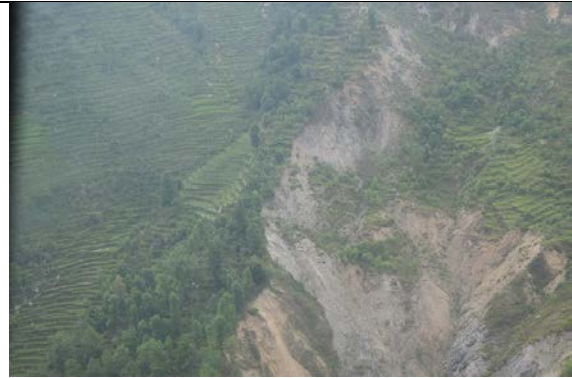
Figure 5-116 Landslides that damaged the road along Arughat-Arukhet road sector.

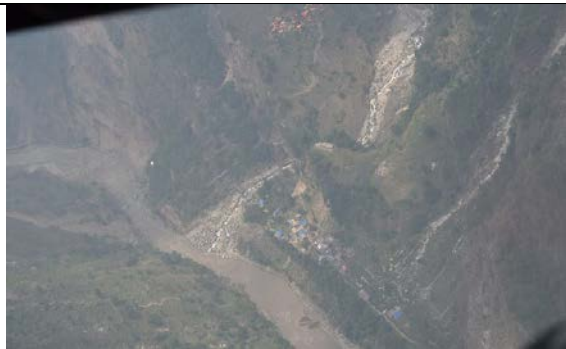
Figure 5-117 A landslide along the bank of Budi Gandaki River.

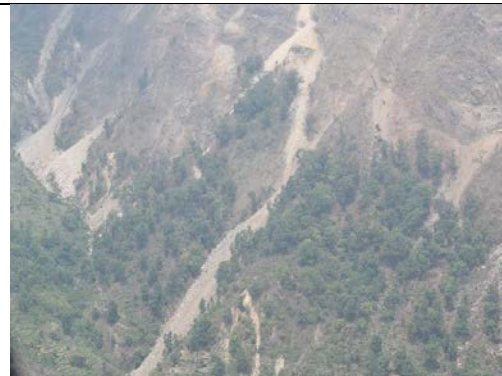
Figure 5-118 Multiple landslide observed along a tributary of Budi Gandaki River near Prok right after the 2015 Gorkha Earthquake.

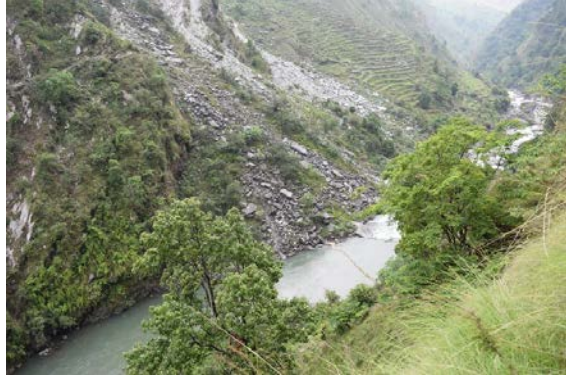
A landslide dam was observed at Pandise, located in the Sertung Village Development Committee of the Dhading District (Figure 5-119). The landslide occurred at Ankhu Khola, a tributary of the Budi Gandaki River. The slope gradient of the tributary was approximately 30-35°, and large boulders traveled down the tributary of Ankhu Khola, blocking the river channel for about a week (Figure 5-120). The landslide dam was breached naturally.

Figure 5-119 A landslide dam at the tributary of Ankhu Khola right after the 2015 Gorkha earthquake main shock (28°40.6'0"N 83°59.8'0"E).

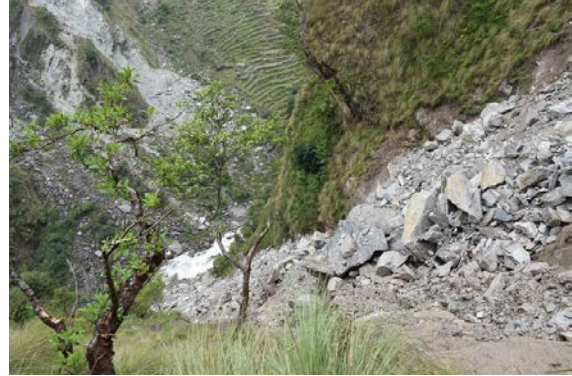
Figure 5-120 Debris mass from the left bank of the river that caused the landslide damming.

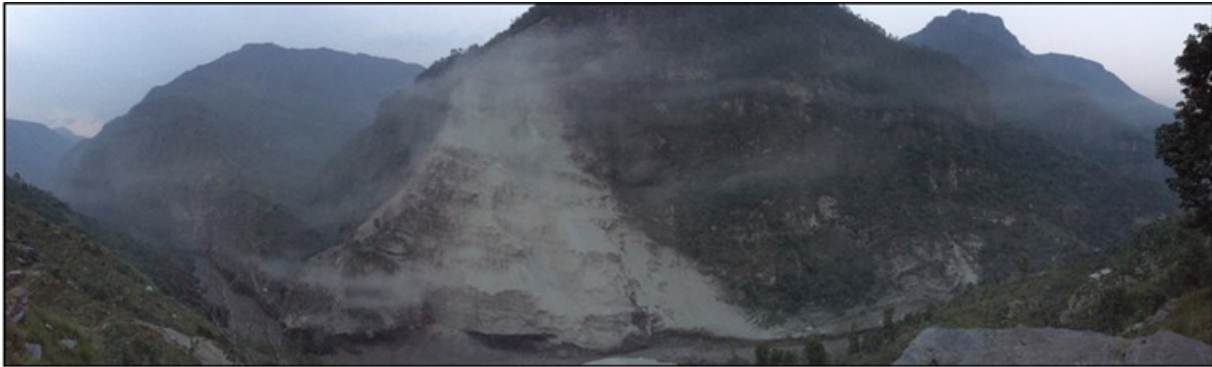
Figure 5-123 The landslide blocked the Kali Gandaki River forming approximately 2 km long and 150 m deep artificial lake, 28 24' 8.48"N 83 35' 47.5"E.

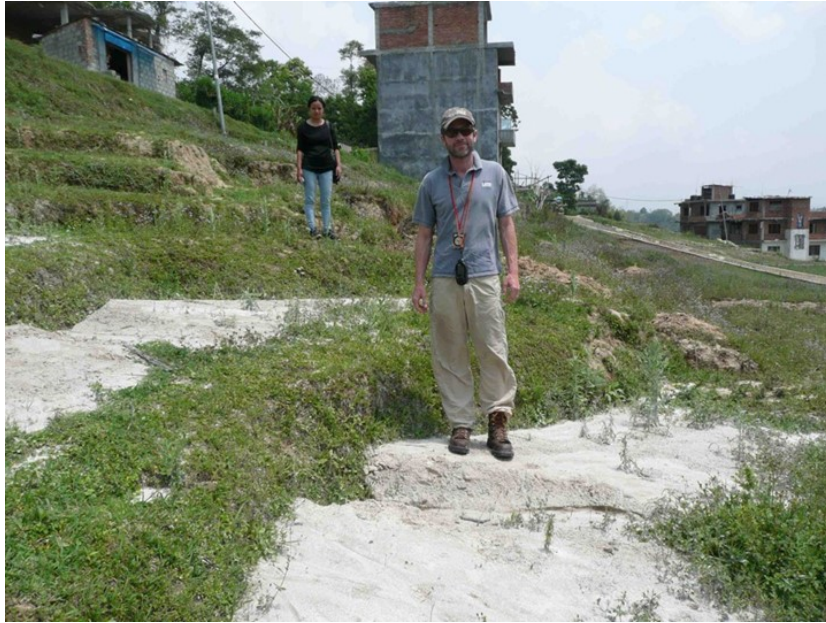
Ramkot is located on the western edge of the Kathmandu Valley. Liquefaction of very fine material was observed on steep terraces (Figure 6-5 and Figure 6-6). No lateral deformation of terraces was found. Ejecta located in the terraces and on lower fields was confined to a narrow swath of the hillside (see Figure 6-5). Similar features were found down by the creek (Figure 6-6), but the biggest sand boils were on the steep (20 degree) slopes. Locals reported that the boils issued for 2+ hours following the M7.8 earthquake. Foundation damage of two small poorly constructed houses correlated with this narrow swath of liquefaction. Other taller more modern structures experienced no damage. Increased driving stress due to taller building may have inhibited liquefaction by locking up the soil. Slope failures were observed in the surrounding hills but were not associated with liquefaction. Structural damage was heavy in the town of Ramkot but not associated with liquefaction.

Figure 6-5. Liquefaction ejecta on steep terraced slopes (27.711025° N 085.262290° E). No lateral movement was observed. No damage to the building in the background.

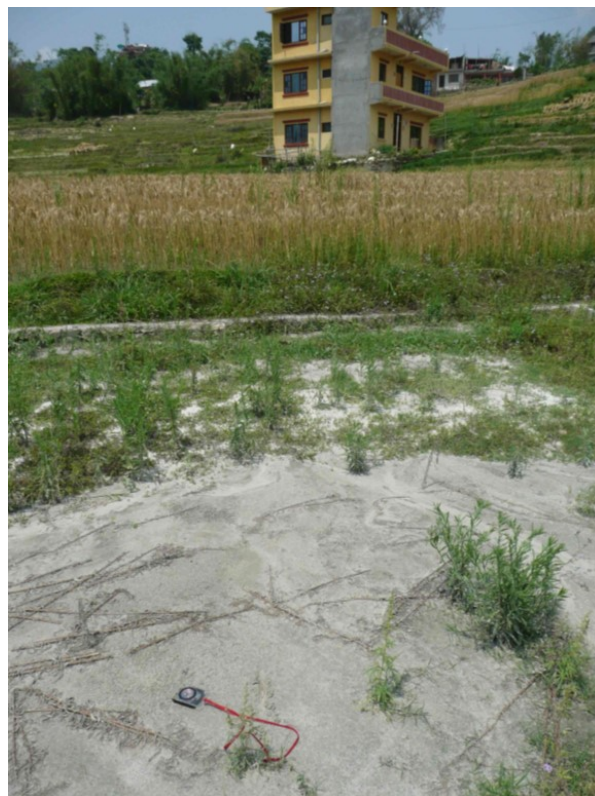
Figure 6-6. Liquefaction ejecta in agricultural field. Material was very fine, primarily silt with some sand. No damage to the building in the background (27.711025°N, 085.262290°E).

Sand boils were observed in an empty plot of land (Figure 6-6). This site is located about 90 m northeast of a meandering river; it is elevated above the floodplain. According to the locals, the ground flooded during the earthquake and remained flooded for two days. Locals also claimed that other plots in the vicinity liquefied, but we could not find surface effects of liquefaction elsewhere. After auguring on this site, we found that the soil profile generally

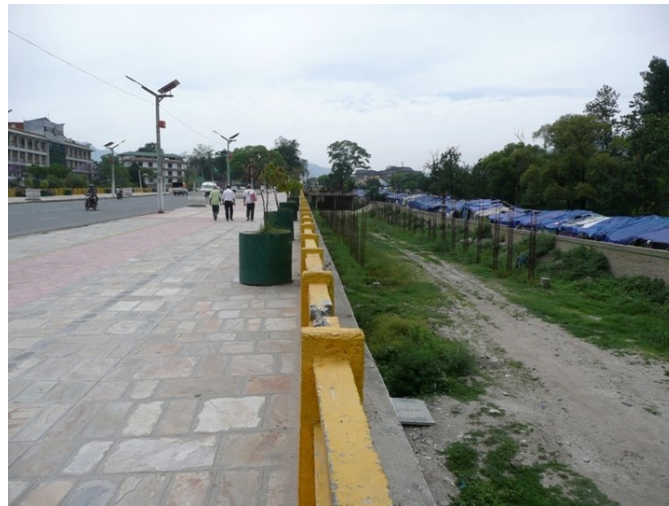
One bridge case history of interest is the Singa Durbar Bridge in the center of Kathmandu (Figure 6-7). This bridge was undamaged after the M7.8 and first aftershock, but sustained damage in the M7.3 event. There appears to be a soft soil failure that aligns with the width of the creek deposits under the bridge. Lateral cracks in the raised concrete sidewalk sections run on both sides of the bridge parallel to the creek and are separated by roughly 100m along the length of the bridge. Talking with a local who is currently building a deep foundation in the affected area, he says the subsurface conditions are fill over “black cotton” silty clays, the same lake deposit found throughout the Kathmandu valley. It is anticipated that there are underlying sandy soils as well but currently there are not subsurface investigations to confirm this. The mode of soil failure, liquefaction or cyclic failure, at this site is undetermined at this moment.

Figure 6-7. Singa Durbar Bridge (27.698793°N, 85.320060° E). To the right of the bridge can be seen the deep foundation that is currently being installed for a building.

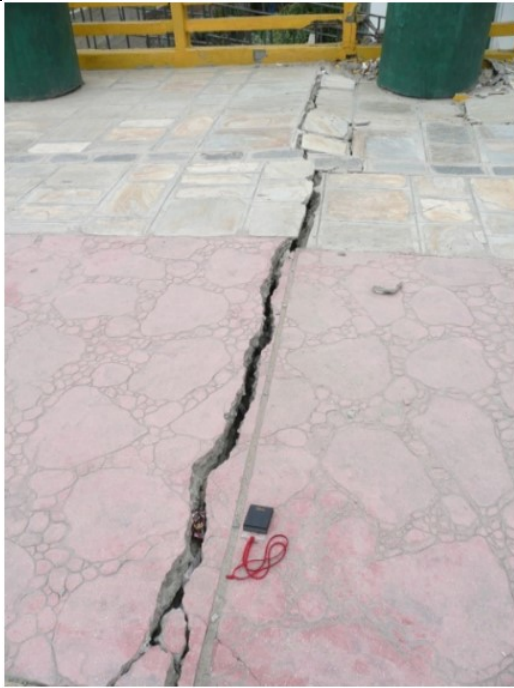
Figure 6-8. Cracking in concrete section of bridge (27.698793° 85.320060°). Cracks on both sides of the bridge line up with the creek below. No cracking in the asphalt over fill section, it behaved in a ductile manner

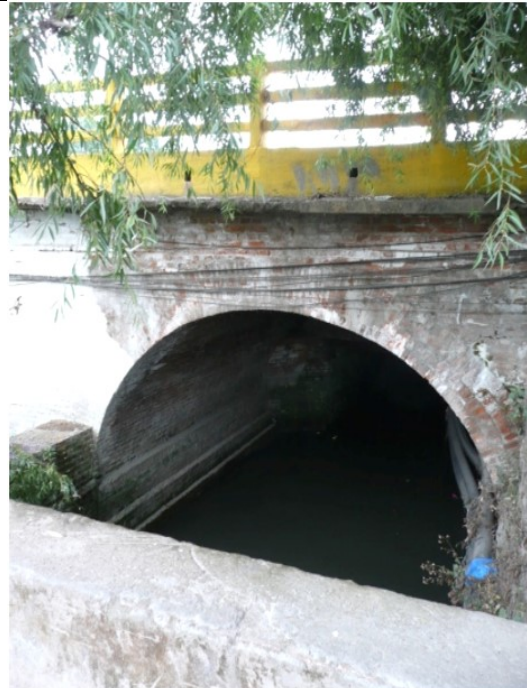
Figure 6-9. Creek below the bridge (27.698793° 85.320060°). The flood plain of this creek defines the extent of the cracking, with the cracks parallel to the creek alignment.

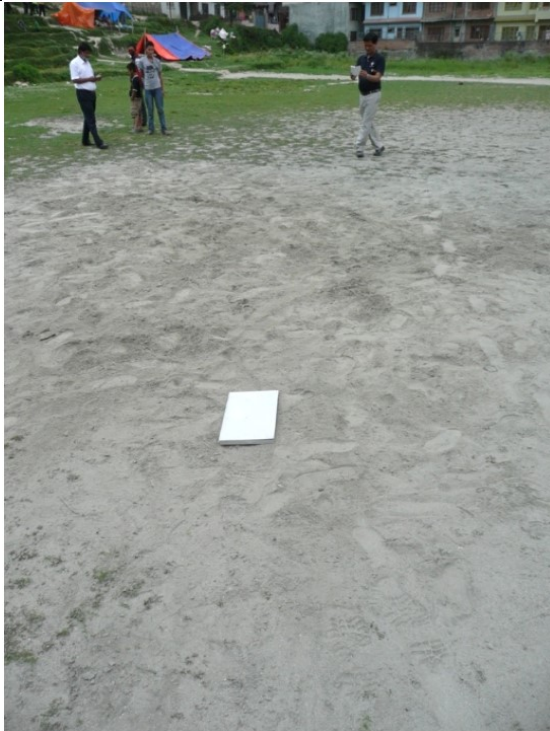
Liquefaction was observed in free field conditions as well as under building foundations at Manamaiju (Figure 6-10 and Figure 6-11). The location is an old abandoned river channel. There were sand boils of fine micaceous sand (see lab tests, Figure 6-12), some minor building tilting/punching, and a possible incipient lateral spread along a free face. Locals stated that sand boils ejected material up to 1 m above the ground surface. Here liquefaction was triggered but not enough shaking occurred to get large displacements. This would be called a “marginal” liquefaction site in Seed et al. (1985) terminology, and if the ground shaking can be properly quantified at this site, it would provide a datapoint right near the triggering threshold. A bag sample of ejecta was collected and tested at Tribhuvan University for FC, gradation, and PI. Follow up studies should include acquiring any existing bore logs from nearby site, make detailed measurements of the free face, make more detailed measurements of foundation settlement (on the order of a few cm) and building tilt (less than 2 degrees), and arrange for some penetration measurements (preferably CPT).

Figure 6-10. Large sand boil in a field at Manamaiju. The ejecta was a micaceous silty fine sand. (27.745523° N, 85.302223° E).

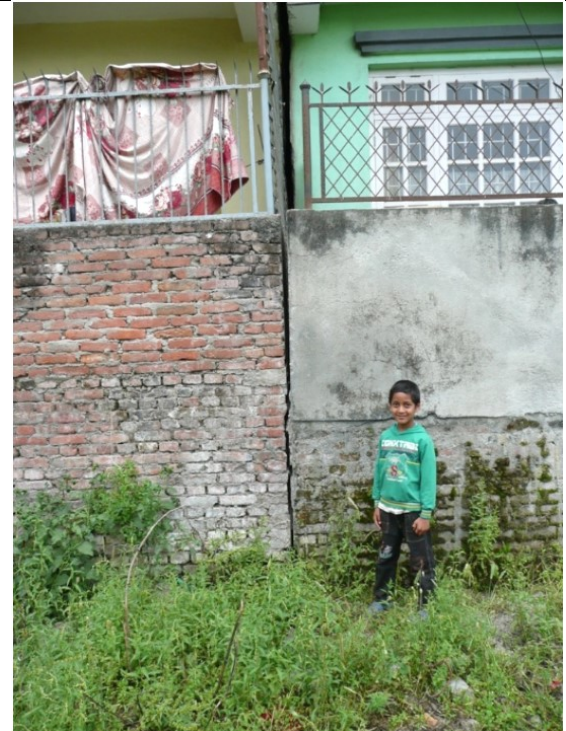
Figure 6-11. Tilt of left building away from right building, measured at roughly 2 degrees (27.745523° N, 85.302223° E).

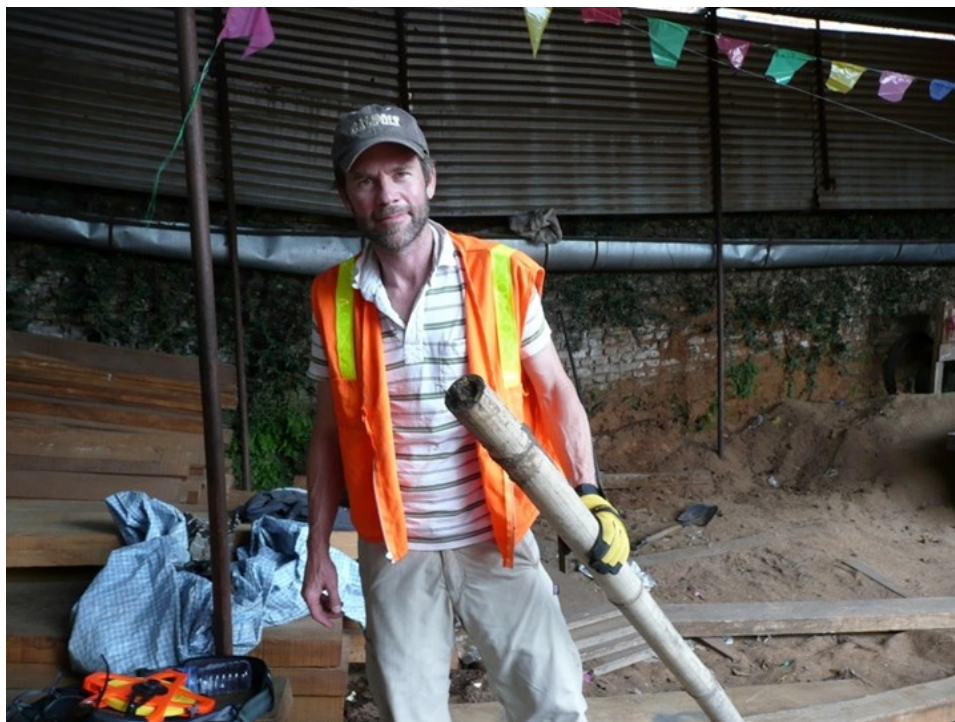
Figure 6-16. Bamboo sample of silty clay soil called “black cotton” in the Kathmandu Valley. ( $27.674816^{\circ}$   $85.362646^{\circ}$ ).

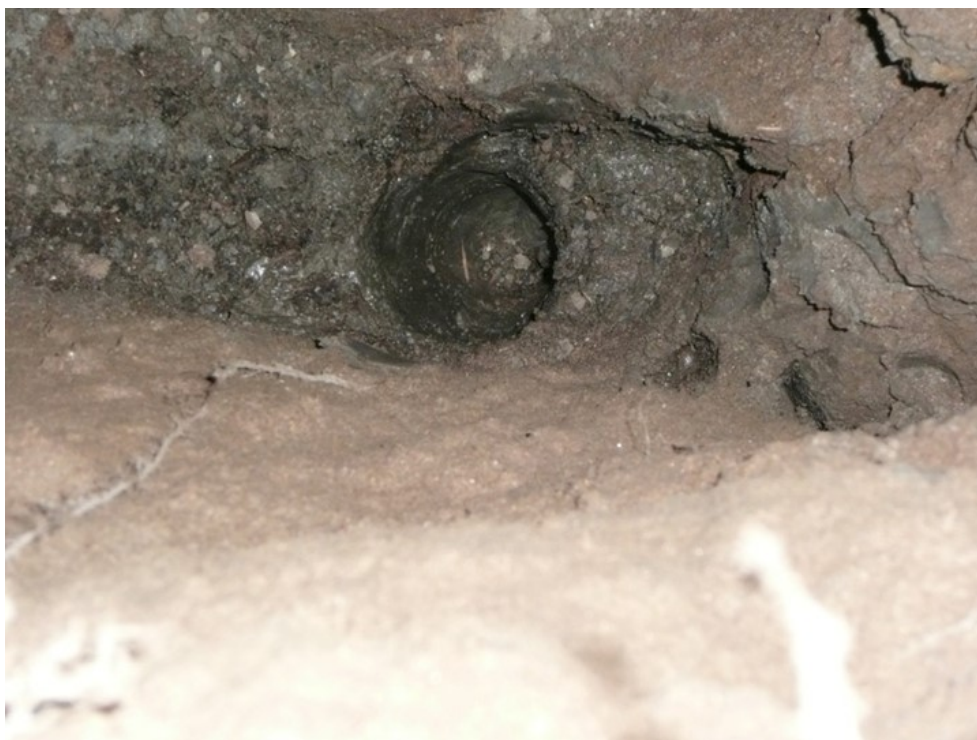
Figure 6-17. Bottom of crack at 2m depth where the "black cotton soil" was sampled. (27.674816° N, 85.362646° E).

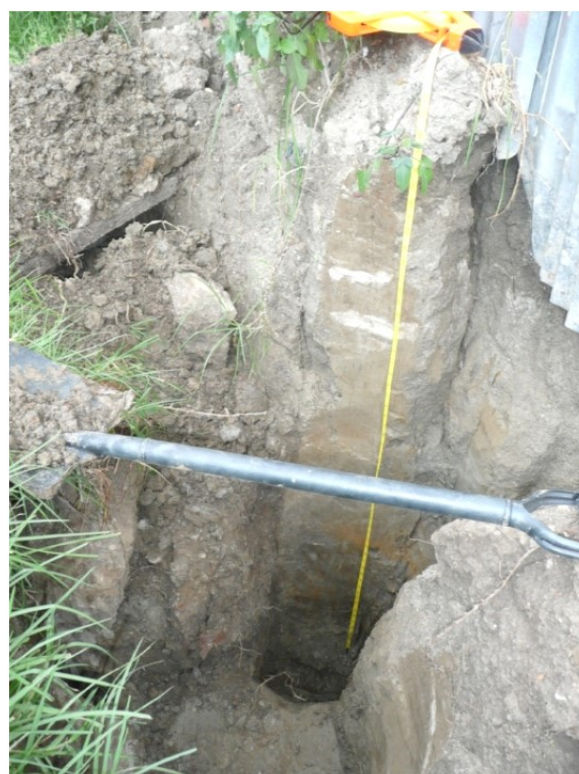
Figure 6-18. Hand trench to 2m depth to acquire bulk sample of "black cotton" silty clay. Depth coincides with slip surface of nearby houses that experienced vertical deformation of up to 0.75 m. Here the trench is dug into the hanging wall of the crack (27.674316° N, 85.362654° E).

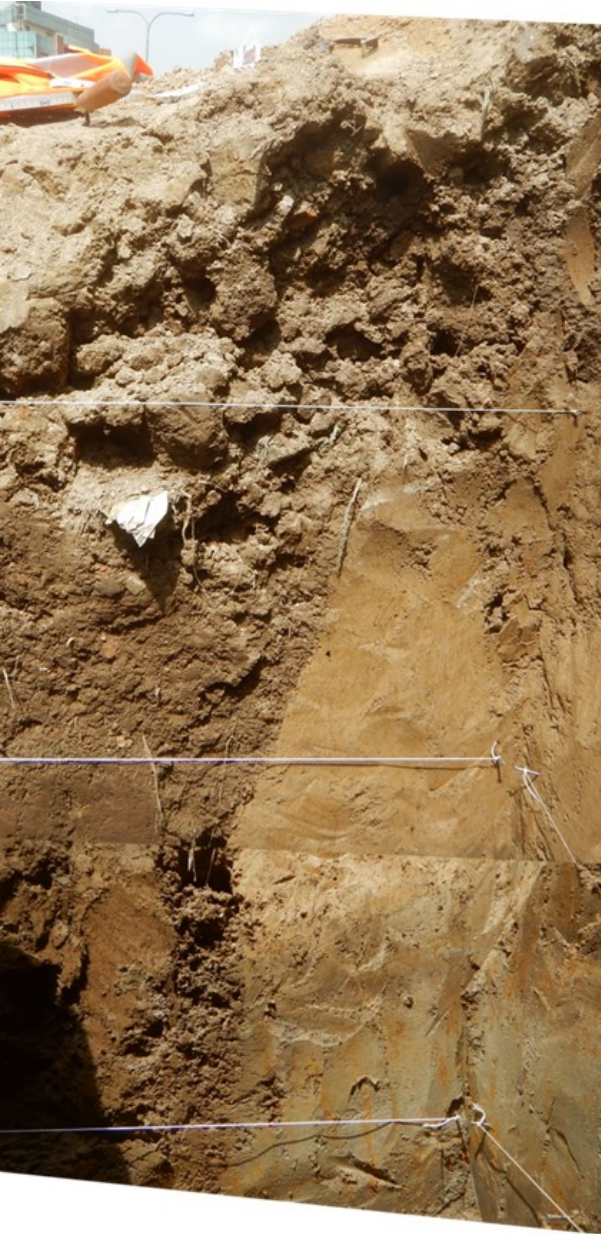
Initial investigations observed that the failure planes entered a silty clay/clayey silt with low PI. Near the location of maximum slip (27.67439 N, 85.36267 E) we dug a pit about 2 m deep (depending on which side of the scarp is considered the ground surface). We used the shear vane to measure the peak shear strength of 150 kPa and residual shear strength of 112 kPa at 1 m below the base of the trench (sensitivity of about 1.3). However, these values should be used with caution since we could not confirm that the silty clay at this depth was fully saturated. Based on the observations described above, as well as the length of the fissures and local accounts that the failures progressed slowly, the failure mechanism was initially attributed to cyclic failure in the clay.

Figure 6-20. Cross section of failure plane on wall of trench at EMT04. Horizontal string is separated vertically by 0.5 m (27.67439 N, 85.36267 E).

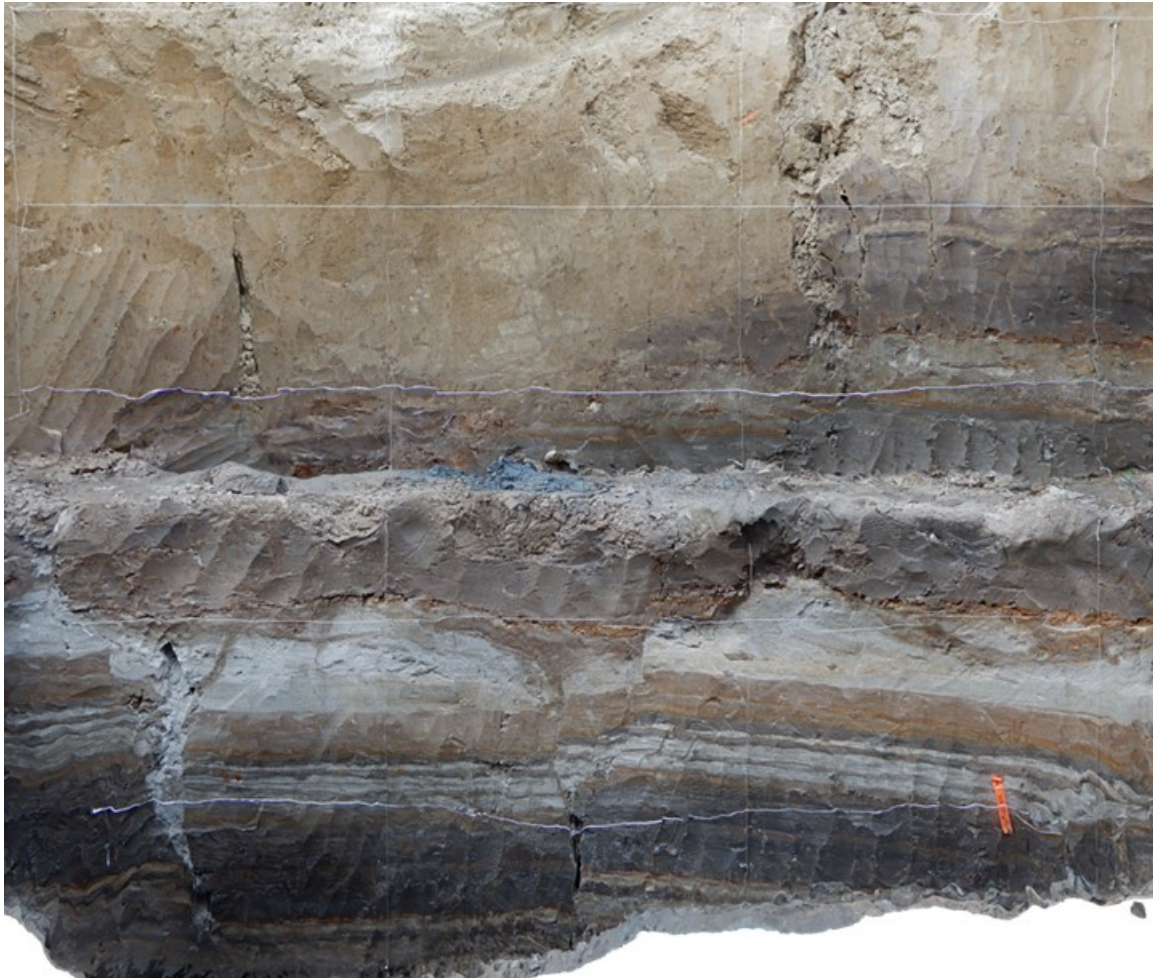
Subsequently, we found an empty lot (27.675524 N, 85.363083 E) with space for a backhoe to dig a large trench a little over 2.25 m deep. The ground is dipping here at about 4 degrees toward the river. The excavation revealed more complex failure planes than were evident on the surface or from the previous trenching efforts. A well in an adjacent house showed that the

water table is at about 13 ft. The trench did not reach the water table, but it did reveal liquefaction escape structures that were capped by the clay/fill layers. We augered from the base of the trench and reached the saturated sand. The water table was 1.8 m below the bottom of the trench (or about 4 m depth) which is consistent with the adjacent well. The slip surfaces in the top layer of clay/silt terminated in the sand that was brought up to the base of the clay. The cracks continue past the sand layers but shift to different paths. Offset beds forming a graben are evident at depths greater than 2 m. Interestingly, the slip between blocks of the graben have created large voids that have not caved in at the time of the trenching. These features were only evident at the base of the trench so it was difficult to determine the full extent of the voids.

Figure 6-21. Cross section perpendicular to scarp at EMT09. Horizontal and vertical spacing of the string is 0.5 m and 1.0 m, respectively (27.675524 N, 85.363083 E).

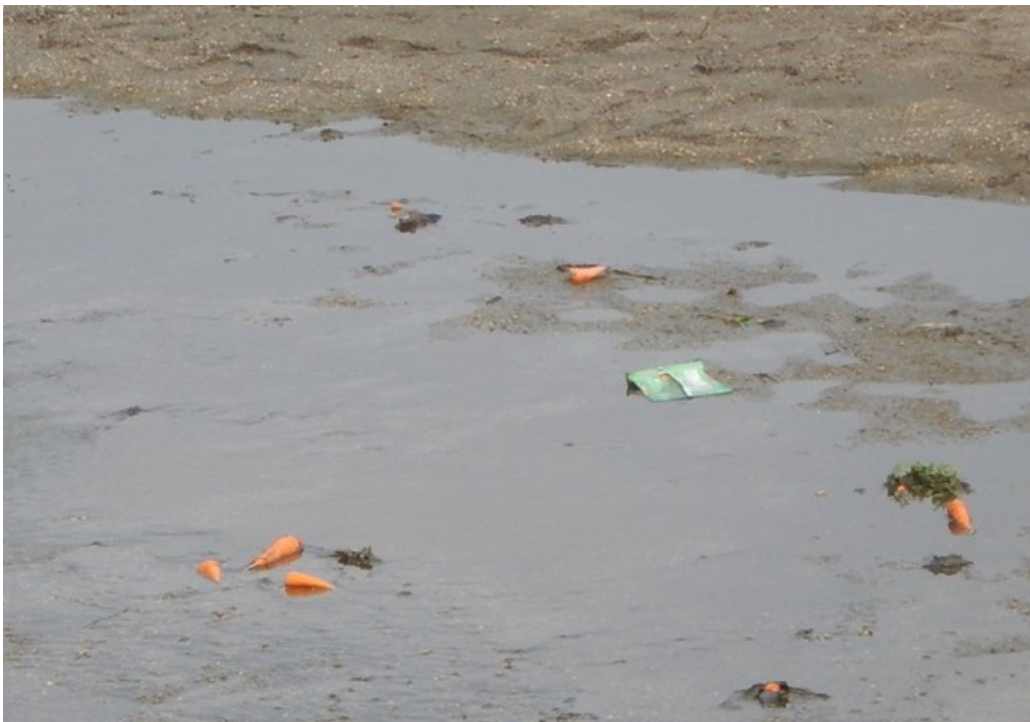
The liquefaction site near Mulpani is located on the same floodplain as Changu Narayan, but about 1.5 km southeast (Figure 6-26). Upon arrival we noticed that a lot of the children were eating raw carrots and that a lot of carrots were lying on the ground in seemingly random locations. We met with the owner of the land and he said that the entire area around the river liquefied, stating that water spouted out of the ground all around them. We asked if the carrots were brought out of the ground during the earthquake shaking and he said that it had. He also noted that he knew of other farms where potatoes had been removed from the ground due to the earthquake shaking.

Figure 6-26. Carrots that were ejected out of the ground due to liquefaction in Mulpani, 27.704575 N, 85.399617 E.

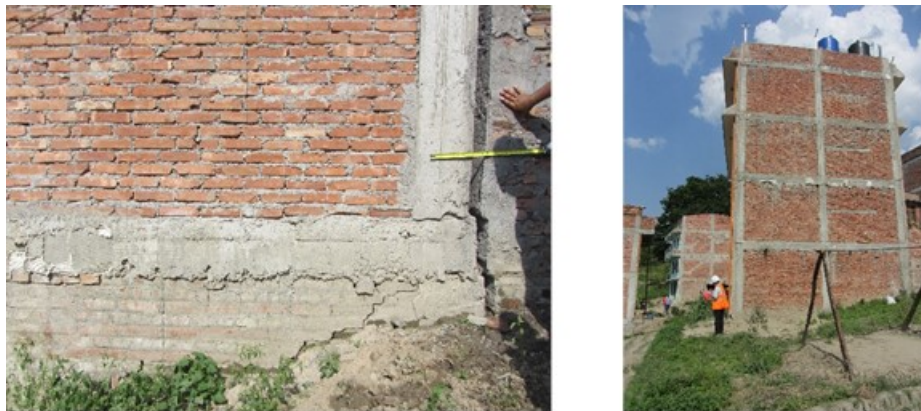
Figure 6-31 (a) Observed cracked in the wall of a RC building due to lateral deformation of ground (b) no damage on a building within the same location as cracks could not pass through the foundation (Location: 27°40'43.22" N, 85°26'10.52" E)

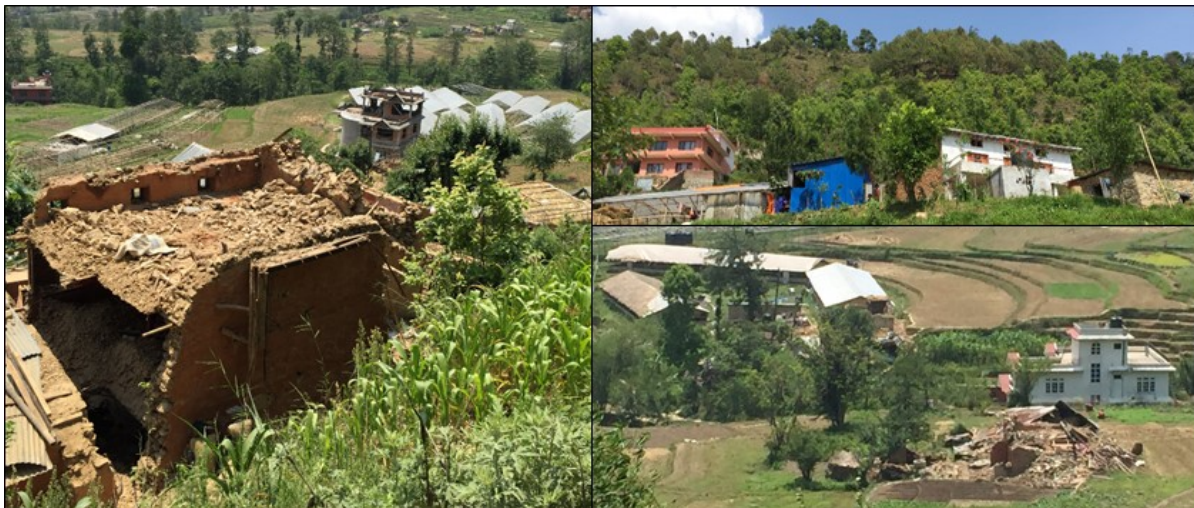
Figure 6-34 Building damage around the surface crack observed in Nagarjun

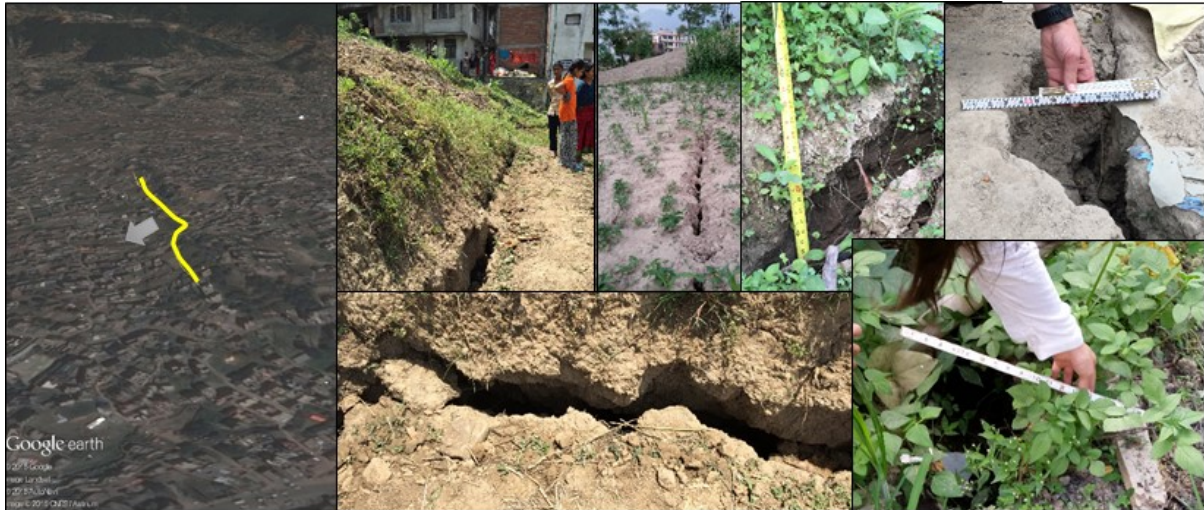
The second site visited by the GEER Team was at Syuchatar. The team walked along the exposed surface crack following the directions of the locals living in the vicinity. The surface crack is found to be on a mildly sloping hill that is occupied by few one to two story, mostly reinforced concrete frame structures (Figure 6-35). Some of the mud-mortar and masonry concrete houses in the area were damaged, however most of the reinforced concrete frame structures did not experience major damage (Figure 6-36). At some locations where the surface crack crosses through the structure a crack on the foundation slab and on the walls were observed (Figure 6-37). The surface crack at this location is estimated to be approximately 1800 ft long, at some locations the depth of the crack is observed to be up to 14 ft. and width of the crack is overserved to be up to to 1 ft. wide (Figure 6-35). The mechanism of the failure is predicted to be lateral spreading. In order to better understand the subsurface soil conditions, GEER Team returned to the site to collect samples and perform in-situ shear strength tests. At three different locations along the crack, team collected soil samples using hand-auguring and performed strength test using in-situ vane shear in collaboration with USGS (Figure 6-38). Collected samples has shown presence of silty sand layer that might have liquefied and caused lateral spreading.

Figure 6-35 Observed surface ~1800 ft. long, ~1 ft. wide, 14ft. deep surface crack in Syuchatar.

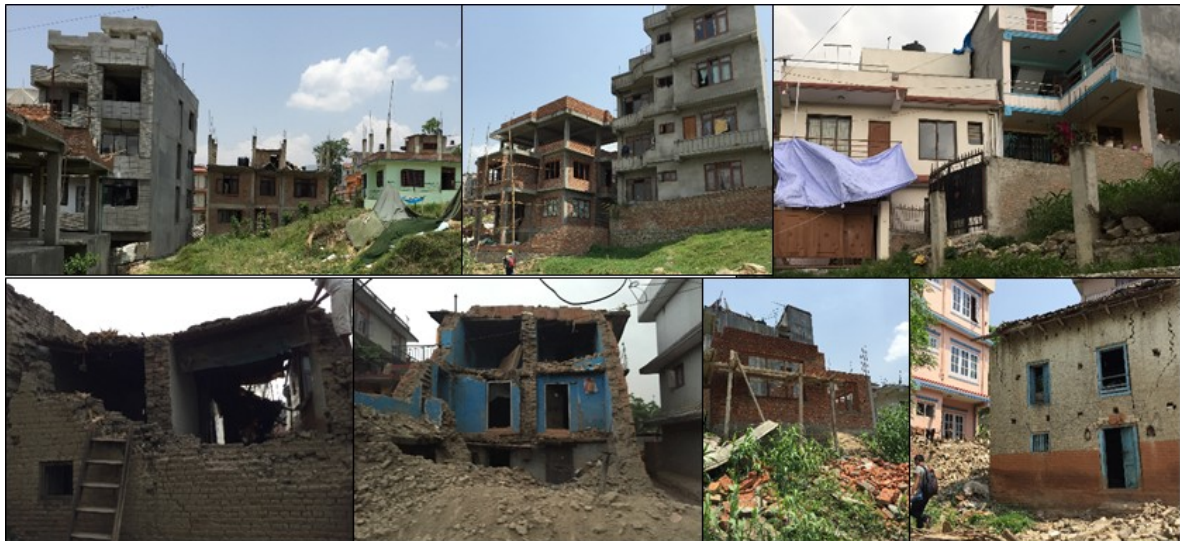
Figure 6-36 Building damage around the surface crack observed in Syuchatar.

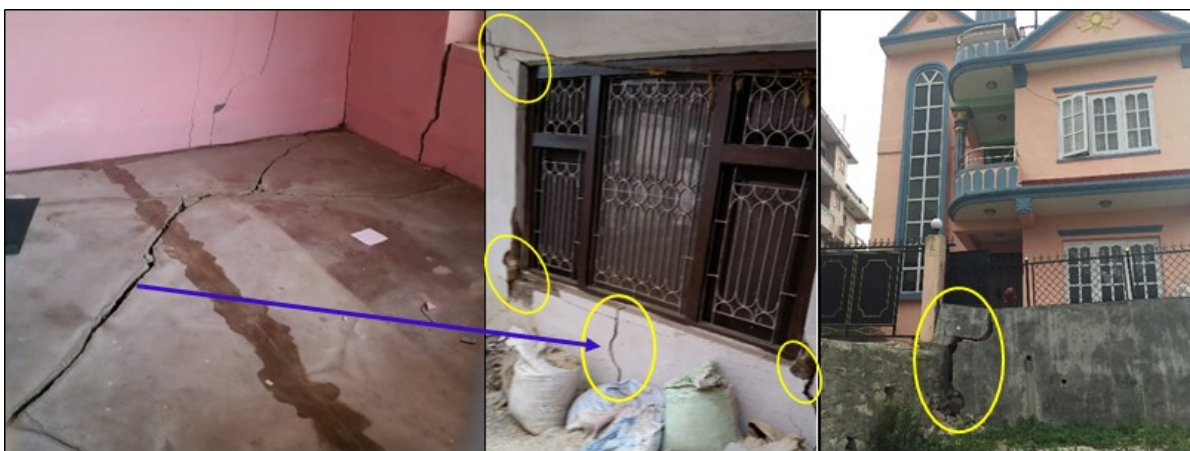
Figure 6-37 Cracks on the floor and walls due to lateral spreading in Syuchatar.

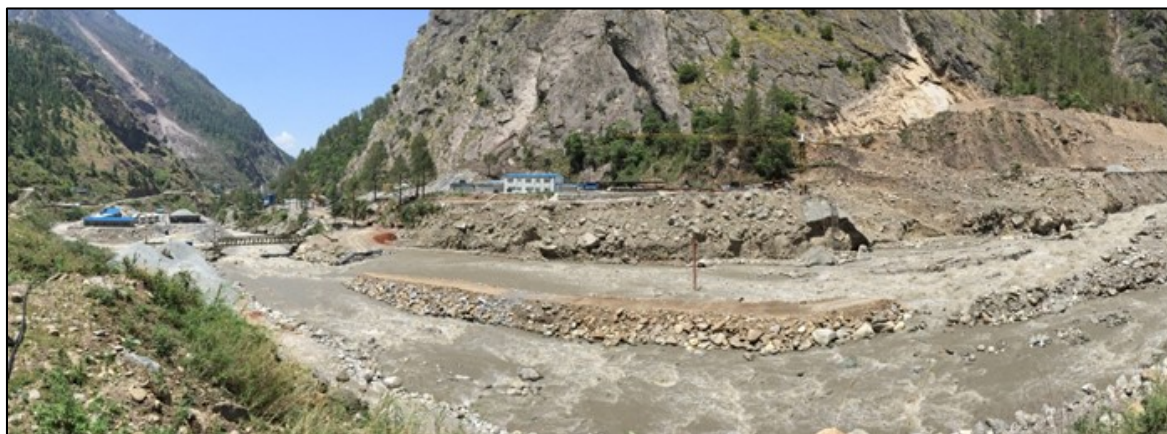
In the headworks area, several rockfalls on the north side of the river damaged construction equipment, including a crane (Figure 7-2). A large rockfall on the south side of the river buried the road to the border and diverted channel flow causing a breach in a temporary coffer dam

and inundating portions of the headwork construction area downstream (Figure 7-2). The same rockfall buried the Nepal welcome center at the Nepal/Chinese border, reportedly killing over 20 people.

Figure 7-2 Site access roads, infrastructure and equipment including a crane in the Rasawugadhi headworks area were damaged by rockfalls. A temporary coffer dam was damaged by the rockfalls and then breached when flow of the river was diverted around the rockfall, directly toward the dam, causing overtopping and erosion (28°16'27.03" N, 85°22'41.59" E).

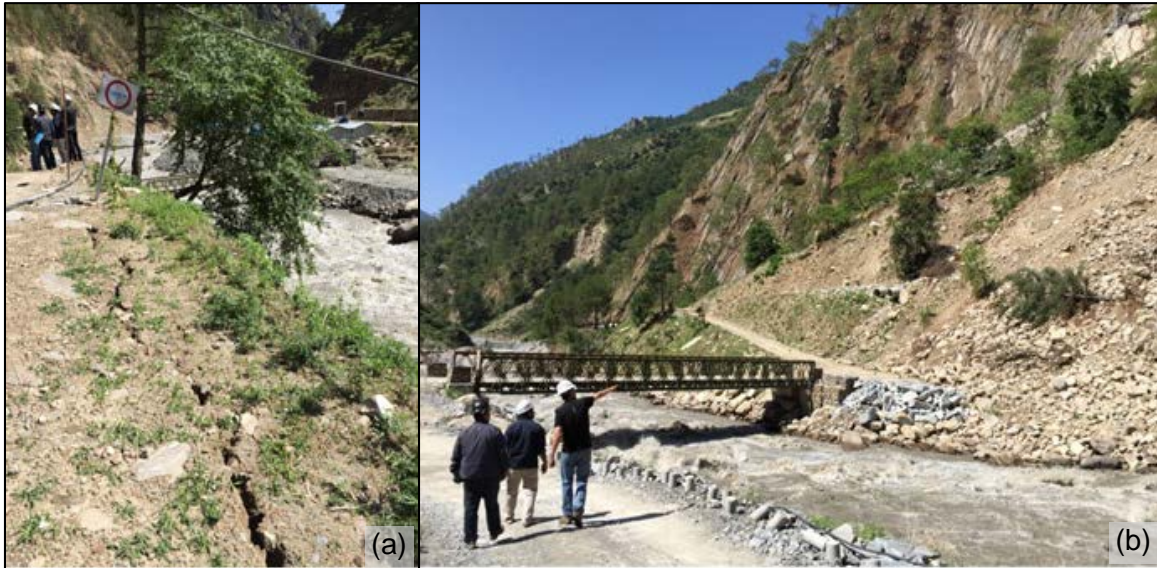
Downstream of the headworks, near the dam office and powerhouse access tunnel, roads and fluvial terraces above oversteepened slopes locally exhibited tension cracks (Figure 7-3). The access road to the surge chamber was blocked by small accumulations of rock debris shed from roadcuts upslope. Rockfalls continued throughout the project area during our site visit.

Figure 7-3 Tension cracks were observed along roads built on cut-fill slopes near the powerhouse access tunnel. Rockfall debris locally blocked access roads to this area, especially on steepened slopes. (a)  $28^{\circ}14'23.91''$  N,  $85^{\circ}21'28.67''$  E, (b)  $28^{\circ}14'28.46''$  N,  $85^{\circ}21'30.18''$  E

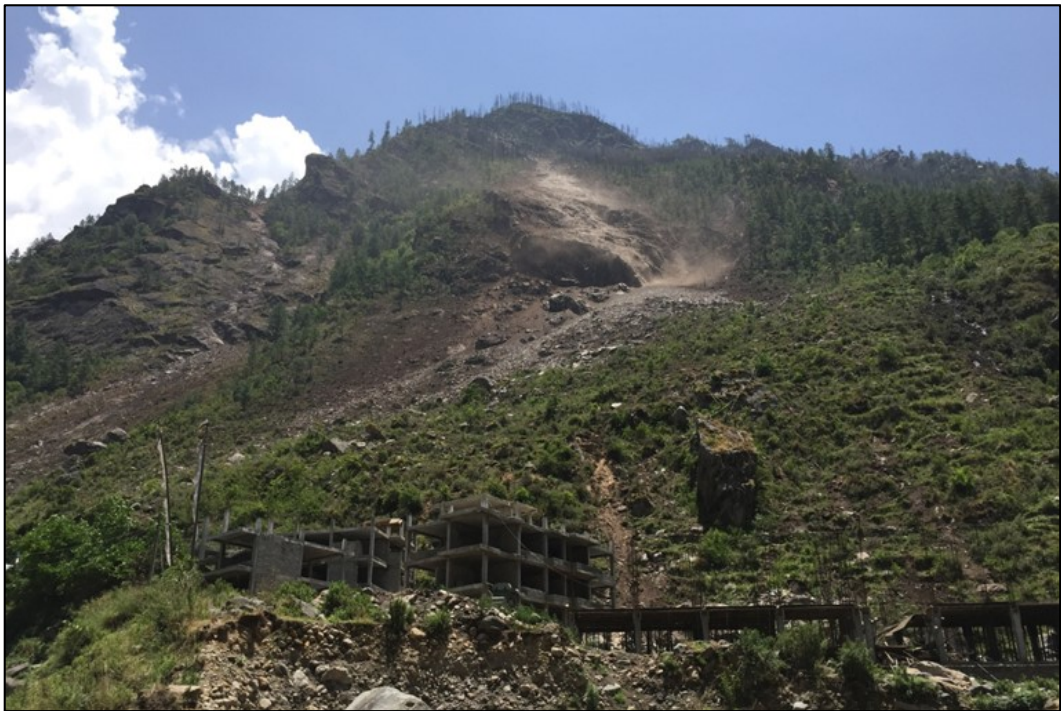
Although many portions of the hydro project are not directly in the path of rockfalls, some areas are directly below debris chutes, such as the new site for the dam workers colony that is currently under construction (Figure 7-4).

Figure 7-4 New hydro camp buildings located between the headworks and powerhouse have been impacted by some rock fall debris from above ( $28^{\circ}15'55.10''$  N,  $85^{\circ}22'30.11''$  E).

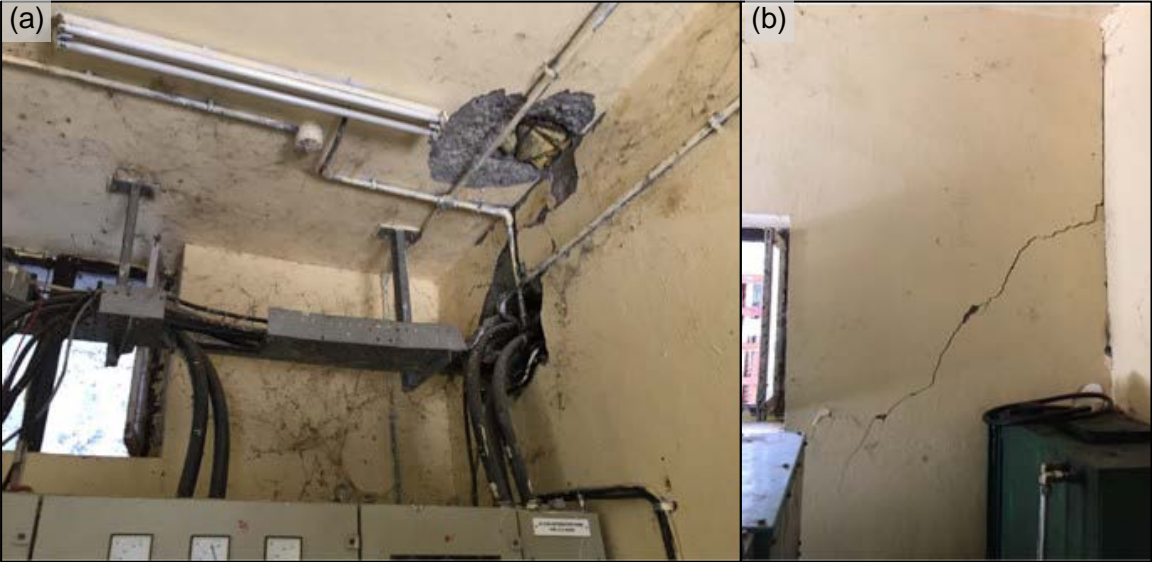
The 22 MW Chilime hydropower project sustained minimal damage from the earthquake and was operational at the time of our visit. The GEER team visited the underground powerhouse on the right bank of the river in the town of Chilime and the powerhouse yard. The powerhouse was operating during our visit. Storage buildings housing the backup diesel generator and other equipment sustained localized cracking from shaking and holes in their roofs where individual rocks measuring up to 0.25 m or more fell from overlying cliffs (Figure 7-5).

Figure 7-5 Secondary buildings at Chilime exhibited minor shaking. Damage was limited to cracks in infill walls and holes in the roofs of some structures. (a) 28°9'27.30" N, 85°16'54.38" E, (b) 28°9'27.30" N, 85°19'54.38" E

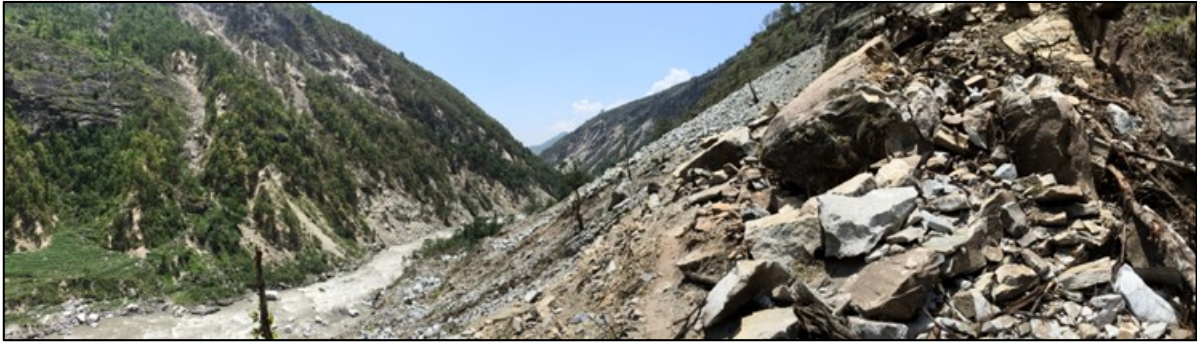
The Upper Trishuli 3A Project is under construction and will have a generating capacity of 60 MW when completed. At the time of the GEER team visit, access to the site was cut off where several kilometers of rockfall debris covered over the main access road to the site (Figure 7-6). GEER personnel accessed the site on foot and surveyed, from upstream to downstream, the headworks area, tunnel portal, workers colony, and concrete batching plant.

Figure 7-6 Continuous rockfalls block the main access road to the Upper Trishuli 3A headworks. The large pile of boulders on the right marks the location of the road. A walking path has been worn into the rockfall debris by villagers and dam workers. Tallus slopes in the background are all from fresh rockfalls. Vegetated debris cones on the left side provide evidence for previous rockfalls that were not reactivated during the 2015 earthquake. View is to the southwest ( $28^{\circ}2'53.76''$  N,  $85^{\circ}12'4.27''$  E).

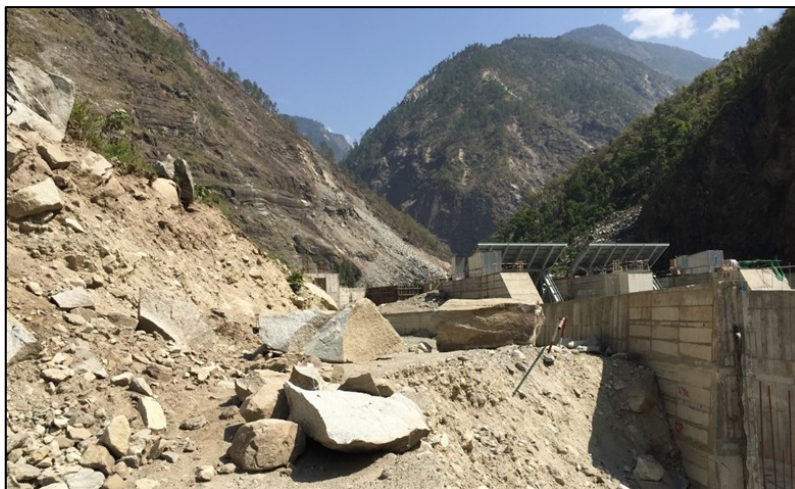
Figure 7-7 Road blocked by rockfalls through the headworks area ( $28^{\circ}3'47.21''$  N,  $85^{\circ}12'23.25''$  E).

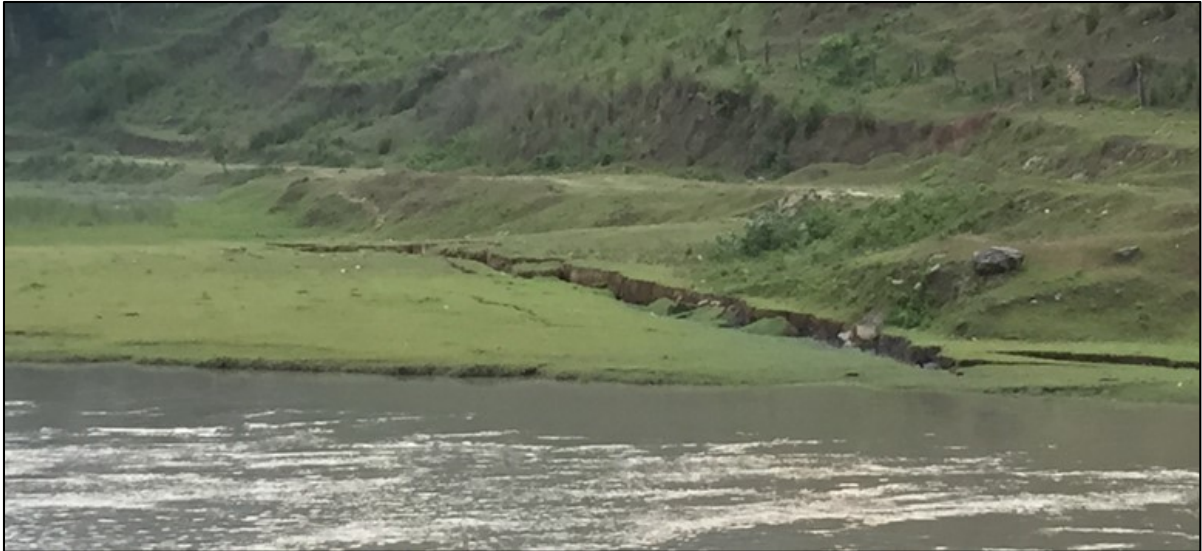
Dam personnel took the team to a section of the canal where several instances of cracking of the canal liner, and in one case piping of water from slopes beneath the canal had been observed. Cracking occurred along the edges of two large settling ponds, one lined and the other unlined. Cracks in the lined settling pond were patched with pitch. Cracks in the walls of unlined pond were patched with mud likely derived from the silt and clay caps on older terrace deposits in the vicinity. The unlined settling pond also experienced lateral spreading (Figure 7-13).

Figure 7-13 Lateral spreading around a settling pond along the canal system between the Trishuli headworks and powerhouse (27°56'15.18" N, 85°9'22.28" E).
