**Authors:** Youssef M.A. Hashash (UIUC), Binod Tiwari (CSF), Robb E. S. Moss (CalPoly), Domniki Asimaki (Caltech), Kevin B. Clahan (LCI), D. Scott Kieffer (TUGraz), Doug S. Dreger (UCB), Amy Macdonald (TT), Chris M. Madugo (PG&E), H. Benjamin Mason (OSU), Menzer Pehlivan (MRCE), Deepak Rayamajhi (OSU), Indra Acharya (TU) and Basanta Adhikari (TU).

## Executive Summary

The April 25, 2015 Gorkha (Nepal) Earthquake and its related aftershocks had a devastating impact on Nepal. The earthquake sequence resulted in nearly 9,000 deaths, tens of thousands of injuries, and has left hundreds of thousands of inhabitants homeless. With economic losses estimated at several billion US dollars, the financial impact to Nepal is severe and the rebuilding phase will likely span many years.

The Geotechnical Extreme Events Reconnaissance (GEER) Association assembled a reconnaissance team under the leadership of D. Scott Kieffer, Binod Tiwari and Youssef M.A. Hashash to evaluate geotechnical impacts of the April 25, 2015 Gorkha Earthquake and its related aftershocks. The focus of the reconnaissance was on time-sensitive (perishable) data, and the GEER team included a large group of experts in the a

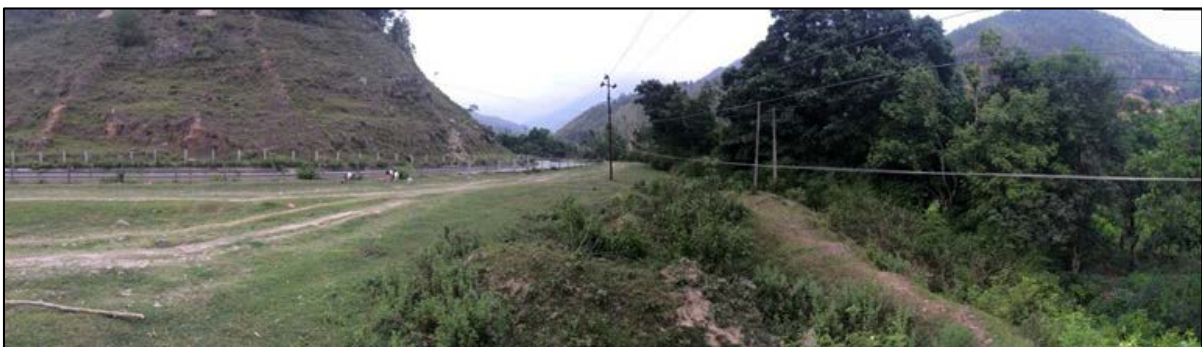
Another section of canal upstream of the settling ponds had cracks in the liner where water escaped and flowed out of the terrace riser below. The leaks stopped when the cracks were patched with pitch. The close proximity of landslide headscarps below the canal wall in this area suggests that the cracking may have been caused by lateral movement of the area adjacent to the canal (Figure 7-14). This area will require monitoring during the monsoon season to assess whether cracks reappear along this section of the canal. The powerhouse and penstocks for the Trishuli Project were not damaged by the earthquake.

Figure 7-14 Section of Trishuli canal that leaked after the April 25th earthquake. Fresh head scarp (hummocky vegetated area left of power lines) along the outer edge of the fluvial terrace to the right of the canal suggest that this area is unstable and may have mobilized during the earthquake, possibly causing extension along cold joints in the canal liner (27°56'49.48"N, 85° 9'37.79"E).

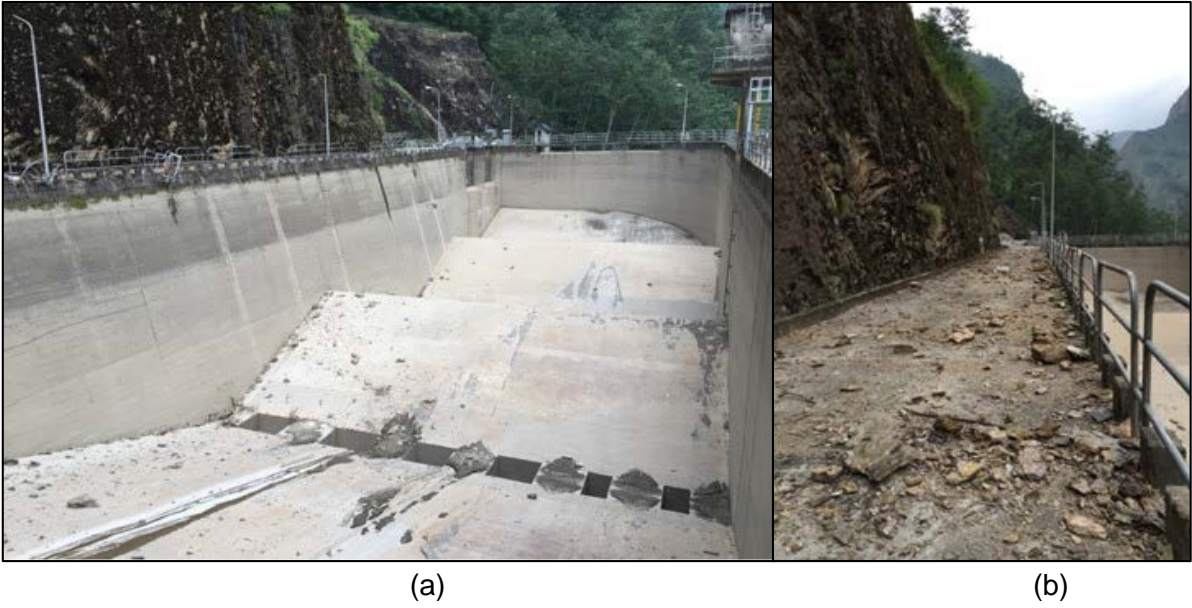
The diversion dam at the headworks was in good condition. The earthquake dislodged only small scattered rocks from the cliffs above the left abutment of the dam, with only railings and light installations damaged by rock impacts (Figure 7-15).

Figure 7-15 The Upper Bhotekoshi Headworks - Handrail damage, surficial debris impact and debris inundation from rock fall was observed at the gravel catchers. Remaining risks of damage and danger to life safety in this area are remaining risks. (a) 27°56'17.80" N, 85°56'42.88" E, (b) 27°56'17.39" N, 85°56'43.10" E

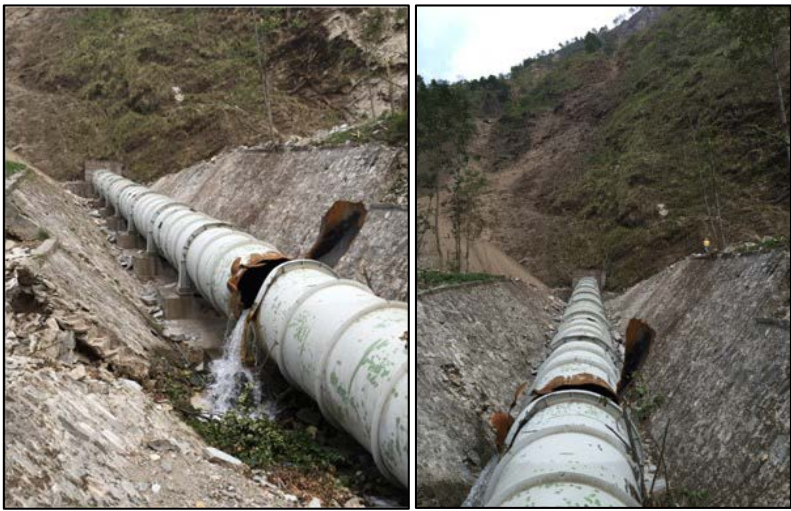
Larger rockfalls affected the powerhouse area, causing significant damage. On the left (southeast) side of the canyon, scattered blocks rained down on the penstock where it exited the canyon wall above the powerhouse. A direct hit by one of these blocks ruptured the penstock at a seam (Figure 7-16).

Figure 7-16 Penstock punctured by rock fall (a) 27°54'48.89" N, 85°55'38.25" E, (b) 27°54'46.11" N, 85°55' 38.28" E.

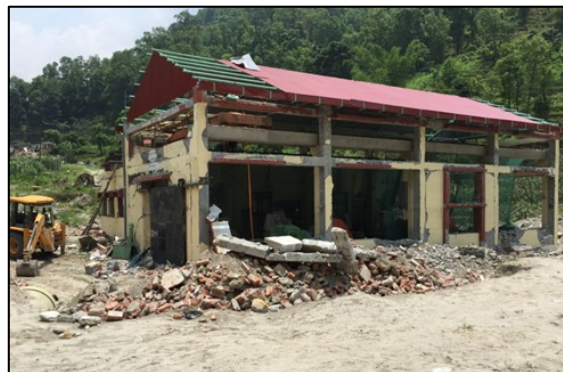
The powerhouse sustained heavy shaking damage from the May 12 aftershock after having reportedly survived the April 25th mainshock relatively unscathed. Shaking from the aftershock caused the infill walls to collapse (Figure 7-23). This may have been caused by amplification of shaking in the young, poorly consolidated alluvium on which the powerhouse was constructed.

Figure 7-23 Shaking damage to powerhouse building observed. Infill walls collapsed. Concrete reinforced frame appeared to suffer little damage. Some liquefaction also evident in the area around the structure. (27°46'36.05" N, 85°53'25.62" E)

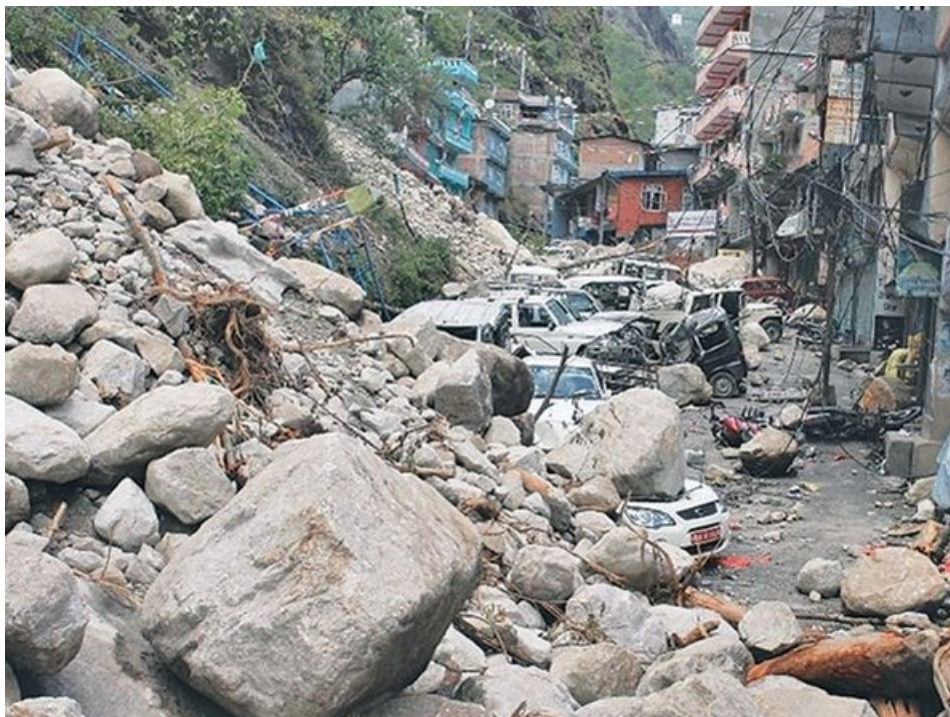
Figure 8-3 Rock falls triggered by the earthquake interrupted transportation along the Arniko Highway in Sindhupalchock. (Ref: <http://www.ekantipur.com/>)

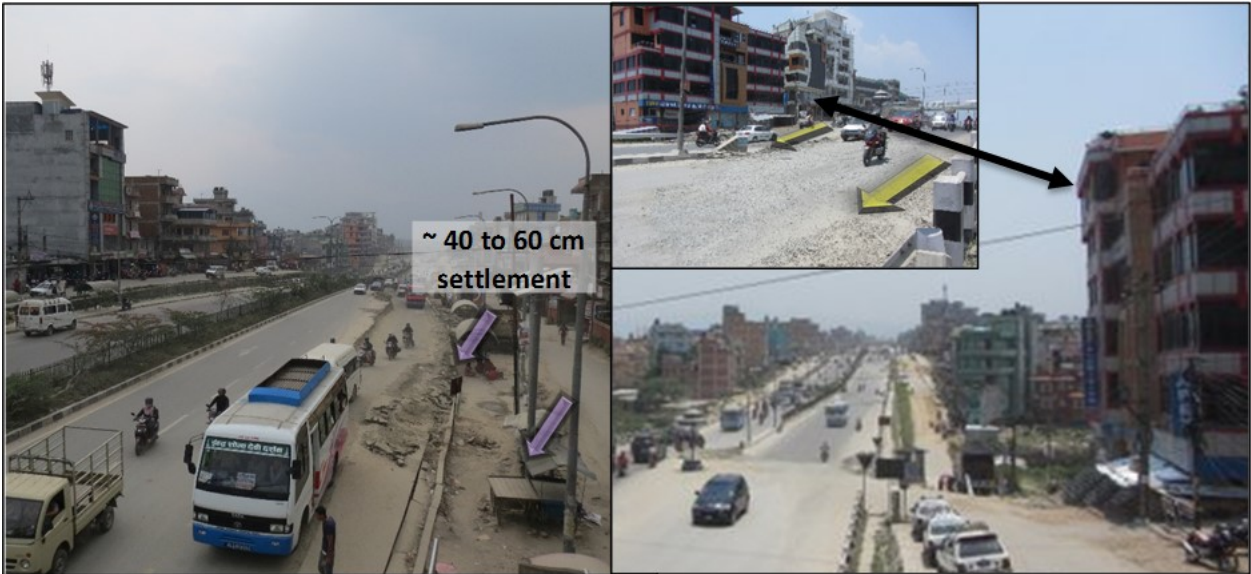
presents pictures of observed lateral cracks and associated vertical offset along the Arniko Highway. Figure 8-4a shows the lateral cracks and associated vertical offset towards the sloping ground, while Figure 8-4b shows the significant vertical offset along the highway.

Figure 8-4 Road damage due to liquefaction induced ground failure in Arniko Highway in Lokanthali, 27°40'29.06"N 85°21'36.77"E.

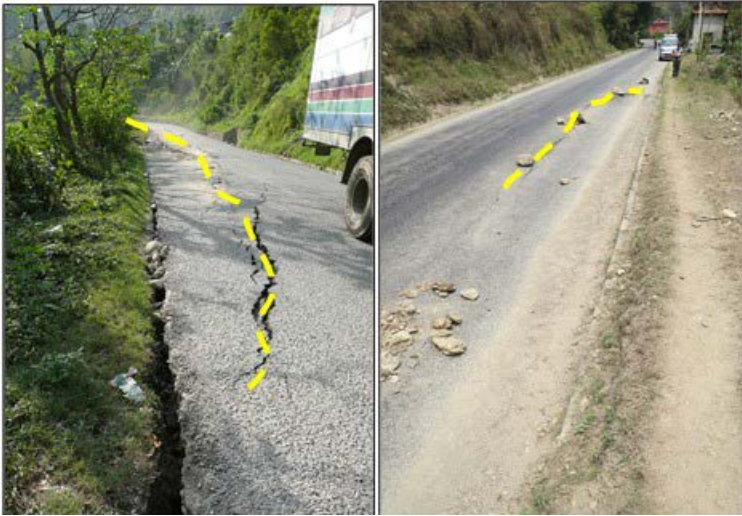
Figure 8-5 Lateral cracks observed on Blacktop roads.

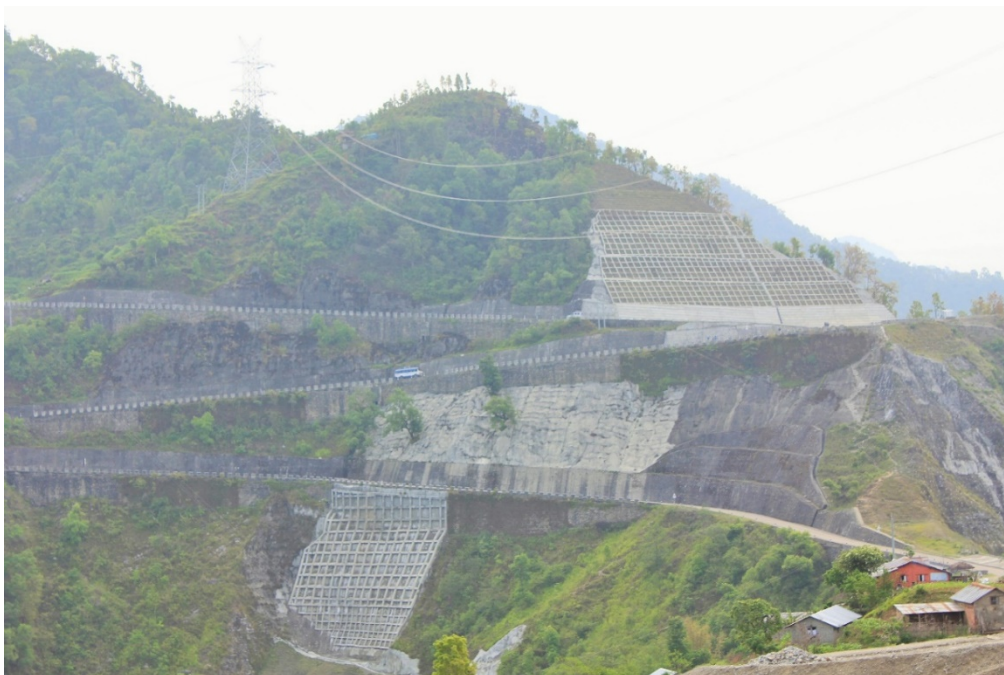
Figure 8-7 Extensive concrete retaining walls and drainage systems of the B.P. Koirala Highway performed very well during the Gorkha earthquake (27° 16' 05.98" N; 85° 56' 40.56" E).

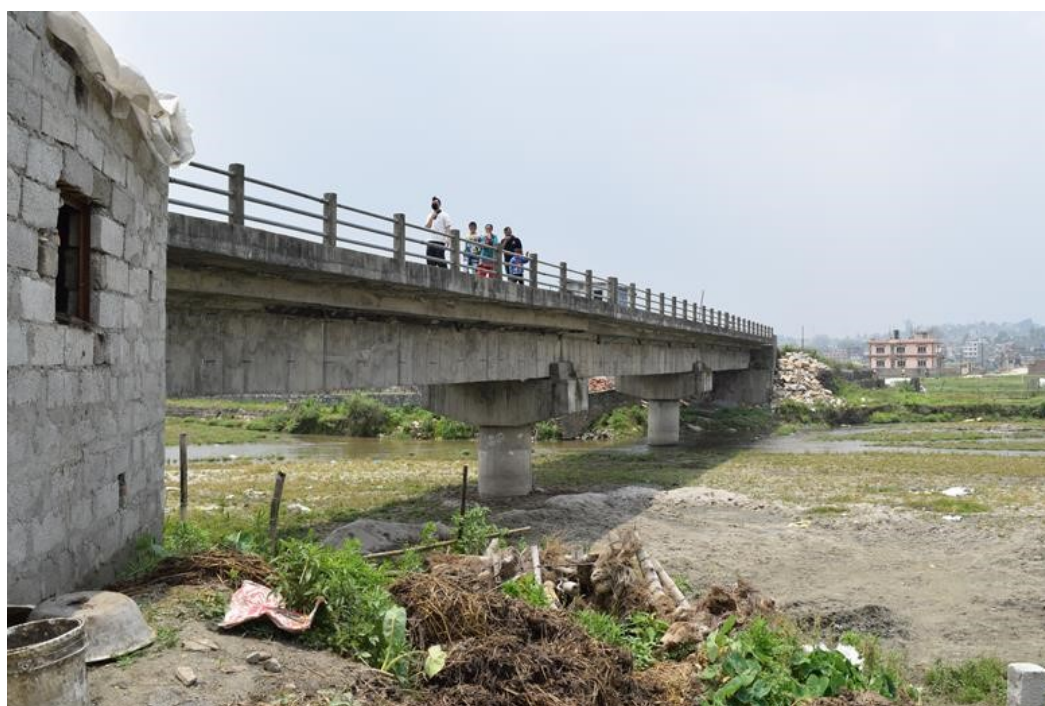
Figure 8-8 Manahara Bridge at Duwakot. This bridge performed well despite of several liquefaction induced sand boils evidenced near the bridge ( $27^{\circ}40'23.1''N$ ,  $85^{\circ}20'30.6''E$  &  $27^{\circ}42'49.584''N$   $85^{\circ}24'42.26''E$ ).

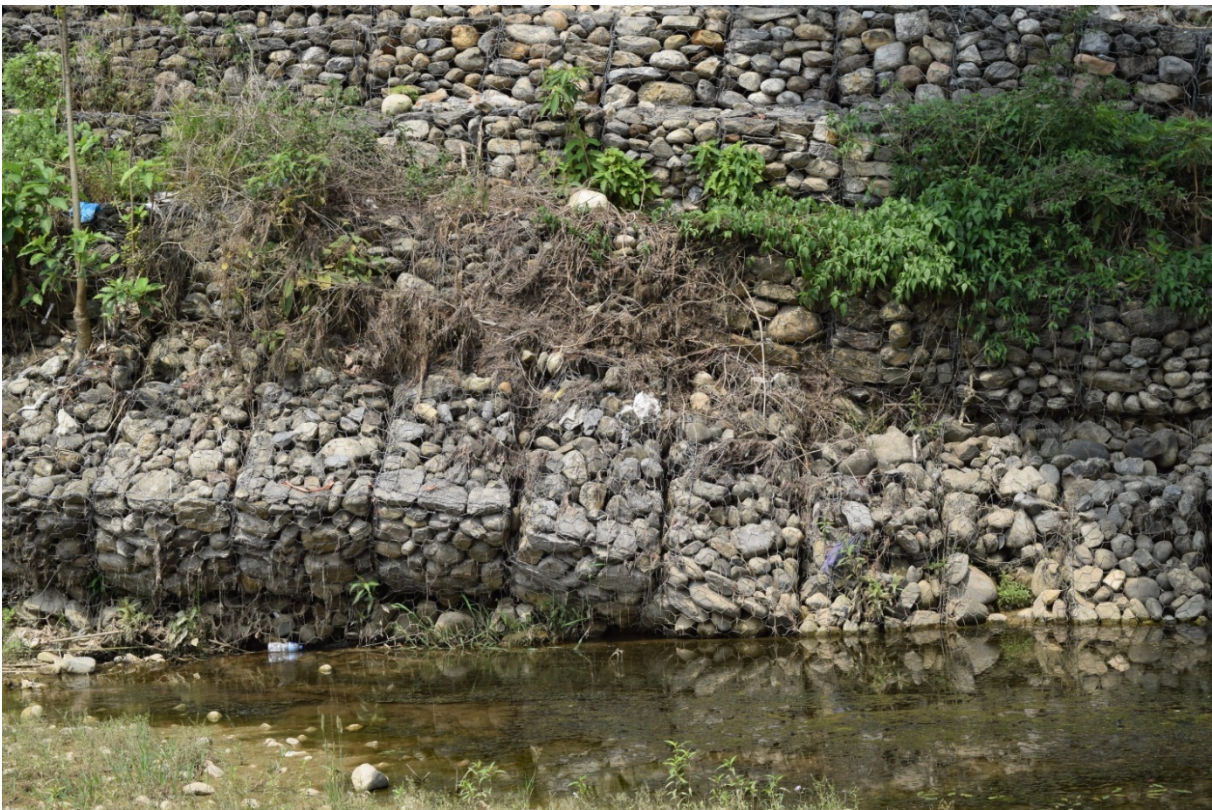
Figure 8-10 Collapse of gabion bank protection retaining wall along Madi Khola due to river bank erosion

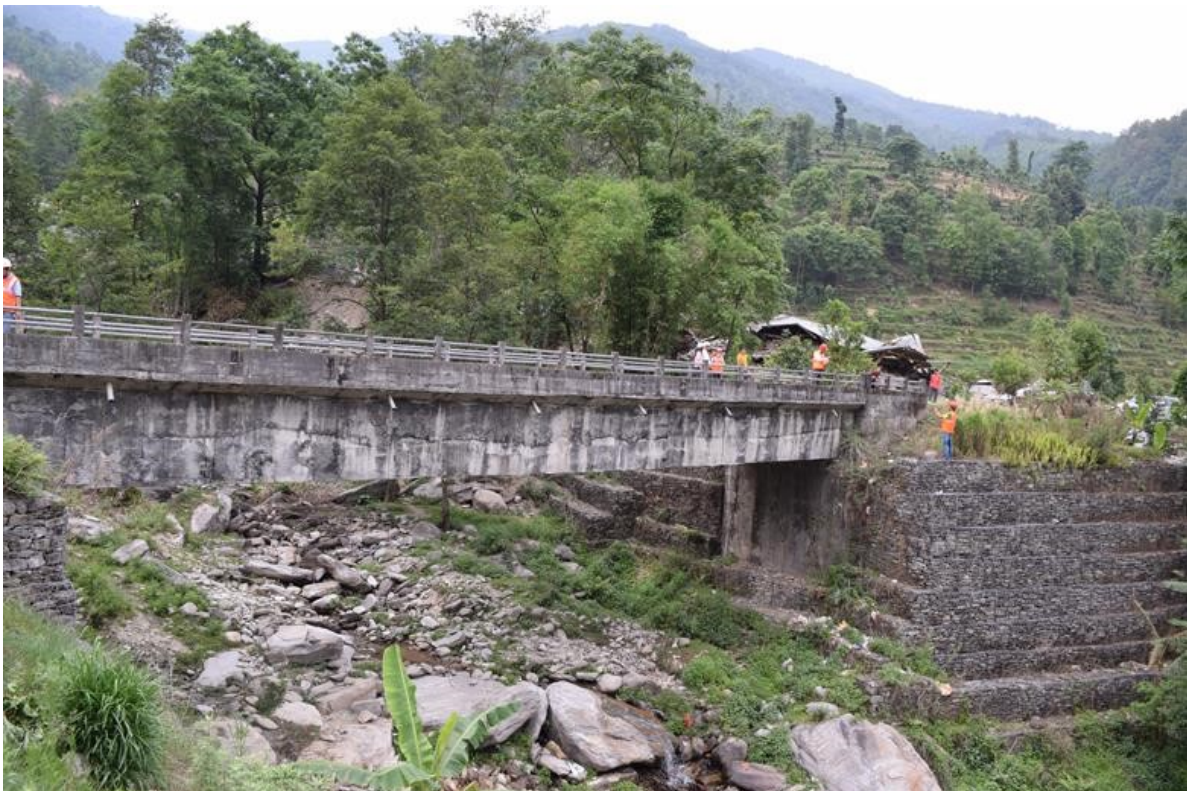
Figure 8-12 Bridge along the access road of Melamchi Water Supply Project being threatened by potential landslides along river banks and seismic settlement of road fill materials ( $27^{\circ}55'38.43''\text{N}$   $85^{\circ}33'14.510''\text{E}$ ).

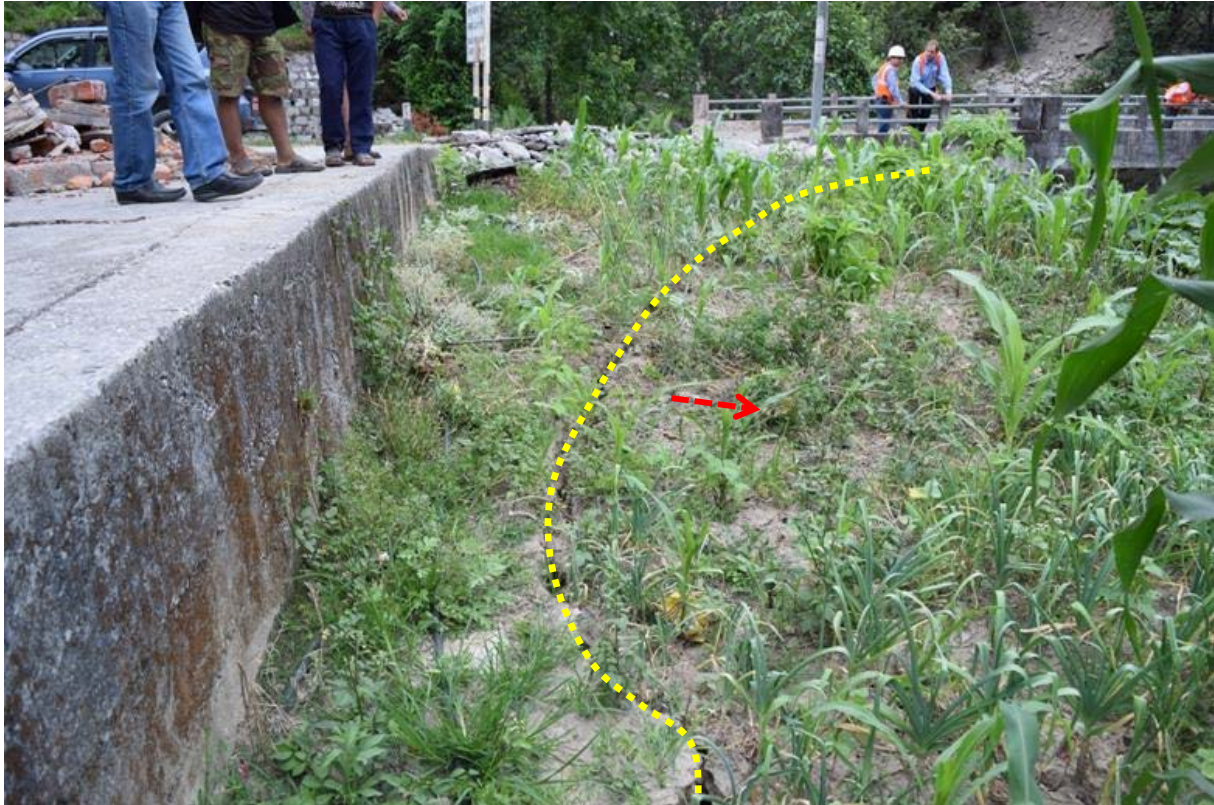
Figure 8-13 Potential landslides along the river bank that are endangering the bridge approach road (27°55'38.988"N 85°33'14.598"E).

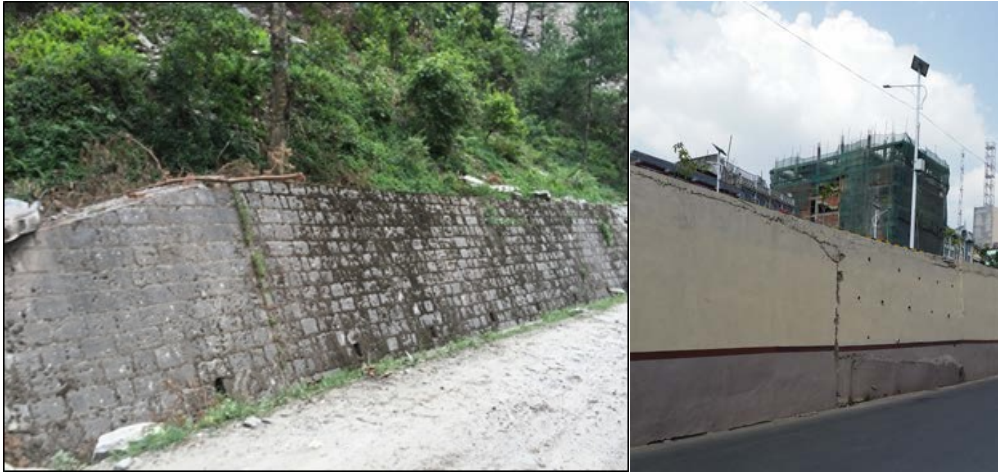
Figure 8-14 Retaining walls generally behaved well during after the April 25 mainshock and aftershocks with limited cracking (a) 27 54' 59.2"N 85 55' 48.4"E, (b) 27 41' 20.1"N 85 19' 51.2".

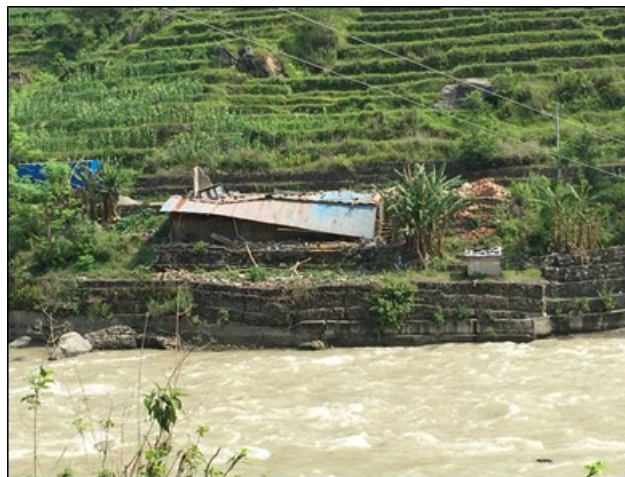
Figure 8-15 Damage in retaining walls due to the slope failures (a) 27 45' 22.2"N 85 51' 8.18"E

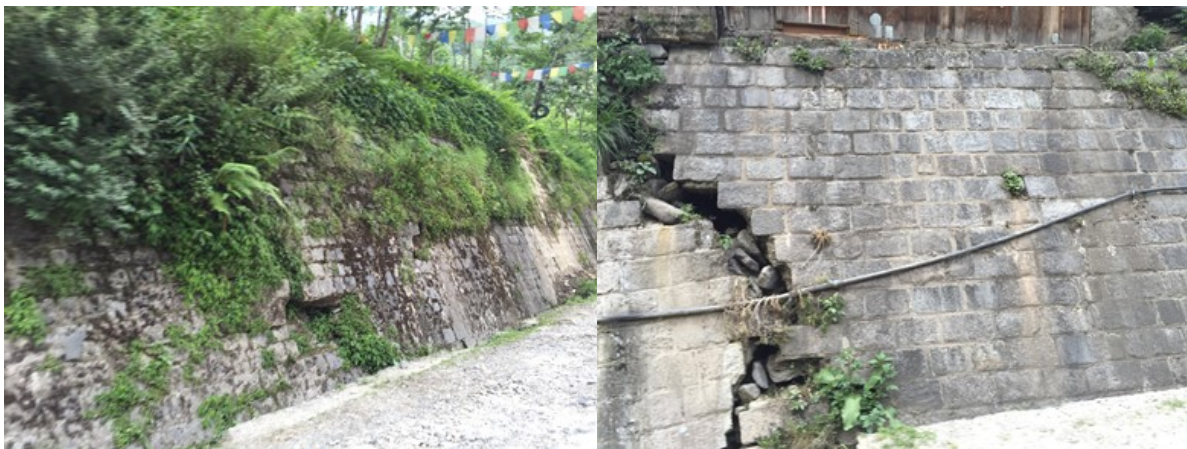
Figure 8-16 Damaged Retaining Wall (a) 27 57' 36.4"N 85 57' 24.2"E, (b) 27 56' 57.2"N 85 57' 8.28"E.

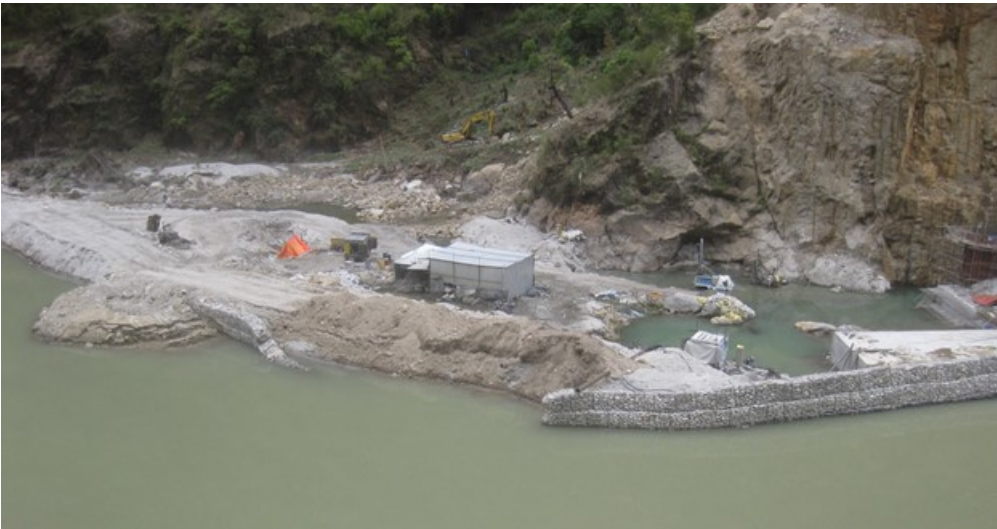
Figure 8-18 Lost diversion wall at Upper Tamakoshi Hydropower Plant ( 27 55'29.1"N, 86 12'47.26"E)

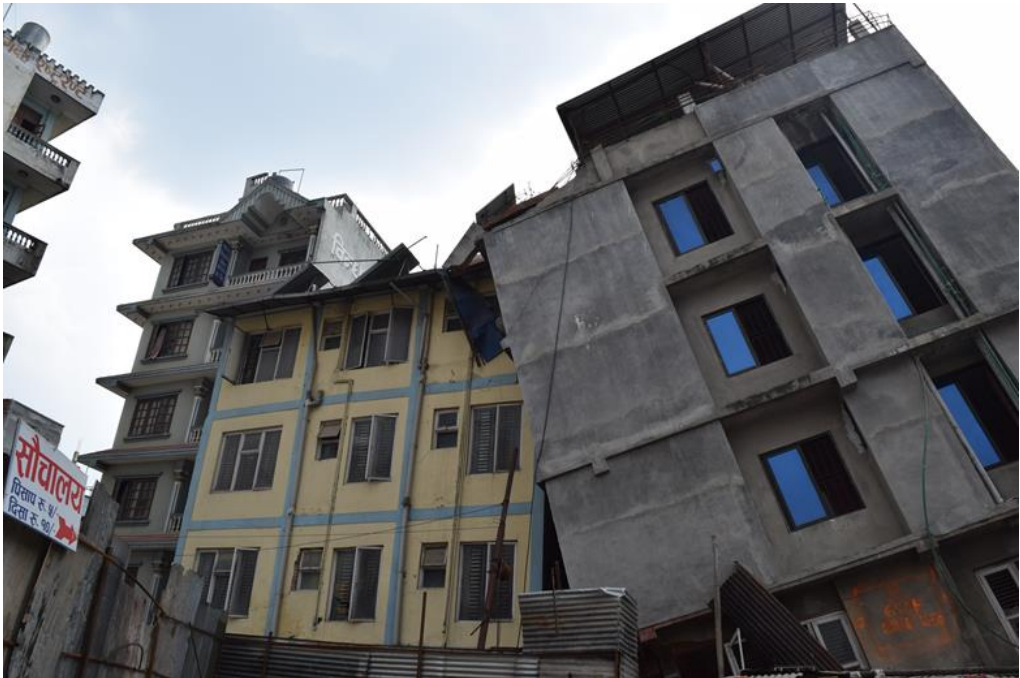
Figure 9-5 Soft-story collapse of a five story building at Gogabu area (27°44'2" N, 85°18'42" E).

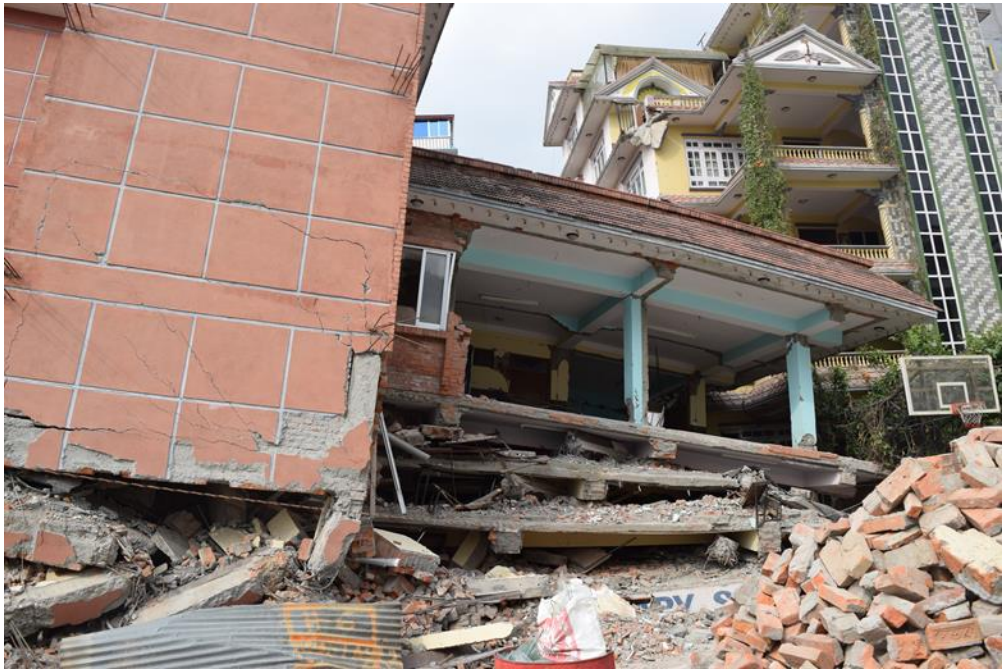
Several buildings in Balaju area (and Gogabu area, which is close to Balaju) collapsed during the earthquake. The majority of these buildings (such as Figure 9-6 through Figure 9-9) have an open ground floor level, and failure might have occurred due to the lack of shear walls. However, a detailed study is required to understand the actual cause of the damage. The cause for the collapse of a six story school building (Figure 9-6) is still unknown.

Figure 9-6 Soft story collapse of a six-story school building during the earthquake shaking (27°44'15.5" N, 85°18'33.8" E).

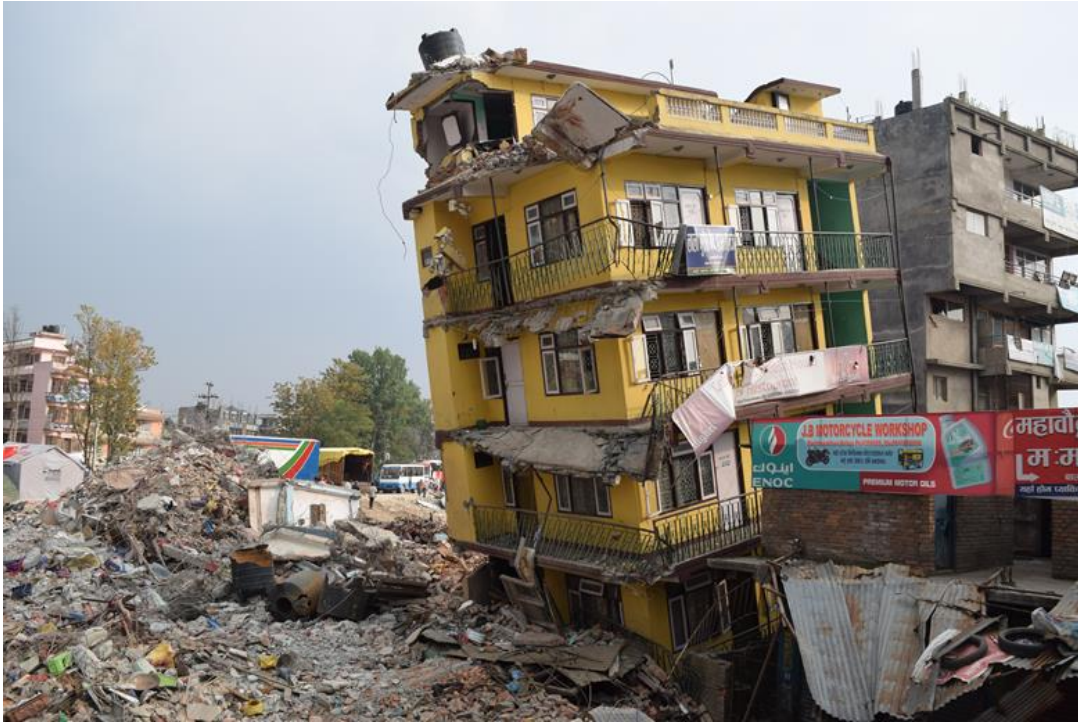
Figure 9-9 Collapse of a six-story lodge at Balaju killed more than 20 people ( $27^{\circ}44'06''$  N,  $85^{\circ}18'20''$ ).

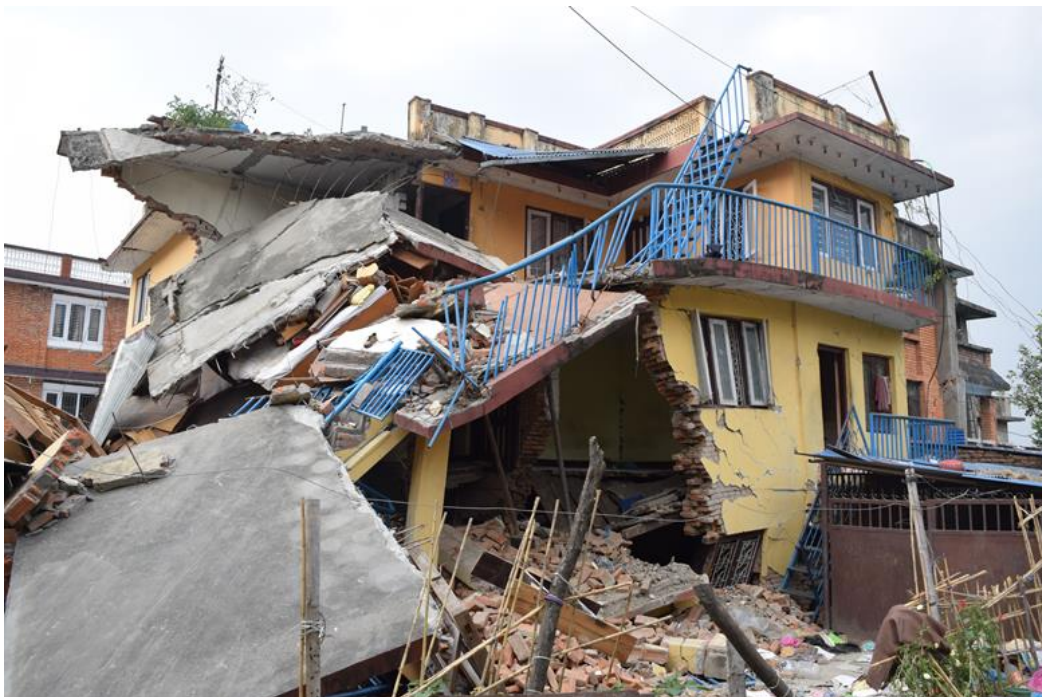
At the ridge of Balaju (known as the Bashara area), several buildings collapsed in a row (Figure 9-10). This could possibly be due to basin edge amplification effects, although detailed investigation is required to confirm this. One RCC frame structure under construction at that area sustained only minor damage (Figure 9-11).

Figure 9-10 Building damage pattern at the ridge of Balaju Baisdhara area. This area is considered a rock site ( $27^{\circ}44'6.71''$  N,  $85^{\circ}18'11.51''$  E).

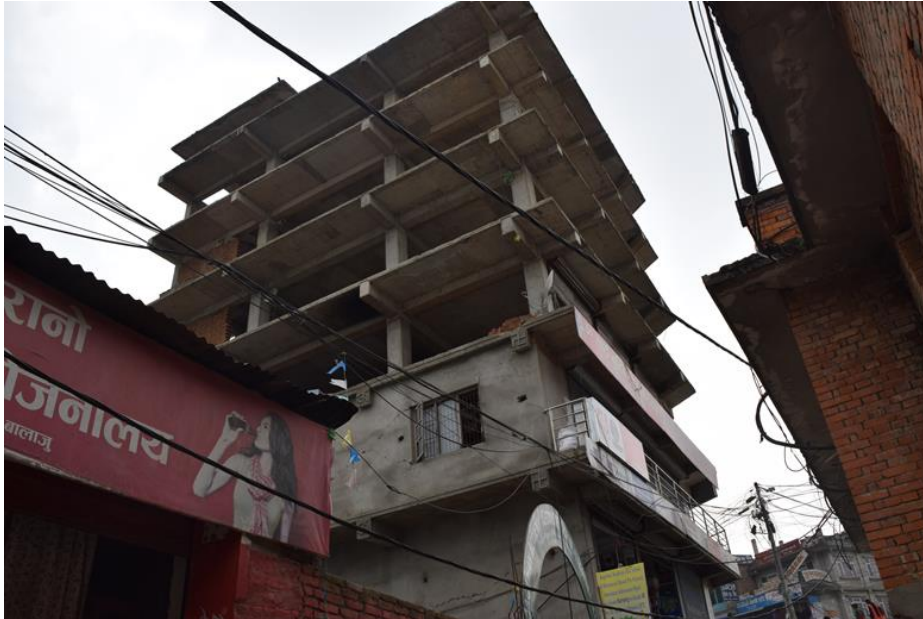
Figure 9-11 Building under construction at Balaju Baisdharma area ( $27^{\circ}44'8.28''$  N,  $85^{\circ}18'6.91''$  E).

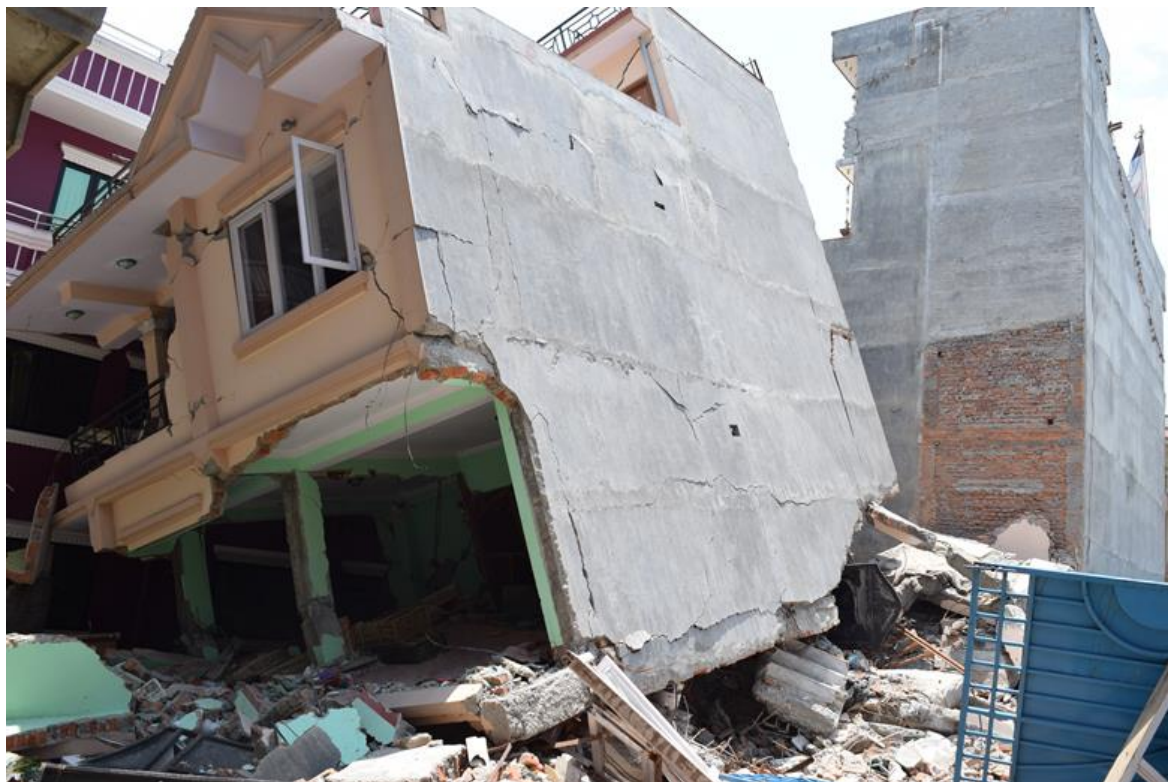
Figure 9-16 More than 5 buildings were collapsed near this building at Sitapaila area (next to the building shown in Figure 9-15).

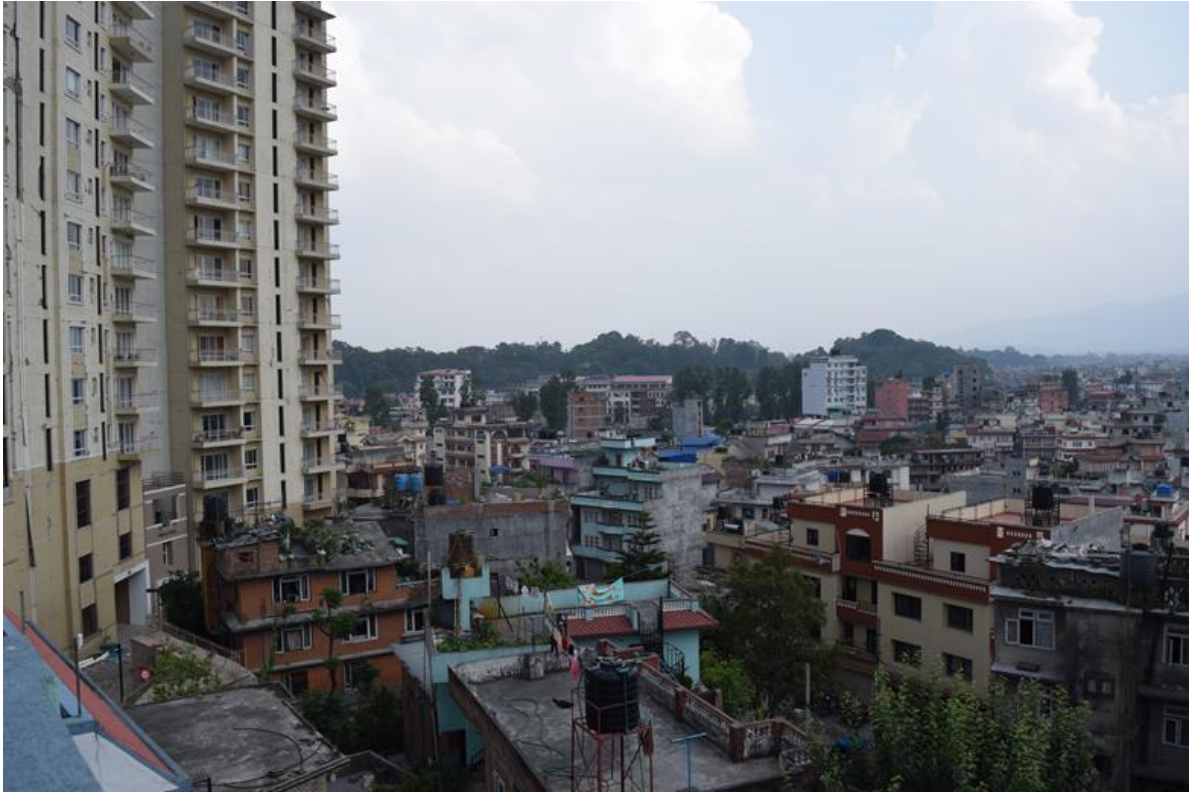
Figure 9-20 None of the other 3-4 story buildings in the area were damaged by the ground shaking.

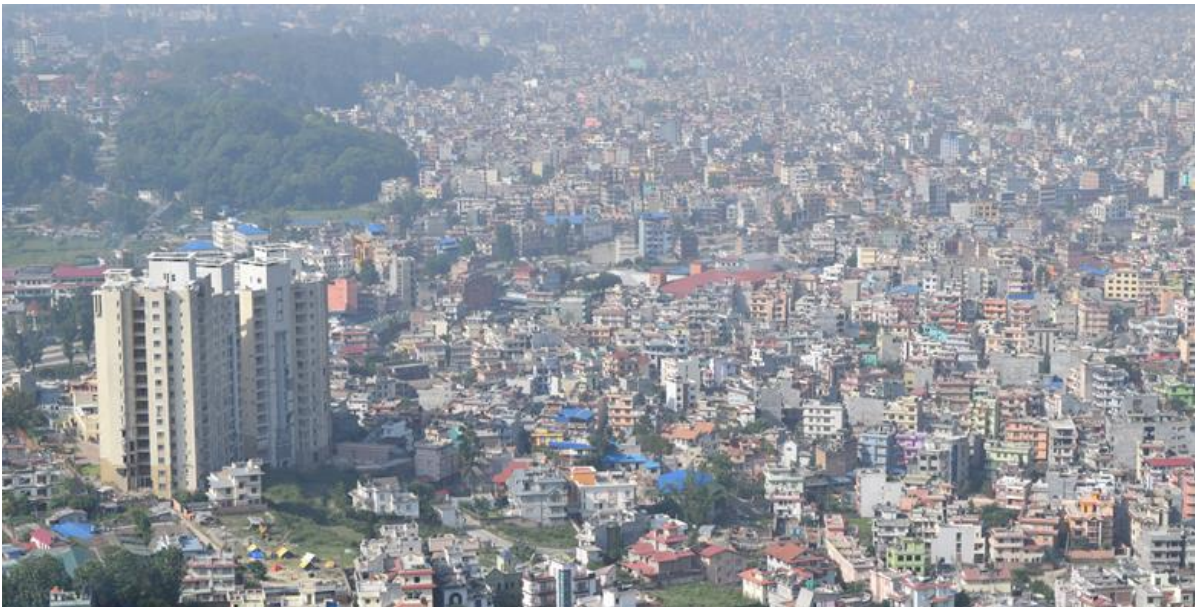
Figure 9-21 Aerial view of the apartment complex.

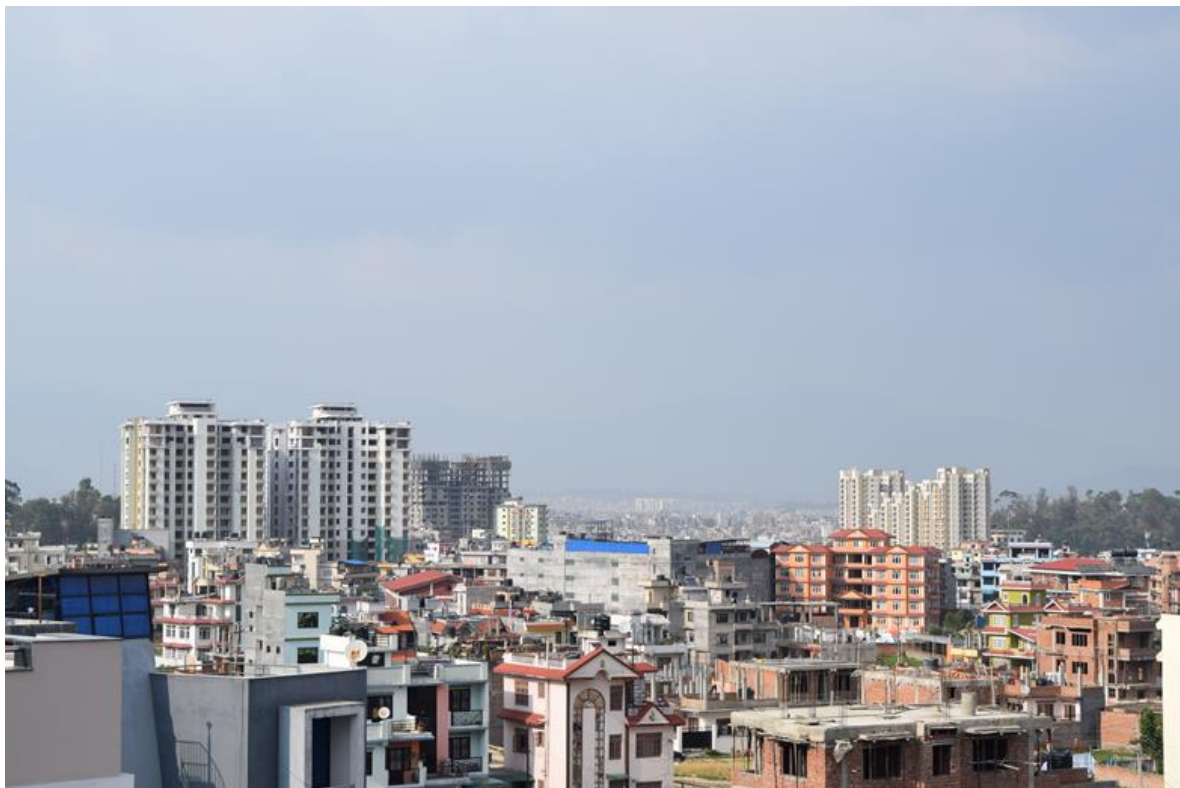
Figure 9-24 Aerial view of the apartment complexes at Hattiban ( $27^{\circ}38'58''$ N,  $85^{\circ}19'45''$  E).

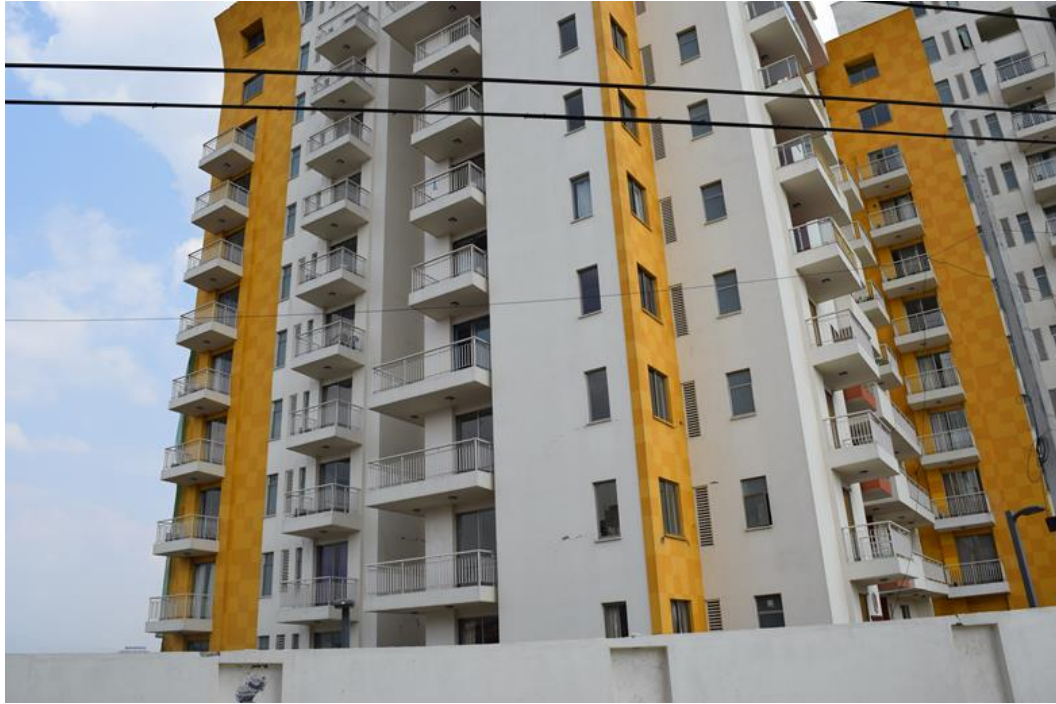
Figure 9-27 Minor damage sustained by an apartment complex at Bishal Nagar ( $27^{\circ}43'40''\text{N}$ ,  $85^{\circ}20'05''\text{E}$ ).

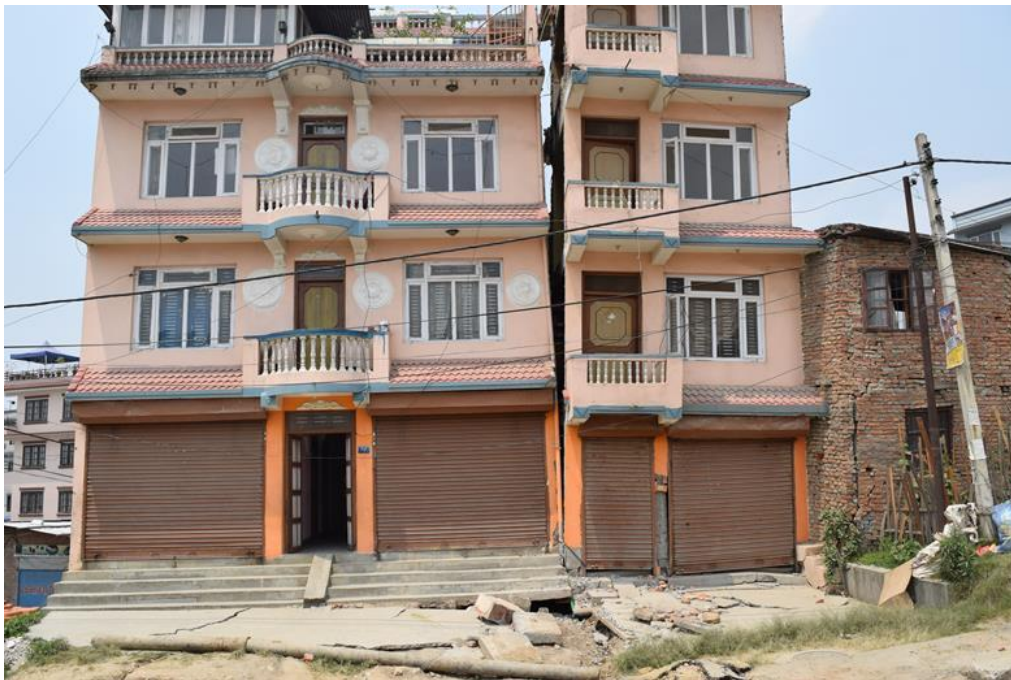
There were some locations where buildings were damaged due to geotechnical effects such as ground failure or foundation failure. One example of such failure are the buildings damaged at Lokanthali due to the liquefaction induced lateral spreading (Figure 9-28 and Figure 9-29).

Figure 9-28 House tilted at Lokanthali area due to the lateral spread ( $27^{\circ}40'29.28''\text{N}$ ,  $85^{\circ}21'49''\text{E}$ ).

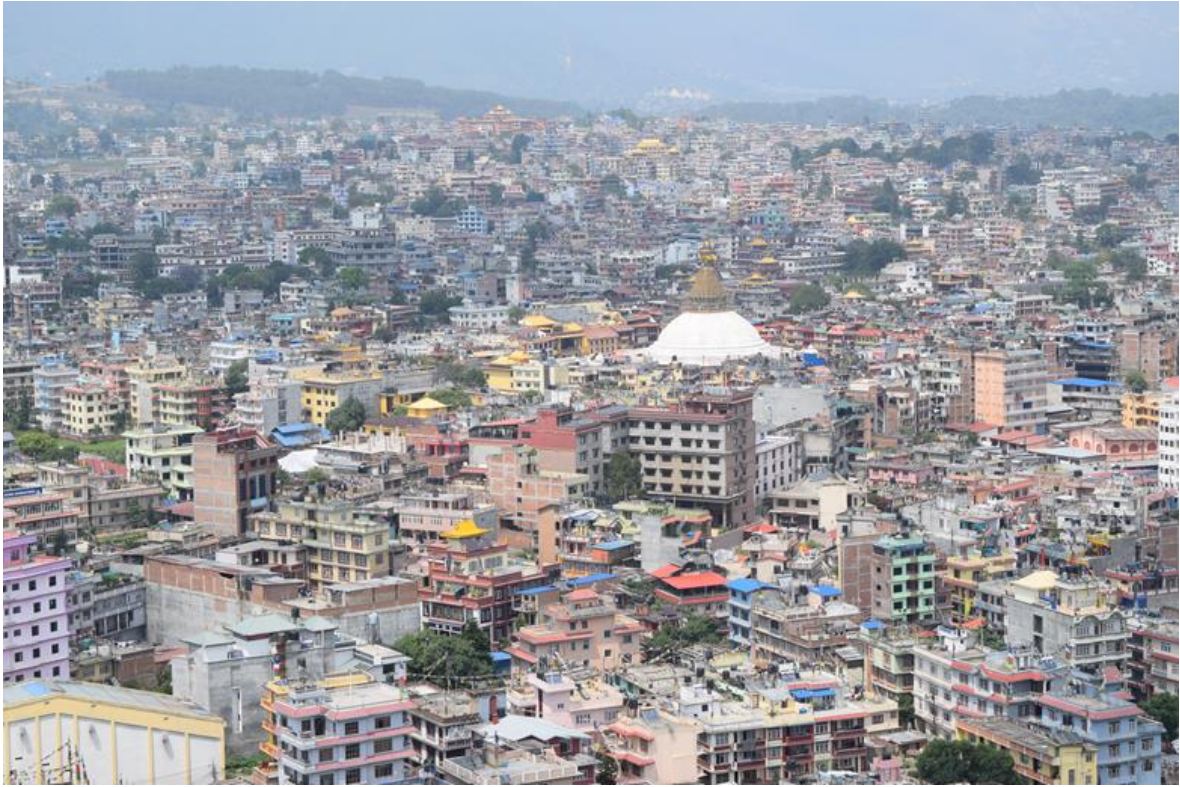
In the north-eastern part of the basin, extensive structural damage was not noted (Figure 9-30). Stupas sustained less damage compared to temples. Many old buildings with unreinforced brick masonry in mud mortar and temples in Bhaktapur sustained serious damage due to the strong ground motion (Figure 9-31 and Figure 9-32). The majority of modern buildings showed only a small extent of damage. There were several isolated cases in Kathmandu where multi-story buildings collapsed (Figure 9-33). The team visited Indrayani village, which is located along a broad ridge, and observed similar damage patterns as in Bhaktapur (where old buildings collapsed and the RCC buildings sustained less damage) (Figure 9-34).

Figure 9-30 Aerial view of north-eastern part of Kathmandu near Bouddhanath temple.

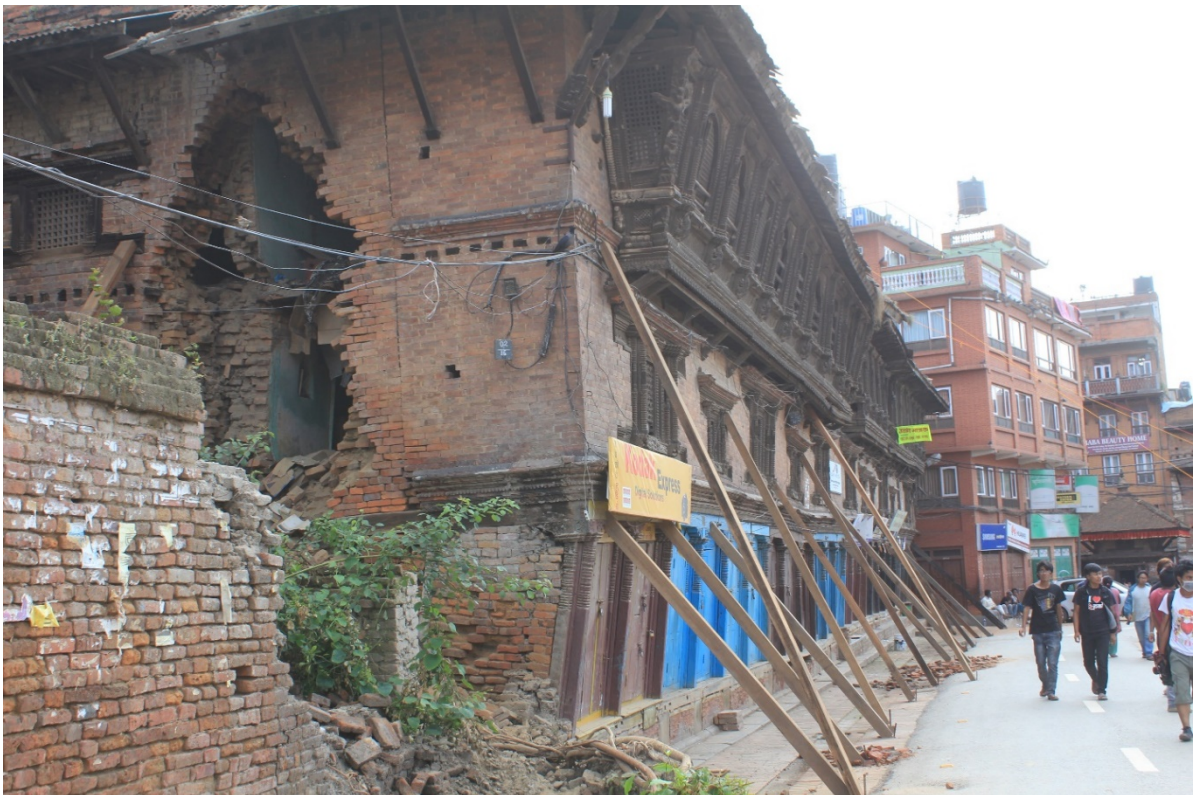
Figure 9-36 Distressed unreinforced masonry building and façade following the May 12, 2015,  $M_w$  7.3 aftershock (27° 40' 19.45" N; 85° 25' 40.80" E).

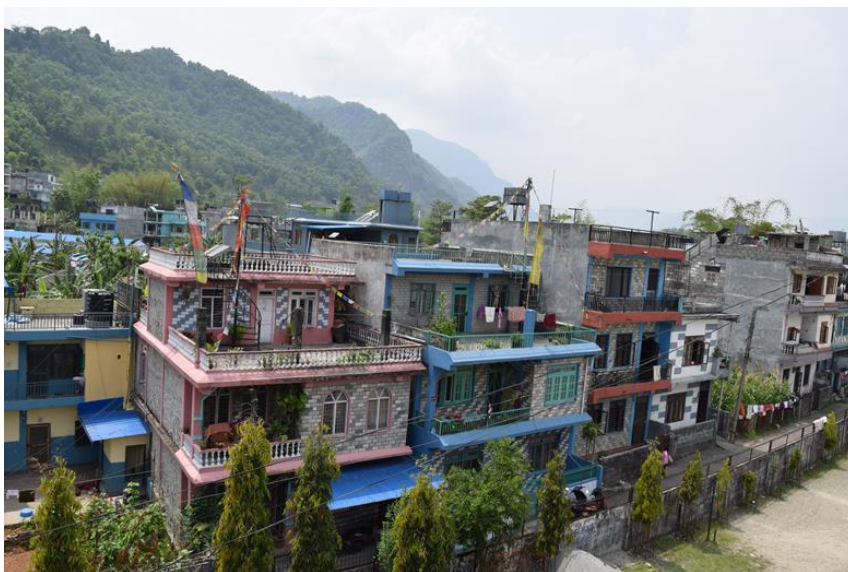
Figure 9-38 Typical building pattern in Pokhara. Majority of these buildings performed well.
