**Authors:** Youssef M.A. Hashash (UIUC), Binod Tiwari (CSF), Robb E. S. Moss (CalPoly), Domniki Asimaki (Caltech), Kevin B. Clahan (LCI), D. Scott Kieffer (TUGraz), Doug S. Dreger (UCB), Amy Macdonald (TT), Chris M. Madugo (PG&E), H. Benjamin Mason (OSU), Menzer Pehlivan (MRCE), Deepak Rayamajhi (OSU), Indra Acharya (TU) and Basanta Adhikari (TU).

## Executive Summary

The April 25, 2015 Gorkha (Nepal) Earthquake and its related aftershocks had a devastating impact on Nepal. The earthquake sequence resulted in nearly 9,000 deaths, tens of thousands of injuries, and has left hundreds of thousands of inhabitants homeless. With economic losses estimated at several billion US dollars, the financial impact to Nepal is severe and the rebuilding phase will likely span many years.

The Geotechnical Extreme Events Reconnaissance (GEER) Association assembled a reconnaissance team under the leadership of D. Scott Kieffer, Binod Tiwari and Youssef M.A. Hashash to evaluate geotechnical impacts of the April 25, 2015 Gorkha Earthquake and its related aftershocks. The focus of the reconnaissance was on time-sensitive (perishable) data, and the GEER team included a large group of experts in the a

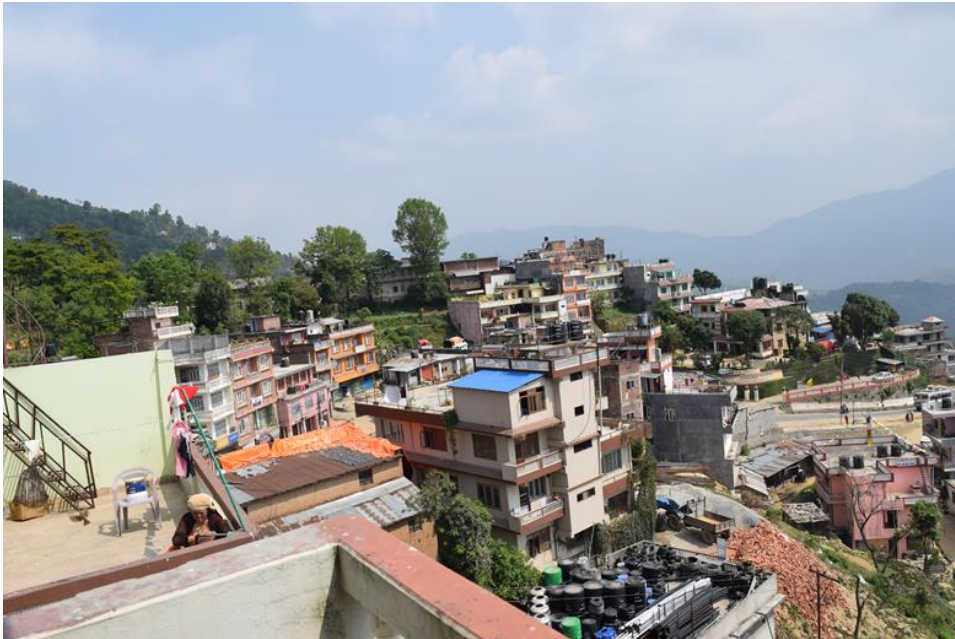
Figure 9-41 Modern buildings in Gorkha Bazar did not sustain massive damage due to the ground shaking.

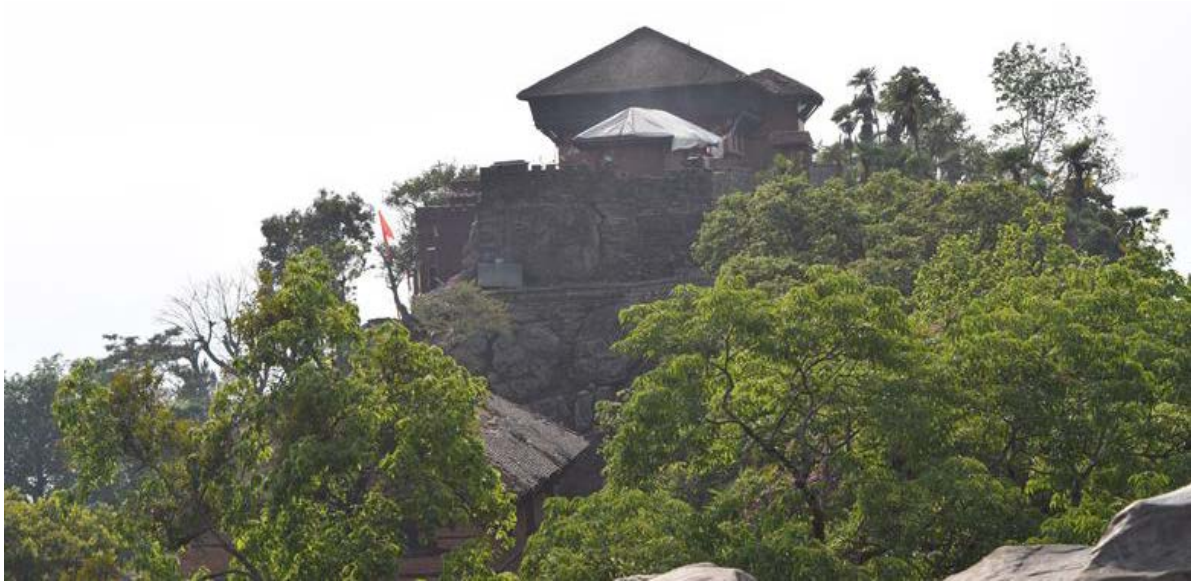
Figure 9-43 Retaining walls of Gorkhna Temple/Gorkha Palace showing shear cracks.

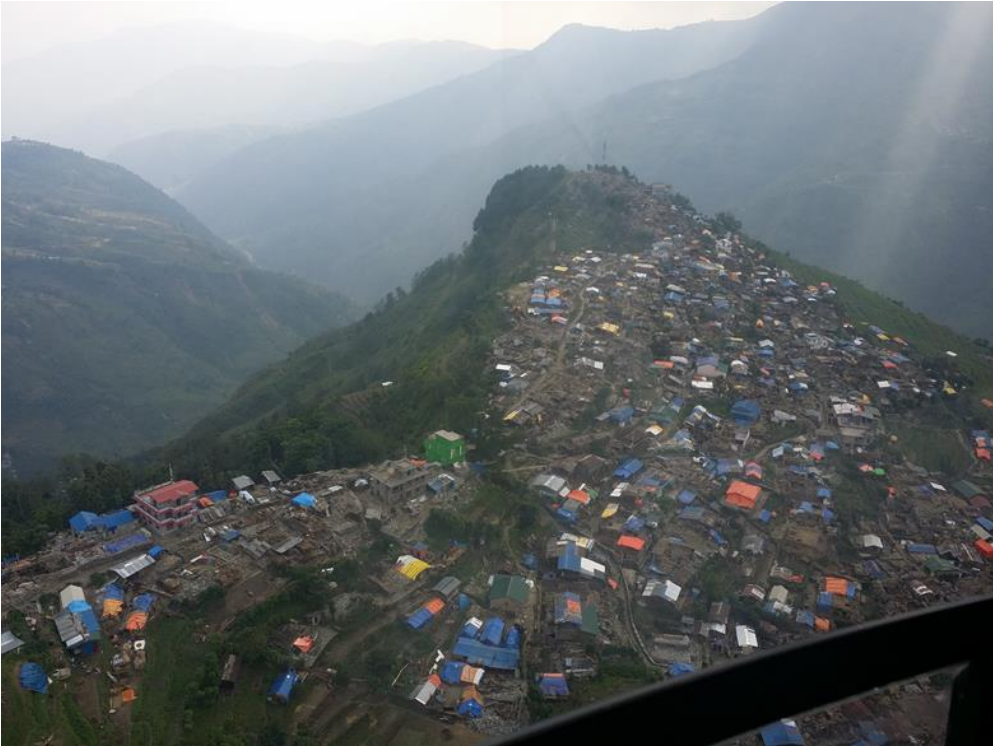
Figure 9-45 An aerial view of seismic damage at Barpak Village.

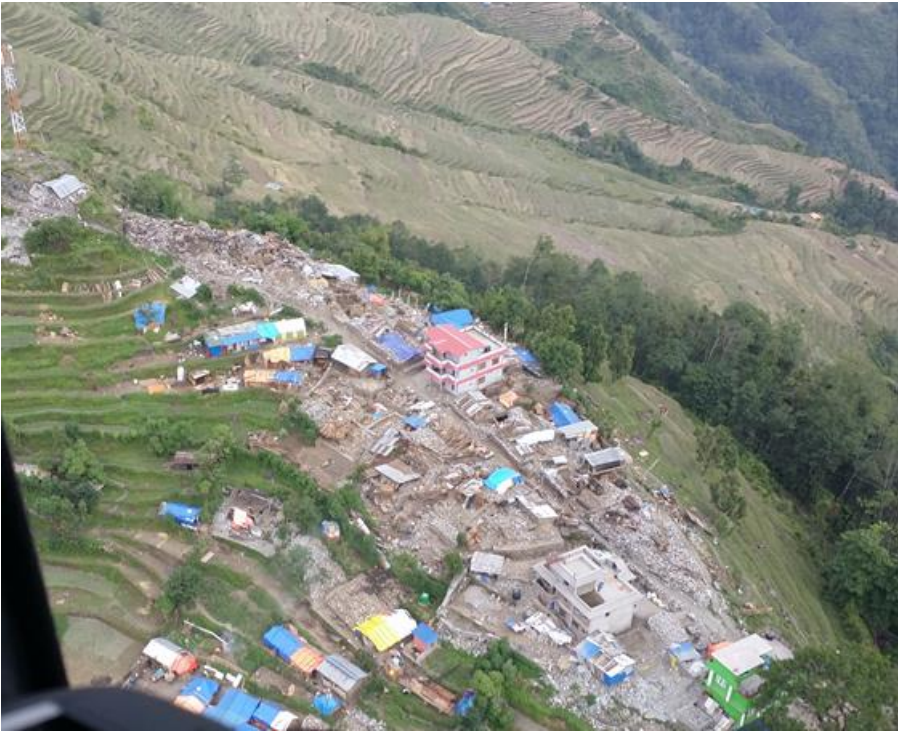
Figure 9-46 A closer look at the damage pattern in Barpak Village.

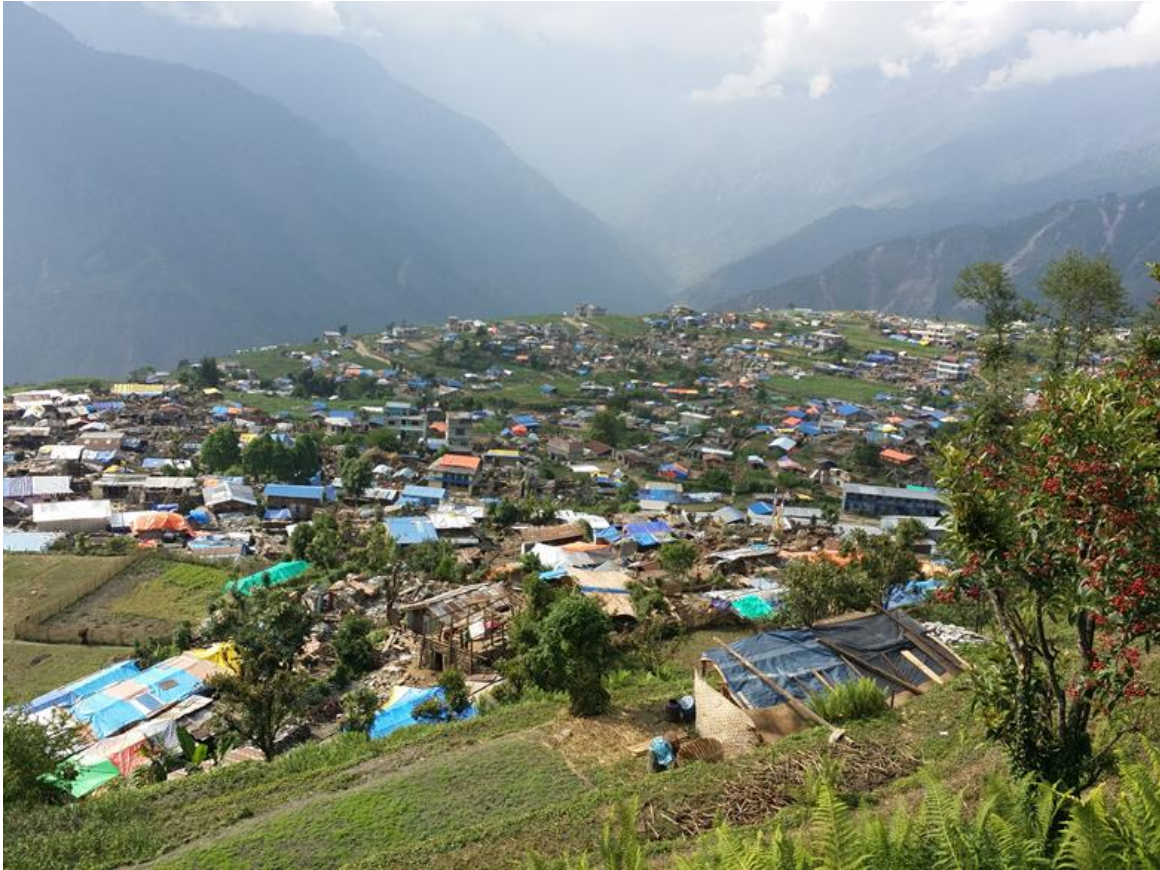
Figure 9-47 A few RCC building at Barpak Village standing well after the earthquake.

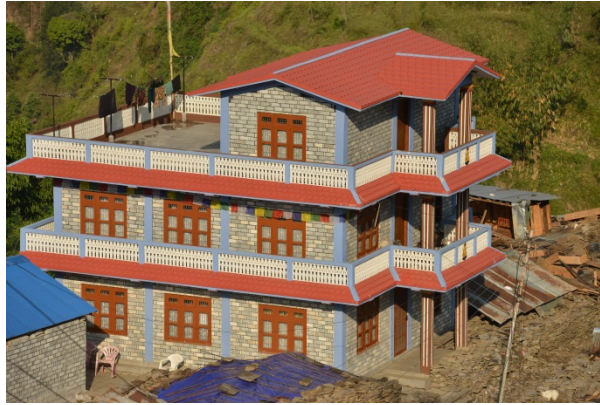
Figure 9-49 Typical condition of RCC structures in Barpak.

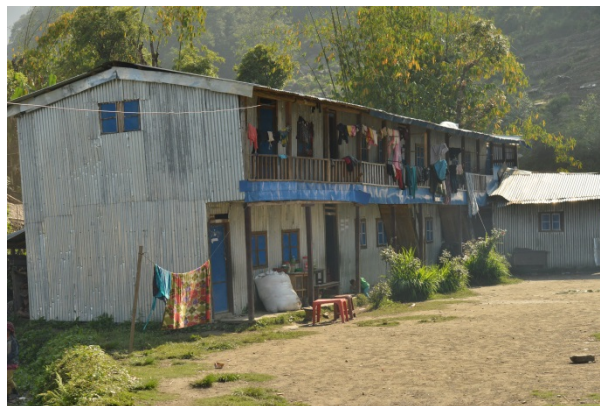
Figure 9-50 The school building of Barpak (wood framing with metal sheet siding).

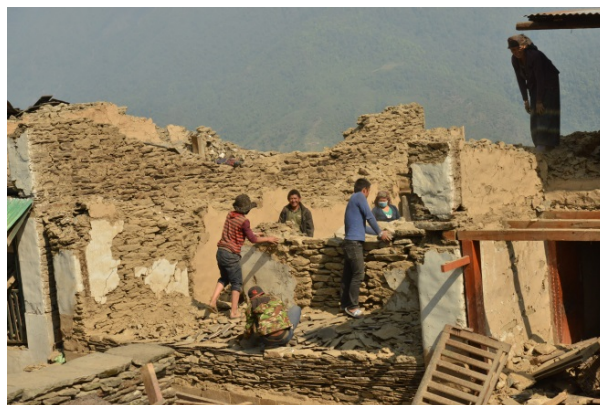
Figure 9-50). Unfortunately, with the limited available local resources and urgency to provide shelter through the monsoon and winter, Barpak is being actively rebuilt with highly vulnerable stone rubble structures (Figure 9-51)

Figure 9-51 Rebuilding Barpak with stone rubble.

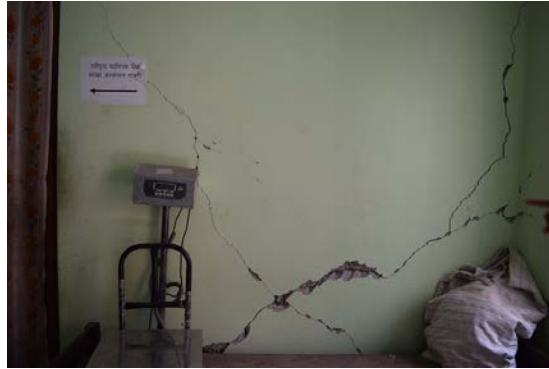
Figure 9-52 Structural damage pattern at a building in Gajuri, Dhading.

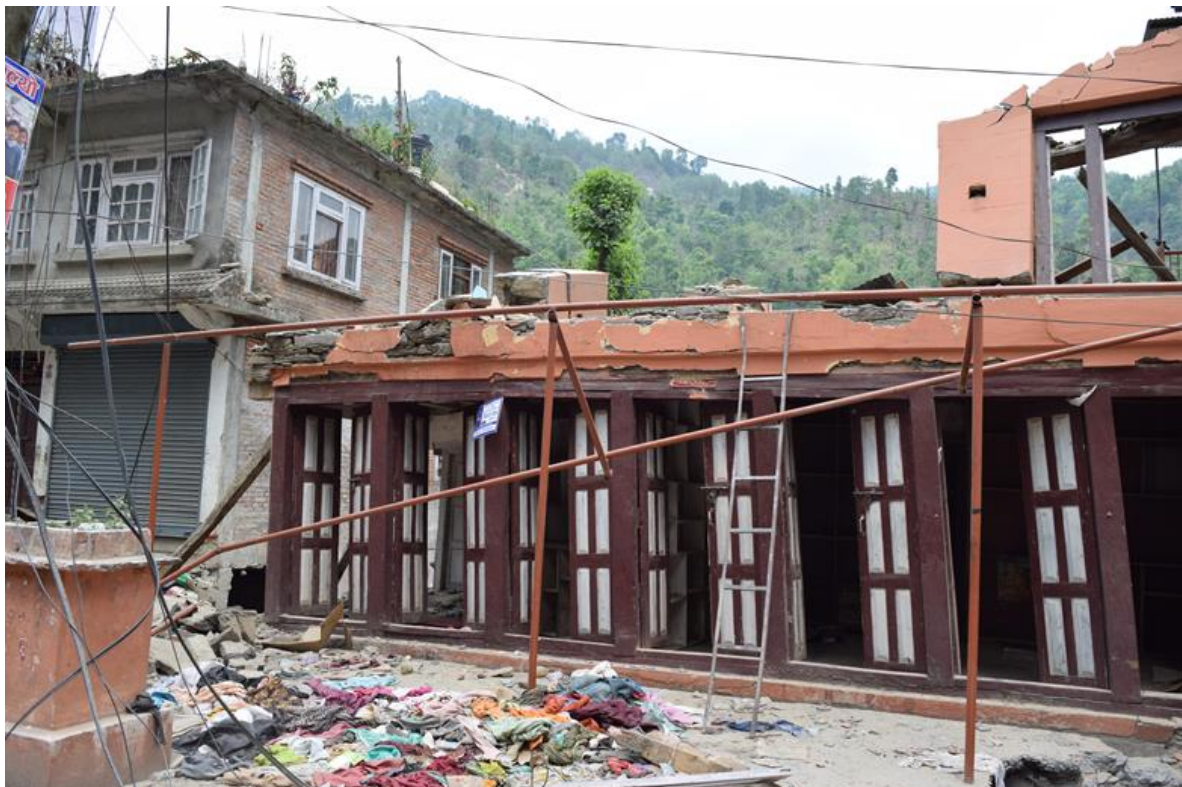
Figure 9-55 Comparison of performance of unreinforced and reinforced buildings in Melamchi, Sindhupalchowk.

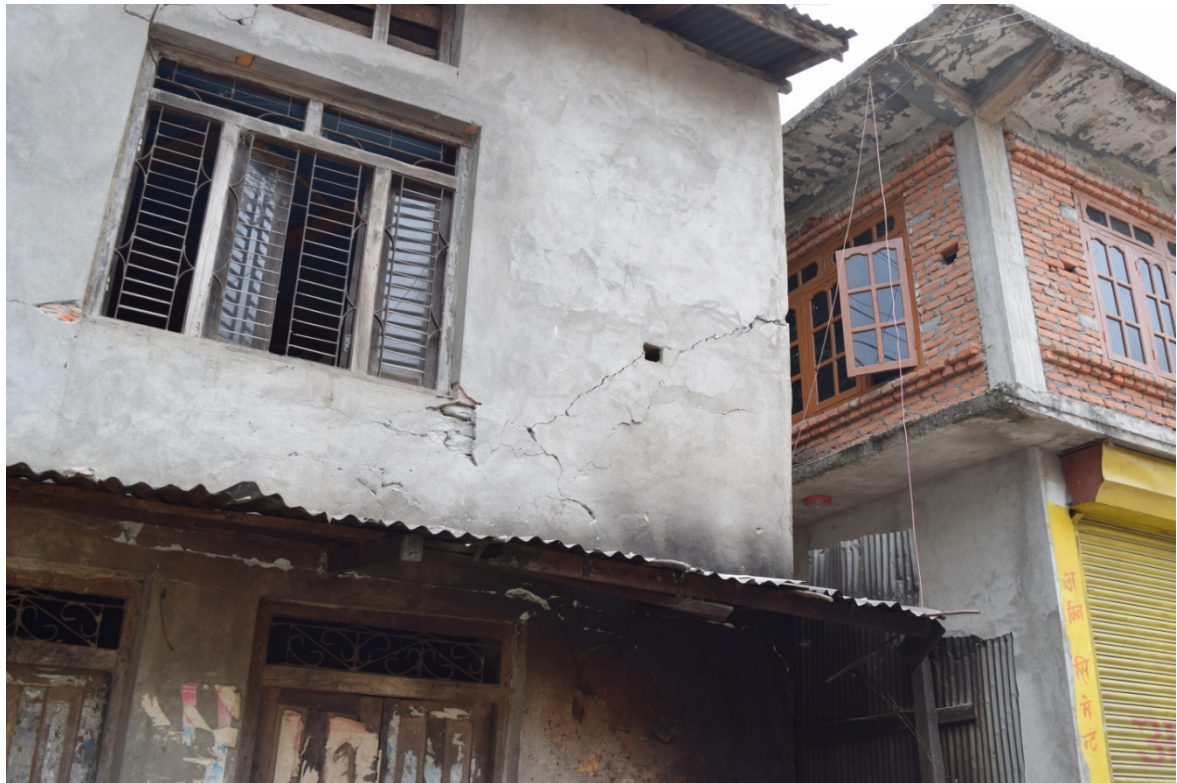
Figure 9-56 Another example of comparative performance of unreinforced and reinforced buildings in Melamchi, Sindhupalchowk.

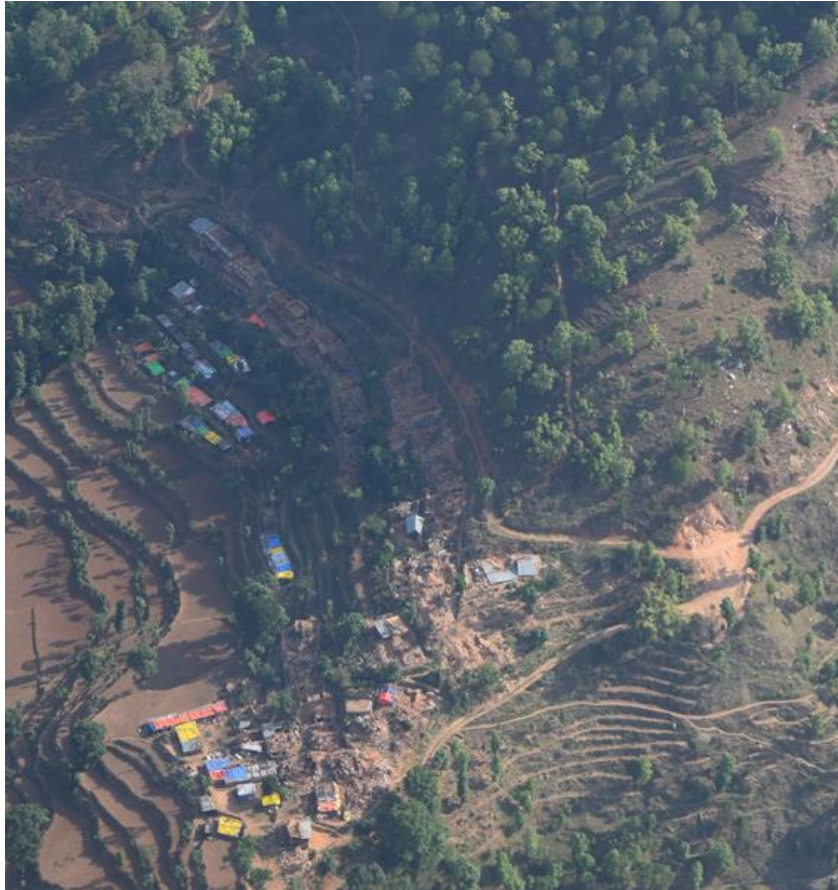
Figure 9-58 An entire village flattened in Sindhupalchowk due to strong ground shaking.

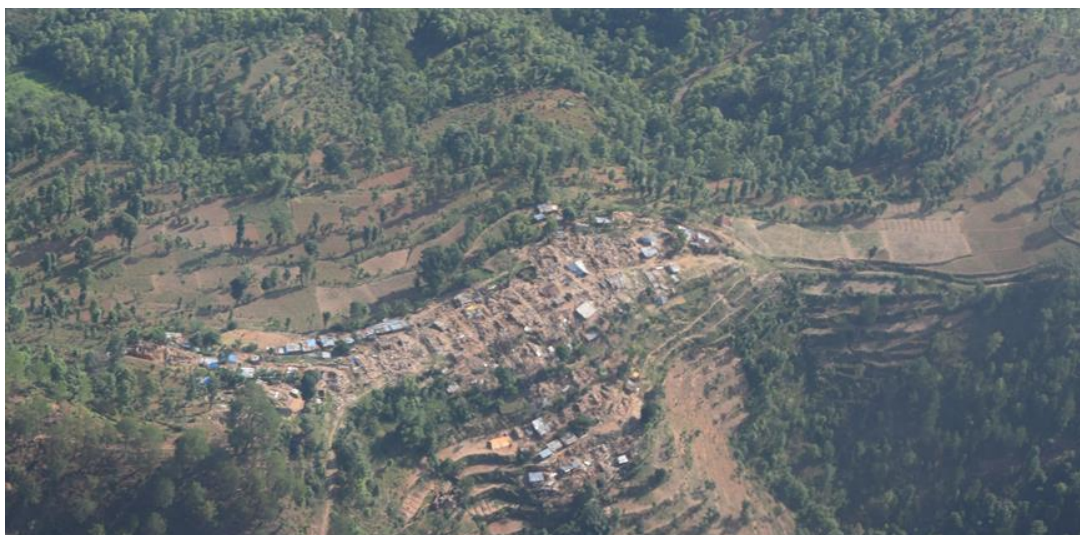
Figure 9-59 Another example of entire village flattened due to earthquake shaking in Sindhupalchowk.

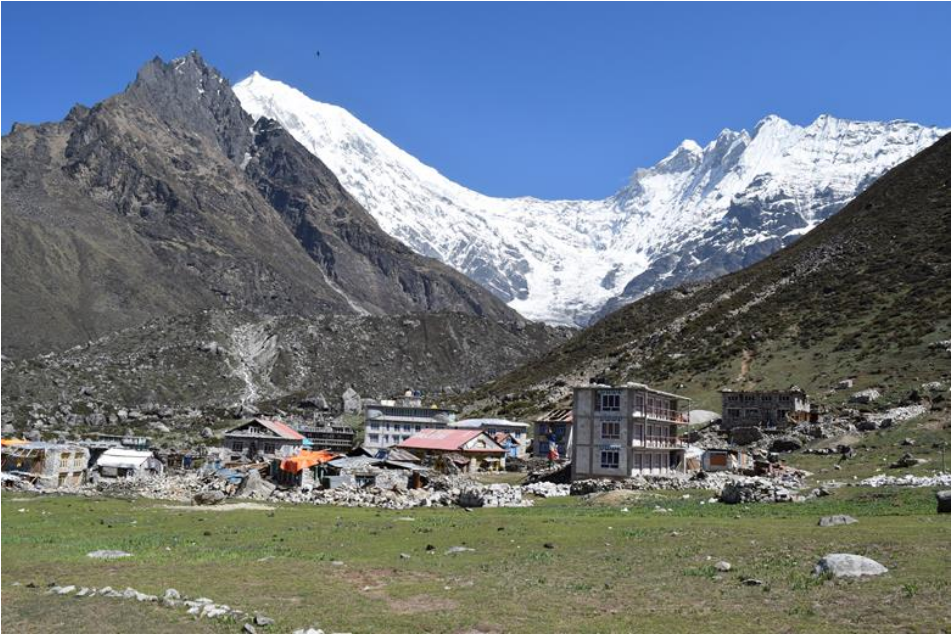
Figure 9-60 RCC structures at Kangjun Gumba, Langtang Trekking Route performed well whereas the unreinforced stone masonry walls flattened due to seismic shaking (28°12.7'0" N, 85°34.1'0" E).

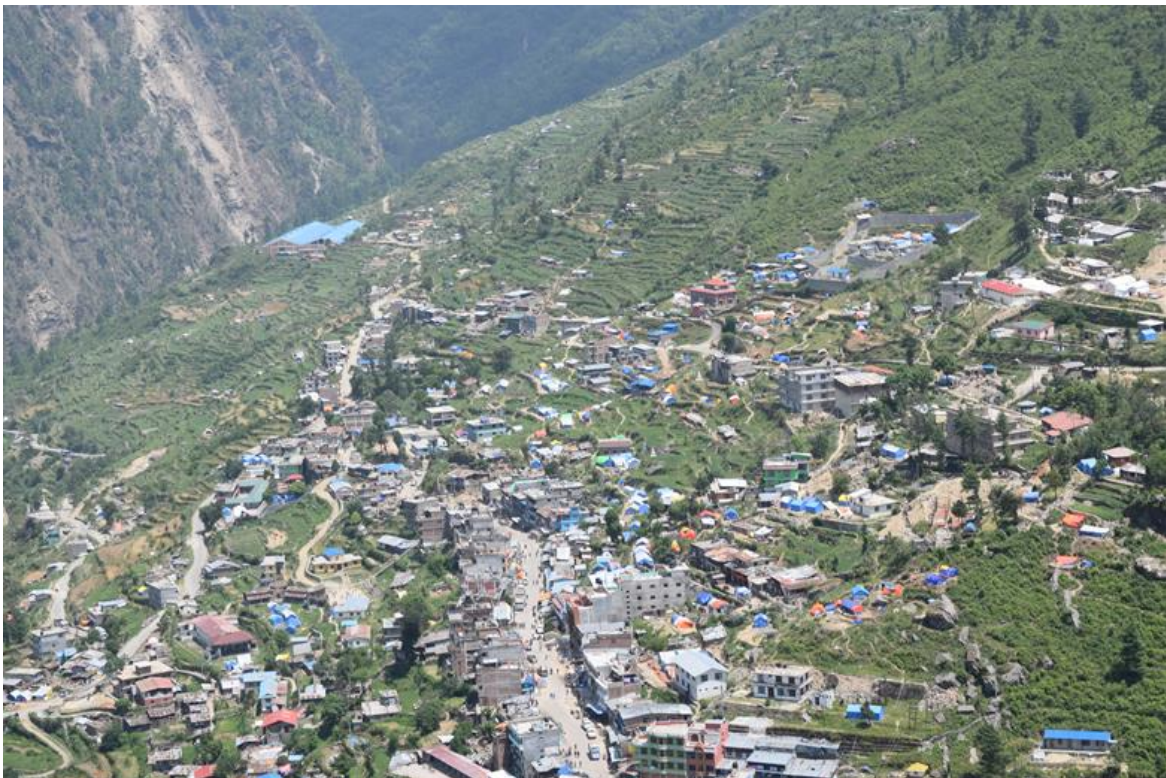
Figure 9-63 Several modern RCC structures at Dhunche of Rasuwa District performed well during the earthquake.

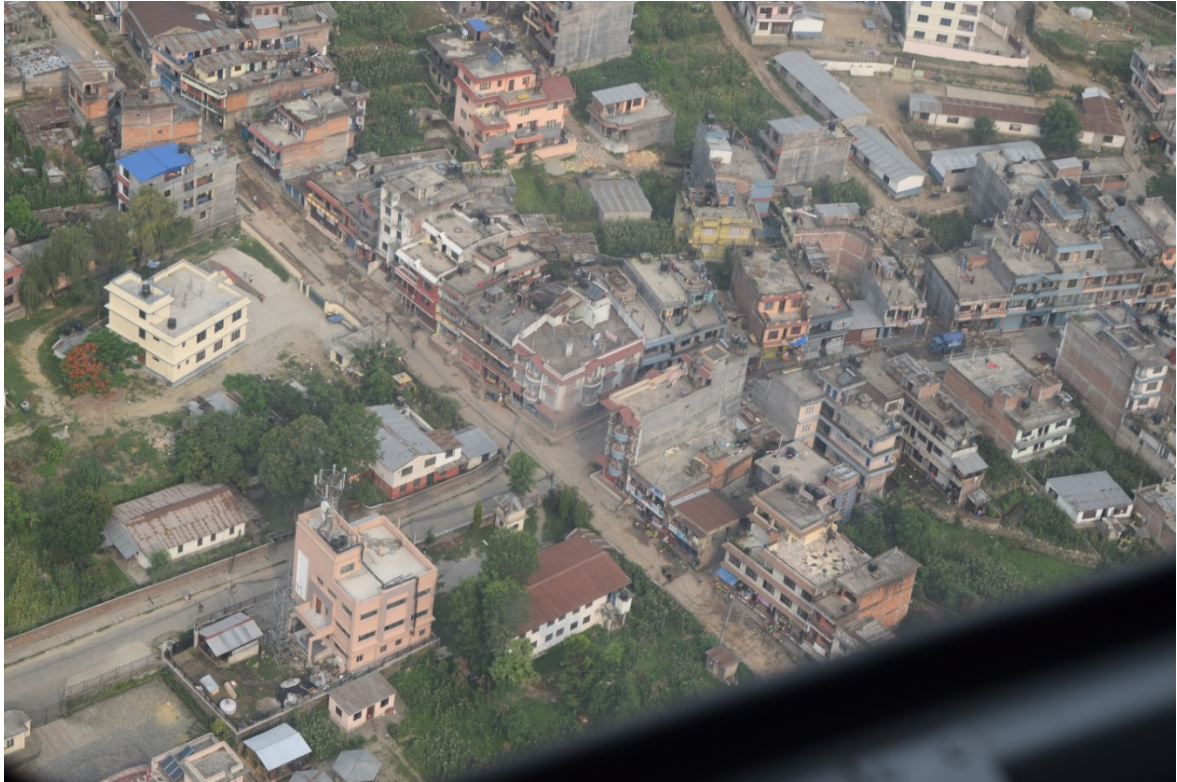
Figure 9-64 Many of the modern RCC structures in Sundarbazar of Lamjung District performed well during the earthquake.

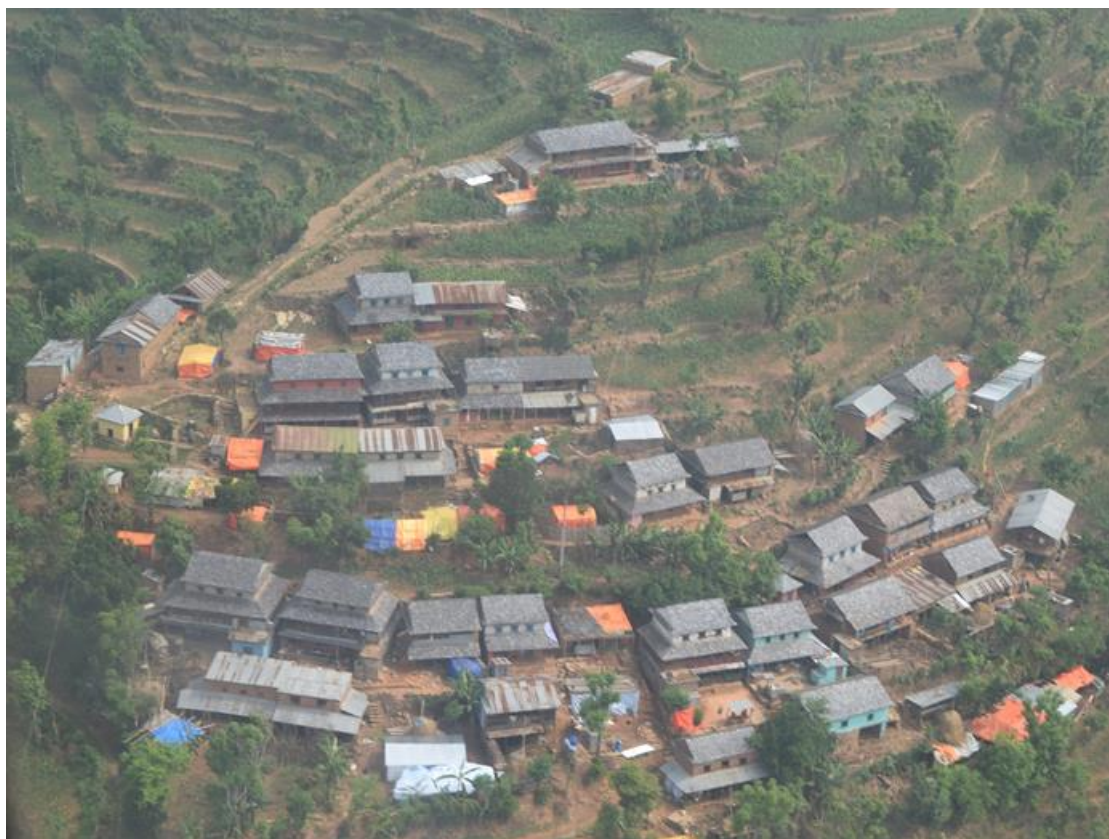
Figure 9-65 Villages near Sundarbazar did not show similar extent of damage as was observed in Rasuwa and Sindhupalchowk.

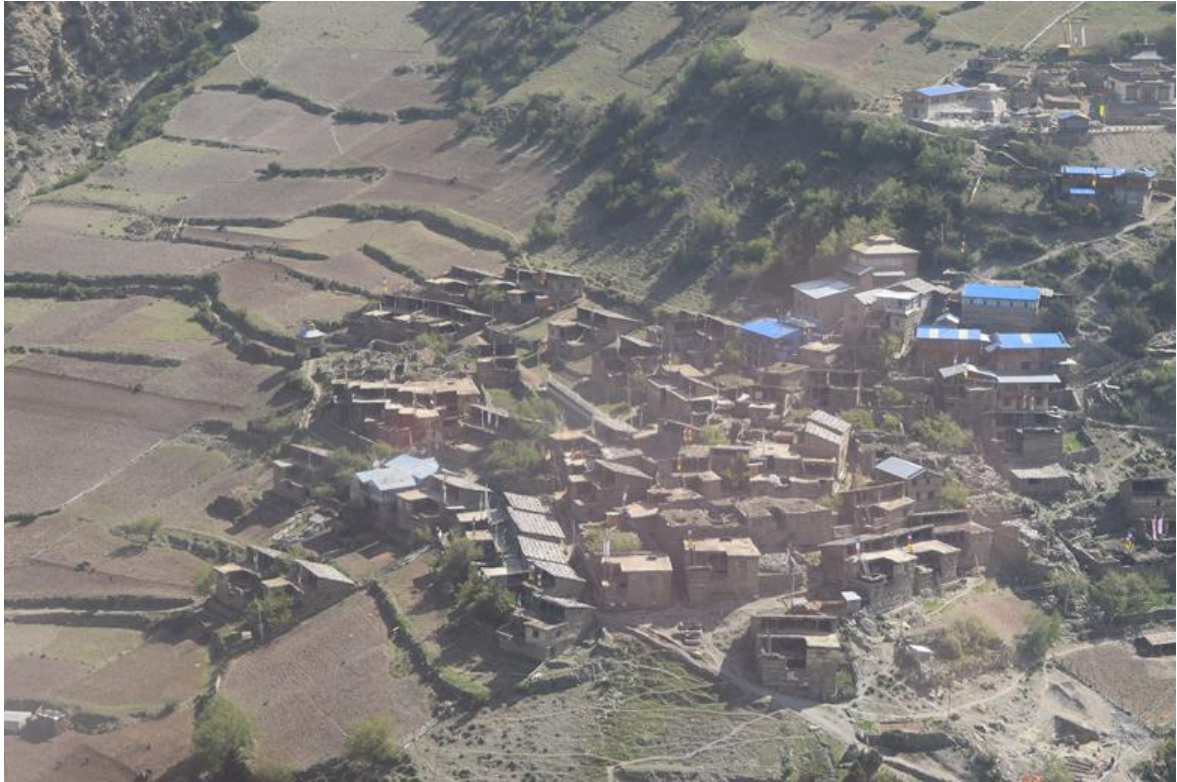
Figure 9-66 Manang village had minimum damage compared to other places ( $28^{\circ}36.8'0''$  N,  $84^{\circ}8.99'0''$  E).

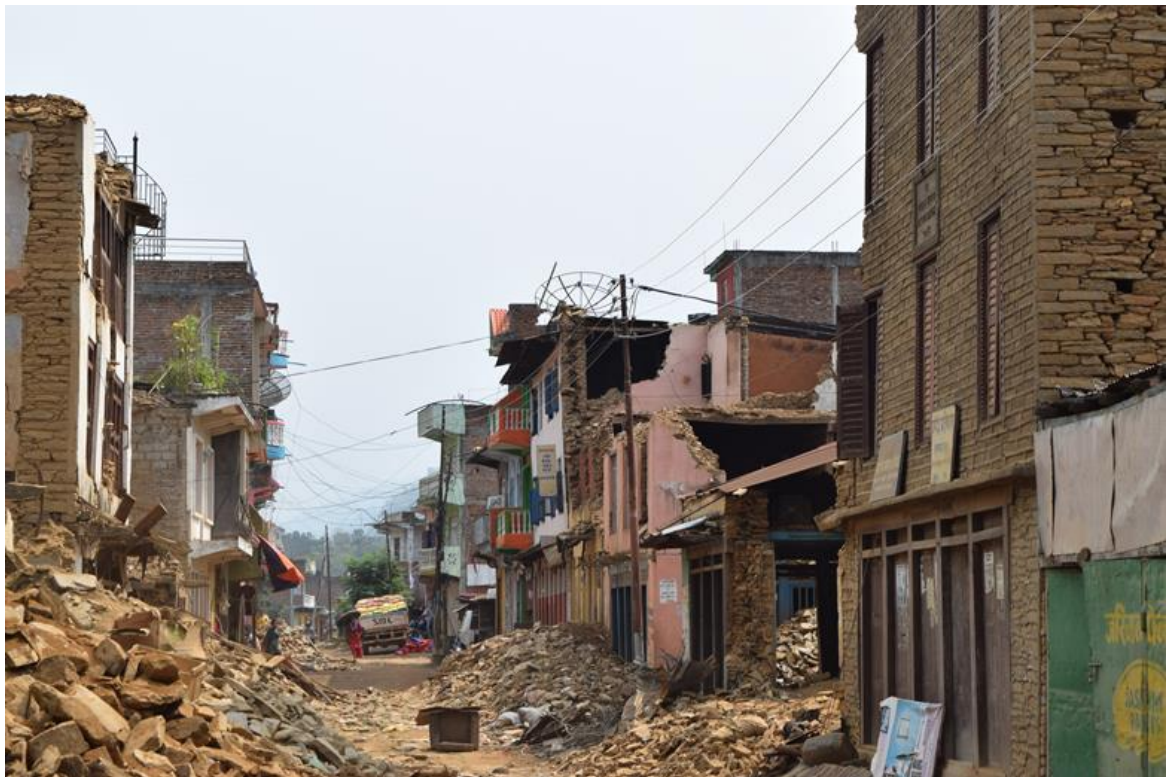
Figure 9-67 Modern RCC structures in Arughat of Gorkha showed more limited damage compared to unreinforced masonry.

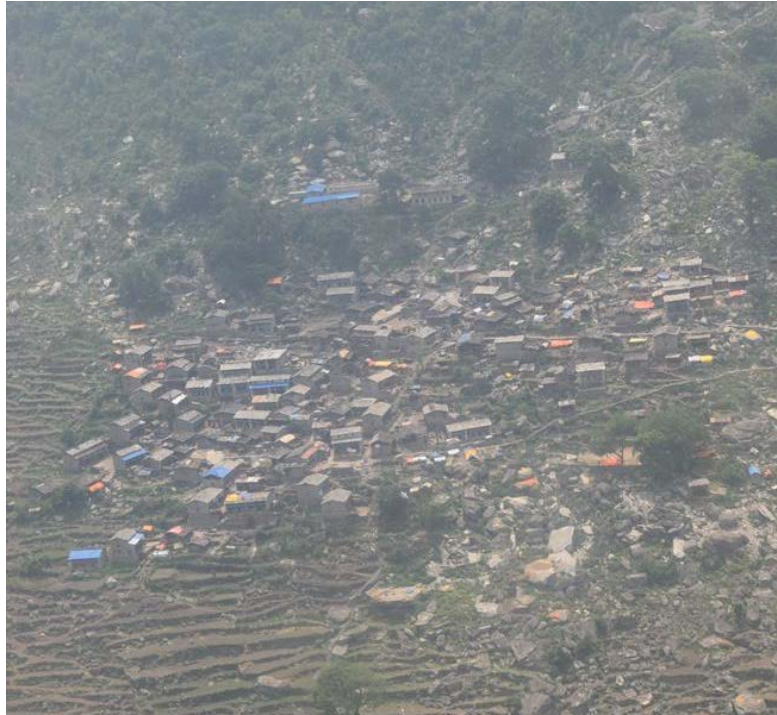
Figure 9-68 Buildings shattered at Machhigaon of Gorkha, which is close to the epicenter.

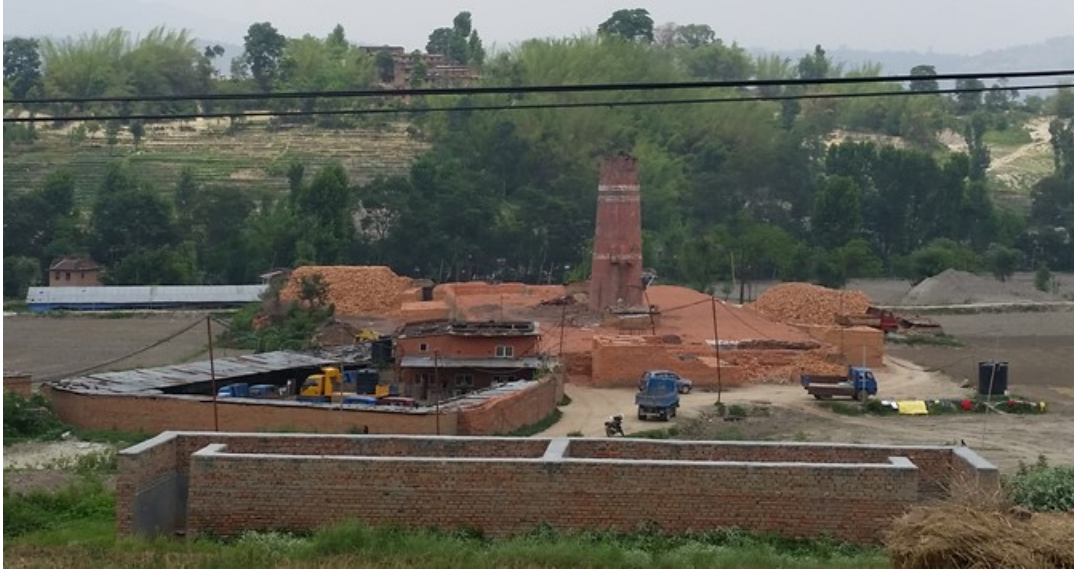
Brick is a primary construction material in Nepal and is produced in kilns located across the country. These kilns have also been a dominant source of air pollution in the Kathmandu Valley. Many kilns stopped operation after the earthquake due to damage to their smokestacks (Figure 9-70). This resulted in likely temporary improvement in air quality however resulting in shortage in building material necessary for reconstruction.

Figure 9-70 Damaged smokestack at a brick kiln in the Kathmandu Valley southeast of Bhaktapur (27° 29' 52.9" N, 85° 26' 52.9" E).
