# The Geotechnical Aspects of the September 3, 2016 M5.8 Pawnee, Oklahoma Earthquake

Patricia Clayton, George Zalachoris, Ellen Rathje (Univ. of Texas at Austin) Tejo Bheemasetti, Santiago Caballero, Xinbao Yu (Univ. of Texas at Arlington) Scott Bennett (USGS)

Report Date: October 17, 2016

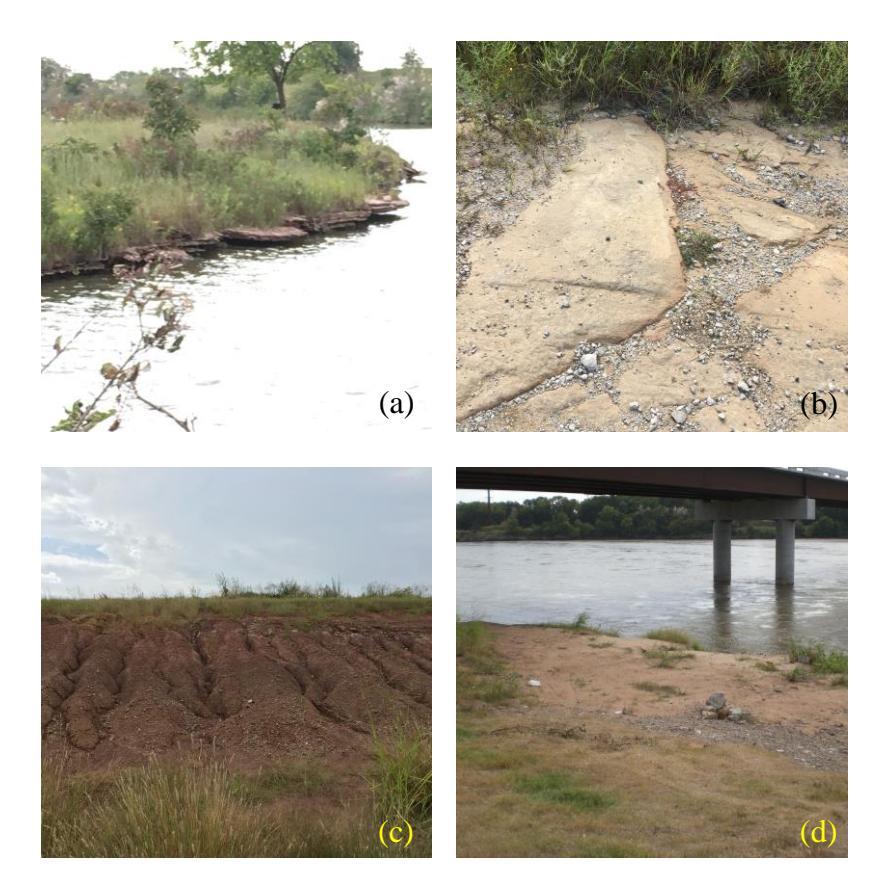
Figure 3: Photographs of typical geologic features across the visited area. Latitude/Longitude: a) (36.403393°, -97.050589°), b) (36.370872°, -96.728596°), c) (36.505261°, -96.723785°), d) (36.433255°, -96.926117°)
