SUPPLEMENTAL TO SURFACE FAULT RUPTURE ASSOCIATED WITH THE M6.0 SOUTH NAPA EARTHQUAKE OF AUGUST 24, 2014

National Science Foundation (NSF)
Geotechnical Extreme Events Reconnaissance (GEER)

B.1 Preliminary Observations of Surface Cracking Within the Epicentral Area of the M6.0 South Napa Earthquake of August 24, 2014

Prepared by Keith Kelson¹ C.E.G., and John Wesling² C.E.G.

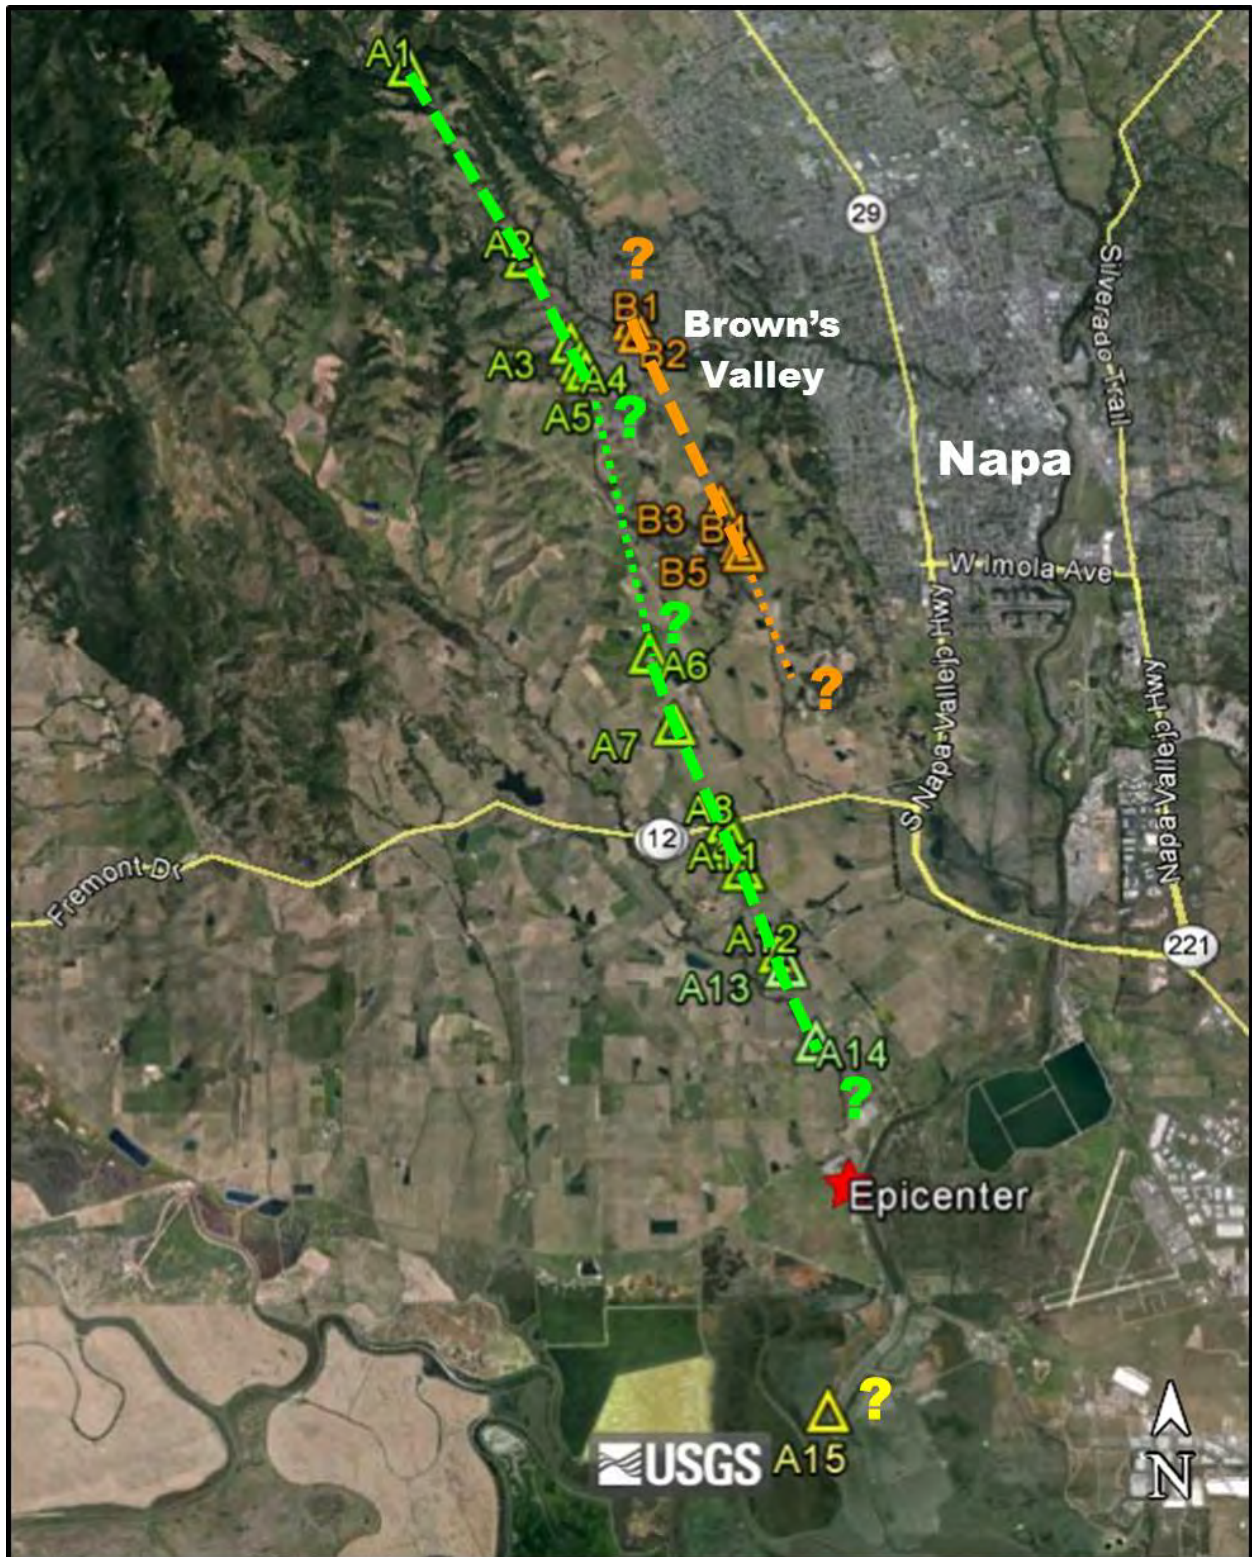
The total length of potential surface rupture between Points A1 and A14 (green dashed line) would thus be estimated to be approximately 12½ kilometers, running from Las Amigas Road (Point A14) to Redwood Road (Point A1). The length of rupture could potentially be greater given that the southern end of observed rupture ended in the marshy waters associated with the Napa River and thus could not be observed further south. Point A15 is located on Milton Road on the southern portion of Edgerley Island where ground cracking across the road was observed. However, it was not clear that this ground cracking represents the surface expression of the fault rupture as it was south of the epicenter and the pattern of cracking was not definitive. Nevertheless, the potential for surface fault rupture would have to be assumed to be somewhat greater than the 12½ kilometers observed across roadways.

A second semi-linear alignment of ground cracking, Alignment B (orange line in Figure 1), was also observed about 800 meters to east of Alignment A. Where observed, it had crack dimensions and offsets similar in magnitude to those associated with Alignment A.

Figure 1: Alignment of surface cracking observed following August 24, 2014 Magnitude 6 Napa Earthquake (adapted from Google Earth [NSF-GEER; Napa, CA, processed 09/03/14])
