## Appendix C: Effects of Surface Fault Rupture on Infrastructure

Numbering of the Appendix C contents for individually mapped houses are denoted with an “H##” that represents the house reference number. The first figure for each house includes a site map (Figure C-H##-1); subsequent figures numbers are photographs associated with the house. As an example, the second photo for house no. 7 would be: “Figure C-H07-3.”

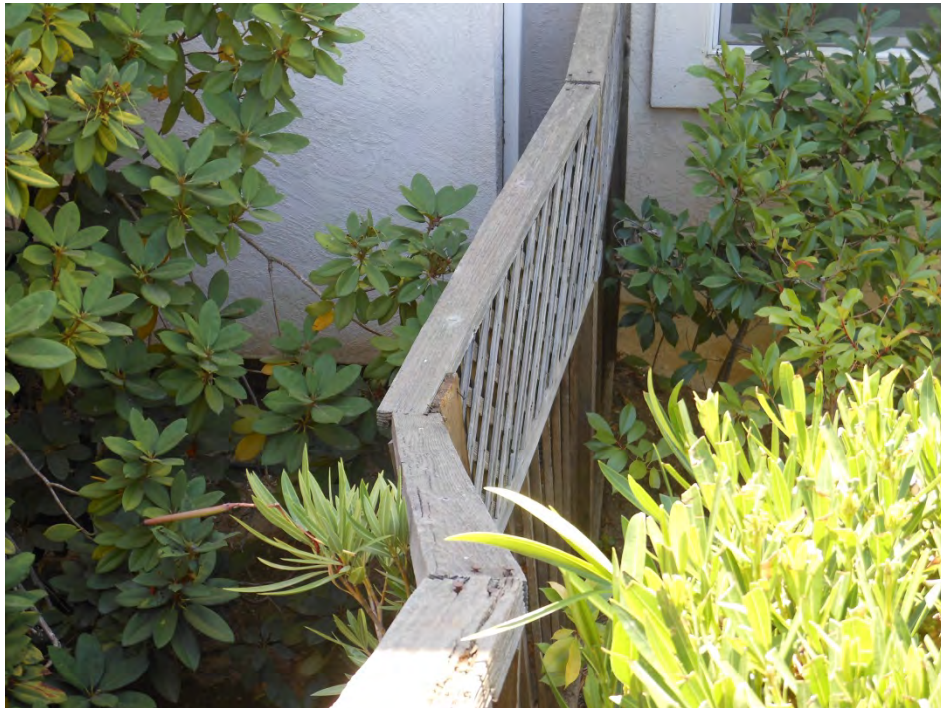
Figure C-H03-5: Fence buckled in compression. [NSF-GEER; N 38.3131 W 122.3431; 08/28/14]

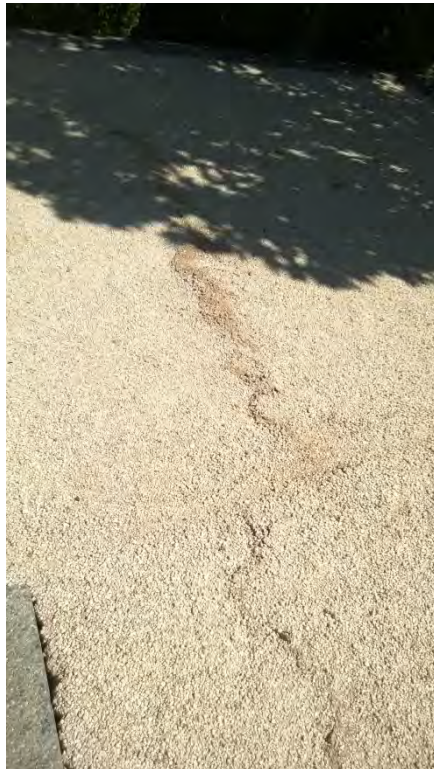
Figure C-H04-3: Compression ridge in gravel above wall. [NSF-GEER; N 38.3128 W 122.3431; 08/28/14, 14:40]

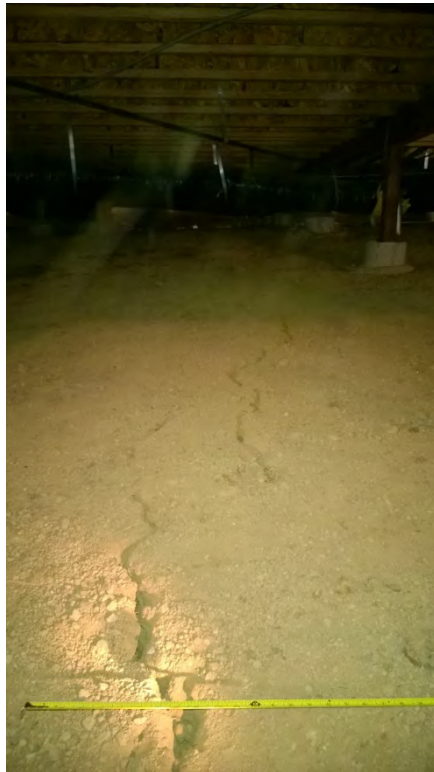
Figure C-H04-5: Soil fissure in basement. [NSF-GEER; N 38.3128 W 122.3431; 08/28/14, 12:08]

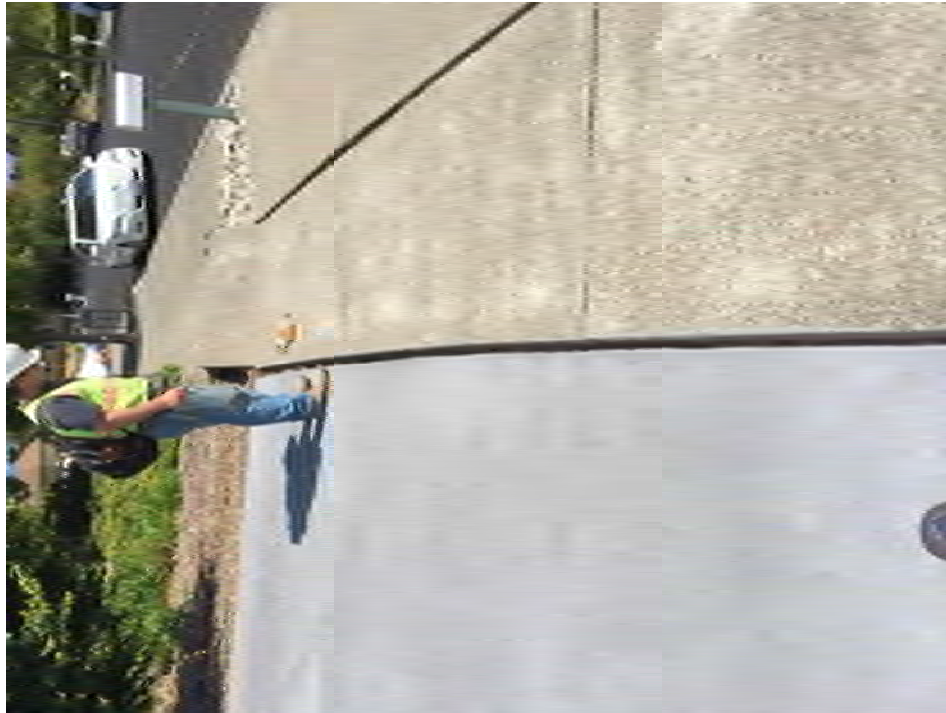
Figure C-H25-2: Offset of driveway, sidewalk and driveway bib [NSF-GEER; N 38.3038 W 122.3431; 08/25/14 13:29]

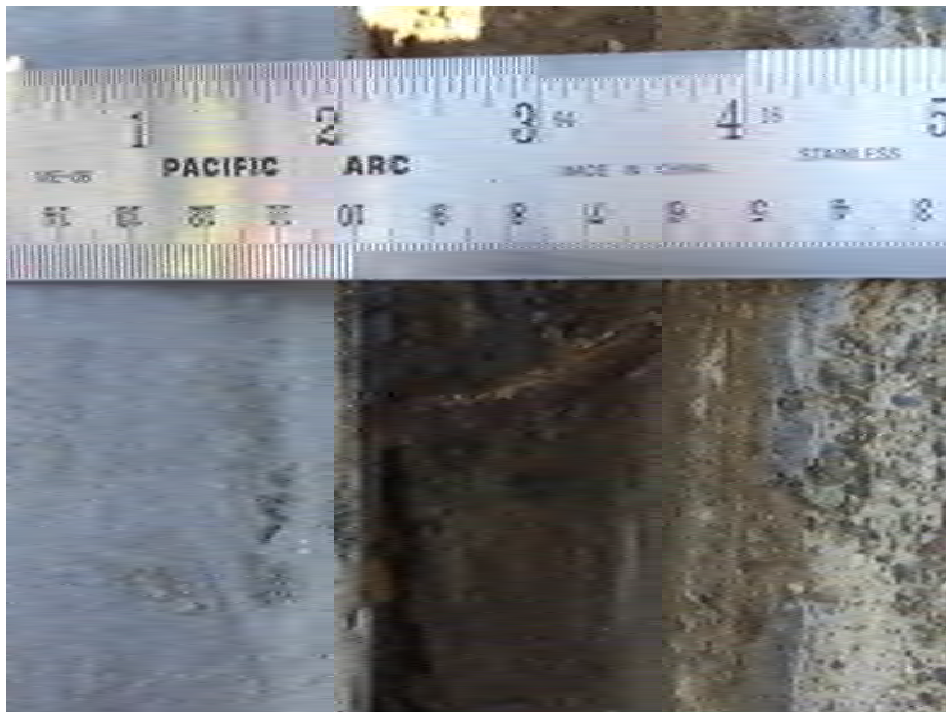
Figure C-H25-3: Deformation of rebar between driveway and sidewalk [NSF-GEER; N 38.3038 W 122.3430; 08/25/14 13:29]

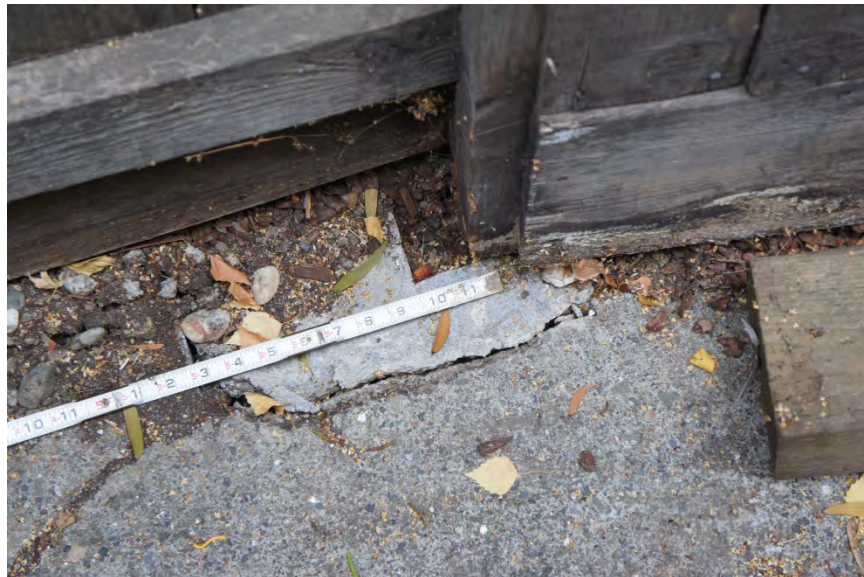
Figure C-H28-H29-3: Buckling of wooden fence showing post displacement [NSF-GEER; N 38.3033 W 122.3434; 08/25/14 09:52]

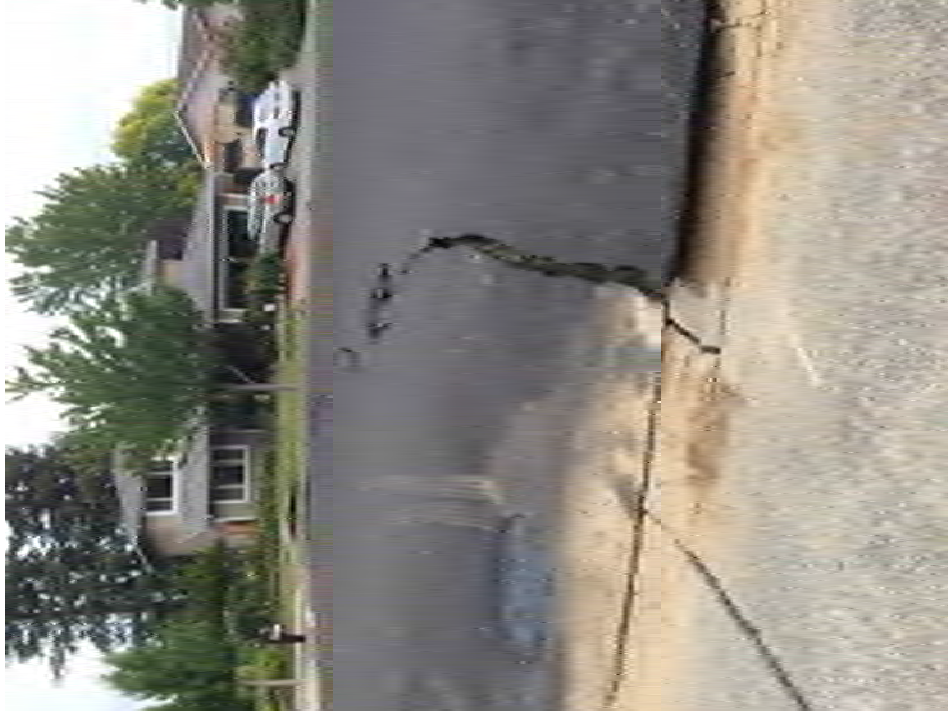
Figure C-H33-2: View across court to residence [NSF-GEER; N 38.3015 W 122.3443; 08/25/14 10:23]

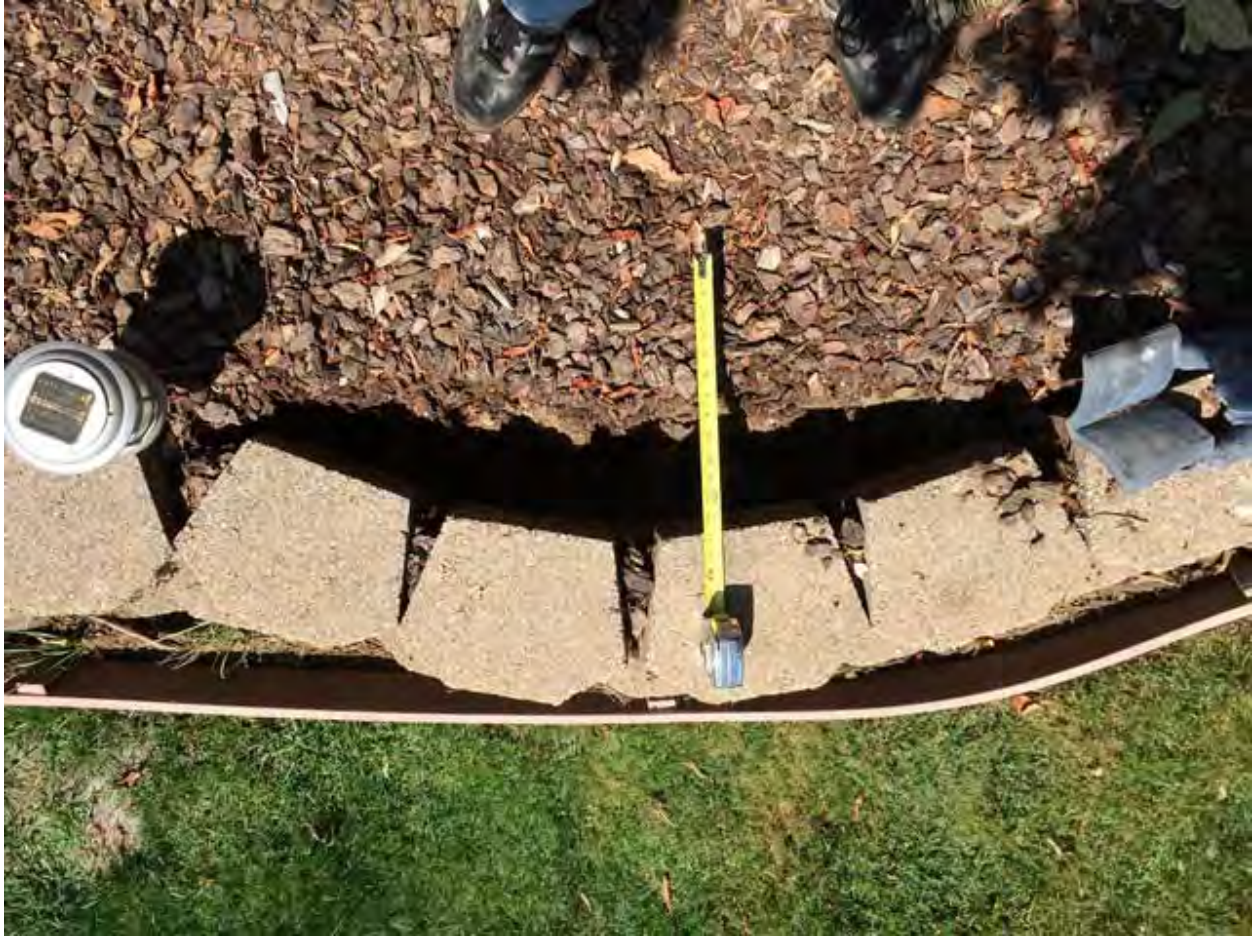
Figure C-H36-2: Buckled retaining wall [NSF-GEER; N 38.3013 W 122.3441; 08/25/14 11:57]
