Appendix F: Performance of Dams and Levees

Preliminary reconnaissance efforts of dams and levees were made by GEER team members between August 24 and September 7, 2014 following the main shock. Reconnaissance efforts included several flights in a California Highway Patrol (CHP) helicopter over several dams and levee reaches to look for any major damage from the air. No significant damage was observed at any of the areas viewed from the air. These efforts were then followed up by ground investigations in areas where higher accelerations were thought to have been sustained, notably in the central Napa area and in Vallejo. Again, no major damage was observed at any of the dams or levee reaches visited by GEER team members. The majority of damage observed on either dams or levees consisted of relatively small longitudinal cracks either on the dam/levee crest, or in one location along the landside toe of a small dike on Green Island. New cracking associated with the earthquake, or any other damage, was often not observed at all. Where present, the cracking was commonly less than a few millimeters in width. The largest crack observed was on the crest of Lake Marie Dam and was only about

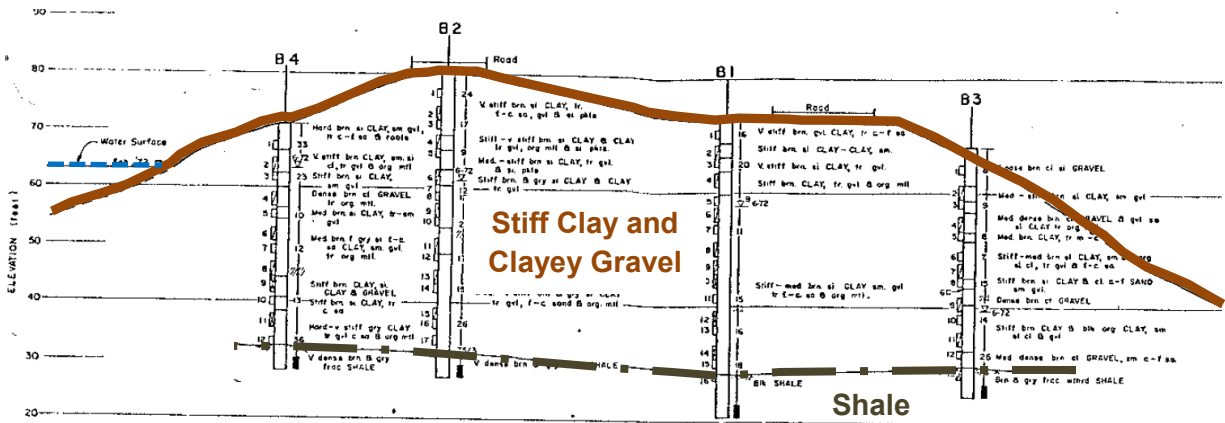
Figure F-5: Cross section of Lake Chabot Dam [Vallejo, CA; N38.141 W 122.241; from DSOD files]

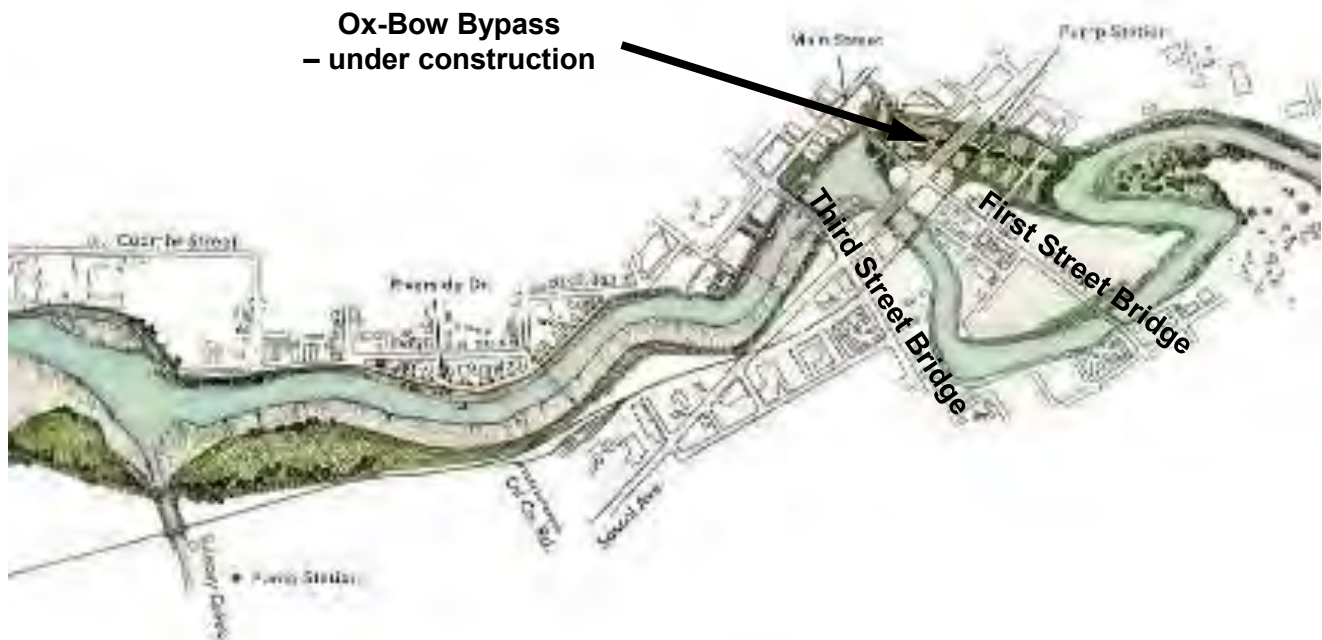
Figure F-15: Views of improvement area of confined Napa River in downtown Napa [from County of Napa and USACE]

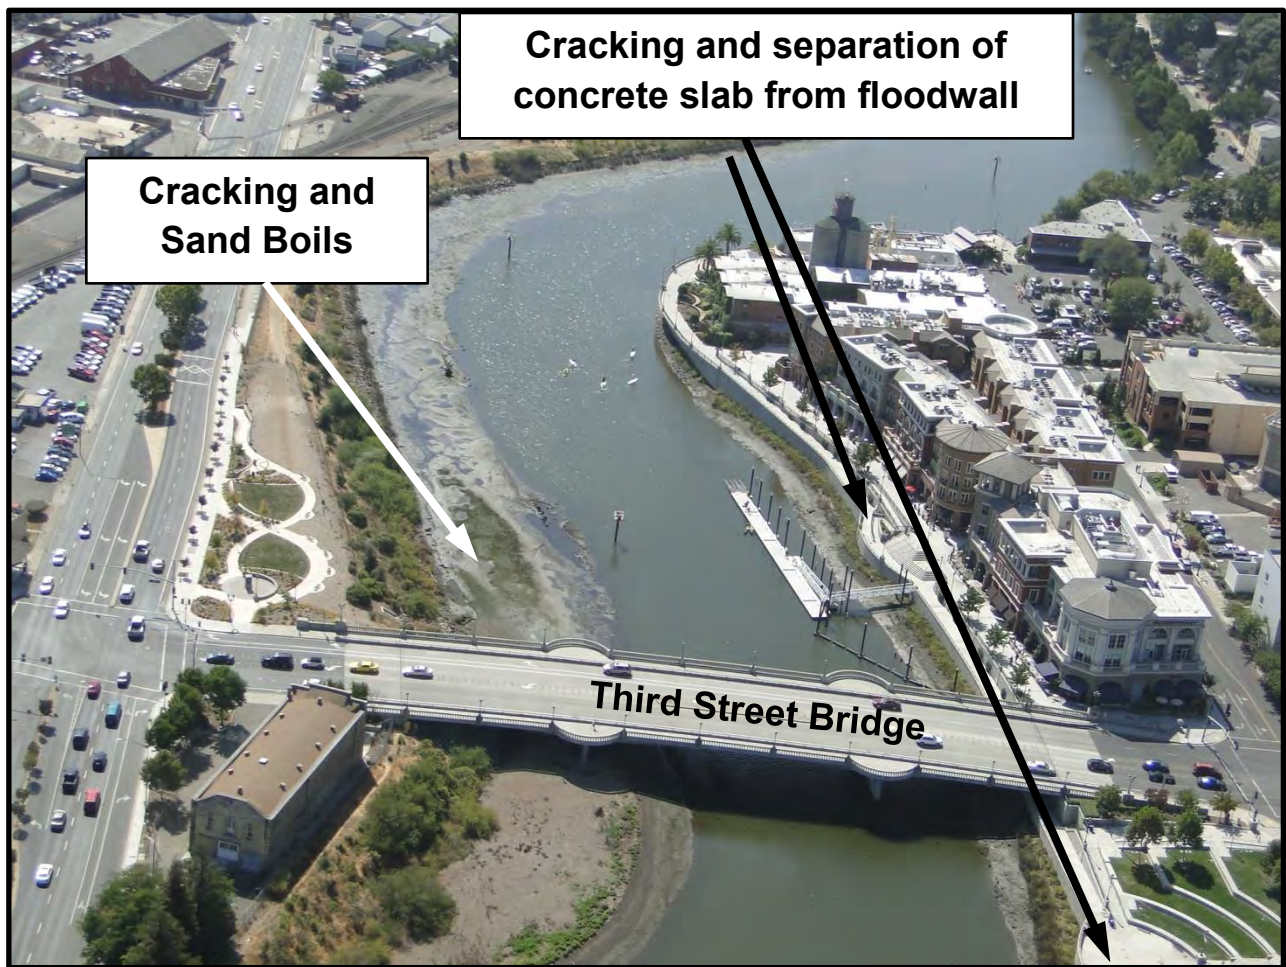
Figure F-17: Aerial photograph of Napa River looking downstream near Third Street Bridge
[NSF-GEER; Napa, CA; N38.308 W 122.281; Harder, L. F.; 09/01/14]

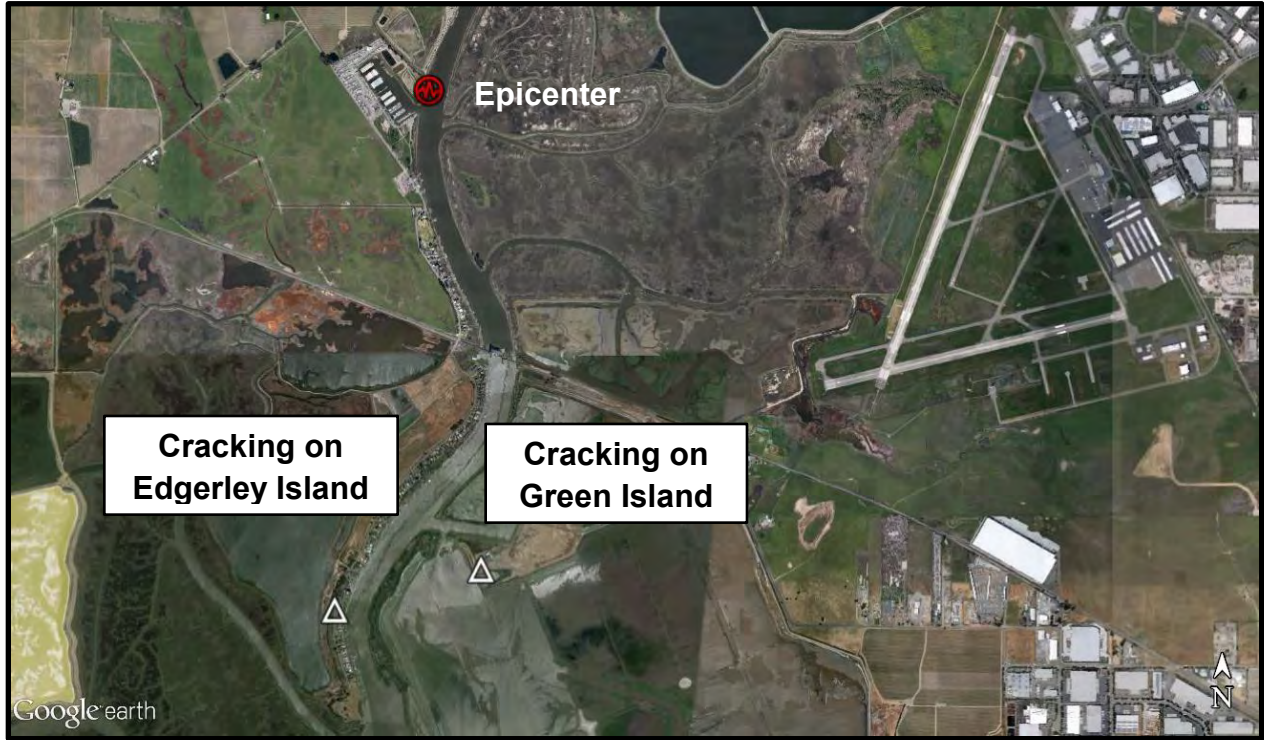
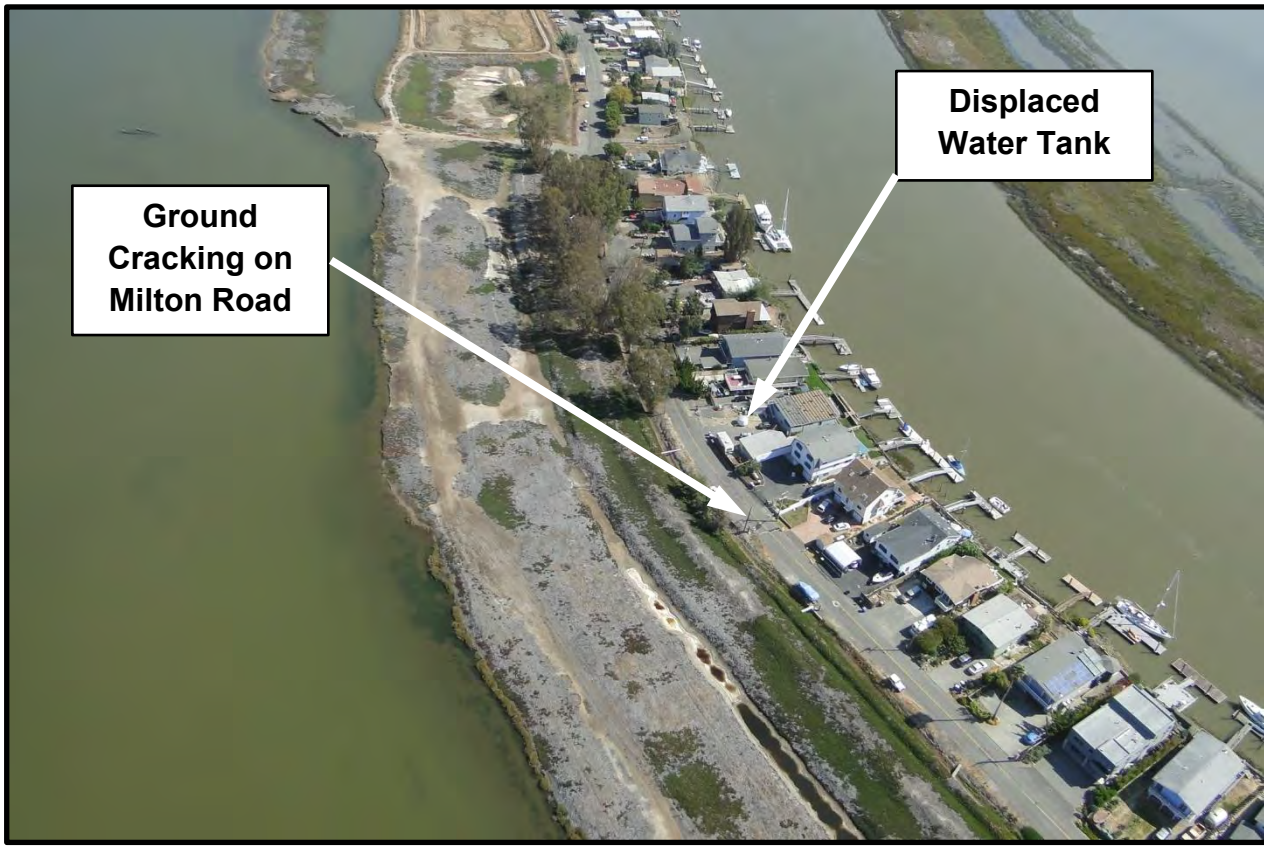
Figure F-20: Google Earth plot and aerial photograph of Napa River along Edgerley Island south of the epicenter [NSF-GEER; Napa, CA; N38.198 W 122.316; Harder, L. F.; 09/01/14]
