## 7 PERFORMANCE OF DAMS AND LEVEES

### 7.1 Introduction

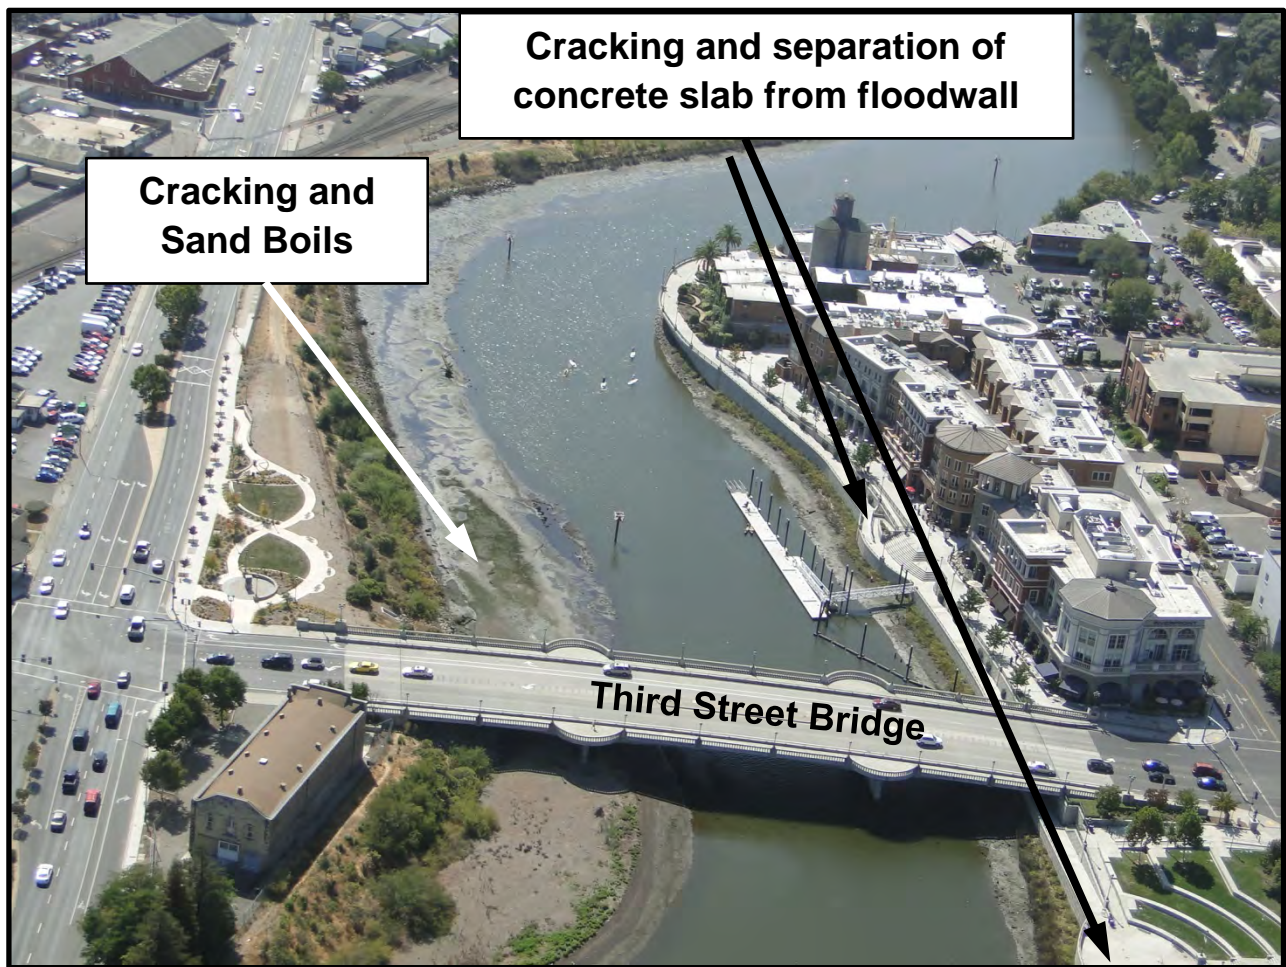
Downstream of the Third Street Bridge, remnant cracking and sand boils were observed in the sand/mud bar along the left (east) bank of the river and was suggestive that river sediments had liquefied during the earthquake (see Figures 7-12 and 7-13). The crack openings here were estimated to have a maximum width of approximately 2 centimeters. However, the adjacent riverbank appeared undamaged and there was no sign of cracking or lateral spreading on the concrete and gravel walkways above.

Figure 7-12: Aerial photograph of Napa River looking downstream near Third Street Bridge  
[NSF-GEER; Napa, CA; N38.308 W 122.281; Harder, L. F.; 09/01/14]

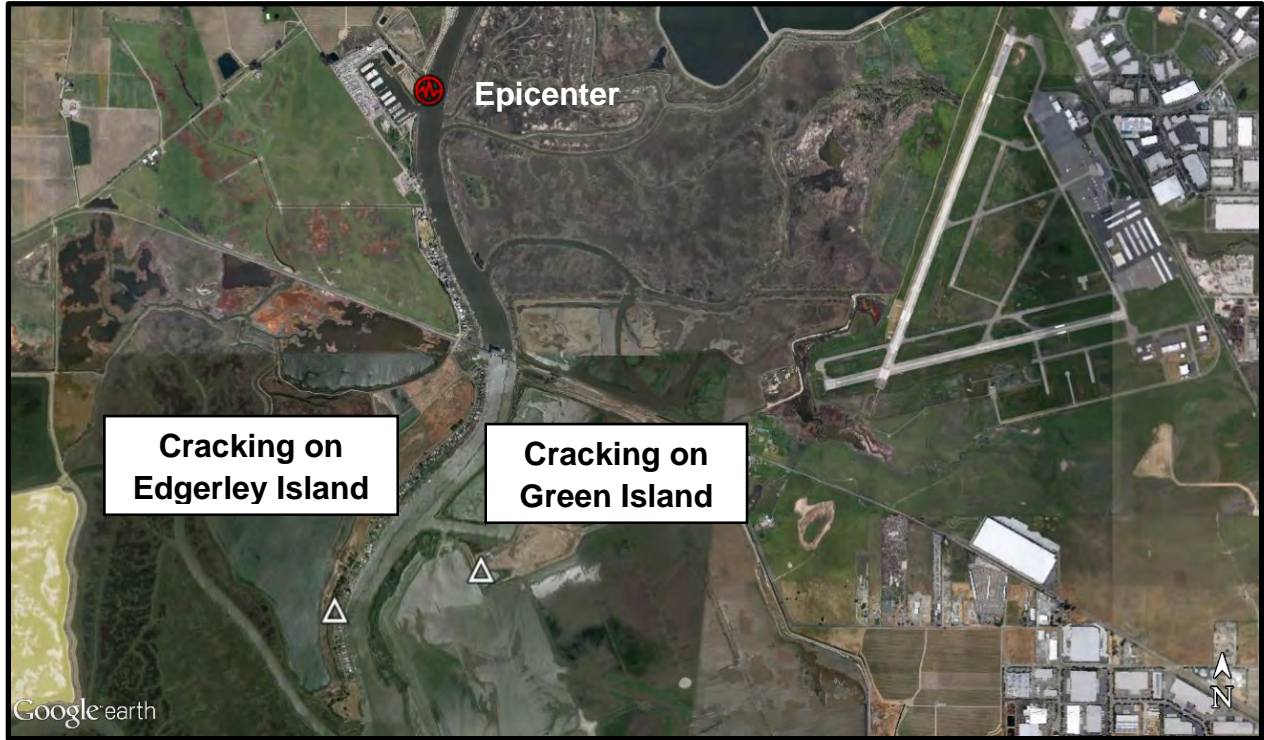
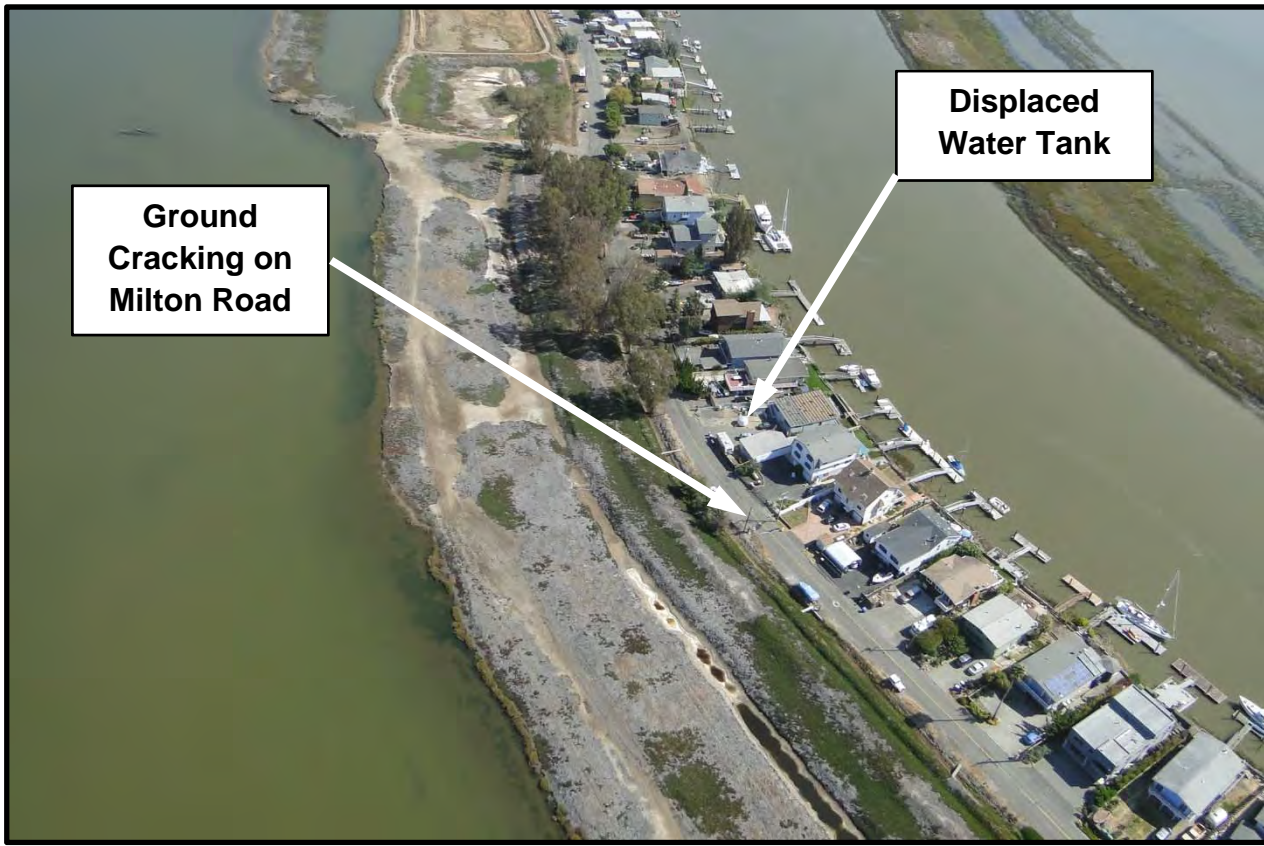
Along the right (west) bank of the Napa River south of the epicenter the levees are commonly about 2 meters in height. On Edgerley Island, residences have been built on top of the levees along Milton Road and pilings and docks have been constructed on the relatively steep waterside slopes along the river. In many places, short floodwalls on the order of up to a meter in height have been constructed to provide wave protection and freeboard. Figure 7-15 presents a Google Earth plot and an aerial photograph illustrating the area.

Figure 7-15: Google Earth plot and aerial photograph of Napa River along Edgerley Island south of the epicenter [NSF-GEER; Napa, CA; N38.198 W 122.316; Harder, L. F.; 09/01/14]
