Engineering Impacts of the August 4, 2020 Port of Beirut, Lebanon Explosion

A report of the NSF-Sponsored Geotechnical Extreme Event Reconnaissance Association in
Collaboration with the American University of Beirut

Report GEER-070: <https://doi.org/10.18118/G6C96C>

February 4 2021

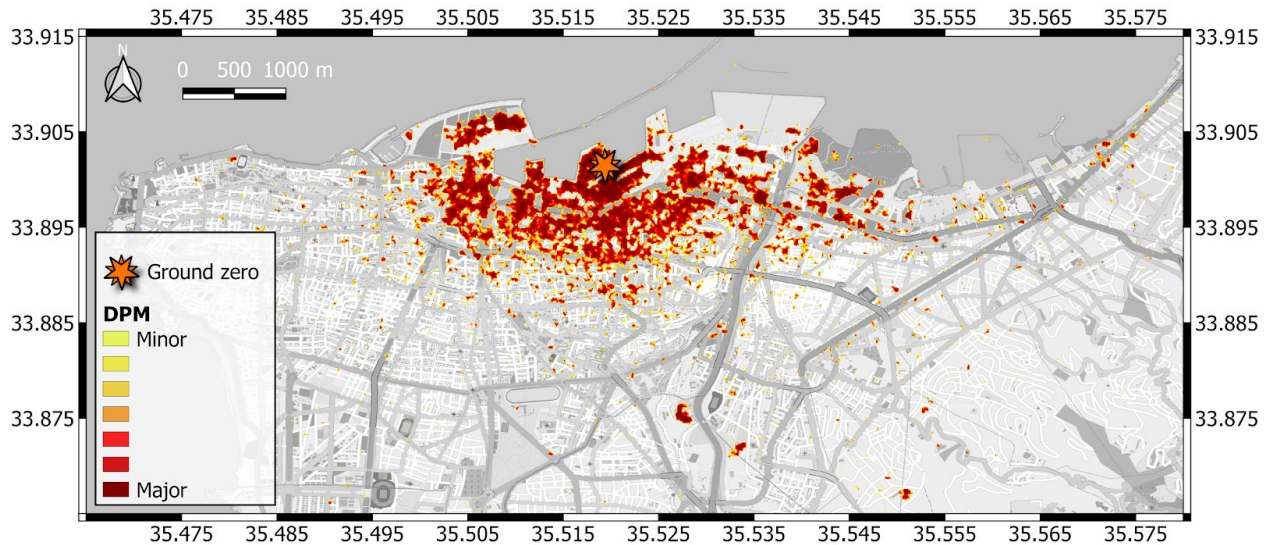
Following the August 4, 2020 Beirut explosion, a DPM was produced using satellite radar data from the Copernicus Sentinel-1 satellites. This DPM was generated comparing pre- and post-explosion SAR scenes acquired from four different tracks. Two of the satellite tracks were oriented looking from west, while two of them from east, with look-angles from vertical ranging between 31°-44°. The map used 12 pre-event and two post-event SAR scenes between May 1, 2020 and September 1, 2020. The map covers an area of 13 by 16 km (Figure 2.1). Each colored pixel measures about 10 by 10 meters. Colored pixels represent zones where there was significant change in radar wave scattering at the reflectors (i.e., ground surface or buildings), which may indicate damage from the stressing event.

Figure 2.1. DPM produced following the 4 August, 2020 blast explosion.

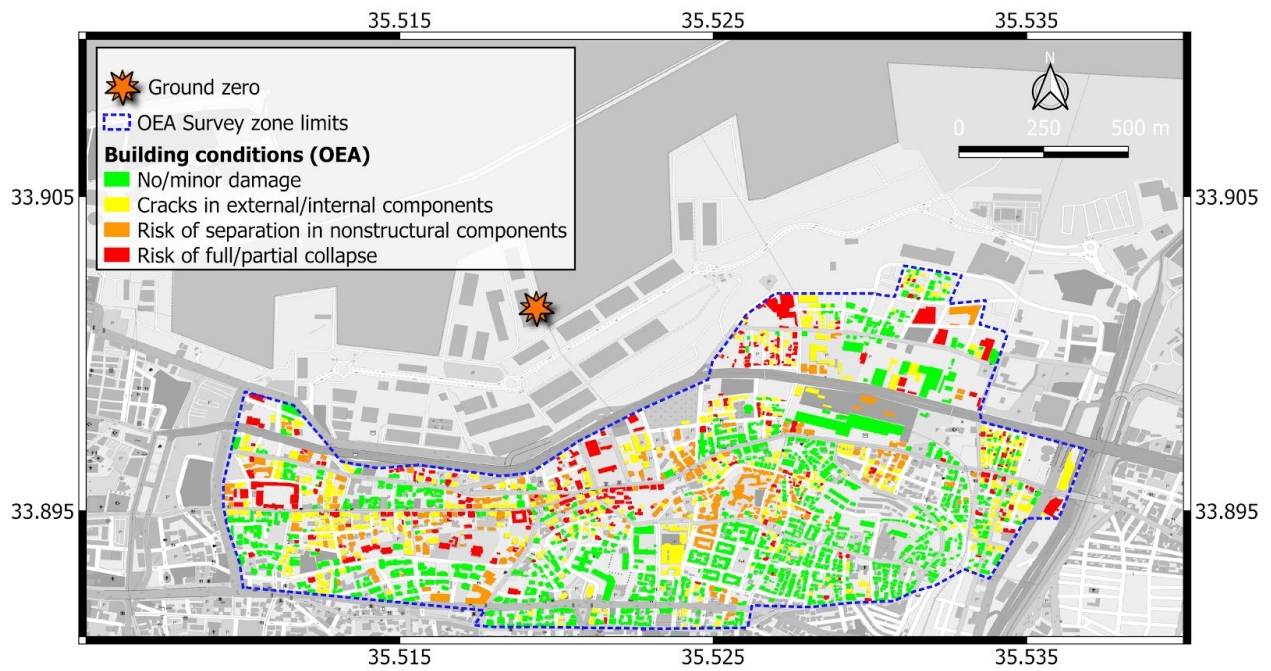
Figure 2.3 Conditions of buildings surveyed by OEA.

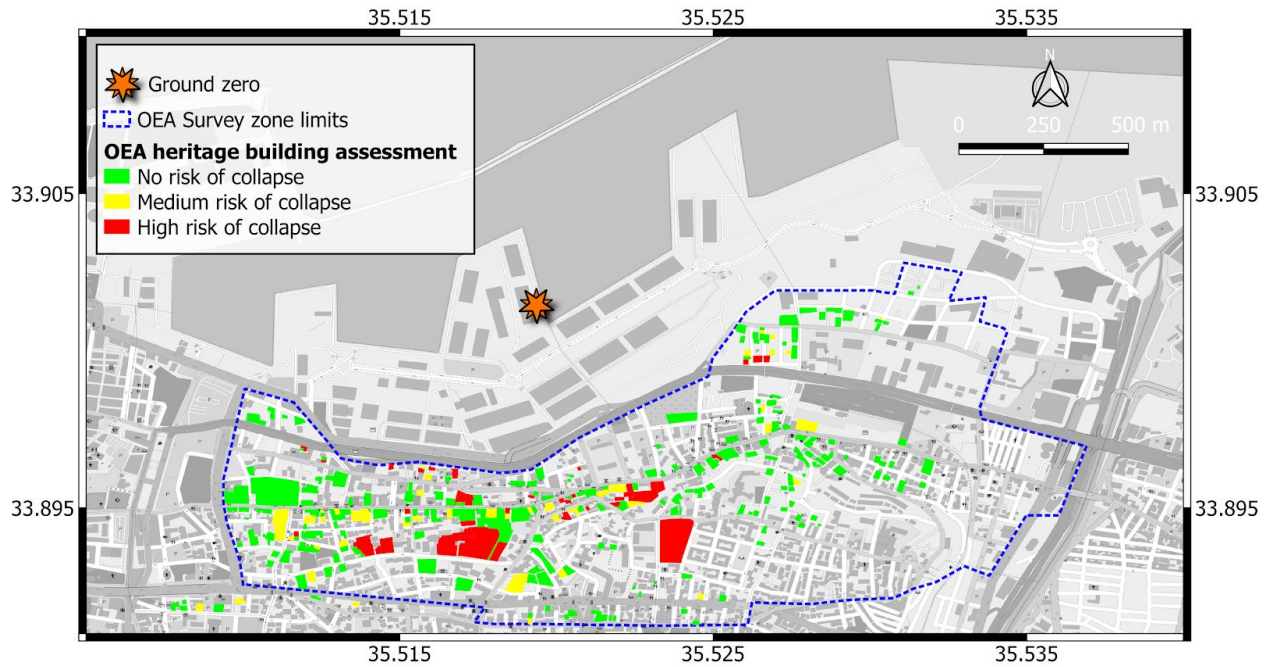
Figure 2.4. Conditions of heritage buildings surveyed by OEA.

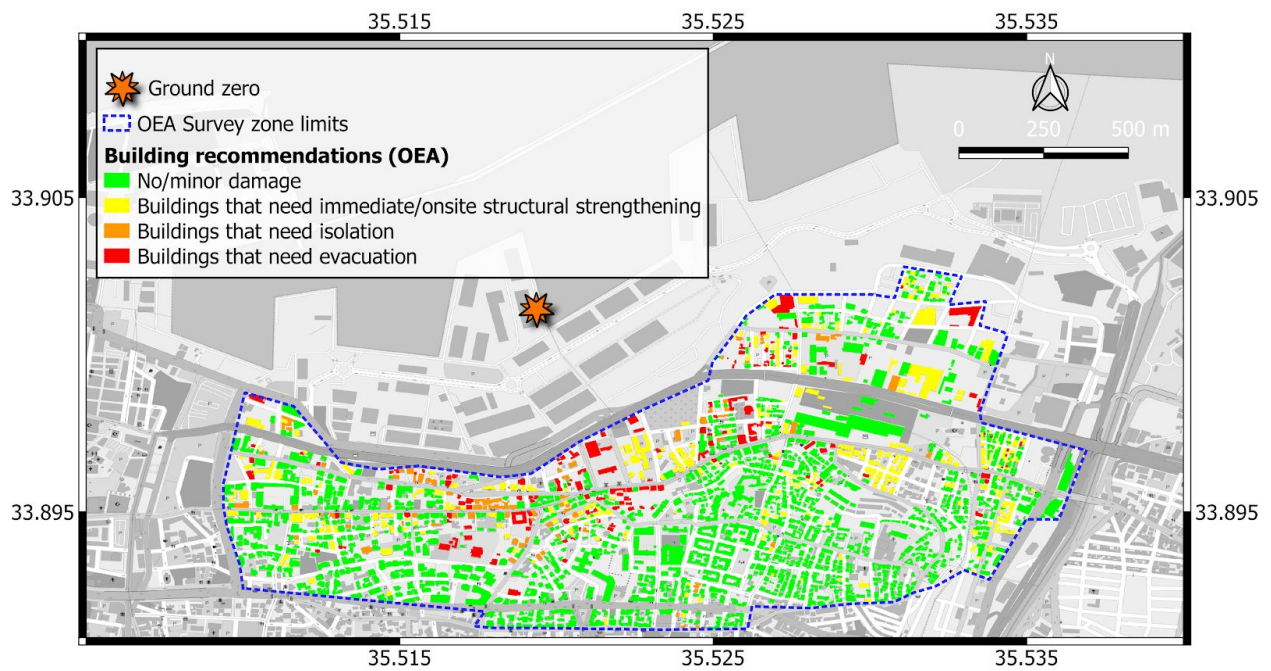
Figure 2.5 OEA recommendations on actions to be taken for surveyed buildings.

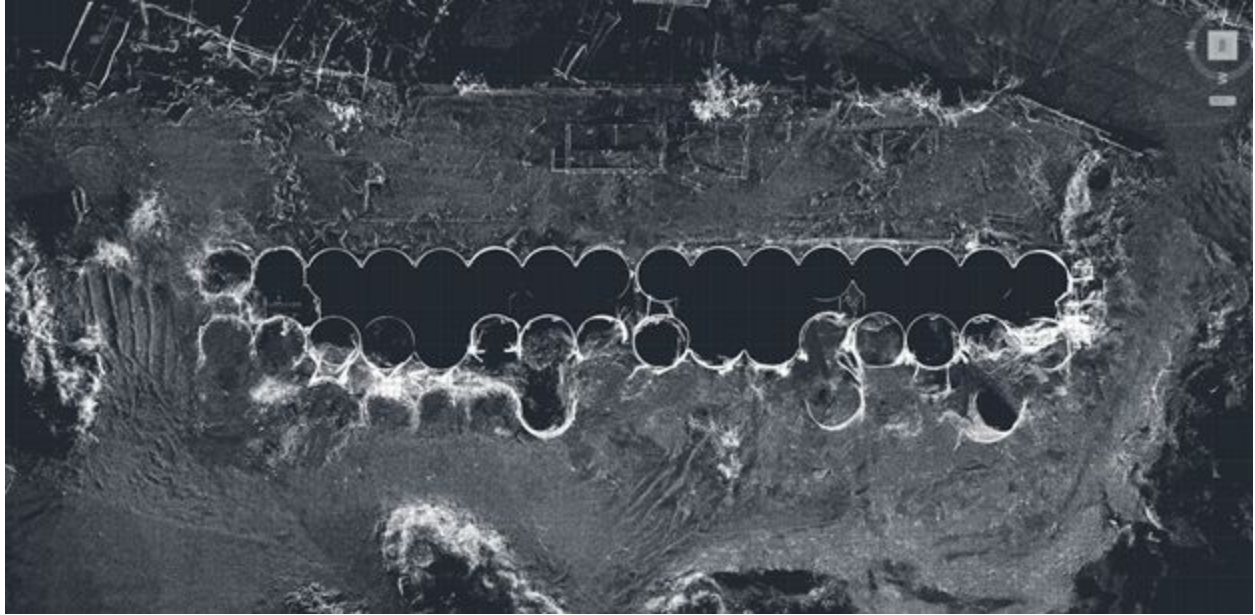
Figures 3.13-3.21 show the extensive damage to the silos from the explosion, which was only 50 m away. Figures 3.13-3.15 show a photograph, diagram, and 3D point cloud from a LiDAR scan of the silos in plan (images from the LiDAR scans were provided by Mr. Emanuel Durand, personal communication, 2020). The point cloud data collected will be made publicly available once further analyses currently underway at the Universite Saint Joseph (USJ) School of Engineering are completed. An interesting web-accessible [3D rendering](#) (Bandera, 2021) of the silos based on LiDAR and photogrammetry reconstruction has been produced from the LiDAR data and drone imaging conducted by the Lebanese ministry of commerce.

Figure 3.15. Processed image from drone-mounted LiDAR scan. The 3D point cloud is viewed from above (courtesy Mr. Emanuel Durand-Amann Engineering).

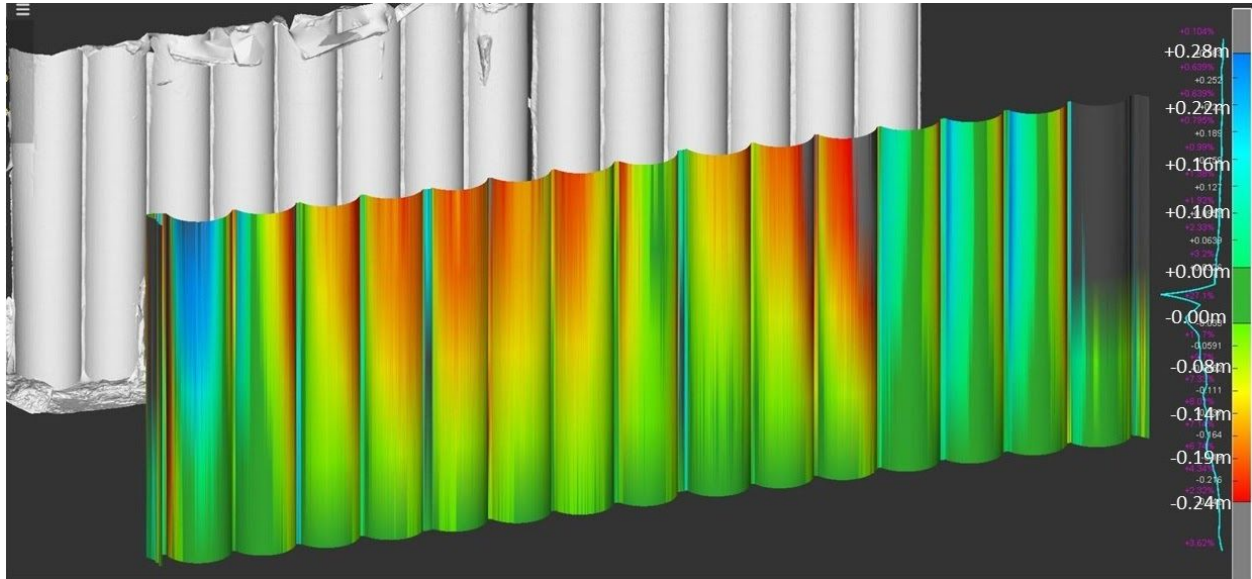
Figure 3.21 shows relative horizontal displacements of the third-row (western-most) silo as measured from LiDAR point cloud data with respect to ideally vertical cylinders of constant diameter. Negative displacement values are away from the blast, while positive ones are towards it. The relative horizontal displacements are measured as ranging from -0.24 to +0.28m. These data can be used to estimate the westward horizontal tilt of the third-row silos from the blast. By taking the relative horizontal displacements in the westerly direction at the top of the silos relative to the bottom (approximately 0.24 m), and dividing by the silo above-ground heights of 50 m, about 0.5% tilt is computed (0.3°). More detailed analyses of the deformations and base movements of the silos are underway at the USJ School of Engineering.

Figure 3.21. Horizontal deflections of west side of silos as evaluated from Lidar point cloud data. The amount of horizontal deflection is shaded as indicated by the scale bar (c. Mr. Durand). They indicate a consistent tilt at the top of multiple silos of around 24cm, all pointing away from the blast (view from the West looking East).

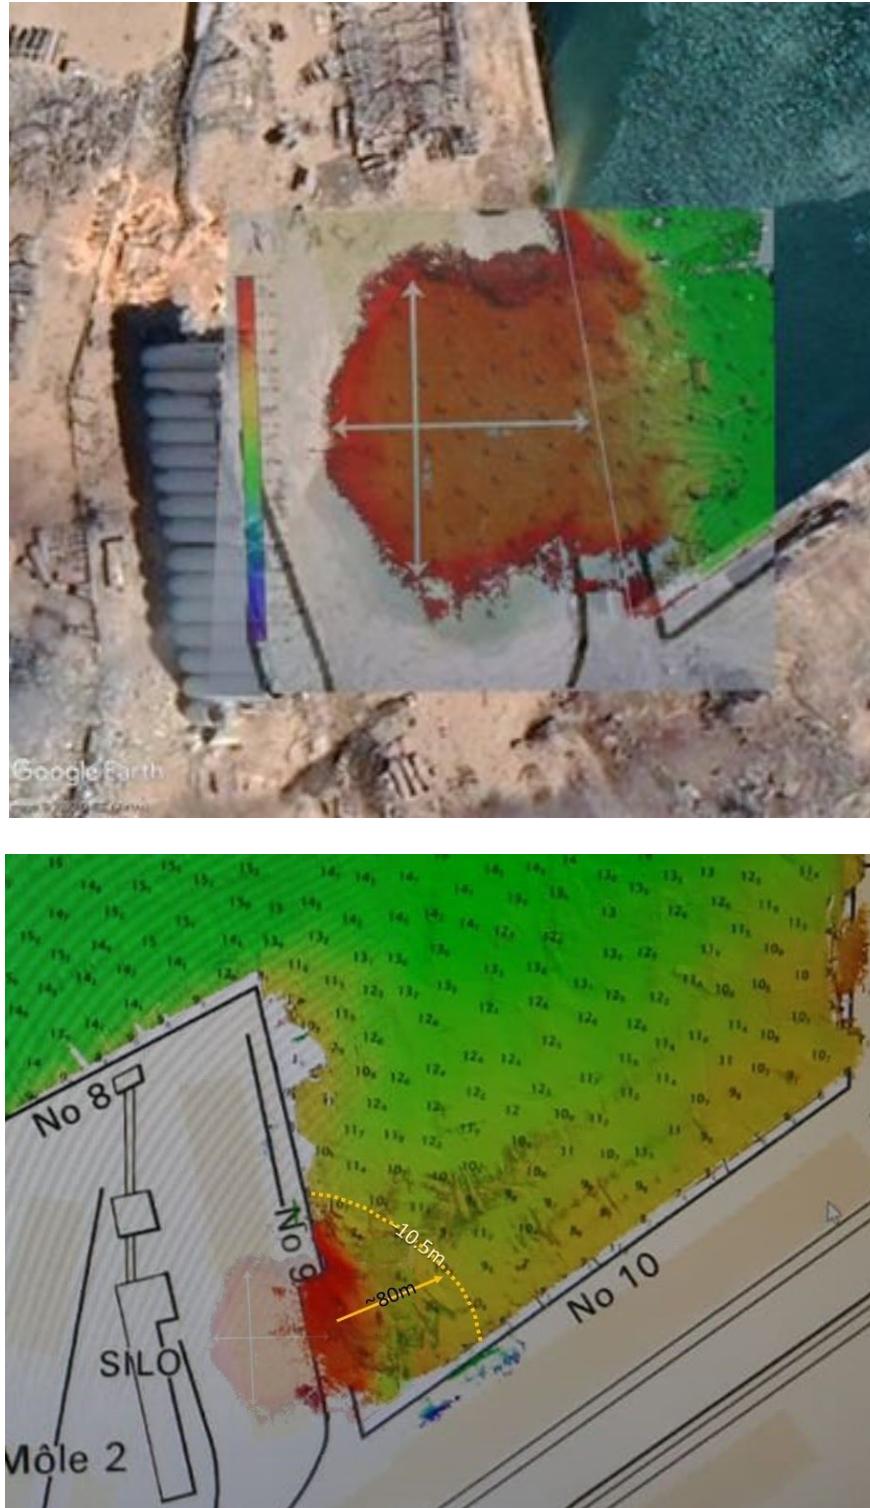
In the aftermath of the event, detailed bathymetric surveys were conducted by teams from the Lebanese and French armies using boat-mounted bottom profilers. The results of those surveys are presented for the area of concern in Figure 3.24. Figures 3.25 and 3.26 provide contour-based and isometric surface representations of the data in the areas near the quay wall. The 3D isometric surface rendering in Figure 3.26 provides a clearer view of the crater and earth movement as the original quay-wall was displaced/failed by the force of the blast. The localized high points visible in this rendering are artifacts of the interpolation.

Figure 3.24. Top: Superposition of bathymetry survey on Google Earth image of crater and adjacent area; Bottom: Water depths from bathymetric survey and approximate limit of depth decrease from flow slide. Data from the Lebanese Ministry of Commerce.

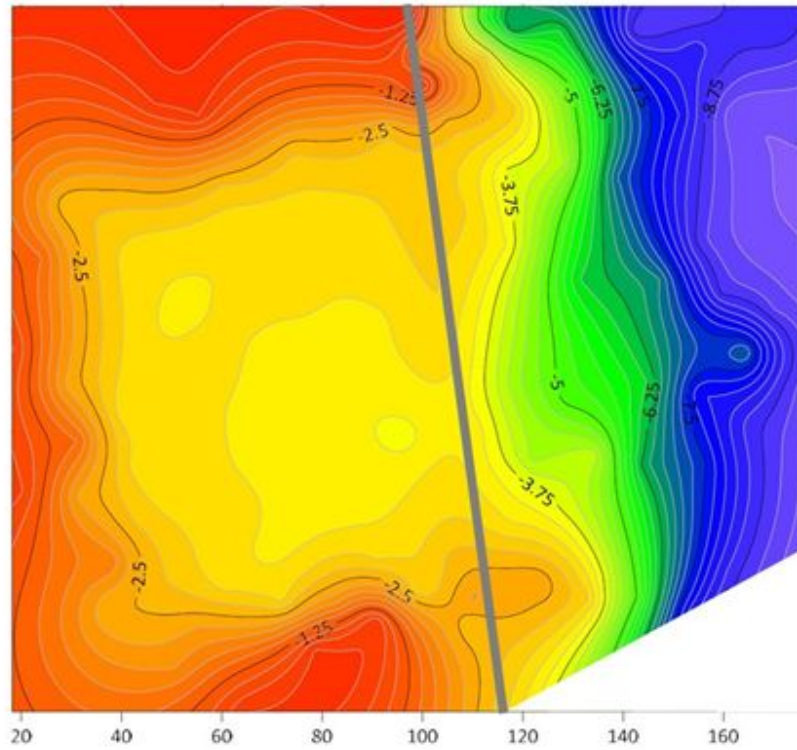
Figure 3.25. Depth contours (in meters relative to MSL) in the crater area. Gray line indicates the location of the former quay wall.

Recalling that the originally reported bathymetric level for this part of the Port was approximately -10.5m (Figure 3.11), the extent of the significant flow of materials beyond the original position of the quay wall becomes clear. The depth of the crater (including original ground level taken as approximately +1.5m and the part reflected in the bathymetric contours below the waterline) can be estimated to have a maximum value of 4 to 5m. The resulting Depth to Diameter Ratio (DDR) would then be approximately 0.04, which is below the lower range of typical measured DDR for large blasts (>100 tons of TNT equivalent). The somewhat shallower impact depth in the Beirut Port event could be attributed to the high water level (only 1.5m below surface), and the lateral release/flow of some of the material into the adjacent deeper basin.

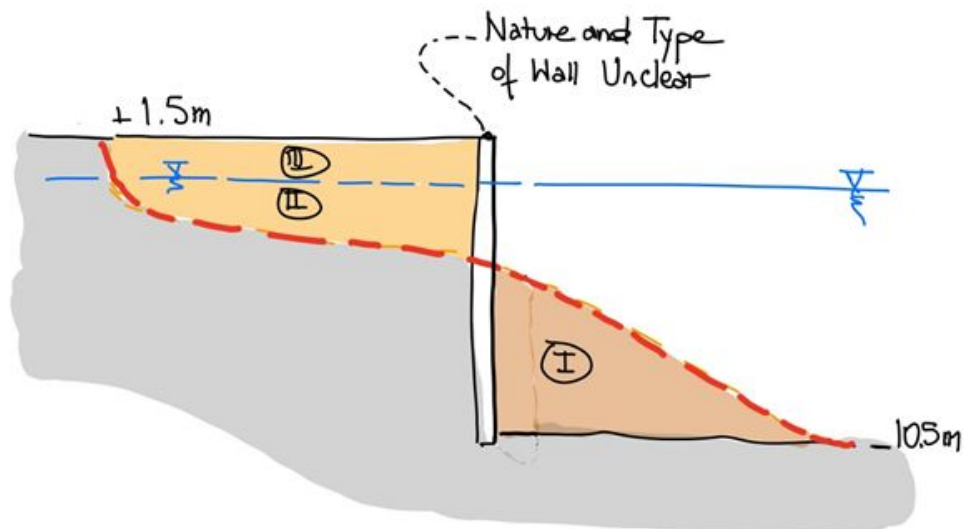
If we consider a pre- and post-explosion section along the center of the crater, it may be represented by the schematic shown in Figure 3.27. This conceptual rendering shows how we can use the data from the bathymetric contours and the original ground surface level to calculate volumes of soil displaced from behind the wall (volumes II and III) and accumulated below the wall within the original basin (volume I).

Figure 3.27. Schematic of a pre and post event section through the crater.

- Volume I: Material displaced into the basin $\sim 38,500 \text{ m}^3$
- Volume II: Below-water material “lost” from behind the original quay wall $\sim 29,500 \text{ m}^3$
- Volume III: Above-water material “lost” from behind the original quay wall $\sim 16,000 \text{ m}^3$

The balance of the material on either side of the quay wall is $(v\text{-II}+v\text{-III}) - v\text{-I} \sim 7000\text{m}^3$. This “unaccounted” for soil was probably thrown up into the air for longer distances in various directions by the blast (mostly the above water level fill) and/or due to the many simplifying assumptions we made in the analysis, including all uncertainties related to the original system and levels, etc. Nonetheless, these numbers confirm the likelihood of a flow of the retained fill as the quay-wall structure was “lost”/failed due to the blast. The material apparently flowed up to a maximum distance of approximately 60 to 80m as can be seen from Figures 3.24. As such, the data could be used in a back-calculation of residual strength.

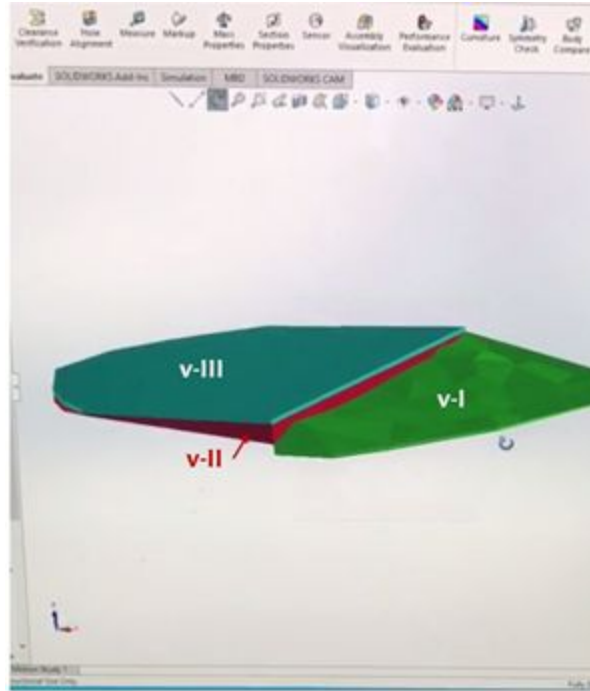
This analysis was done using the software packages Mathematica[®] and Solidworks[®]. The shapes of the volumes as rendered in the analyses are shown in Figure 3.28. The following results were obtained:

Figure 3.28. Screen shot from Solidworks software showing the 3D volumes analyzed.

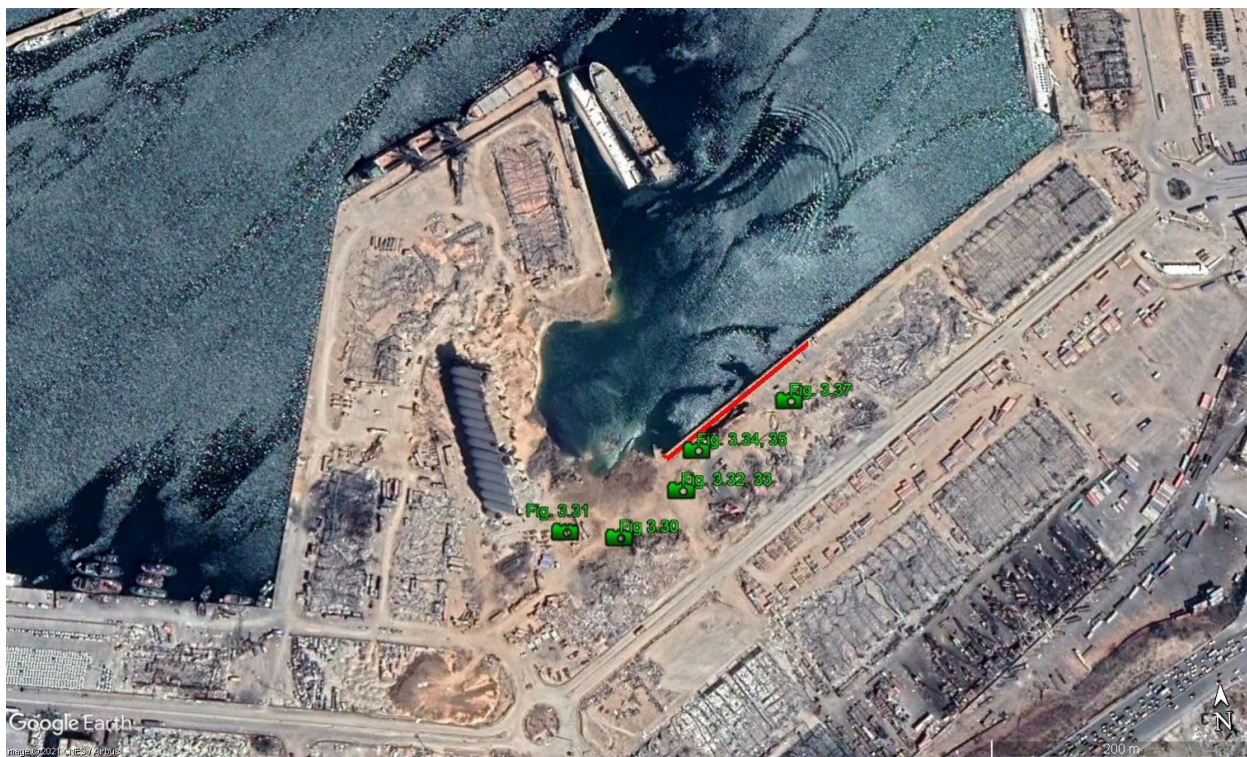
Figure 3.29. Reference map for the observations and pictures included in this section.

At the time we visited the site, much of the scene had been significantly changed and modified by the rescue and emergency removal operations. Nevertheless, it still was possible to note some surface deformations, loss of material via possible internal erosion or water overtopping and eroding unpaved parts of the docks. These observations are presented and commented upon in Figures 3.29 to 3.37.

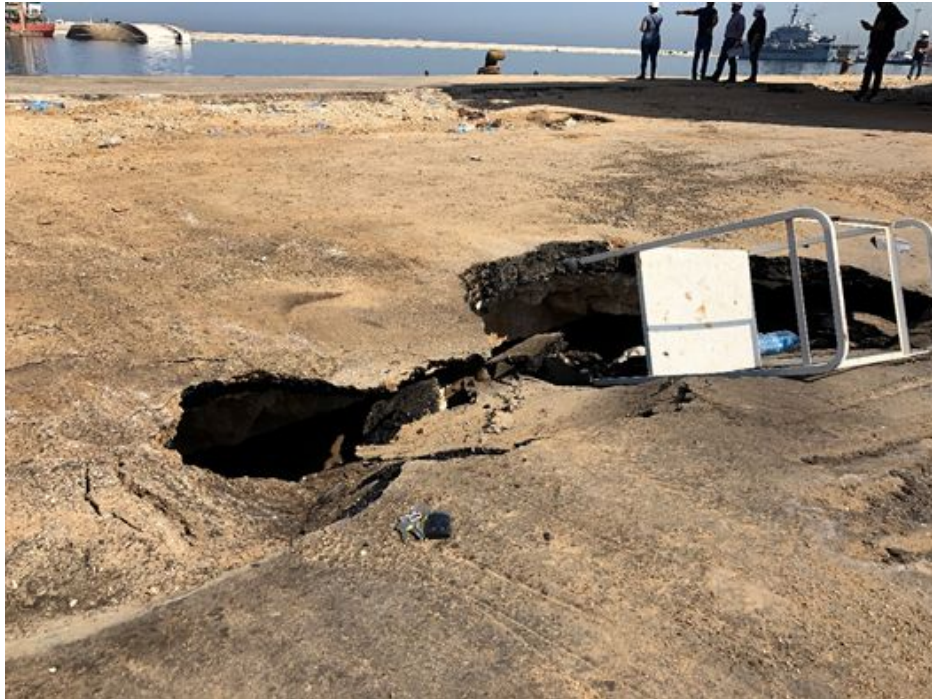
Figure 3.32. Dock along Quay 10. This location was paved. The expression of the ground deformation below the surface was exposed as a result of heavy earth moving equipment. Note the overall downwards settlement from the presumed original quay level ($33^{\circ}54'2.00''\text{N}$; $35^{\circ}31'11.36''\text{E}$).

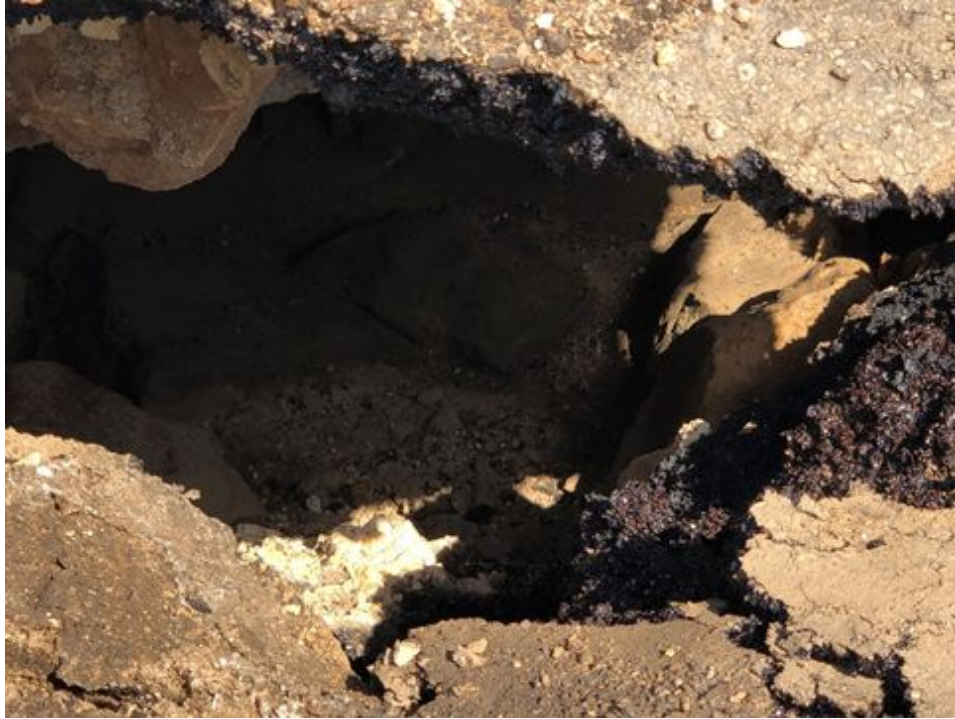
Figure 3.33. Close-up of the void below the asphalted section/pavement (33°54'2.00"N; 35°31'11.36"E).

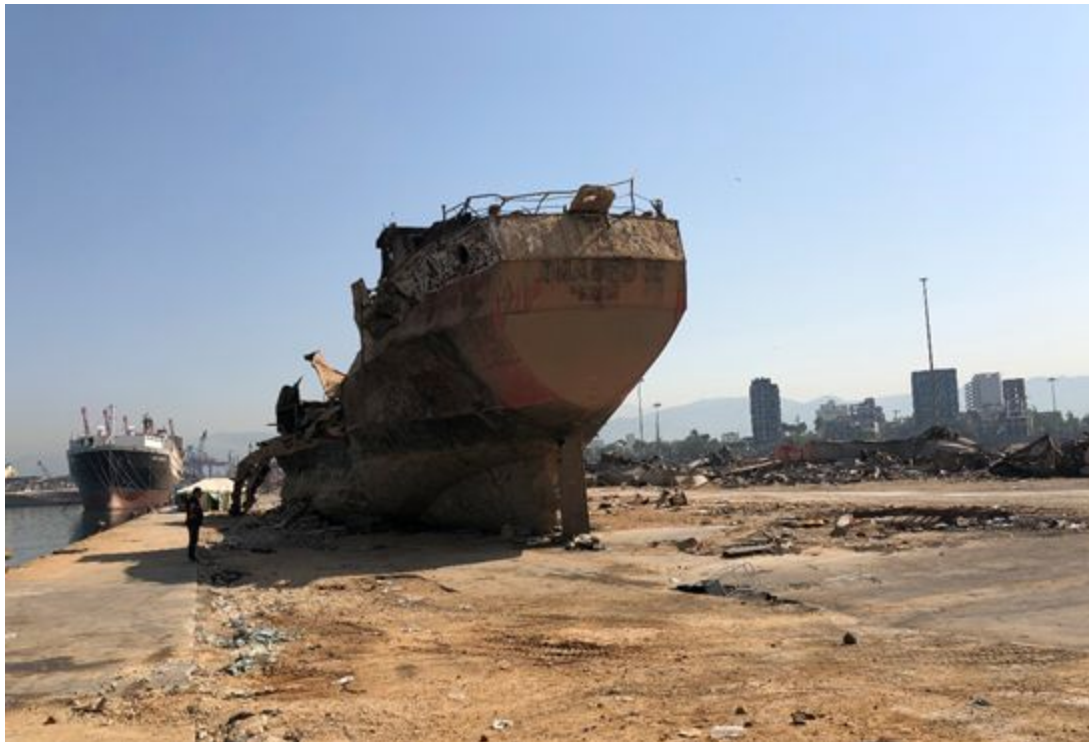
Figure 3.34. Medium-size vessel that was docked at Quay 9, lifted by the water wave generated by the explosion and left on the dock at Quay 10.(33°54'3.04"N; 35°31'11.94"E).

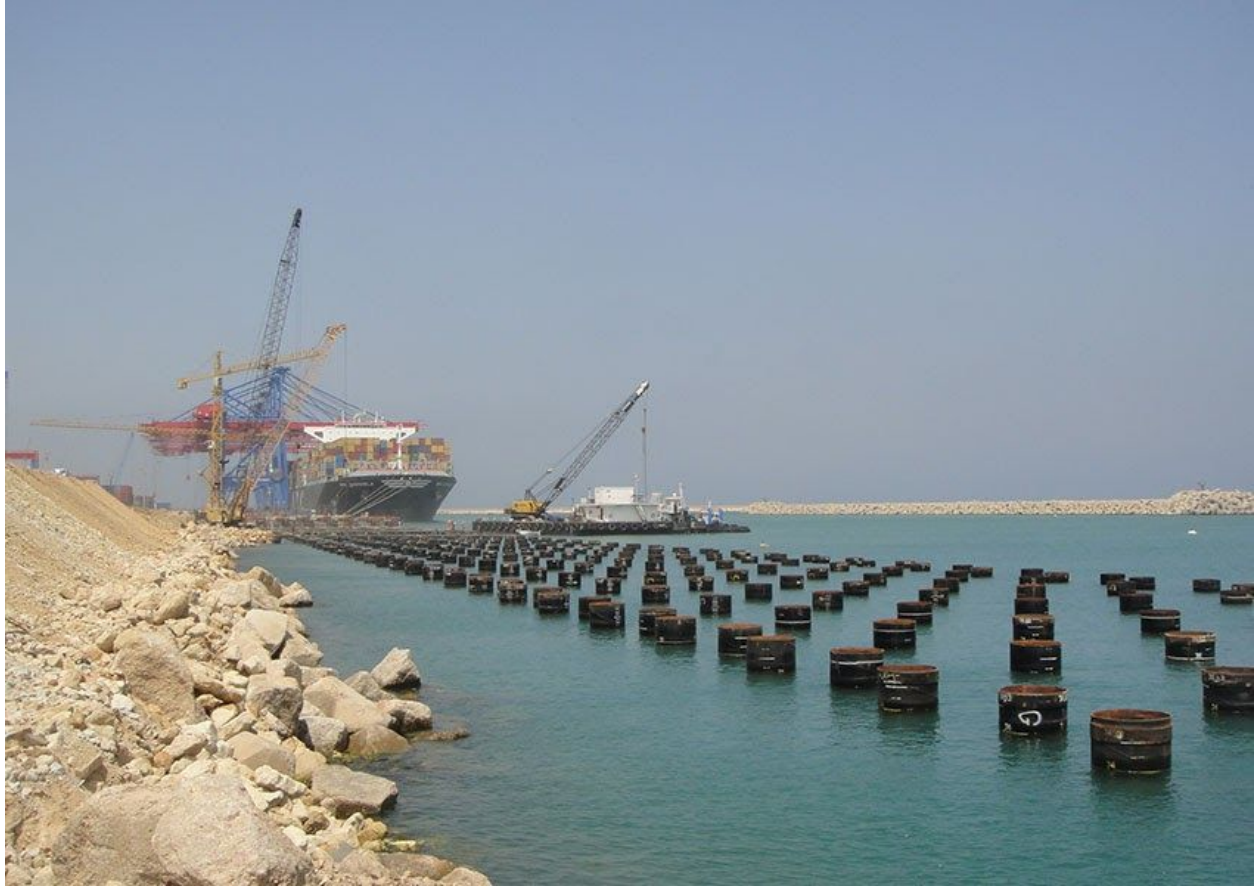
As noted previously, the Port of Beirut was not completely out of service following the 4 August 2020 explosion. In particular, quays to the south and east of Basin 4 (locations shown in Figure 3.10) and the Container Terminal remained operational. These areas are further from the blast source (approximately 1200m) than the quays bounding Basin 3. However, the standards of construction in this part of the Port were also higher, being part of the post-1950 Port expansion. The quay slabs were built on driven large diameter steel piles, as shown in Figure 3.38. Permanent ground deformations were not observed in this area and the cranes remained operational with no distortion to their tracks.

Figure 3.38. Piles driving in Container Terminal portion of Port of Beirut as part of 2011 expansion.

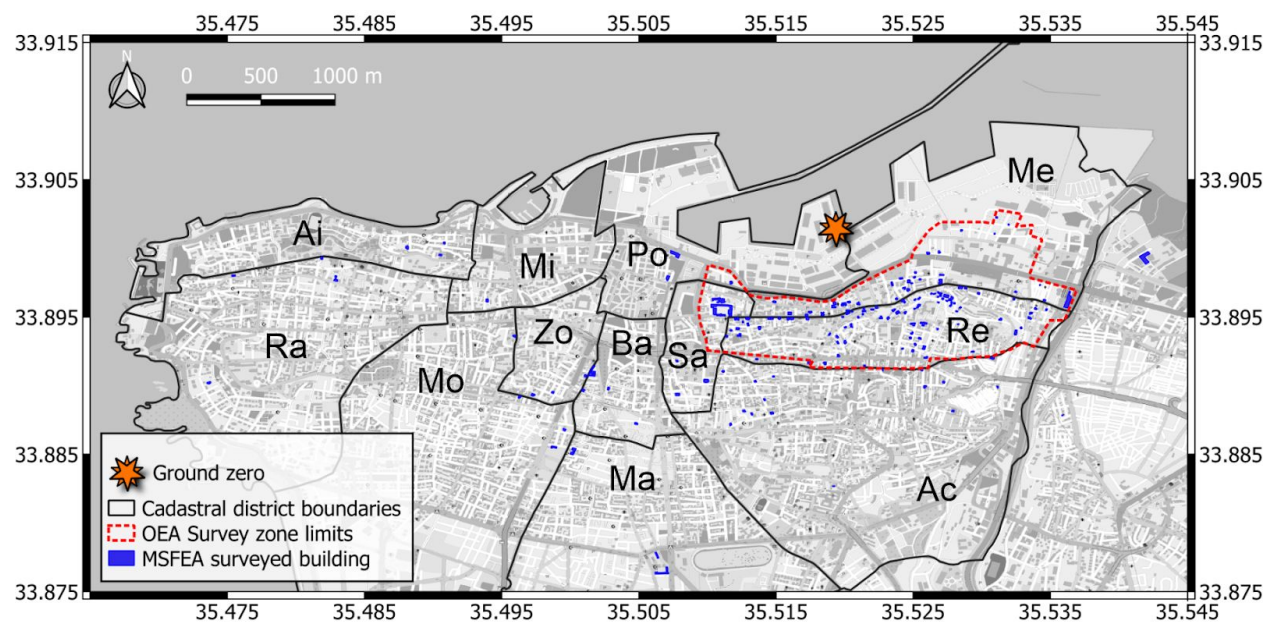
A total of 172 buildings were inspected during this effort. The locations of these buildings are shown in Figure 4.1. Most of them are located within 2 km from the blast. The buildings were classified into one of three damage categories, adapted from ATC-20 (1995) and ATC-45 (2004) rapid and detailed evaluation safety assessment forms to suit the local setting: safe (green), restricted use (yellow), and unsafe (red). A more detailed description of these categories is provided in Table 4.2.

Figure 4.1. Buildings inspected by MSFEA as part of the GEER reconnaissance.

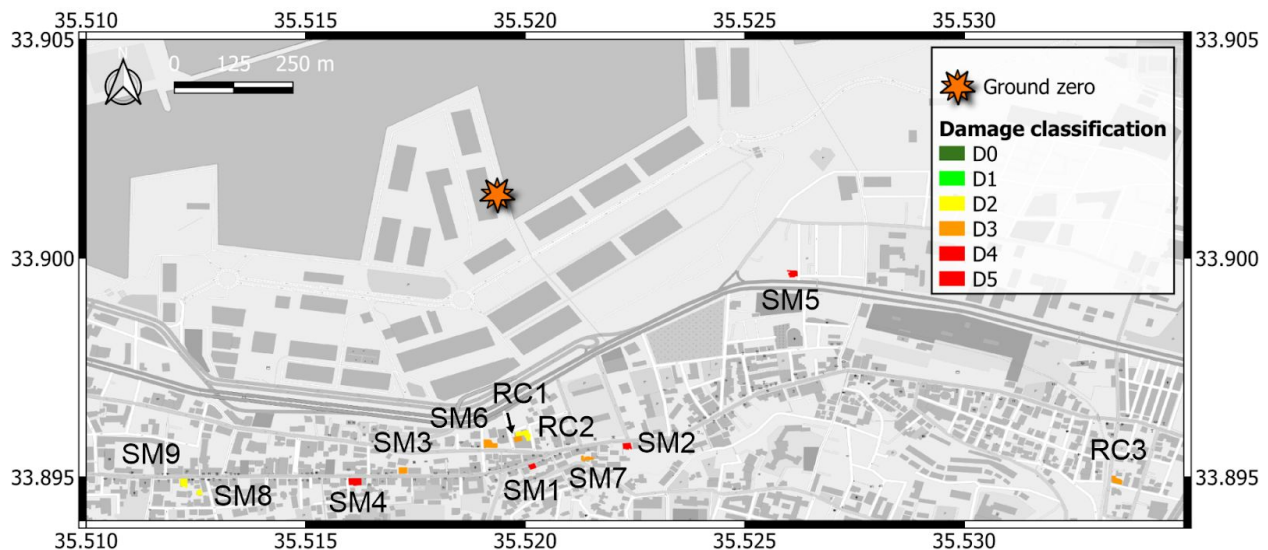
Figure 4.4 shows the locations of example buildings that will be discussed here: stone masonry (SM) structures 1 to 9 and reinforced concrete (RC) buildings 1-3. Four of these structures are located close to each other at distances between 600 and 700 m from the blast (Figure 4.5) -- SM1, SM6, RC1 and RC2. They sustained different levels of damage, which are likely a consequence of their different structural typology and quality. Another possible factor is the presence of a direct line of sight from the blast, versus the line of sight being blocked by neighboring high-rise buildings.

Figure 4.4. Locations of example stone masonry (SM) and reinforced concrete (RC) structures with varying levels of structural damage.

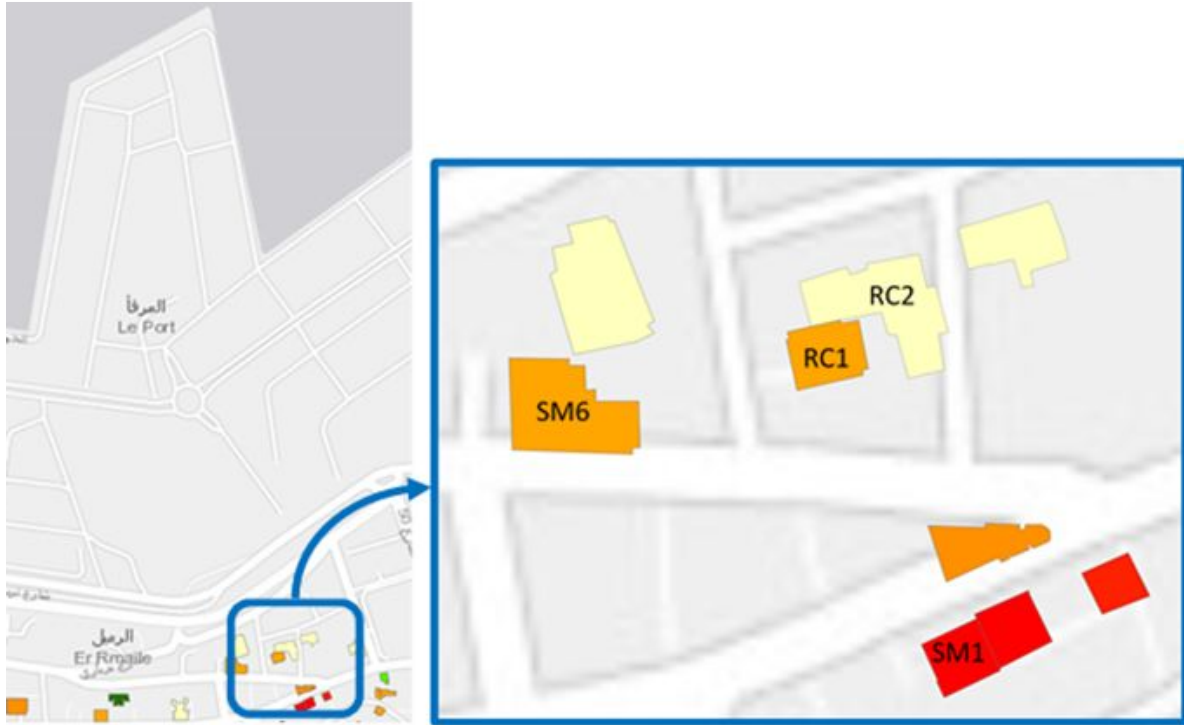
Figure 4.5. Set of buildings with varying structural typologies and damage classes.

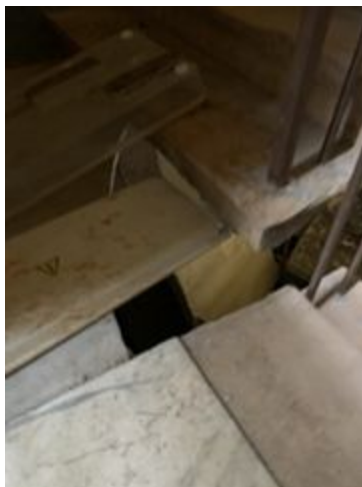
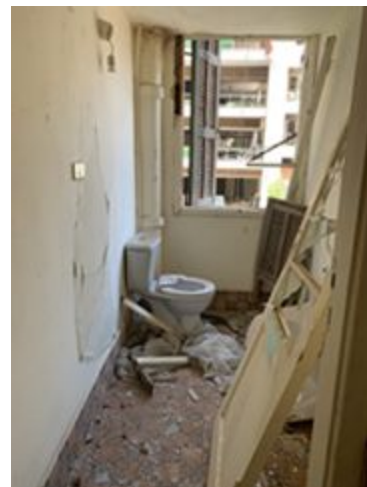
Figures 4.7 to 4.11 show pictures of stone masonry buildings located within 1 km from the blast and that were inspected from both the exterior and interior. SM4, shown in Figure 4.7, is a partially collapsed (D4) 4-story structure. Observations include partial collapse of the roof, heavy damage or collapse to some of the ceilings and interior partition walls, as well as some damage to the staircase and a façade column. SM5, shown in Figure 4.8, is a partially collapsed (D4) 3-story structure. Part of this structure was recently strengthened by adding a steel frame. The building sustained partial collapse only of the portion that was not strengthened, in addition to cracking in external walls and balcony failure. SM6, shown in Figure 4.9, is a heavily damaged (D3) 4-story building. Notable damages include cracking within and between stone masonry walls, separation between walls and slabs, permanent displacement of interior marble columns, and collapse of partition walls. Figure 4.10 shows another heavily damaged (D3) stone masonry building, SM7, which sustained extensive cracking in its walls, while Figure 4.11 shows some moderately damaged (D2) stone masonry buildings; SM8 sustained damage and partial failure of its roof, façade and balcony, while SM9 sustained some damage to its wooden roof truss.

Figure 4.7. Partially collapsed (D4) stone masonry building SM4 (33.8948° N, 35.5161° E).

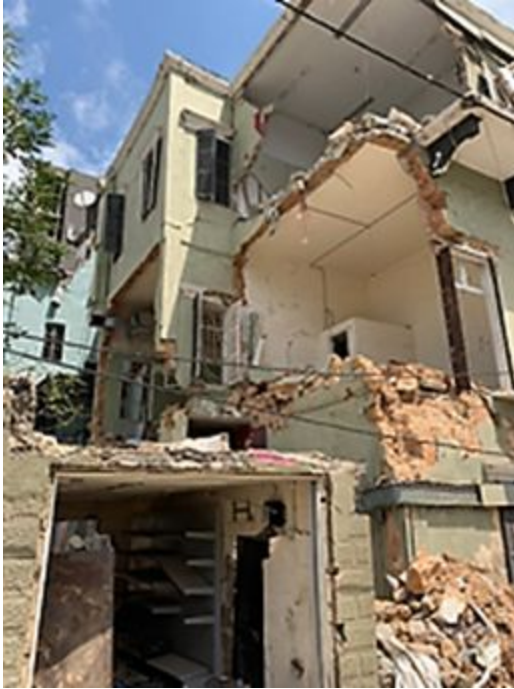
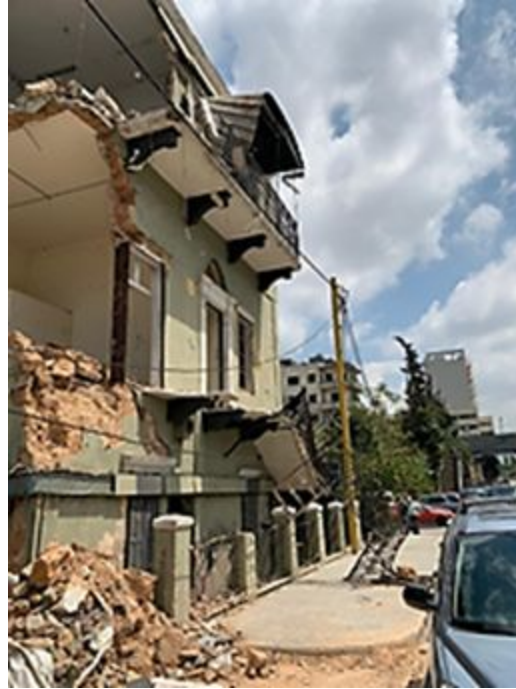
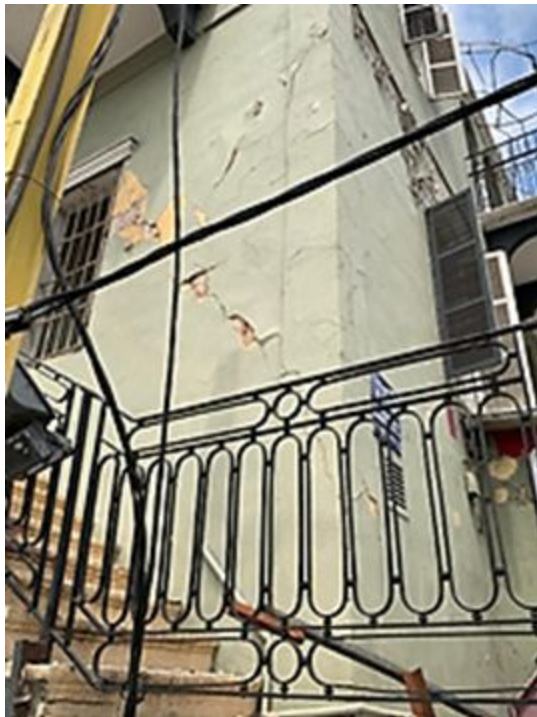
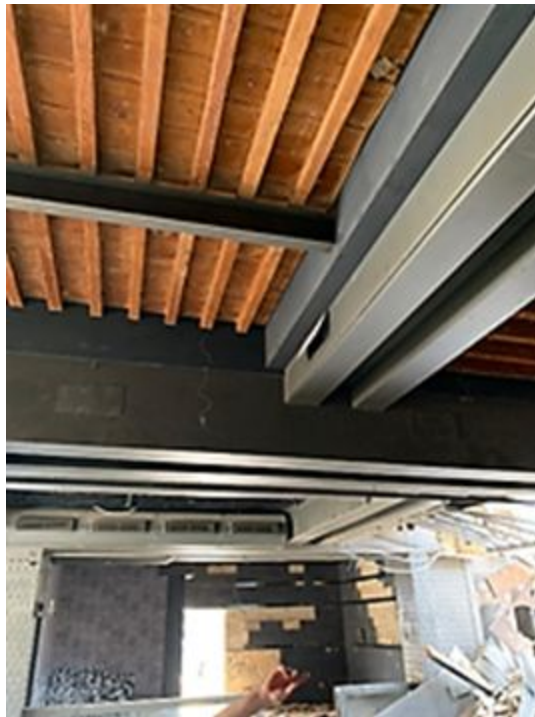
Figure 4.8. Partially collapsed (D4) stone masonry building SM5 (33.8996° N, 35.5260° E).

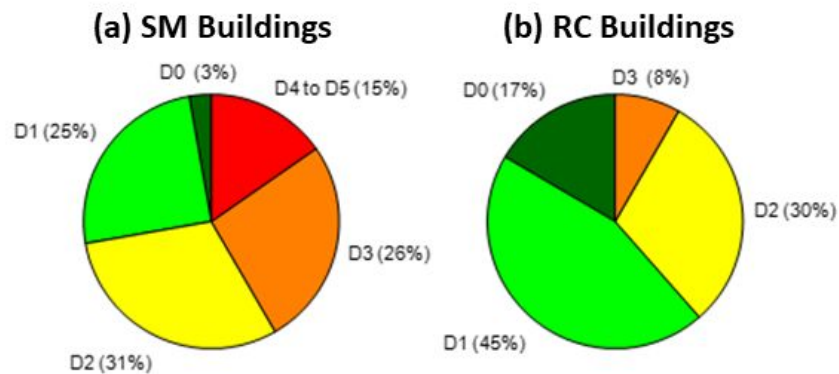
Figure 4.15(a) illustrates the distribution of damage classes D0 to D5 within stone masonry (SM) structures, whereas Figure 4.16(b) provides the same for RC buildings. It can be noted that the SM buildings generally suffered more damage than RC buildings. Moreover, none of the RC buildings assessed suffered partial or full collapse (D4 to D5). For the plots in Figure 4.15, intermediate damage categories (D0-D1, D1-D2, D2-D3 and D3-D4) were combined with their corresponding lower bound damage category, namely D0, D1, D2 and D3, respectively.

Figure 4.15. Distribution of damage classes in (a) Stone Masonry and (b) Reinforced Concrete buildings.

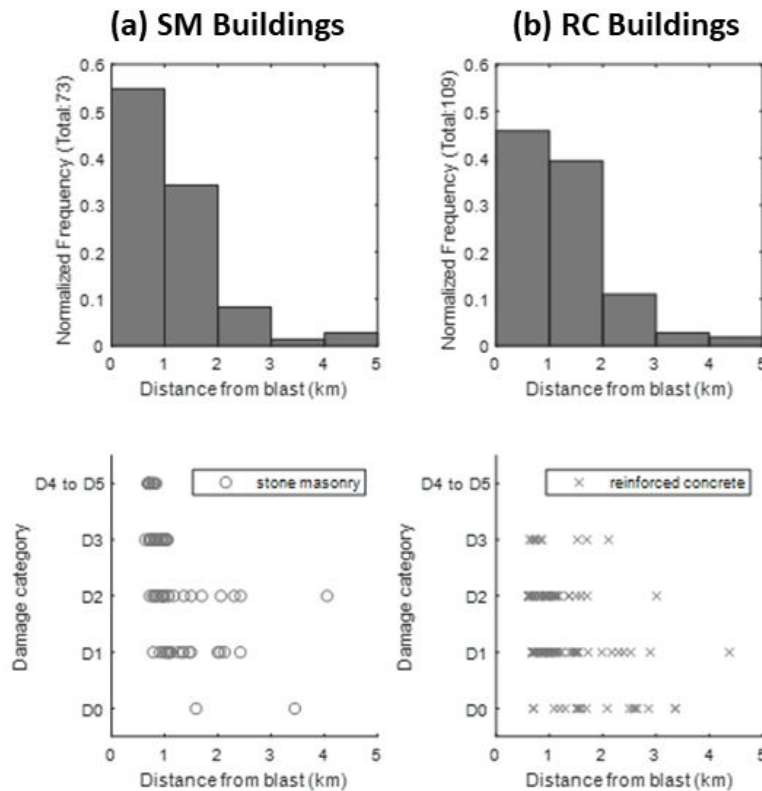
Figure 4.16 shows the distribution of damage classes D0 to D5 with distance from the blast. The top panels show histograms of the distances of the assessed buildings. The distributions are generally similar for both structural typologies, with most buildings within 2 km of the blast. The bottom panels show damage category versus distance for the two types of buildings. Figures 4.2(a) and (b) show that, in general, SM buildings suffered more damage than RC buildings at a similar distance from the blast. Moreover, SM buildings that sustained heavy damage or suffered partial or full collapse (damage categories D3 to D5) were located within 1 km from the blast. Those located at distances larger than 1 km sustained light to moderate

damage (D1 or D2), e.g. falling of pieces of plaster, some cracking in the walls, or some damage to façade arches, balconies, ceilings or roofs.

Figure 4.16. Top: Distribution of classified buildings with blast distance. Bottom: Blast distance dependence of damage categories. Part (a) corresponds to SM buildings and Part (b) to RC buildings.

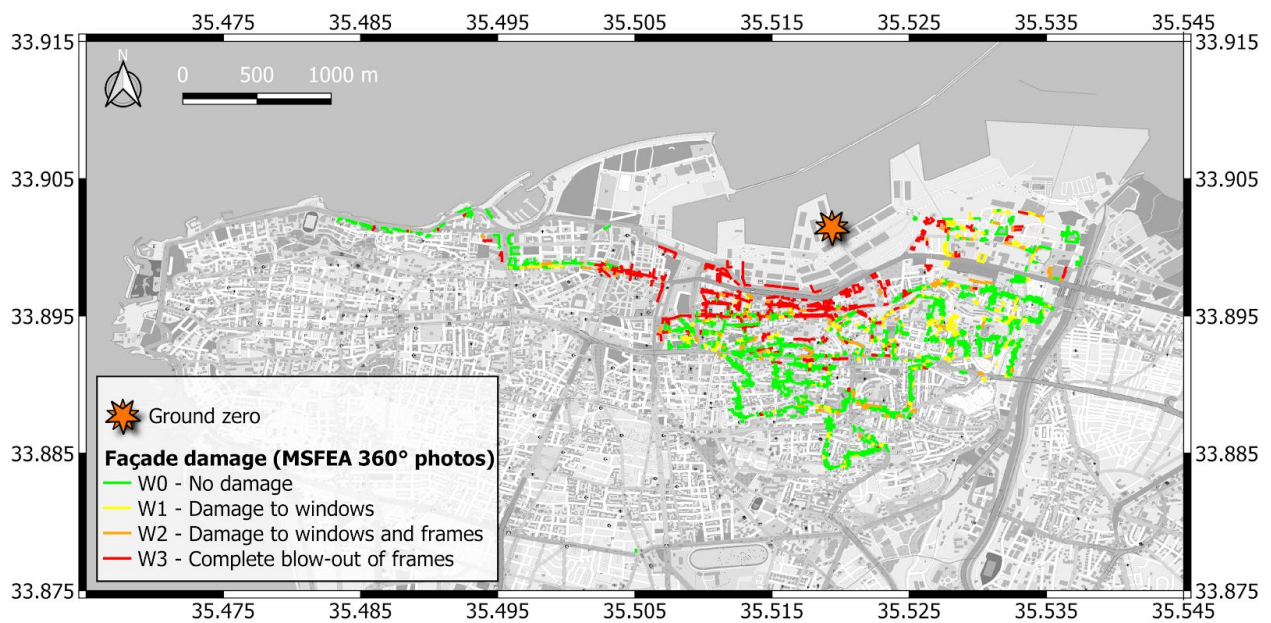
Figure 4.18. Non-structural damage assessment map.

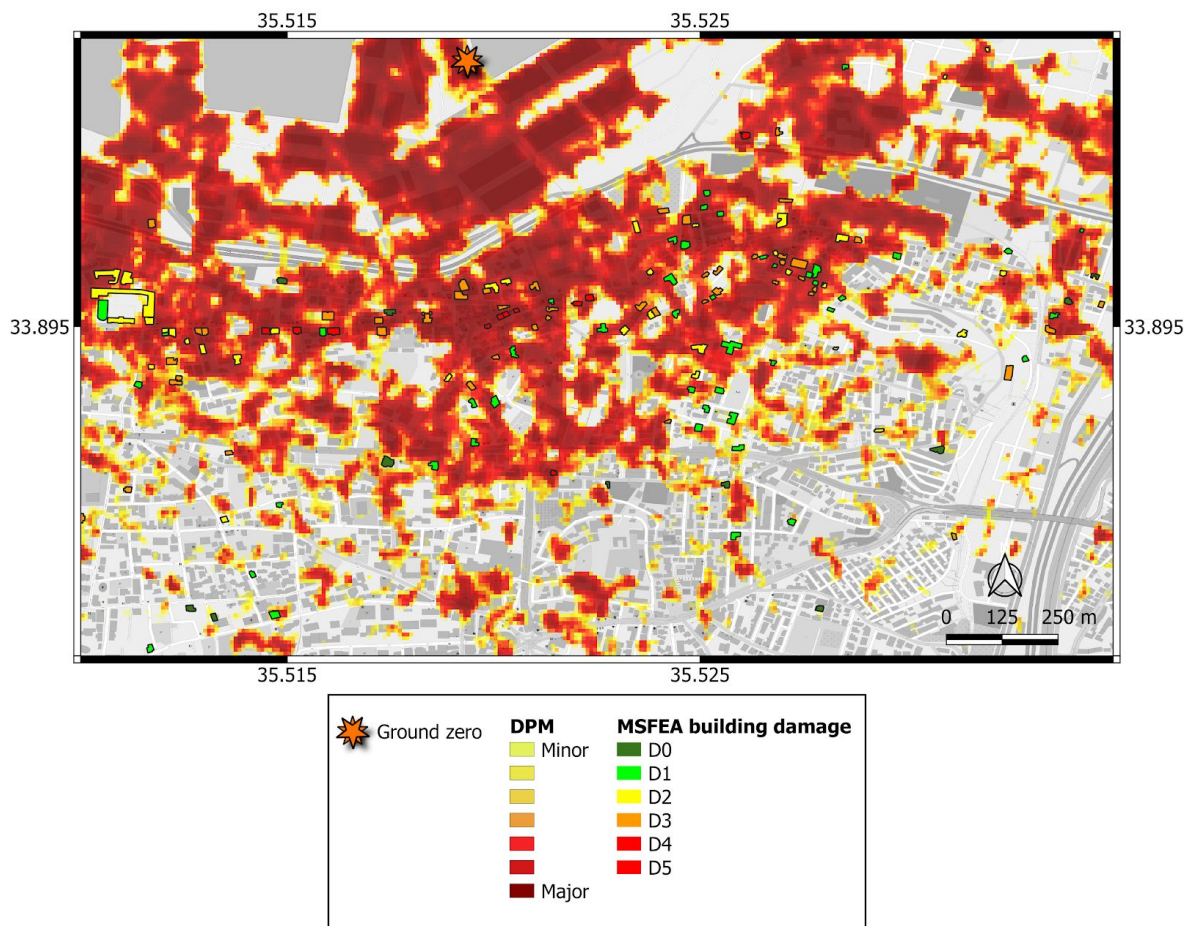
Figure 4.19 shows the DPM produced following the August 4 explosion along with structural damage levels (Table 4.3). Figure 4.20 shows a box and whisker plot highlighting how DPM correlates with structural damage; DPM in this plot has been converted to a numerical index between 0 and 1.0. This index corresponds to the colors on maps over the index range of 0.75-1.0, as shown in the plot (the index range of 0-0.75 produces no map coloration). In this plot, the two ends of the boxes represent the upper quartile (25% of the data is greater than this value) and lower quartile (25% of the data is smaller than this value), respectively, the line inside the box represents the median value, and two whiskers represent the minimum and maximum values within that category. The undamaged structures consistently occur at index values < 0.75 , and the damaged structures occur at index values > 0.75 , indicating that the DPM is effective at capturing incidents of structural damage. Among structures with damage (classes D1 to D5), DPM index is lowest for the low damage state D1 (median of about 0.8), approximately the same for D2 and D3 (median of about 0.85), and highest for D4-D5 (median > 0.9). This indicates an ability of DPM index to distinguish among damage levels.

Figure 4.19. DPM and structural damage category distributions across Beirut.
