Engineering Impacts of the August 4, 2020 Port of Beirut, Lebanon Explosion

A report of the NSF-Sponsored Geotechnical Extreme Event Reconnaissance Association in
Collaboration with the American University of Beirut

Report GEER-070: <https://doi.org/10.18118/G6C96C>

February 4 2021

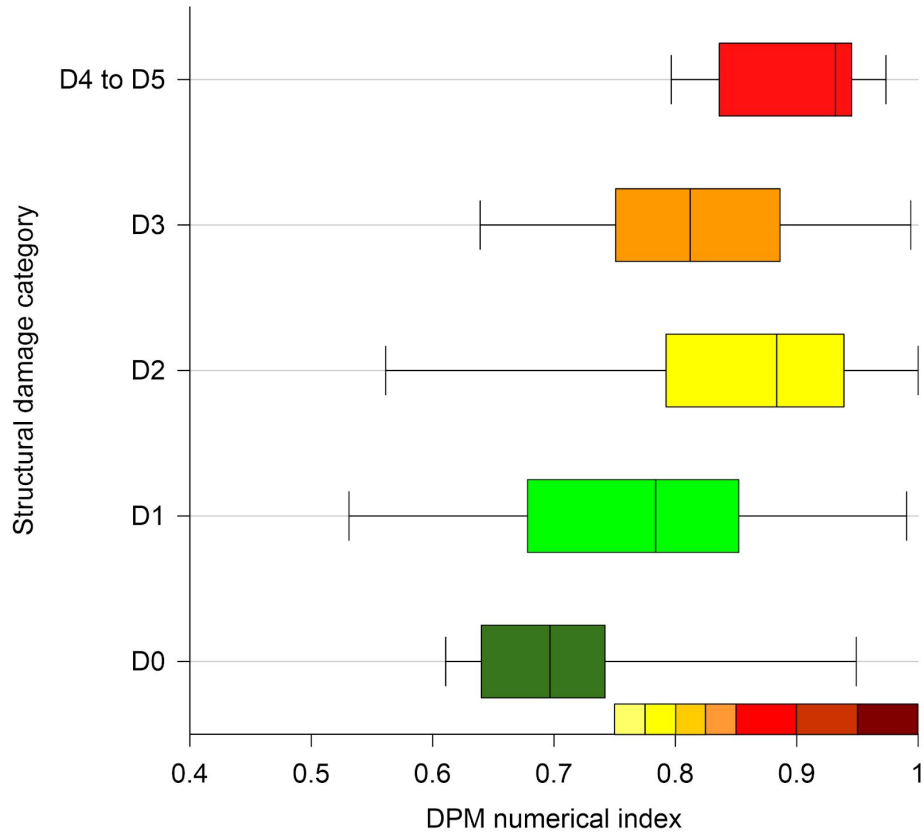
Figure 4.19 shows the DPM produced following the August 4 explosion along with structural damage levels (Table 4.3). Figure 4.20 shows a box and whisker plot highlighting how DPM correlates with structural damage; DPM in this plot has been converted to a numerical index between 0 and 1.0. This index corresponds to the colors on maps over the index range of 0.75-1.0, as shown in the plot (the index range of 0-0.75 produces no map coloration). In this plot, the two ends of the boxes represent the upper quartile (25% of the data is greater than this value) and lower quartile (25% of the data is smaller than this value), respectively, the line inside the box represents the median value, and two whiskers represent the minimum and maximum values within that category. The undamaged structures consistently occur at index values < 0.75 , and the damaged structures occur at index values > 0.75 , indicating that the DPM is effective at capturing incidents of structural damage. Among structures with damage (classes D1 to D5), DPM index is lowest for the low damage state D1 (median of about 0.8), approximately the same for D2 and D3 (median of about 0.85), and highest for D4-D5 (median > 0.9). This indicates an ability of DPM index to distinguish among damage levels.

Figure 4.20. Relationship between numerical index of DPM (0-1) and structural damage categories

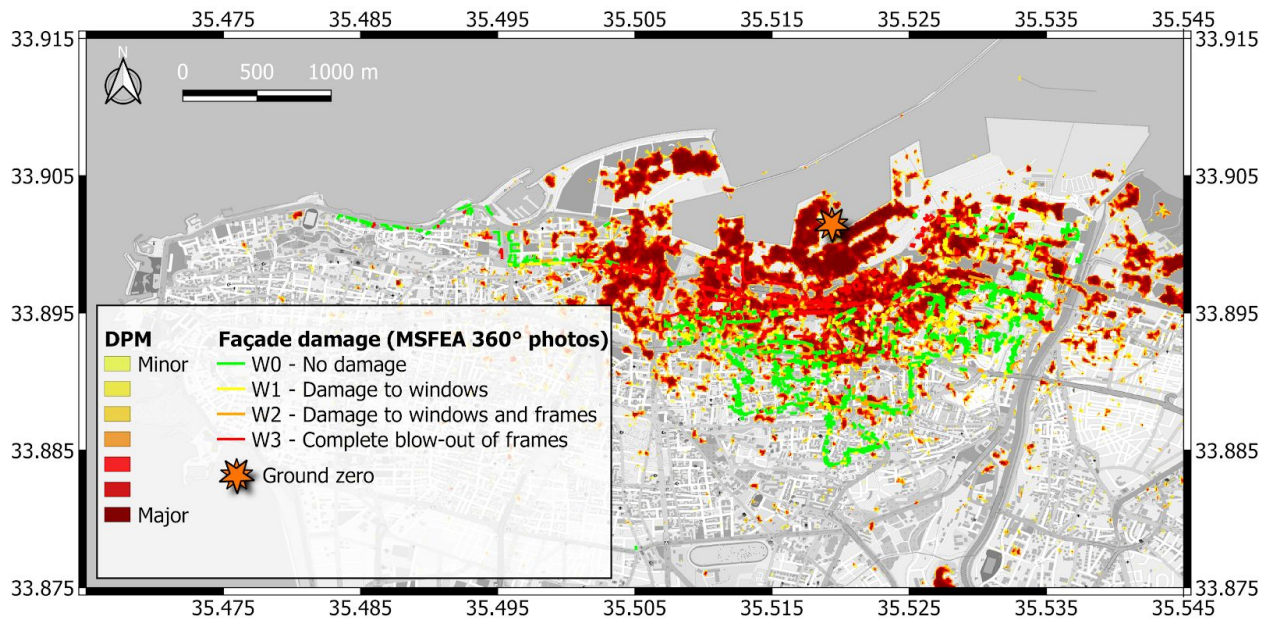
Figure 4.21 shows DPM along with façade damage levels (Table 4.4). The DPM seems to agree well with the overall non-structural damage pattern. The DPM identifies the fringe area separating the undamaged zone from the damaged area. The DPM also suggests high damage in the areas next to the blast source, within the Port and in the zone immediately outside of the Port zone. No street-view photos were available in this zone. However, the OEA damage maps clearly show that this zone was severely damaged by the explosion in all directions. Figure 4.22 shows a box and whisker plot highlighting how DPM correlates with non-structural damage. The correlation of facade damage with DPM is weaker than that for structural damage. The undamaged state (Wxx-0) has a median DPM index near the lower limit of shading (about 0.75). Among structures with non-structural damage, DPM index cannot distinguish between facade damage levels Wxx-1 and Wxx-2 (median DPM index of about 0.8), whereas the strongest level of damage (Wxx-3) has a clearly higher median DPM index of 0.9.

Figure 4.21. DPM and non-structural damage assessment map.

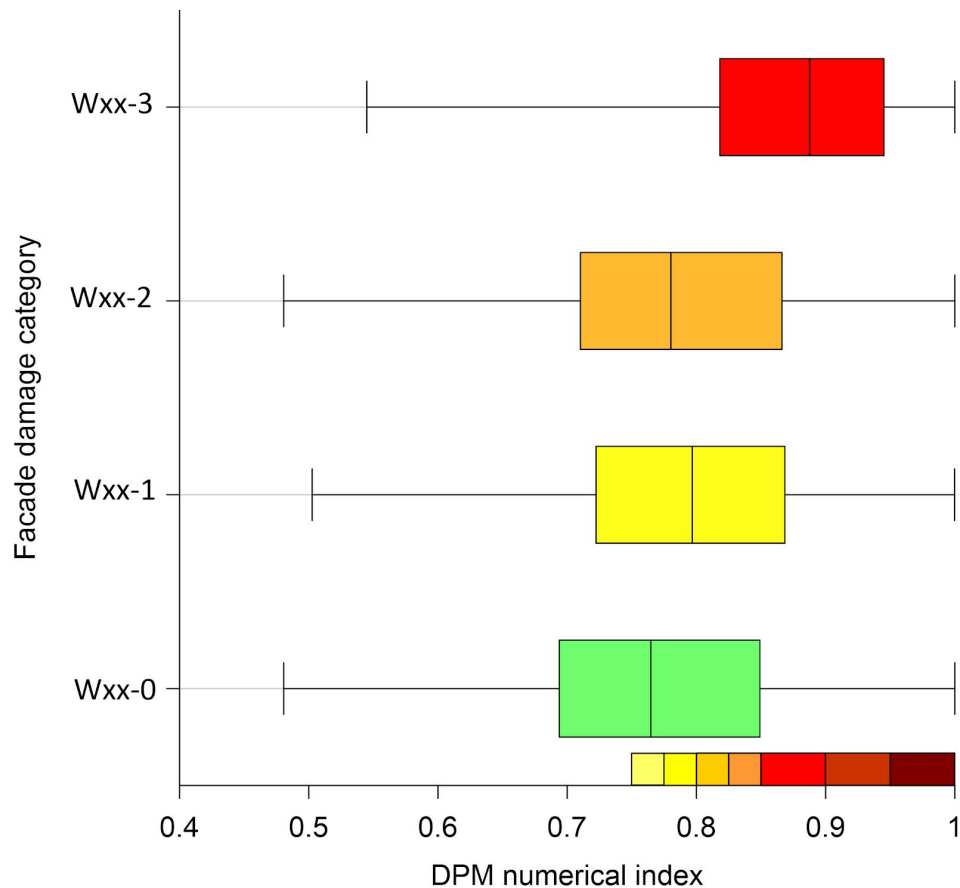
Figure 4.22. Relationship between numerical index of DPM (0-1) and non-structural damage categories.
