Geotechnical Extreme Events Reconnaissance

Geotechnical Reconnaissance:
The 28 September 2018 M7.5 Palu-Donggala, Indonesia Earthquake

(Version 1.0; 3 April 2019)

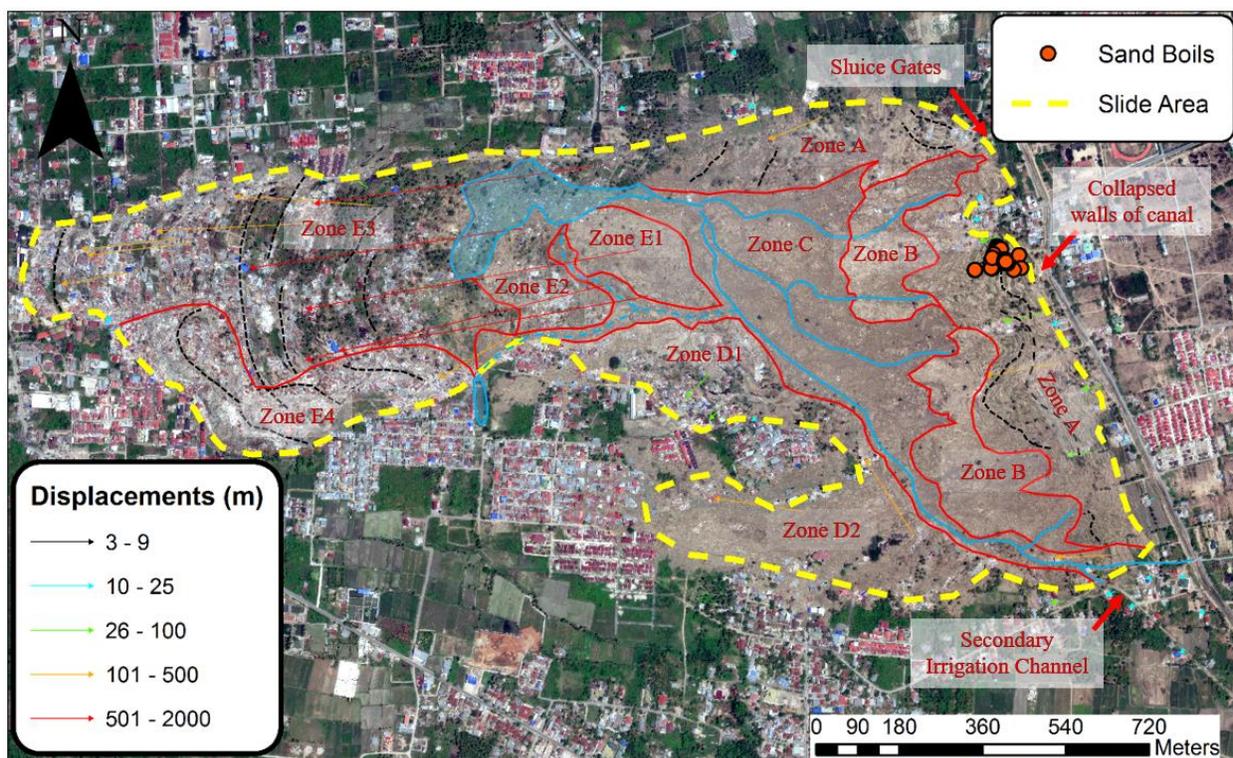
The GEER team has divided the flowslide into five distinctive zones in Figure 3.5 (A through E), which are characterized by unique morphologies with different styles of ground deformation (horizontal and vertical, and rotational), cracking, surface roughness, and soil block shearing, and reworking. Larger buildings and infrastructure in the eastern half of the slide footprint were generally well-preserved and relatively undisturbed. Pre- and post-earthquake satellite imagery

Figure 3.5. Orthomosaic map indicating limits of Petobo landslide, location of sand boils, vector displacements, and zones delineated by morphological features and key observations.

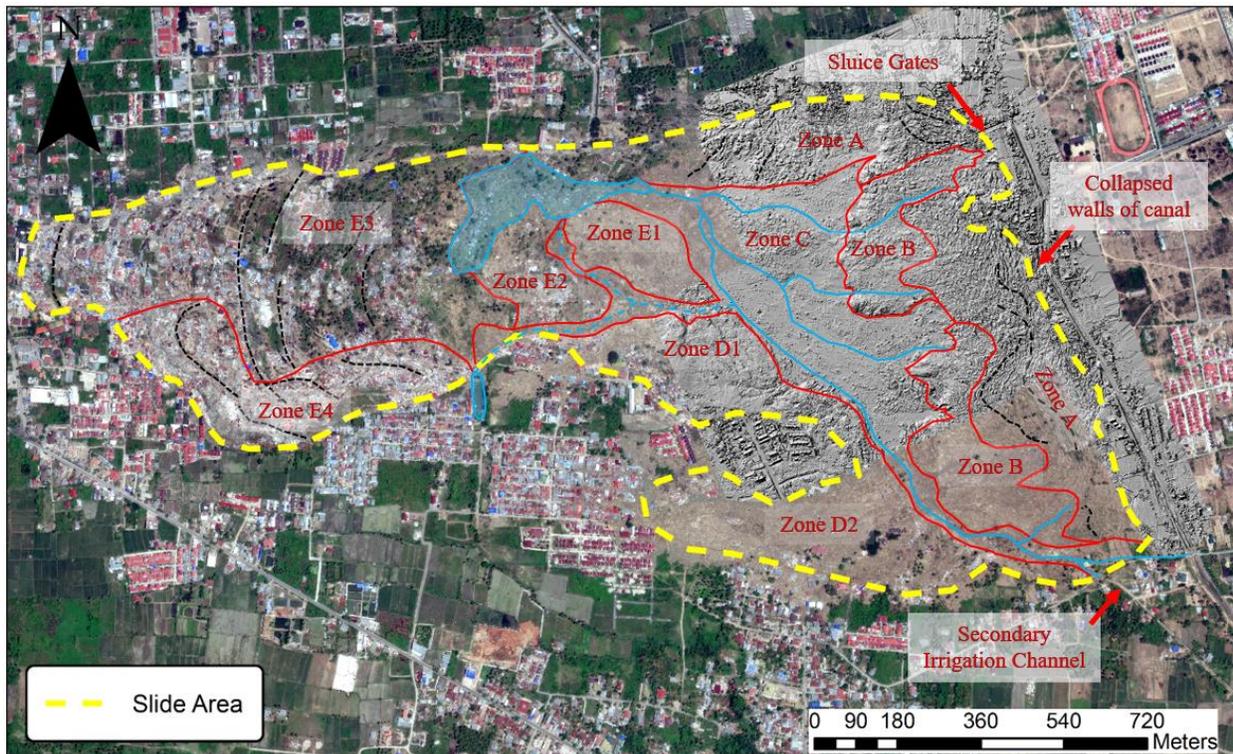
Figure 3.6. Digital elevation model illustrating 3D morphological features in the northeast section of the slide.

Zone B is an area containing a mix of flowslide materials including highly softened soil masses and most conspicuously, soil blocks that were heavily reworked as the slide progressed, disintegrating into smaller, rounded mounds (Figure 3.6). Zone B also contains several large, isolated soil mounds. The blocks and mounds in Zone B were noticeably smoother and more rounded than the angular, back-rotated blocks found in Zone A (Figure 3.9a). The Zone B deposits appear to override the materials located downslope in Zone C. This is shown in the DEM by the localized over-steepened surface across the interface of Zones B and C (Figure 3.6). Comparing the surface conditions of Zone B (Figure 3.9b) and with those of Zone C (Figure 3.10a) indicates that the Zone B sediments were notably dryer at the time of reconnaissance. It is believed this is because the Zone B materials glided along the lower-lying sediments comprising the floor of Zone C, which were likely liquefied at the time of the slide.

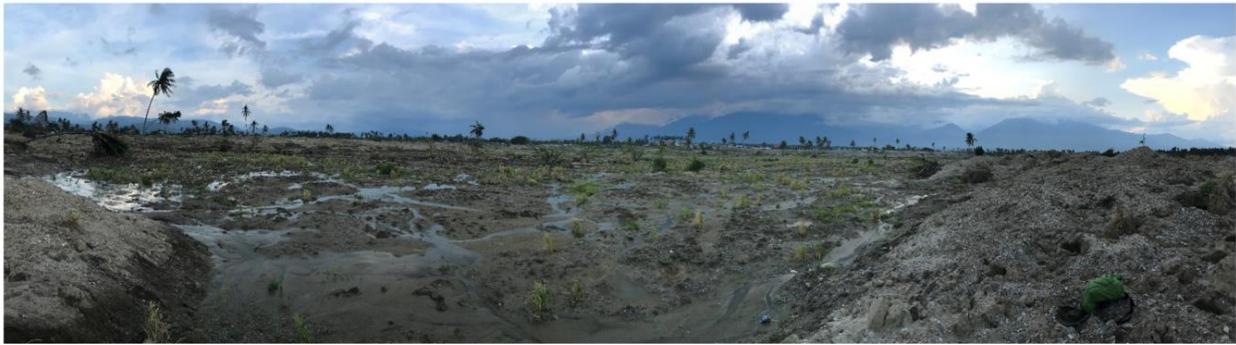
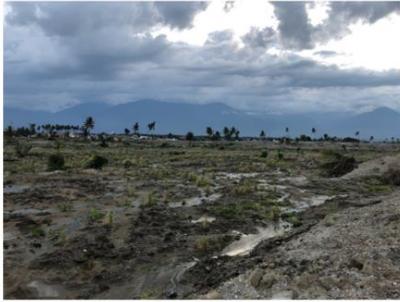
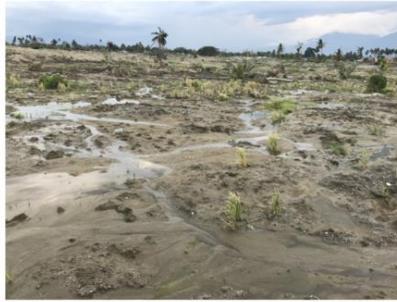
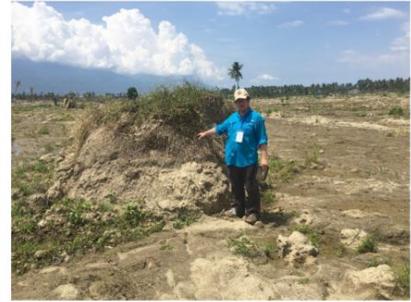
At the time of the reconnaissance, an actively eroding rill network conveyed water across the surface of Zone C towards the northwest. The rill network channels extend upslope into Zone B (this is indicated by the discoloration shown in Figure 3.5) and reached into the lower part of the Zone A headscarp region. There are several possible sources of water in Zone C including: (i) seepage emanating from Zone B (this was visible during the reconnaissance), (ii) dissipation of earthquake-induced elevated pore water pressures within Zones A to C, (iii) surface flow from natural rivulet that previously ran through the southern portion of the slide footprint (visible Figure 3.3), and (iv) secondary irrigation channels that previously conveyed water from the main irrigation canal to rice paddy fields in the southern portion of the slide footprint (Figure 3.5). It is unknown if a breach of the secondary irrigation channel was a source of surface water that contributed to erosion and scour during and after the slide, or if it merely added to the saturation of sediments. If the secondary irrigation channel provided surface water Zone C immediately after the landslide, the gentle morphology of the zone suggests that flow was much less energetic than at other locations where the main irrigation canal was breached (e.g., Jono Oge and Sibalaya, see §3.2 and §3.4, respectively). The combination of the reworked sediments, wet conditions, and very low strengths together support the hypothesis that the sediments in Zone C liquefied during the earthquake, and served as a layer upon which groundmasses were carried during the flowslide.

Figure 3.10. Zone C: a.) view facing south-southeast at the margin of Zones B and C, with a clear difference in elevation and visible water in Zone C (-0.93971, 119.91859); b-c.) observed rill network and drainage channels carrying water through the zone (-0.939725, 119.918577 and 0.93974, 119.91859); d.) an erratic, relatively intact, block in the zone (-0.940918, 119.917806)

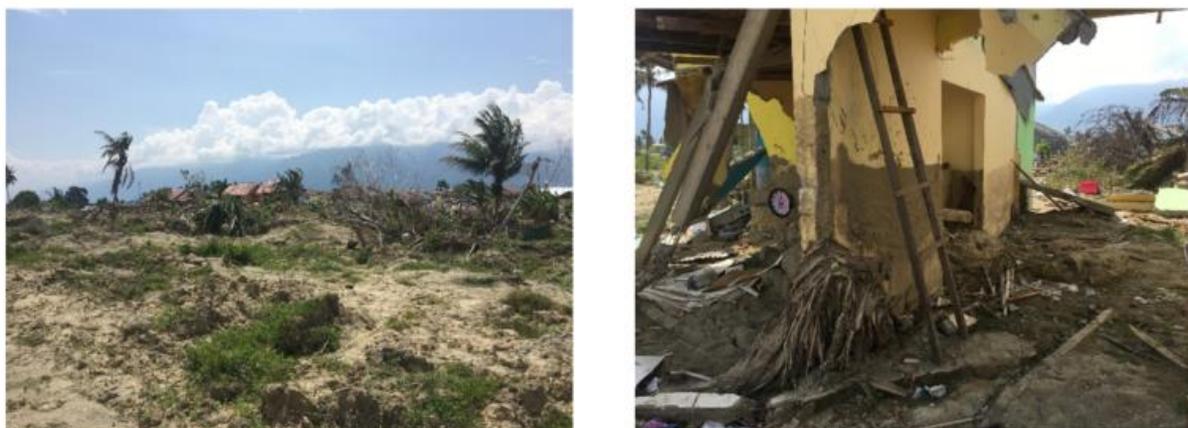
Zone D consists of flowslide runout materials deposited across the southern part of the landslide. The deposits largely consisted of thoroughly reworked (i.e., fully unstructured) fine sandy sediments that appeared to have been highly fluidized at the time of the flowslide. The zone includes a range of surface features including disintegrated soil blocks and mounds, and rafted blocks of soil reinforced by the root mass of low-lying vegetation and trees (Figure 3.11a). Many of the surface features traveled several hundred meters before being deposited in Zone D. As they slid these surface features became rotated, tilted, sheared, and fragmented. The ground surface of Zone D is marked by north-south oriented compression ridges, uplifted ground, stacked and overridden surface features, and emplaced soil mounds. The runout deposits collided with and inundated numerous buildings and infrastructure elements in Zone D. Across the middle to the east part of the zone, buildings were torn from their foundations and carried by the fluidized deposits. In other nearby locations, buildings were entirely buried by the deposits (Figure 3.5). Along the western margin of the flowslide, homes were uplifted many meters along compression ridges. At the distal edge of Zone D, flowslide deposits fanned out and flowed through streets, penetrating through the walls, doors, and windows of residential structures lining these roads (Figure 3.11b).

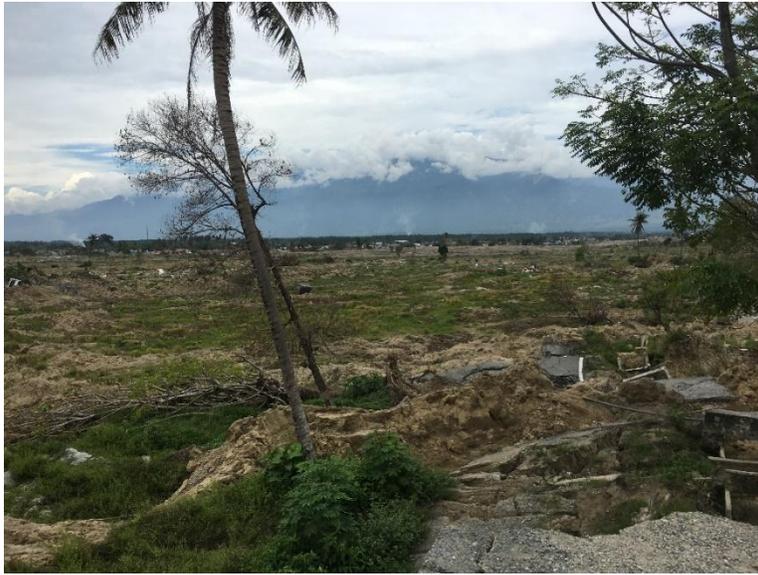
flowslide and its westward progression and advancement. Because of the large size of the flowslide, most of the observers witnesses only a portion of the event; however, one individual who was located on an elevated plane in the northeast corner of the flowslide (Figure 3.13) viewed nearly all the event as it progressed over several minutes. In general, the eyewitness accounts, which were provided voluntarily, were remarkably consistent and provided significant detail on the timing, sequencing, and progression of the flowslide. These accounts are also compatible with other sources of information about the flowslide including: (i) eyewitness videos posted to social media, (ii) pre- and post-earthquake satellite imagery, (ii) drone-derived images and DEMs, and (iv) morphologic expressions observed on the ground.

Figure 3.13. Perspective of eyewitness account (facing west-southwest) from northeast corner of slide (-0.93622, 119.920207).

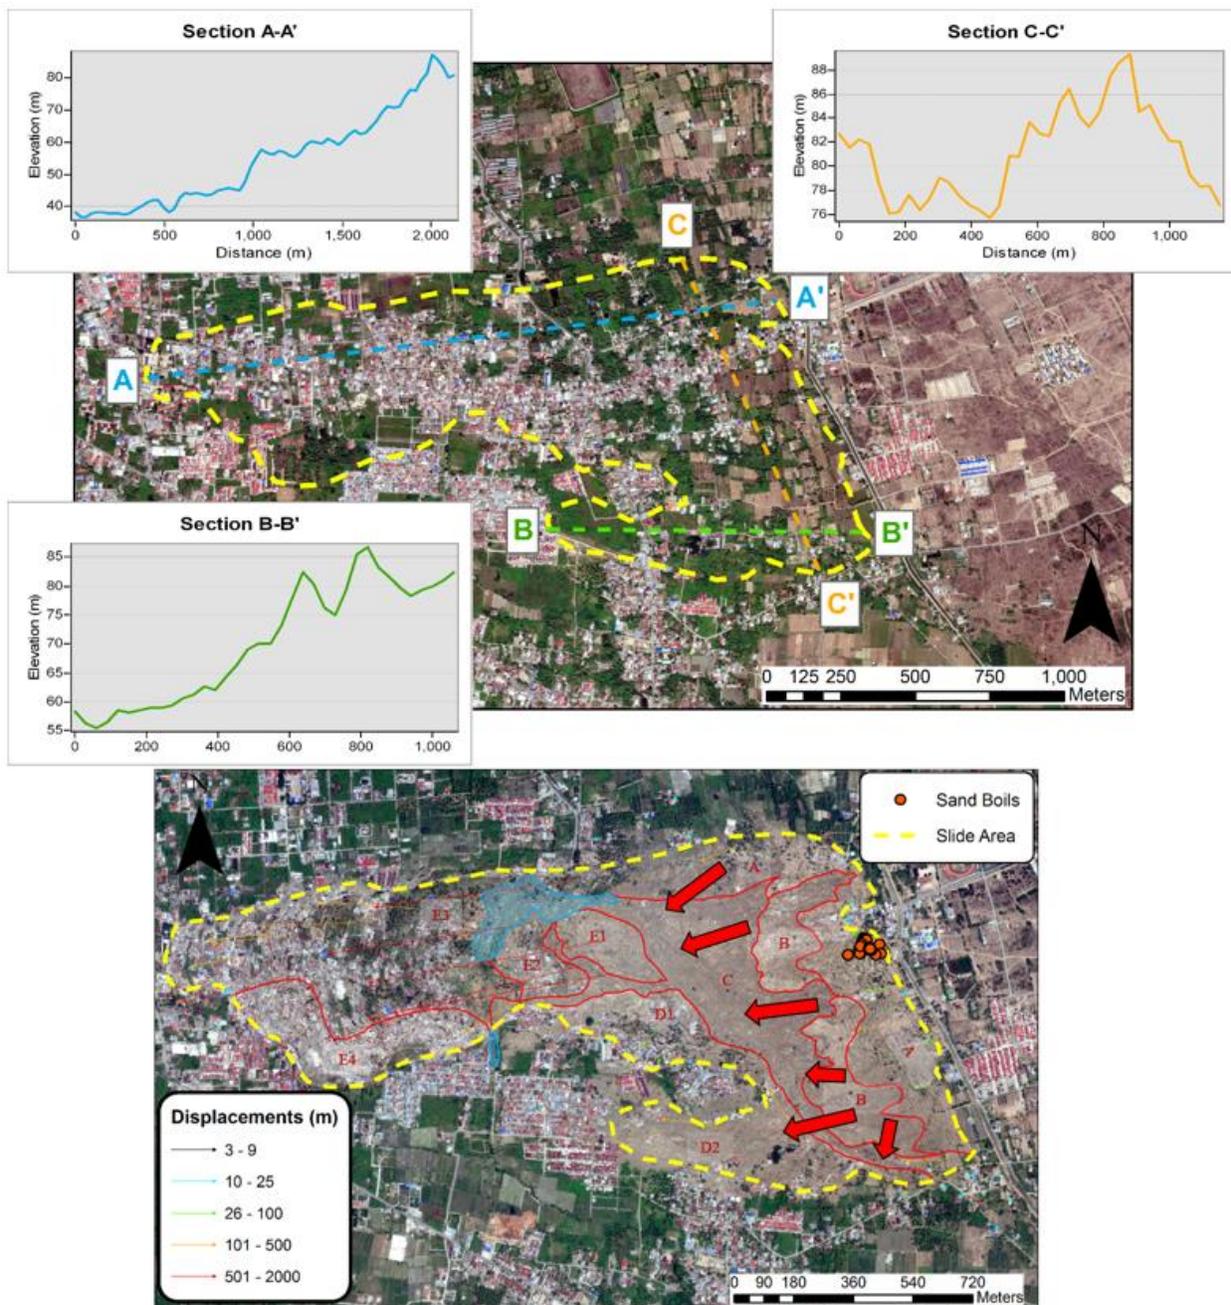
Figure 3.14. Pre-slide cross-sections and topography and post-earthquake satellite imagery of slide at Petobo.

The elevation profile across the eastern footprint of the slide (section C-C’) also helps elucidate observed geomorphic expressions and explain why the two legs manifested in this manner. In the southern portion of the flowslide, there is a rise in elevation or knoll-like feature that transitions to a shallow, channelized depression to the north (Figure 3.14). The flow of debris in the north appears to have been funneled towards this lower-lying area, which is also supported by extensive scarp development along the northern margins of the slide (i.e., an extension of Zone A west on this margin). Unlike the northern margin, a significant amount of debris flowed towards (not away from) the southern limits of the flowslide footprint. Deposits likely cascaded in multiple directions off the knoll (e.g., west, southwest, and northwest) as the flowslide progressed in the southern portion of the site, as there was no natural topography to funnel it in any single direction. Flowslide deposits obscured the scarp along the southern boundary. Note how scarp development (Zone A) extends much further west on the northern margin and runout deposits (Zone D) extend further

east on the southern limits of the slide. An understanding of pre-earthquake topography helps reconcile these observations.

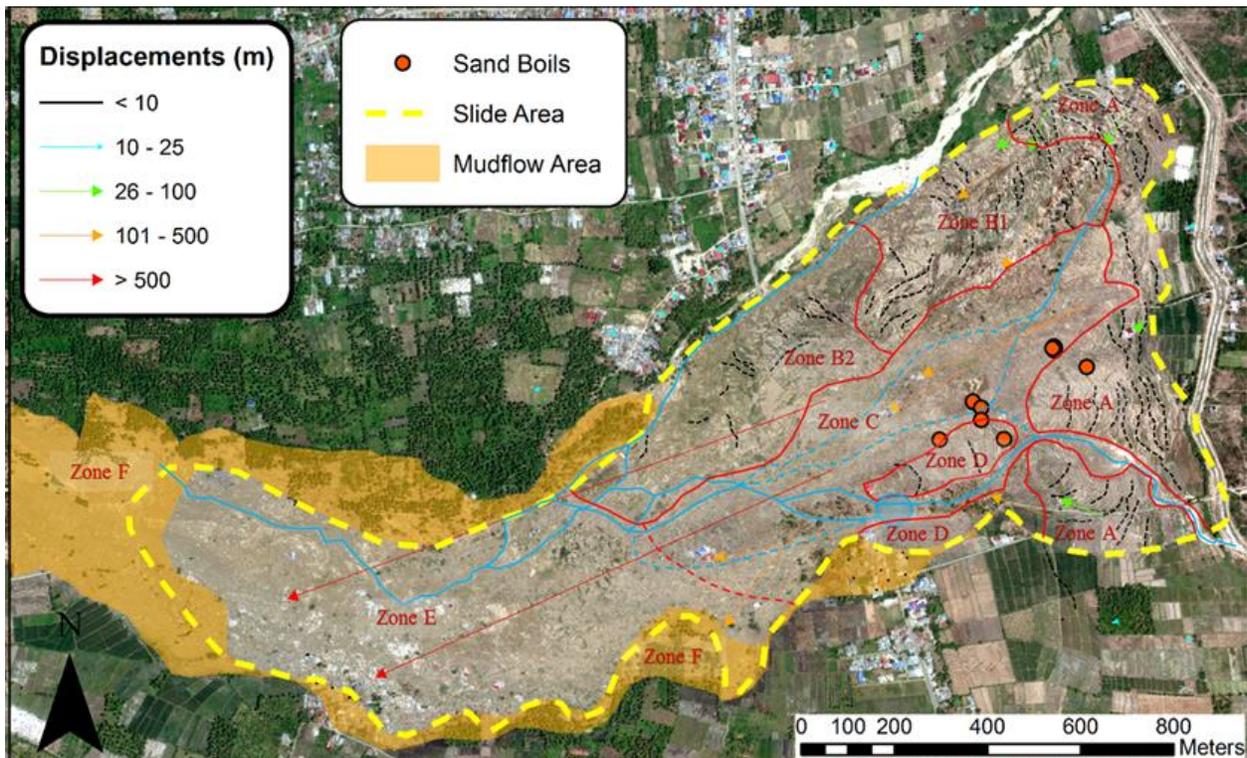
Figure 3.16. Orthomosaic map indicating limits of Jono Oge landslide, location of sand boils, vector displacements, and zones delimited by morphological features and key observations.

available from BNPD and were used to confirm post-earthquake locations of structures. The slide area was divided into five zones (A through E), which shared similar displacement patterns and morphological features. A sixth zone (F) was included to describe the areas that did not experience significant displacement, but were inundated by the mudflow. Displacements were largest in the central area of the flowslide (Figure 3.16). The structures within this zone were all destroyed by the earthquake and only two buildings from the central portion of the slide (the Patra Poultry Market and the church Pusdiklat GPID Patmos Jono Oge) could be reliably identified in post-earthquake imagery. The final location of the Patra Poultry Market was photographed by the reconnaissance team (Figure 3.18a) and the final location of the church was identified by comparing post-earthquake satellite images with photos of the images of the collapsed church published online (Figure 3.18b). Pre-earthquake locations for these structures were determined using Google Street View images from December 2015. Based on these sources, the displacement of the poultry market was measured as 1,230 meters and displacement of the church was measured as 1,080 meters. Many other buildings located in this same area likely experienced similar magnitudes of displacement, but were too damaged to be reliably identified in post-earthquake imagery.

Similar to the slide at Petobo (described above), Zone A at Jono Oge (Figure 3.16) encompasses the head scarp region of the flowslide. Zone A was primarily rice paddies (Figure 3.19a) with few structures. The head scarp extends along the western margin of the slide and intersected the canal

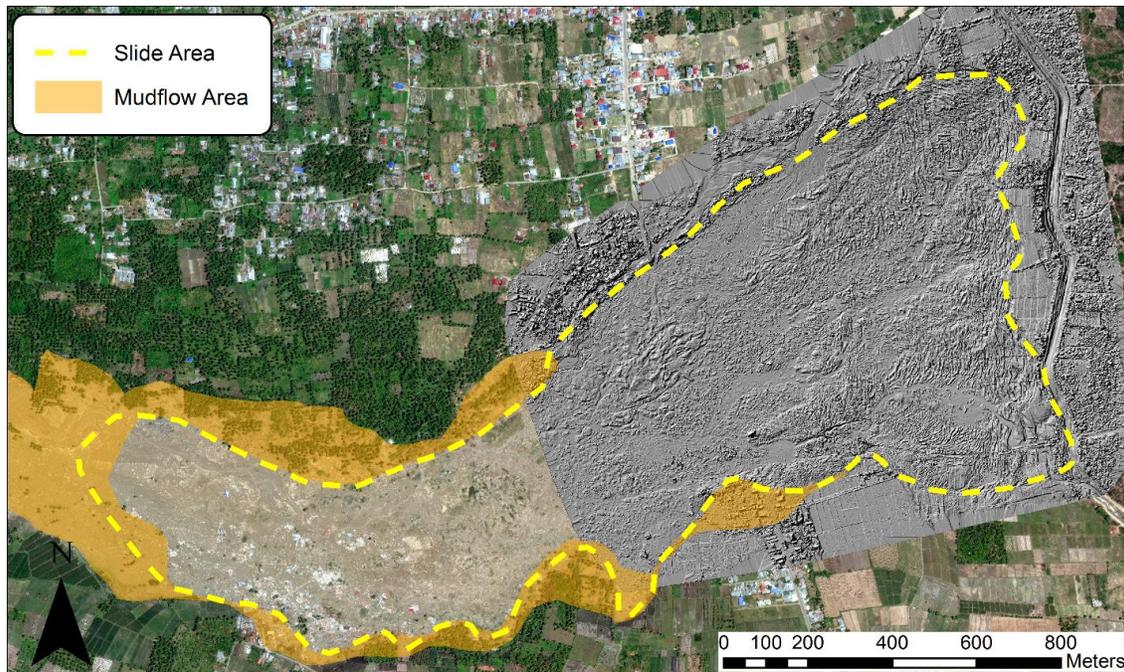
Figure 3.17. Digital elevation model and drone-derived shaded relief image illustrating 3D morphological features in the eastern region of the slide.

The failure process and morphology of Jono Oge is largely similar to Petobo with the exception of the canal breach. Due to the erosion from that breach and the large area, the reconnaissance team primarily relied on pre- and post-earthquake satellite images to map displacement of structures and identify morphological features (Figure 3.16). The satellite images were supplemented by aerial maps and high-resolution DEMs created from drone flights conducted by the reconnaissance team (Figure 3.17). UAV images from immediately after the earthquake were

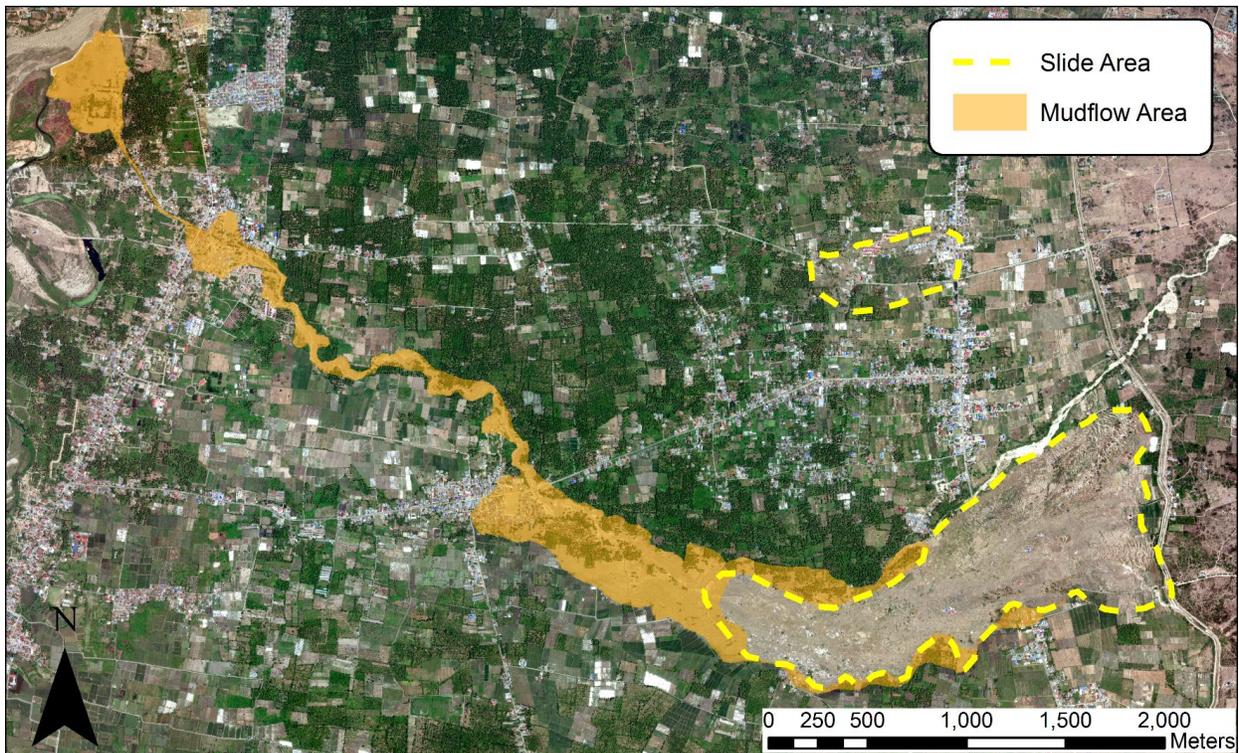
Figure 3.26. Approximate extent of the mudflow caused by the canal breach at Jono Oge.

After the flowslide occurred at Jono Oge, the canal breached at the southeastern corner of the slide, sending a flood of water from the canal through the failed area. The flood of water eroded significant amounts of the slide material and created a mudflow that traveled to the Palu River (more than six kilometers from the site of the breach). The approximate extent of the mudflow is shown relative to the slide area in Figure 3.26. The mudflow flooded multiple communities along the path that were not damaged by the flowslide (Figure 3.27a). The mudflow primarily followed the channel of the river that ran along the northern edge of the slide (Figure 3.27b). In two locations, the river channel was constricted by bridges (Figure 3.27c), which caused the mudflow to back-up and flood the surrounding community (Figure 3.27d).

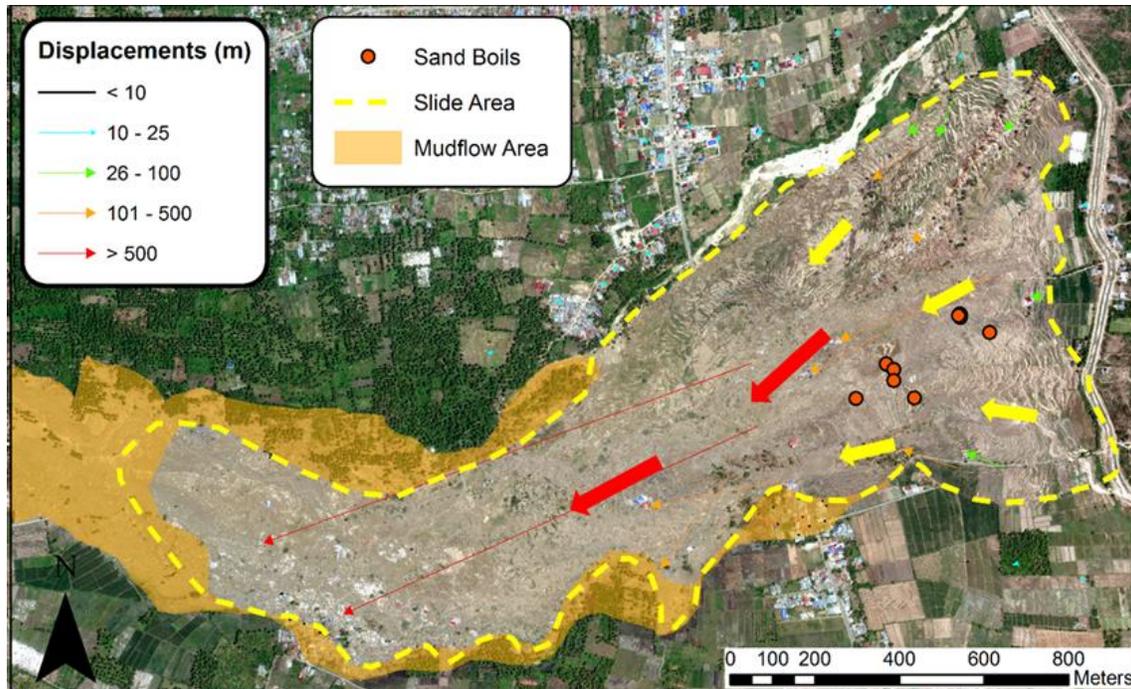
Figure 3.28. Interpreted progression of the flowslide at Jono Oge. The large red arrows indicate initial movements, while the yellow arrows indicate secondary movements.

The interpreted progression of the flowslide at Jono Oge is shown in Figure 3.28. The eyewitness accounts and video recordings suggest that the failure began somewhere in the eastern portion of Zone C after earthquake shaking had ended (shown with red arrows in Figure 3.28). The failure then moved southwest before depositing many of the structures along the southwestern corner of the slide area. The direction of movement was driven by the topography (Figure 3.29), which pushed the failure to the south. Movement stopped when the topography flattened out. After the initial movement started, the surrounding areas lost confinement and began to move into the zone left behind by the initial failure mass. The secondary movements are shown with yellow arrows in Figure 3.28. Progressive failures eventually reached the canal and initiated the breach. One area where the progression is uncertain is along the southern edge of the slide near the red-roofed house (Figure 3.22). The video recording (Figure 3.23) shows that this area failed after the initial movement took place, but it is not clear if this was simply part of the progressive failures that were occurring across the eastern edge of the slide area or if this represents a secondary failure that may

have been partially driven by the canal breach. The scour from the canal obscured any morphological features in this area, so the order of movements is unknown.

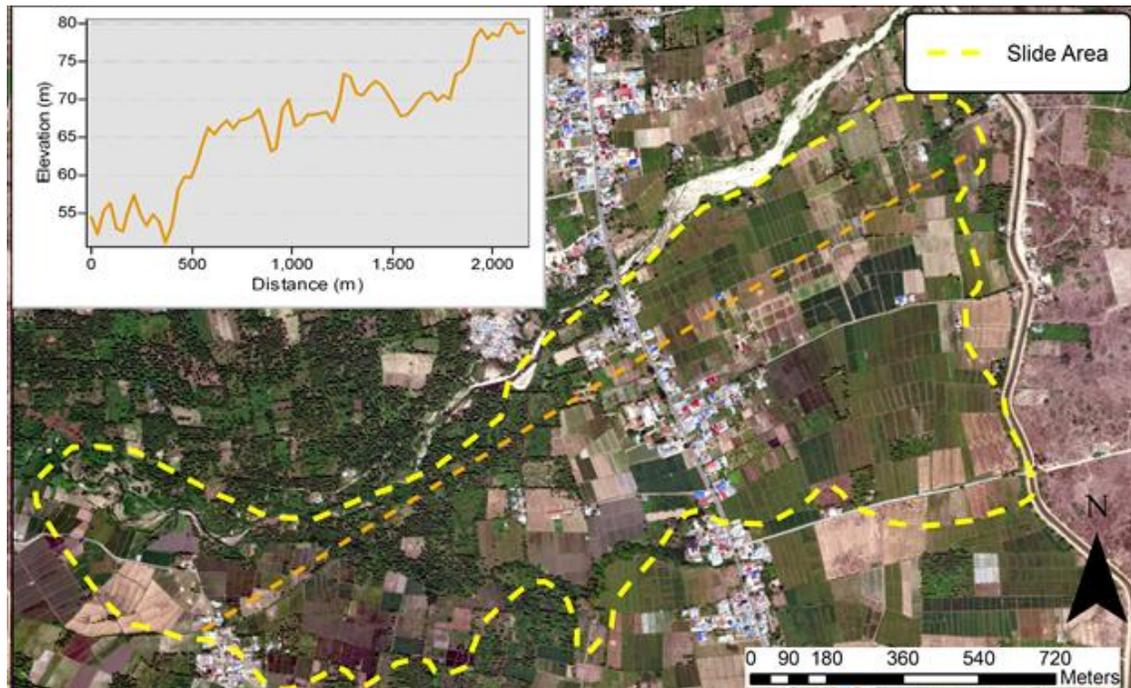
Figure 3.29. Pre-earthquake profile of the Jono Oge flowslide.

The hypothesized failure mechanisms at Jono Oge are the same as those previously described for Petobo. Sand boils were observed in low-lying areas of the site, which indicates that liquefaction likely occurred at depth and the sand boils manifested when the overlying material was removed by the slide. Liquefaction is believed to be the primary driver behind the flowslide. The initiation of the flowslide itself seems to have been driven by locally steeper terrain (Figure 3.29) and the termination of the flowslide occurred where the topography became relatively flat. The distinguishing feature at Jono Oge was the breach of the canal and the subsequent mudflow. The mudflow caused further damage to areas affected by the flowslide and inundated communities that were not affected by the original flowslide. The breach of the canal had a larger effect at Jono Oge because it was the southernmost breach on this section of the canal and a much larger volume of water drained through this failure than Petobo.

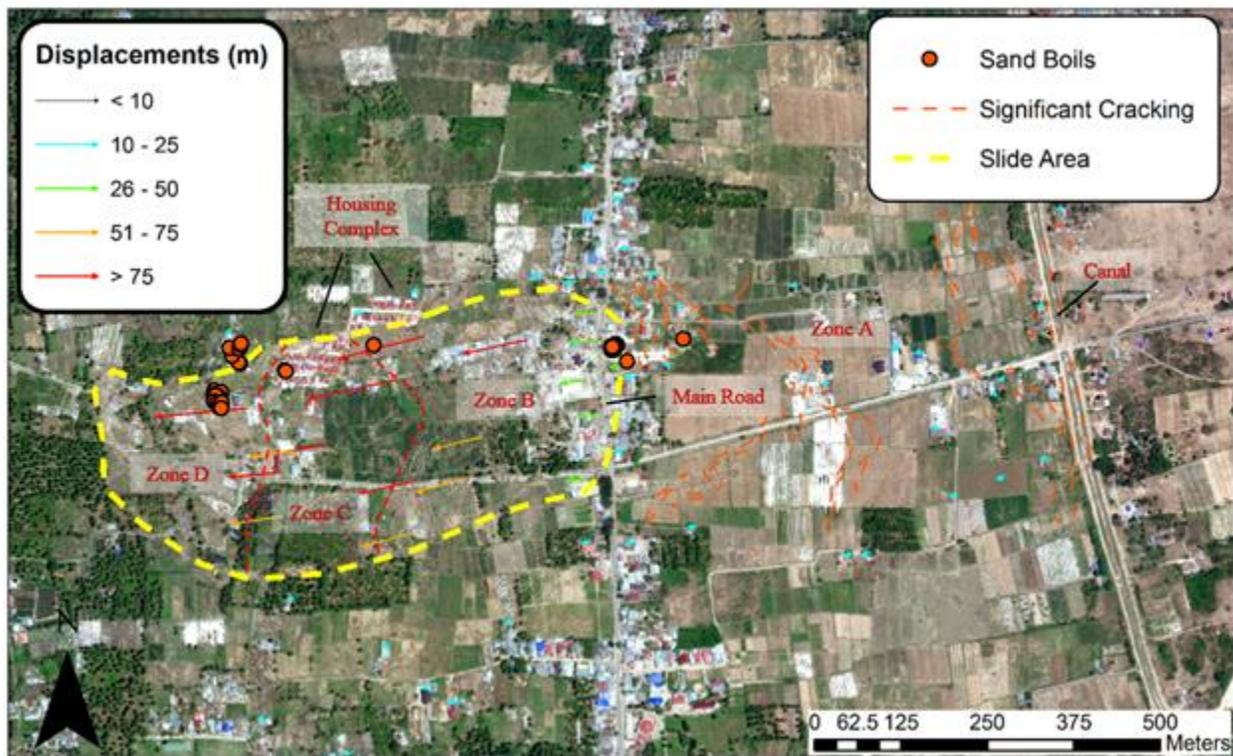
Figure 3.30. Orthomosaic map with sand boil locations and vector displacements at Lolu Village.

Lolu Village was the location of a partially mobilized flowslide characterized by smaller ground displacements and lower degrees of geomorphic destruction than Petobo and Jono Oge. This failure affected 0.22 km² and stretched 750 m from the main road to the distal margins of runout deposits on the western edge of the slide (Figure 3.30). Although displacements were smaller, ground deformations were still as great as 150 m in some areas (Figure 3.30). The greatest displacements occurred below the main road approximately 650 m downhill from the irrigation canal, though laterally extended ground and partial scarp development was observed above the road and propagated up to the canal. Aside from repairs to the main road, which was impassable after the earthquake, geomorphologic expressions were preserved, including evidence of elevated pore water pressures and liquefaction via sand boils documented throughout the site.

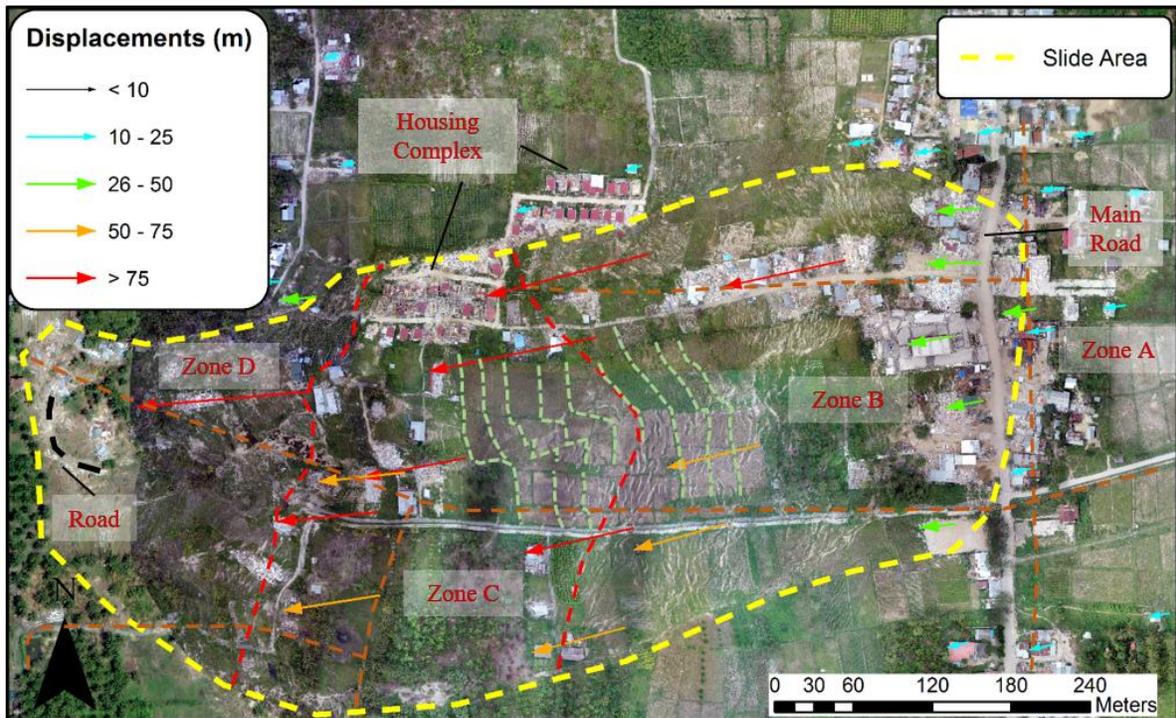
Figure 3.31. Orthomosaic map in area of the lower slide area indicating vector displacements. Also shown are the deformation patterns of ground masses near the center of the slide area (dashed green lines) and previous location of roads (brown dashed lines).

Below the main road transverse seams between laterally extended ground are visible in satellite imagery from immediately after the earthquake (Figure 3.31). The extension of blocks and width of depressed areas between blocks are generally greater than displaced groundmasses uphill, and recognized in aerial photographs by the decreasing density of vegetation. The preceding observations were used to delineate Zones A and B. On the eastern margin of Zone B (near main road) a gas station in Lolu Village displaced west and was severely damaged, causing cracking and splitting of the concrete pavement (Figure 3.36). Moving west (downhill), structures were subjected to greater displacements and either partially or totally collapsed (Figure 3.37). The foregoing observation is notable, because it supports the conclusion that ground was laterally

extended to a greater extent in the western portions of Zone B. Mapped displacements also corroborate the finding (Figure 3.31).

Zone C is a relatively “intact” area at the center of the slide footprint where some of the greatest displacements were observed. Zone C is distinguished from Zone B by fewer visible extension seams that ripple through this ground mass, and from Zone D by a lower degree of geomorphic destruction (Figure 3.31). Zone C appears to have slid on a bed of liquefied sediment, where compression ridges and uplifted features on the western margin of the Zone suggest movements were arrested by the buildup of debris (Zone D) as the flowslide progressed. Greater displacements were observed in the northern half of this area, resulting in shear ruptures and initial extension near the center of the Zone, and subsequent compression and rotation as that ground mass came to a halt. Perhaps the most compelling evidence that supports this hypothetical sequence of events is the deformation pattern of the agricultural field in this area, as shown in Figure 3.31.

partially disintegrated blocks and mounds, stacked or uplifted vegetation, downed or forward rotated trees, and compression ridges (Figure 3.40). Debris sheared through the eastern portion of an east-west trending road that previously cut through the center of Zone D (Figure 3.31). A remaining section of road, which was compressed and deformed, is still visible in Figure 3.31. The GEER team also documented extensive evidence of elevated pore water pressures and liquefaction in a sand boil field near the eastern margin of Zone D, where sand boils had diameters as great as 2.5 m (Figure 3.41).

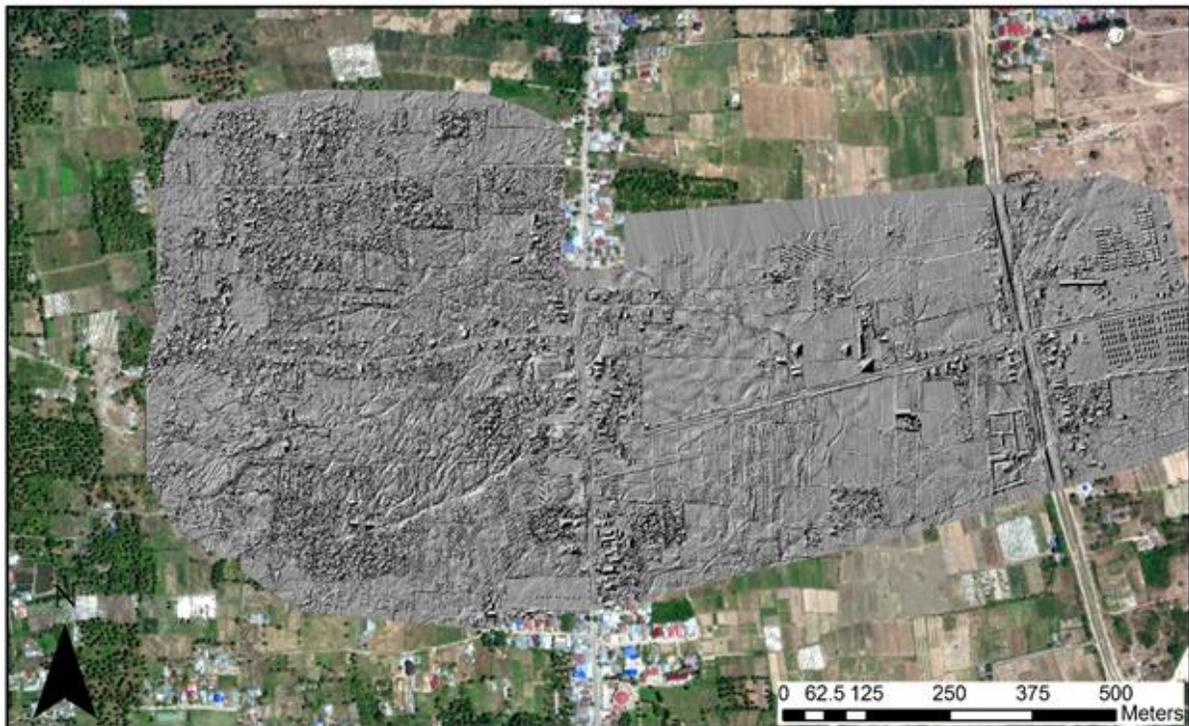
Figure 3.32. Drone-derived digital elevation model illustrating 3D morphological features at Lolu Village.

The area east of the main road predominantly consists of large laterally extended cracks that propagated up to the irrigation canal (Figure 3.32). Unlike Petobo and Jone Oge, the flowslide did not result in complete loss of confinement and breaching of the canal walls, though significant cracking in the canal was documented (Figure 3.33a,b). A sluice gate located at the intersection of an access road remained largely intact (Figure 3.33c). Laterally extended cracks were also observed throughout previously irrigated agricultural fields between the main road and irrigation canal (Figure 3.34a). Vertical dislocation of laterally extended ground and partial scarp development is more apparent near the western margins of Zone A, where a series of imbricated failure surfaces are visible near the main road (Figure 3.34b,c). However, downhill displacements were not great enough for the loss of confinement to result in full separation and large, individually back-rotated blocks to form like the geomorphic expressions observed near the crest of flowslides at Petobo and Jono Oge. Documentation of sand boils near the main road also provide evidence of elevated pore water pressures in this region (Figure 3.35).

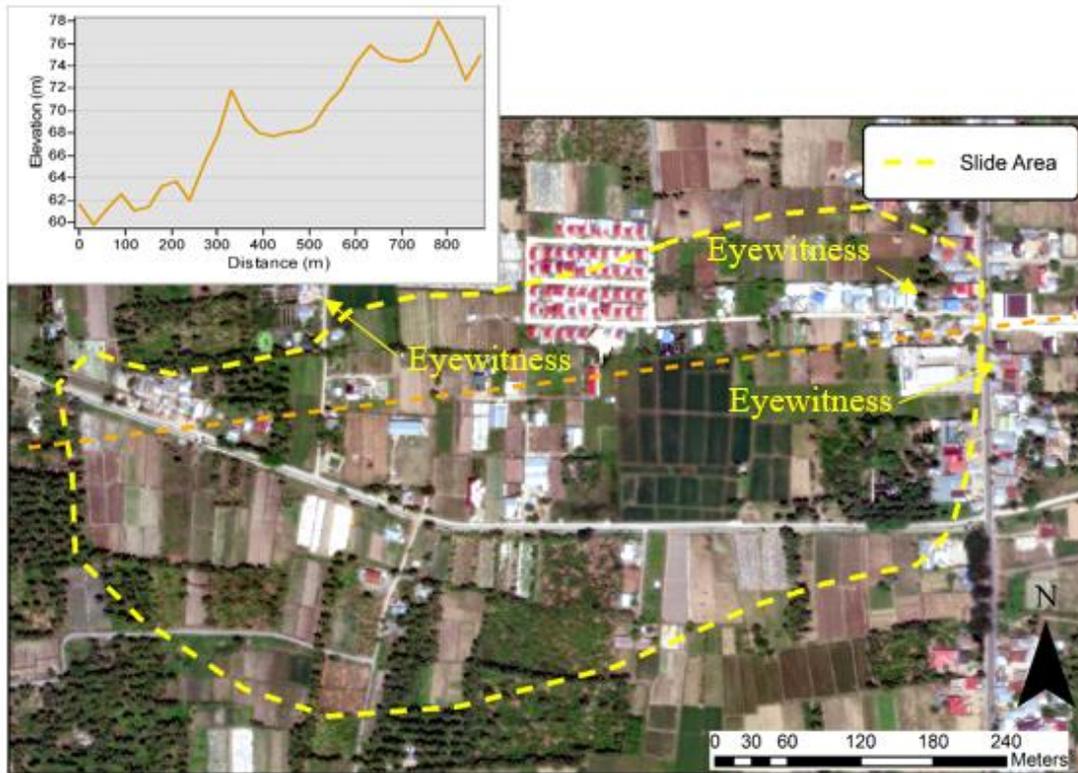
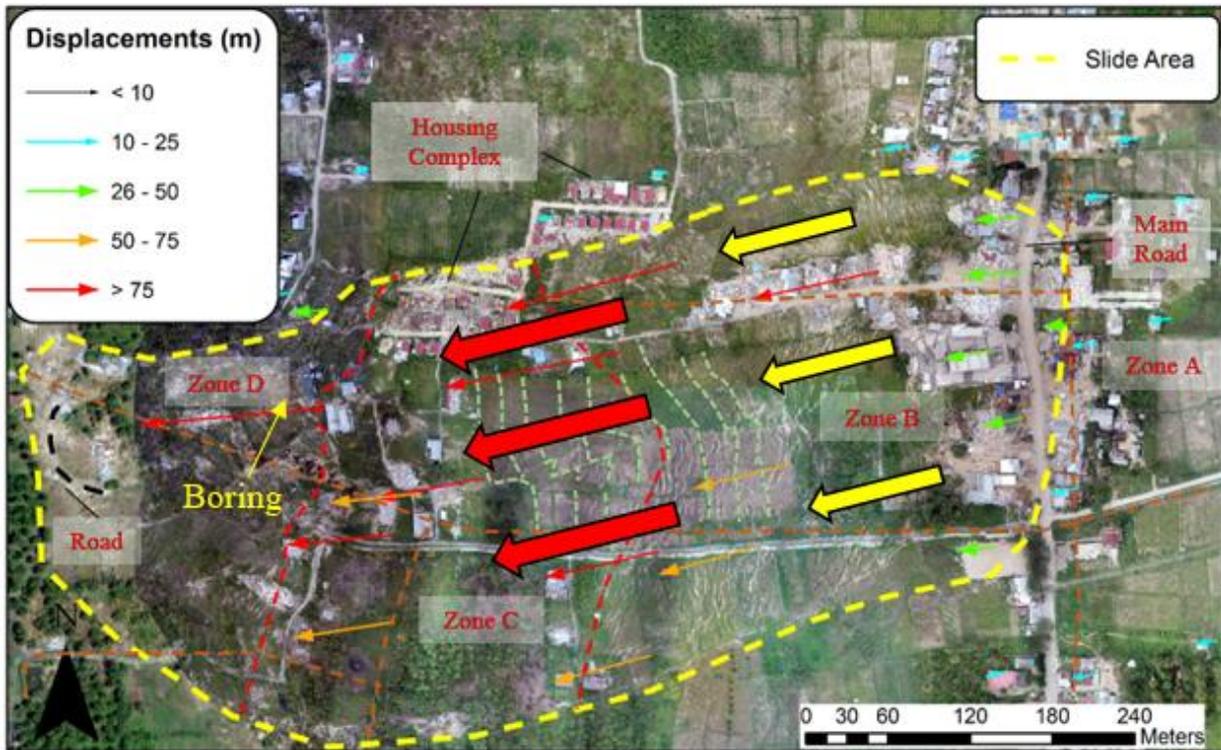
Figure 3.42. Pre-slide topography and interpreted slide progression indicating initial (red arrows) and secondary (yellow arrows) movements.

Three eyewitness accounts were documented at Lolu Village. Two survivors witnessed the events unfold in the upper portion of the slide. The third eyewitness provided a detailed account from the toe and was able to describe the general progression of movements of the sheared housing complex (Figure 3.42). Similar to Petobo, earthquake shaking was described as an initial period of intense horizontal ground motions, followed by a brief quiescence with no shaking, and then violent vertical motions and a significant vertical drop at the end of shaking. One eyewitness witnessed the events unfold near a mosque located on an access road that extends west from the main road (Figure 3.42). In addition to the general ground motions, they also provided a detailed description of the ground rotating and the mosque "spinning" violently, followed by rolling ground, believed to be Love and Rayleigh surface waves, respectively. During the earthquake, they were running east (towards the main road) and recalled the ground continuously splitting and closing as they traversed this area during the event. The preceding observation is consistent with significant cracking observed in the lower portion of the access road. Note that the upper portion of this access road had been repaired when the reconnaissance team arrived, as shown in Figure 3.37b. The other eyewitness account from the top of the slide was from a relative of the first eyewitness, who was located on the eastern side of the main road across from the gas station during the event. They recall extensive cracking and lateral extension of the main road, and noted that these cracks were much greater than those that manifested on the eastern (uphill) side. This is consistent with a video recording taken in front of the gas station (<https://twitter.com/i/status/1049533431699234816>; accessed 1 April 2019). They described the road as impassable by traffic after the event, which had since been repaired when the GEER team arrived. The third eyewitness, located at the toe of the flowslide, first recalls the housing complex moving in unison before the southern half of the

complex sheared and slid towards their home. At some point during the flowslide the eyewitness also noted that the sheared portion of the complex began to move away (uphill). However, the GEER team believes this may be a perspective issue, and that ground where they were standing began to displace downhill towards the end of the event, giving the illusion that the sheared housing complex was moving away. As shown in Figure 3.42, ground displacements in the vicinity of this eyewitness were approximately 20 to 30 m.

Based on eyewitness accounts, mapped ground displacements, and geomorphic expressions, the flowslide appears to have initiated near the center of the flowslide area below the main road, followed by secondary movements and lateral spreading uphill (Figure 3.42). The direction, initiation, and termination of movements appears to be influenced, in large part, by topography. Movements initiated in areas with locally steeper terrain (Figure 3.42) and terminated downhill where there was little to no relief (i.e. flat terrain). Once movements initiated near the center of the flowslide, attendant loss of confinement uphill resulted in lateral extension and secondary movements. It is also noted that mapped displacements indicate secondary movements were greatest in areas where localized relief was steeper.

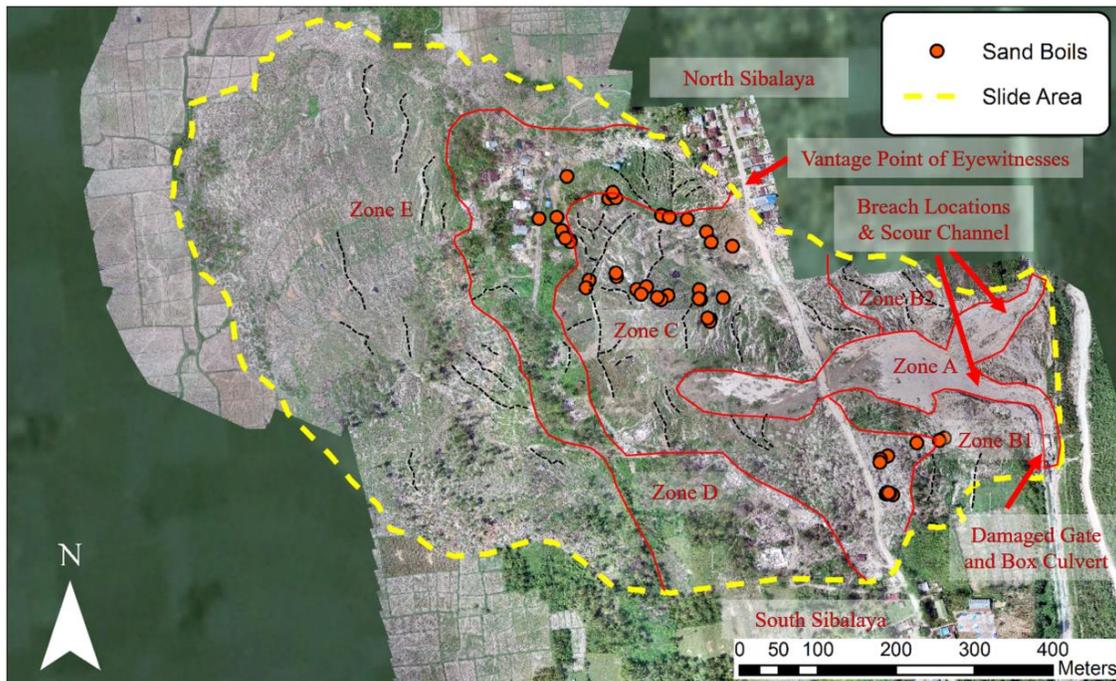
Figure 3.43. Orthomosaic map indicating limits of Sibalaya landslide location of sand boils, and zones delimited by morphological features and key observations.

Sibalaya is located 18 km in the south part of Jono Oge, and is also crossed by the irrigation canal. The width of the canal at this area is relatively large compared to Jono Oge and Petobo. This was the southernmost landslide investigated by the GEER team, and divided into five zones (A through E) based on morphological differences and key observations in each area. This failure affected 0.52 m² and extended more than 1.2 km from the irrigation channel to the distal margins of runout deposits on the western edge of the slide (Figure 3.43). A breach of the irrigation canal resulted in two scour channels that converged and split the villages of North and South Sibalaya. A portion of the roadway is clearly visible in Zone D, and remained largely intact during translation to its current location. Aside from minor repairs made to the main road to make it passable for traffic, there was little disturbance and most geomorphologic features were preserved after the earthquake. Sand boils and evidence of liquefaction were documented in several areas throughout this site.

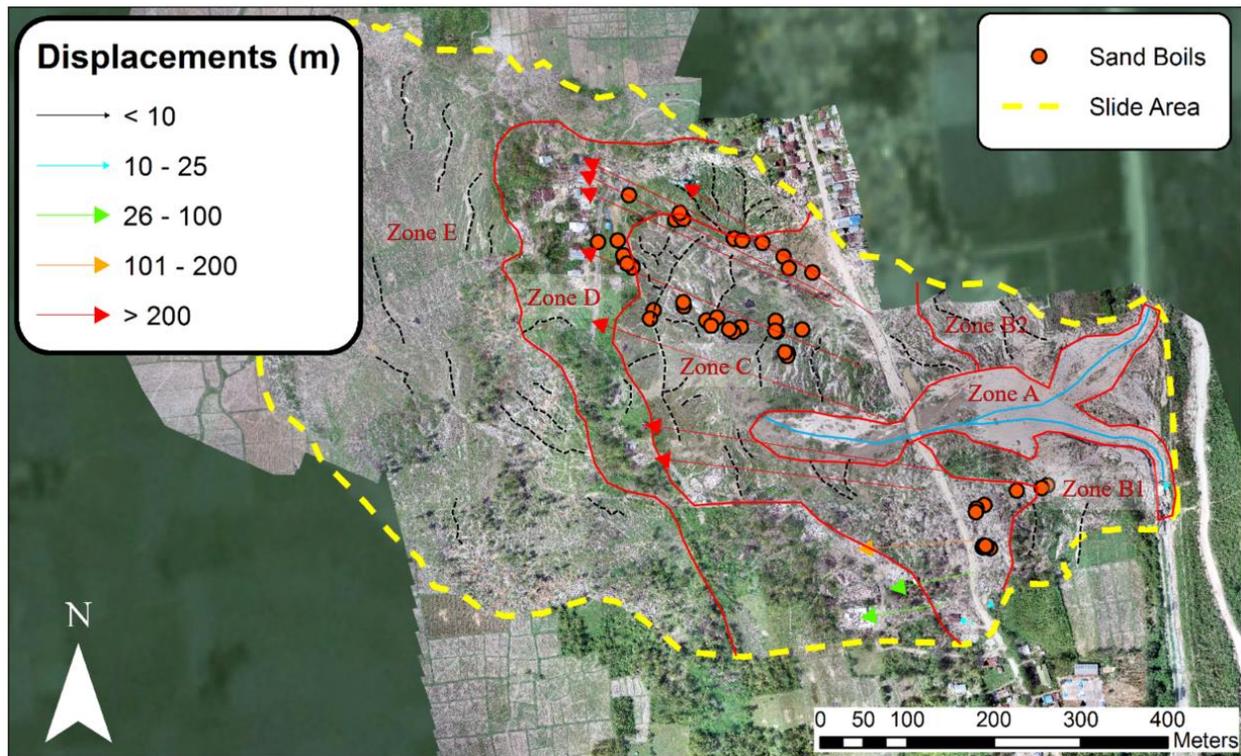
Figure 3.44. Orthomosaic map indicating locations of sand boils, vector displacements, and zones delimited by morphological features and key observations.

Figure 3.44 shows the vector displacements of several structures, which indicate ground movements and runout distances as great as 400m at some locations. Based on the vector displacements shown in Figure 3.44, the slide generally flowed west-northwest and fanned out, spreading in the north south direction as the ground displaced. Displacements at the center of the slide are greatest and decrease near the margins of the affected area, though movements along the southern margin of the slide are significantly smaller but oriented in the general direction that the landslide masses flowed.
