Geotechnical Extreme Events Reconnaissance

Geotechnical Reconnaissance:
The 28 September 2018 M7.5 Palu-Donggala, Indonesia Earthquake

(Version 1.0; 3 April 2019)

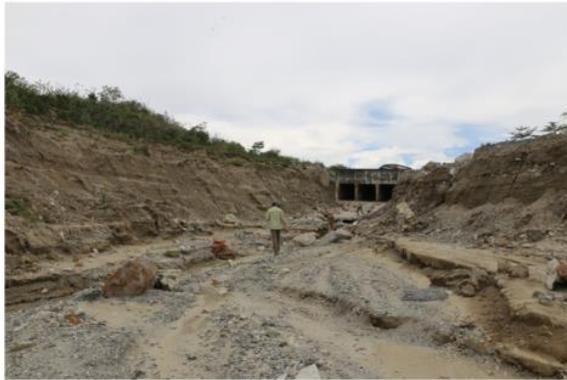
Other notable features include destruction of a concrete box culvert and steel framed gate near the southeastern breach of the canal. Lateral extension and cracking, which lead to the breach at this location, facilitated scour and erosion around these structures, as well as sloughing along the canal

walls. This also resulted in severe damage to a non-continuous, unreinforced concrete liner connecting the box culvert and gate (Figure 3.45a, c, d).

Figure 3.45. Zone A: a.) scour channel and damaged box culvert (-1,14844, 119.92477); b.) east-southeast facing perspective of southern scour channel where scour channels converge (-1.14788, 119.92281); c.) damaged gate and cracking in the canal on southeastern margin of slide (-1.149652, 119.924991); d.) damaged liner between box culvert and gate and sloughing of canal walls in the background (-1.14915, 119.92493).

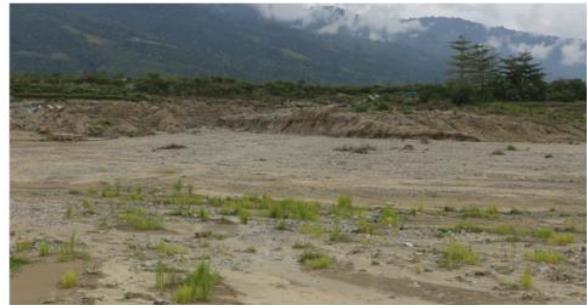
b.)

Breach of the canal at two locations resulted in significant scour and erosional features, including development of two channels at the southeast and northeast margins of the slide that converge towards the center of Zone A. Scour channels in Zone A resulted in an unconformity in structural features observed in Zones B and C near the center of the slide (Figure 3.43). These scour channels made deep cuts roughly 4 to 6 m through what was previously gently sloping alluvial fan deposits of fine to medium sand and silty sand. The presence of gravel, cobbles, and boulders near the bottom of these channels suggest scouring mechanisms likely intersected older colluvium debris deposits underlying surficial sediments (Figure 3.45a,b). Finer sands and silts were eroded and carried by water draining from the canal and deposited towards the center and western margins of Zone A.

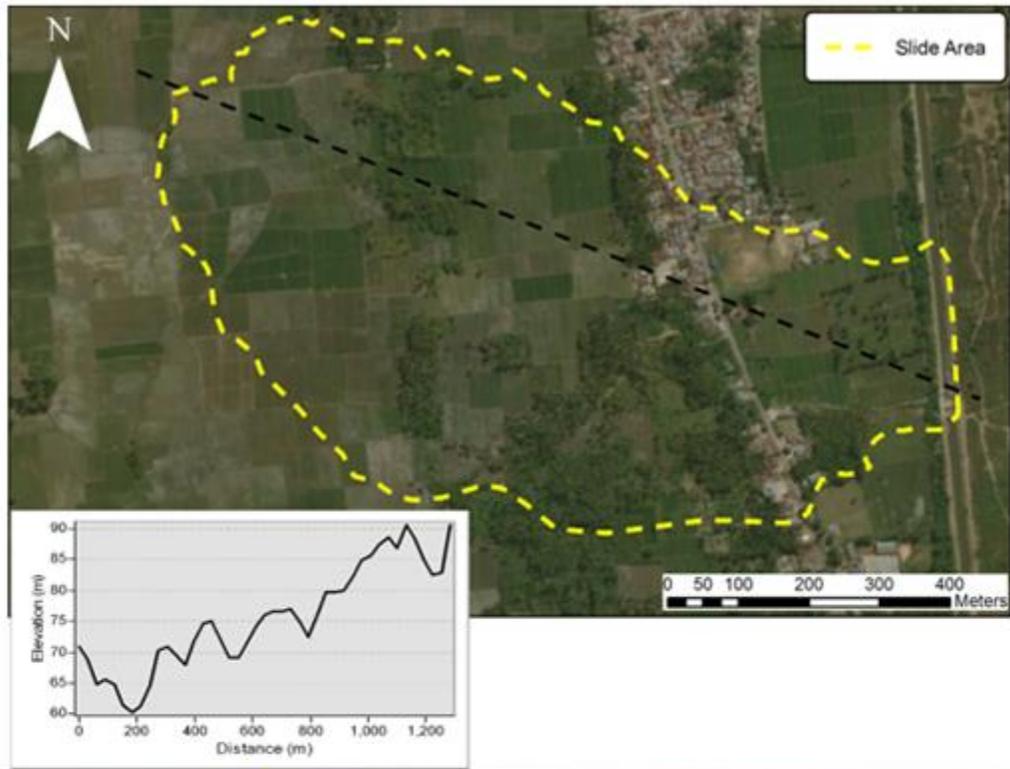
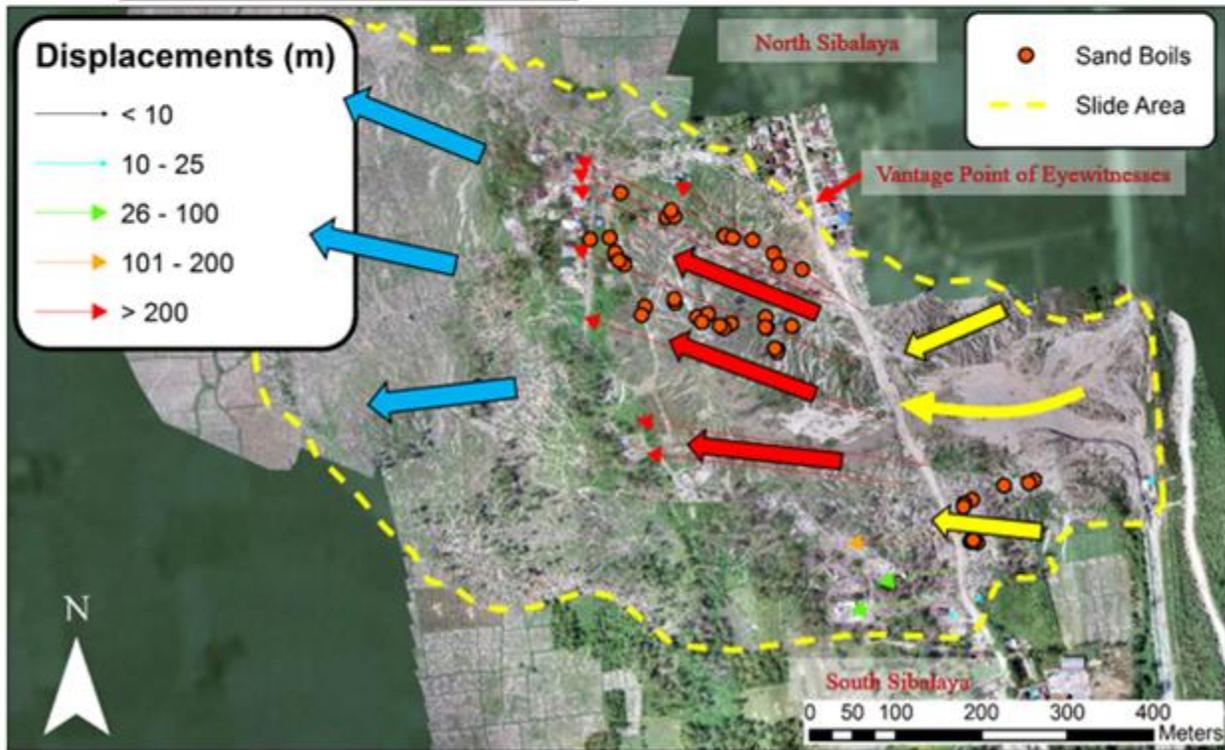
Figure 3.50. Pre-slide topography and interpreted slide progression indicating initial (red arrows) and secondary (yellow arrows) movements as well as runout displacements (blue arrows).

(Figure 3.50). The direction, initiation, and termination of movements appears to be influenced, in large part, by topography. Movements initiated in areas near the “toe” of locally steep terrain. This location is approximately 800 m from the terminus of debris flow (Figure 3.50), and consistent with eyewitness accounts of where coconut trees were first observed moving. Once movements initiated just west of the main road, attendant loss of confinement east of the road resulted in lateral extension and secondary movements (Figure 3.50). Debris flow and runoff terminated in areas with little to no relief, or where there was a slight incline in the terrain.

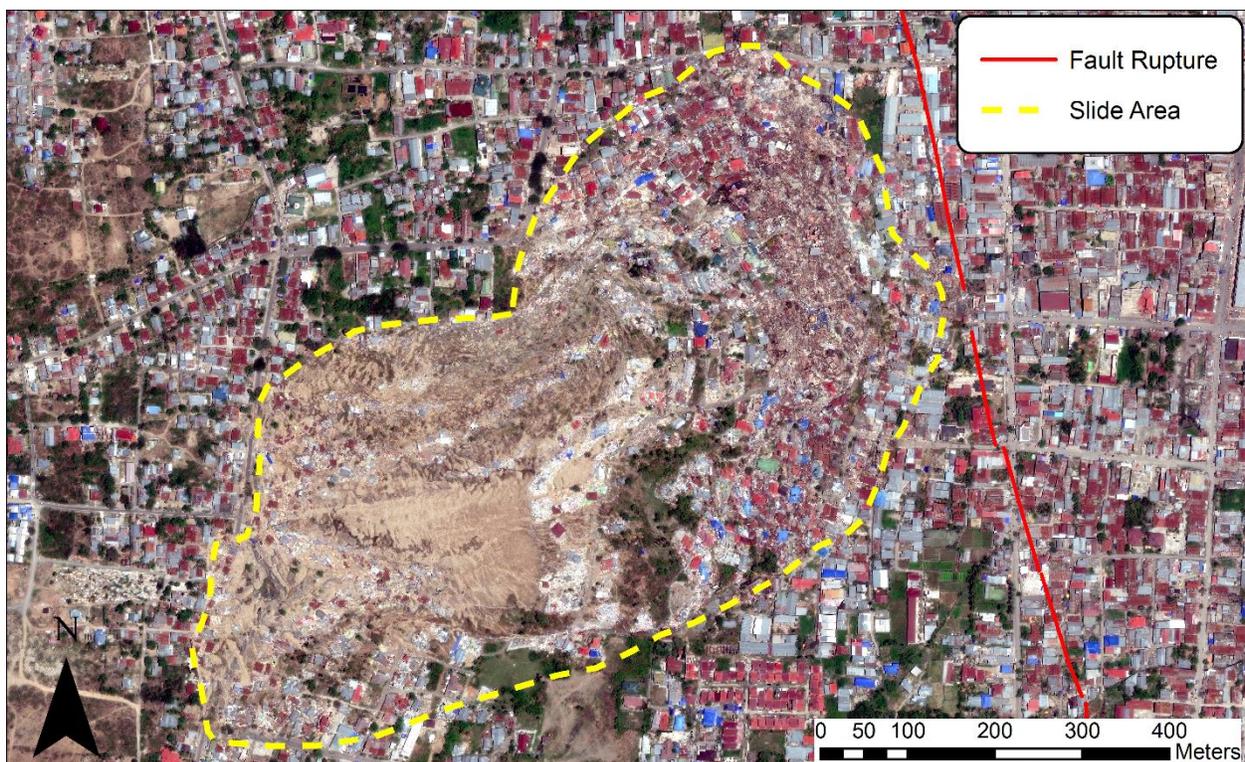
Figure 3.51. Landslide in the Balaroa neighborhood.

The Balaroa flowslide was the only failure observed on the west side of the valley. The landslide encompassed 0.4 km² with a length of approximately 980 m. The failure occurred in a very densely populated residential neighborhood (Figure 3.51) and BNPB estimated 2,895 buildings were damaged or destroyed. The toe of the landslide was located next to the fault rupture, so it was difficult to distinguish damage from the slide and damage from surface rupture in some areas (Figure 3.51). The GEER team visited this site on 14 November 2018, but many of the damaged structures had been removed and significant earthwork had been completed to level the site. The clean-up efforts made any detailed mapping of the site or morphological interpretations very difficult (Figure 3.52).

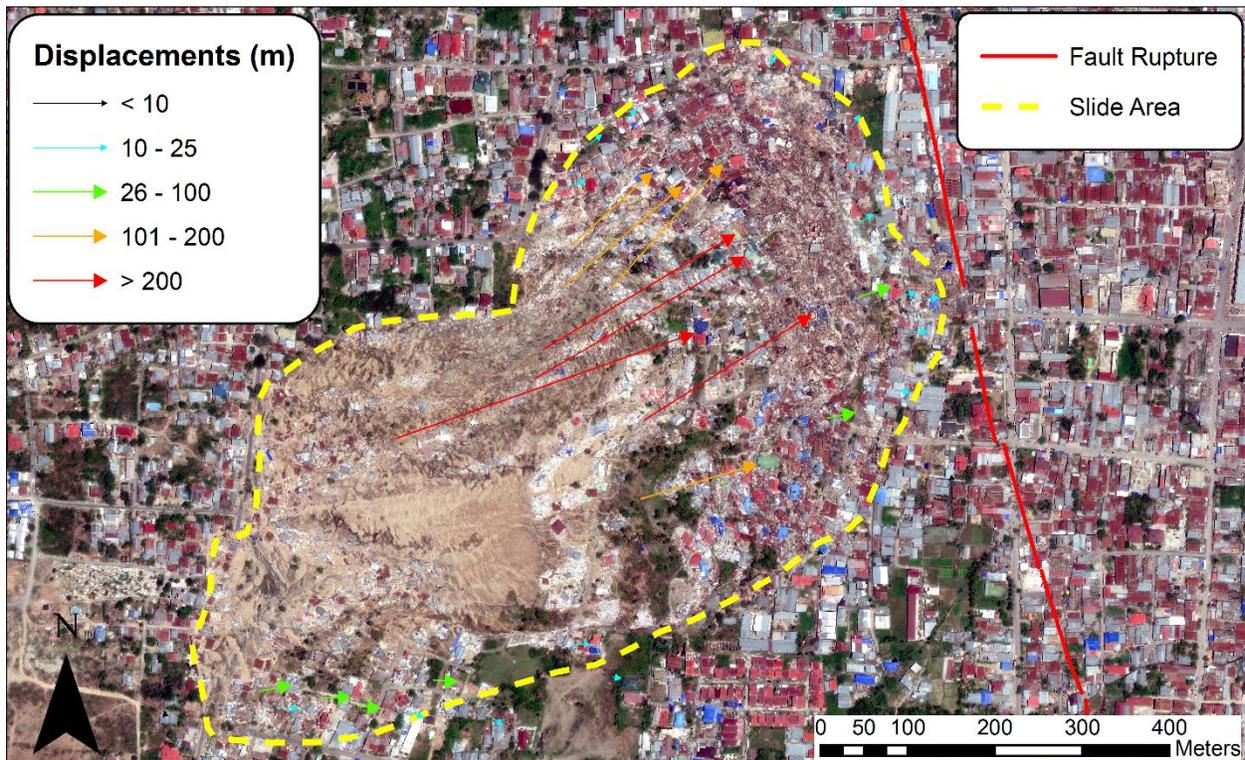
Figure 3.53. Displacement mapping of the Balaroa landslide.

The general direction of movement of the Balaroa landslide was to the northwest (Figure 3.53). Displacement mapping of the landslide was performed by matching points on individual structures in pre- and post-earthquake satellite imagery (Digital Globe 2018) at the site. The displacement mapping showed maximum building displacements of more than 350 meters in the central portion of the failure (Figure 3.53). Many of the buildings could not be identified in the post-earthquake imagery, which led to incomplete mapping of the failure. The GEER team observed high groundwater during the site visit, including deep ponding of water near the toe (Figure 3.54).

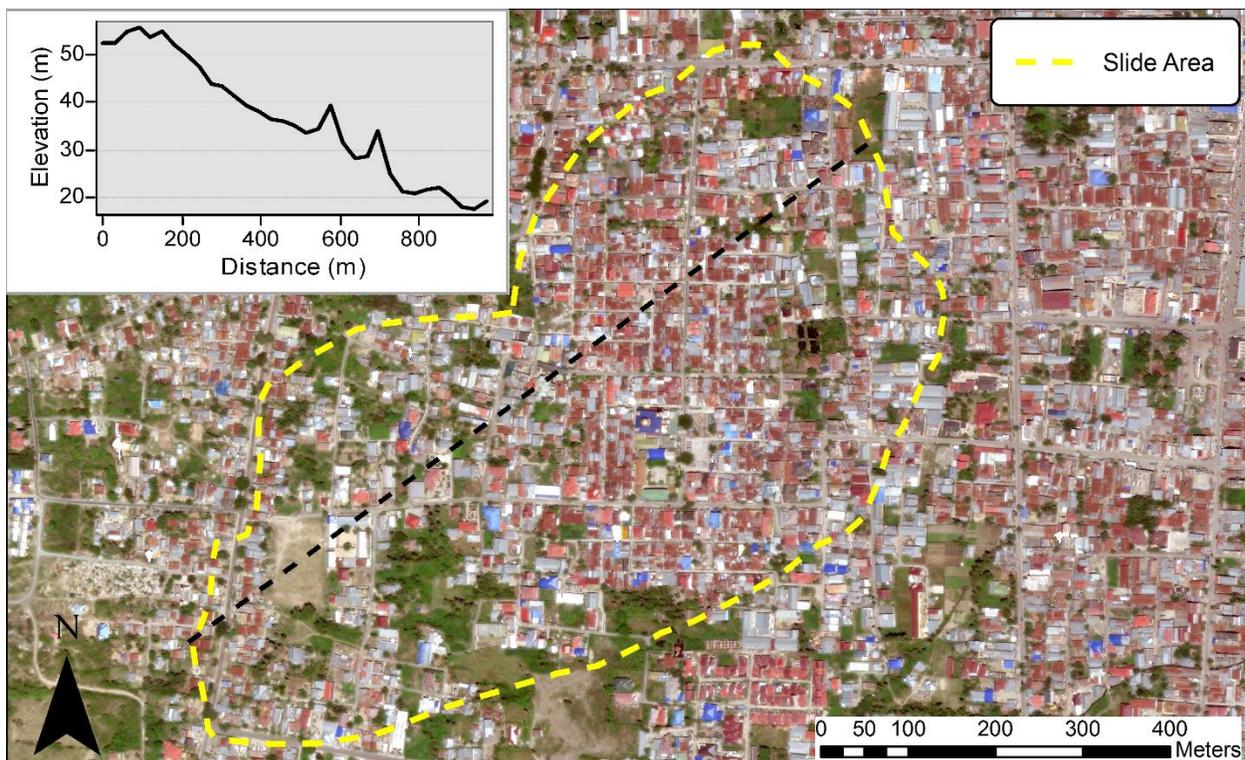
Figure 3.55. Pre-slide topography of the Balaroa landslide.

The Balaroa landslide differs from the previously described landslides in some important ways. The first is that no irrigation canal is present on this side of the valley. Rice farming does still occur

in this area at a smaller scale, but the rice paddies are located near the toe of the landslide rather than the scarp (Figure 3.55). Satellite images from 2005 show that significantly more of this area was devoted to rice paddies in the past, but much of it was replaced by buildings. A second important difference at this landslide was that no sand boils were observed or reported. It is possible that sand boils occurred, but the GEER team was able to observe boils at the other four failure areas. A third important difference is the topography in this location. The previously described landslides occurred on relatively uniform slopes, which lead to long runouts relative to the area of sliding. The Balaroa failure occurred in an area with steeper slopes than those observed at the other sites, but the toe of the failure was very flat. This reduced the amount of runout and led to a piling up of debris at this location. In some cases, multiple buildings became stacked on top of one another (Figure 3.54).
