Preliminary Report on Engineering and Geological Effects of the July 2019 Ridgecrest Earthquake Sequence

A report of the NSF-Sponsored Geotechnical Extreme Event Reconnaissance Association

Report GEER-064: <https://doi.org/10.18118/G6H66K>

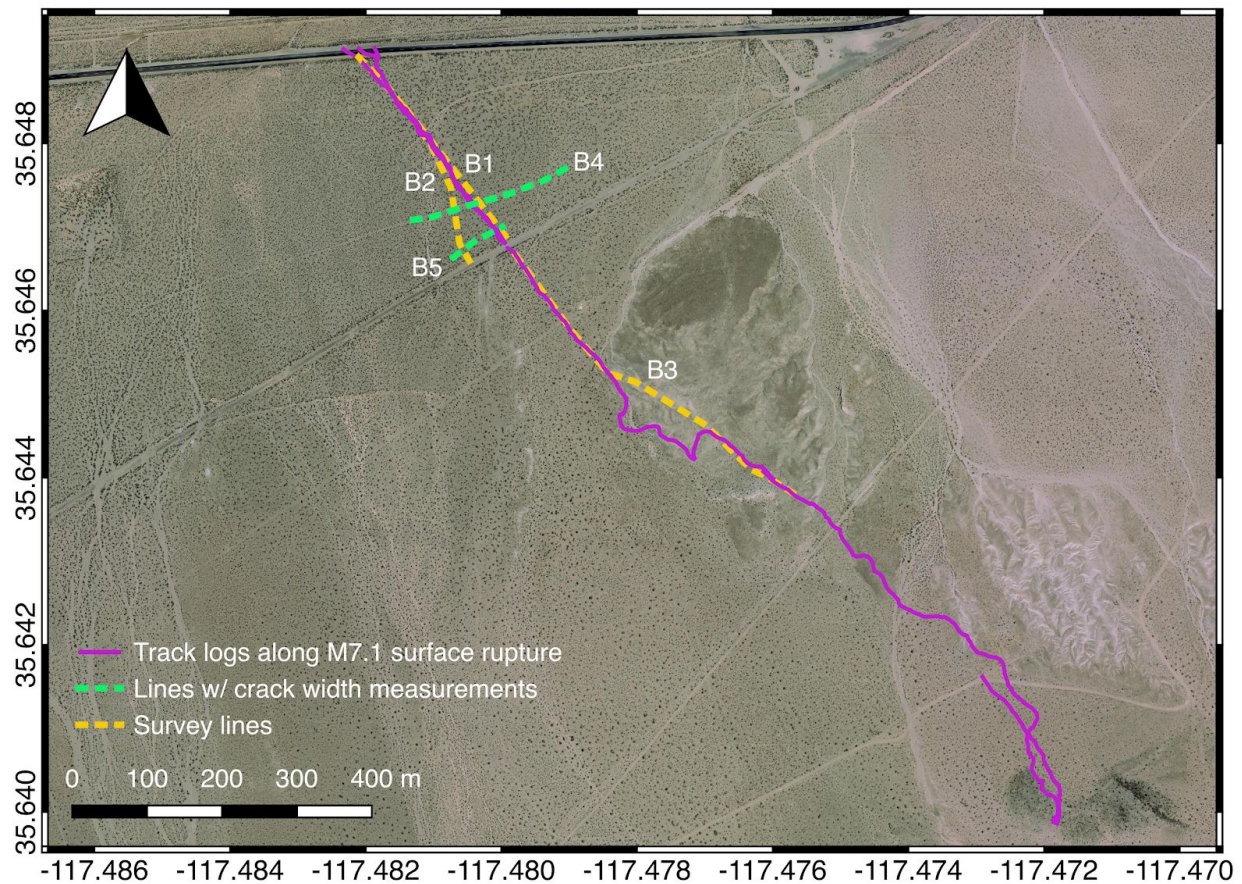
Figure 21. Fault trace mapping at location of the surface rupture from the **M7.1** event just south of Highway 178.

For the fault trace from the **M7.1** event, one team focused on documenting the two main strands of the fault from Highway 178 to the first dirt service road (B1 to the East and B2 to the West, Figure 21). At the north end near Highway 178, the strands mostly coincide. South of Highway 178, the zone remains relatively narrow, for example as shown in Figure 22 where the width is 3 m about a third of the way south of Highway 178 towards the service road. The strands diverge towards the service road, creating a localized extensional graben that is 60 m wide along line B5. The ground in the extension zone is about 40 cm lower relative to the zones outside of the fault strands. Line B1 followed the main eastern strand starting at Highway 178 and extended in a SE-direction for 1150 ft (350 m) and line B2 followed the second strand toward the south. Generally, longitudinal cracks appeared in the stiff upper crust of the arid alluvial soil, with openings ranging from a few mm to 50 cm right at the surface. Lateral offsets in that area are marginal and vertical offsets were observed up to 16 in (40 cm) in some locations (Figure 23). The fault crossing at the dirt service road near line B5 as shown in Figure 24.

Transects B4 and B5 were followed to capture the full fault zone width. We bound the transect end-points by walking several meters past the points shown on Figure 21 to ensure no cracks were visible beyond those points. On these transects, we took continuous and overlapping pictures of the fault zone following a measuring tape on the ground. The cracks' location and width data are to be quantified in the lab.

The GEER team also recorded track logs along surface fault rupture traces using the “GPS Tracks” app. The track logs are shown in purple in Figure 21. These tracks generally follow the fault rupture zone, but they do not delineate individual ground cracks. The ground cracks were generally observed to be parallel to the track logs over much of the fault trace, though ground cracks transitioned to lie at approximately 45° angles from the fault strike toward the southeastern limit of the track.

Line B1 and the purple tracks shown on Figure 21 were mapped on July 6. Lines B2 and B5 were captured on July 7. Line B3 and B4 were documented on July 11. Line B4 outside of the main strands was not damaged by trampling and its intersection with features documented in lines B1 and B2 allows us to anchor the fault zone location.

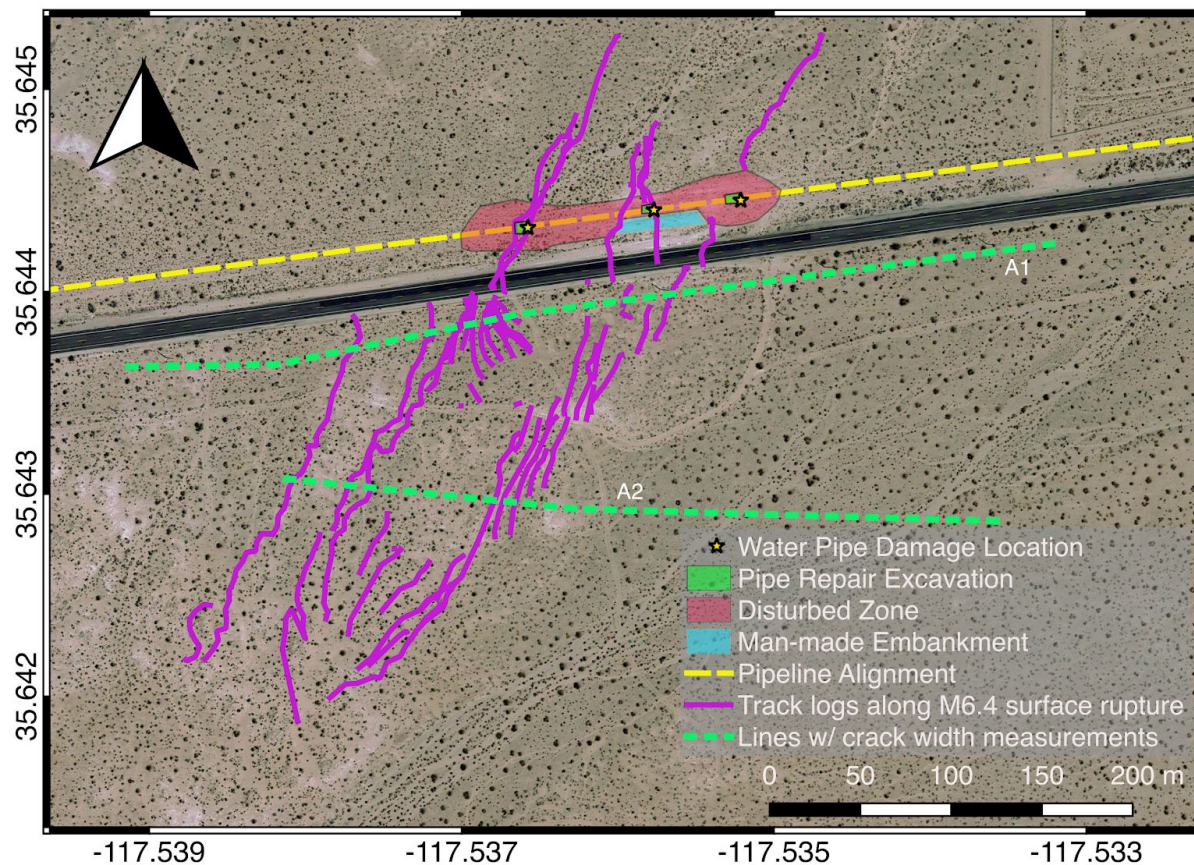
Figure 25. Fault trace mapping at location where surface rupture for **M6.4** event crosses Highway 178. Map traces available in DesignSafe at Community Data / Main / Recon Portal / 2019 Ridgecrest, CA Earthquake / GEER Resources (see also Fig. 3 from this same location).

The process for performing detailed mapping along the **M6.4** fault was similar to that described for the **M7.1** trace. The study area extended from Highway 178 to approximately 300 m to the south. In that area, the fault zone appeared more diffuse than for the **M7.1** fault, so detailed crack measurements along continuous longitudinal lines were not performed. Transects A1 and A2 were documented in detail so as to constrain the fault zone width, using continuous and overlapping pictures of the cracks along the extended measuring tape. As for the **M7.1** fault, the limits of the transects were defined by the teams walking further SE and NW until no more deformations were visible. Two teams measured crack widths and documented their locations along transects A1 and A2 just south of Highway 178. Another team tracked continuous cracks using the “GPS Tracks” app as described above (purple lines on Figure 25). A separate track log was recorded for each surface rupture splay by starting the track log, walking along the surface rupture a distance of a few hundred meters on either side of Highway 178, then terminating the track log. This process was repeated for surface rupture splays over a width of a few hundred meters. We walked in a direction perpendicular to the fault strike about a hundred meters further in both the NW and SE directions, and did not encounter additional ground cracks. The surface rupture extended further toward the northeast and toward the southwest as this mapping effort focused on the region near Highway 178, and was conducted in parallel with an effort by other GEER team members to map the crack widths along transects perpendicular to the fault strike. The followed tracks are shown in purple in Figure 21. The purple lines do not represent all of the ground cracks, but the most obvious continuous ones. Additional cracks were observed along A1 and A2, which were documented on July 7.

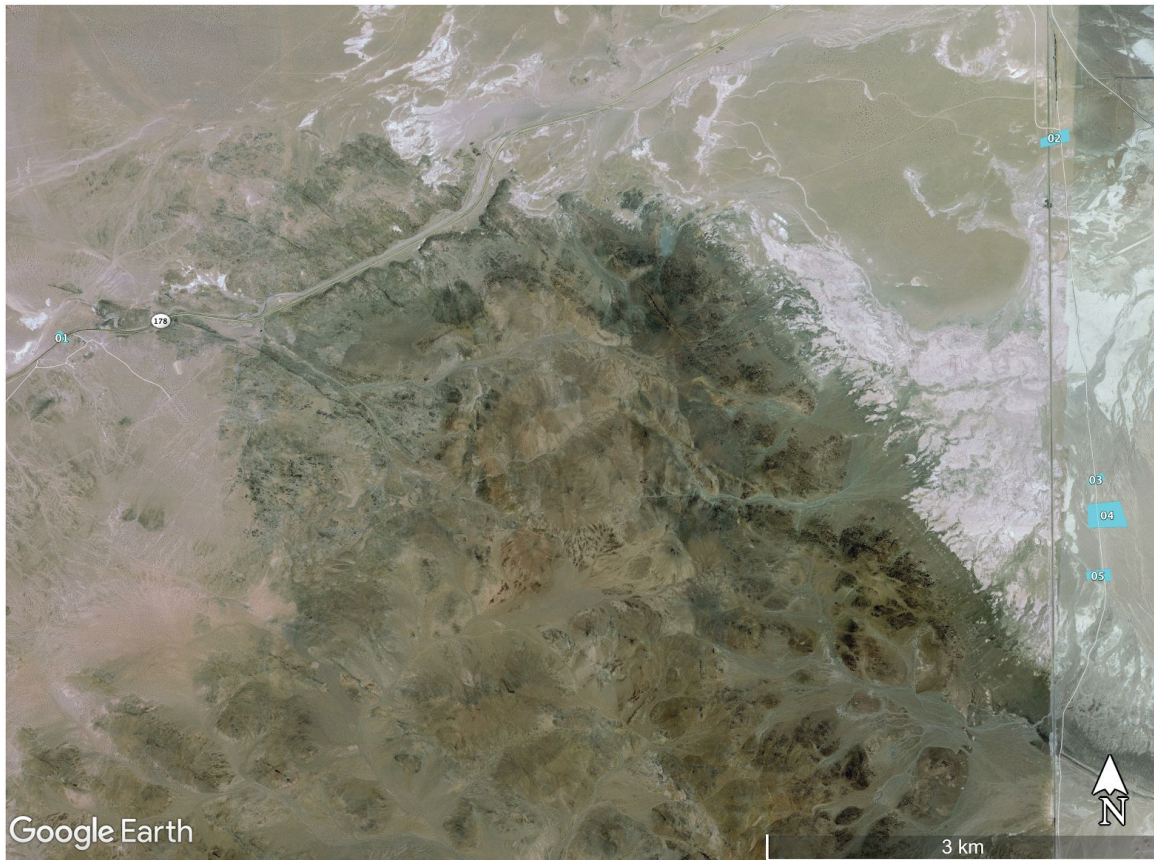
Figure 26. Map showing the different zones exhibiting cracks (numbered cyan polygons).

We have documented additional ground deformations that appear to be fault strands located away from the main ruptures from the **M6.4** and **M7.1** events. These areas are shown on Figure 26. We have shared the location of those features with several groups, including the USGS and SCEC, so that future reconnaissance and remote sensing teams can add them to their investigation region.

The first displacement area (01 in Figure 26) was observed East of the **M7.1** rupture and contained cracks parallel to the main rupture. The cracks appeared on Highway 178 following the **M7.1** (they were not observed right after the **M6.4** event), crossing it perpendicularly. The cracks were not continuous and we were only able to observe them up to roughly 50 m away from the road, on the north and south side. The observed cracks were fairly narrow and concentrated in a narrow area as well. The site was visited on July 7 and 11.

The other three zones of cracks were found crossing the Pinnacles Road, the dirt road leading to the Trona Pinnacles National Natural Landmark. These observations were made on July 12. The four areas showed persistent cracks generally trending from E to ENE to NE and were interspersed with variably trending set of secondary cracks (example on Figure 27). It is possible that some of the observed ground failure may be due to lateral spreading, however, we have not observed any sand boil or moisture in the cracked areas. The cracks were followed on the east and west sides of the road for about 60 m to 120 m on each side.

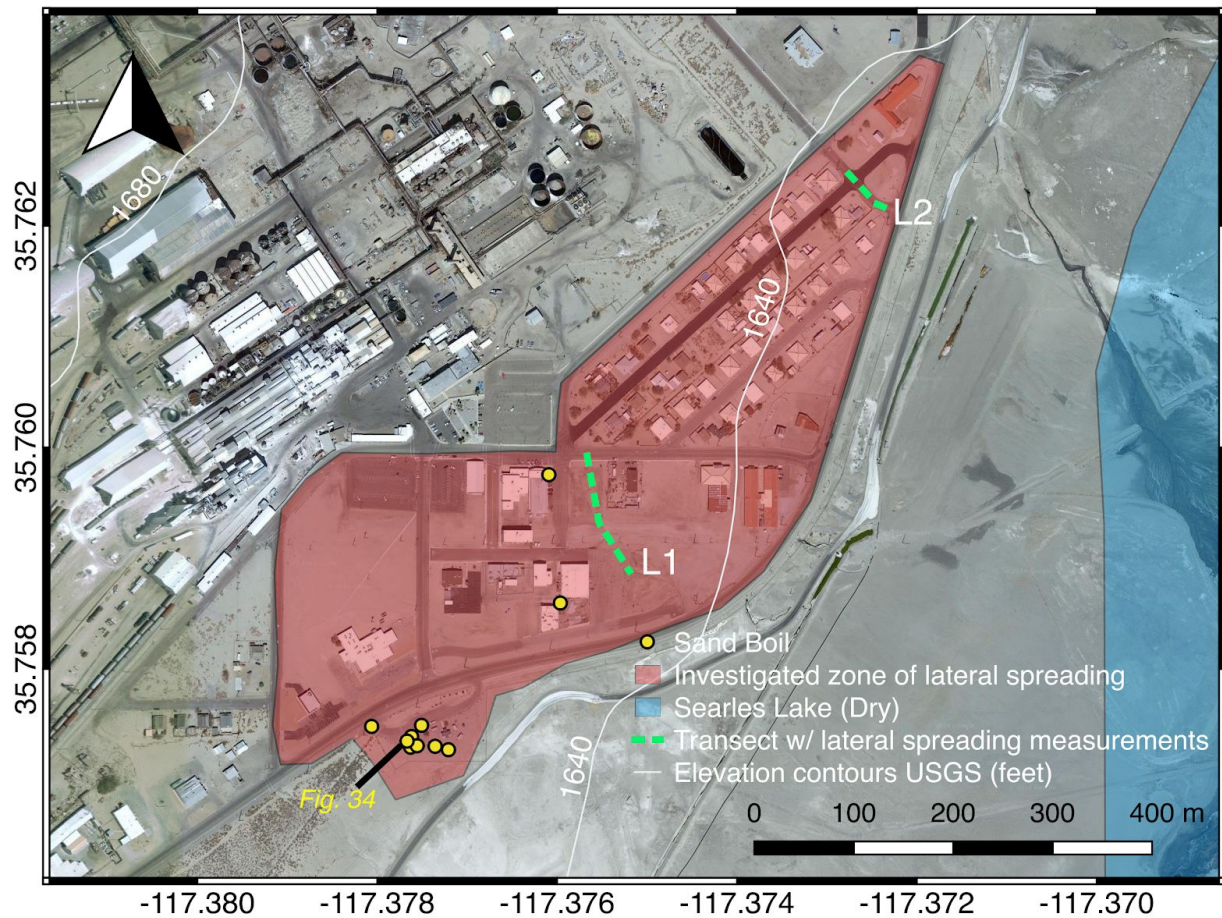
Figure 33. Map of Trona showing region investigated by the GEER team, along with selected sand boils that were photographed by the team. Lateral spreading features, including tensile cracks and compressional features, were observed throughout the investigated zone.

Figure 33 highlights the region of Trona investigated by the GEER team. Liquefaction features were apparent throughout this region. Yellow markers indicate regions where the team

photographed sand boils (e.g., Figure 34). The team did not perform an exhaustive survey of all sand boils in Trona, and it is therefore possible that sand boils existed in additional areas. Sand boils were encountered along the southern margin of Trona near the northern margin of Searles Lake. The GEER team could not access Searles Lake near Trona because it was protected by a chain link fence with barbed wire at the top. Ground cracks caused by extensional strain due to lateral spreading were apparent near the sand boils, and throughout the region investigated by the GEER team. The orientation of the extensional cracks was highly variable. Many cracks trended toward the northeast, parallel to the lake perimeter, but many other cracks were at different angles. We interpret this to indicate that the lateral spreading was predominantly toward the lakebed, but spreading occurred in many other directions as well, possibly due to the influence of structures on ground displacements, or due to ground lurch. In addition to the extensional ground cracks (Fig. 35), compressional features were also observed in various regions (Fig. 36), as evidenced by buckled concrete curbs, and regions where the asphalt pavement cracked and rode up over adjacent pavement. Structures appear to have been affected by the lateral spreading, including the restaurant shown in Fig. 37, which experiences wall cracks in the **M6.4** event that were widened in the **M7.1** event. It is possible that many cracks pre-dated the earthquake sequence, and were subsequently widened by the earthquake. Considering the complicated deformation patterns and possibility of pre-earthquake cracks, we suggest that future remote sensing surveys may be valuable at this site.

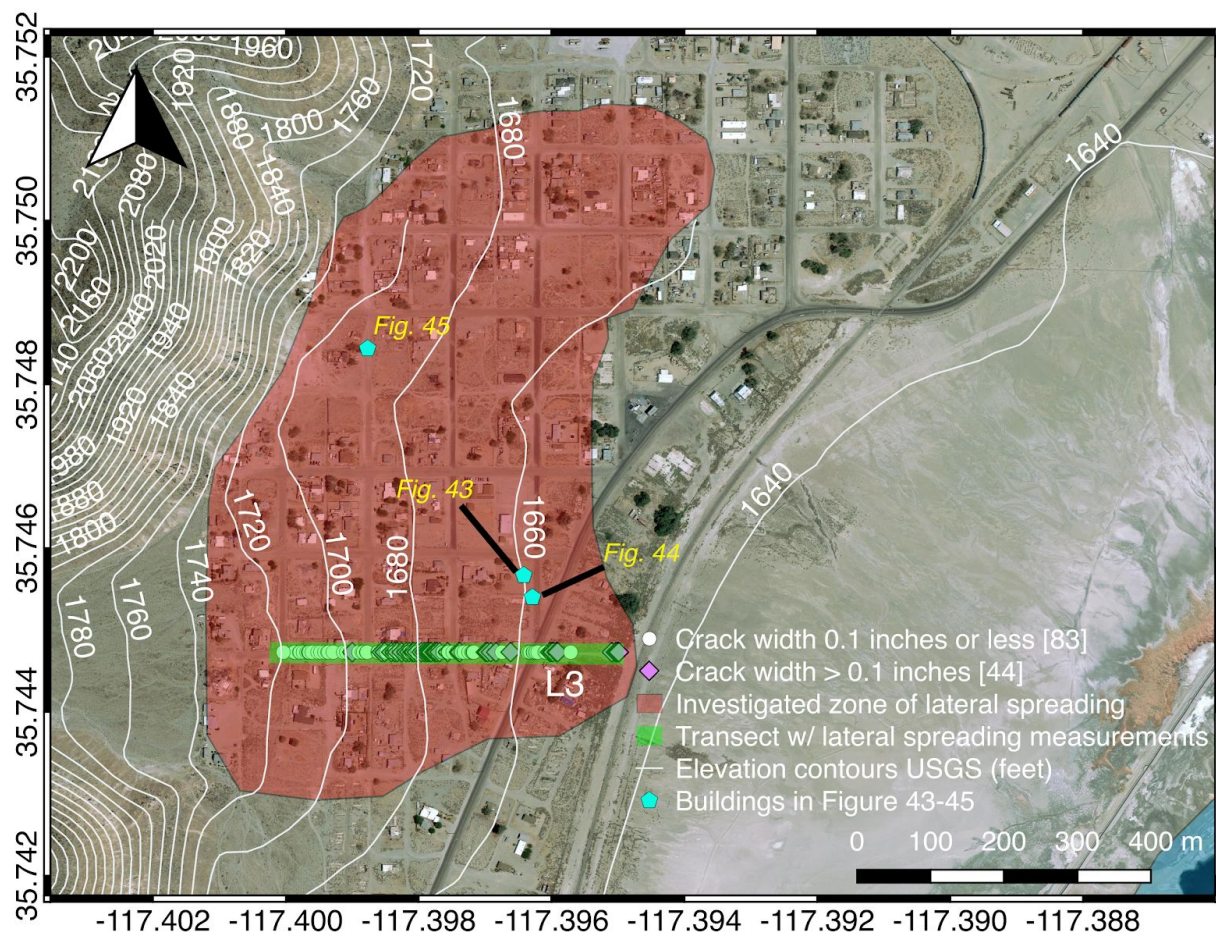
Figure 38. Map of Argus showing region investigated by the GEER team. Lateral spreading features, including tensile cracks and compressional features, were observed throughout the investigated zone. Lateral spread cracks were measured along a transect on A Street.

Figure 38 displays the areas of Argus surveyed by the GEER team. Similarly to Trona, many liquefaction related features were observed throughout Argus. The ground surface in the area shown as experiencing liquefaction has a gentle slope. The ground surface exhibited

extensional cracks ranging from less than a millimeter to approximately 10 cm in width. The lateral spreading features became less frequent with proximity to the hills to the west of Argus. The lateral spreading features were more pervasive along the axis of a large alluvial fan coming from the ridge to the west. A photo survey was performed along a transect on A Street, approximately along the axis of the alluvial fan as shown in Figure 38. The transect was 1,500 feet long, and the elevation difference (from USGS Topographic Map) ranged from 1640 to 1720 MSL (east to west), indicating an average ground surface slope along the transect of approximately 5%. The extensional features were measured along the transect and the cumulative displacement is shown in Figure 39. The sum of ground cracks measured across the 1500-foot long photo survey was approximately 22 inches.

Figure 38 shows the locations of several buildings that illustrate these effects and described here. Figure 43 shows a heavily damaged structure (Structure A1) which is on the alluvial fan, near many liquefaction-induced lateral spreading cracks (as shown in Figure 44). In contrast, Figure 45 shows an unreinforced stone structure with a stone chimney (Structure A2), which is within a few blocks of the house shown in Figure 43, but has relatively little damage. Structure A2 is near the base of the mountain, with no observable effects of liquefaction on the ground in the immediate vicinity.

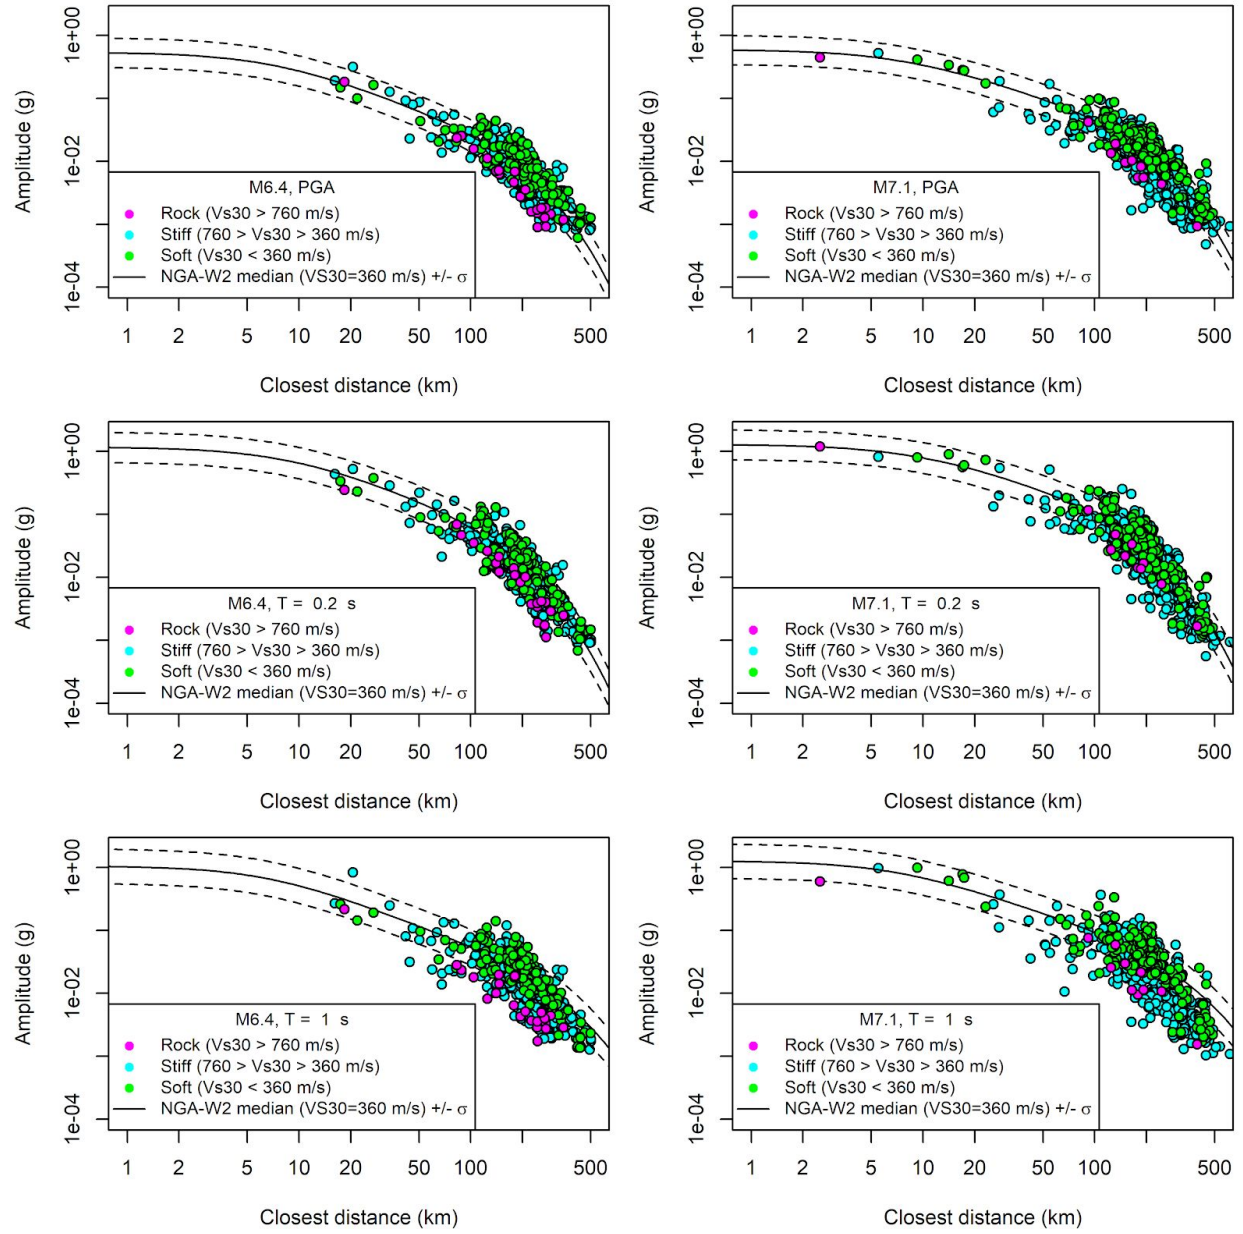
Figure 40. Attenuation with distance of ground motions from **M6.4** event (left column) and **M7.1** event (right column). RotD50 component PGA and PSA at 0.2 and 1.0 sec.

Figure 40 compares median-component (RotD50, as given by Boore 2010) ground motions as a function of rupture distance for three general groups of site class (> 760 , $360-760$, and < 360 m/s), using the intensity measures of peak acceleration (PGA) and pseudo-spectral acceleration response spectra (PSA) for two oscillator periods (0.2 and 1.0 s). Also shown in Figure 40 is the average prediction of four NGA-West2 models (Abrahamson et al. 2014; Boore et al. 2014; Campbell and Bozorgnia 2014; Chiou and Youngs 2014) along with a range of plus and minus one total standard deviation. The ground motion models are plotted for $V_{s30} = 360$ m/s. Three key findings of this preliminary analyses are:

2. The California-specific path model used in the models captures relatively well the attenuation of ground motions with distance;
3. Ground motions are amplified as site condition softens, with the largest amplification at the longest periods. This is consistent with typical patterns of behavior in California.

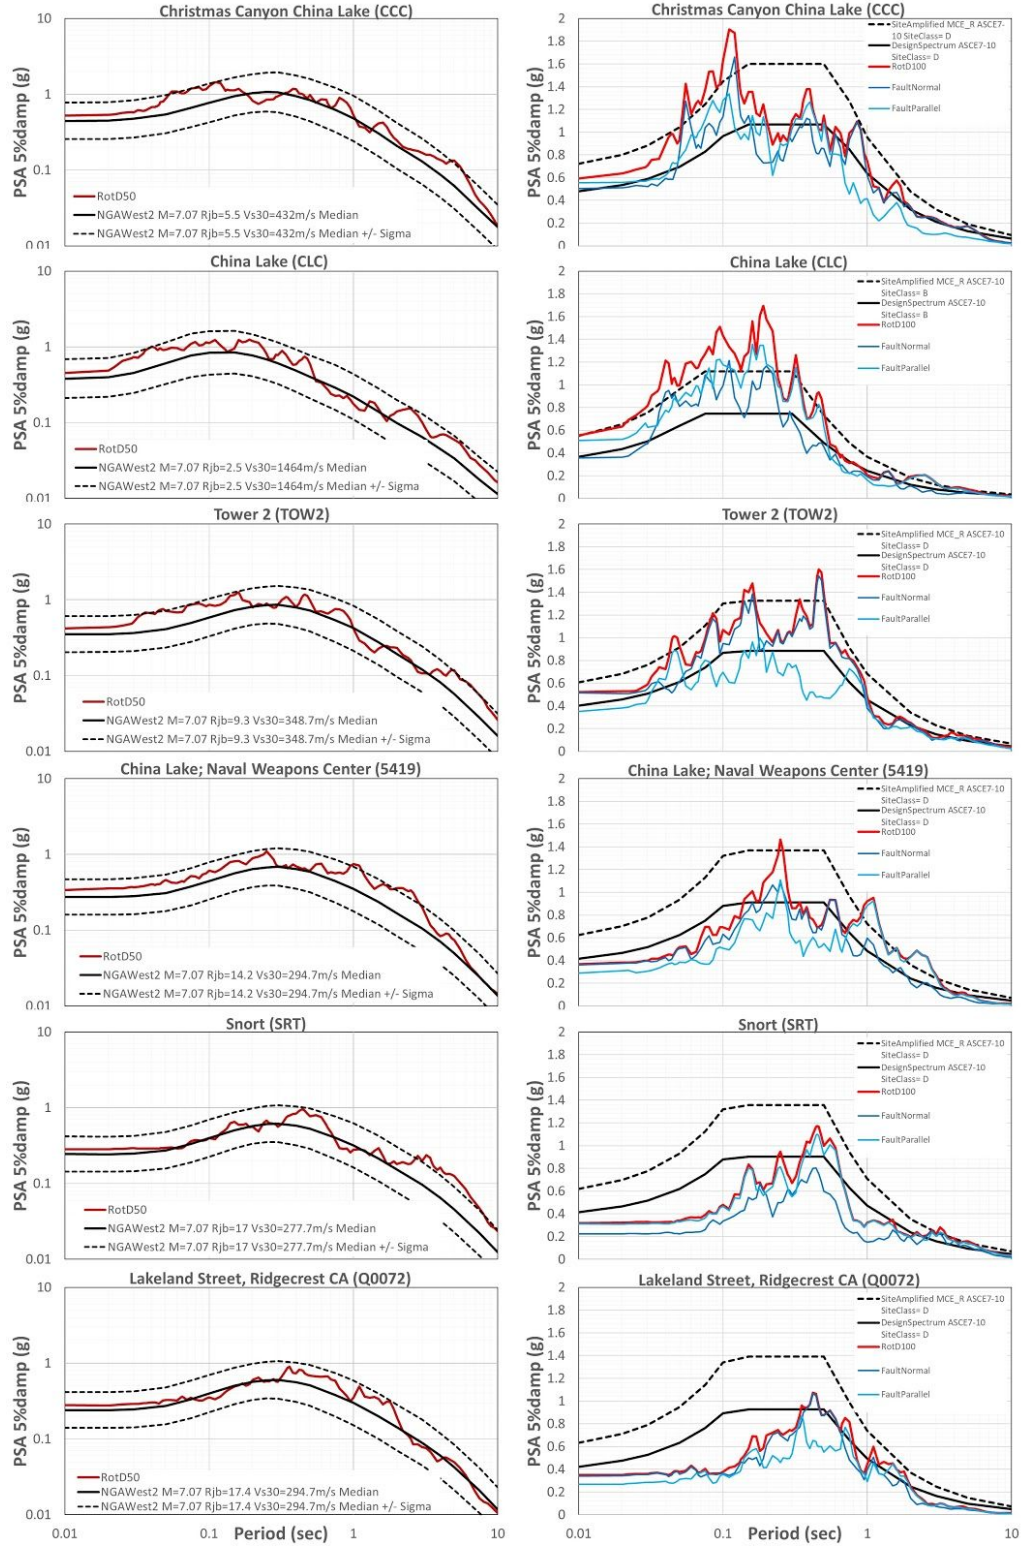
Figure 41. Pseudo-acceleration spectra for stations proximate to fault rupture of M7.1 event. Right plots show RotD50 components (data) and median predictions from NGA-West2 models. Left plots show RotD100, fault-normal, and fault-parallel components, along with design and MCE_r spectra (ASCE 7/10).

Figure 41 shows 5% damped PSA for six stations most proximate to the **M7.1** mainshock rupture (CCC, CLC, TOW2, 5419, SRT, Q0072), which are shown in Figure 1. The left panel of Figure 41 shows that the RotD50 component of these records is reasonably consistent with predicted spectra from ground motion models. The right panel shows that the motions are generally at or below the risk-targeted maximum considered earthquake (MCE_R) levels, with the exception of CLC, which exceeds MCE_R for periods below about 0.5 sec. Along with CLC, other near-fault motions (CCC and TOW2) exceed design levels. The corrected ground motions have been rotated into fault-normal (FN) and fault-parallel (FP) components. Station CCC is located south of the fault, aligned with the fault strike, and hence would be expected to experience forward directivity effects. The FN component carries most of the energy, producing the maximum component at long periods (> 1 sec). The FN component also controls the maximum component for TOW2. Station CLC is located near the epicenter, and hence is in a backward directivity region. This record has appreciably lower long-period spectral ordinates than CCC and does not have polarization of the energy in the FN direction.

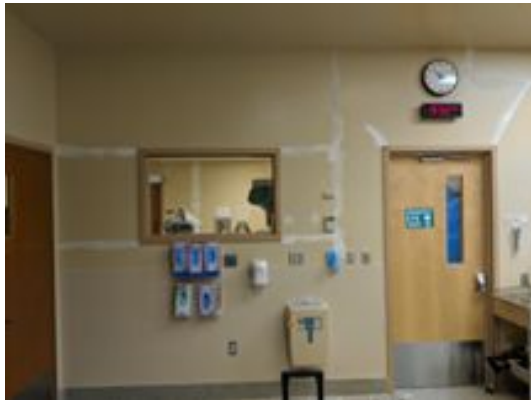
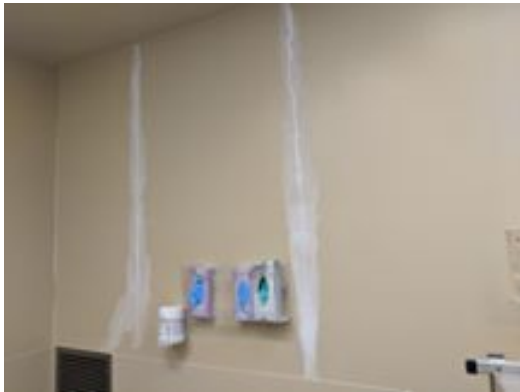
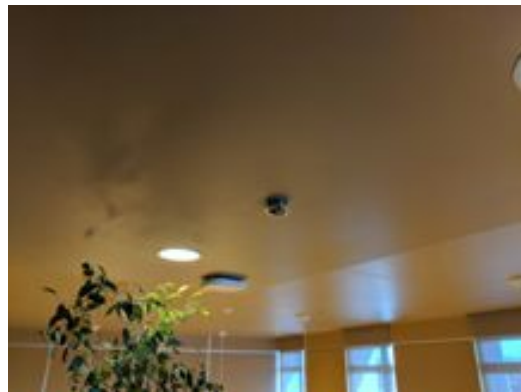
Figure 49. Damages to Ridgecrest Regional Hospital after the **M6.4** event (35.6410, -117.6707) Photo credit: Farzin Zareian

Ridgecrest Regional Hospital after the **M6.4** and **M7.1** events did not suffer any observable structural damage; much of the damage was limited to nonstructural components. These damages, however, triggered the shutdown of the hospital after the **M6.4** event. The reconnaissance team visited the hospital after each event.

Three independent sets of nonstructural damages were observed after the **M6.4** event. The first one is related to the breakage of copper pipes on three out of four water pumps in the mechanical housing (at the penthouse level, see Figure 49a). This breakage led to release of hot and cold water into the elevator shaft. In the second set of nonstructural damage, a hot water pipe leaked in the ceiling of one of the operation rooms (i.e., OR1) which led to release of water on the operation room's floor (See Figure 49b). Lastly, partition walls were cracked, and some sprinklers were displaced with damage (Figures 49c, 49d, 49e, 49f). Partition wall cracks were mainly vertical and horizontal; some diagonal shear crack were observed around openings.

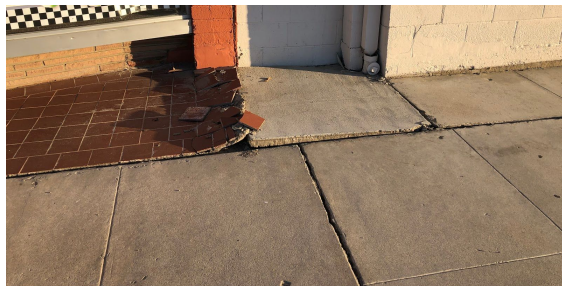
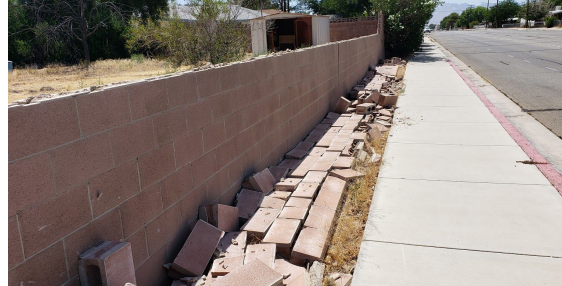
Figure 51. Damages to Masonry components after the M7.1 event (a: 35.7595, -117.7357, b: 35.7592, -117.3766, c: 35.7595, -117.7357, d: 35.6444, -117.6720) Photo credit: Christine Goulet and Jawad Fayaz

Horizontal and vertical cracks were induced and widened in masonry walls during the **M6.4** and **M7.1** events in Trona (See Figure 48a). These damages were related to possible liquefaction-induced lateral spreading, which also caused damages to pavements (See Figure 51c). Yard walls were displaced in Trona and Ridgecrest resulting in fall over of walls (see Figure 51d). There have been reports of chimney failure in Trona after the **M7.1** event (Figure 51b).

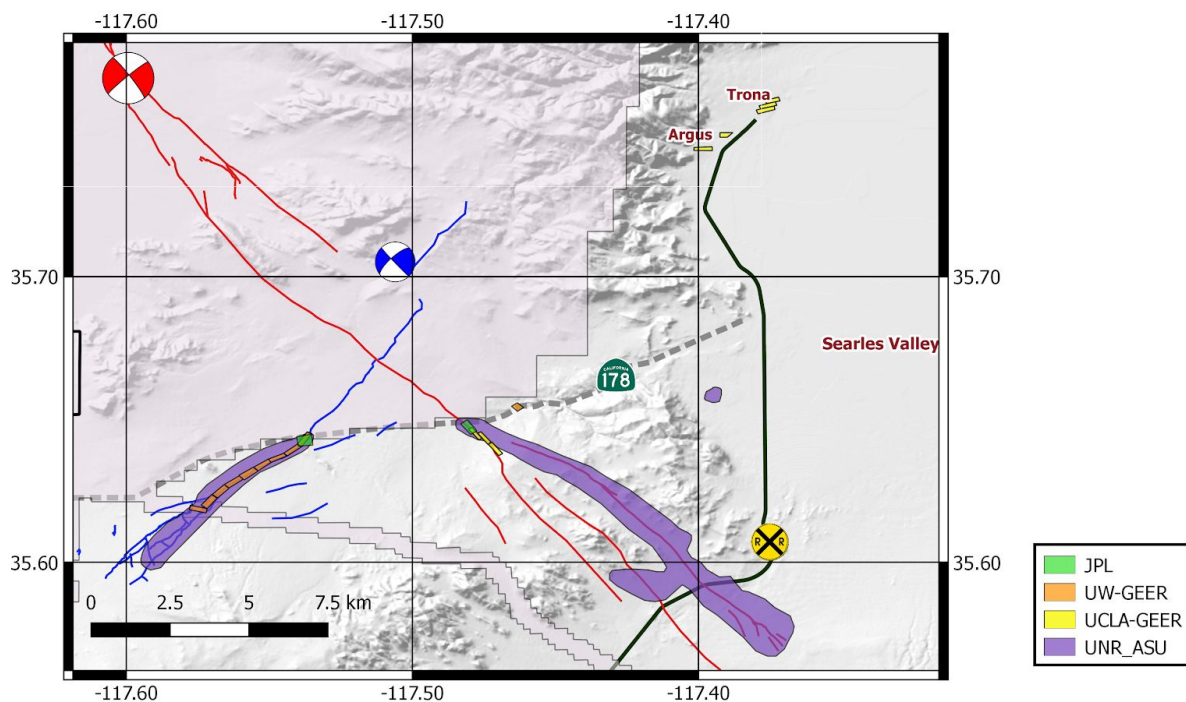
Figure 54. Map of regions imaged by GEER team and collaborators outside of the NAWSCL using UAVs.

UAV imagery outside of the NAWSCL has been completed at the locations shown in Figure 54 by GEER and collaborating organizations (UNR/ASU, JPL, UCLA, and UW Rapid). These deployments had different objectives regarding level of precision and extent of coverage.

Between July 5-8, the UNR/ASU team collected UAV images along the entire publicly accessible areas of the main strands of both the **M6.4** and **M7.1** ruptures south of Highway 178. Low resolution models for the southern part of the **M7.1** rupture have been produced and high resolution models are in process. Due to field issues with the Trimble R10 in the field, ground control points were not collected. It is anticipated that ground control points from the other GEER activities can be incorporated into the models for geo-referencing. The UNR/ASU anticipates producing detailed maps of the ground deformation once high resolution models are completed, and may reimage to evaluate scarp degradation.

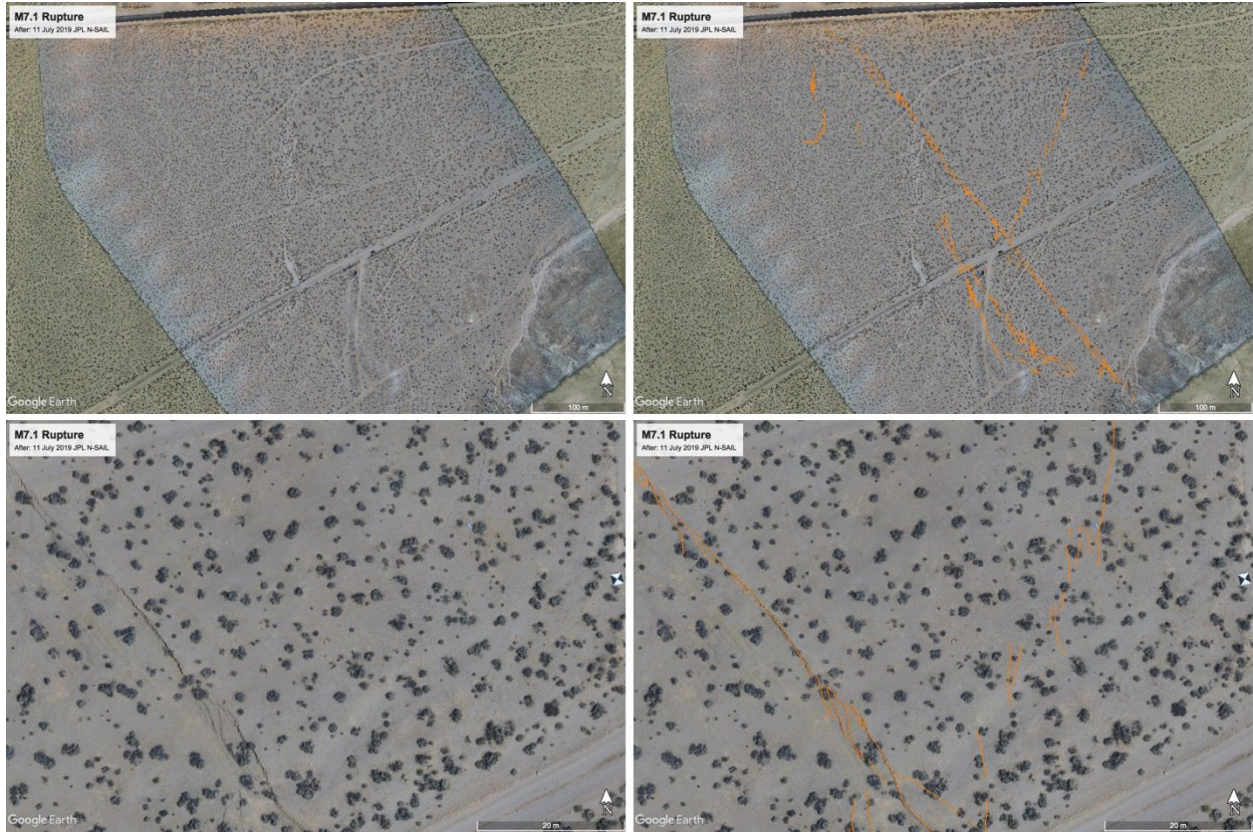
Figure 55. Images showing a portion of the detailed mapping area of the **M7.1** rupture near line B5 as shown on Figure 21. Top row shows images at width of 100 m, bottom row shows zoomed portion of image at width of 20 m. Right side is image with locations of ruptures highlighted. JPL SfM initial image created on July 11 following their UAV flight showing the main fault strands as well as the distributed cracks in the rupture zone.

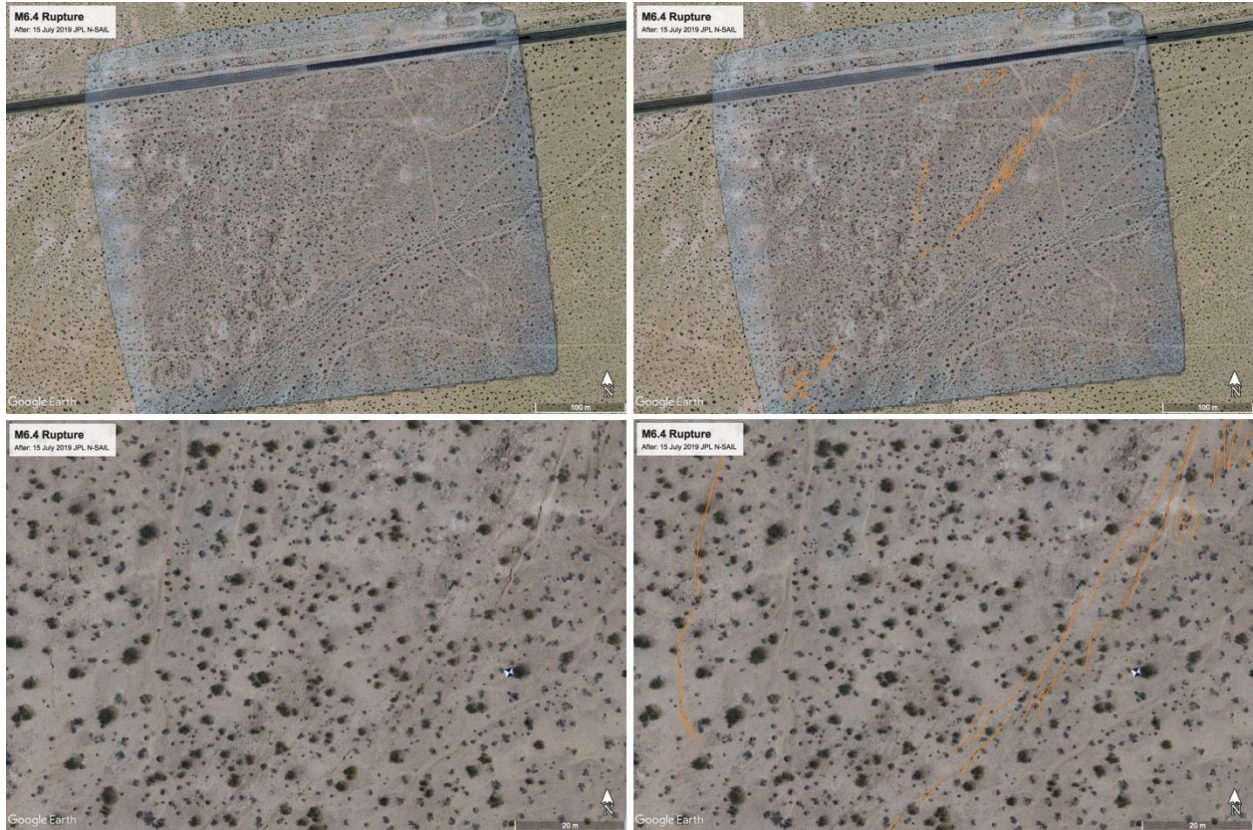
Figure 56. Similar to Figure 55, but for detailed mapping area of the **M6.4** rupture immediately south of Highway 178 at location shown on Figure 25.
