# Capturing the Effects of Liquefaction- Induced Ground Deformation

Jonathan D. Bray, Ph.D., P.E., NAE

Faculty Chair in Earthquake Engineering Excellence  
University of California, Berkeley

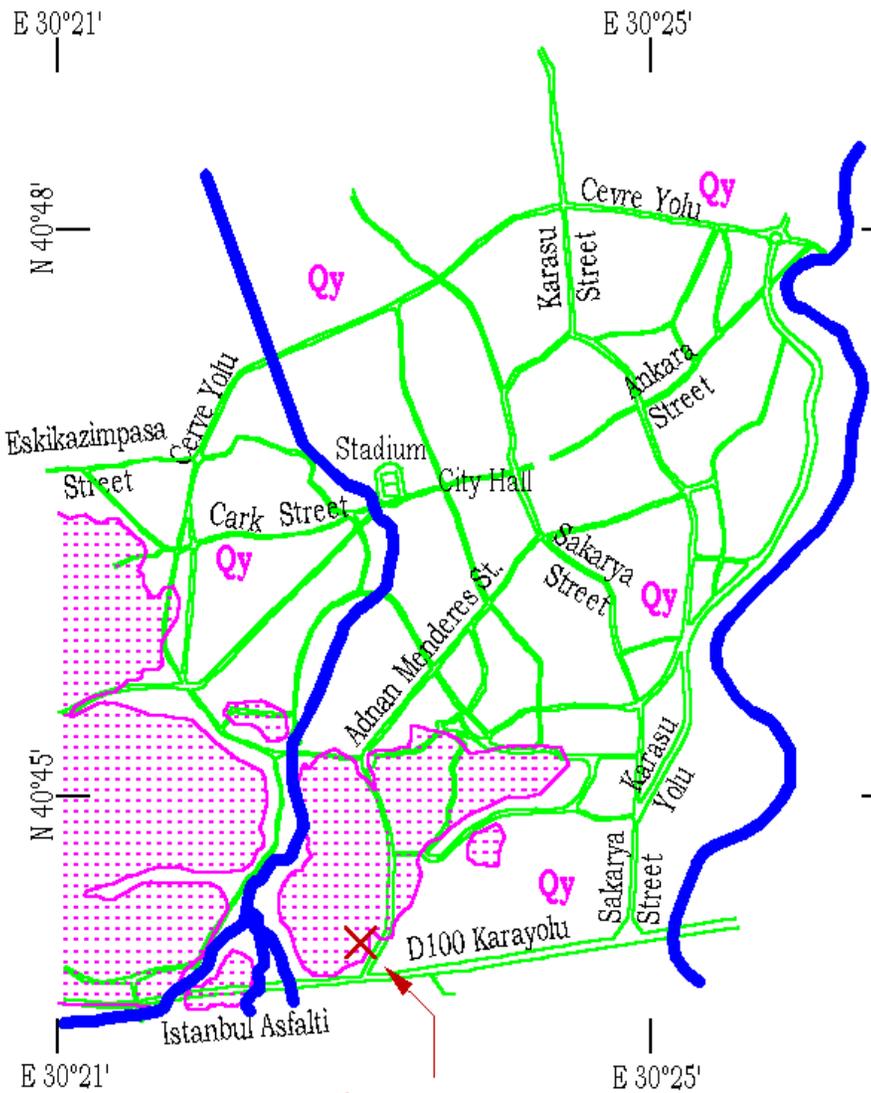
*Sakarya Strong  
Ground Motion Station (PGA = 0.41 g PGV)*

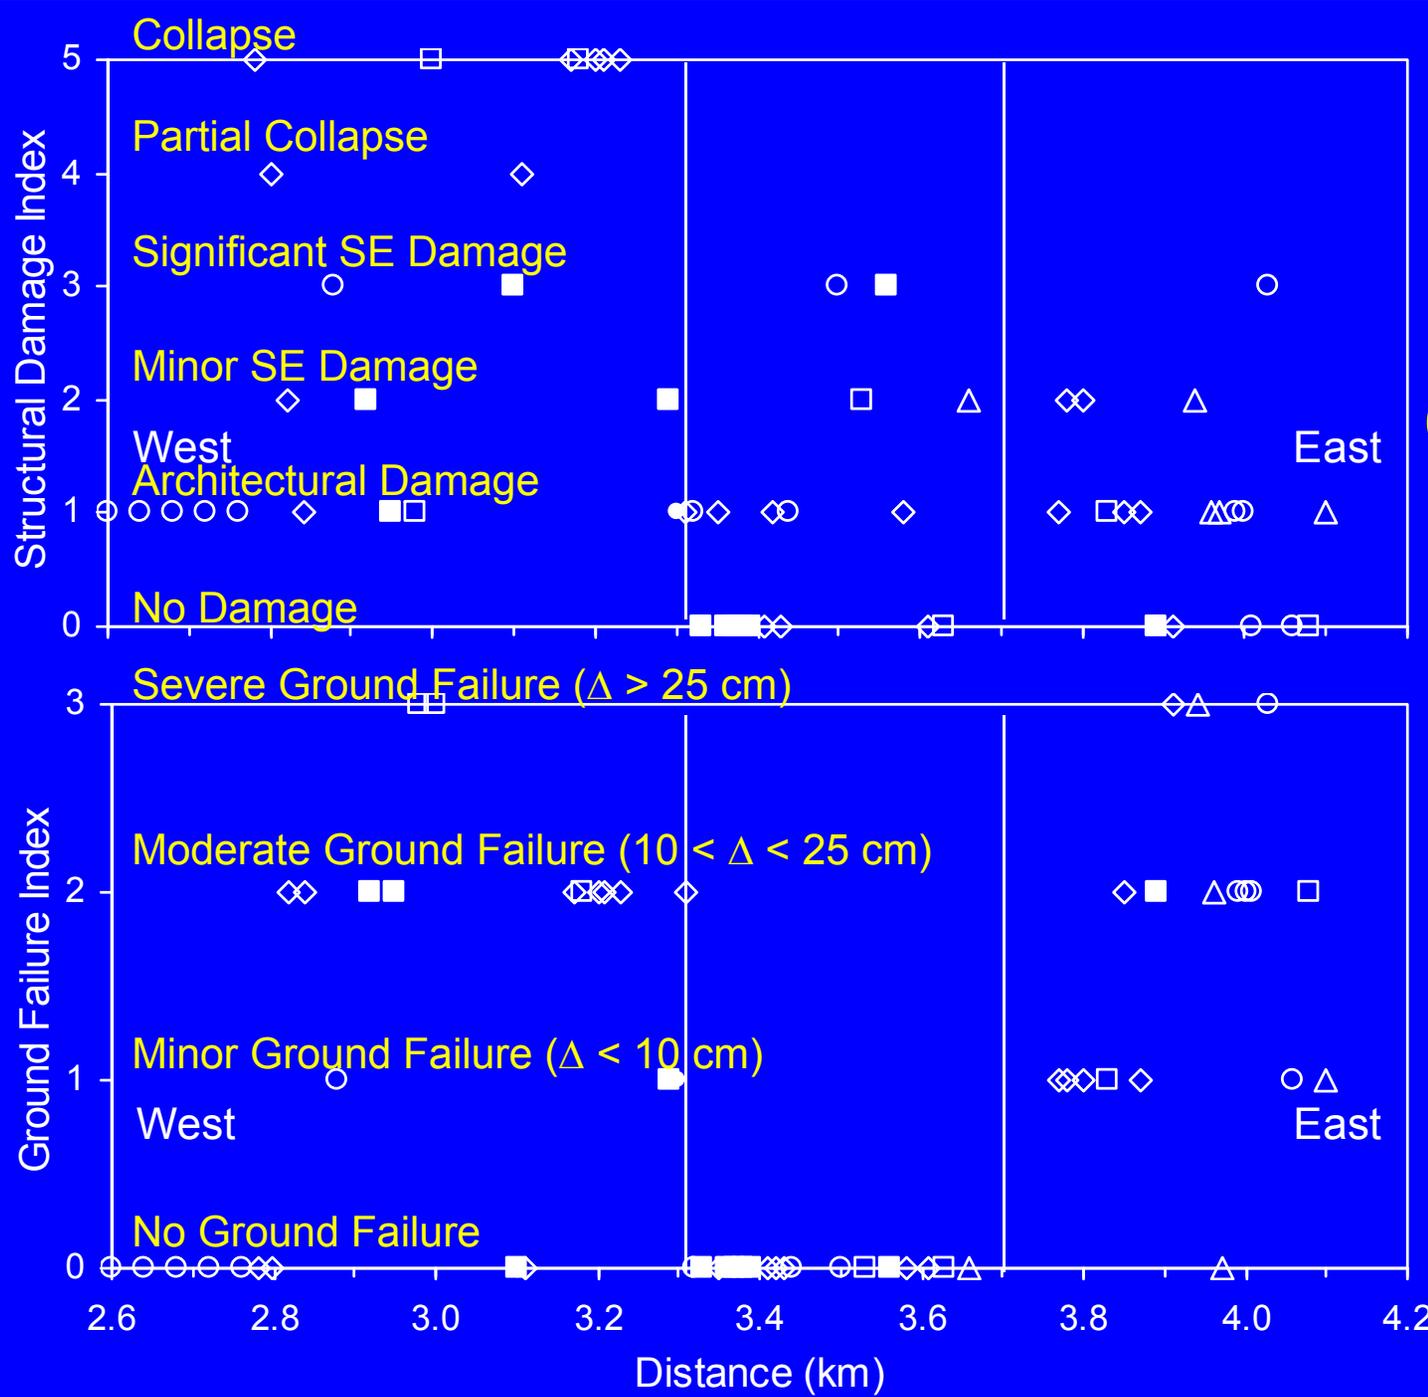
# Damage Distribution along Line 1 (60 Structures)

- 1 Story
- △ 2 Stories
- 3 Stories
- 4 Stories
- ◇ 5 Stories
- 6 Stories

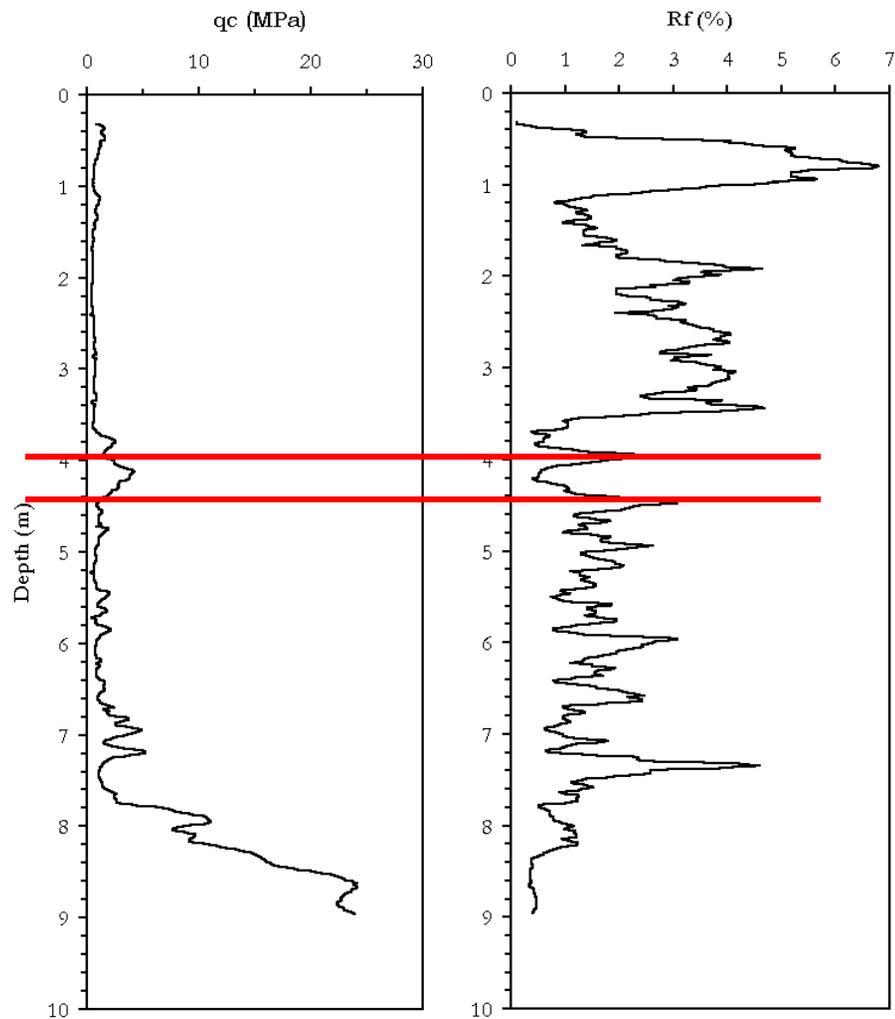
## Fieldwork in Adapazari (Bray et al. 2004)

Depth Scale (m)	Lithology	USCS	Sample Type and No.	Recovery/Length (cm)	SPT Blows / 15 cm	Casing Depth (m)	Rod Length (m)	Energy Ratio (%)	Description
0									ASPH: Asphalt of Yakin Street.
0									Fill
1	ML/CL	S-A2-1	28/45	1-2-1	-	2.60	37		
2	ML	S-A2-2	42/45	1-2-2	-	4.13	53		ML: Brown clayey silt to silty clay with some red oxidation points and some fine sand
3	CH/MH	SH-A2-3	42/42		2.55	-	-		CH: Brown high plasticity silty clay to clayey silt. Some fine to medium sand in a silty clay matrix was observed in the wash water
4	CL/CH	S-A2-4	40/45	2-1-1	3.35	5.65	52		
5	ML	S-A2-5	28/45	2-3-4	4.15	5.65	65		ML: Brown/gray clayey silt with traces of fine sand
6	CL	SH-A2-6	42/42		4.95	-	-		CH: Gray silty clay of medium to high plasticity. Sticky to the fingers. Softens when remoulded
7	MH/CH	S-A2-7	39/45	1-1-2	5.95	7.17	65		
8	ML	S-A2-8	32/45	3-5-8	6.95	8.70	60		ML: Gray clayey silt with some fine sand
9	SP-SM	S-A2-9	38/45	12-20-16	8.45	10.22	61		SP-SM: Poorly graded gray fine sand with silt. Gravel content ~ 8% in sample S-A2-10

10	SP-SM	S-A2-10	38/45	7-10-15	9.95	11.45	-

**166 CPT/SCPTu & 61 BORINGS with SPT**

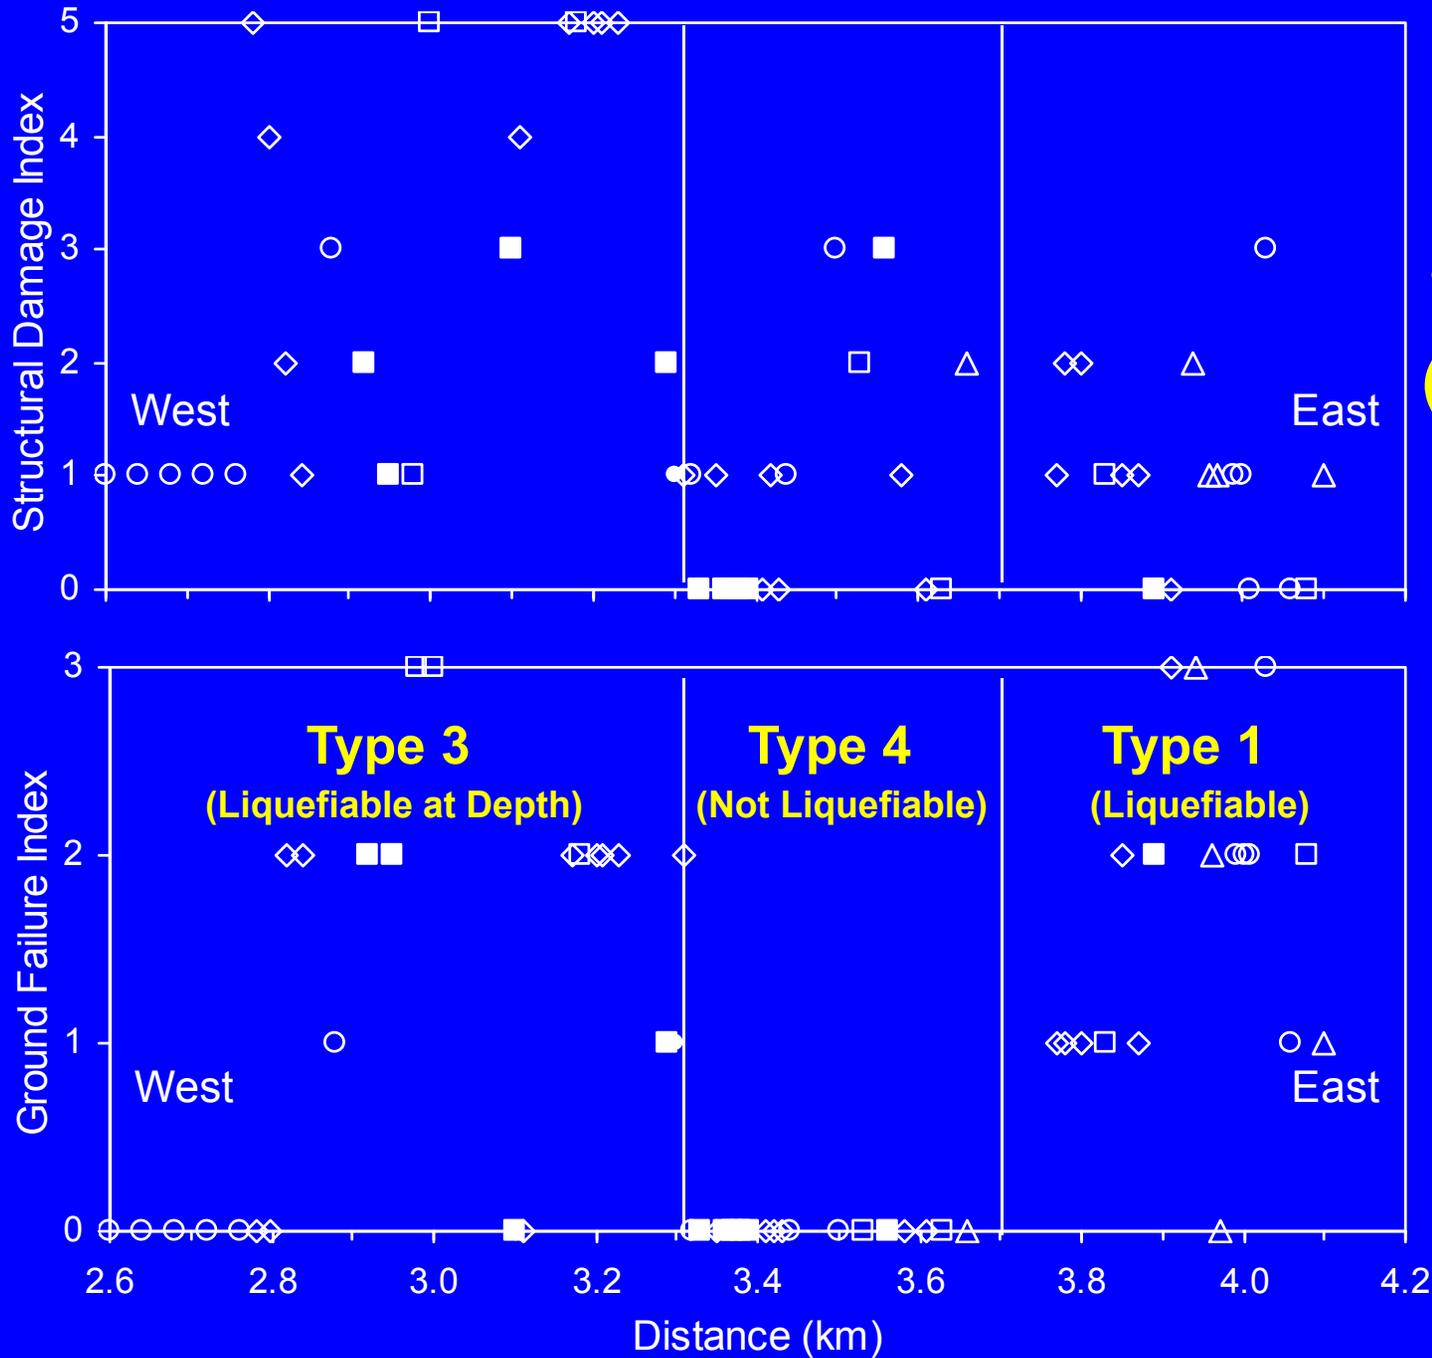
# Damage Distribution along Line 1 (60 Structures)

Bray & Stewart 2000

- 1 Story
- △ 2 Stories
- 3 Stories
- 4 Stories
- ◇ 5 Stories
- 6 Stories

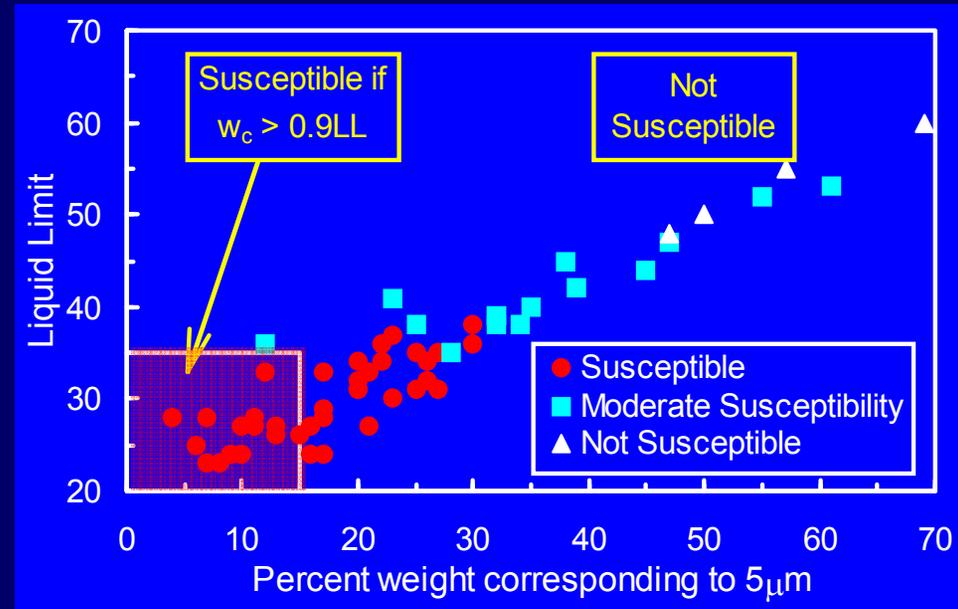
## Chinese Criteria

(Seed and Idriss 1982  
in Youd et al. 2001)

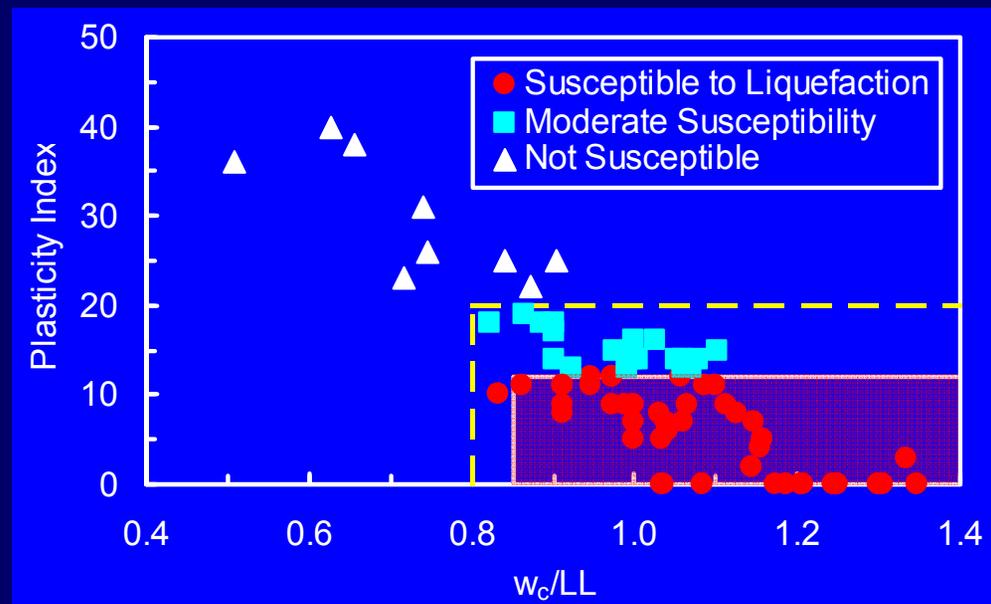
## PI & $w_c/LL$ Criteria

(Bray & Sancio 2006)

**Susceptible:**

$$PI \leq 12 \text{ \& } w_c/LL \geq 0.85$$

**Moderate Susceptibility:**

$$w_c/LL > 0.8 \text{ \& } 12 < PI \leq 20$$

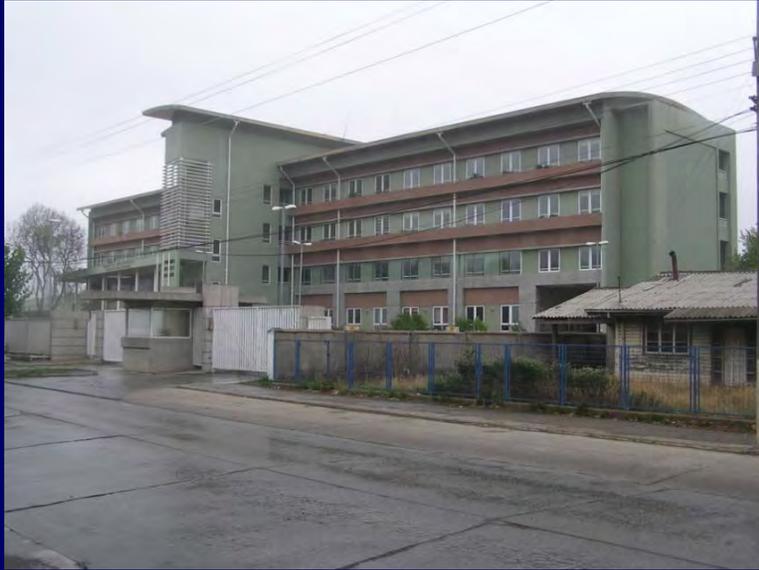
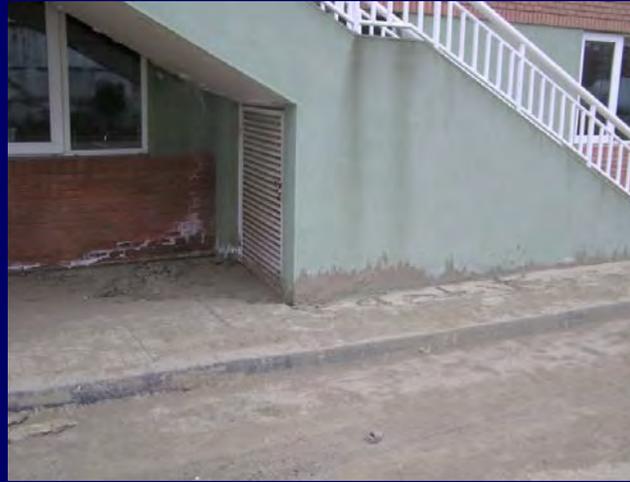
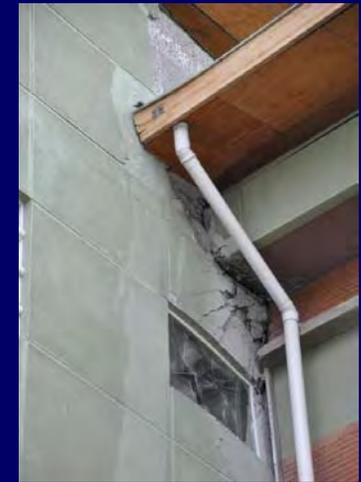
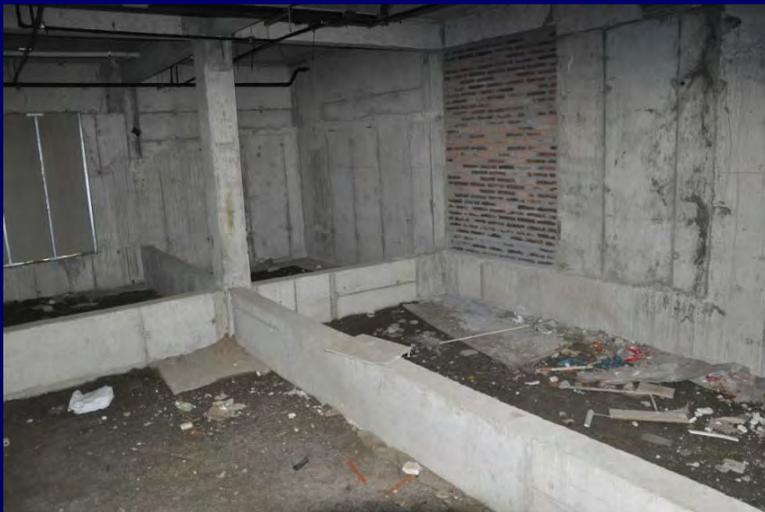
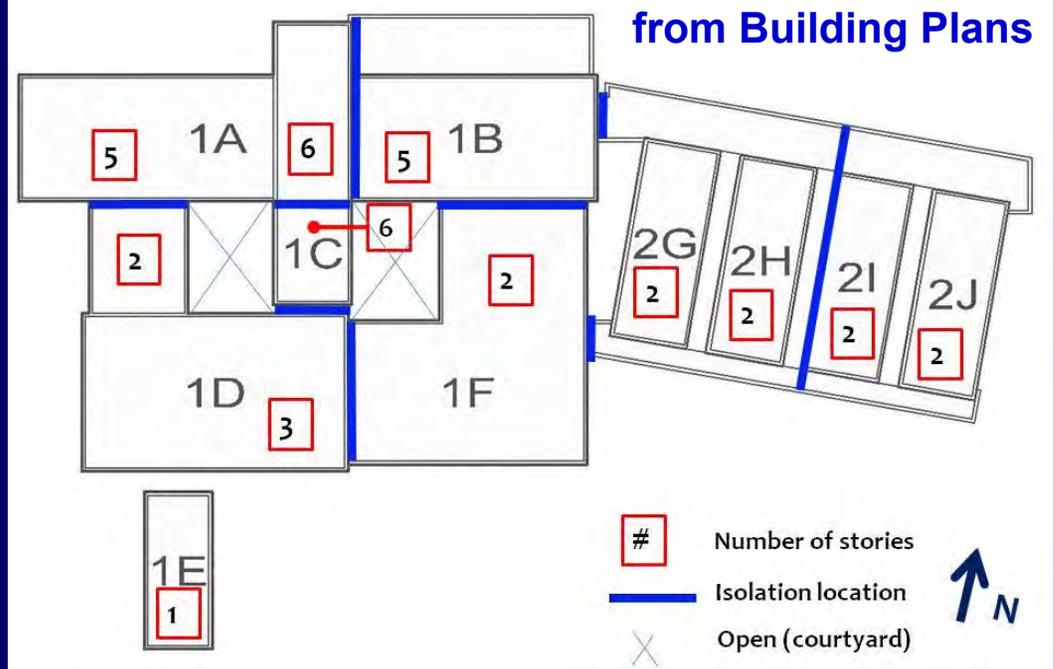
## Hospital in Curanilahue

# Effects of Ground Failure on Buildings – 2010 Chile EQ ( $M_w = 8.8$ )

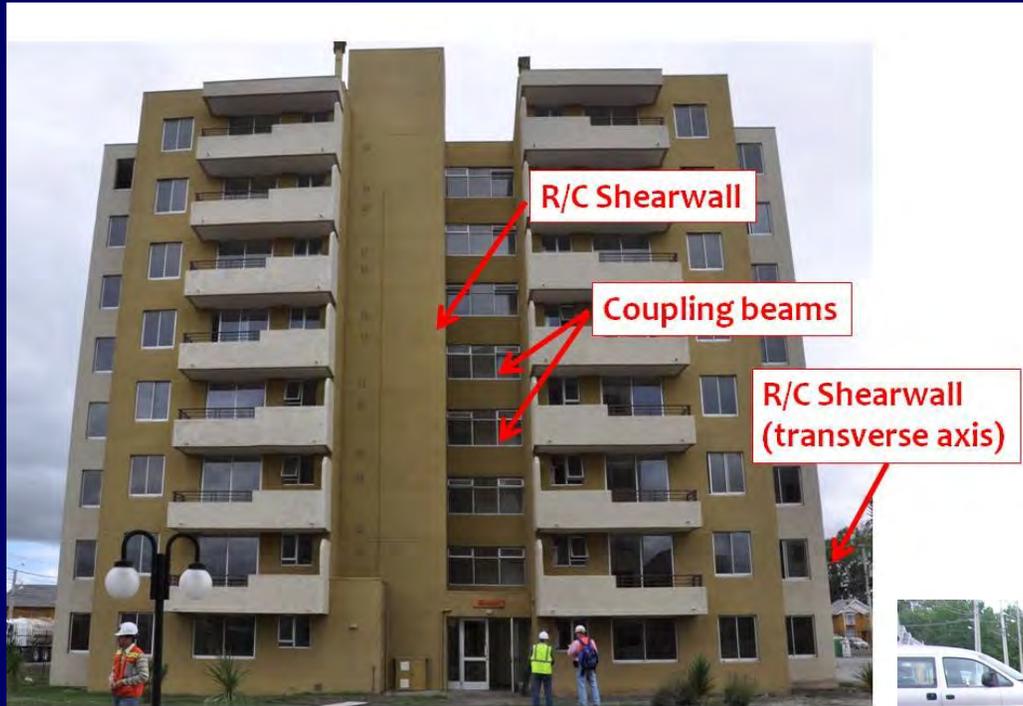
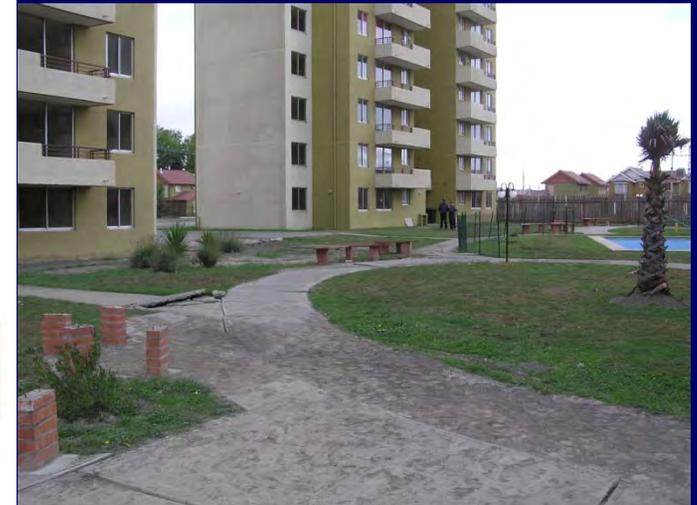
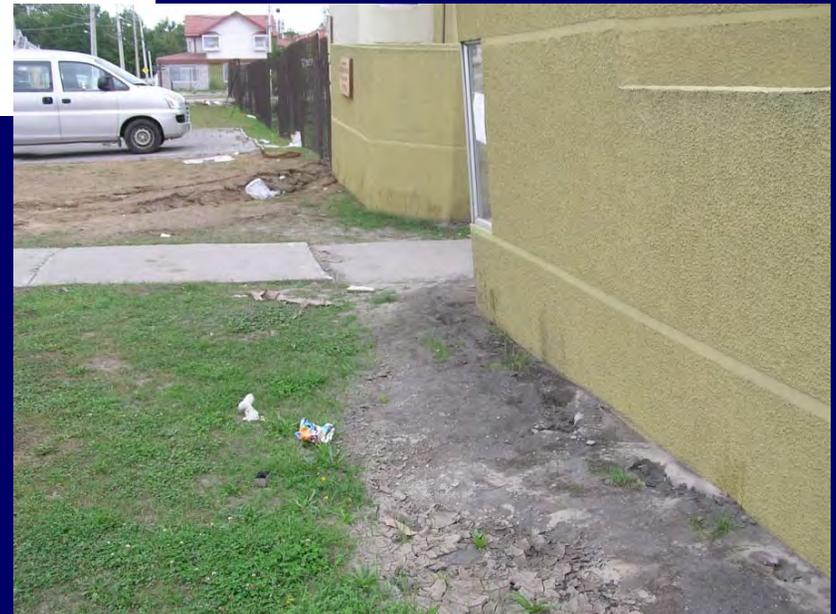
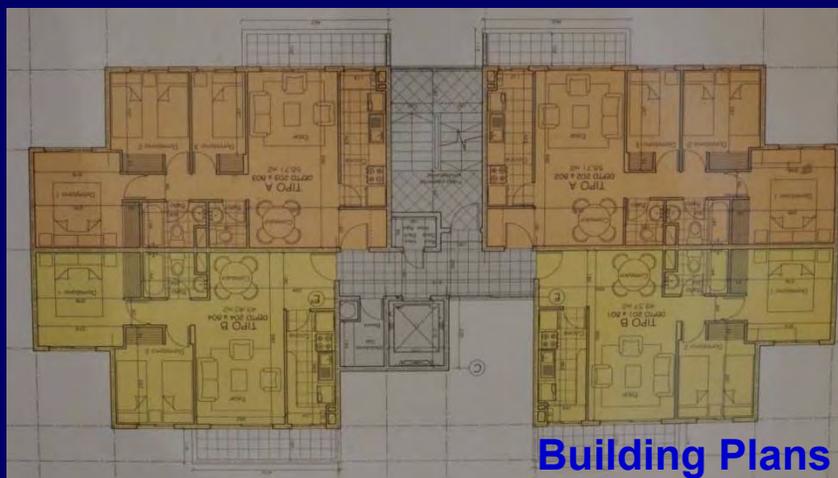
## Four 8-Story Condominiums, Concepcion

# Effects of Ground Failure on Buildings – 2010 Chile EQ

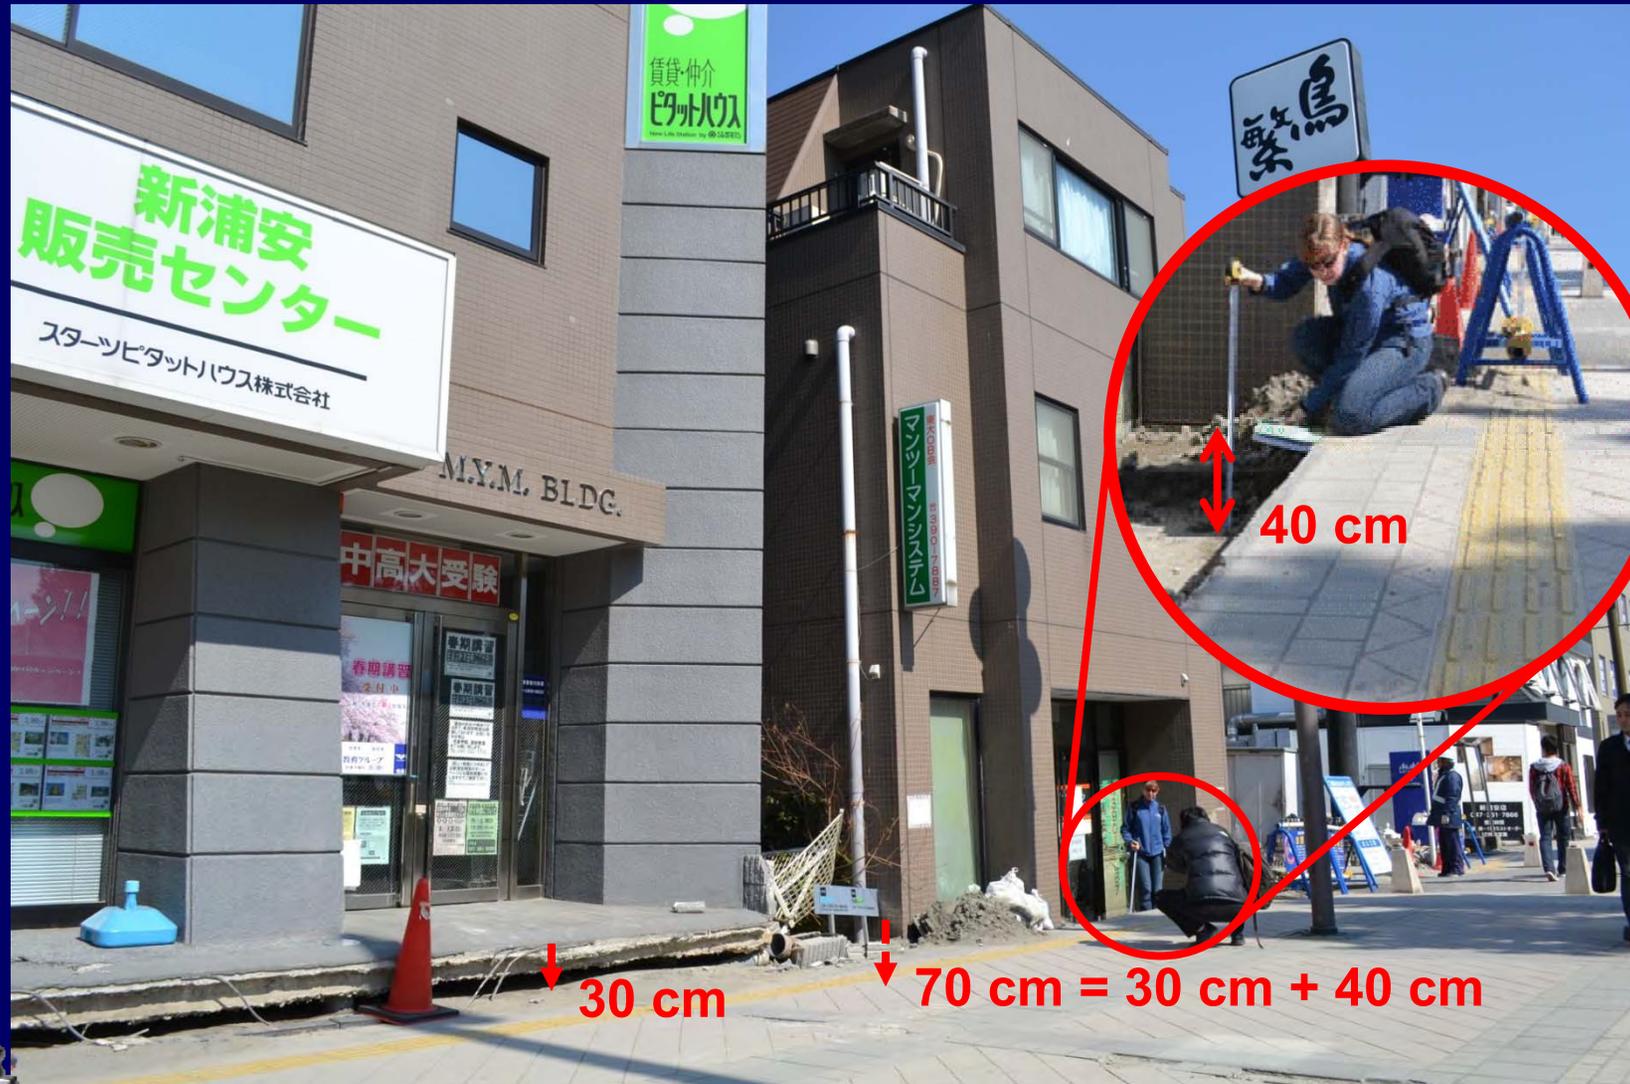
# Liquefaction-Induced Building Movements

2011 Tohoku, Japan EQ ( $M_w = 9.0$ )

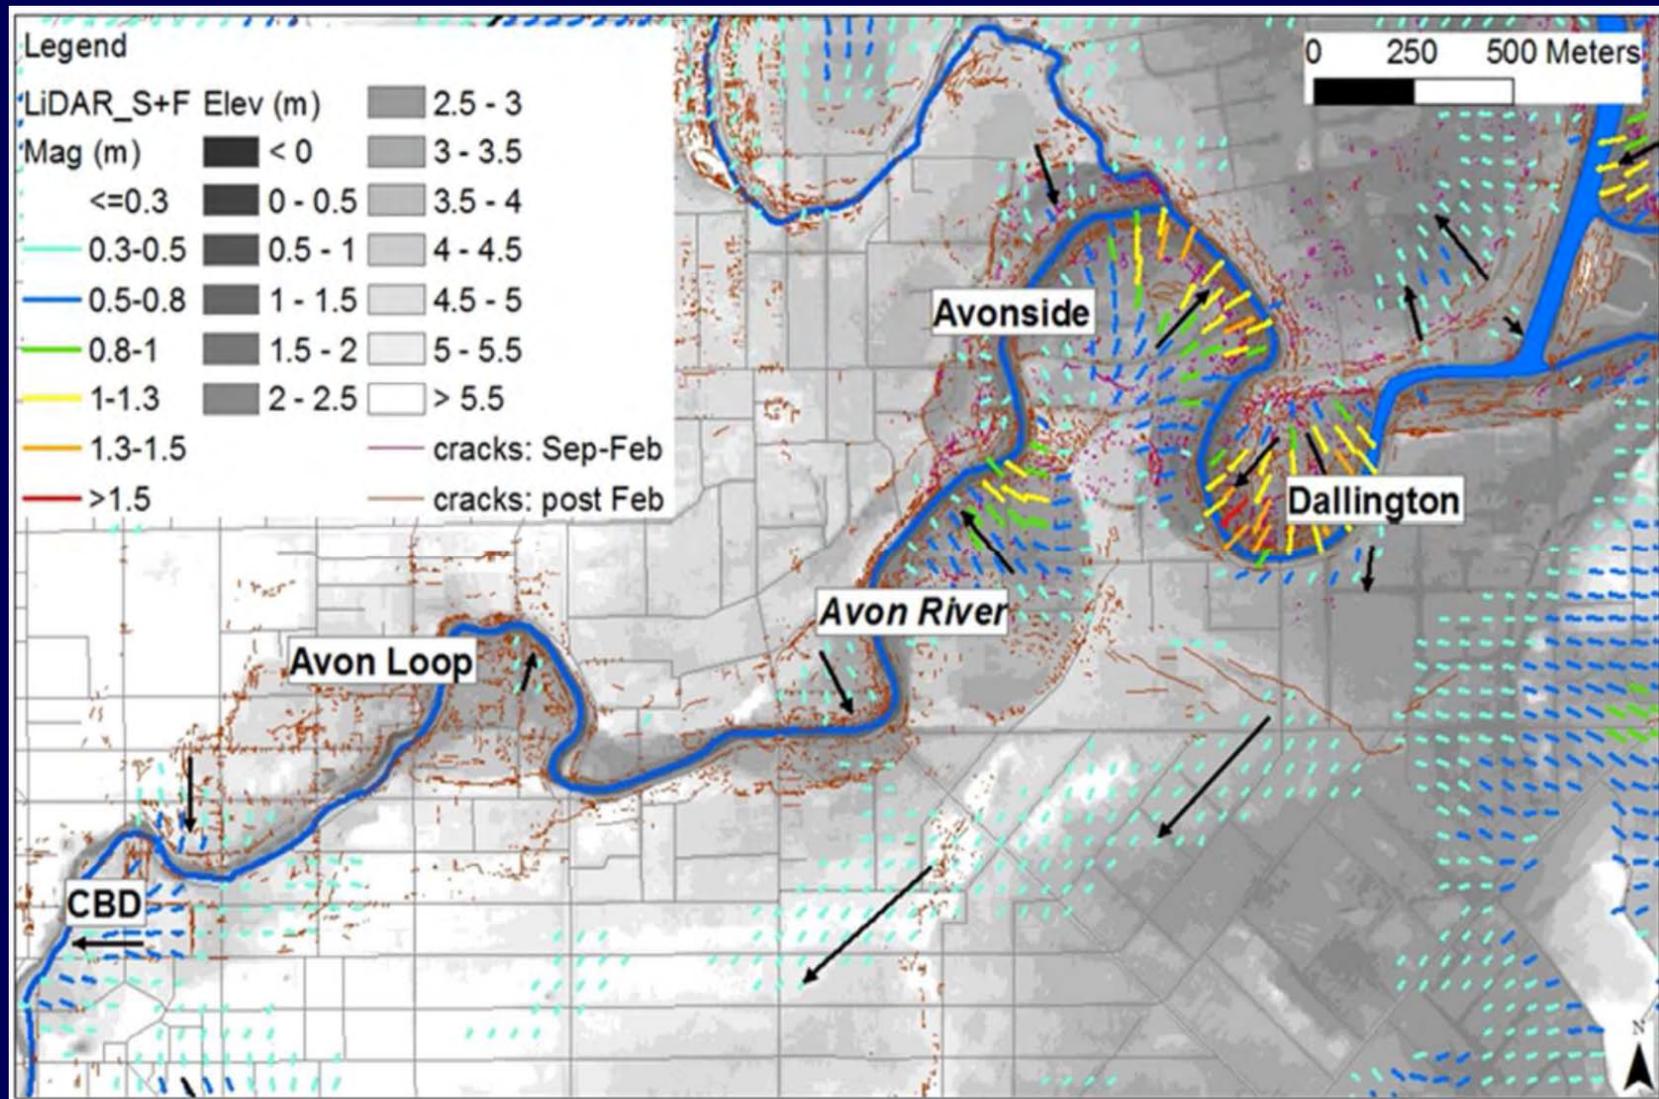
# Permanent Ground Displacements (LiDAR)

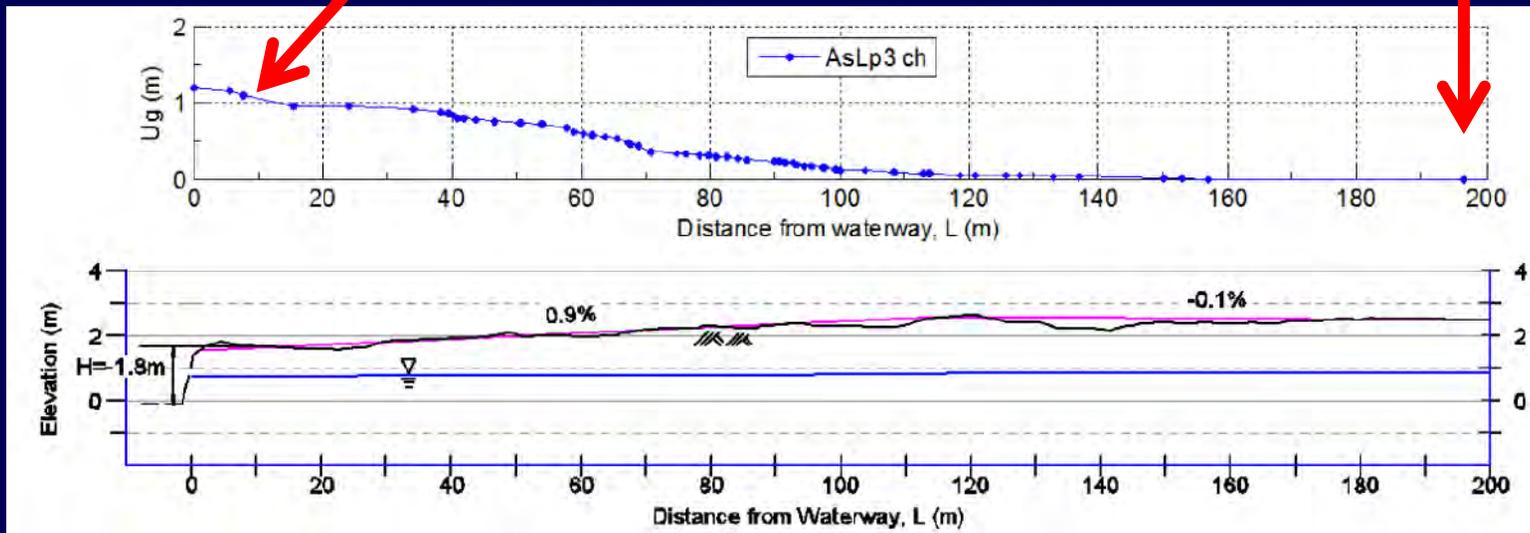
# Ground Surveying Measurements (GSM)

Displacement relative to the reference point

Reference point

Captures details of local spreading features within 150 m (200 m) from the river.

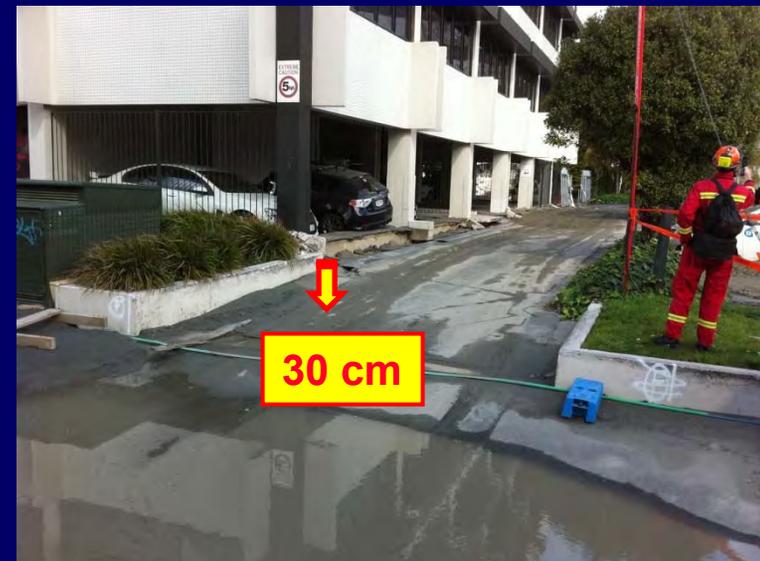
Tilting and Sliding of Buildings

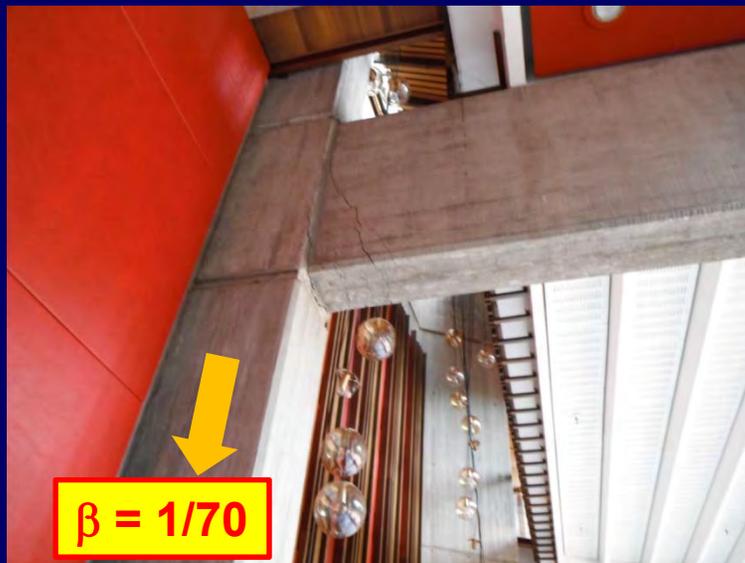
Settlement of Ground next to Piled Bldg.

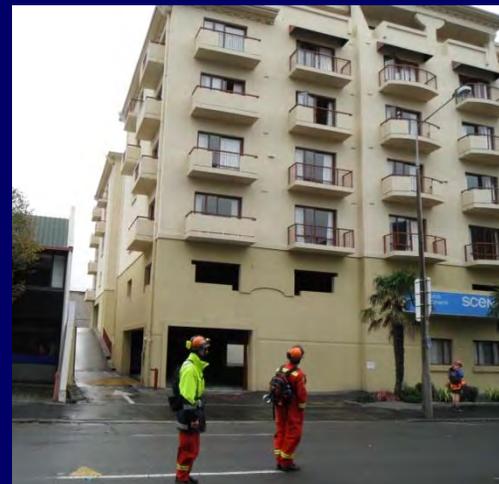
Cracking due to Differential Settlement

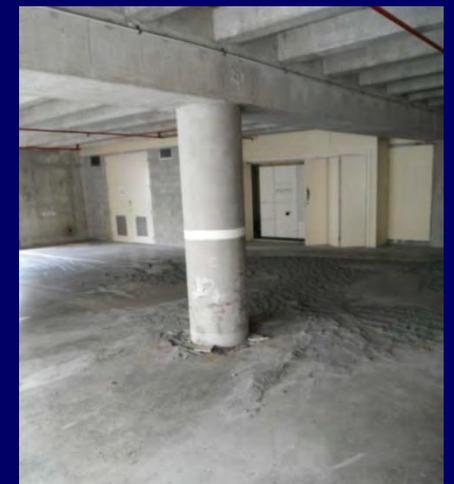
Uniform Settlement of Building

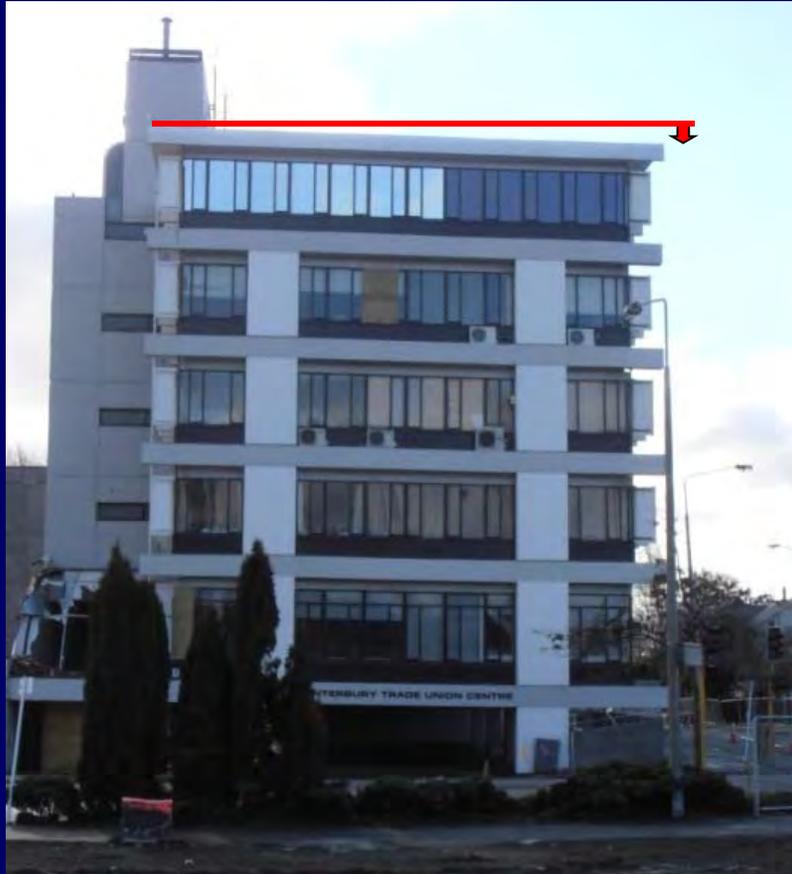
# CTUC Building

Liquefaction-Induced Differential Settlement Induces Distress

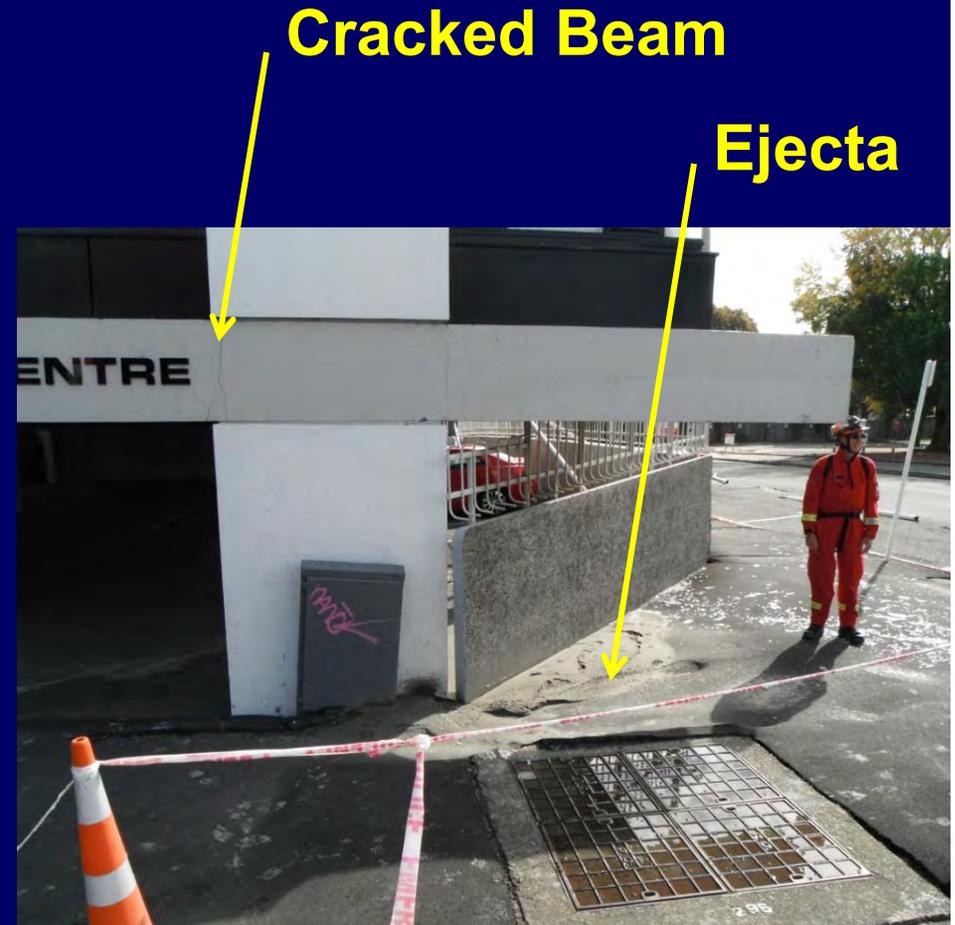
Building Settlement

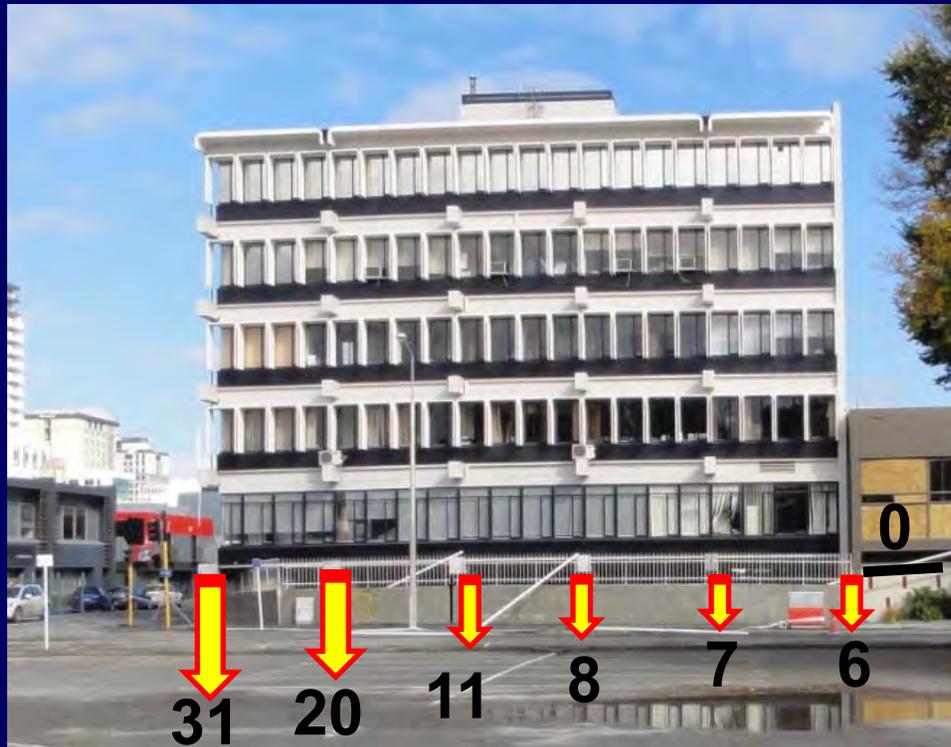
## Liquefaction-Induced Differential Settlement

**Building Settlement (cm)**  
Maximum Angular Distortion  $\approx 1/50$

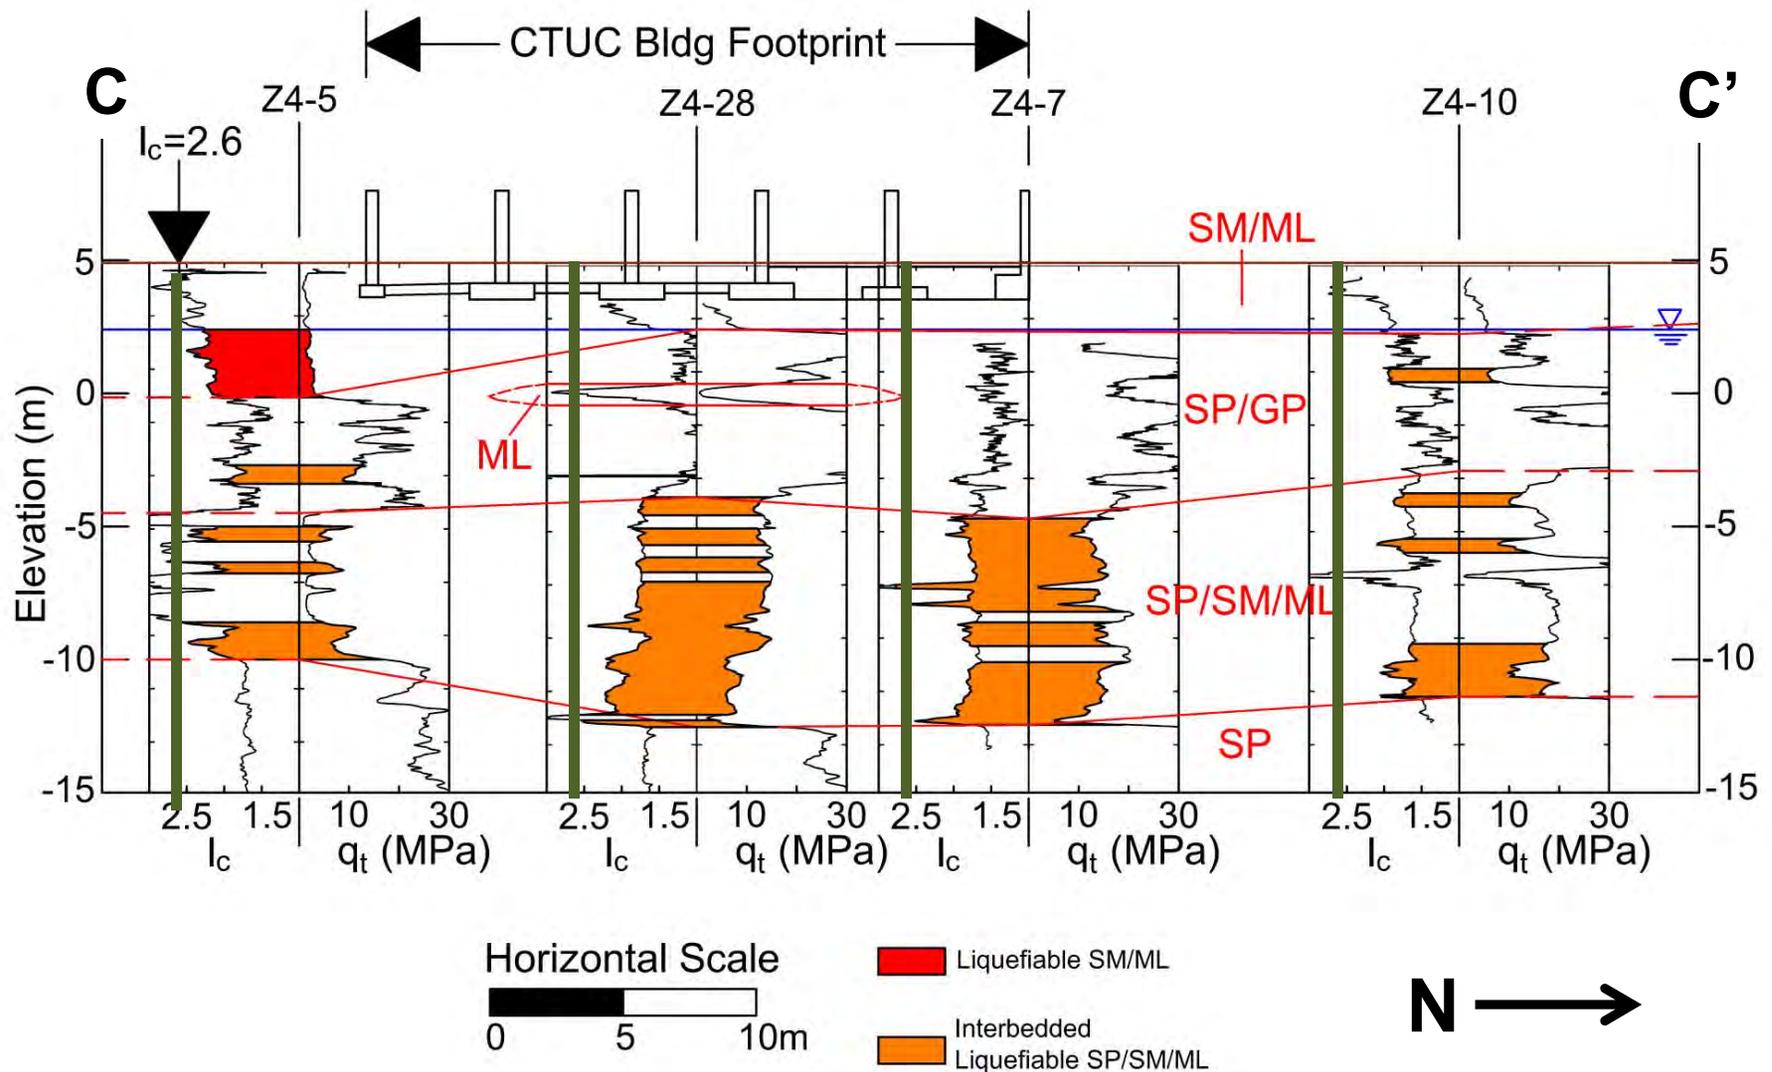
# CTUC Building: Christchurch EQ

2011 Christchurch EQ: Robertson & Wride (1998)

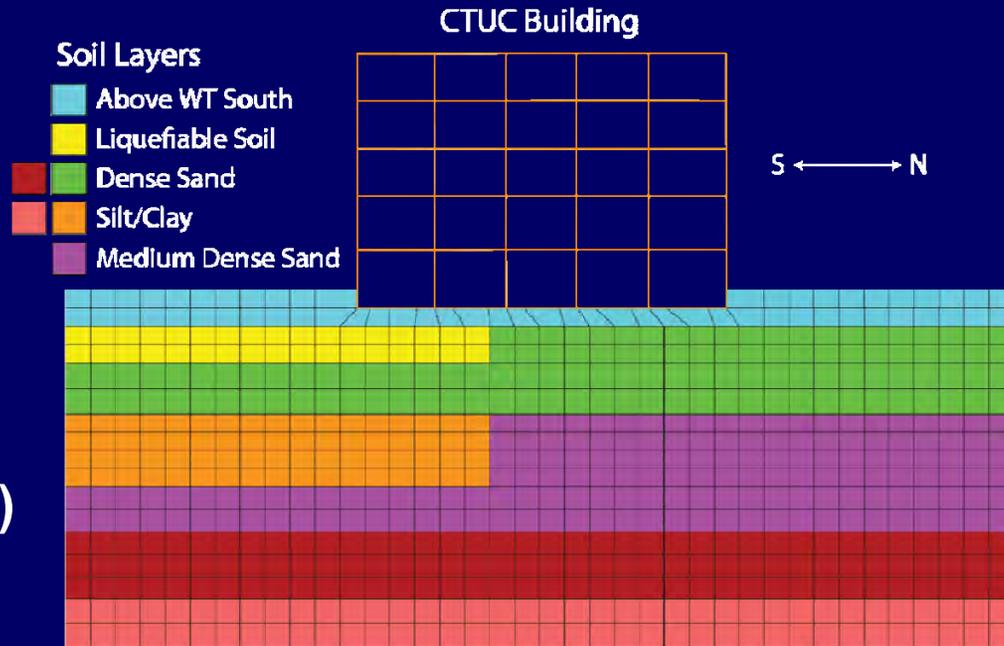
# SSI Analyses of CTUC Building

FLAC Analyses  
with PM4Sand  
(Luque & Bray 2017)

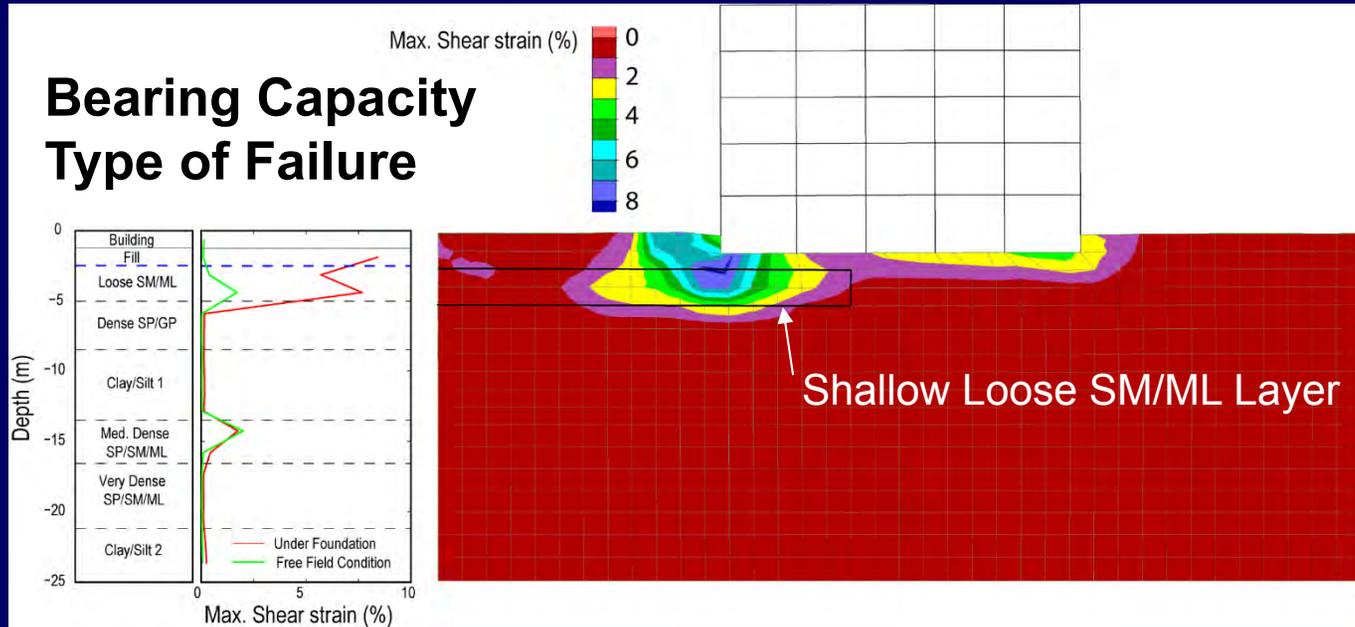
## Bearing Capacity Type of Failure
