# Capturing the Effects of Liquefaction- Induced Ground Deformation

Jonathan D. Bray, Ph.D., P.E., NAE

Faculty Chair in Earthquake Engineering Excellence  
University of California, Berkeley

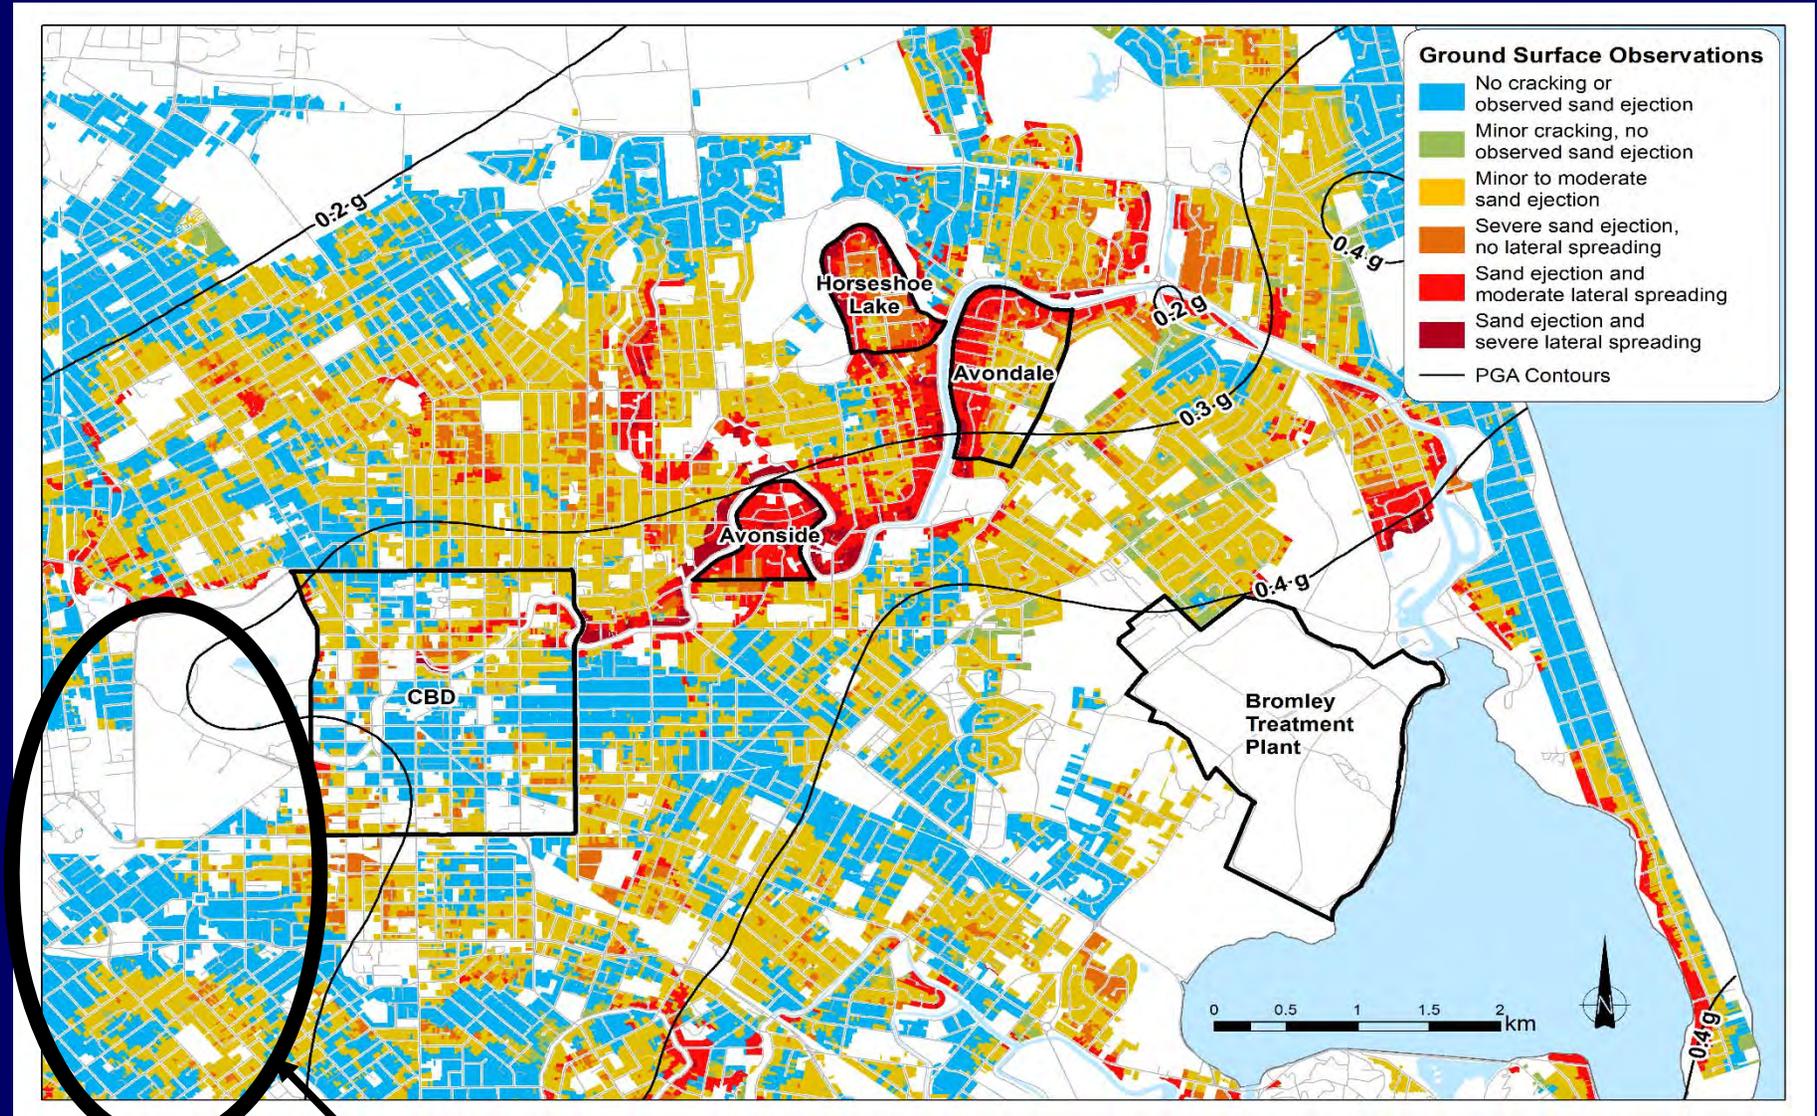
# Liquefaction in Christchurch

**Relative lack of liquefaction**

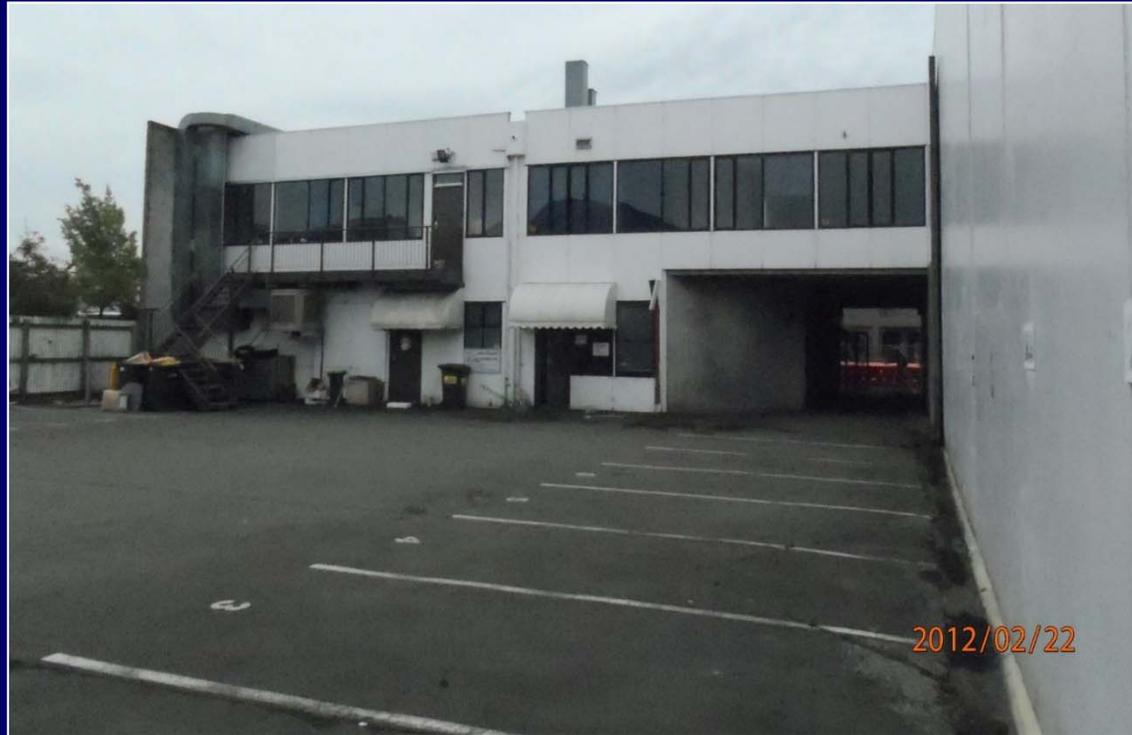
## Site 23

# Non-Liquefaction of Silty Soil Sites

site where no liquefaction effects were observed;  
yet simplified procedures indicate liquefaction was expected

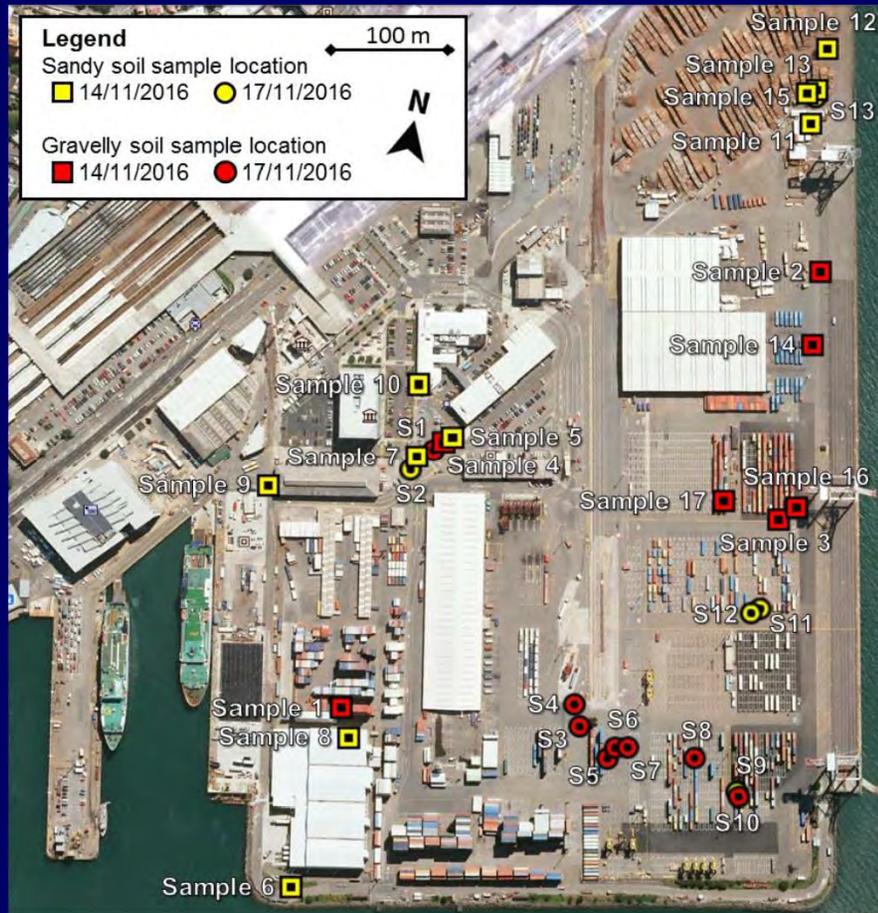
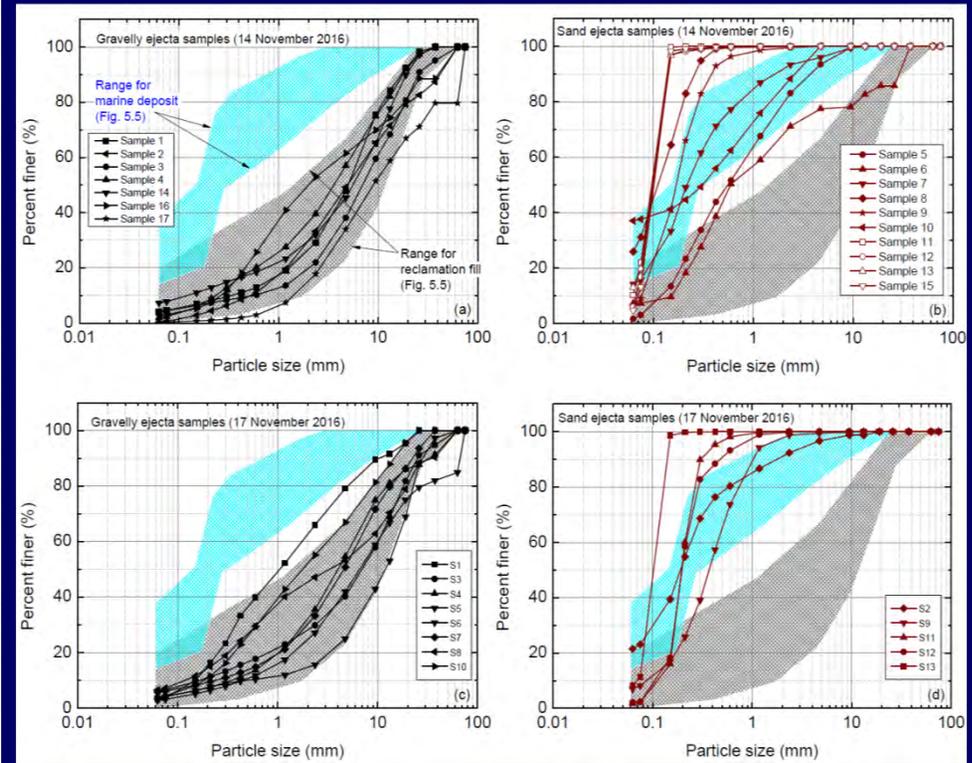
## Documenting Sediment Ejecta

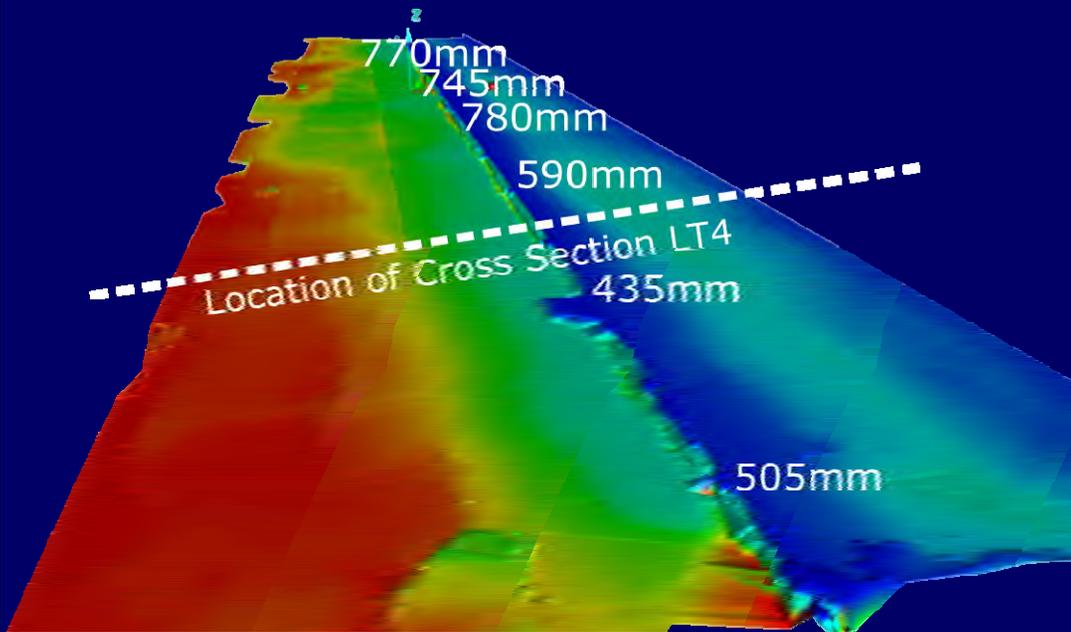
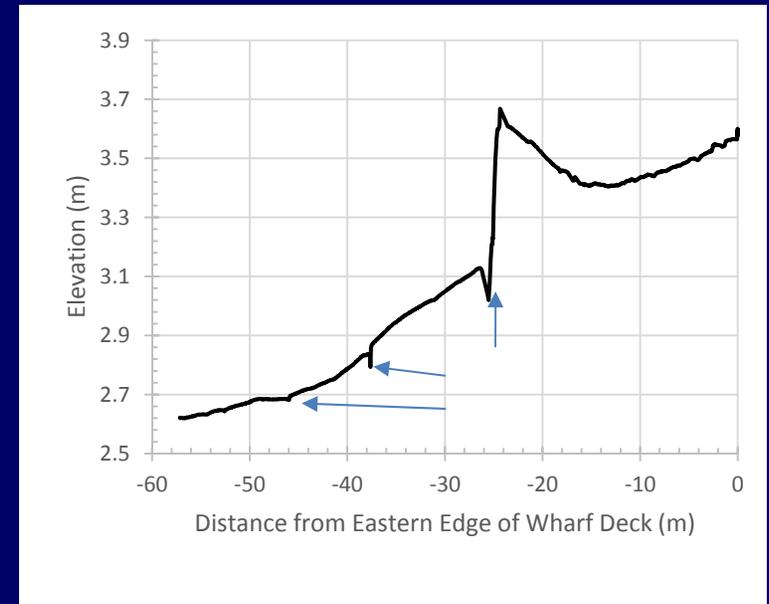
## Ground Survey – LiDAR (M. Olsen OSU)

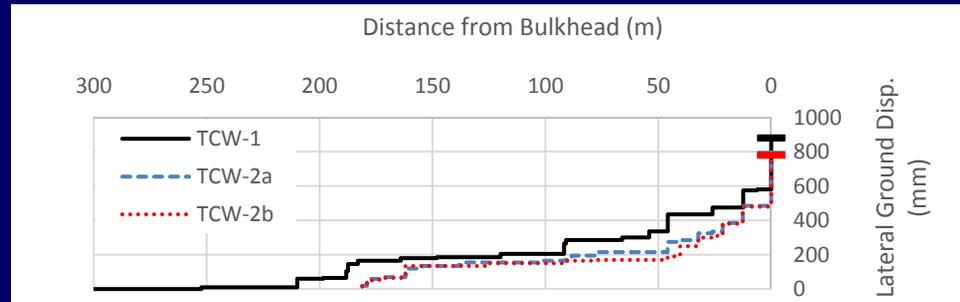
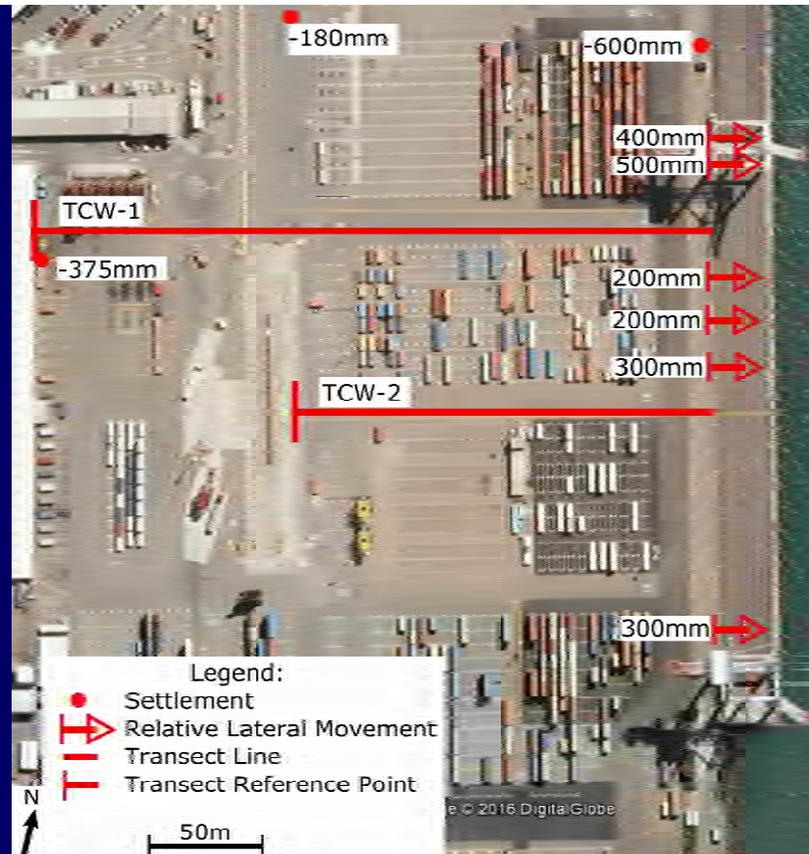
## Ground Surveys of Liquefaction-Induced Lateral Movements

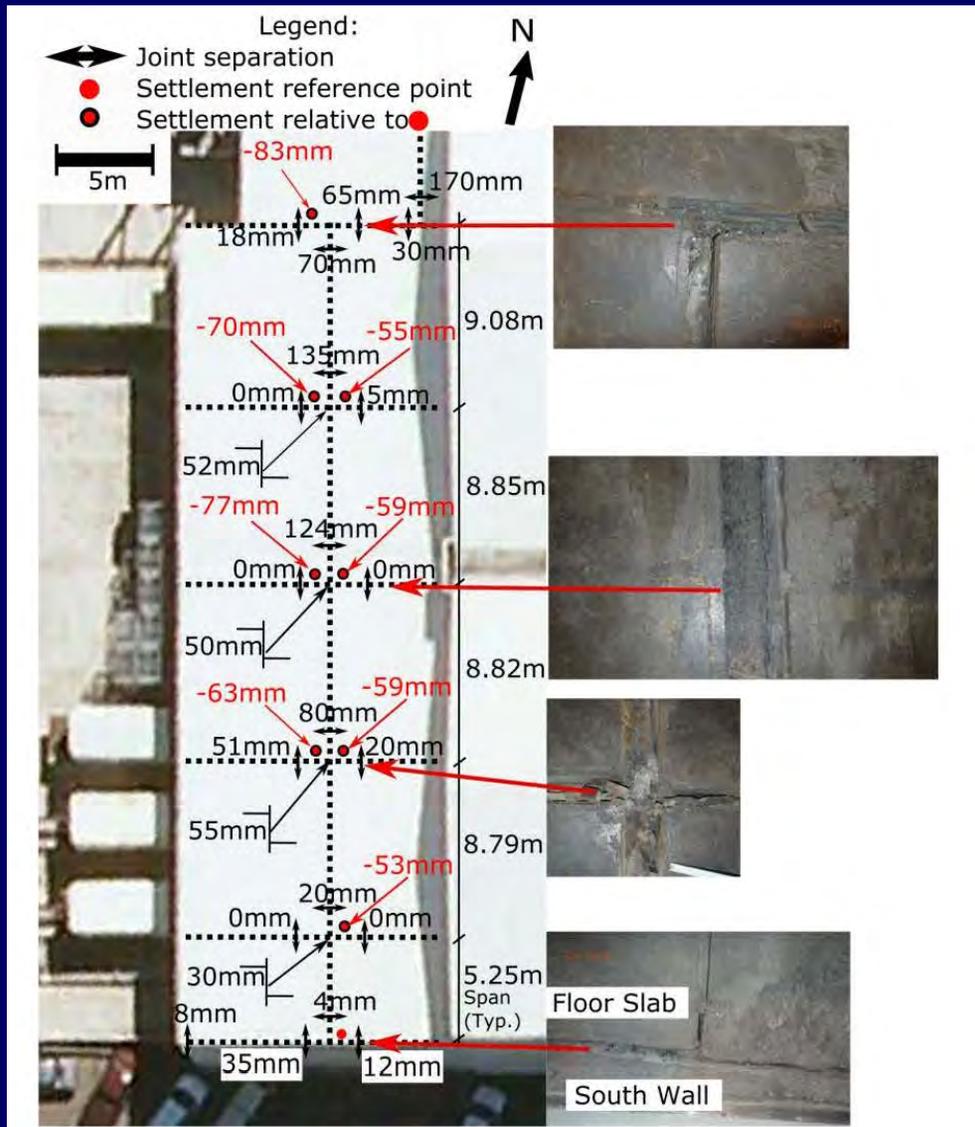
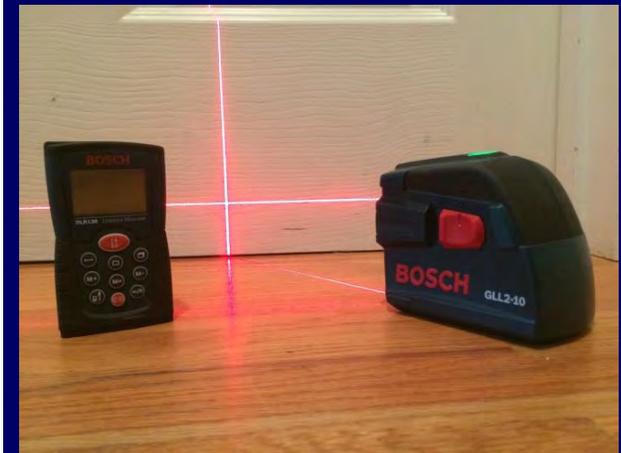
## Documenting Liquefaction-Induced Building Damage

survey by Bray & de la Torre
