# The Future of Seismic Geo-Forensics

J. David Frost, Ph.D., P.E., P.Eng.  
Georgia Institute of Technology

# PSoft™ Overview

# PQuake™ Overview

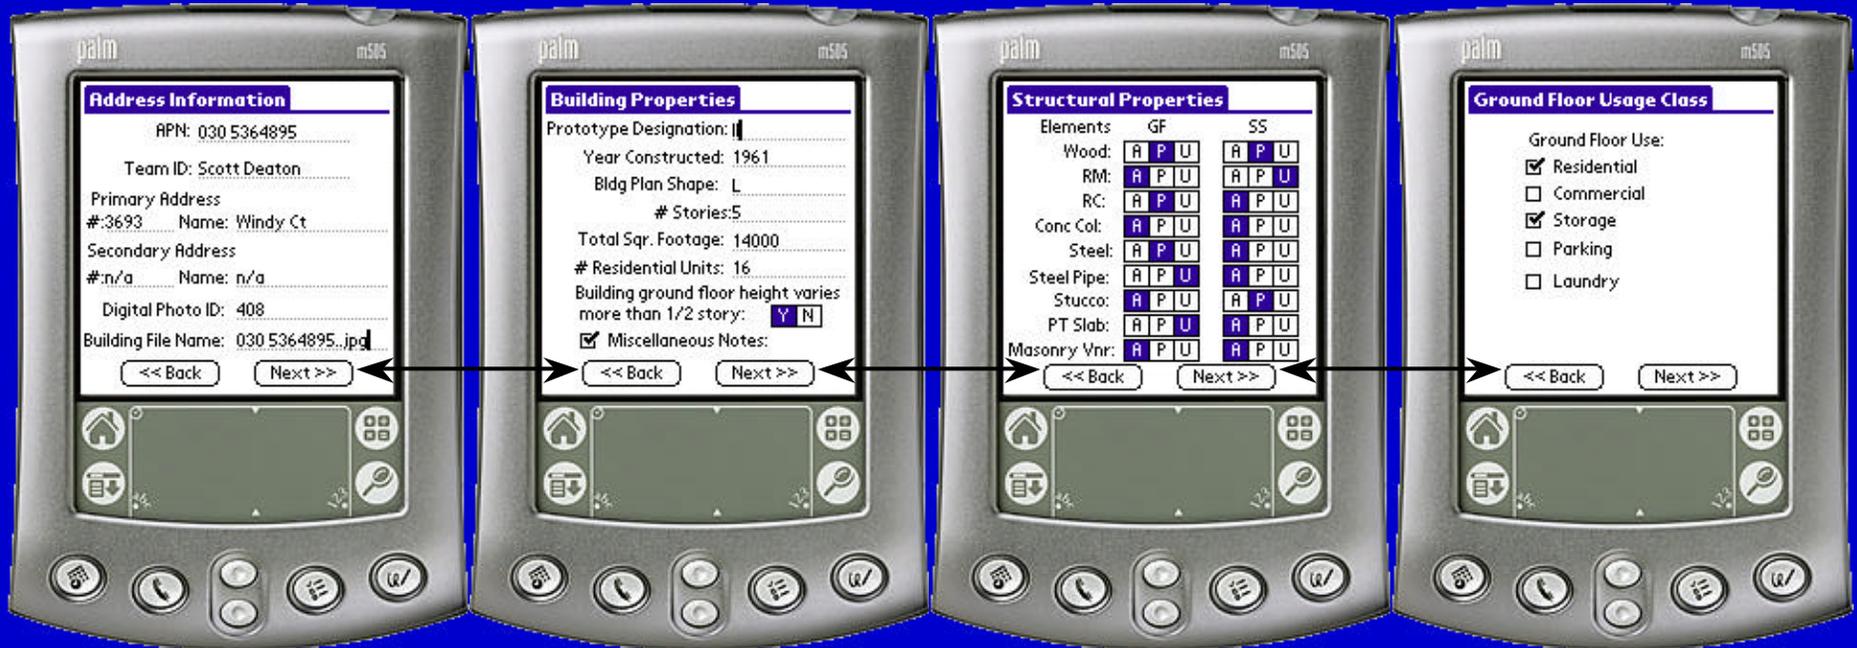
# PSoft™ Example

- Utilized for rapid pre-event screening of buildings with a potential soft story for municipal program.
- Software based on a form that city engineers created
- Types of data recorded
  - Building/structure properties
  - Usage (know where to search for survivors)
  - Vulnerabilities
  - Possible solutions/retrofit
- Upload field data into Access database

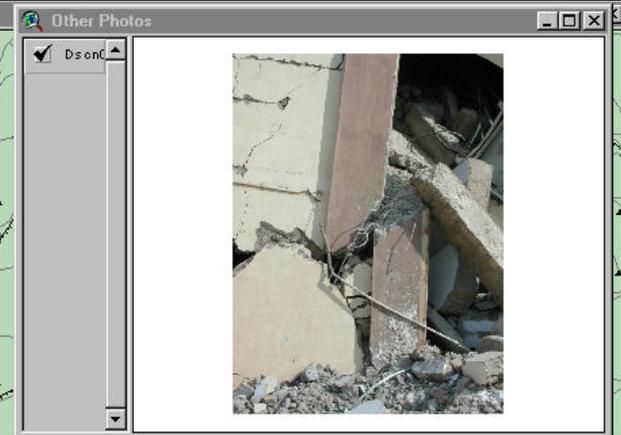
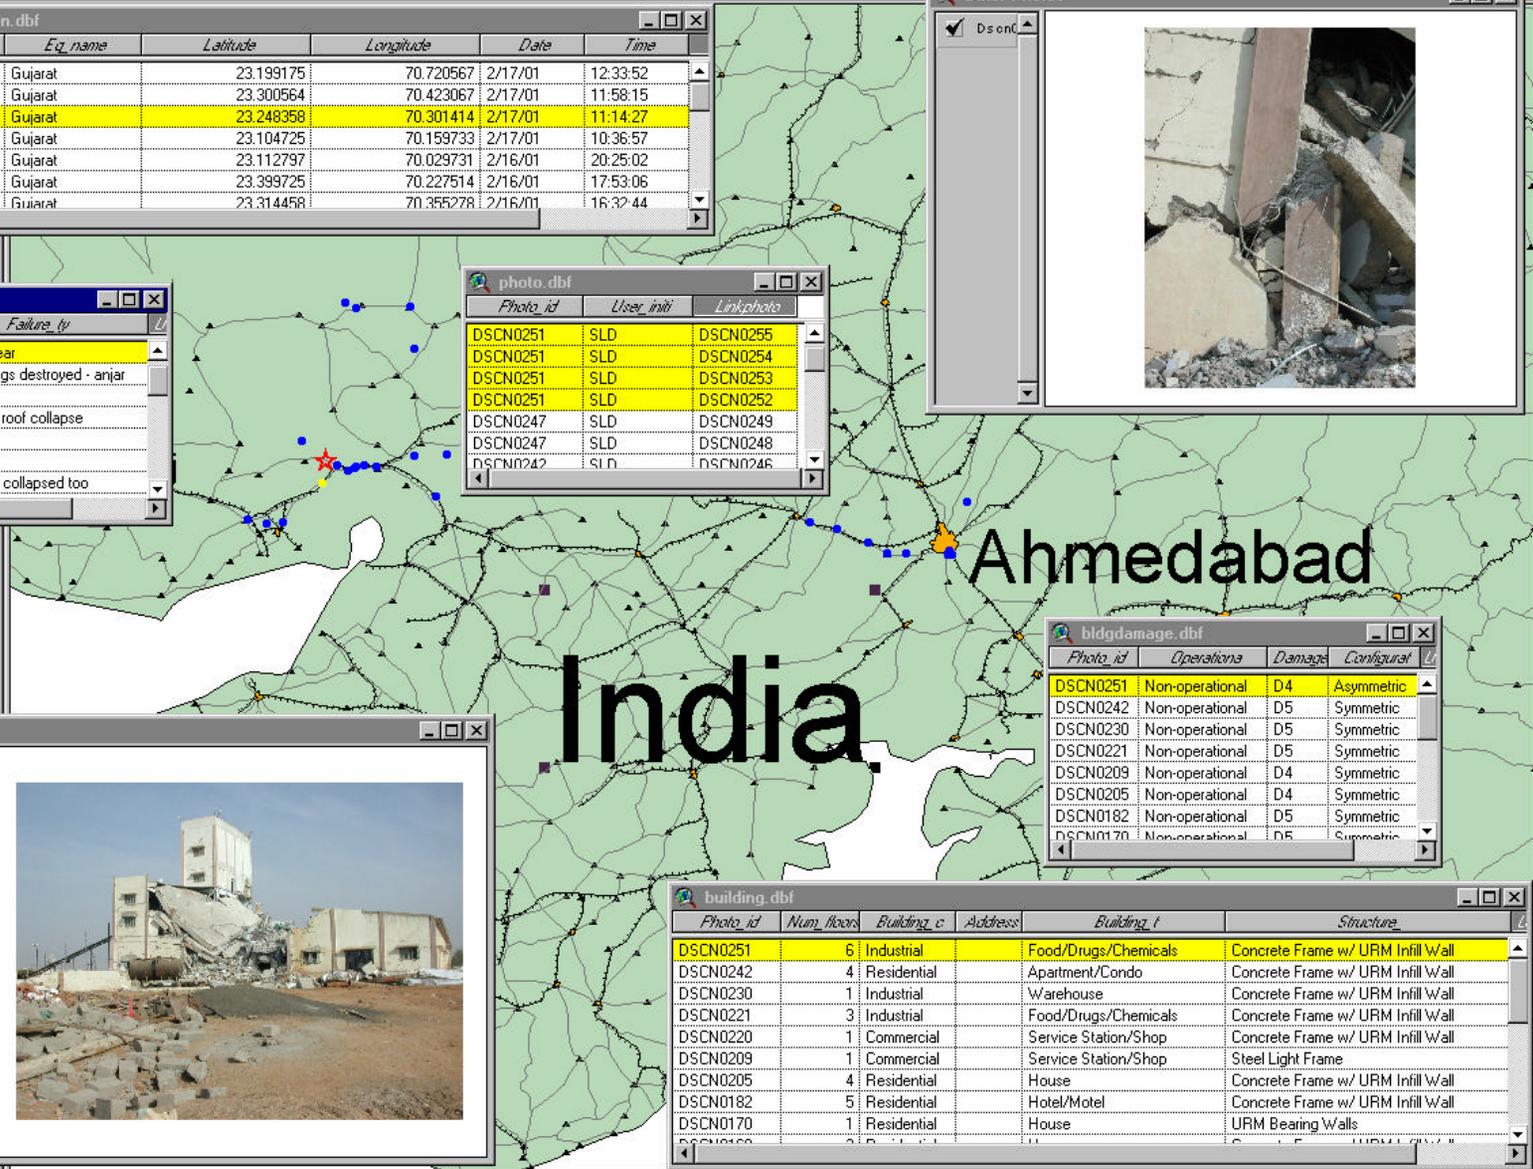
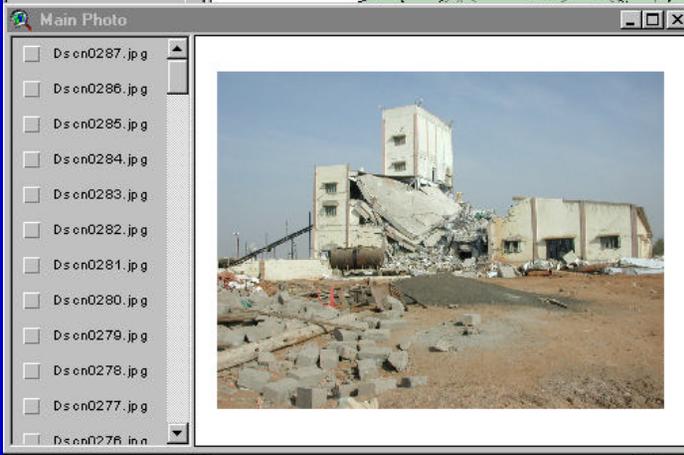
# PQuake™ Event Query

Photo_id	Failure_ty
DSCN0251	Column shear
DSCN0242	95% buildings destroyed - anjar
DSCN0242	Wall shear
DSCN0230	wall tilting - roof collapse
DSCN0230	Wall shear
DSCN0221	Wall shear
DSCN0221	warehouse collapsed too

Photo_id	Operational	Damage	Configurat
DSCN0251	Non-operational	D4	Asymmetric
DSCN0242	Non-operational	D5	Symmetric
DSCN0230	Non-operational	D5	Symmetric
DSCN0221	Non-operational	D5	Symmetric
DSCN0209	Non-operational	D4	Symmetric
DSCN0205	Non-operational	D4	Symmetric
DSCN0182	Non-operational	D5	Symmetric
DSCN0170	Non-operational	D5	Symmetric

Photo_id	Num_floors	Building_c	Address	Building_t	Structure
DSCN0251	6	Industrial	Food/Drugs/Chemicals	Concrete Frame w/ URM Infill Wall	
DSCN0242	4	Residential	Apartment/Condo	Concrete Frame w/ URM Infill Wall	
DSCN0230	1	Industrial	Warehouse	Concrete Frame w/ URM Infill Wall	
DSCN0221	3	Industrial	Food/Drugs/Chemicals	Concrete Frame w/ URM Infill Wall	
DSCN0220	1	Commercial	Service Station/Shop	Concrete Frame w/ URM Infill Wall	
DSCN0209	1	Commercial	Service Station/Shop	Steel Light Frame	
DSCN0205	4	Residential	House	Concrete Frame w/ URM Infill Wall	
DSCN0182	5	Residential	Hotel/Motel	Concrete Frame w/ URM Infill Wall	
DSCN0170	1	Residential	House	URM Bearing Walls

- Rapidly assimilate data from multiple users
- Query data based on information type
  - e.g. Select all 5 story buildings that collapsed from soft story failure
  - e.g. Show location of all sand blow features
- Query individual features
- Create comprehensive maps of damage sites
- Real-time reconnaissance planning
- Integrated transfer of data to "home base"

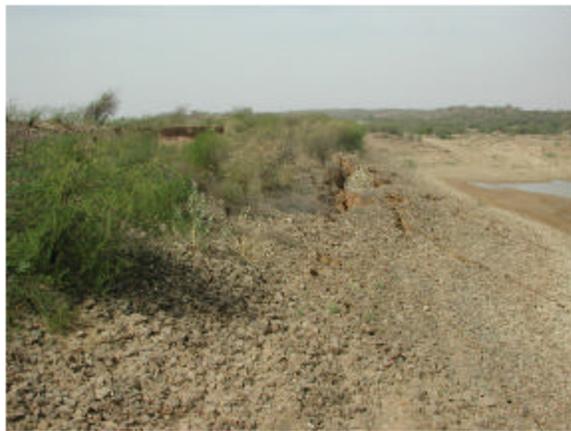
# PQuake™ Feature Query

The screenshot displays the ArcView GIS 3.2a interface. The main map window shows a map of India with a focus on the Great Rann of Kachchh (Desert) and Little Rann of Kachchh (Desert) regions. A red star indicates an earthquake epicenter. A yellow arrow labeled "Click" points to a specific feature on the map. The feature query window is open, showing the following information:

ID	Discn0192	User ID	SLD	Earthquake Name	Gujarat		
E	23.4129	Longitude	70.6406	Date	9/9/2001	Time	16:32:32

Type	Geotechnical Structure	Dam Type	Gravity	Material	Earth
Location	Dam	Height	50	Length	200
Width	3	Upstream Slope		Downstream Slope

Upstream	Failure Type	Slope Stability	Length	100	Width	30	Inclination		Scarp Height	3
----------	--------------	-----------------	--------	-----	-------	----	-------------	--	--------------	---
