**Authors:** Youssef M.A. Hashash (UIUC), Binod Tiwari (CSF), Robb E. S. Moss (CalPoly), Domniki Asimaki (Caltech), Kevin B. Clahan (LCI), D. Scott Kieffer (TUGraz), Doug S. Dreger (UCB), Amy Macdonald (TT), Chris M. Madugo (PG&E), H. Benjamin Mason (OSU), Menzer Pehlivan (MRCE), Deepak Rayamajhi (OSU), Indra Acharya (TU) and Basanta Adhikari (TU).

## Executive Summary

The April 25, 2015 Gorkha (Nepal) Earthquake and its related aftershocks had a devastating impact on Nepal. The earthquake sequence resulted in nearly 9,000 deaths, tens of thousands of injuries, and has left hundreds of thousands of inhabitants homeless. With economic losses estimated at several billion US dollars, the financial impact to Nepal is severe and the rebuilding phase will likely span many years.

The Geotechnical Extreme Events Reconnaissance (GEER) Association assembled a reconnaissance team under the leadership of D. Scott Kieffer, Binod Tiwari and Youssef M.A. Hashash to evaluate geotechnical impacts of the April 25, 2015 Gorkha Earthquake and its related aftershocks. The focus of the reconnaissance was on time-sensitive (perishable) data, and the GEER team included a large group of experts in the a

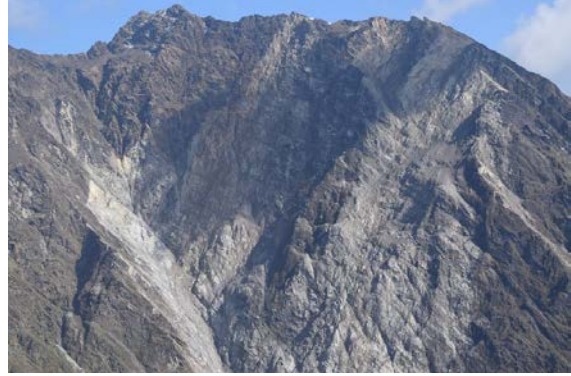
Sunkoshi River are locally highly fractured (Figure 5-40 through Figure 5-44) and may potentially experience additional significant activity during the monsoon season. Some of these landslide deposits contain large boulders (Figure 5-45 and Figure 5-46) can potentially be destabilized during the monsoon season or future seismic events.

Figure 5-45 Potential large debris flow source during rainy season.

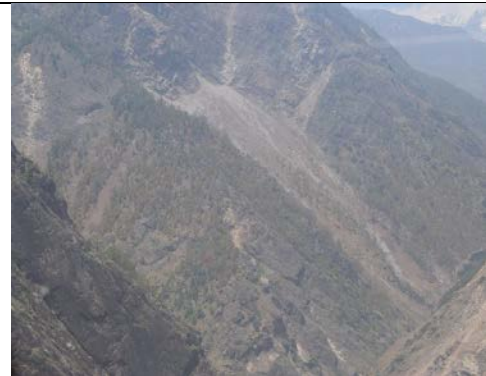
Figure 5-64 Large landslide along the Trishuli River.

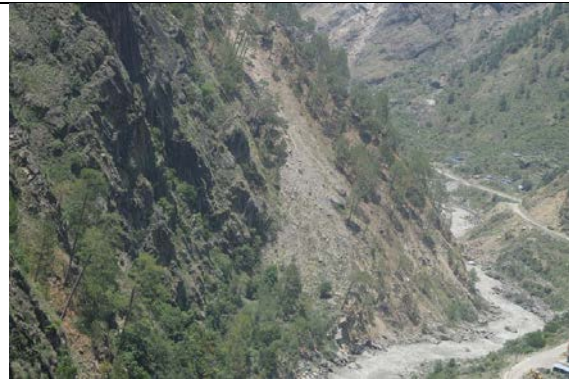
Figure 5-66 Landslide debris adjacent to the Trishuli River.

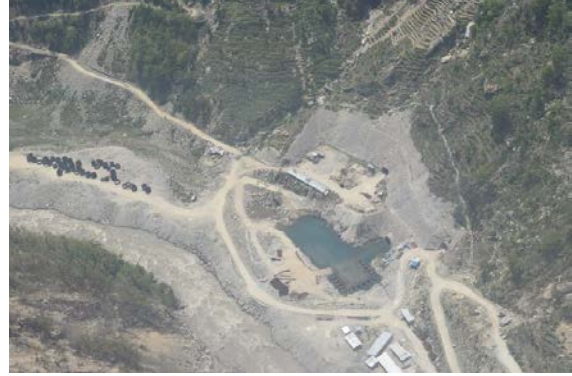
Figure 5-74 Landslides damaging the desilting basin area of a hydropower project.

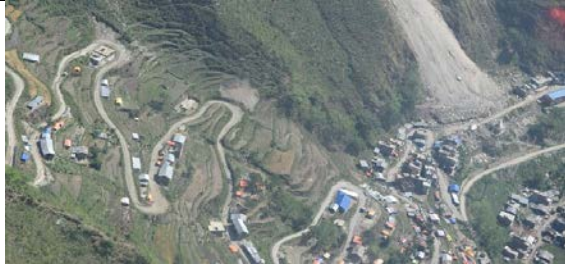
Figure 5-79 Access road sector of a hydropower project affected by an earthquake induced landslide.

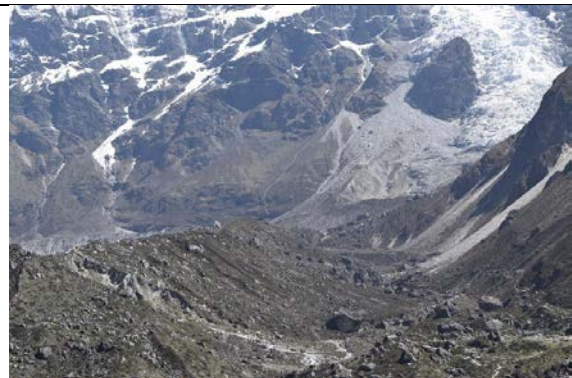
Figure 5-86 Typical loose debris observed along a slope in the Langtang Valley.

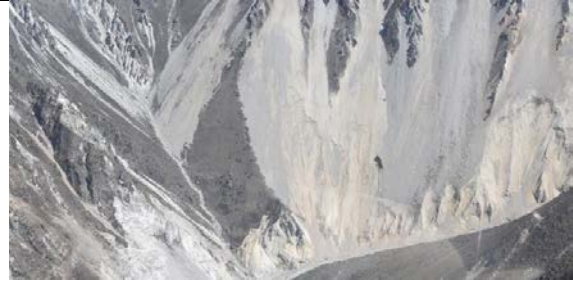
Figure 5-90 Langtang River blocked at multiple locations (28°12.5'0"N 85°35.1'0"E).

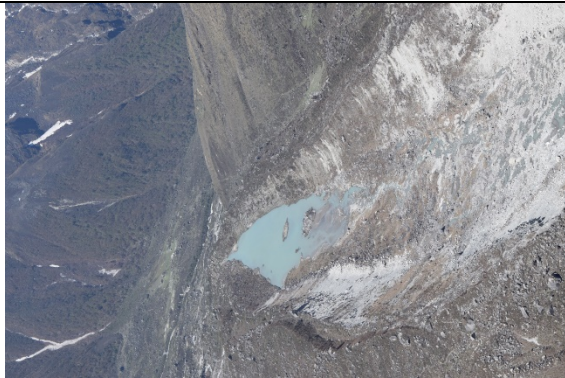
Figure 5-91 Ground fissure observed at the edge of a glacier lake above Kyamgjon Kharka.

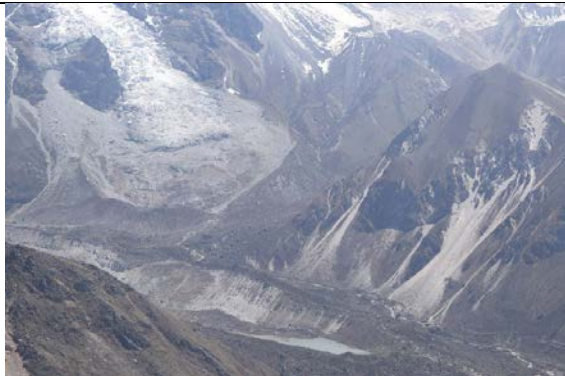
Figure 5-93 Loose sediments observed along mountain slopes.

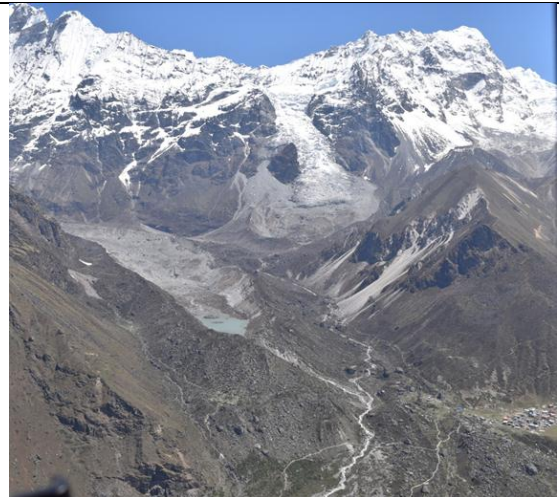
Figure 5-94 Loose sediments observed near the glacier lake.

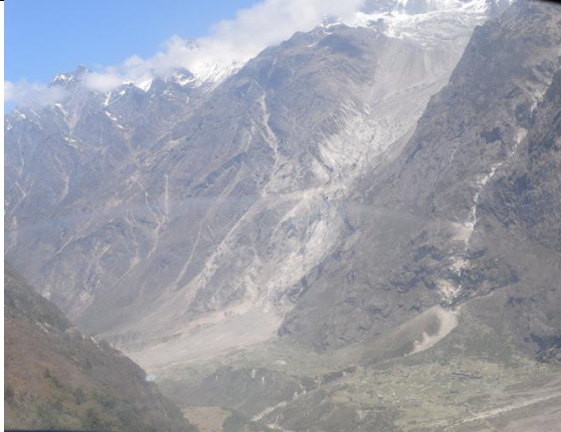
Figure 5-97 Aerial view of the debris avalanche (28°12.7'0"N 85°34.1'0"E).

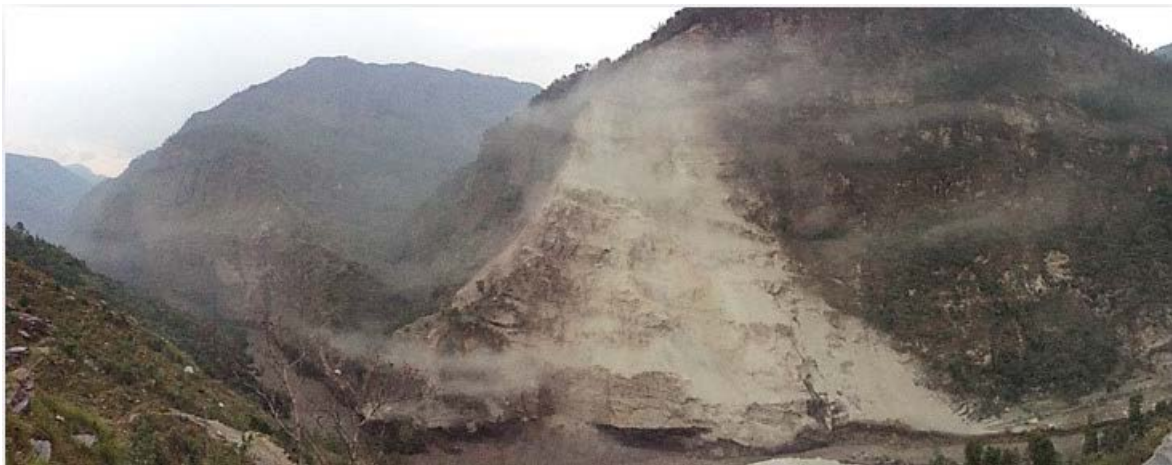
Figure 5-121 Kali Gandaki Landslide

A significant landslide occurred in the early morning of May 24, 2015 on Kali Gandaki River in the Myagdi District, which is located to the northwest of Kathmandu. The Kali Gandaki landslide is a dry, raveling-type landslide that was presumably weakened by the April 25 main shock and subsequent aftershocks. The landslide buried a village with 25 houses but did not cause any human casualties, as the area had already been evacuated before the landslide. Rock's toppling in the day before the landslide and observations of surface cracks at the top of the slope after the April 25, 2015  $M_w$ 7.8 main shock and subsequent aftershocks provided sufficient warning to evacuate the village below the landslide.. The massive landslide blocked the Kali Gandaki River forming an artificial earth dam. The water level rose rapidly behind the landslide dam and formed lake upstream of the dam. According to local reports, the lake extended approximately 1 to 3 km upstream within 12 hours of the landslide dam formation.

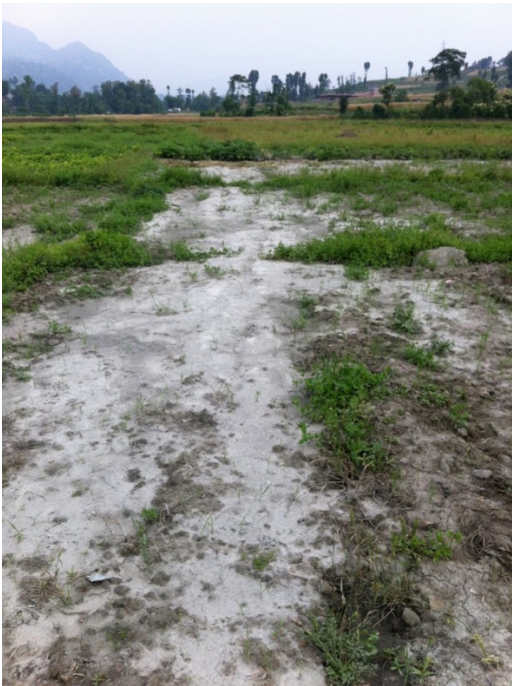
Sand boils occurred on the floodplain about 200 m from the Bagmati River (Figure 6-23). The ground water table was measured at about 1.3 m. We hand augered to get the stratigraphy along a 23 m long transect. The stratigraphy was relatively consistent: 0.5 m of micaceous brown silty clay topsoil, followed by Black Cotton Clay to about 1.5 m, followed by fine sand that coarsened with depth. It is likely that this saturated sand layer liquefied, but of course we are unable to determine what is present at greater depths. The local residents told us that water ejected from the ground surface approximately 1 m in height for 30 minutes after strong shaking had ceased, and that the flooding lasted 2 to 3 days. In addition, residents mentioned that nearby agricultural fields along the Bagmati River had also shown surficial signs of liquefaction after the April 25 earthquake. The land owner mentioned that the Nepal Government plans to build a super highway through this site within the next 25 years.

Figure 6-23. Sand boils in Bungamati (photo courtesy of Dewakur Khadka, 27.62863 N, 85.29665 E).

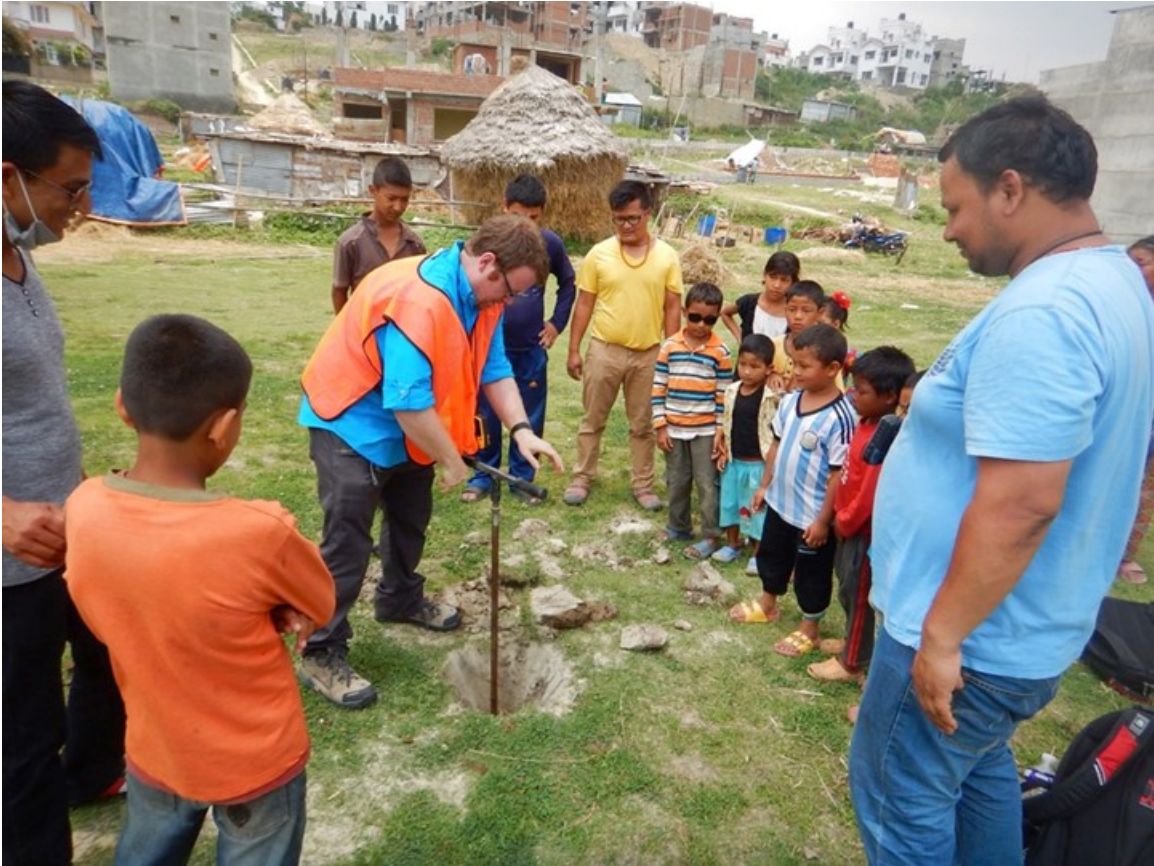
Numerous sand boils were observed at the Hattiban site. Unlike other liquefaction sites that the GEER team visited, this site was not a borrow pit for sand. We performed an auger (Figure 6-27). At the auger location, about 25 mm of fine sand ejecta was on the surface. Below the ejecta, we found that the site was characterized by a low plasticity silt or silty clay in the top 1.9 m. Dykes of fine sand were found in the auger samples from approximately 0.9 to 1.6 m. Below the silt and silty clay layers was a 0.5 m thick layer of black cotton clay. Below the black cotton layer was a fine sand layer, and the groundwater table was found at 2.5 m below the ground surface.

Figure 6-27. Hand augering a sand boil in Hattiban, 85.33441 N, 27.65567 E.

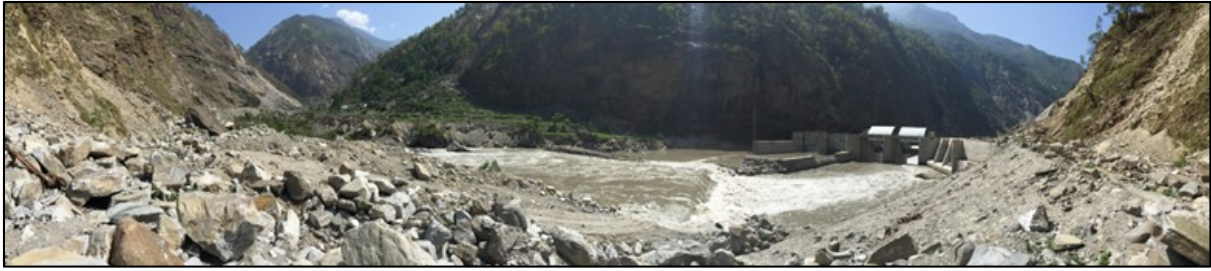
Figure 7-8 View downstream of the Upper Trishuli 3A headworks. Two of the gates are open, two closed. Due to damage to equipment and lack of vehicle access to the site, the remaining two gates cannot be opened before monsoon, which will likely lead to additional damage to the site. Flooding is also expected at the workers colony downstream (28°3'52.35" N, 85°12'20.86" E).

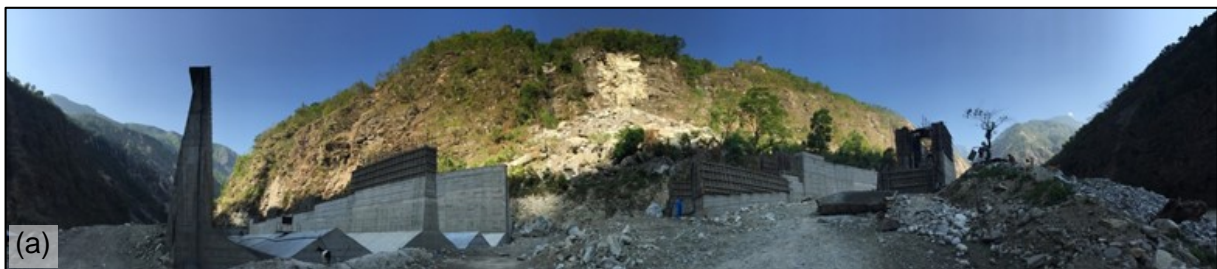
The Upper Trishuli area exhibited the most extensive rockfalls of any of the hydro projects that we visited. Rockfalls occurred primarily on the southeast side of the river, and were typically sourced where steep canyon walls met lower gradient slopes high above the site. The largest rockfalls occurred in areas of hard granitic augen gneiss, with large resistant blocks, typically several meters in diameter mantling the lower slopes of the canyon in the order of 10 to 100s of meters above the river. Although not as extensive as to the southwest, localized rockfalls also blocked access roads in the headworks areas (Figure 7-7). Infrastructure in the headworks area sustained minimal damage, with the diversion dam, sand catcher and canal structures mostly unaffected (Figure 7-8). Rock impacts to the sand catcher, for example, produced small (<1 m diameter, < 0.25 m deep) impact craters in the outermost concrete (Figure 7-9).

Figure 7-9 Sand trap under construction downstream of the headworks diversion dam were impacted by rockfall from above. Damaged observed was not consequential. (a) 28°3'41.77" N, 85°12'24.74" E, (b) 28°3'40.03" N, 85°12'23.69" E

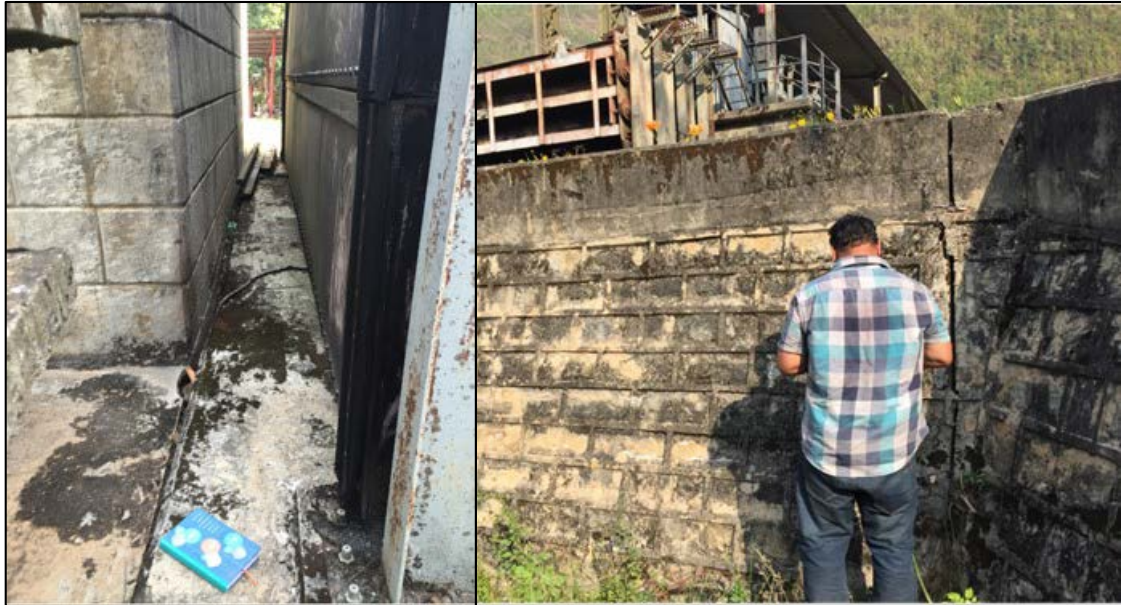
At the headworks, a concrete diversion dam extends from the right bank to the mid-point of the river. The dam control room and a gate rack sit on a fill pad adjacent to the right dam abutment. Although the team did not observe significant cracks or other damage to the dam, slight settling of the fill pad during the earthquake produced several centimeters of gap between the concrete pad beneath the gate rack and the dam abutment (Figure 7-11). Movement of the fill also produced a crack in a retaining wall at the edge of the fill. Shaking from the earthquake produced localized cracking in the walls of the dam control room focused around the support columns (Figure 7-12).

Figure 7-11 Minor damage observed from settling of fill platform adjacent to right abutment of Trishuli diversion dam. (a) foundation of the gate rack structure built on the fill pad (27°57'48.01" N, 85°10'12.52" E) and (b) Several centimeters of dilational cracking between the dam abutment, showing cracking at the edge of a retaining wall at the edge of the fill pad and the gate rack in the background (27°57'47.96" N, 85°10'13.34" E)

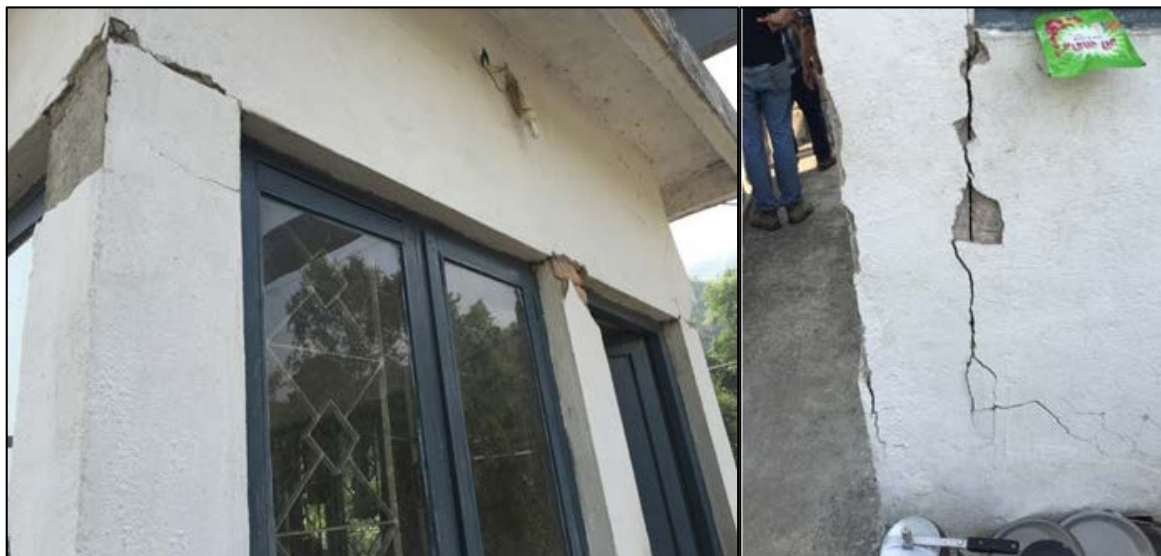
Figure 7-12 Shaking damage in walls of dam control room. (a) 27°57'48.55" N, 85°10'14.49" E, (b) 27°57'48.55" N, 85°10'14.49" E
