## Appendix C: Effects of Surface Fault Rupture on Infrastructure

Numbering of the Appendix C contents for individually mapped houses are denoted with an “H##” that represents the house reference number. The first figure for each house includes a site map (Figure C-H##-1); subsequent figures numbers are photographs associated with the house. As an example, the second photo for house no. 7 would be: “Figure C-H07-3.”

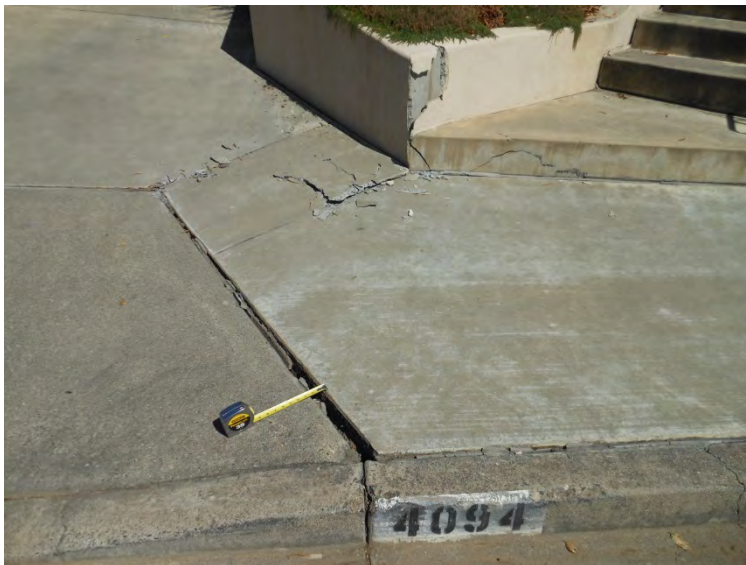
Figure C-H07-3: Crack extending along stair case and joint. [NSF-GEER; N 38.3122 W 122.3432; 08/28/14]

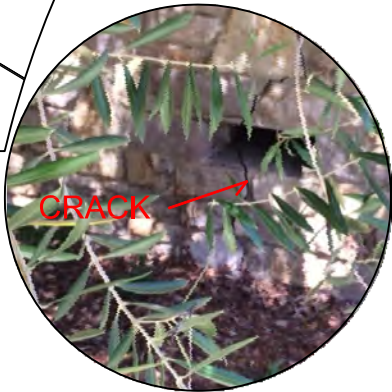
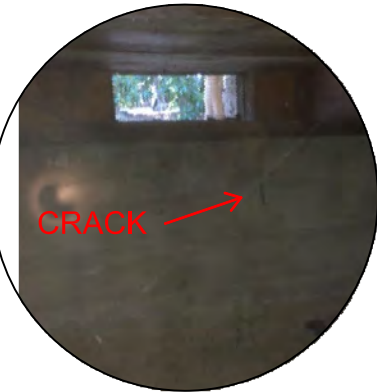
NOTE:  
 FOUNDATION CONSIST OF  
 A CONCRETE PERIMETER  
 WALL SUPPORTED ON  
 STRIP FOOTING AND  
 INDIVIDUAL FOOTING FOR  
 INTERIOR WOODEN  
 COLUMNS

DESCRIPTION: DAMAGE IN HOUSE	DATE OF INSPECTION: 08 / 29 / 2014	DATE OF DRAWING: 08 / 29 / 2014

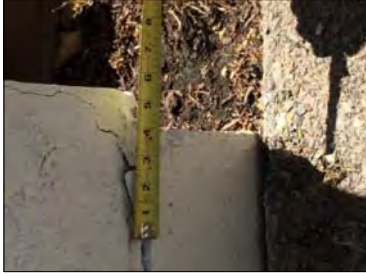
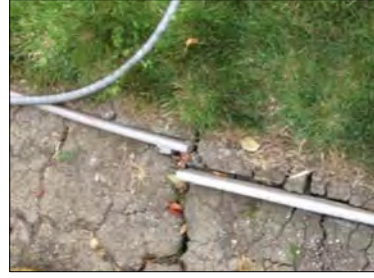
<b>EVENT:</b> AMERICAN CANYON EQ $M_w = 6.0$	<b>LOCATION:</b> LAT 38.3061° LON -122.3427°	<b>DRAWING BY:</b> ROBERTO LUQUE JUSTIN HOLLENBACK

<b>DESCRIPTION:</b> DAMAGE IN HOUSE	<b>DATE OF INSPECTION:</b> 08 / 29 / 2014	<b>DATE OF DRAWING:</b> 08 / 29 / 2014	<b>SCALE:</b> 1 cm : 2 m
